Television Service Tips

Volume XIX
Issue 1
March 15, 1968

Prepared and Distributed by RCA Sales Corporation, Product Performance
600 N. Sherman Drive, Indianapolis, Indiana 46201

"Safety"-Back Retaining Nut
Models—AJ 095, 153, 157—Chassis KCS 158

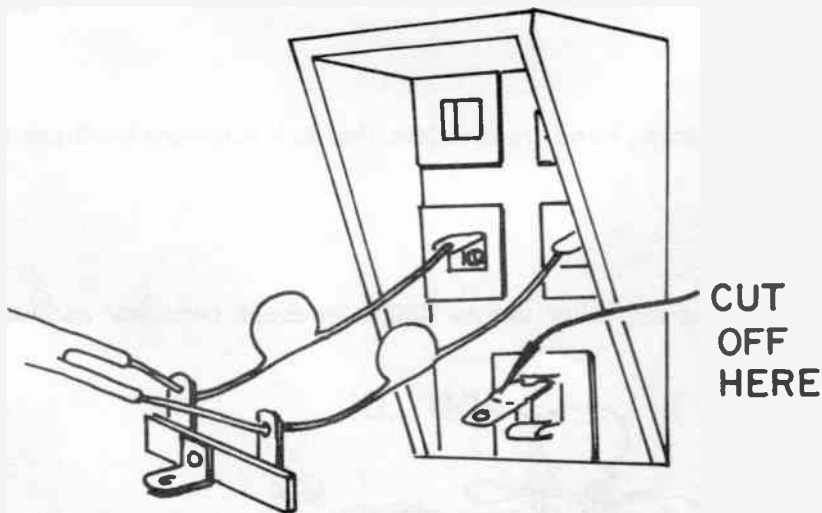
In instruments using the KCS 158 chassis, a metal screw is attached to a "tinnerman" nut on the antenna terminal board—used to help secure the rear cover. This "tinnerman" clip has a spade-type extension used in some instruments for antenna connections. However, in the KCS 158 instruments, the spade is **not** used.

Inasmuch as this spade is not used, it is recommended that when this chassis is serviced the spade be cut off. This would eliminate any possibility of a service man redressing the antenna capristor lead, and in doing so bring the lead in contact with the spade which would cause the rear mounting screw to become hot and create a possible shock hazard.

Manufacturing specification regarding the physical orientation of the capristor leads, with respect to the spade clip, provide sufficient clearance to avoid contact between the leads and the lug. However, a technician could exert some "extra" bending force to actually mis-dress and "short" the leads to the lug.

Please instruct service technicians in your area to **CUT OFF THE EXCESS LUG ANYTIME THE KCS 158 CHASSIS SERIES** is serviced, as illustrated below. The lead dress of the capristors should also be checked.

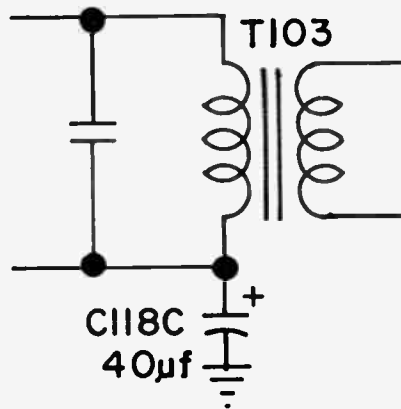
Some field reports indicate low or intermittent sound output may develop in the above listed chassis. Adjusting volume control up to "high" position **may** or **may not** cause normal operation to resume.

This condition may be caused by an intermittent open C206 (500 mfd. 15V) capacitor in the emitter circuit of the audio output transistor.

Some capacitors used in this circuit application have lead connections to the body of the capacitor which are "riveted." The open develops at the "rivet" connection causing low or intermittent sound. This capacitor should be **replaced, not repaired** and the replacement should be of a welded connection type. By ordering stock number 119608 you will get the correct capacitor.

In addition to above capacitor C118C across B+ to output transformer T103 should be examined for leakage or open condition. Replace with RCA stock number 119591 or equivalent.

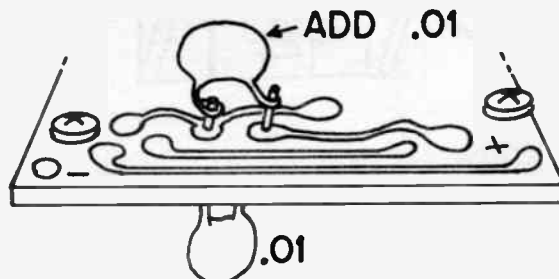
Intermittent operation may occur in these hand transmitters, due to insufficient feedback in the base circuit of the oscillator.

Add an additional .01µf ceramic capacitor across C2001 feedback capacitor as illustrated.

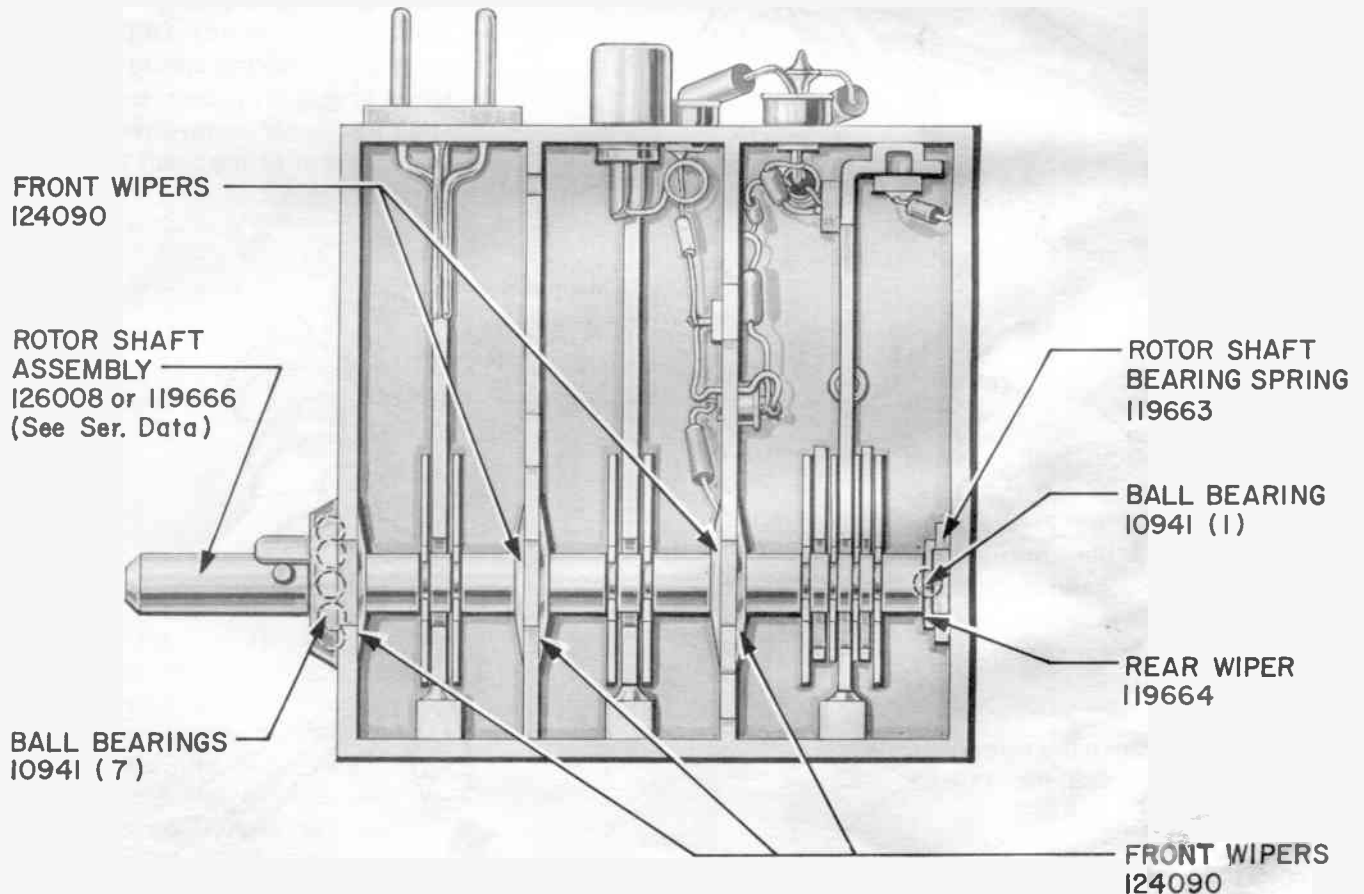
A noisy UHF tuner may indicate insufficient wiper tension on the rotor shaft. To correct this condition, the Rotor Bearing Spring and the Wipers should be replaced following the procedure outlined in this publication.

If the Rotor Shaft Assembly is to be replaced, the same procedure should be followed. In either case, discard and replace the wipers and the rotor bearing spring. The stock numbers for the wipers, rotor bearing spring, and associated parts are given in the illustration below.

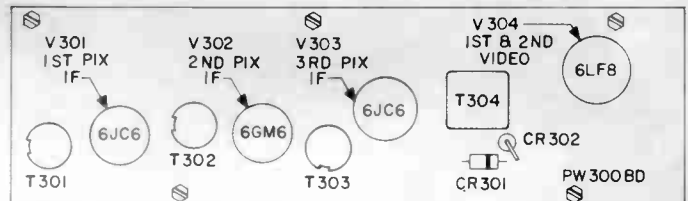
In the chassis layout of Service Data 1967 No. T16 and 1967 No. T18, the top view illustration on top of page 8 of both data, PW 300 Pix-Video board should be as shown in the illustration at the right.

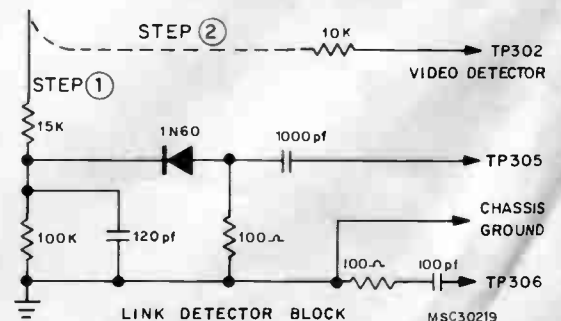
At the bottom of Page 22 of 1968 No. T2 and Page 8 of 1968 No. T20 the Link Detector Block should have a 100 ohm resistor and a 100 pf capacitor between TP306 and ground. The Link Detector Block should be as shown to the right.
