VOL. 25, NO. 1      SPRING, 1973

# Techni-talk

VOL. 25, No. 2

## VDR's (VOLTAGE DEPENDENT RESISTORS – VARISTORS) and TDR's (TEMPERATURE DEPENDENT RESISTORS – THERMISTORS)

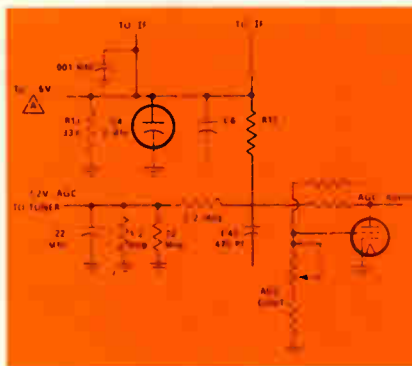
## EMERSON MODELS 13C12 to 19P21

Gradual darkening of the left side of the screen, which is similar to parasitic oscillation in the horizontal output circuit. This problem in these Emerson models were in the AGC circuit. The electrolytic capacitor C-4 (2 mfd) will usually be open.

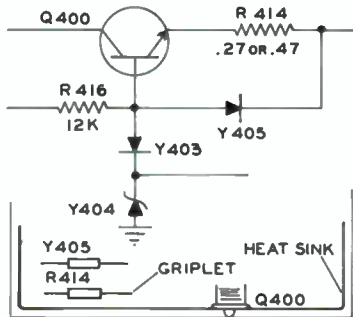
Beginning with receivers having serial numbers 5F40 and higher, the circuitry of the B+ regulator, Q400, has been changed to improve the regulation of the scan-rectified 22 volt supply. This voltage should vary ½ volt or less as the line voltage is changed from 112 to 128 volts. Failure to regulate properly could cause symptoms such as **low brightness, or overload with strong signal.**

The original Q400 circuit and physical layout is shown at the left below.

The circuitry and physical layout of the improved circuit is shown at the right. If you service a receiver which has poor regulation of the 22 volt scan-rectified supply or has a failure in the regulator circuit, we recommend that you modify it to incorporate the improved circuitry.

Remove Y405, R414, and the gripet. Replace R414 with a 2.2 ohm, ½ watt resistor. Replace Y405 with a Q402 Transistor (EP15X1). A Q402 and a 2.2 ohm, ½ watt resistor are supplied with replacement Q400 transistors (EP15X11).

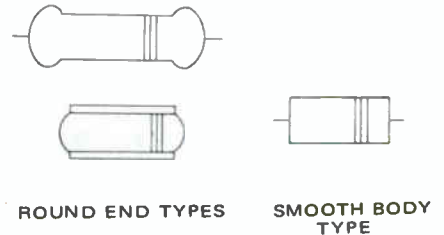
**Chroma Circuit** – One Predominate Color with Retrace Lines

This symptom could be due to a failure of one of the color output transistors, Q600, 604 or 606. If this is the case, inspect R624, 626 and 628 (6.8K, ½W) to see if they are the rounded end type as illustrated at the left. If they are, change them to the smooth body type as shown at the right. Stackpole or Allen-Bradley are preferred types in this application.
