# ACTUAL TROUBLES IN COMMERCIAL RADIO RECEIVERS

1927 — 1934

**BERTRAM M. FREED**

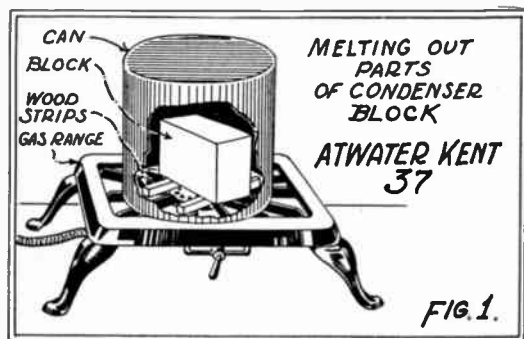
The most common cause for complaint with the Atwater Kent 37 probably is "shot" filter condensers. As these condensers are connected internally to the chokes in the power pack which consists of two sections, the power transformer block and the filter block, the problem of the best method of repair arises. At the time these sets were considered the "last word" in radio receivers, the cost of a new filter block was high, because only the original could

from the pack, it may be inverted upon two strips of wood in a can as shown in Figure I and heated in an oven or over a gas flame. The heat will soon melt the pitch used as a sealing compound, and if care is taken, the filter choke and output choke and small condensers may be saved as they fall out. After the can has been cleaned, all necessary parts are replaced, together with the salvaged parts, and melted paraffin or other insulating compound may be poured into the assembly to complete the job.

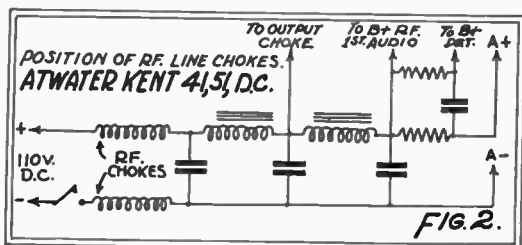
Should the condition be encountered, where the tubes, in this model, fail to light up, the first thought is a burnt-out tube because of the series filament circuit. Although this is usually the case, where it is found that the tubes have tested correctly and that the current supply is available at the receiver, the probability is, that one or both of the R. F. chokes in series with either side of the line has open-circuited. These chokes are wound on small composition bobbins and are located beneath the terminal strip in the power pack. They may be easily repaired by rewinding the bobbins with No. 22 cotton or enamelled wire. A diagram showing the connections may be seen in Figure 2.

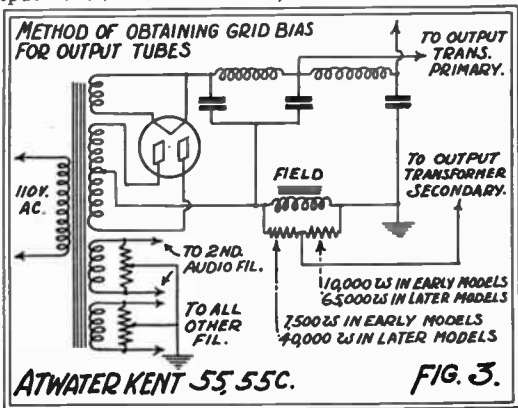
Should the condition of distorted reproduction be observed with the symptoms of unusually high grid bias, usually about twice its normal value, impressed upon the output tubes, the trouble may be traced to one of the

two resistors connected in series across the field coil, dividing the voltage drop across the field to obtain the proper grid bias for the output tubes as shown in Figure 3.

Most often the open resistor will be found to be that connected from the control grid bias tap to ground. In the early models, the value of this resistor was 10,000 ohms, while in the later model a 65,000 ohm unit is employed. This failure may be checked without removing the chassis from the cabinet by means of a point-to-point resistance test, but in order to accomplish this, it is necessary to remove the speaker plug or else an erroneous indication will be obtained.

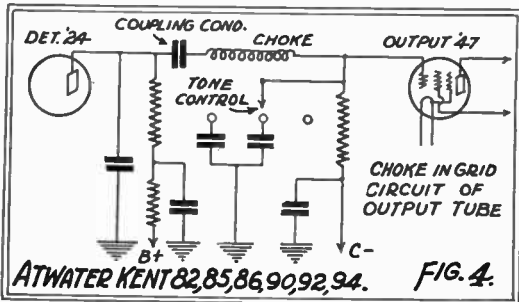
The complaint of low volume and poor tone and especially little response when the tone control is set at the

"bass" position, will be found to be caused by an open R.F. choke in the output pentode control grid circuit.

This failure will not be disclosed by the use of a set analyzer, as all voltages will be intact when this choke open-circuits resulting only in breaking the coupling between the plate of the second detector and the grid of the pentode tube as shown in Figure 4. In some cases, the open circuit in this choke will consist of a break in one of the leads which may easily be repaired as it emerges from the bobbin winding, although shorting out the choke entirely has produced no noticeable ill-effects. Where it is desired however, a new unit may be installed.

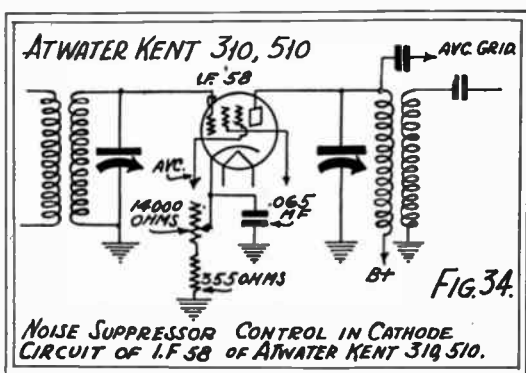
This receiver employs a noise suppressor control in the cathode circuit of the '58 intermediate frequency ampli-

fier as shown in Figure 34. The purpose of this control is that of reducing the sensitivity of the receiver so that a minimum of interference will be present when the dial is rotated from station to station. Where little or no effect is obtained, when this control is adjusted, the trouble

has been found to be caused by the variable resistance. The remedy is replacement.

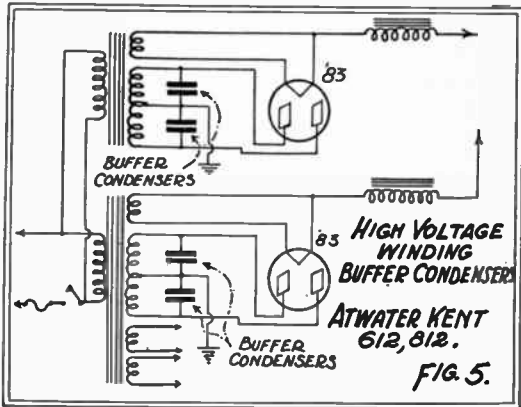
These models have the notorious reputation of "blowing" line fuses. Because of a pair of 83 mercury vapor rectifiers, small buffer condensers are connected across the high voltage windings to filter out noise caused by these rectifiers. These rectifiers break down or become leaky and short that portion of the high voltage winding across which it is connected, thus increasing the load upon the primary and causing the fuse to blow. As there are two power transformers, four buffer condensers are necessary.

They are connected as shown in Figure 5. All four condensers are contained in a single block located on the side wall of the chassis near the 83 sockets. Although the value specified is .07 mf., the capacity is not critical and .1 mf. condensers may be used to replace the leaky or short circuited section, providing its working voltage is over 400 volts.

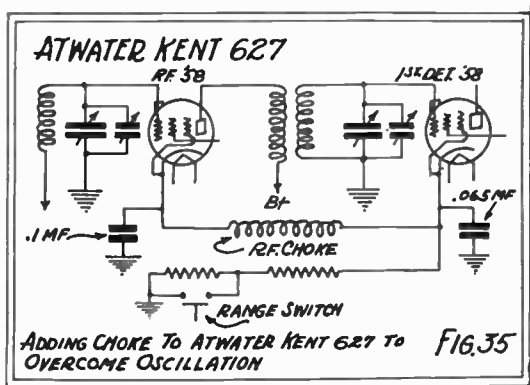
Where the symptoms of oscillation and erratic operation are encountered on this model, which are not caused by open-circuited condensers or incorrect alignment of the tuned circuits, the difficulty has been overcome by con-

necting a small R.F. 85 millihenry choke in the R.F. stage cathode circuit. In these receivers, a common bias resistor is employed for both the R.F. and I.F. 58 tubes.

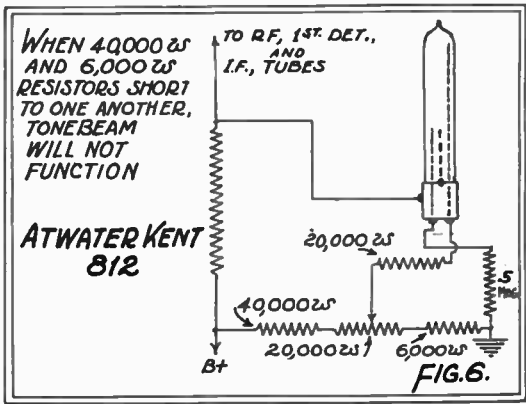
Frequently, the Tonebeam employed in this model is the cause of many complaints, the operation of the beam being very erratic with the light column slowly falling, disappearing and then suddenly climbing, to be repeated several times. This condition is caused by the shorting of the 40,000 and 6,000 ohm carbon resistors in the Tonebeam voltage divider circuit. The two resistors, together with a third resistor which is in the 2nd detector cathode circuit are mounted in an insulating paper container and separated by small wads of pitch. Vibration causes the two resistors in question, due to the fact that the Wood's metal ends are pointed, to work their way

through the pitch and short to one another. The shorting of these two resistors, as shown in Figure 6, shorts the Tonebeam potentiometer out of circuit, disturbing the

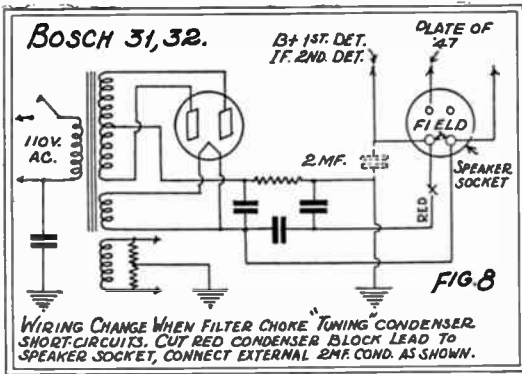
On some occasions, the symptoms of very low reception will be observed with the additional circumstance of no voltage drop across the speaker field coil. If the speaker plug is removed and the field coil is measured, its resistance will be found correct, but if the ohmmeter is connected across the field terminals of the speaker plug socket, a direct short will be indicated. This is due to a short-circuited bypass condenser used to "tune" the field coil. Replacement of this condenser presents its

own problem, for it is located within the filter condenser block and connected internally. However, it is not necessary to replace the entire filter block, which is sometimes

done, to effect a repair, if the procedure outlined in Figure 8 is closely followed.

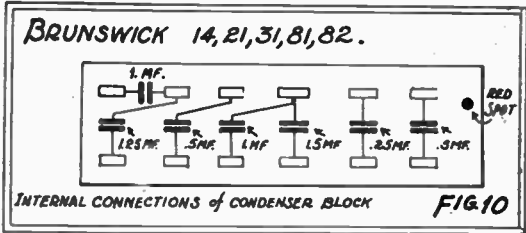
When the condition of hum is encountered on these models, look for one or more open-circuited condensers in the proper pack. This failure is easily checked by shunting each filter condenser with a 2 mf. unit. Because of the fact that a common terminal is not used, the

lug arrangement of the filter block is often confusing. Figure 10 shows the internal connections of the block.

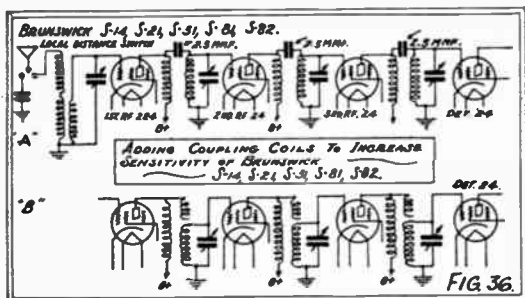
Noisy reception on these models is a complaint fre-

quently due to bad contacts on the local-distance switch. The contact points should be carefully cleaned and the springs bent slightly to secure increased tension. The two screws holding the switch assembly together should be tightened after this is done.

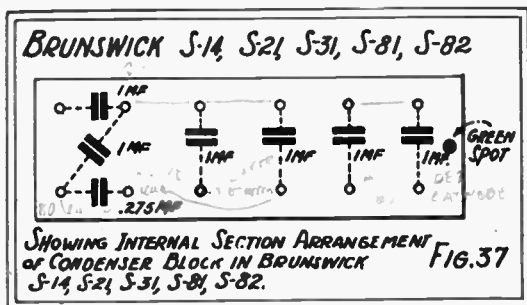
A frequent failure with these models lies in an open-circuited section of the condenser block in the power pack. An open-circuited section will produce the symptoms of hum, and oscillation in some instances. The open-circuited section is most easily checked by shunting each section of the condenser block with a one or two mf. unit, in turn. Similar to the filter block employed with the models 14, 21, 31, 81 and 82, a single common

terminal is not employed, thus making the arrangement of the terminal lugs confusing. The internal connections and the various capacities of the sections are shown at Figure 37.

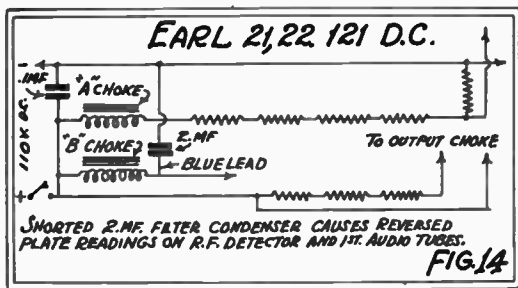
of the 2 mf. filter condenser connected from the negative side of the line supply to the receiver side of the "B" filter choke. This condenser is identified by the blue lead emerging from the condenser block. An explanation for this reversed polarity obtained on the R.F., detector and first audio tubes, lies in the fact that the high voltage impressed on the output tubes is not filtered by the choke, but is obtained directly from the positive side of the line as shown in Figure 14.

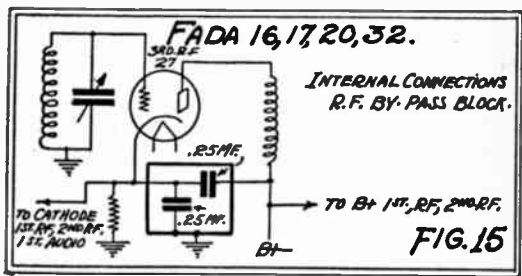
A sharp drop in volume accompanied by oscillation, has been traced on many occasions to an open-circuiting cathode or plate by-pass condenser. Both these .25 mf.

condensers are contained in a single unit, the plate by-pass return being connected to the cathode internally as shown in Figure 15.

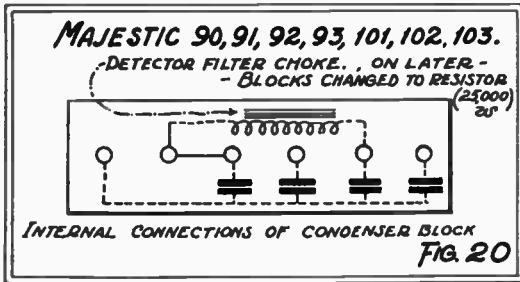
Weak reception, if any at all, with the attendant circumstance of low plate voltages on all tubes, is often due to a leaky or short-circuited detector plate voltage supply filter condenser in the condenser block. Although a new condenser or block may be installed, a repair may be easily accomplished without any disturbance in voltage distribution or increase in hum level by disconnecting and taping the lead to the top terminal lug of the condenser block and connecting this lug to the second lug, after removing the jumper between the second and third terminal lugs. If no detector plate voltage is obtained and the detector plate voltage supply filter condenser checks satisfactorily, look for an open-circuited 2000 ohm choke in the condenser block, connected between the second and fifth lugs. The later production power units employed a

condenser block with a resistor of approximately 25,000 ohms, in place of the choke, connected between the same lugs. The internal connections of this block is shown in Figure 20.

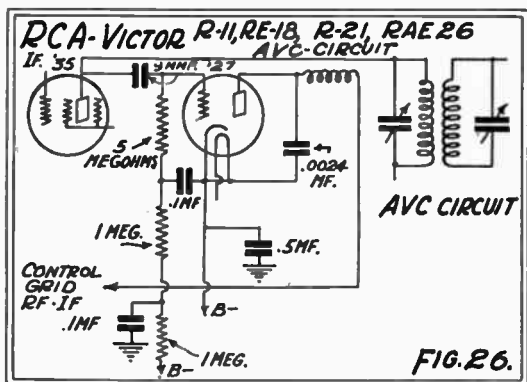
Where the symptoms of low volume and poor sensitivity are encountered, check the two .1 mf. condensers bypassing the grid return of the A.V.C. tube, as shown in Figure 26, for high resistance leakage. A high range ohmmeter will be necessary to test these condensers. If the volume increases when the A.V.C. tube is withdrawn, it is a fairly good sign of faulty condensers.

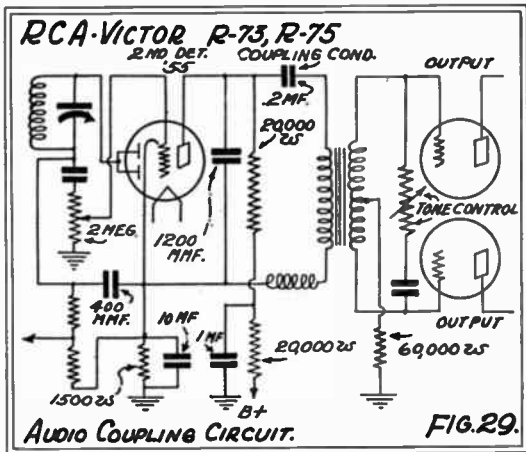
Where the complaint of weak and distorted reception is received, and the usual loud hum cannot be obtained by placing a finger upon the control grid of the 55 tube with the cap connection removed, check for an open-circuited .2 mf. audio coupling condenser. This unit is located beneath the resistor terminal strip and is connected in the circuit as shown in Figure 29.
