TELEVISION SERVICE TIPS

SERVICE DATA - Chassis CTC16X 1965 No. T6

The PW700 Solid Copper Circuit Component Assembly Board on page 34, 1965 No. T6, shows a seven pin tube instead of a nine pin tube for V702. The correct phantom view of PW700 is shown below.

SERVICE HINTS AND PARTS AVAILABILITY FOR CTP 10F, G REMOTE CONTROL MOTOR

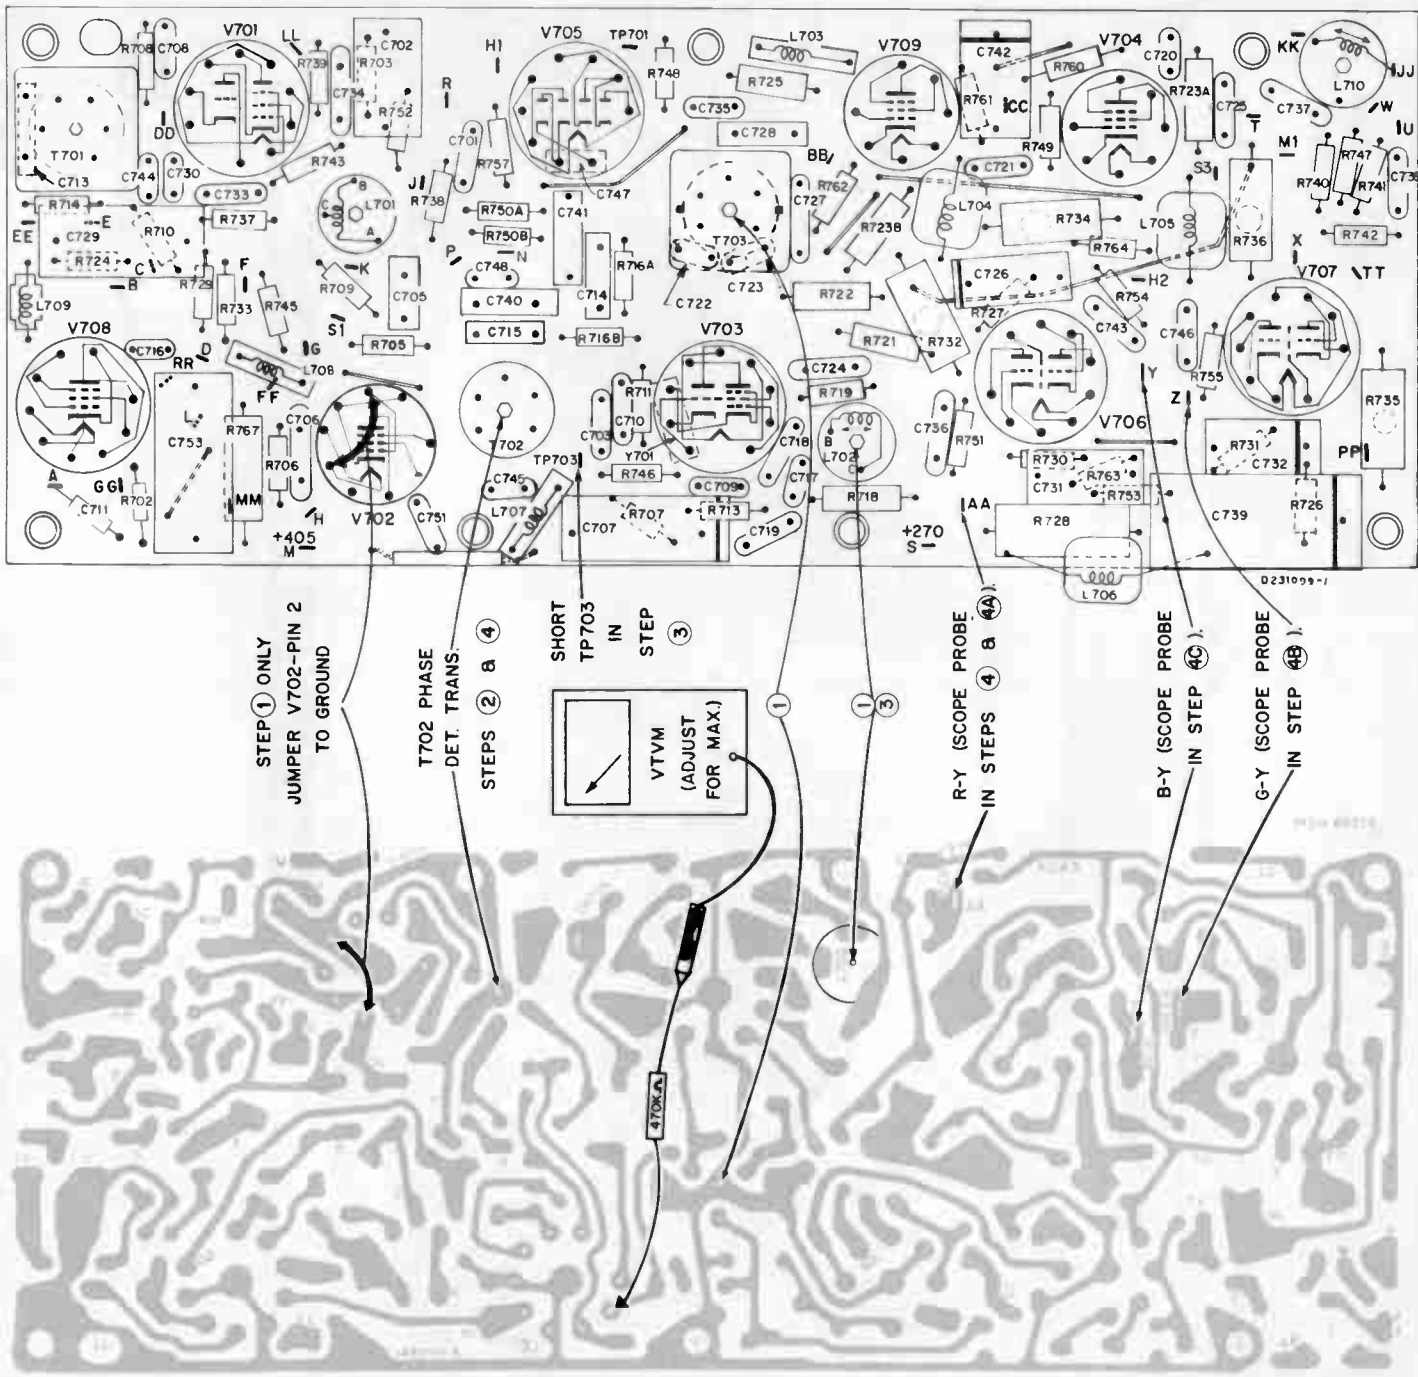
COLOR AFPC ALIGNMENT
(SHOP PROCEDURE)

The shop procedure for color AFPC Alignment on page 23 should also have a 9 pin tube as V702. In Step ① pin 2 should be grounded. The corrected drawing is shown on the back of this page.

In the alignment chart on page 22, the instruction in Step 1 pin 2 of V702 should be grounded as shown below.

STEP ① ONLY
JUMPER V702-PIN 2
TO GROUND

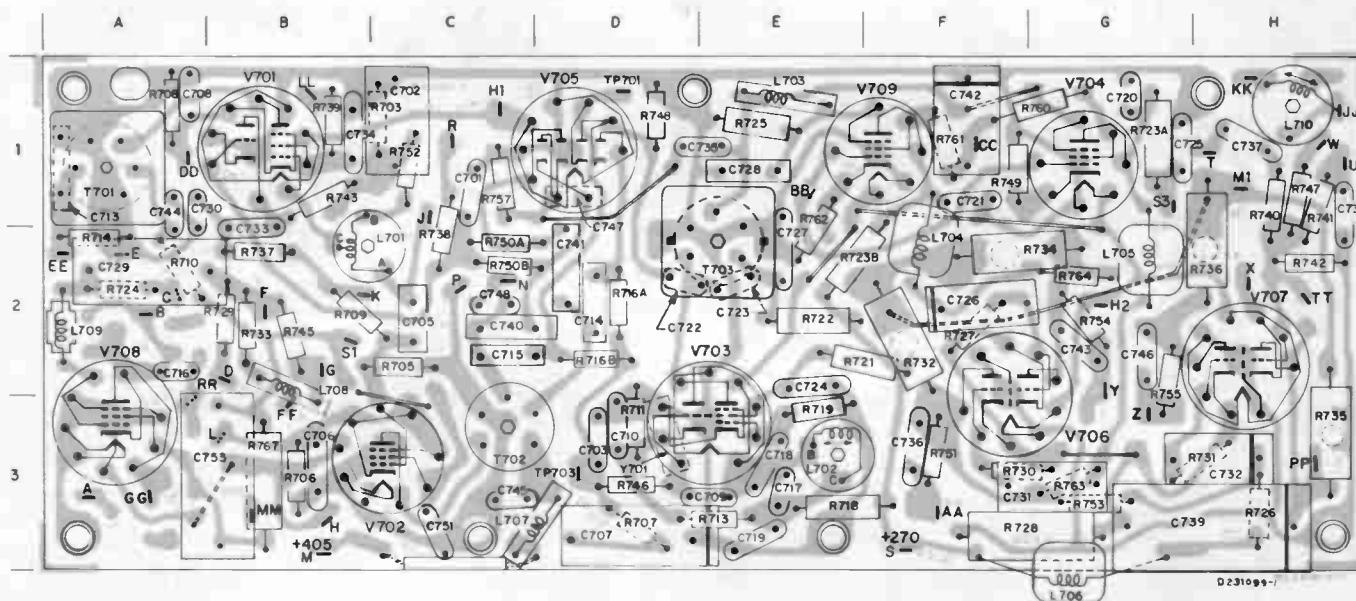
PW700 Solid Copper Circuit Assembly for Chassis CTC17X (Chroma)

The PW700 Solid Copper Circuit Component Assembly on page 34, 1965 No. T12, shows a seven pin tube instead of a nine pin tube for V702. The correct phantom view of PW700 is shown below.

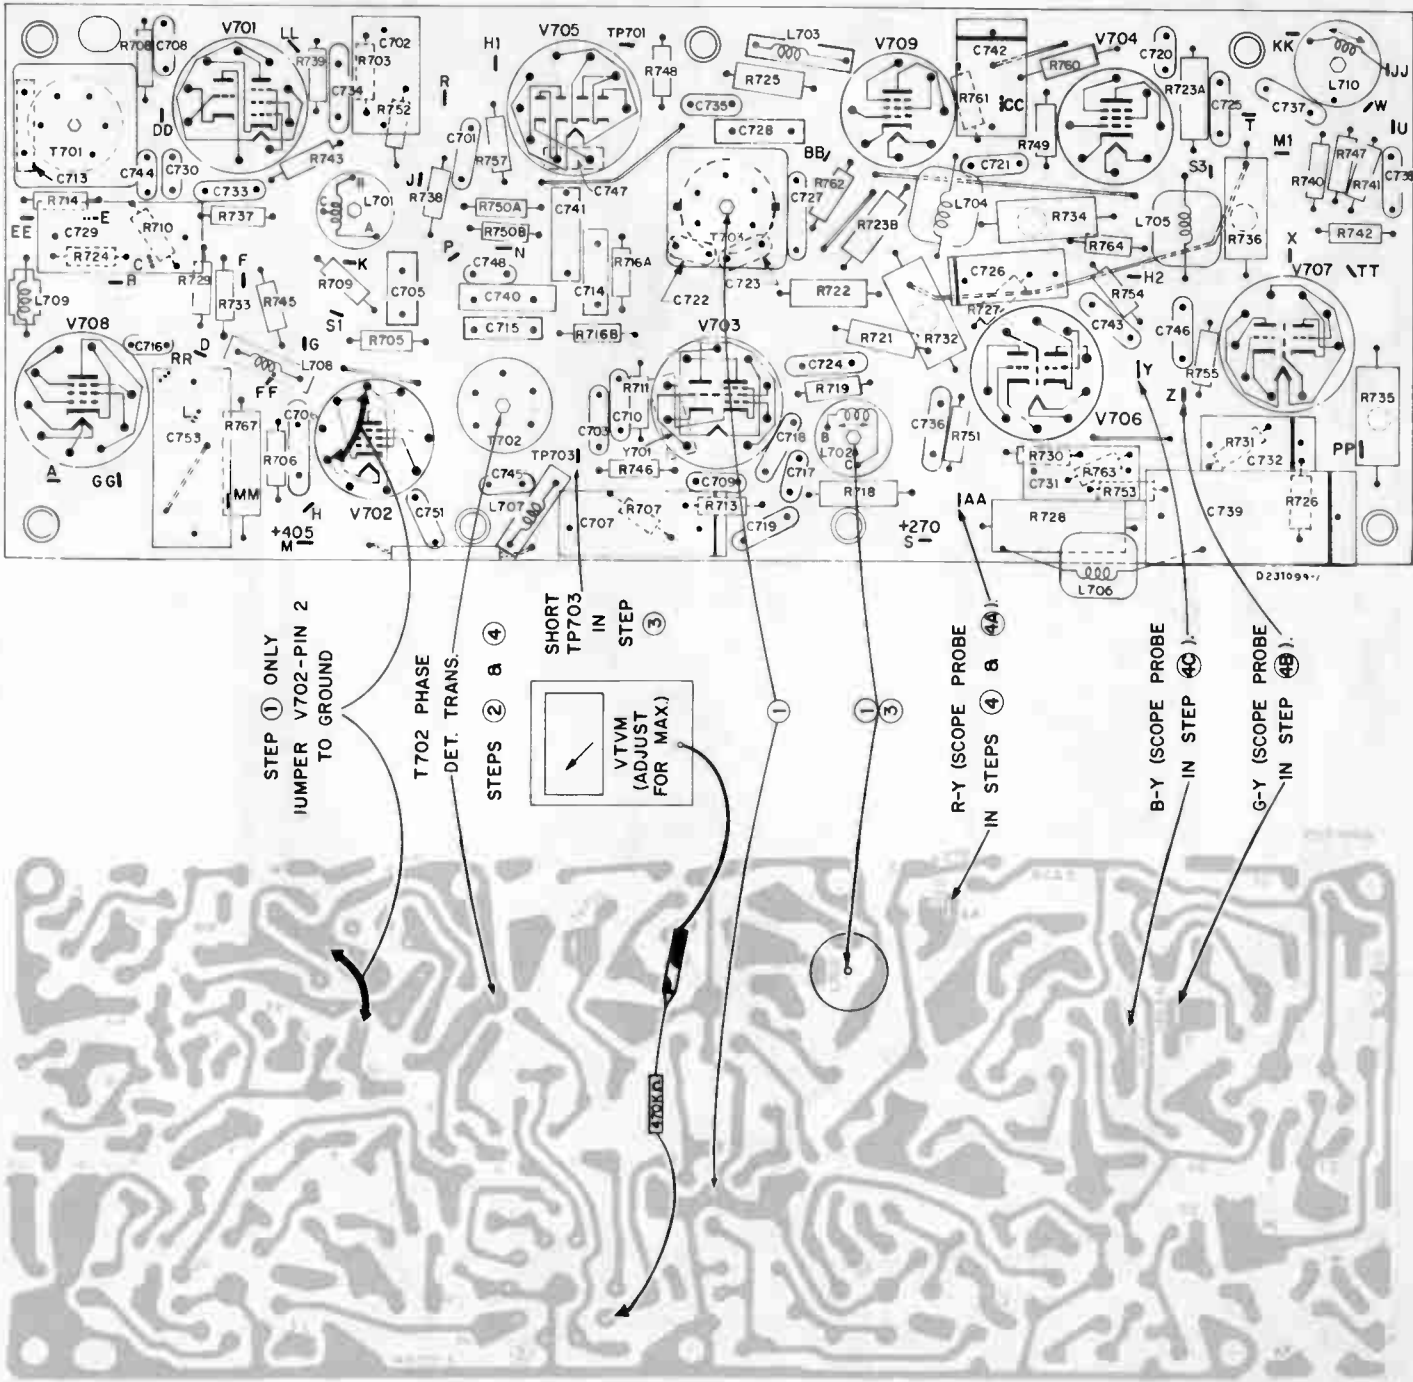
COLOR AFC ALIGNMENT
(SHOP PROCEDURE)

The shop procedure for color AFPC Alignment on page 23 should also have a 9 pin tube as V702. In Step ① pin 2 should be grounded. The corrected drawing is shown on the back of this page.

In the alignment chart on page 22, the instruction in Step 1 pin 2 of V702 should be grounded as shown below.

STEP ① ONLY
JUMPER V702-PIN 2
TO GROUND

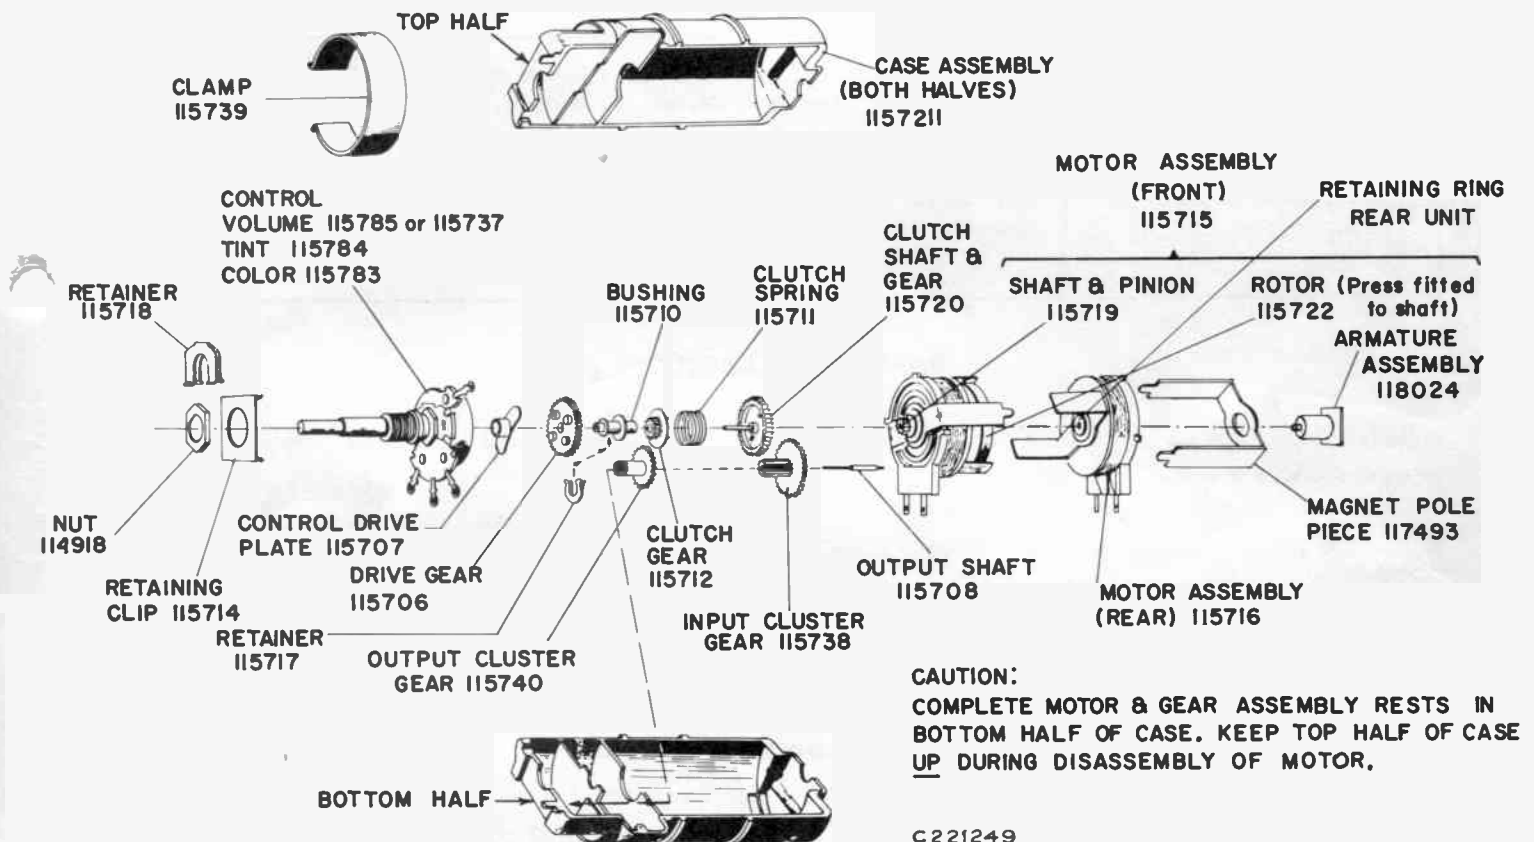
An identical type motor is used for volume, color, and tint functions in color chassis CTC 16X and 17X, although the potentiometer is different. This Tip includes Special Notes, Parts Availability, and a Service Chart for the motor. An exploded view of the motor identifies the individual parts.

SYMPTOM	MOST LIKELY CAUSE	CHECKS AND/OR CURES
Noisy Motor <i>(buzzing sound)</i>	Large rear pole piece bent or distorted.	Straighten or replace rear pole piece.
	Large rear pole piece improperly seated.	Check rear pole piece and/or replace.
	Burrs on back of rear pole piece; burrs on armature flange.	Remove burrs or replace parts.
Noisy Motor <i>(metallic clicking sound)</i>	Rotor hitting bent pole piece.	Leave motor in case, "spin" manually, make visual check for rotor clearance. Straighten and/or replace bent pole piece.
	Bent rotor shaft.	Replace shaft and/or rotor; or front motor assembly.
Loss of Torque <i>(motor fails to operate control and/or switch)</i>	Short pole piece on rear motor assembly loose or improperly seated.	Reseat short pole piece and tighten retainer ring or replace rear motor assembly.
	Pole pieces loose on front motor assembly.	Reseat pole pieces and tighten retainer ring or replace front motor assembly.

1. Armature adjust screw is factory adjusted to within .002". Adjustment of armature in field is not advised. Replace armature if necessary.
2. Do not continue to run motor at end of potentiometer travel.
3. Do not continue to run motor having insufficient torque.
4. Do not add "shims" to any gear train or shaft assembly.
5. After removal of top motor case, make a visual check on placement of potentiometer and other parts before further disassembly.
6. Make sure all parts are seated and positioned properly in bottom case before top case is attached.
7. Apply power to motor and check operation before reinstallation on TMA.
