Television Service Tips

Volume XXI
Issue 1
January 19, 1970

Prepared and Distributed by **RCA Sales Corporation, Product Performance**
600 N. Sherman Drive, Indianapolis, Indiana 46201

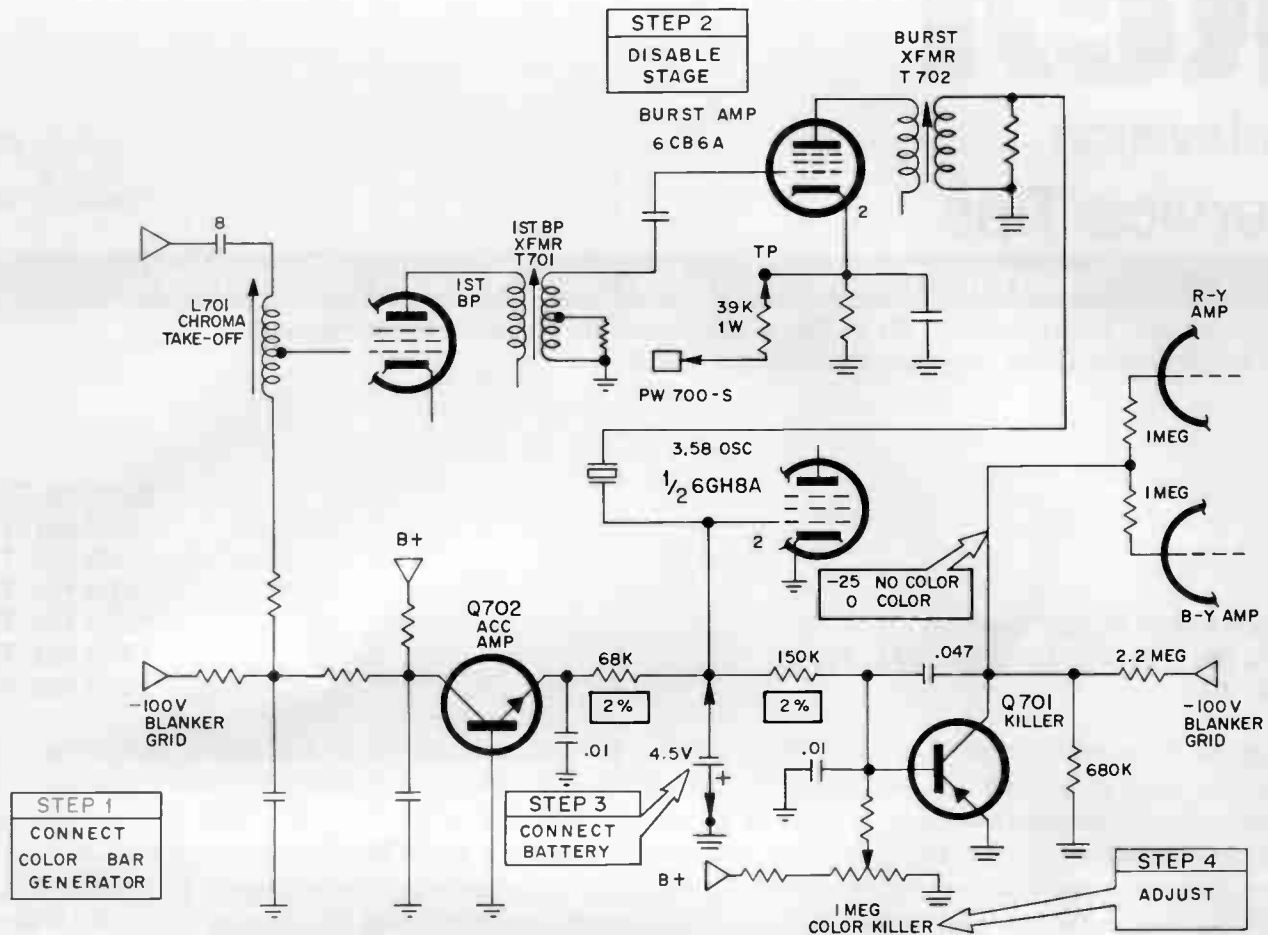
Simplified ACC/Color Killer Circuits

In those areas where a transmitter is known to leak burst, the best policy is to refrain from changing the original setting of the color killer. If this control has been adjusted, it may be returned to the optimum setting using the factory set-up procedure which follows:

- Step 1. Connect a color bar generator to the chassis in order to supply a constant-level color signal.
- Step 2. Defeat the burst amplifier stage by connecting the cathode of the burst amplifier tube to approximately 270 volts B+ through a 39K, 1 watt resistor. The burst amplifier cathode is TP701 in the CTC 38 and CTC 39 chassis; TP 704 in the CTC 41, CTC 42 and CTC 43 chassis. The necessary B+ potential is available at terminal PW700-S in all chassis. This step makes the oscillator grid voltage independent of incoming color signal amplitude.

- Step 3. Connect negative 4.5 volts bias (use a battery—VS 1149 or equivalent) to the 3.58 MHz oscillator grid (Pin 2) through a 470-uH choke (Stock No. 124271). It is necessary to isolate the grid with a choke to prevent loading, since the oscillator must be running during the setup procedure to produce color on the screen. This step establishes the optimum oscillator grid bias for killer adjustment.

- Step 4. Adjust the killer control to kill the color bars on the picture tube screen.

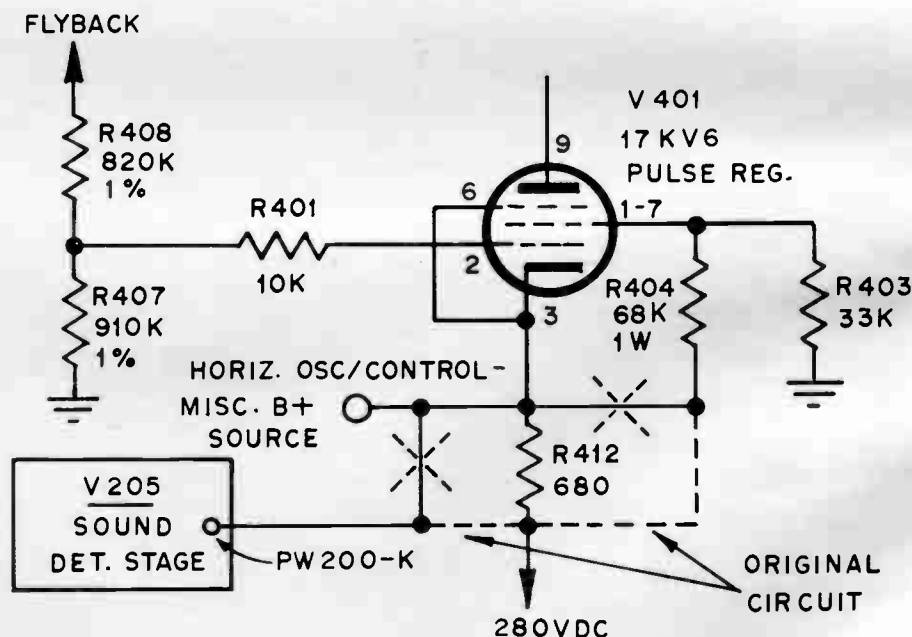
Pulse regulator circuit—CTC 22AD

In early-production versions of the CTC 22AD, if Pulse Regulator tube failure in turn causes R412 to open, the instrument may operate, with marginal picture quality after the tube is replaced. The symptoms would be those associated with reduced horizontal drive.

Later-production instruments reflect the circuit changes outlined in the simplified schematic. Changing the B+ source point for the regulator screen grid resistor (R404) as shown "shuts down" horizontal operation in the event of R412 failure. The B+ source for the Sound Detector stage is also changed to this point. Symptoms for R412 failure in instruments with these changes will be: **no sound, no raster**.

In addition, R407 and R408 values may be either 820K, 1% or 910K, 1%. If replacement is required, use the same value resistor as the original. Stock numbers are: 820K, 1%—126429; 910K, 1%—126428. Check high voltage operation (per Service Data) after resistor replacement.

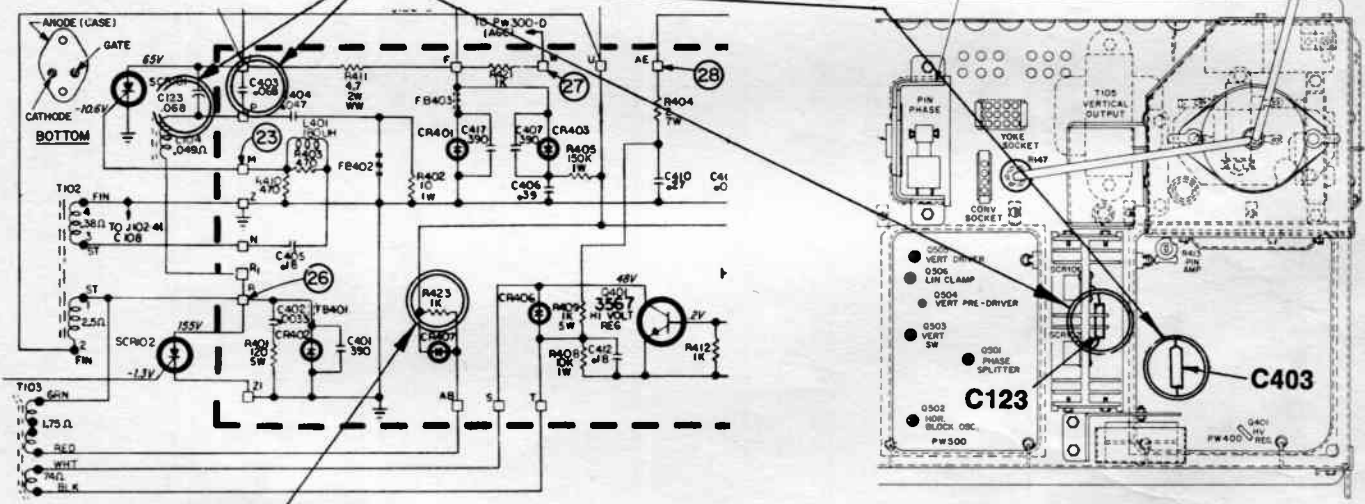
Horizontal deflection circuit—CTC 40

The .068 μ f commutator capacitor used in the horizontal deflection circuit of these chassis is located either on the PW400 board or on a terminal board under the SCR heat sink. Two capacitors in parallel are **never** used. If the capacitor is on PW400, it is C403; off the board, it is C123. In either case, the capacitor is the same type and the replacement stock number is 165437.

“Piecrust” or “geartooth” effect in the raster (scalloped edges) at different brightness levels may be the result of R423 opening. High voltage and brightness limiter operation appear to be normal. In some instances the symptom may be accompanied by a high pitched squeal.

Capacitor may be located either place—never both.

Can cause “piecrust” effect.

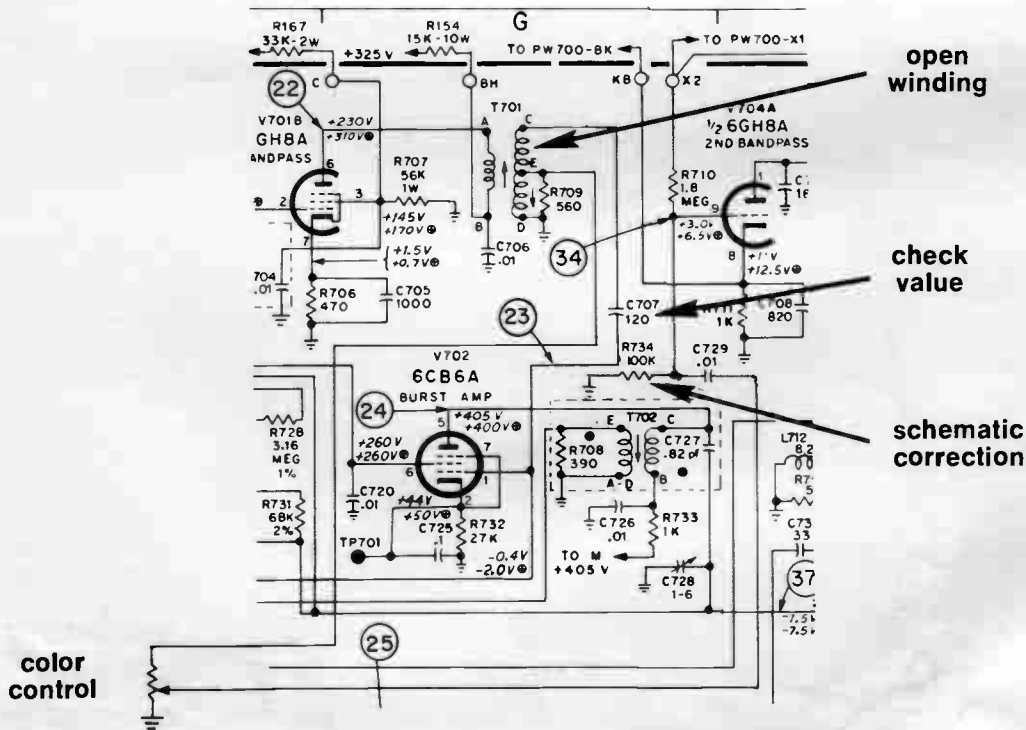
Color burst circuit—CTC 38, CTC 39

Some symptoms associated with the color sync and/or ACC-killer circuitry in instruments utilizing these chassis may be the result of an open winding in the first bandpass transformer, T701 (Stock No. 124761). If the open occurs in the winding connected between terminals C and E the color signal input to the burst amplifier stage will be incorrect. However, the path for chroma input to the second bandpass amplifier stage will be normal.

In addition, make certain capacitor C707 is the correct value (120pf).

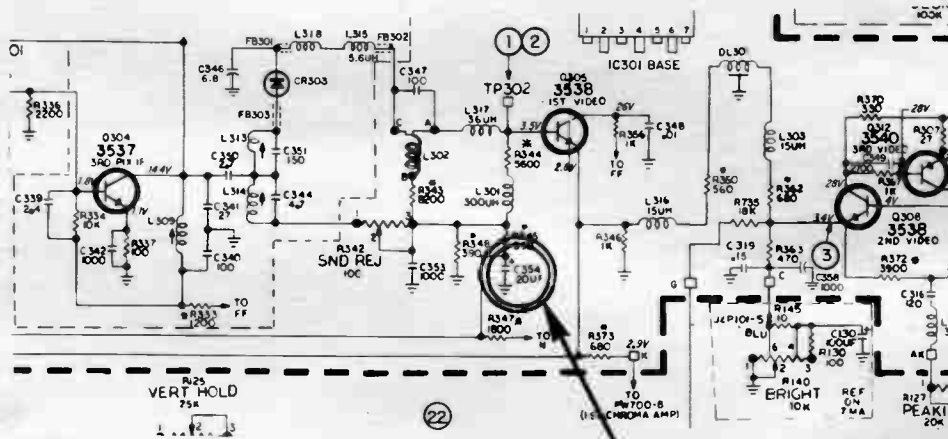
First video amplifier circuit—CTC 40

A wide variety of video and/or sync symptoms in these chassis may be the result of an electrolytic capacitor changing value. Possible symptoms include: video "smear"; video "bends"; unstable sync; various combinations of these symptoms. In addition, the symptom may vary with the brightness control setting.

Check Electrolytic

SYMBOL No.	STOCK No.	DRAWING No.	DESCRIPTION
C354	121995	1471882-14	20 μ f, 15V, electrolytic

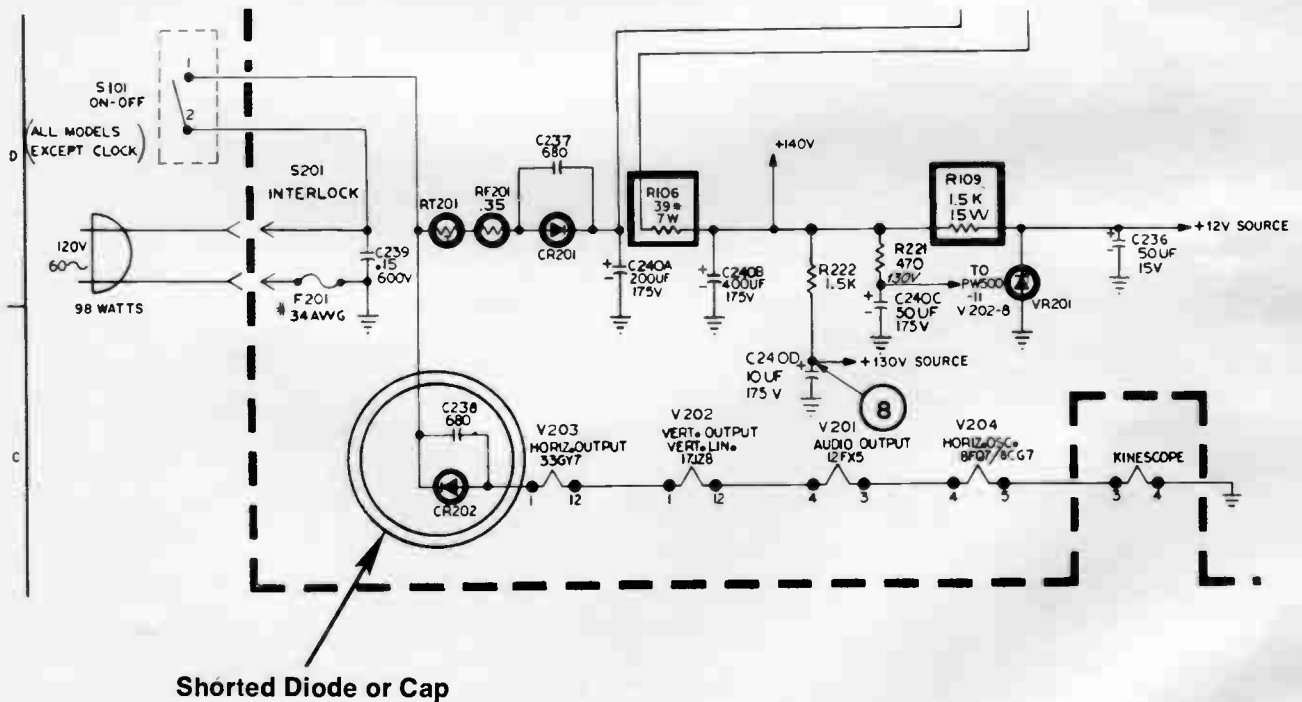
Filament power circuit—KCS 177

These chassis use a half-wave rectifier for filament power. Should the diode (or the capacitor across it) short, the filament string will be operating on full line voltage (120V AC) rather than the normal half-wave rectifier output. The tube filaments will glow brighter than normal and may result in reduced tube life. In addition, a hum bar in the raster and/or poor vertical sync may be evident.

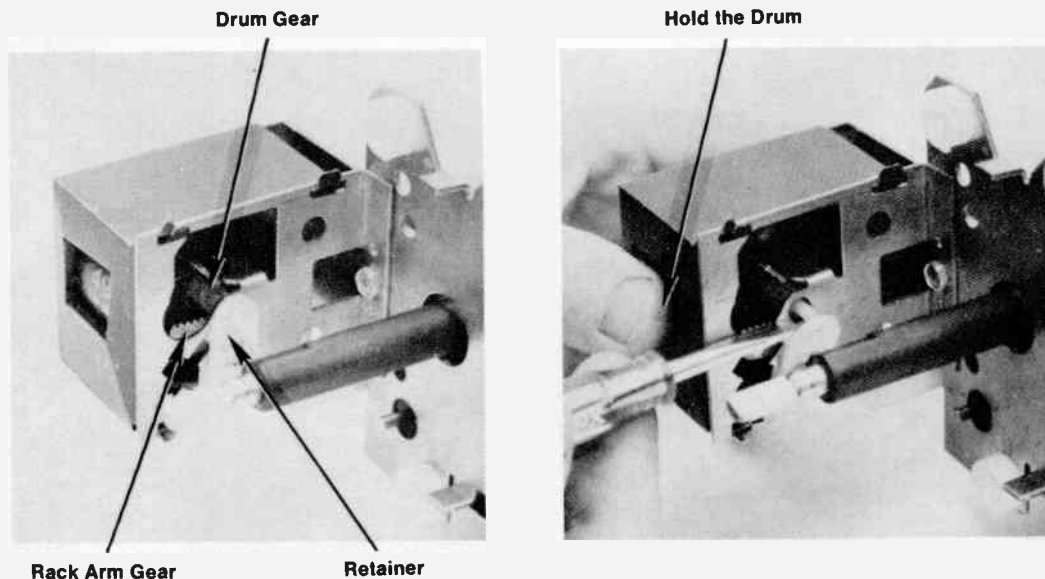
UHF channel indicator—CTC 39X

In areas of multiple UHF channel reception (where the channels are relatively close together), some difficulty may be encountered identifying specific channels on instruments utilizing the six-detent U tuner (KRK 170).

1. Tune the mechanism so that the lowest channel in the area is indicated on the drum.
2. Loosen three $\frac{1}{4}$ inch U tuner mounting screws and slide the tuner (holes are slotted) until that channel is received, then tighten the screws.

1. Tune the KRK 170 for reception of a known channel, preferably one between channels 45 and 55.
2. While holding the indicator drum, spring the nylon retainer out until the teeth of the drum gear are disengaged from the teeth of the rack gear arm.

3. Turn the U drum until the indicator shows the channel being received.
4. Mesh the teeth of the drum gear and the rack gear, then return the nylon retainer to its original position.

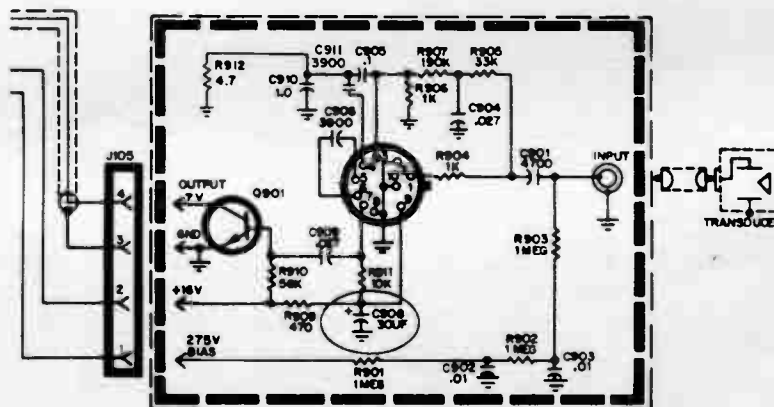
Remote preamplifier circuit—PW 900

Reduced remote control sensitivity of instruments utilizing these chassis may be the result of an off-value electrolytic capacitor in the preamplifier. The capacitor is:

If this capacitor must be replaced, for maximum reliability use the following tantalum type:

SYMBOL No.	STOCK No.	DRAWING No.	DESCRIPTION
C908	132062	1446192-14	27 μ f, 15V, electrolytic

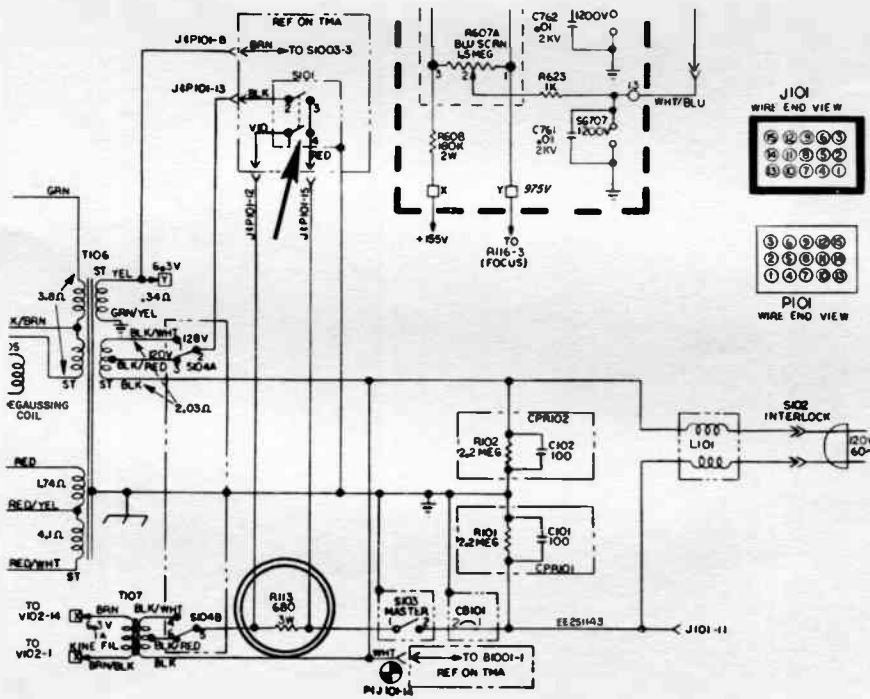
Power standby circuit—CTC 40

Some color tracking problems in instruments utilizing the CTC 40 chassis—which seem to relate to a defective picture tube—may actually be the result of a defective on/off switch. Should that section of the switch used to bypass the picture tube filament dropping resistor (R113) become intermittent, the filament voltage could vary between 5 (standby) and 6.3 (on) volts. This can cause variations in color tracking.

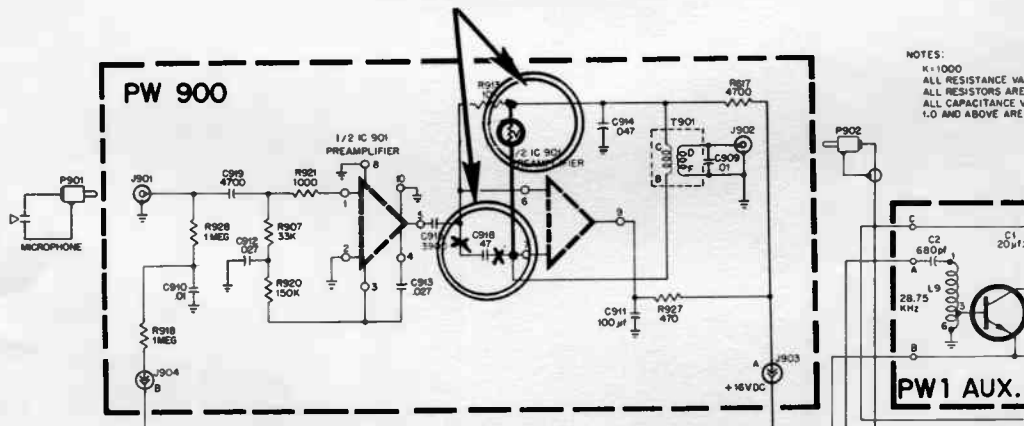
Remote preamplifier circuit—CTP 13A

Some versions of the PW900 board utilized in CTP 13A remote amplifiers may have a circuit modification. As shown in the schematic, C918 is deleted and a varistor (Stock No. 130042, Drawing No. 1472668-7) added in parallel with the primary of T901.

**Capacitor
replaced
with
varistor**

Marginal remote sensitivity in amplifiers that have been modified may be improved by removing the varistor. It is not necessary to replace the capacitor unless high frequency interference is evident in the picture during remote functions.
