Eliminating Horizontal Pull

PRODUCTION CHANGES

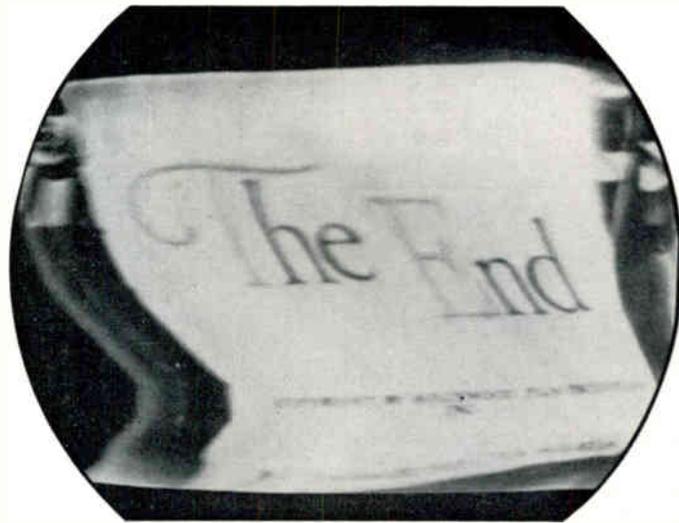
An article on horizontal-sync problems was published in the January issue of the SERVICE NEWS. One of the problems discussed results in an effect referred to as horizontal "pulling" or "wobble" as shown in Figure A-1.

Fundamentally the problem is due to an improper sync-to-video ratio in the transmitted signal. This condition occurs as a result of over-modulation of the transmitted signal.

Figure A-1. Horizontal pull.

Recently, a production change was made in all Telesets to reduce the possibility of pull and wobble. This change consisted of replacing the un-bypassed 270-ohm resistor in the cathode circuit of the 6BA6 narrow-band sync amplifier with a 470-ohm unit.

If the receiver experiencing the difficulty does not already include the 470-ohm resistor, the change should be made.

If changing the above resistor and readjusting the narrow-band sync transformer does not completely eliminate the horizontal pulling, short the 10K resistor (R284) located in the output of the sync detector. This permits the signal to produce a larger bias across C249, the coupling capacitor. The increased bias depresses the pedestal and video level of the signal to below cutoff. This prevents the video signal from entering the sync circuits and eliminates the horizontal pulling.

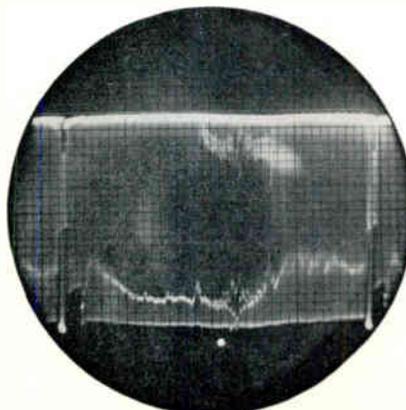
4. Set the contrast and brightness controls to obtain a normal picture and adjust the a-g-c control until the picture brightens up. This will usually cause video to appear at the plate of the first sync amplifier, as shown in figure A-2.
5. Vary the adjustments at the top

Figure A-2. Output of first sync clipper showing video in sync.

and bottom of the narrow-band sync transformer until the video in the sync is eliminated, as observed on the oscillograph. When this adjustment has been made properly, the oscillograph pattern should appear as shown in figure A-3.

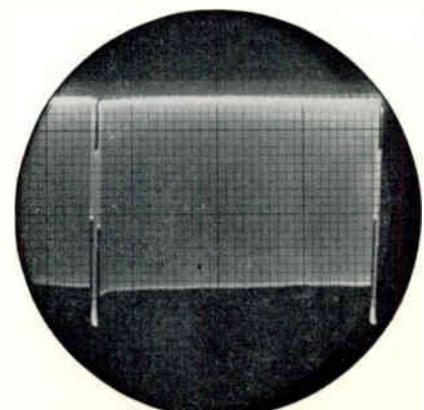
Figure A-3. Output of first sync clipper with narrow-band transformer properly adjusted.

5 to eliminate it. Continue repeating steps 4 and 5 until it is no longer possible to eliminate the video in the output of the first sync amplifier by tuning the narrow-band sync transformer.

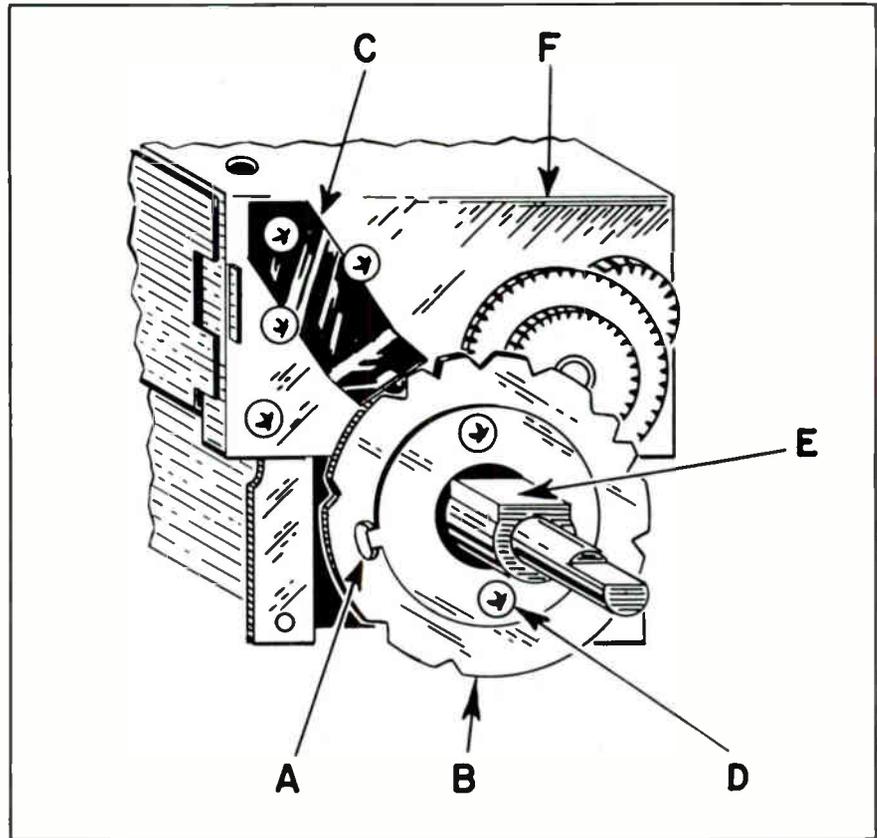
Figure S-1. RA-117A Selectuner.

Aging of components or replacement of the oscillator tube in the Selectuner may cause the proper tuning point, for each channel, to fall out of the range of the detent. When this condition is encountered, the following procedure should be followed to correct it:

3. Observe the position of the detent for the channel to which the Teleset is tuned, with respect to the detent spring, C in figure S1. The detent spring should be centered in the proper detent.

4. If the position of the detent is incorrect, loosen the two Phillips screws (D) on the front of the clutch disc one-half turn; while holding the detent disc in position.

5. Rotate the detent disc until the detent spring is centered in the proper detent.
6. Rotate the clutch disc until the stop is centered in the slot, when the tuning indicator shows proper tuning.
7. Tighten the two Phillips screws and make a final check of the dial calibration on all stations.

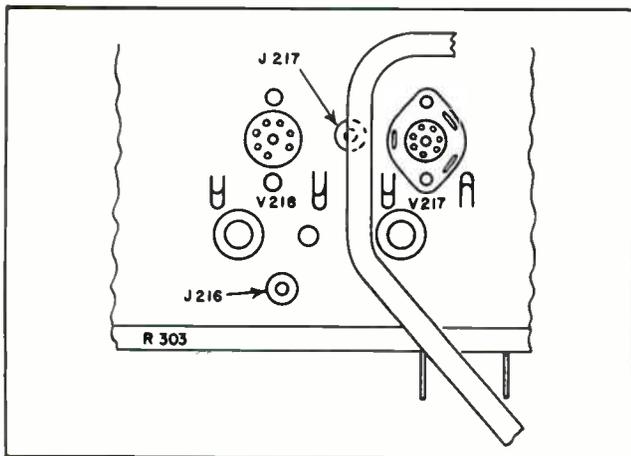
Figure P-1. Change No. 41, RA-109A.

To reduce horizontal pulling, two jacks are provided as described in the article entitled "Eliminating Horizontal Pull," in this issue.

Mount the two jacks, J216 and J217 as shown in figure P1.

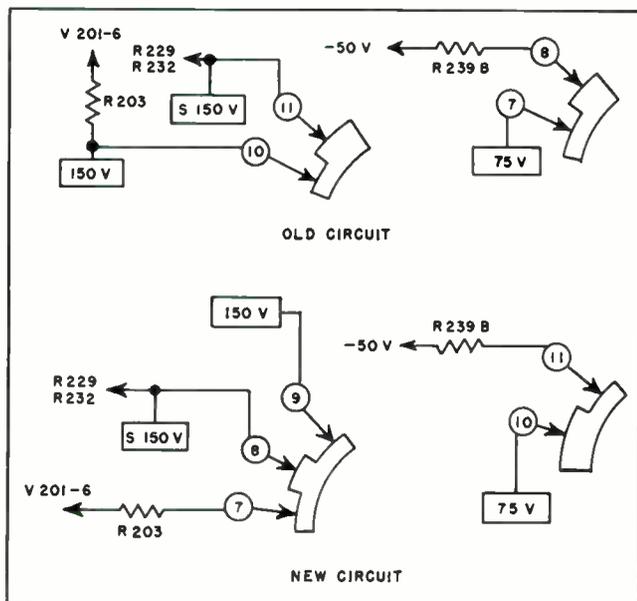
Figure P-2. Change No. 39, RA-112A - RA-113.

To eliminate f-m pickup when the Teleset is being used for phonograph reproduction. This pickup occurs in areas where very strong f-m signals are present and is coupled to the first sound amplifier through the stray capacitance of S201. A position is added to this switch to remove the B+ from the screen of the first sound i.f., V201.

Replace and rewire S201 as shown in figure P2. Connections not shown remain the same.

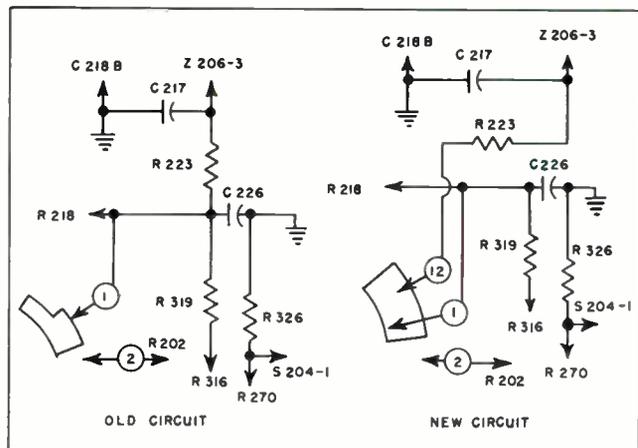
Figure P-3. Change No. 40, RA-112A - RA-113.

To obtain maximum sensitivity when receiving f-m stations in areas where both extremely strong and weak signals are received. If both strong and weak f-m signals are present at the antenna terminals of the Teleset, it is possible for a strong signal to reduce the gain of the receiver when it is tuned to a weak signal. When this occurs, the reduction in gain may be sufficient to make satisfactory reception of the weak signal impossible.

The above condition can occur if a strong signal is close enough in frequency, to a weak signal so that both signals fall within the pass band of the r-f and video i-f stages, when the receiver is tuned to the weak signal. The strong signal will pass through these stages to the grid of the third video i.f., V207. If the amplitude of the strong signal is great enough, the grid of V207 will be driven positive causing it to draw current. This current will flow through resistors R223, R319 and R251. The voltage developed, by this current, across R319 and R251, appears on the a-g-c line and is applied to the grids of the r-f amplifier (V101), and the 1st and 2nd sound i-f amplifiers (V201 and V202). Since this voltage is negative, it increases the bias on these stages and reduces the gain of the receiver. To eliminate this effect, the grid circuit of the third video i-f stage is disconnected from the a-g-c line when the Selector Switch is in the FM position. To accomplish this, a new Selector Switch is required.

1. Change S201
2. Disconnect R223 from junction of C226 and R319 and connect this end to S201-12, as shown in figure P3.
