# Service Talk

FROM  
TELEVISION RECEIVER PRODUCT SERVICE  
ELECTRONICS PARK SYRACUSE, N. Y.

FEBRUARY 1960

## SPECIAL COMPONENTS IN TELEVISION RECEIVERS

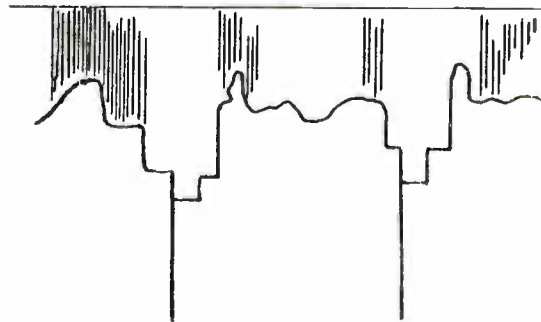
Certain instances of poor horizontal sync stability and a soft vertical hold condition may be traced to the AGC filter capacitor C252. This condition results from the capacitor becoming open.

When measured with a VTVM, the average AGC voltage may be normal but examining the waveform at Test Point VII (AGC line) shows the presence of the Keyer pulse. The scope should be set to give two waveforms of 60 cycle sync. Further checking of Test Point IV at the video detector shows an excessively peaked and narrowed sync pulse as shown below. This waveform results from the cancelling of AGC at pulse time by the keying pulse and therefore produces greatly exaggerated sync spikes which cause the sync instability.

The cure for this condition is to replace the capacitor, G-E catalog number WT25X23. The red durez dipped type capacitor should be used as a replacement rather than those with a black molded case.

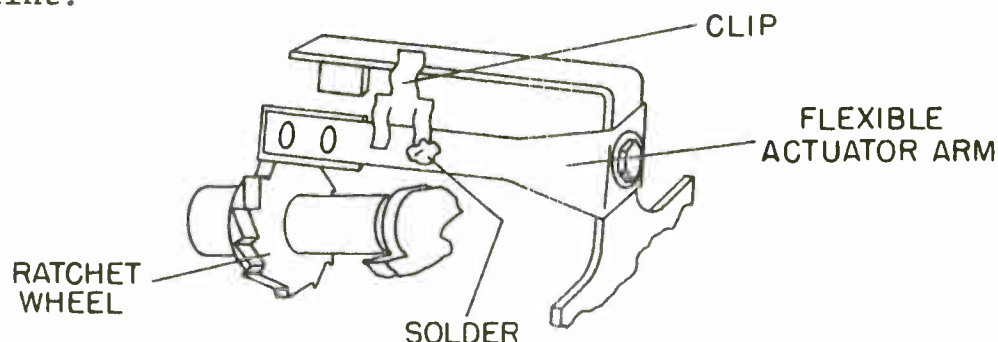
The remote control system, being introduced to the field presently, employs a stepping type relay for volume level selection. It has been noted on some early shipments that the flexible actuating arm of this relay may become stuck during shipping or when the receiver is subjected to a sudden jar. If this condition occurs, it is necessary to open the remote receiver chassis and move the flexible arm away from the ratchet wheel to its natural position. This will clear the condition as long as the receiver is not transported. However, to permanently remove the possibility of a sticking relay, a detector mounting clip (WT3X48) may be installed and soldered to the actuator arm as shown below. It is not necessary to remove the relay from the unit to make this modification.

Relays now supplied have been modified to prevent future complaint.

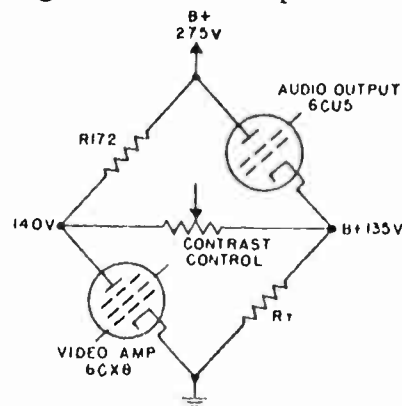
The contrast control circuit used in the M6 and several other chassis may exhibit a secondary failure under certain conditions. This is most easily shown by re-arranging the video amplifier and contrast control circuit as follows:

As shown at the right, R T (representing all circuits appearing between ground and B+ 135V) together with the audio output tube, form a voltage divider. Likewise, the video amplifier tube and its plate load R172 form another divider. The contrast control connects from the plate of the video amplifier to the B+ 135 or to about 5 volts difference in potential. It is readily seen that if the video amplifier tube opens, the plate assumes a potential of 275V and places 140 volts across the contrast control. Similarly, if for some reason the B+ 135V becomes shorted to ground, the control has 140 volts applied. Again if the 6CU5 shorts or R172 opens, excessive voltage appears across the contrast control. Its wattage dissipation is exceeded under these conditions and may result in damage, if continued.

To avoid setting up the above condition, the receiver should be turned off before changing tubes, particularly the 6CX8 and 6CU5. The contrast control should be checked through its range for proper operation, following any condition of overload. Any sudden change of contrast or erratic video when the control is rotated indicates burned spots. An open control will result in a very little change of contrast, but will introduce a progressive smear as the control is rotated toward the counter-clockwise end.

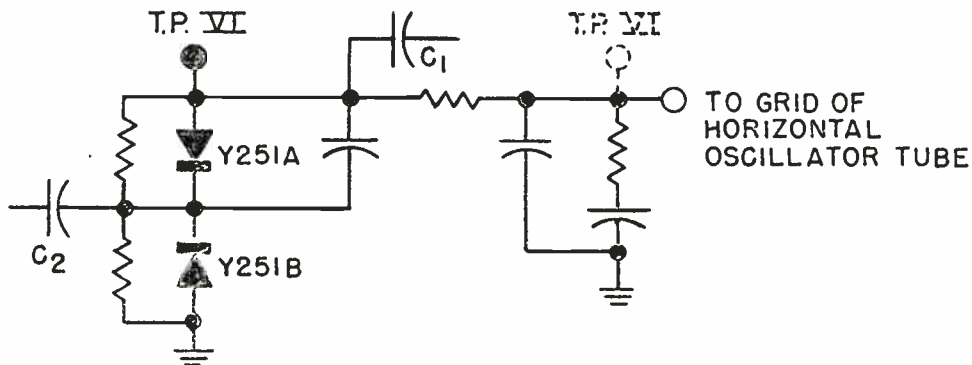
The majority of phase detector defects is an open or a shorted diode condition. A VTVM connected to T.P.VI of the diagram below should show about -1.0 volt with a signal present on a normally operating receiver. If the voltage at T.P.VI is quite far off, a bad diode can be suspected. Obviously, horizontal circuit tubes should be tried first. Other receiver components can also cause the frequency to be far off.

With the VTVM connected to T.P.VI, measure the voltage available. If the voltage rises to -6 to -8 volts, diode Y251B is open. If the voltage is +6 to +8 volts, diode Y251A is open. A reading of -10 to -12 volts at T.P.VI indicates a shorted Y251B. Positive readings of the same magnitude indicate a shorted diode Y251A. If  $C_1$ , or  $C_2$  are shorted, a positive voltage will be present at T.P.VI. The probability of a reading of +6 to +12 volts is very small, however.

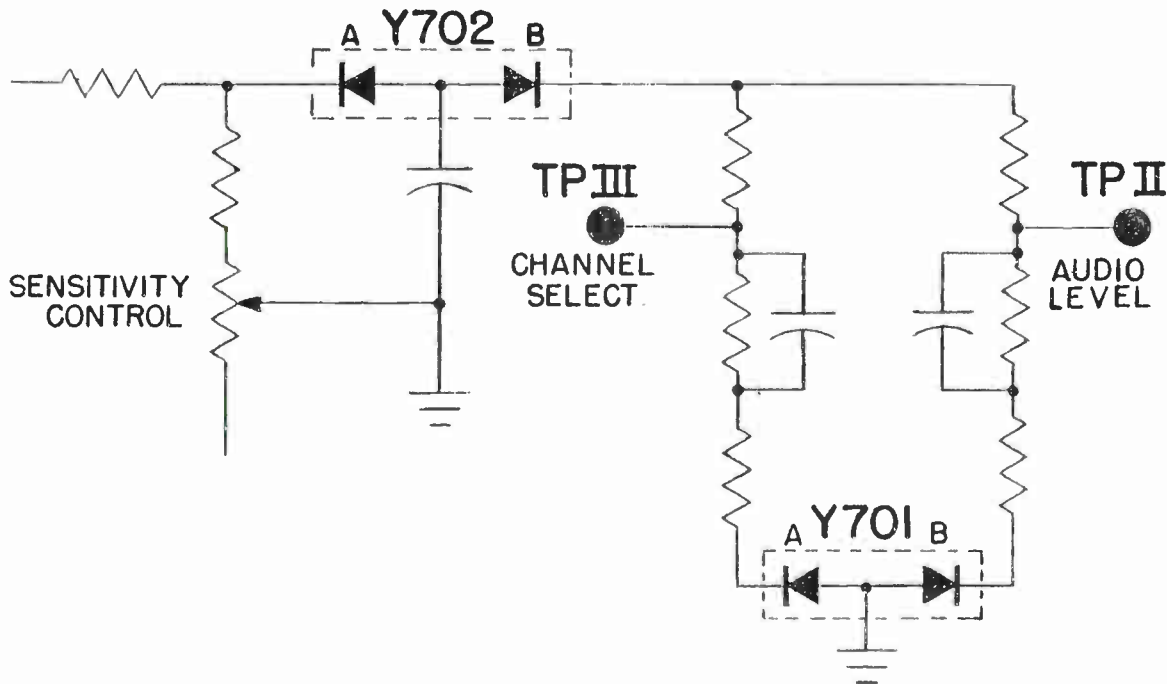
Diagram showing Bias and Signal Detector Diodes in the Sonic Remote Receiver System.

1. Check for 5 to 12 volts AC at cathode of Y702A as sensitivity control is turned from maximum clockwise to maximum counterclockwise. If proper AC voltage is present, place a short across Y702A. Should DC bias now appear at T.P.II or T.P.III, Y702A is open.
2. If bias does not appear, remove short from Y702A and short across Y702B. If bias now appears, Y702B is open.
3. If bias still fails to be present, diodes Y702A and B can be assumed to be good, and fault lies within the other circuitry.

Using a VTVM where the DC bias measured at T.P.II and/or T.P. III is about -7 volts, place a short across Y702A. If DC bias disappears, Y702B is shorted. Check Y702A for a short condition by shorting across Y702B. If Y702A is shorted, noise immunity of sonic receiver is eliminated, and even the television receiver's horizontal pulses will trigger the remote control functions.

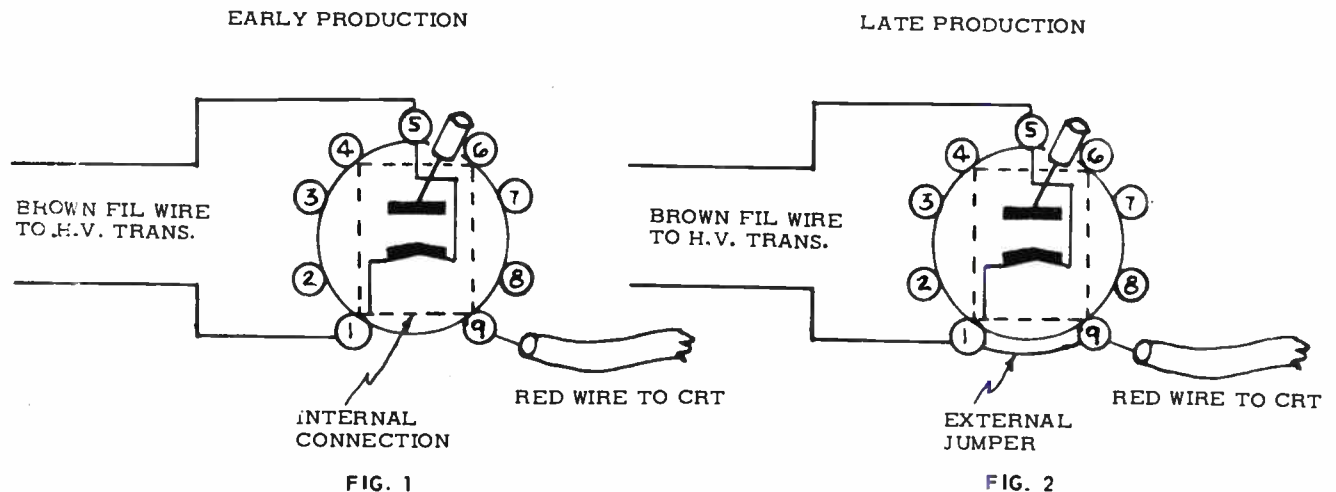
The internal construction of the 1BC2 includes a corona shield which is supported by welding to the inner ends of pins 1, 4, 6 and 9. For convenience in assembly, early production sets were connected as shown in Fig. 1.

It is apparent that the HV connections must pass through the internal connections in the tube and may be opened in the event of a weld failure in the tube.

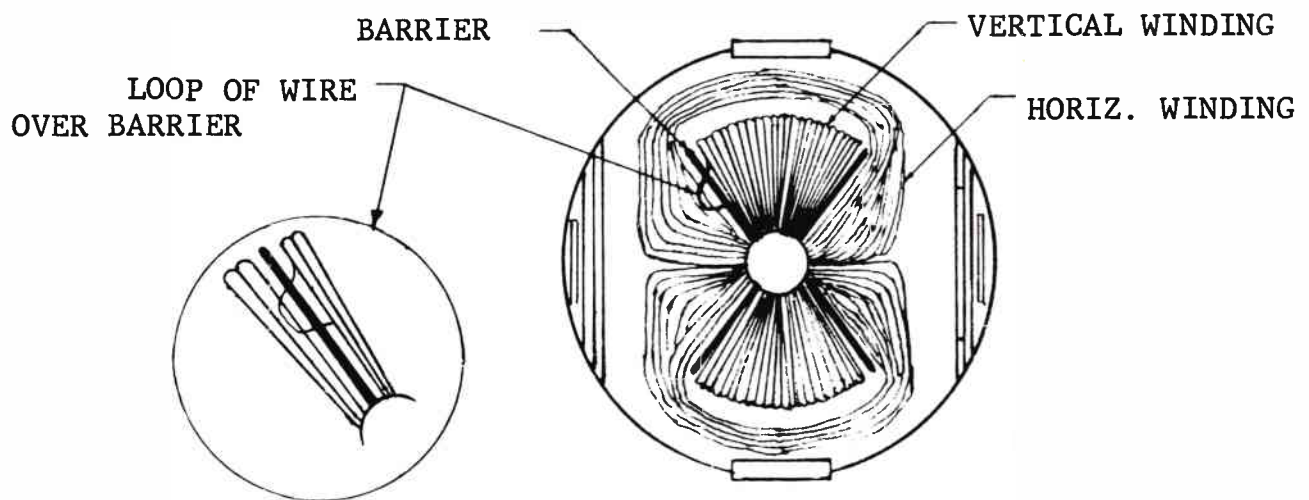
A visual inspection of the inside of the yoke may reveal a loop of wire from a vertical winding looped over the barrier and touching the horizontal winding. Redressing the wire to the correct side of the barrier will restore normal operation. See illustration below. (over)

Any SB yokes which appear to be defective, should be inspected and redressed rather than replacing.

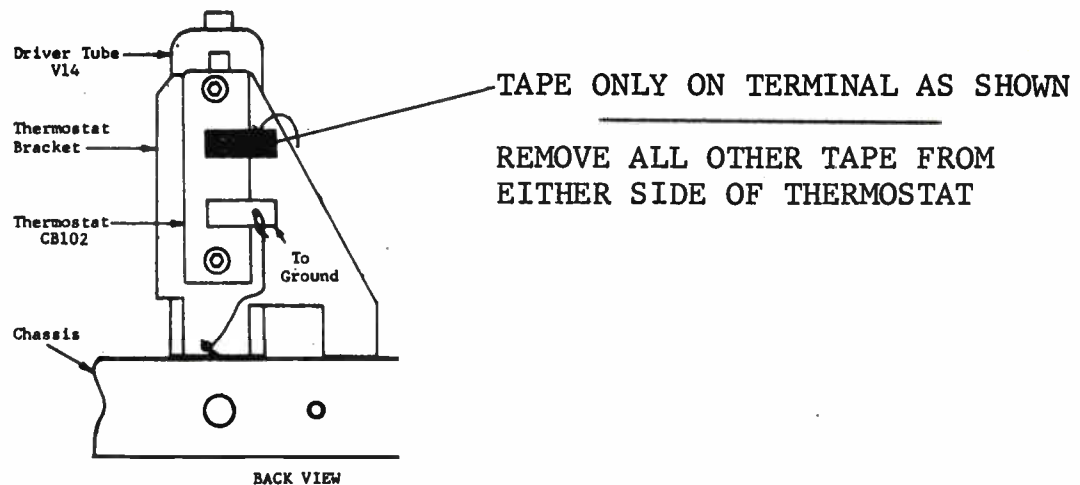
This tape should be removed, whenever it is found, since it may result in tripping of the cutout when there is no fault in the set. The only tape required is around the top terminal, as illustrated, to prevent shock. The top terminal is at B+ potential when the cutout is open.

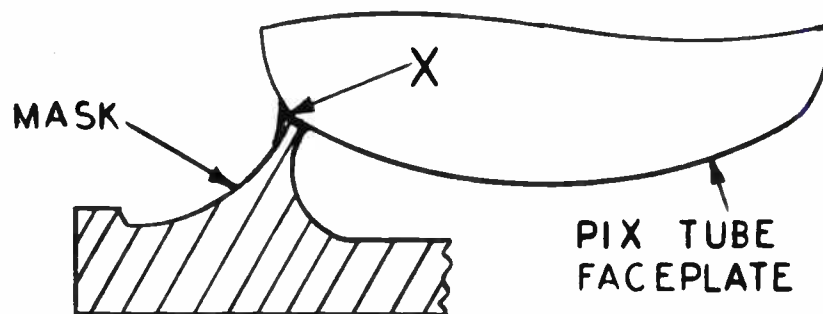
With the picture tube removed, examine surface X (See sketch) of the diecast metal mask for roughness, bumps or "flash".

Remove any roughness with a scraper, knife blade or fine file. Follow by smoothing with fine emery cloth.

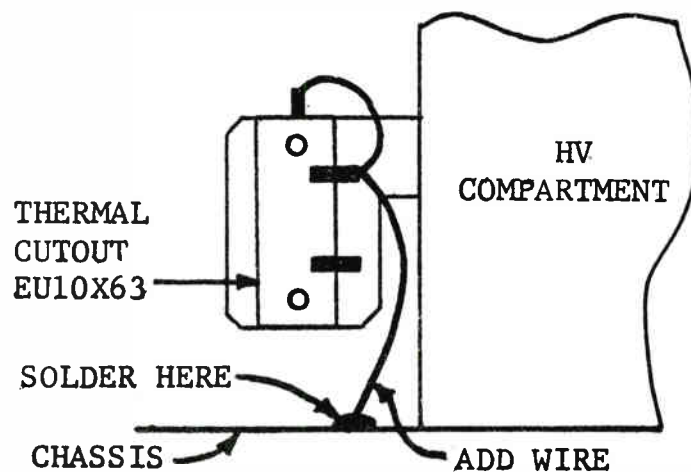
Some of the first production units do not have this ground wire to the chassis. If you receive any EU77X5 unit which does not have the wire, you should add the ground wire as shown below when installing the unit in a set.

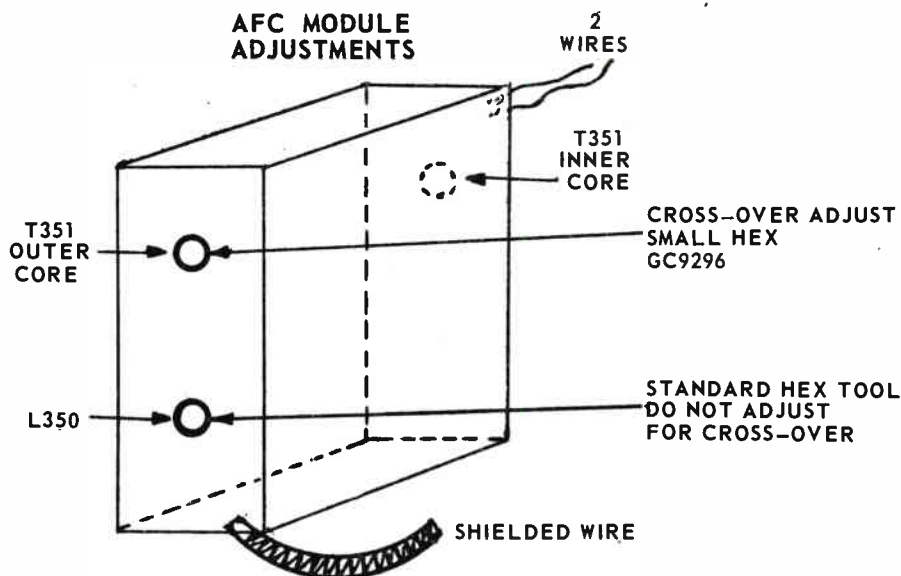
Since the standard hex tool fits only L350, it is our feeling that this may account for the mis-alignment.
