# Tele-Clues

**Tele-Clue K-274**

**Receiver:** G-E "U-4" line (See "U-4" Tele-Clue Schematic).  
**Component:** C254, 5000 mmfd, 450 volt capacitor, temperature range 10° - 105° C - SHORTED.  
**Circuit:** Grid circuit of V8 Clipper tube.  
**Symptom:** Soft sync, horizontal side lock and possible audio buzz.

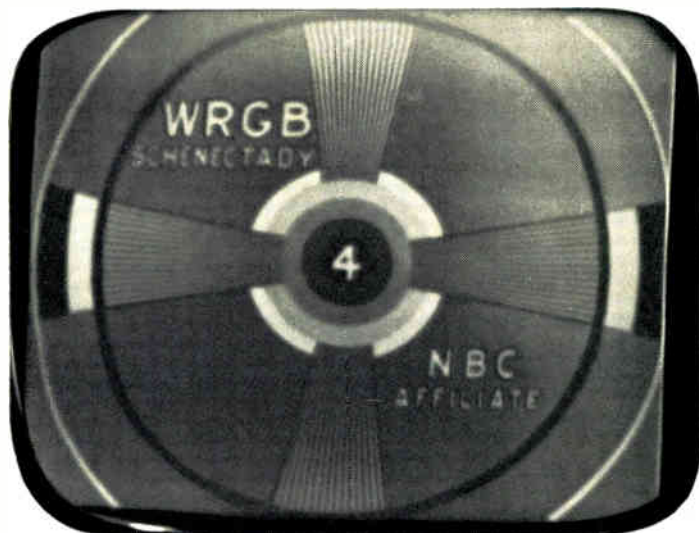
**Tele-Clue No. F-111.** This photograph illustrates the effect of reducing the line voltage to 110 volts on the same receiver. The height, width, focus and brightness have all been reduced.

Whenever a TV receiver must be removed from the customer's home, the line voltage should be checked at that time and noted on the chassis. This same voltage should then be used when repairing and adjusting the receiver. If the receiver is repaired and adjusted at the voltage noted on the chassis, no further adjustments should be necessary when the receiver is returned. Chances are, the voltage in the service shop will vary from the required voltage. If so, a variac or variable voltage transformer can be used to obtain the desired voltage.

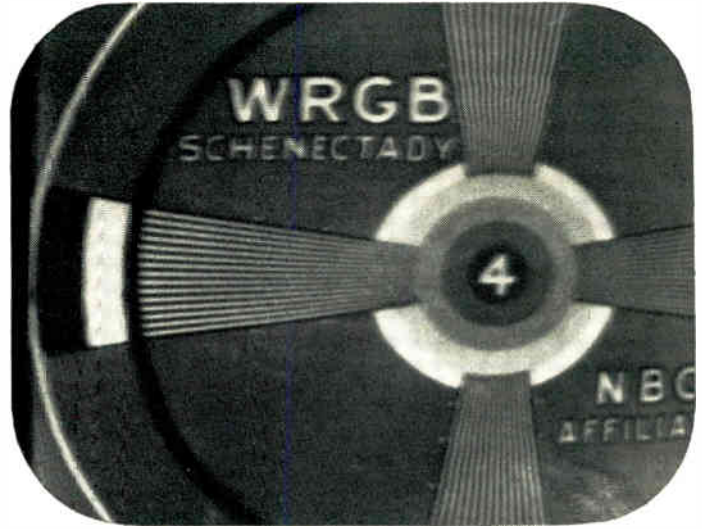
**Tele-Clue E-114.** If capacitor C356 in Fig. 1 is leaky (10K) the picture will weave considerably but will sync with the horizontal blanking bar near the left side. The voltage at pins 1 and 5 of V12 will be considerably more positive than the normal 2.5 volts. Leakage across C357, C359, or C361 or a change in the value of R356 or R357 capacitors will also cause this same condition. If R359, R360 or C357 is open, the picture will only sync with either the horizontal blanking bar at the left as shown above or at the right as shown in Tele-Clue E-115.

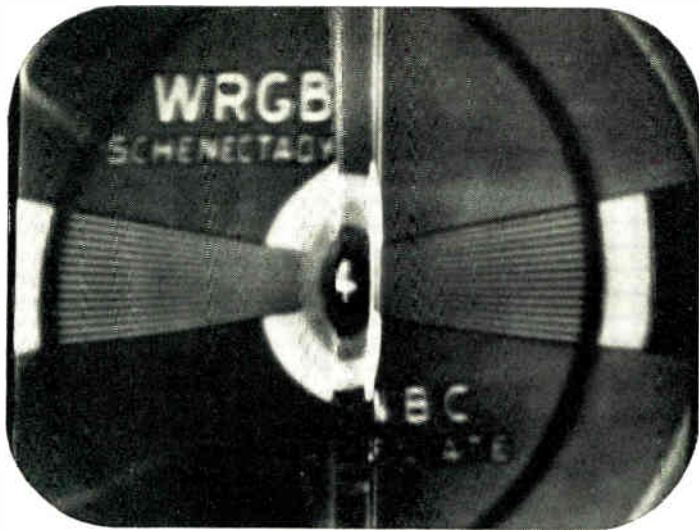
**Tele-Clue E-117.** If capacitor C365 in Fig. 1 becomes leaky (2K) the brightness and width are decreased and several white lines appear near the center of the pictures as shown above.

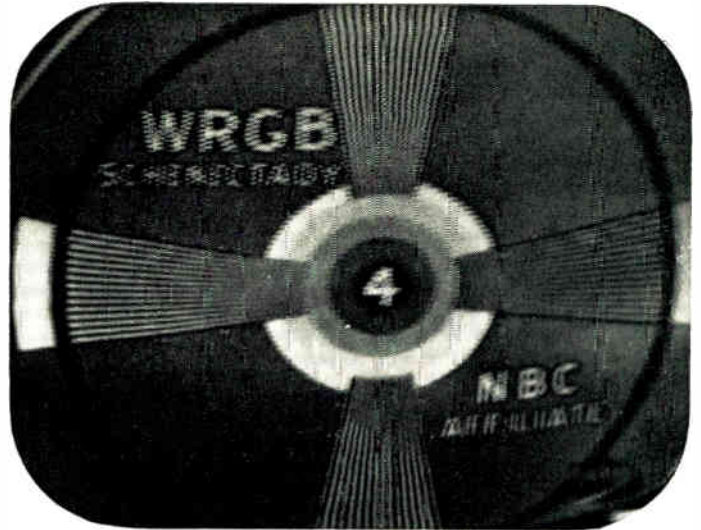
**Tele-Clue E-118.** A somewhat unusual condition appears when R366 in Fig. 1 is open. The picture looks as if every other frame in each field is displaced slightly to the left. A similar defect will also appear if C369 is leaky (1 meg).

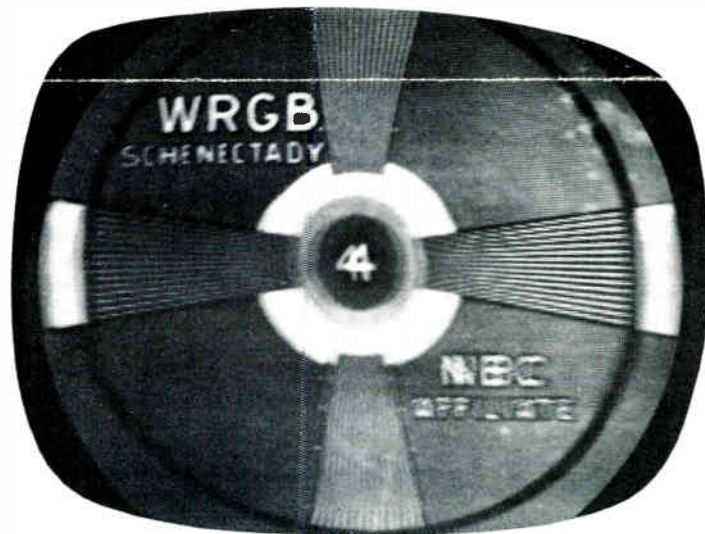
**TELE-CLUE E-151.** The horizontal jitter shown here was due to a defective 12SN7-GT horizontal oscillator tube in a General Electric Model 10T1 receiver. Since this same circuit is used in a number of other model receivers, this same defect may occur in any of these models. This same tube when used in the vertical circuit also produced a vertical jitter. The tube tested OK in both sections. The only unusual characteristic was the erratic motion of the pointer on the tube tester while one side of the tube was heating up. After it reached operating temperature, the pointer remained at a steady "good" reading.

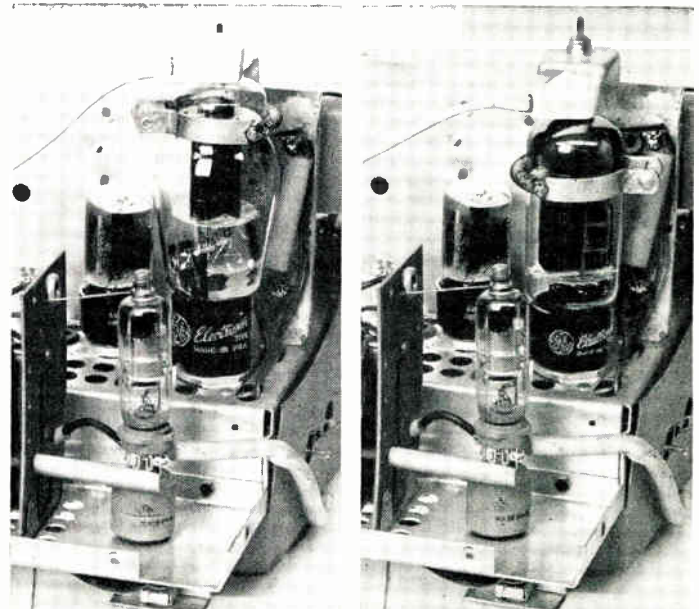
**TELE-CLUE E-207**—This shows the effect of "snivets" when a picture is received. A different horizontal output tube may eliminate the "snivets" entirely or change the frequency so the picture is "clean." Another method which may be used is to place an ion-trap magnet over the horizontal output tube as shown in the photographs on the right. The ion-trap is then slowly turned until the "snivets" disappear.

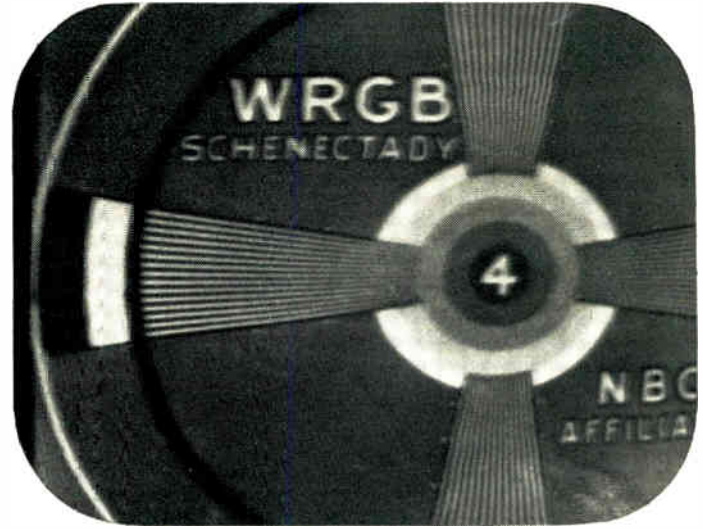
**Tele-Clue E-114.** If capacitor C356 in Fig. 1 is leaky (10K) the picture will weave considerably but will sync with the horizontal blanking bar near the left side. The voltage at pins 1 and 5 of V12 will be considerably more positive than the normal 2.5 volts. Leakage across C357, C359, or C361 or a change in the value of R356 or R357 capacitors will also cause this same condition. If R359, R360 or C357 is open, the picture will only sync with either the horizontal blanking bar at the left as shown above or at the right as shown in Tele-Clue E-115.

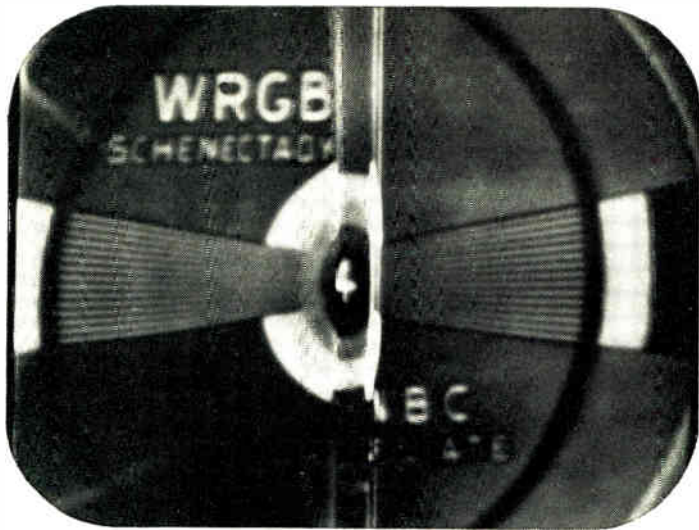
**Tele-Clue E-117.** If capacitor C365 in Fig. 1 becomes leaky (2K) the brightness and width are decreased and several white lines appear near the center of the pictures as shown above.

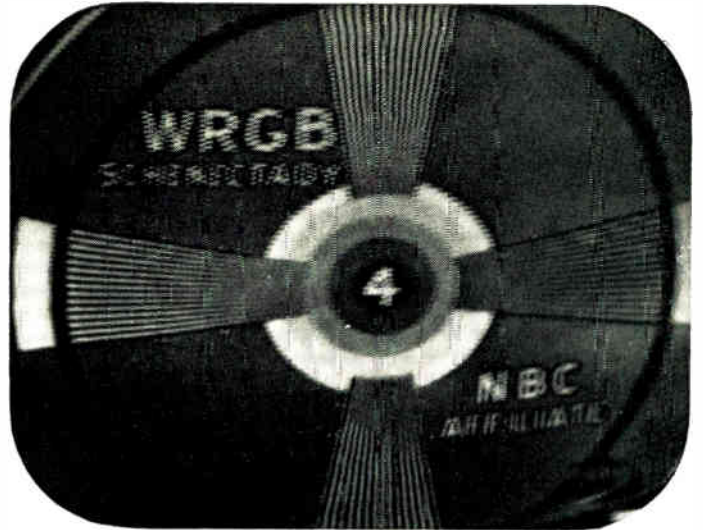
**Tele-Clue E-118.** A somewhat unusual condition appears when R366 in Fig. 1 is open. The picture looks as if every other frame in each field is displaced slightly to the left. A similar defect will also appear if C369 is leaky (1 meg).

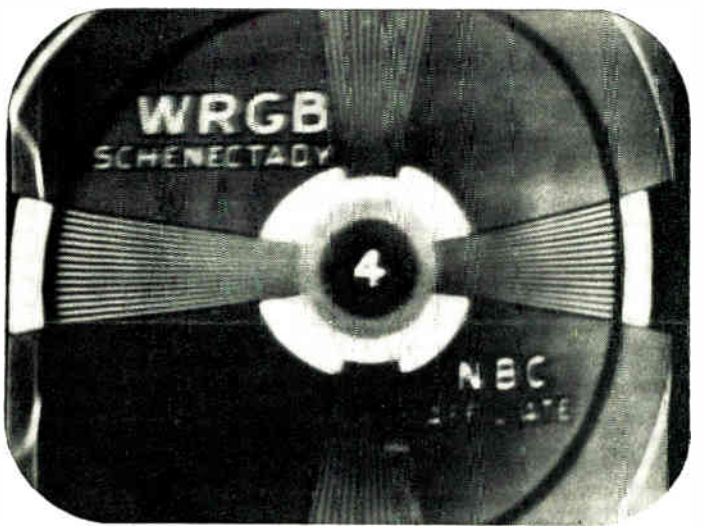
**Tele-Clue E-120.** Leakage across capacitor C368 (100K) in Fig. 1 will cause the width to be reduced with a slight foldover on the left side as shown in the above photograph.

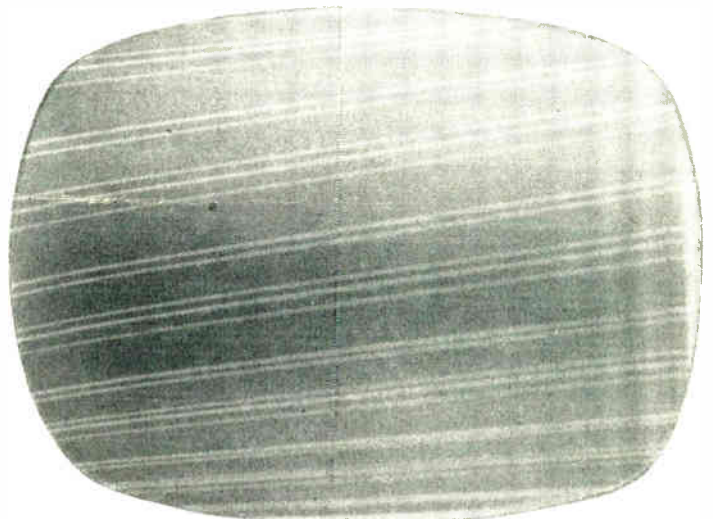
**Tele-Clue No. F-121.** Loss of sound, picture and screen illumination can be caused by any one of several defects which can be checked in the following order:

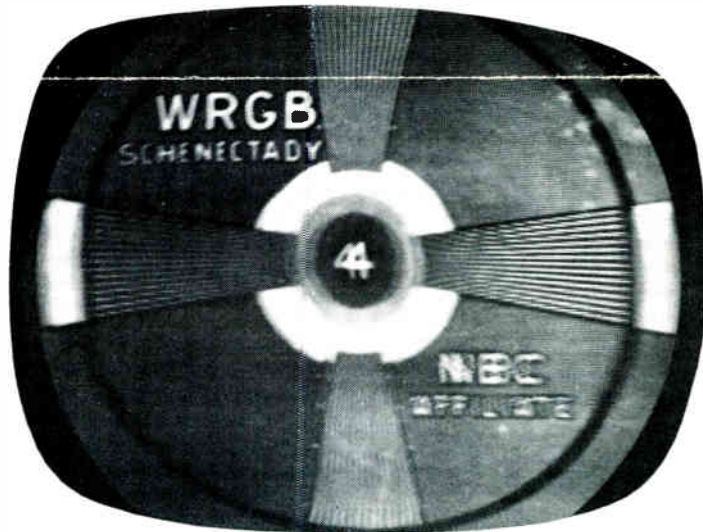
**TELE-CLUE E-151.** The horizontal jitter shown here was due to a defective 12SN7-GT horizontal oscillator tube in a General Electric Model 10T1 receiver. Since this same circuit is used in a number of other model receivers, this same defect may occur in any of these models. This same tube when used in the vertical circuit also produced a vertical jitter. The tube tested OK in both sections. The only unusual characteristic was the erratic motion of the pointer on the tube tester while one side of the tube was heating up. After it reached operating temperature, the pointer remained at a steady "good" reading.

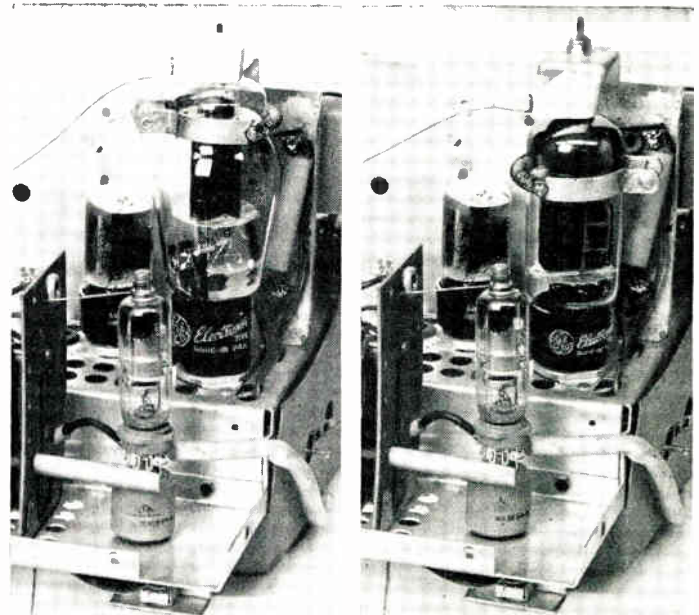
**TELE-CLUE E-207**—This shows the effect of "snivets" when a picture is received. A different horizontal output tube may eliminate the "snivets" entirely or change the frequency so the picture is "clean." Another method which may be used is to place an ion-trap magnet over the horizontal output tube as shown in the photographs on the right. The ion-trap is then slowly turned until the "snivets" disappear.
