Nov.-Dec., 1971 • Volume 14/No. 11-12

Product Safety and Servicing

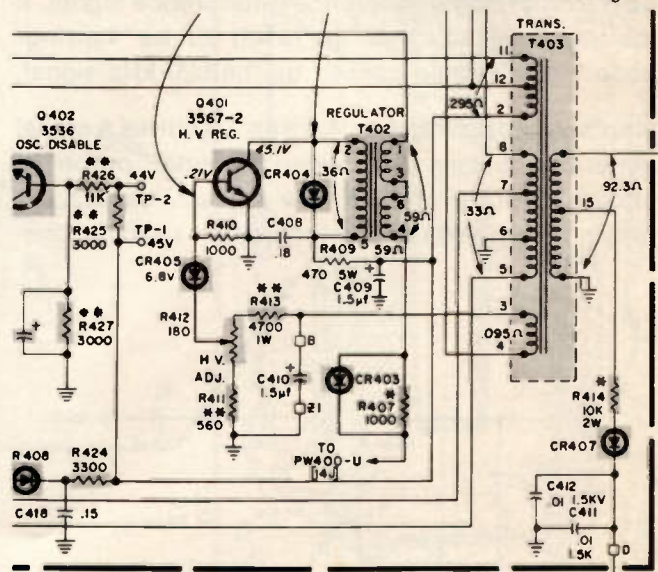
Figure 1—Special Components Areas

These special safety components and circuit areas are identified in RCA Service Data by use of a gray overprint on the appropriate schematic areas. The reader may be asking at this time, "What does this mean to me?" This discussion has a very significant meaning to the service technician, for improper and/or careless servicing can defeat the safety designed and manufactured into a consumer product by RCA. For example, the replacement of a flame-retardant resistor with an ordinary carbon type resistor would be an undesirable change in this built-in consumer safety feature of the receiver, and might result in substantial damage to the chassis should this improper replacement component fail.

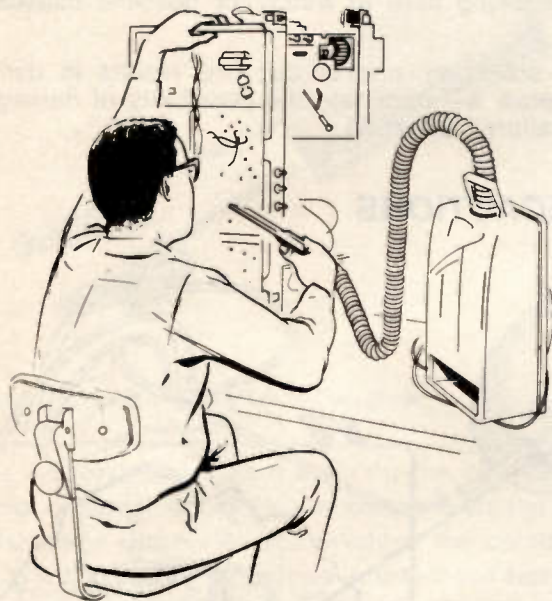
Figure 4—Remove Dirt and Dust from Chassis

Accumulated dust and dirt is another condition that is service-correctable. Older television chassis may often be covered with a thick layer of dust. This dust is more than just a dirty hand and clothing nuisance—it also may reduce the cooling of circuit components. Most technicians, routinely vacuum the dust from a chassis before placing it

on the service bench. But, what about the chassis that does not leave the customer's home? It is equally important that the dust be removed from chassis in these receivers. So do your customer a favor while at the same time protecting his television receiver. Equip yourself with a vacuum cleaner and make it standard policy to always clean the chassis. Your clothes and your customer will appreciate and benefit from the extra moment this takes.
