**COLOR TV**

**FACTBOOK**

**-Problems & Solutions**

By the Editors of Electronic Technician/Dealer

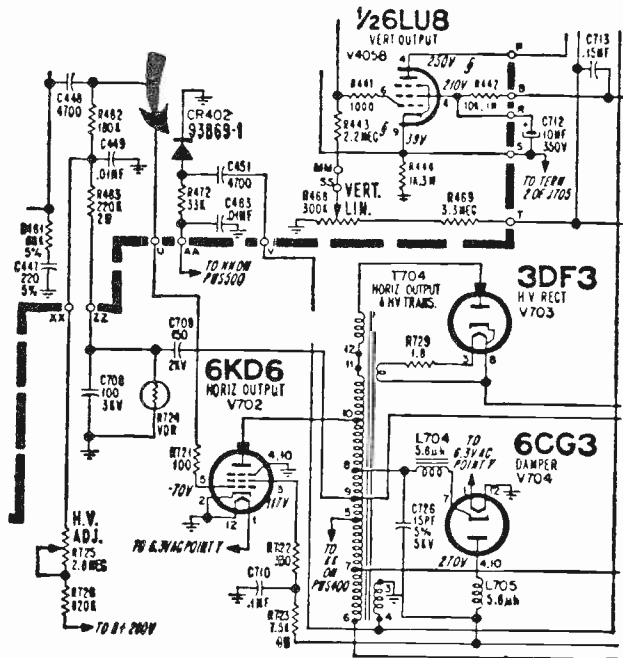
**Complaint:** No control of brightness. **Possible Cause:** Defective diode CR402 (93B69-1). Check for presence of negative voltage at the anode of this diode; it should be approximately -130 to -160v. This diode and associated

components provide the negative voltage for controlling brightness through the master brightness control and for the background controls. This circuit is not used for HV regulation in the K16 chassis as it was in some previous chassis. Diode 93A60-3 may be used in place of 93A69-1.

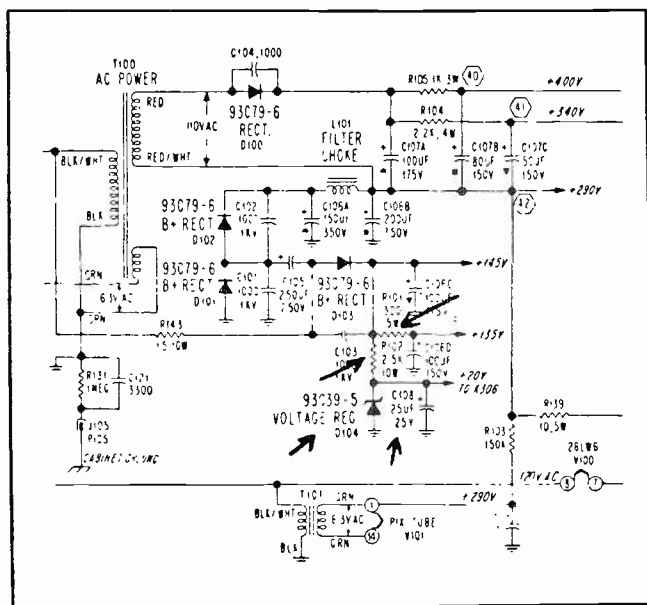
A defective component in the low voltage B+ supply such

as an open R101 (300 ohm, 5 watt resistor, Part No. 61A59-301-150) or open R102 (2.5 K, 10 watt resistor, Part No. 61A20-8) or shorted Zener diode D104, Part No. 93A39-5).

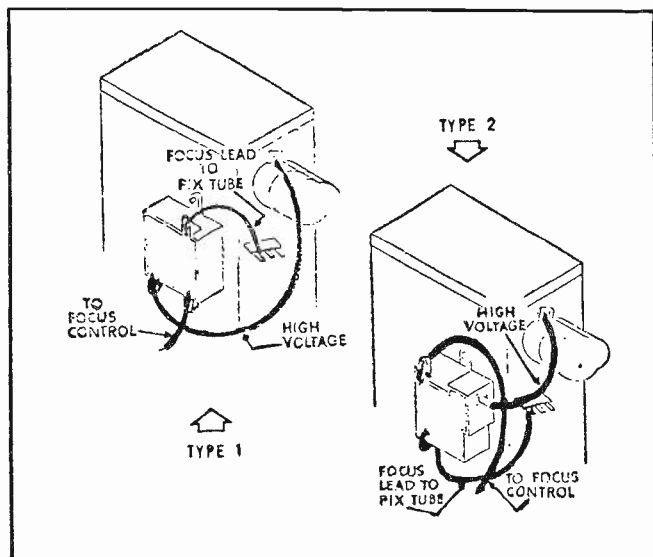
Two different types of 61A66-2 focus modules were used in the K18 chassis; they are electrically identical but differ in their lead arrangements. The type 2 which Admiral

currently supply for replacement must be mounted with the high voltage lead at the upper right as shown in the drawing, to provide adequate lead length.

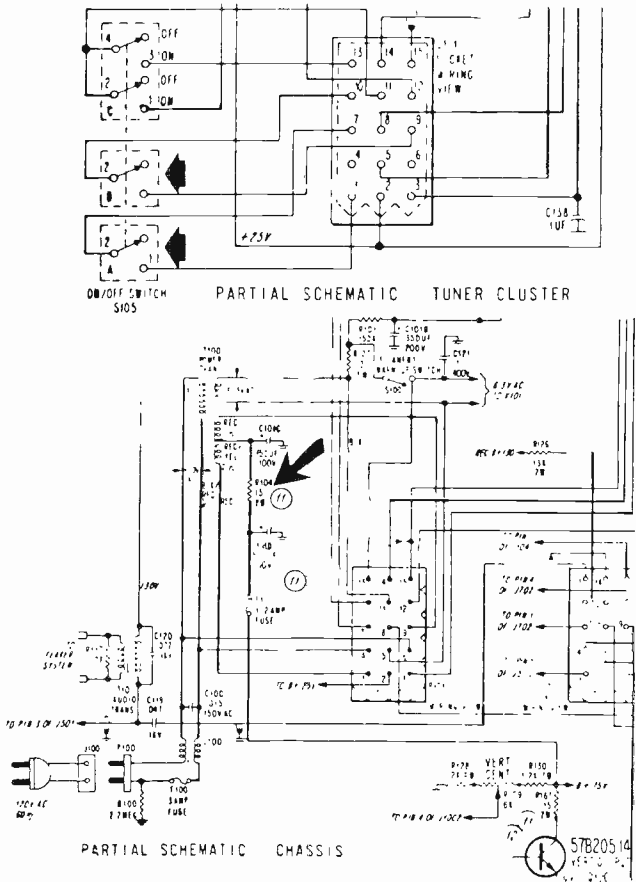
A problem causing R104 (15 ohm, 2 watt) resistor to overheat, and found in the 75 volt power supply can be caused by an open contact in the on/off switch, S105. With the Instant Play feature found in the M25 chassis, the B+ circuit is opened when the on/off switch is in the off position. Both the start and finish of the secondary winding of T100

are opened by sections A and B of S105. With one switch section open, the AC circuit is incomplete, resulting in excessive current in R104.

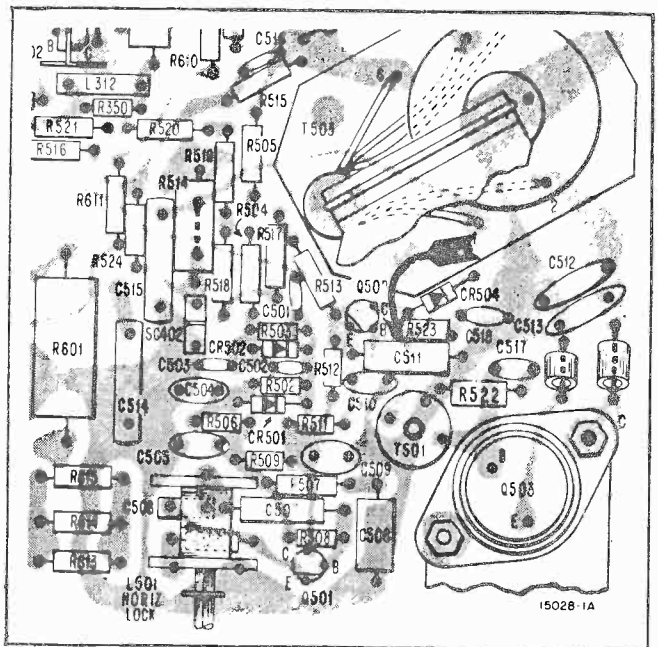
**B/W TV Chassis TL6—Horizontal foldover in center of the picture**  
 The possible cause of this trouble is a leaky capacitor, C511 (5mfd, 25V), as shown in drawing. Replace capacitor. See drawing below.

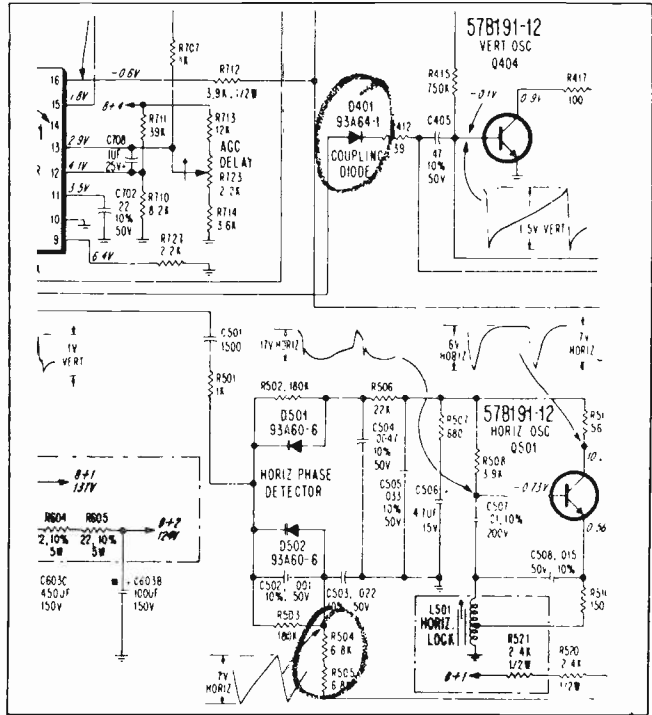
## Chassis N3—Loss of horizontal and vertical sync.

Replacement of IC701 does not correct problem. Voltages on IC701 are substantially different than schematic indicates. A probable cause is a defective D401, (sync coupling diode), and open R504 or R505, (horizontal pulse coupling resistors).

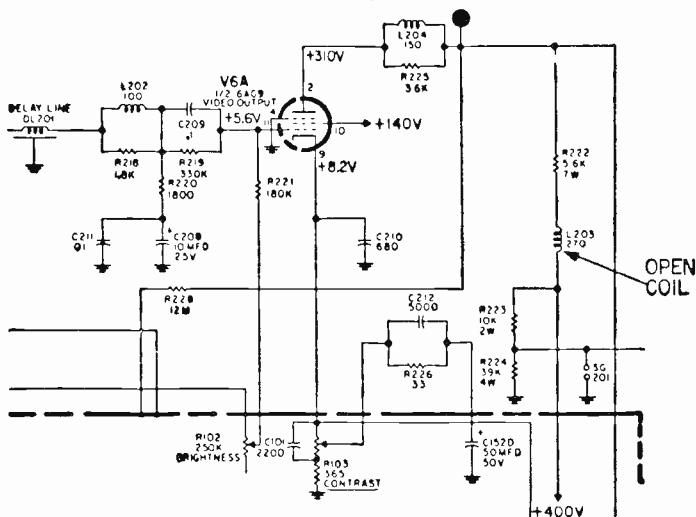
If L203 opens, the 320v B+ on the cathodes of the

picture tube is reduced to a much lower level, which results in insufficient bias on the picture tube. This condition overloads V16, the high voltage rectifier, which usually fails. In addition the extra heat may damage the high voltage rectifier socket and cup.

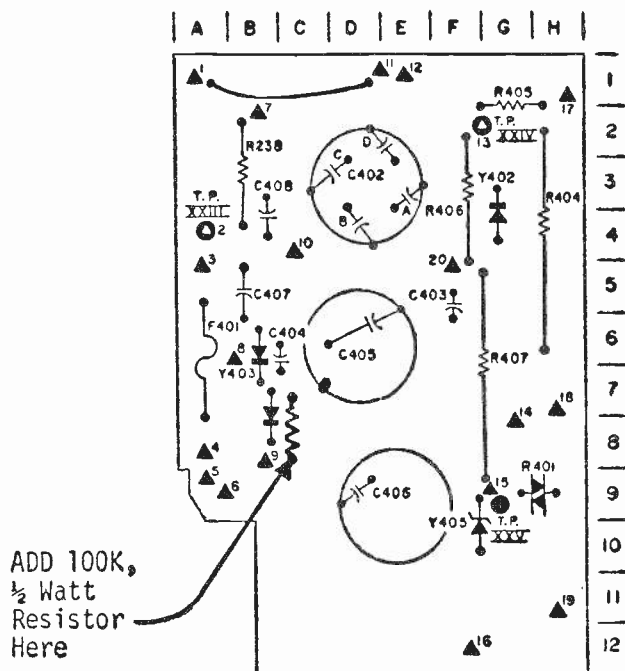
In current C-1 chassis production, a 100K, 1/2w carbon resistor has been added in parallel with 2C405 to provide

a discharge path to ground. Receivers bearing Serial No. 5D4 and higher are equipped with this resistor. It is physically located adjacent to rectifier Y404 on the power supply board.

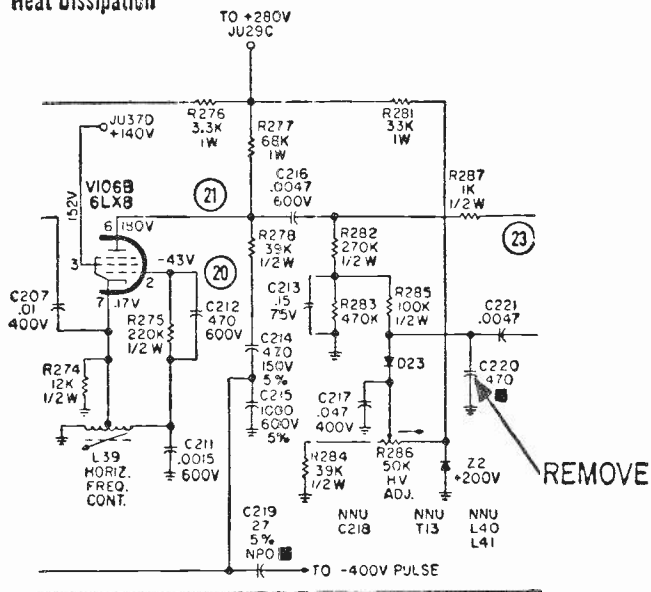
## Color-TV Chassis T952—Removal of Capacitor C220 for Reduction in Heat Dissipation

Capacitor C220 (470pf) was used in some T952 chassis—connected between the junction of C221, resistor R285 and diode D23 to ground. This capacitor was removed in later production and results in a reduction in heat dissipation in the horizontal output circuit. You are requested to remove this capacitor, if found in any T952 chassis that you are servicing.

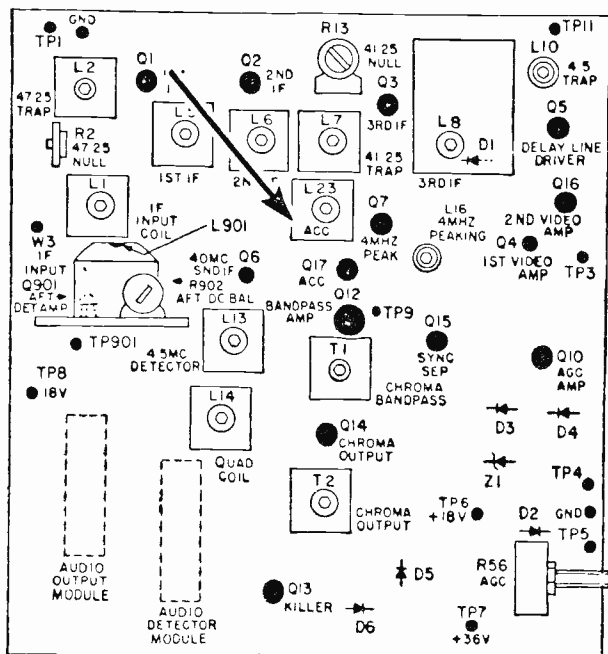
The condition can be alleviated by detuning the ACC coil, L205, on the T974 chassis or L23 on the T936, T956 or T957 chassis. The effect of the ACC action is reduced by the amount of detuning. Best performance was ob-

tained by turning the slug 5 to 6 complete turns clockwise (toward the board).

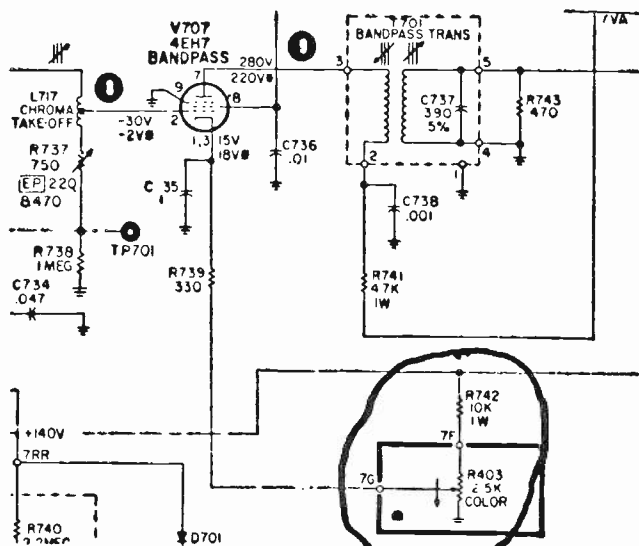
Two cases involving the failure of R742, a 10K, 1w resistor, have been noted. The symptom was no reduction in color saturation when the color control was turned counterclockwise. Investigation showed that R742 was opened

and in one case the COLOR control was damaged. The failure resulted from current flow in excess of the power rating of the resistor.

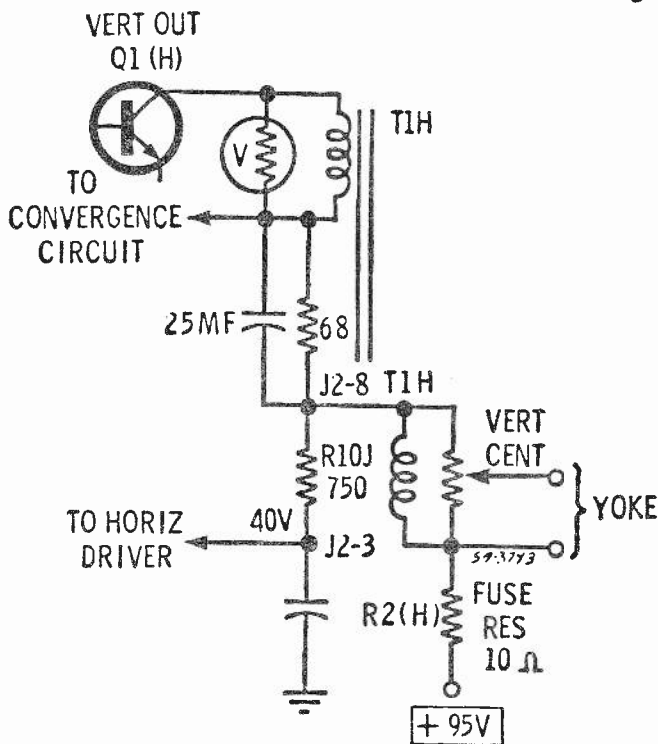
Symptom: No raster and a check reveals there is no high

voltage. Possible Cause: Open vertical fuse resistor, R2(H). The fuse is located on convergence panel door. Procedure: Use voltmeter to check for 95v at both terminals of the resistor. Do not jumper fuse terminals. If resistor is open, check for a short at the load end. Suspect a shorted vertical transistor. See illustration for details on how this open resistor causes loss

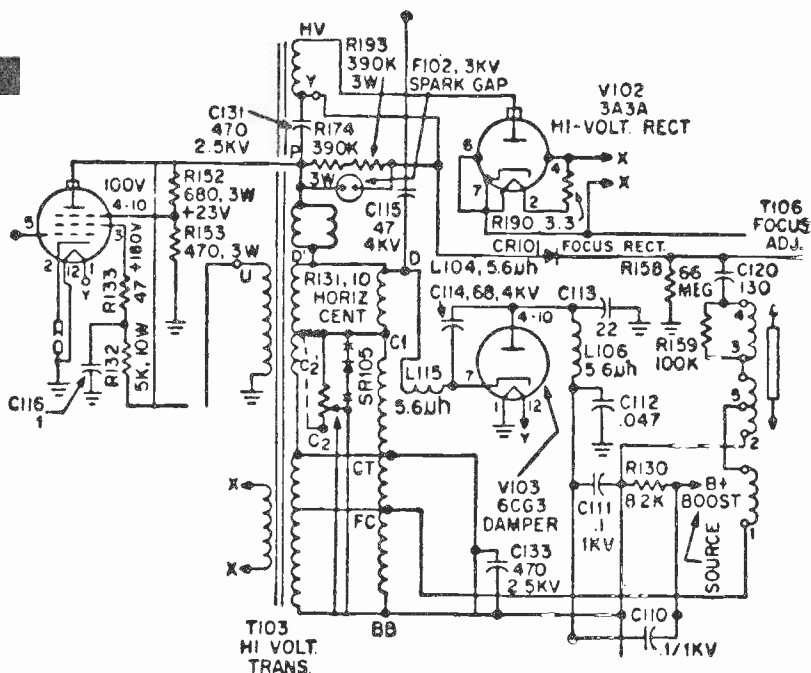
The network consisting of focus tracking resistors R174, R193, spark gap F102, Part No. FU35370 and their associated filter C131, together

with a "split" flyback winding, forms the components of the focus tracking circuit. In a brief analysis, focus tracking is accomplished by the voltage drop across the two resistors because of CRT beam currents. With an increase in CRT conduction, more current is drawn through the resistors which results in an increased voltage drop appearing across them. Consequently, this drop is added to the output of the focus rectifier to adjust focus according to changes in beam current. Filter capacitor C131 forms a long time constant that acts to smooth out variations across the resistors. Spark gap F102 provides protection from overloads which would result in increased voltages beyond the capacities of components.
