RADIO TUBES

Techni-talk

on AM, FM, TV Servicing

DEFLECTION CIRCUITS AND KICKBACK POWER SUPPLIES

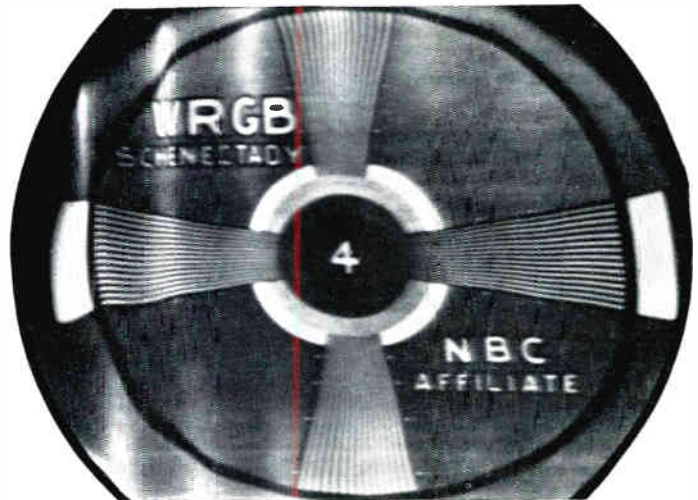
Tele-Clue No. 44. The striations or ripple in both the test pattern and waveform is the result of cross-talk of the horizontal sweep frequency components into the vertical deflection coils. The coupling takes place within the deflection yoke where the horizontal pulse and wave variations are impressed into the vertical deflection coils. This causes a slight amplitude modulation of the vertical sweep voltage that gives the picture the rippled effect. The repetition is maintained until the transient is dissipated in the vertical coils, as indicated by the fact that the ripple gradually disappears in going toward the right-hand edge.

One source of this trouble is when the capacitor shunting one-half of the horizontal deflection coils is incorrect. This capacitor, C56 in Fig. 1, balances one coil against the other with respect to ground, resulting in a minimum of cross-talk. The condition shown in the above photographs resulted when C56 was changed to .001 mfd. These photographs represent an extreme variation which would seldom be seen. Light vertical lines can frequently be eliminated by varying this capacitance. Another possible source is a defective yoke which can only be checked by substitution.

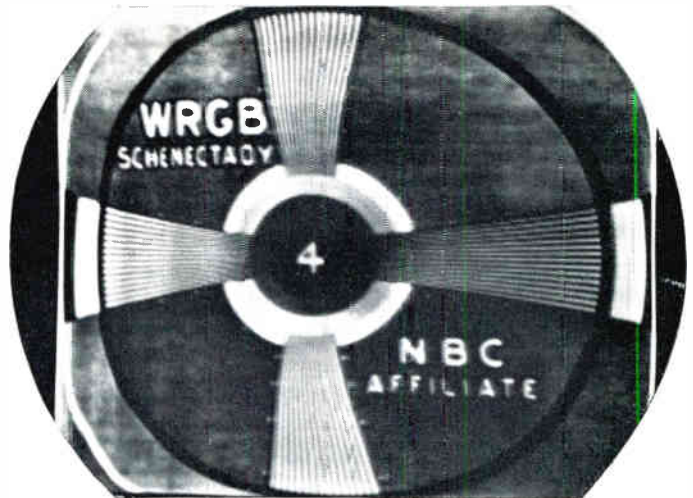
Tele-Clue No. 46. The above photographs are quite similar to those shown in Tele-Clue No. 43. This condition was caused by changing R55 from one megohm to 100,000 ohms which of course, changed the characteristics of V13 the sweep output tube. If we compare this waveform with Tele-Clue No. 43 we find that the principal difference is in the beginning and end of the trace portion of the sawtooth wave. This resulted in the foldover and compression at each edge of the pattern. The same bowed condition, found in the waveform of Tele-Clue No. 43, caused a similar non-linearity of the test pattern.
