ELECTRONIC SERVICING

JUNE
1958 • 50¢

Television SCHEMATICS and SERVICE GUIDE

Including: Alignment Data, Waveforms, Tube Location Guide, Operating Voltages, Essential Parts Numbers, etc.

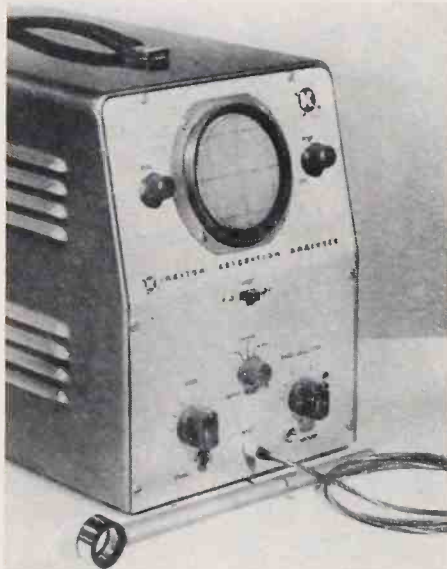
Fig. 1—Absorption analyzer and probe. Note the few controls.

A typical absorption analyzer,* (Fig. 1) is a dynamic test equipment unit capable of extremely fast and

probe, by its special shape and design, is capable of being capacity coupled to the signal in the plate circuit of a tube. Since the plate of a vacuum tube is the outermost electrode, placing a circular metal conductor about the tube envelope per-

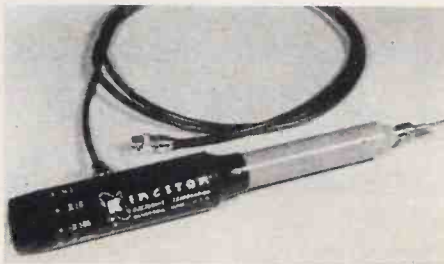
Fig. 3—This probe permits the analyzer to be used as a scope.

Picking up the plate signal in this manner has two great advantages. First, there is no direct connection to the circuit and therefore no loading of the circuit under test. Second, the ease and speed with which it can be accomplished. As shown in Fig. 2, the probes are constructed for the various size tube envelopes. A half ring or crescent probe is for use with dual-type tubes such as the 6SN7, where each half of the tube may have a different signal. In addition to the electrostatic pick-up probe, a direct probe, (Fig. 3) with a built-in attenuator is available for conventional oscilloscope servicing with the analyzer.

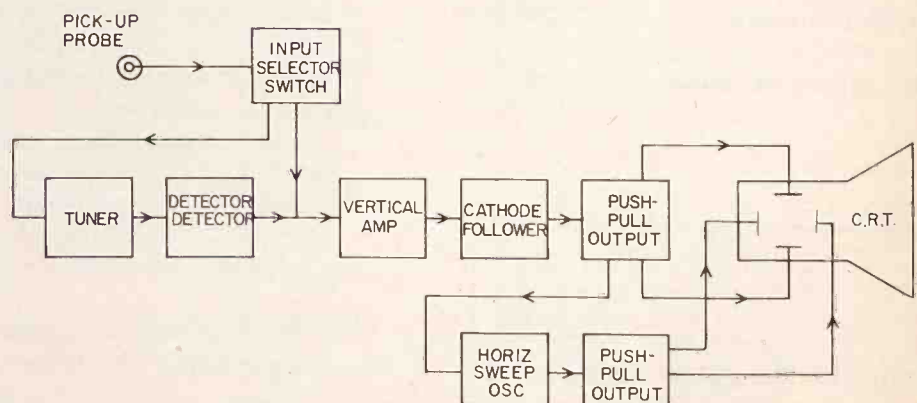
Fig. 4—The block diagram of the absorption analyzer is much the same as that of a scope except for the special input circuit.
