# TELEVISION

AND HOME ELECTRONICS REPAIR

OCTOBER 2003 £3.20

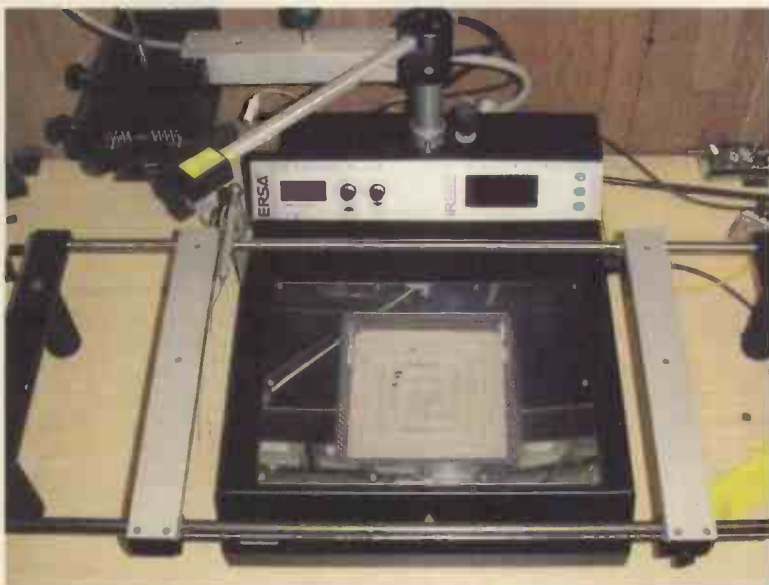
Photo 1: Michael Dranfield's ERSA IR500A PCB rework station. The overhead radiator is at top left.

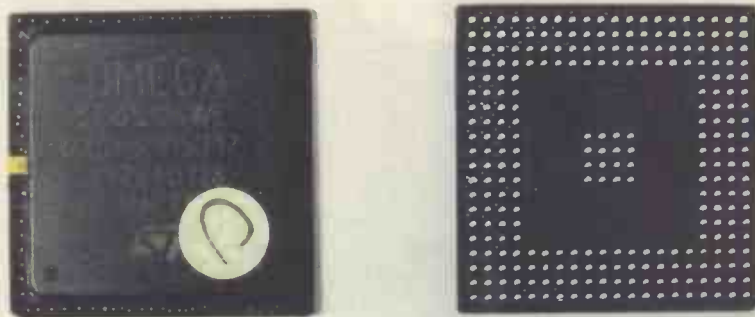
Photo 2: The 256-pin BGA microprocessor chip type STI5512SWE used in the Pace 2500S3 digibox, top and bottom views.

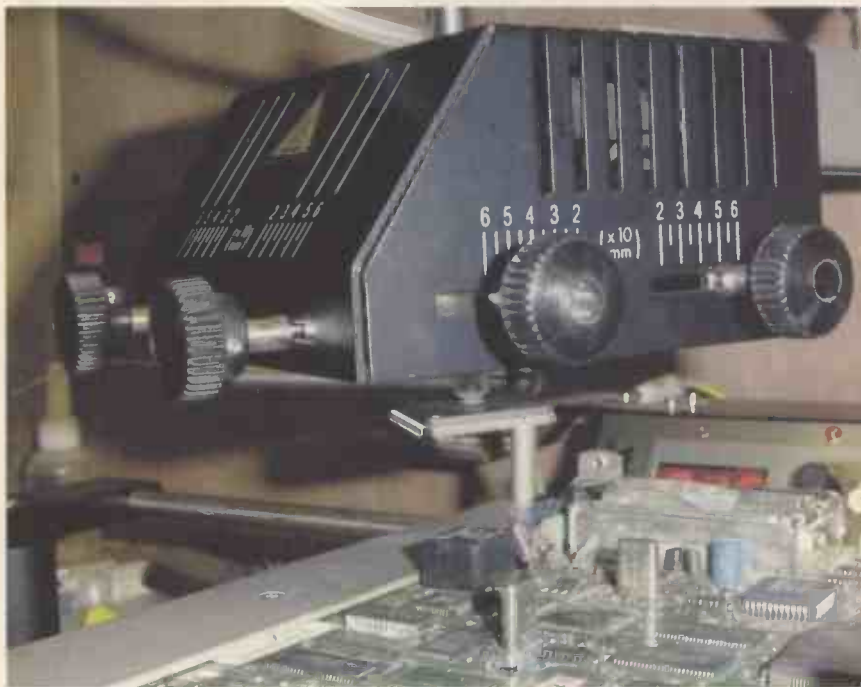
Photo 3: The overhead IR heat radiator, with its suction cup holding a 208-pin ST20 microprocessor chip that has just been removed from a Pace 2500B digibox PCB. There's not a pin out of place, and if the chip proves to be OK it can be reused.

The Erska IR500A uses a patented aperture system. Four control knobs on the overhead radiator, see photo 3, enable you to set the X-Y aperture size from anything between 10 and 50mm, which covers most of the chips you are ever likely to come across. There are no running costs part from the need to replace, quite frequently, the silicone suction cups used by the automatic vacuum chip lifter. They lead a hard life. I've just received some extra long-life samples, but have not yet had time to try them out.

Photo 3 shows a 208-pin ST20 microprocessor chip that has just been removed from a Pace 2500B digibox. Not a single pin has been damaged. Photo 4 shows the PCB after cleaning up with desoldering braid. As you can see, no damage has been done to the tracks and the PCB is ready to have a new IC fitted.

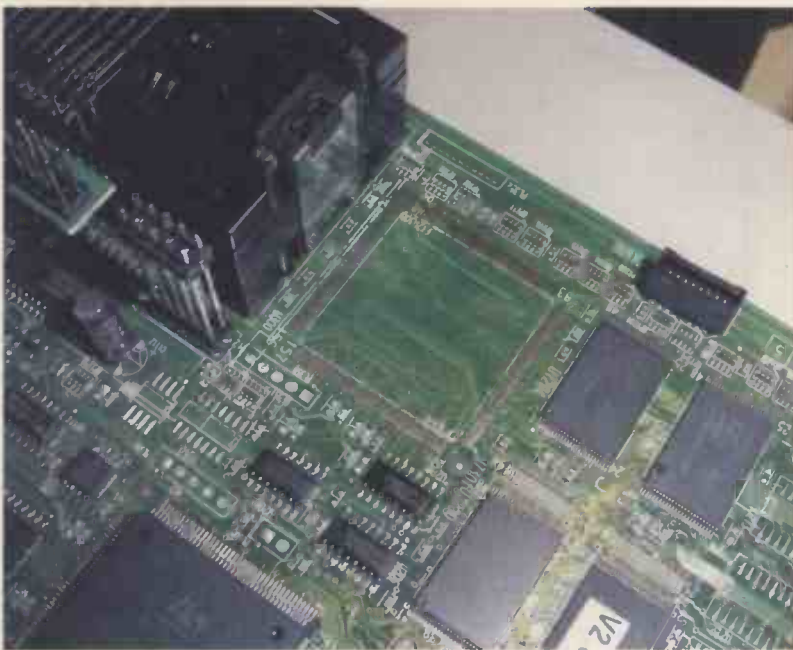
**Photo 4:** PCB after removal of a 208-pin IC and cleaning up with desoldering braid. No PCB or track damage has occurred.

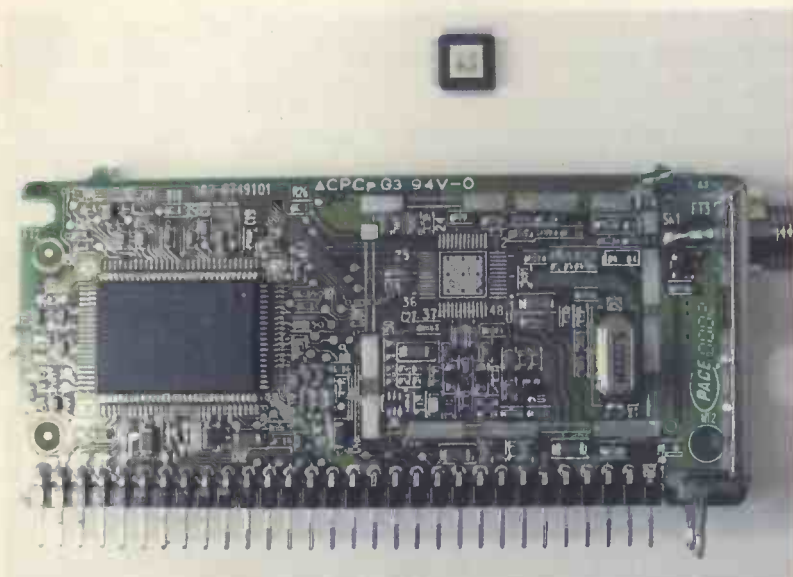
**Photo 5:** A MAX2104 ZIF chip (top) after removal from the tuner (below) used in the Pace 2500B digibox. The metal section at the bottom of the chip, shown in this photo, has to be soldered to the board. This is impossible with conventional soldering gear.

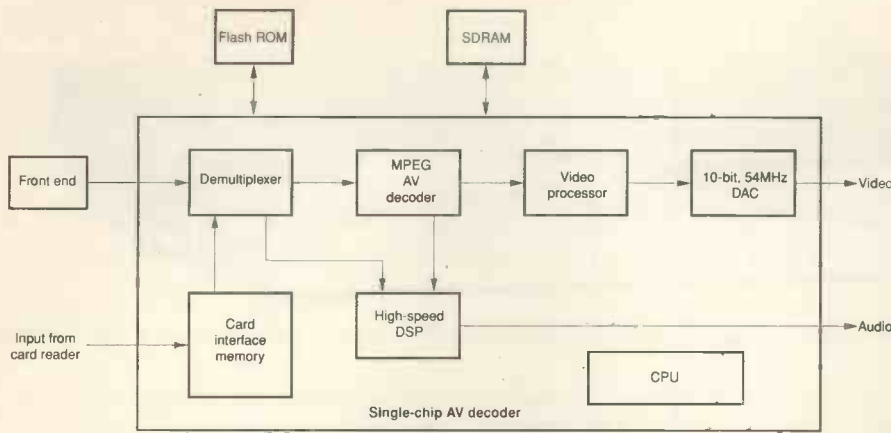
Fig. 1: Block diagram of the decoding system in Model XV-NP1.

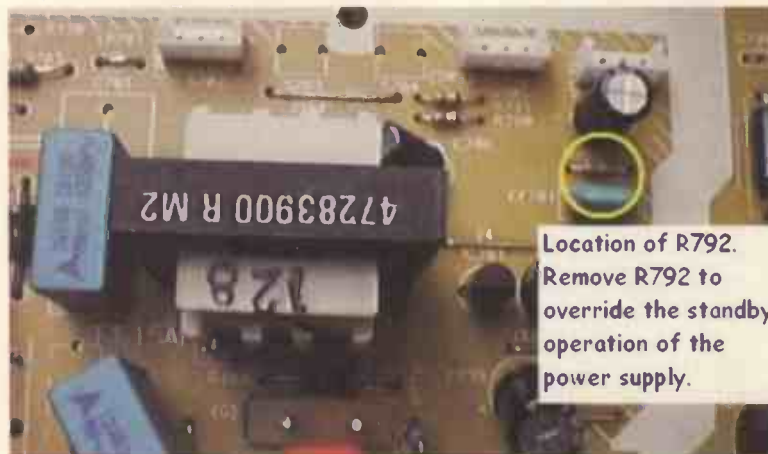
Location of R792. Remove R792 to override the standby operation of the power supply.

When the power supply starts with R792 disconnected it should regulate correctly. The power supply outputs can be disconnected in this condition but the integrity of the regulation feedback loop must be maintained, otherwise the HT will rise to a high level and component failures will occur.

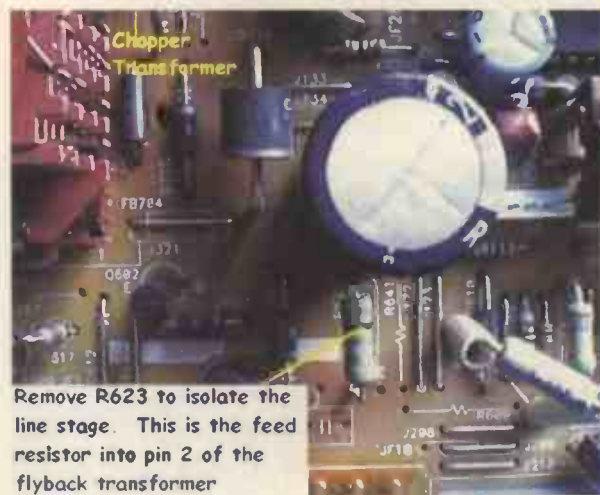
Remove R623 to isolate the line stage. This is the feed resistor into pin 2 of the flyback transformer

Fig. 11: Location of R623 in the feed to the line output (flyback) transformer.

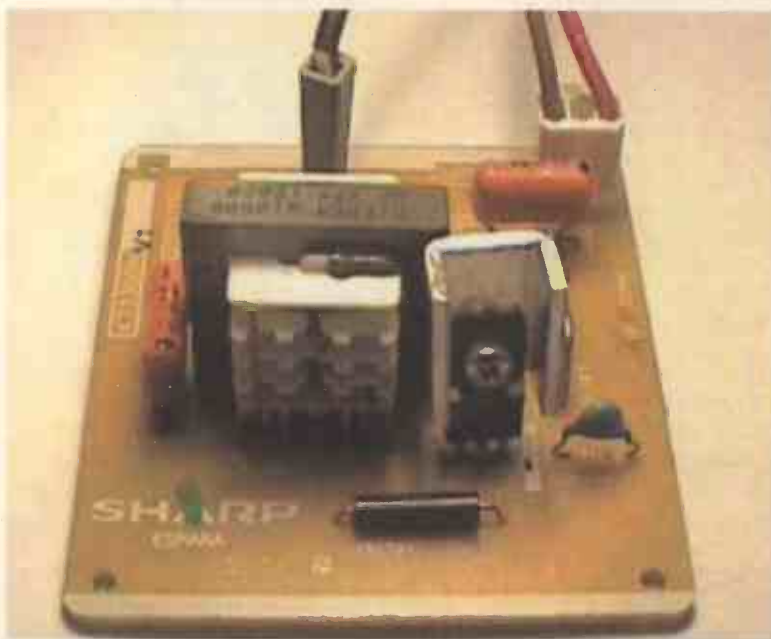
Fig. 14: The power-factor correction PCB used in Model 56FW53H.

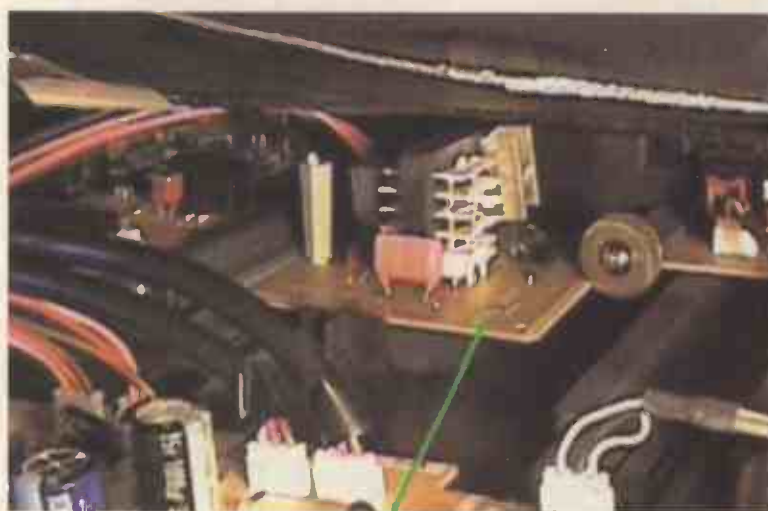
### Location of Power Factor PWB

Fig. 15: Location of the power-factor correction PCB in Model 56FW53H.

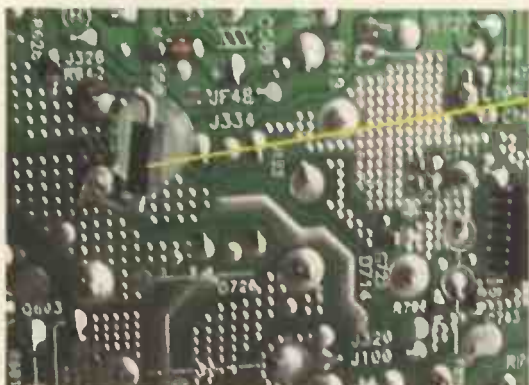
Fig. 16: The location of avalanche diode D735. Note hot-melt glue (see text).

Location of D735 on the print side of the PWB

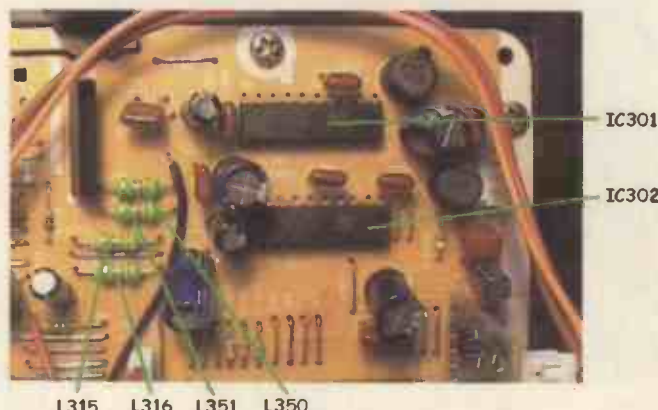
Fig. 17: Location of the audio output stage components on the main PCB.

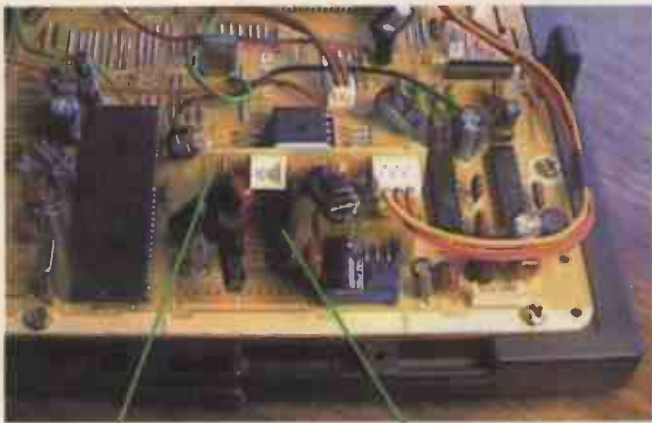
Centre speaker PWB IC1302 - IC1300 is an SMD device mounted on the print side of the PWB

Fig. 18: Location of the centre-speaker PCB.

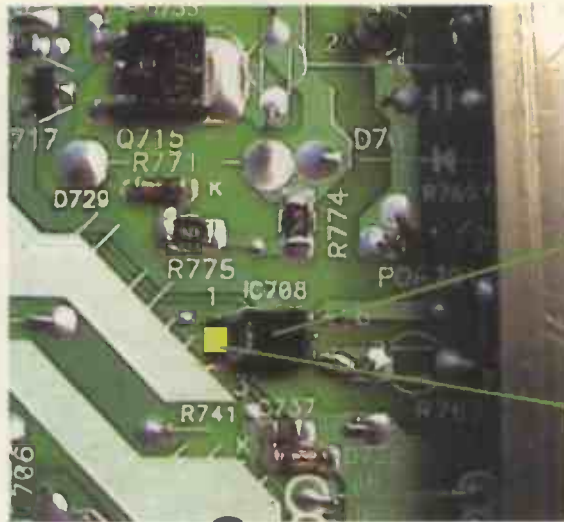
IC708  
Location of SMD capacitor

Fig. 20: Location of the SMD capacitor at IC708.

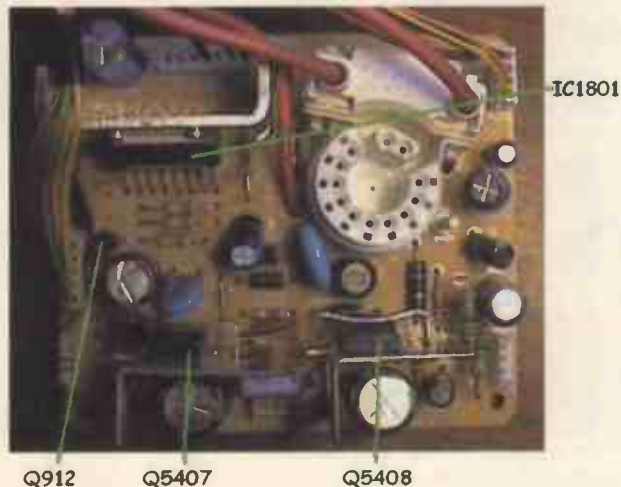
Fig. 19: Position of CRT base PCB components that can fail under high-HT conditions.

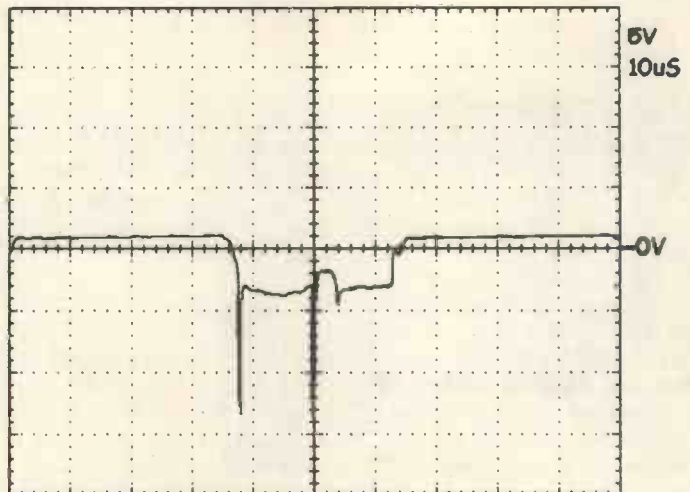
Fig. 21 Drive waveform at the base of the line output transistor Q601.

Once the line output stage is running, D611 provides a low-impedance, high-current path to turn Q601 on. D610 does the same to switch Q601 off. These low-impedance supplies are required to ensure that the output transistor spends a minimal amount of time on the linear portion of its characteristic. When Q601 is

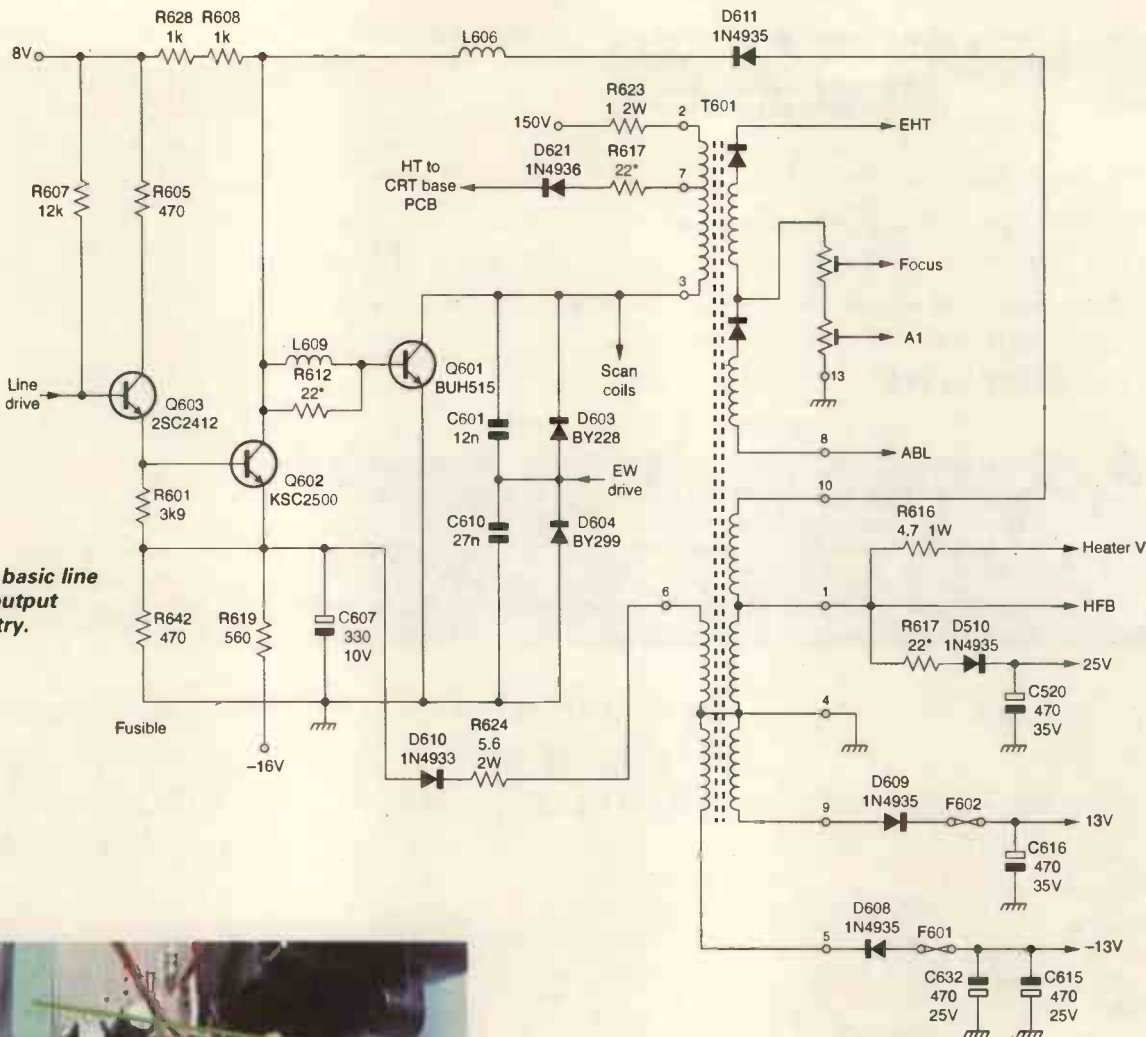
Fig. 22: The basic line driver and output stage circuitry.

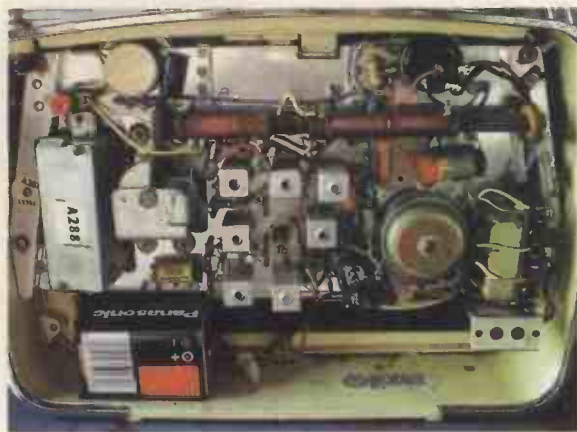
Photo 2: Internal layout of the VTR103.

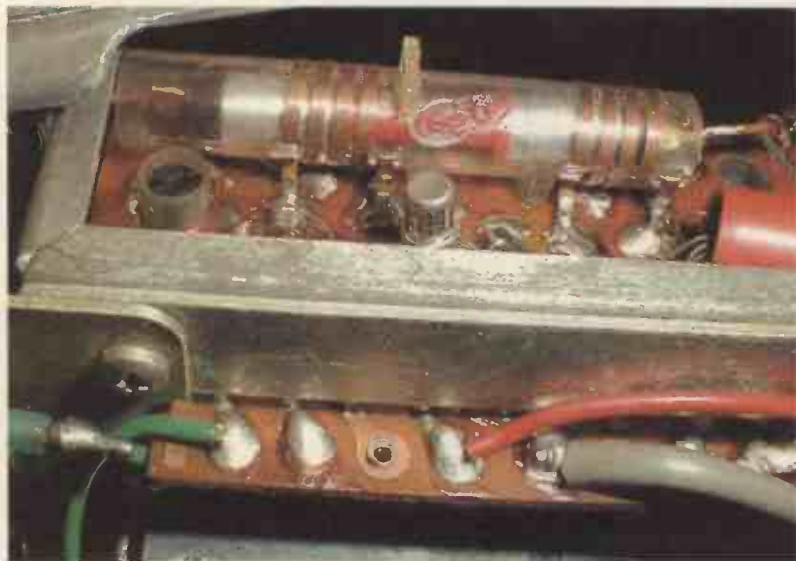
Photo 3: The VHF tuner, after removal of its screening can.

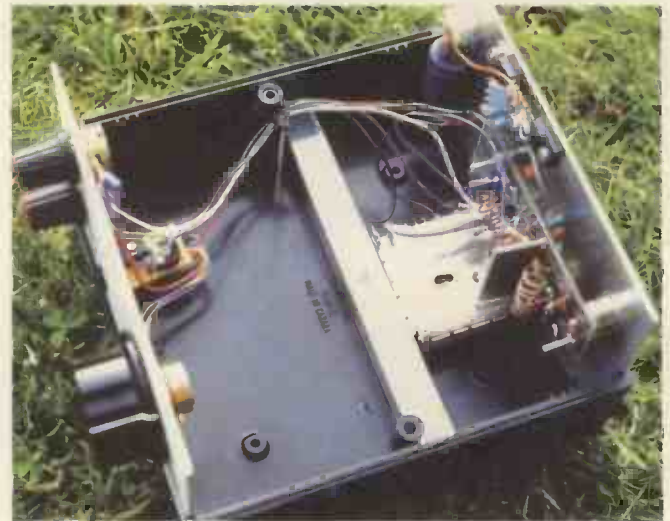
Internal view of the D500 DX-TV converter.

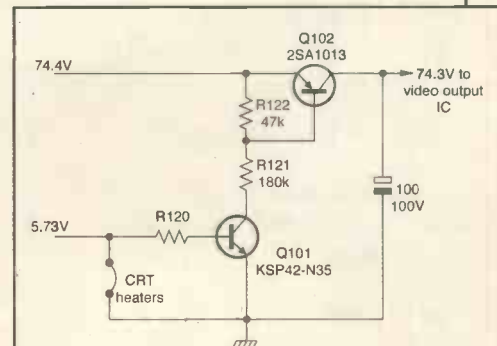
Fig. 1: The unusual circuitry in the supply to the video output chip in the Compaq V55.

While the fault was present I tested the monitor with the first-anode voltage turned to minimum – to protect the shadowmask. In this condition a faint, smeary display was visible. The voltages shown in Fig. 1 were measured after the repair and, yes, the CRT's heater voltage was just 5.73V. The trend seems to be to derive this supply from a chopper transformer wound to drive a Schottky-barrier rectifier diode. Since this type of diode is expensive, manufacturers often use an ordinary diode instead. This doesn't do the tube any good. When I replaced the diode concerned, D117, with a Schottky-barrier type the heater voltage rose to 6.1V. Still some way short of the 6.3V specified, but a considerable improvement. When you carry out this modification don't forget to add at least 0.33 $\mu$ F across the reservoir capacitor (C632, 1,000 $\mu$ F, 16V in this monitor) to swamp the higher junction capacitance of a Schottky-barrier diode. The diode should be rated at not less than 3A, 30V. I usually obtain the diode from a scrap power supply, typically a 12MBR30 (12A, 30V). **I.F.**
