TELEVISION

**IN-SITU
TRANSISTOR
TESTER**

OCTOBER
1976

VOL. 26 NO. 12
ISSUE 312

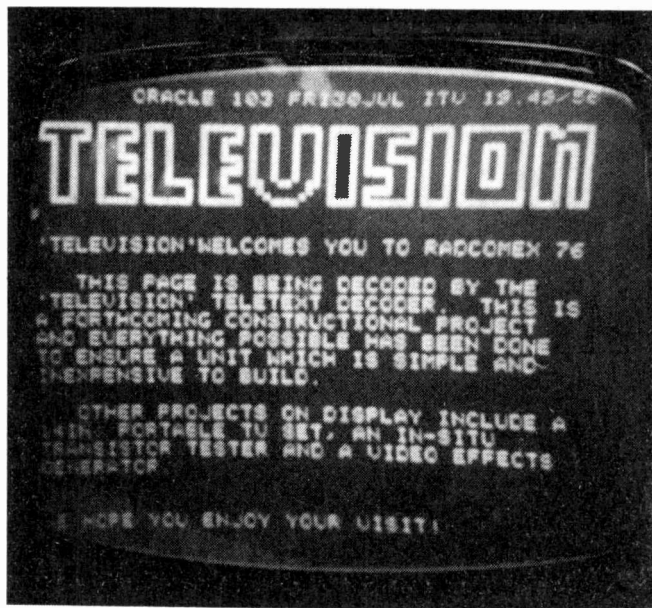
The "Television" Teletext decoder – more news soon – was on show at Radcomex 76. The IBA transmitted this Oracle page as part of the demonstration.

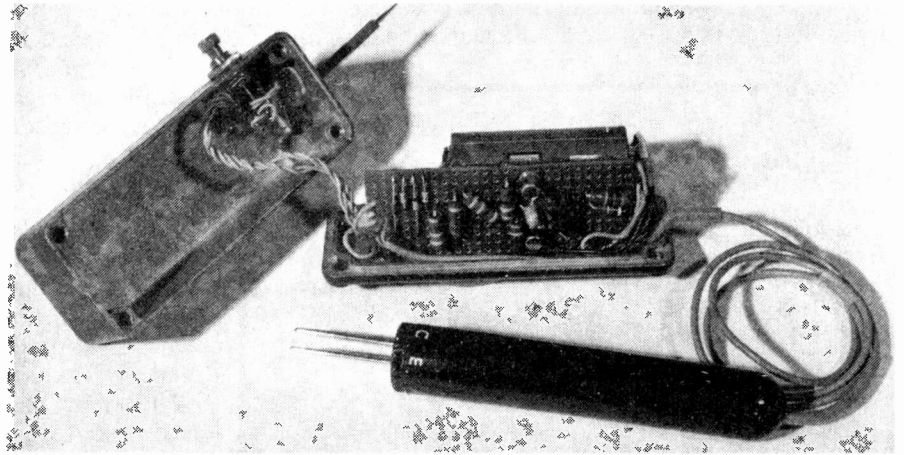
General internal view of the unit, showing the preferred method of construction. All the components are mounted on Veroboard which is attached to the lid of the diecast box. The base probe and on-off switch are mounted on the box itself, the collector and emitter probes being mounted in the cigar tube shown in the foreground.

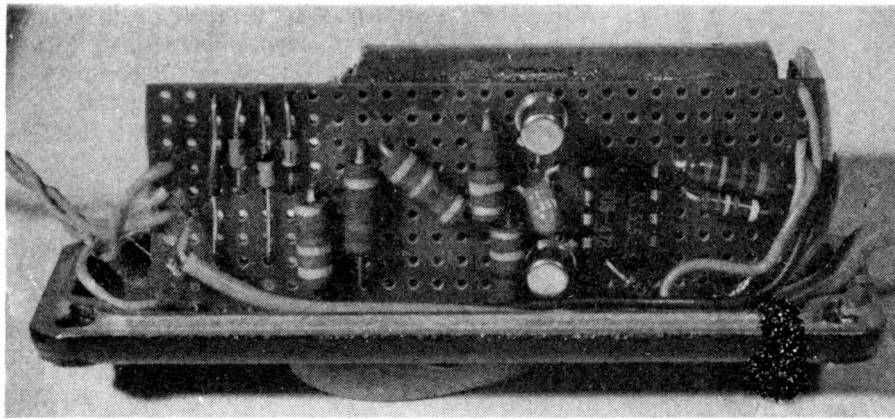
Close-up view of the component layout on the Veroboard. Refer to the layout diagram (Fig. 2) for the positions of the breaks required in the tracks.

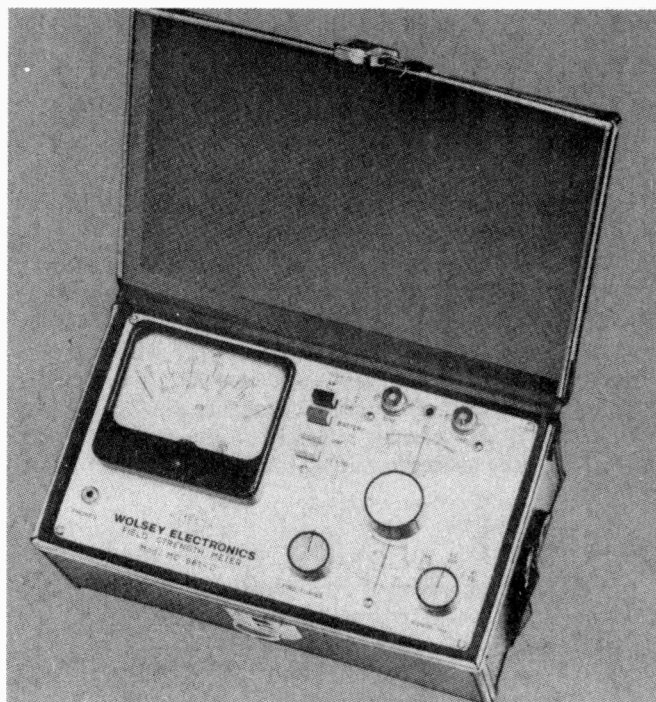
The Wolsey MC661C signal-level meter.

One criticism in use is the tendency for the encased meter to turn over and away from the operator when the lid is open. It is impossible for the meter to fall from the leather case however since a retaining screw passes into the meter

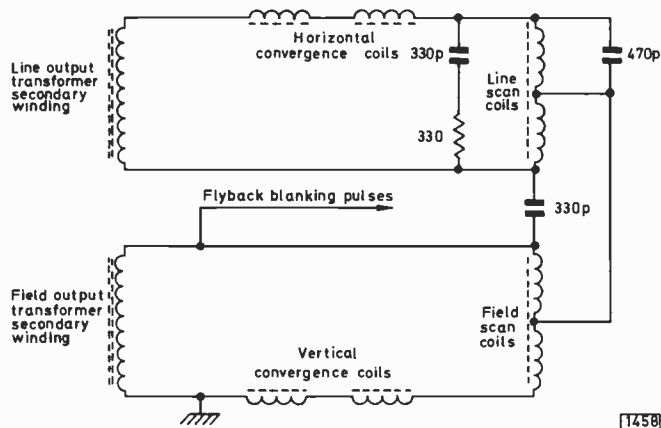
Fig. 1: The deflection coil and dynamic convergence circuitry. There are two sliders on the convergence coil assembly to enable the vertical red and green lines and the vertical yellow and blue lines to be converged at the sides of the screen.

The tube itself is unusual in several respects. First, although the guns are mounted in line – green centre, as in the Trinitron, 20AX and Toshiba tubes but unlike the PIL and Mitsubishi in-line gun tubes which have the red gun in the centre – there is a standard shadowmask and a phosphor dot screen. The dots are in line rather than in triad groups, successive lines being staggered in relation to each other. Secondly the three cathodes are internally connected – the signal drive consists of luminance to the cathodes and the colour-difference signals to the three grids. Thirdly, the deflection angle is 70° . And finally with this small deflection angle, the in-line guns and a toroidal deflection yoke a very simple convergence system can be employed. In fact there are just two dynamic convergence adjustments, while the dynamic convergence coils are simply connected in series with the scan coils which, as shown in Fig. 1, are also linked. The tube is operated at 17kV e.h.t. which is obtained

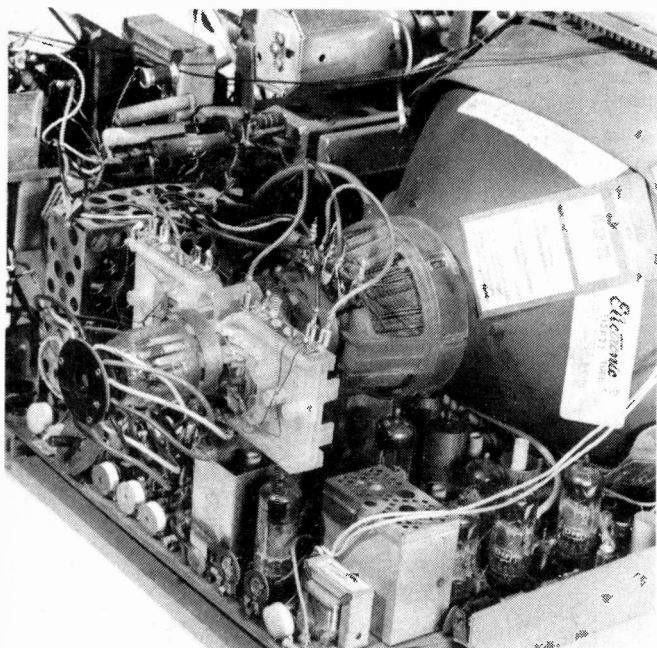
Interior view of the Granada Colourette, showing the unusual arrangement of tube neck components.

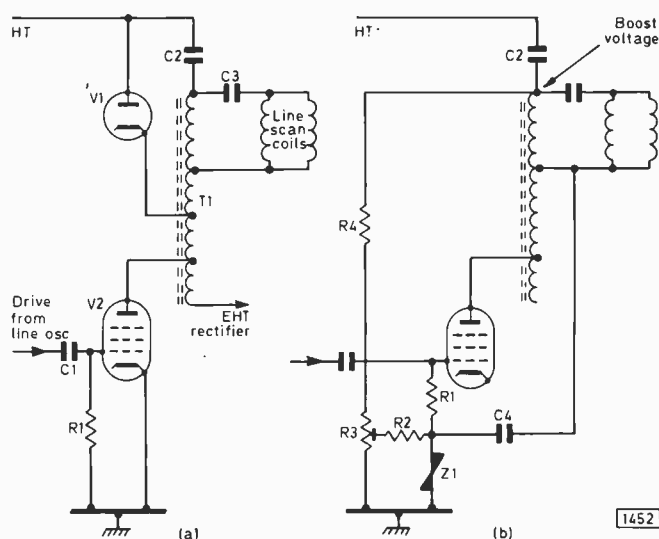
Fig. 1: The basic valve line output stage is shown at (a). V1 is the boost diode, C2 the boost capacitor. The conduction of V1 during the first half of the forward scan charges C2 to several hundred volts, giving a boosted h.t. supply at the junction of C2/T1. Since the early sixties it has been the general practice to incorporate the stabilisation arrangement shown at (b).

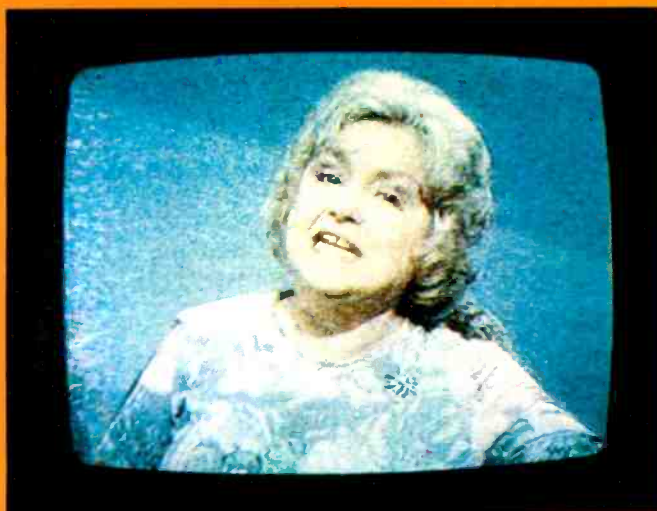
1

Severe picture noise is caused by either poor reception or low gain in the tuner/i.f. amplifier. Normally it will be the tuner, but first, check the coaxial cable feed. All coaxial plugs and sockets should be *soldered* to the cable.

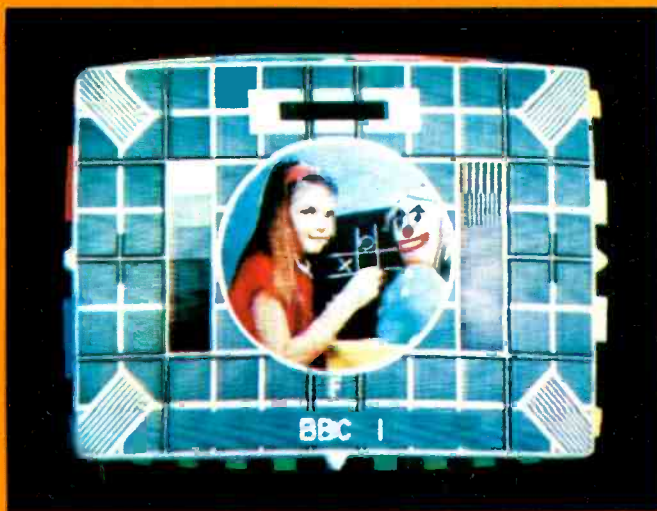
2

R.F. patterning can be one of the most difficult faults to locate. The coarser the pattern the lower the interference frequency. First make sure whether the interference is coming from the set. If not, turn off all other electrical equipment in the house until the offending equipment is found.

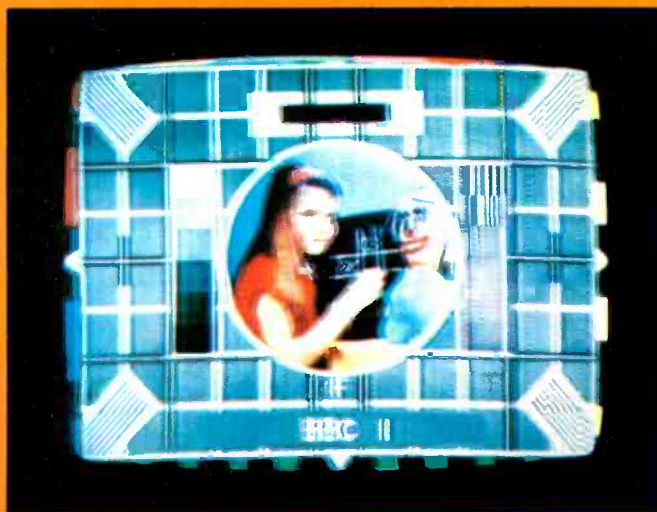
3

H.F. ringing is nearly always caused by a misaligned i.f. amplifier, and that means using a wobulator to realign the strip. If valves are used in the i.f. amplifier *check them all first*.

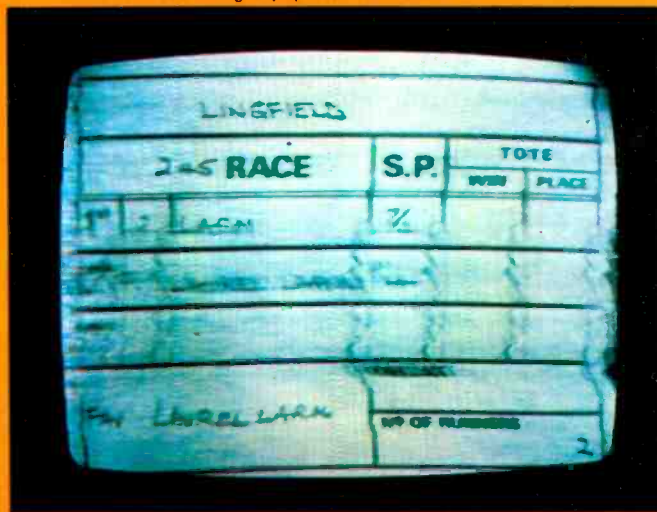
4

Instability is usually found in the i.f. amplifier but could be caused by the failure of the a.g.c. stages. Use of a wobulator and detector probe is still the best way of location.

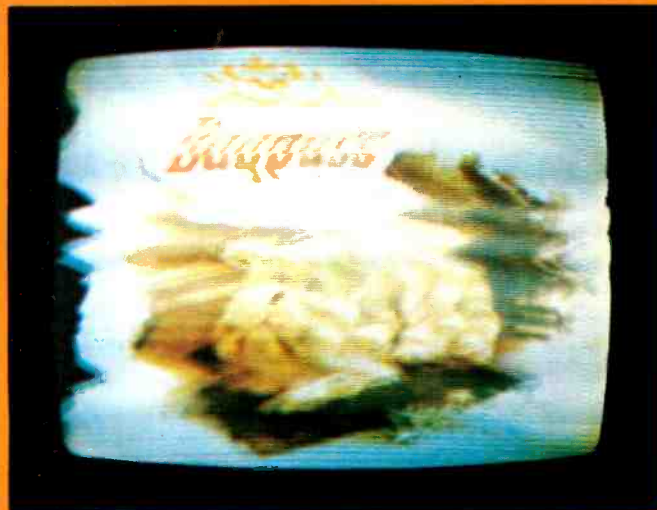
5

The a.g.c. section of a receiver can cause a number of different fault symptoms. This one is the result of poor decoupling of the control voltage to the amplifier and tuner.

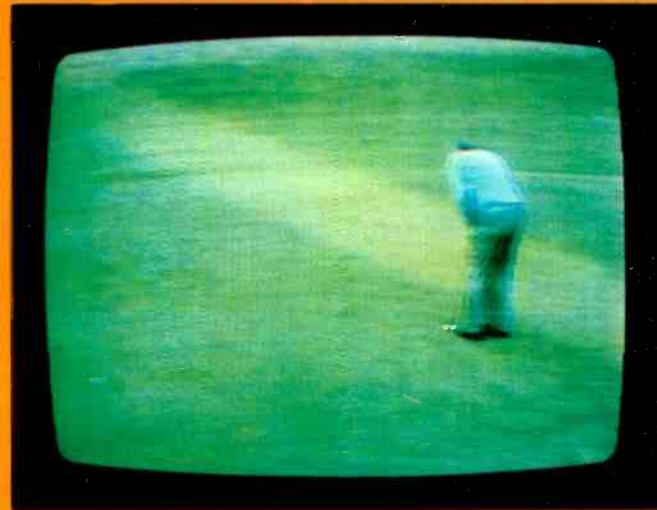
6

Luminance amplifier failures are normally quite obvious, with the exception of a few. This fault is caused by the delay line having shorted turns. The result is ringing of the luminance signal and the displacement of the chrominance information.

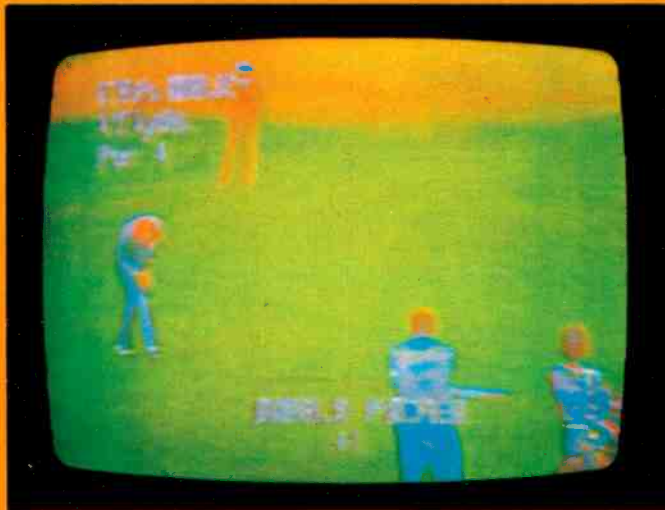
7

Complete failure of the luminance amplifier will result in a colour-difference signal only display on the screen. If the receiver has no picture at all, but sound is present and the scans locked, turn the colour control to maximum to make sure the colour is missing.

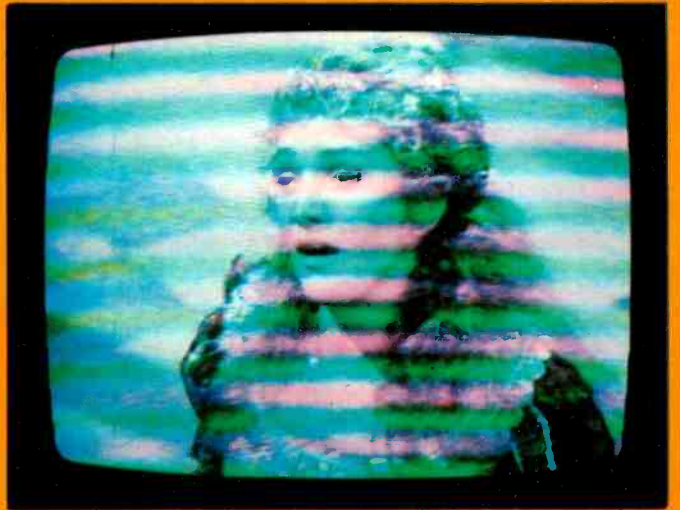
8

When a monochrome only picture is displayed override the colour killer. If the fault is still present the problem probably lies in the a.p.c. loop or the subcarrier oscillator.

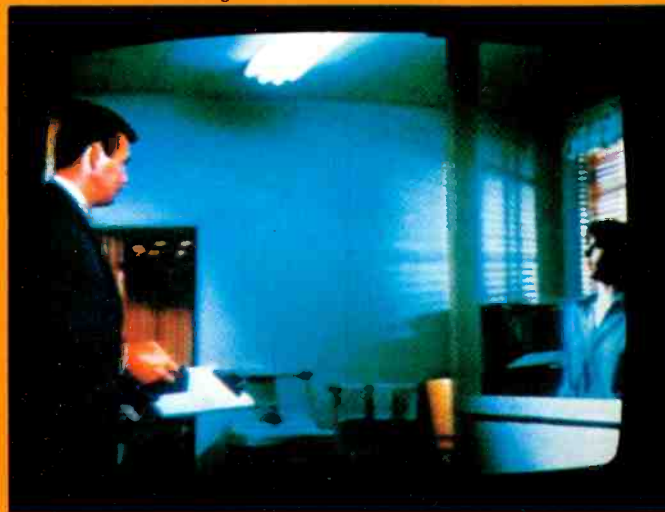
9

Another patterning problem, but this time the colour picture only is affected. The problem must lie in the decoder or the vision demodulator circuit. Check the bandpass filter first, then move to the chroma amplifier.

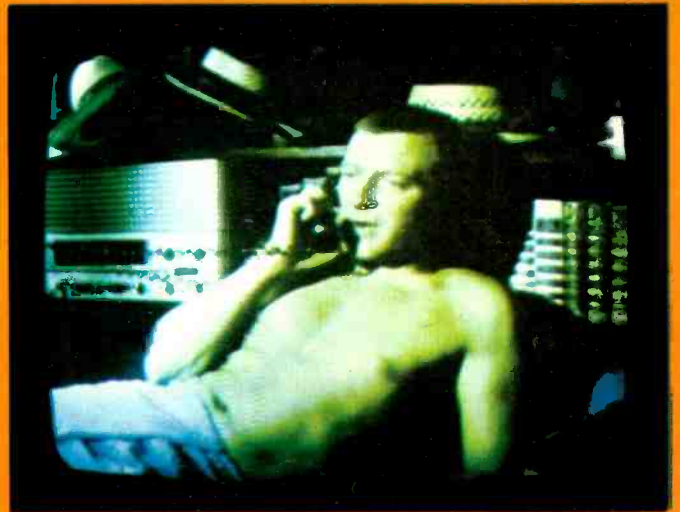
10

Absence or either the U or V signal will affect the green content of the picture as well. In this example the R - Y signal is missing, which could mean failure of the red signal matrix or the R - Y demodulator. The problem could also lie in the delay line matrixing circuit or in the subcarrier feed to the demodulator.

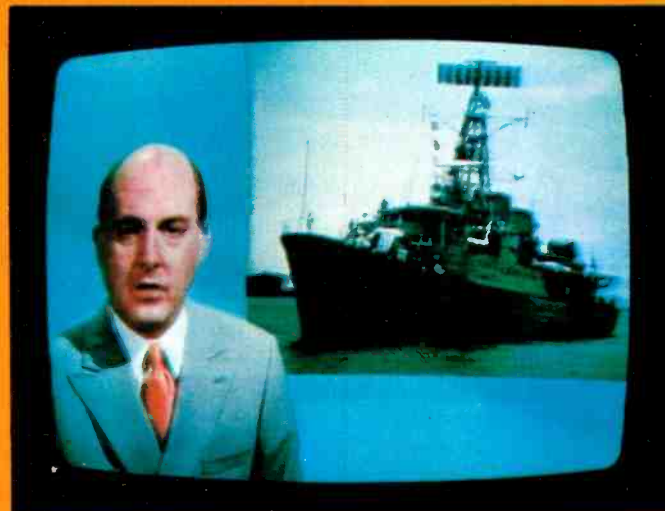
11

No B - Y signal is normally caused by failure of the blue matrix or the B - Y demodulator. Again check the delay line and subcarrier feeds.

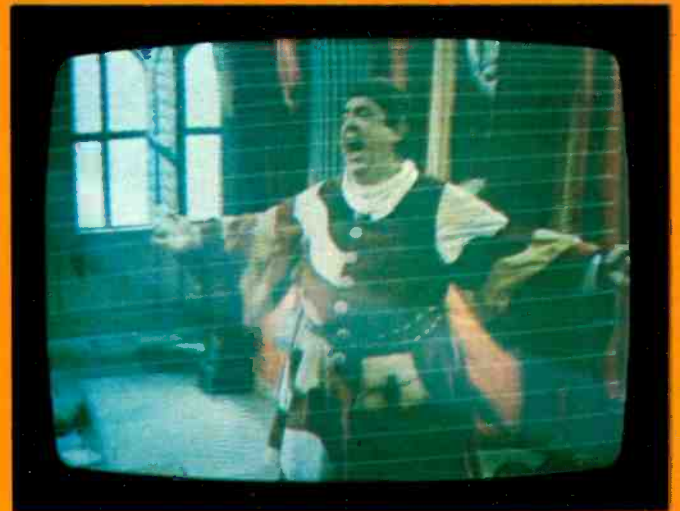
12

Field flyback lines are more noticeable at low brightness levels. In this particular set the fault was due to incorrect clamping conditions, but check the flyback suppression circuits to the c.r.t. as well.

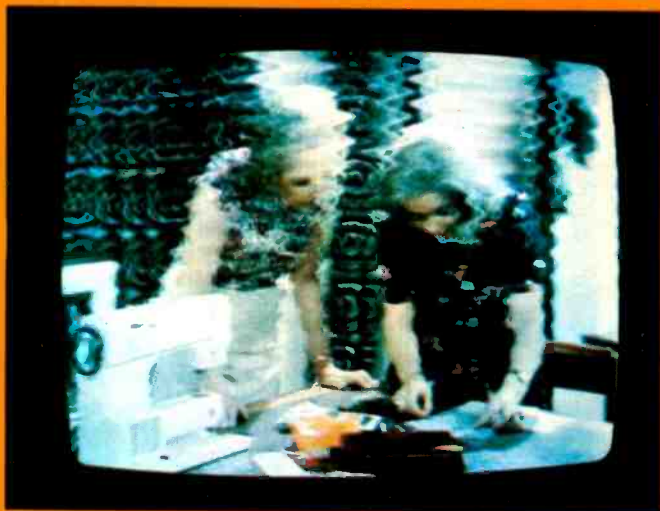
13

The line oscillator and output stages are becoming more complex, and so are the faults. This one is caused by poor decoupling of the line oscillator control voltage from the flywheel sync circuit. The result is severe line oscillator hunting.

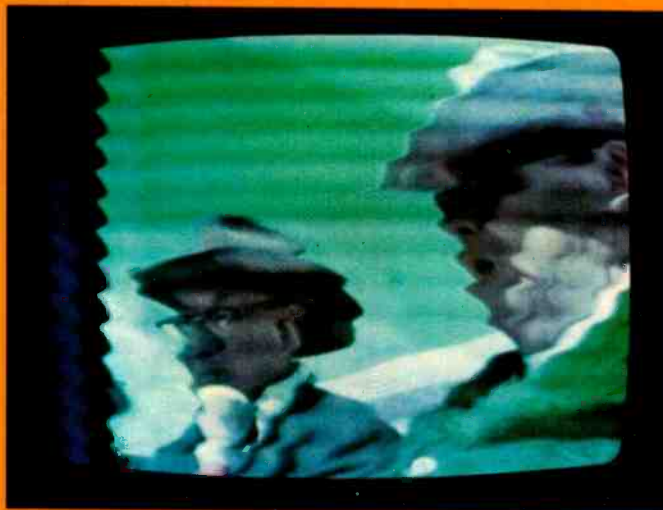
14

Modern line timebase i.c.s incorporate line phase adjustments. If incorrectly set up or fails in some way the picture can be horizontally displaced. In this example the displacement is accompanied by line pulling.

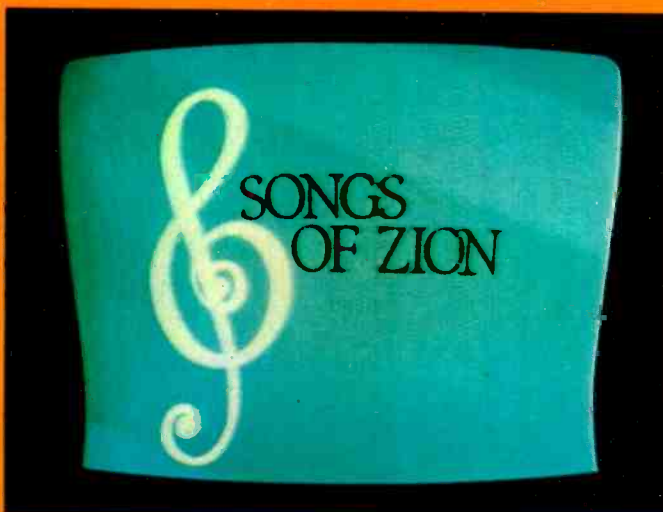
16

Trapezium distortion – a type of fault that is now being found in 110° receivers that employ width modulators to provide EW raster correction. The fault could also be found in 90° sets, due to a defect in the line scan coils.

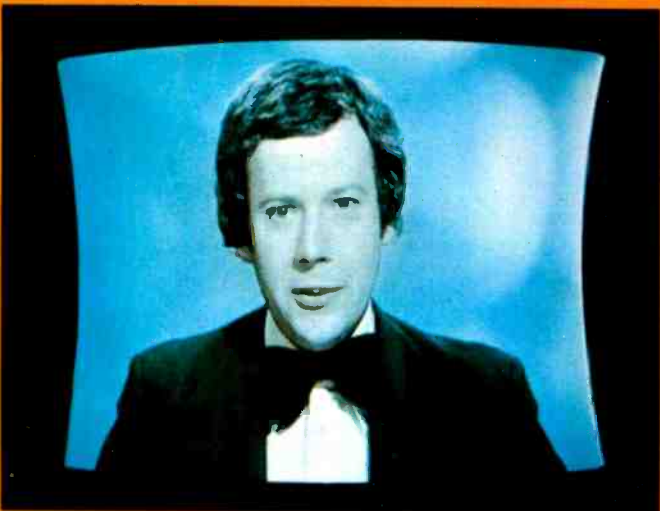
17

Pincushion distortion is another width modulator problem, but failure of the transducer and associated circuits in 90° colour receivers can produce the same result.

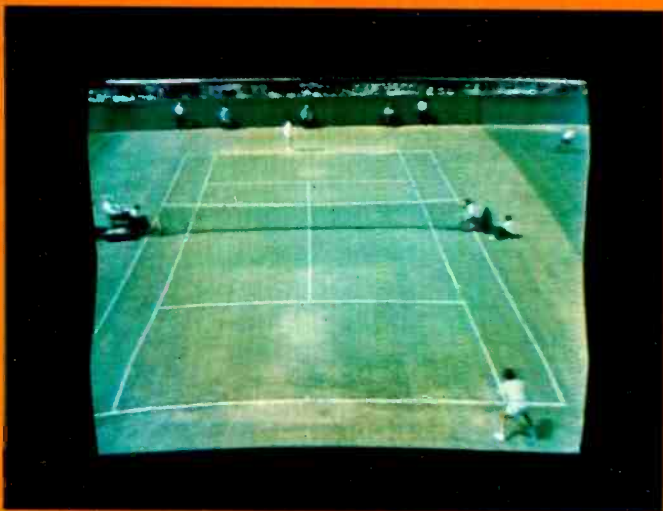
18

Reduced line and field scan amplitudes can only mean one thing – low h.t. The picture colour quality and brightness need not vary, especially if the l.t. supplies are derived from the line output stage. Check the h.t. rails before you start fault finding in any section of the receiver.

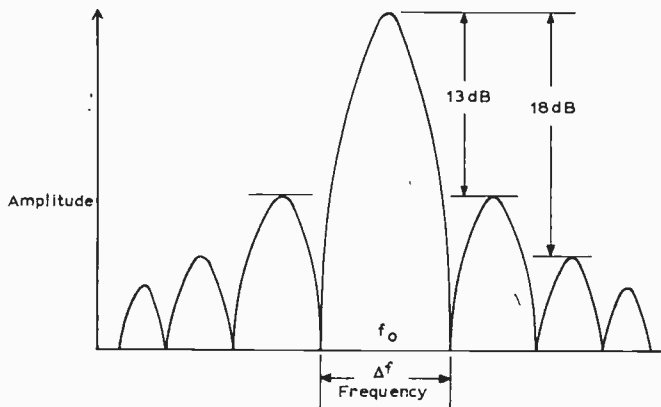
Fig. 2: Fundamental filter response using a large number of evenly spaced electrodes.

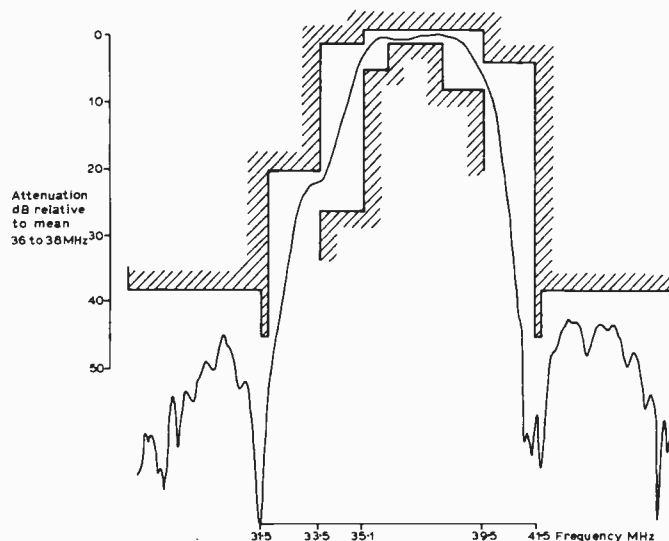
Fig. 3: Response of the Plessey SW150 filter which is tailored for the UK standard I. The shaded areas show the production limit spreads.

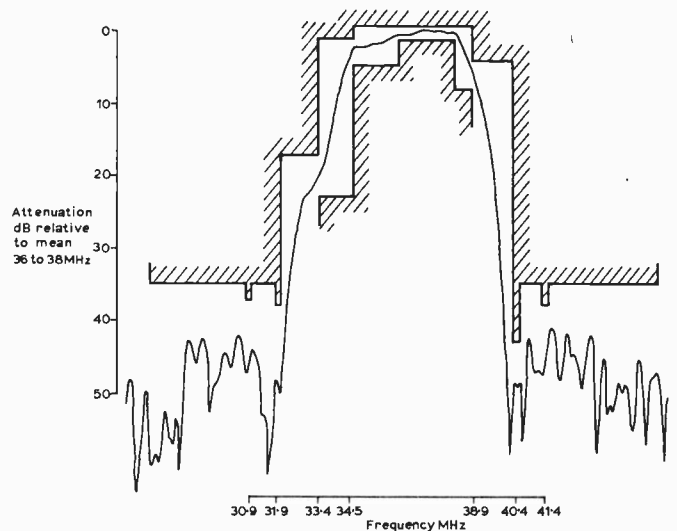
Fig. 4: Response and production limit spreads for the Plessey SW170 filter which is tailored for the European standard G.

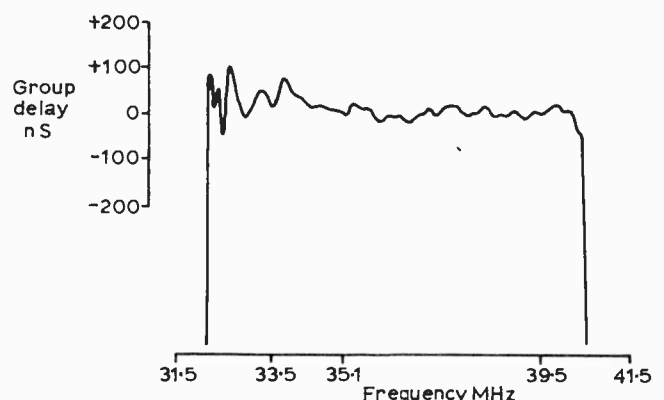
Fig. 5: Group delay response of the SW150. As can be seen this is very linear as compared to LC block filters.

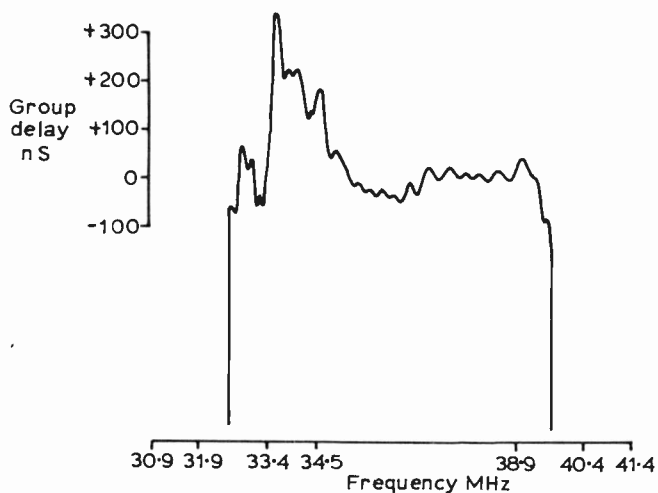
Fig. 6: Controlled group delay response for the SW170 European filter.

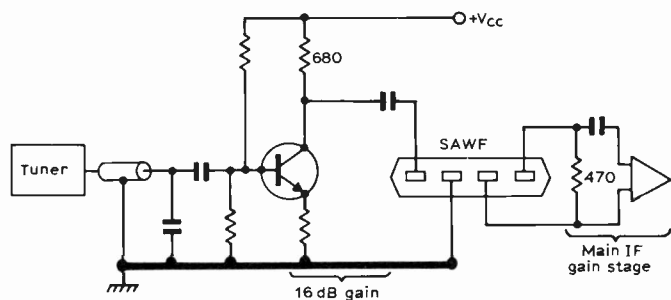
Fig. 7: Basic single transistor preamplifier stage providing 16dB of gain. The output impedance of this stage is 680Ω which is satisfactory for most applications.

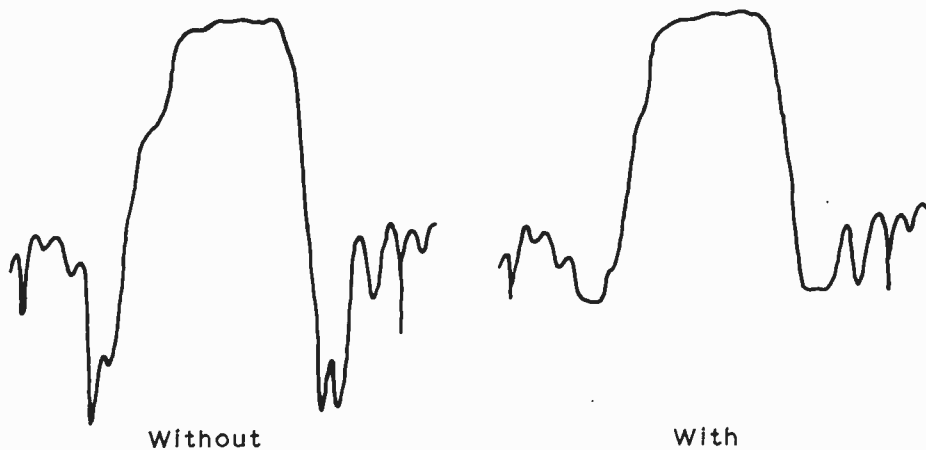
Fig. 12: The result of direct break-through due to poor layout. The response on the left was taken with good layout while the one on the right shows reduced trap depths due to breakthrough.

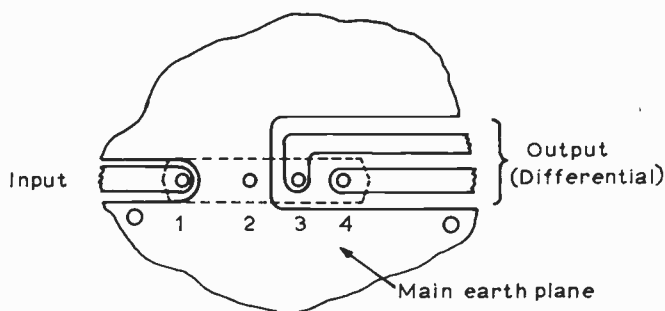
Fig. 14: Recommended p.c.b. layout to ensure low breakthrough. Any departure from this may result in unacceptable performance.

be minimised. The layout shown in Fig. 14 should be used, keeping the input and output track lengths as short as possible.

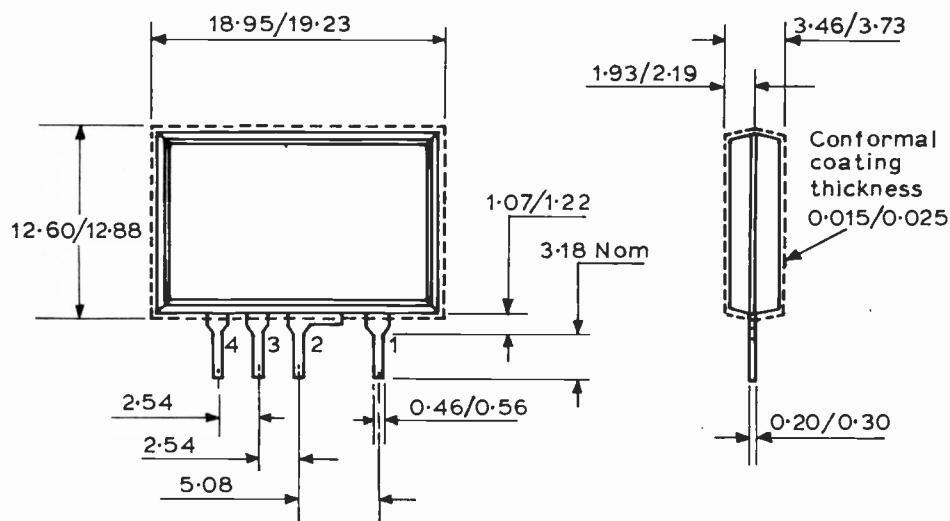
Fig. 15: Package details of the Plessey device. The saving in board space can be clearly seen when compared to say five coils.

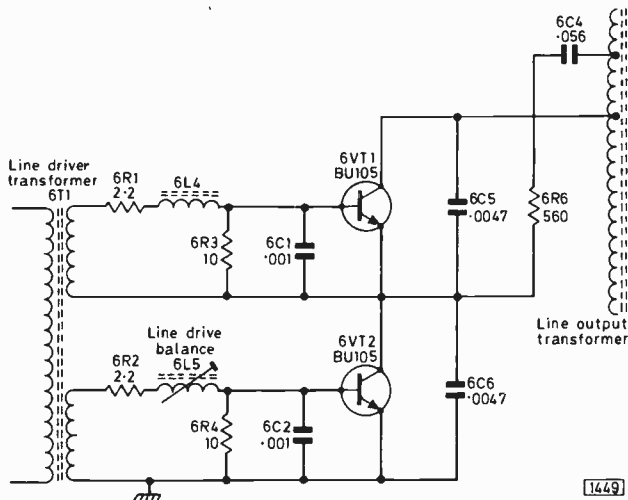
Fig. 1: The two-transistor line output stage widely used in earlier solid-state colour chassis. This example is from the Rank A823 chassis. To ensure that the line flyback pulse voltage developed across the two transistors is equal the output stage tuning capacitance consists of two series connected capacitors 6C5 and 6C6 whose junction is connected to the centre tap on the primary winding of the line output transformer via 6R6 and 6C4. These latter two components were omitted on later versions of the chassis. They can safely be removed from earlier models.

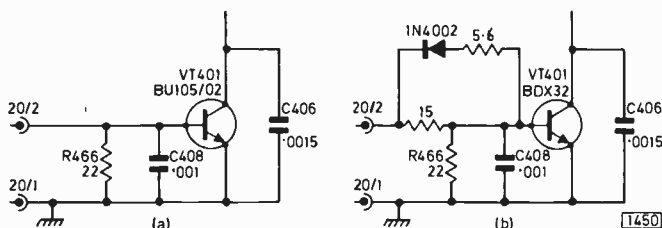
Fig. 2: A BDX32 line output transistor can be used to replace a BU105/02 transistor in the Thorn 8000 and 8000A chassis provided the modifications shown in (b) above are carried out. The extra components modify the drive conditions and can be mounted on the transistor's heatsink. They must be removed if either a BU105/02 or its successor the BU206 is subsequently fitted, restoring the circuit to its original state (a).

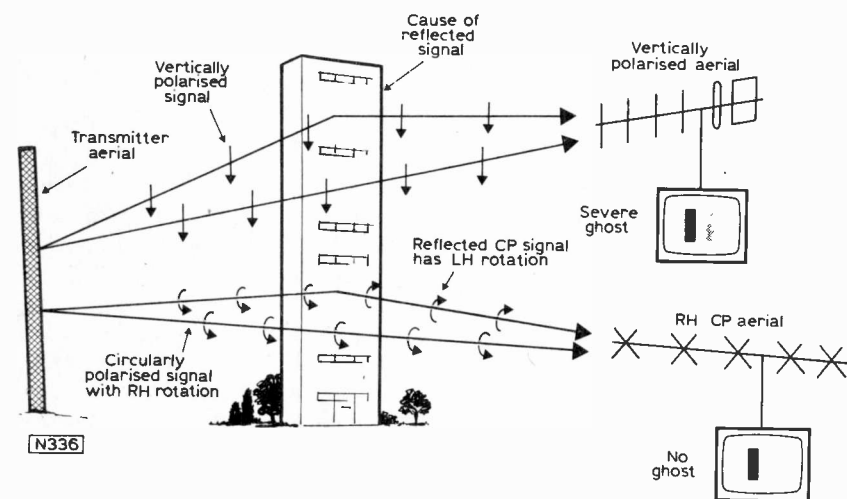
Fig. 1: Illustrating one of the advantages of circularly polarised transmissions: since a reflected CP signal reverses its sense of rotation while a CP receiving aerial discriminates between CP signals of opposite sense, ghosting is considerably reduced.

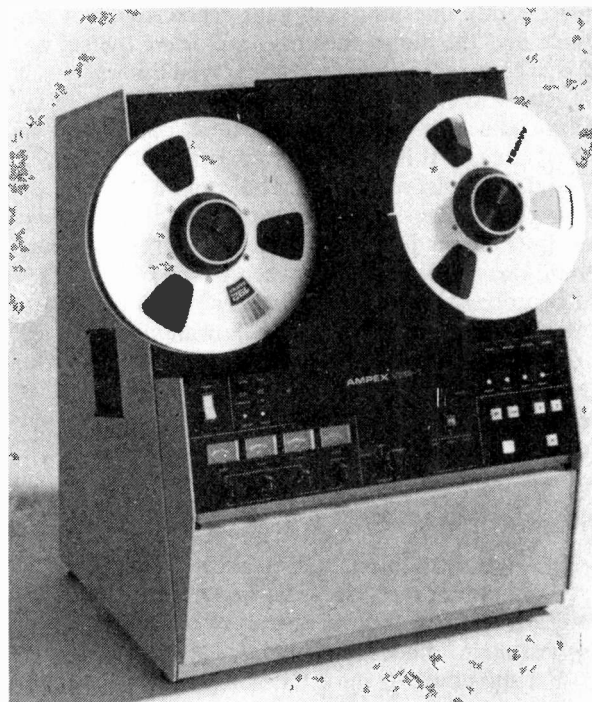
The Ampex VPR-1 helican-scan recorder, with the exclusive automatic scan-tracking (AST) system, provides broadcast quality, slow-motion and still-frame playback. AST eliminates tracking and interchange problems. Other features are $\frac{1}{2}$ speed and manual frame-by-frame jogging for simplified editing. The version shown is the table top model.

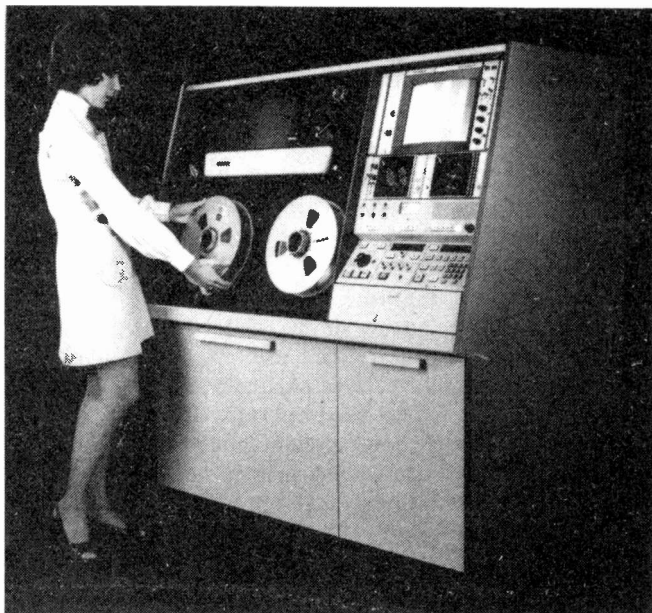
The Ampex Model AVR-3 is the world's first "intelligent" VTR. The AVR-3 allows broadcasters to record and play back live pictures automatically. When equipped with the optional edit controller the AVR-3 can be programmed to handle a wide range of editing functions otherwise currently possible only with computer editing systems. The AVR-3 is a dual-band machine compatible with existing broadcast equipment.
