TELEVISION

SERVICING-VIDEO-CONSTRUCTION-DEVELOPMENTS

SIMPLE TEST CARD GENERATOR

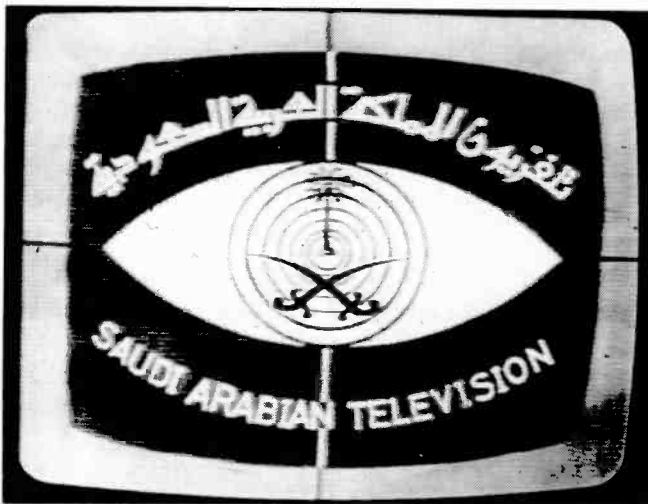
Saudi Arabia ch. E6 station identification card. Photo courtesy Alan Latham.

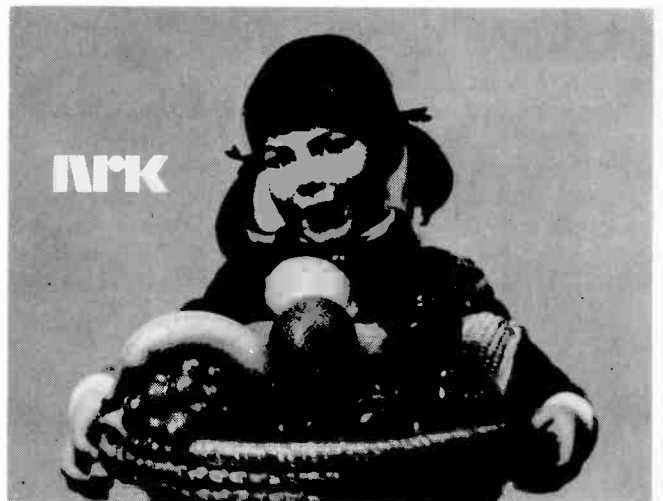
The new NRK (Norway) colour test card. Copyright Norsk Rikskringkasting, photo courtesy HS Publications.

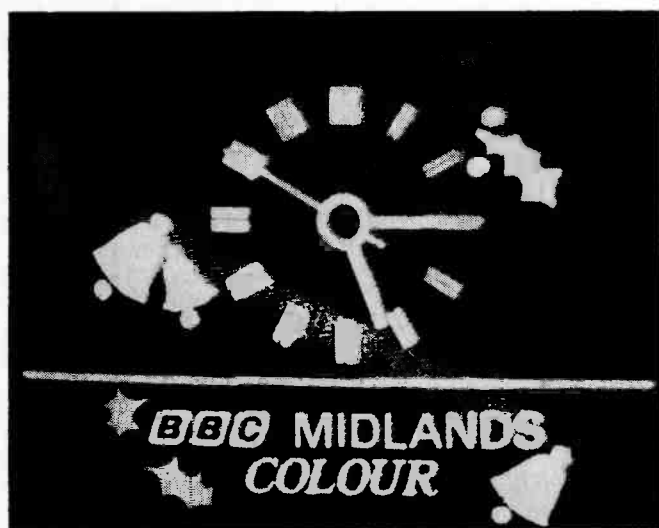
Fig. 3: BBC Midlands Christmas clock caption, 1973. The London Television Centre clock caption is occasionally dressed up.

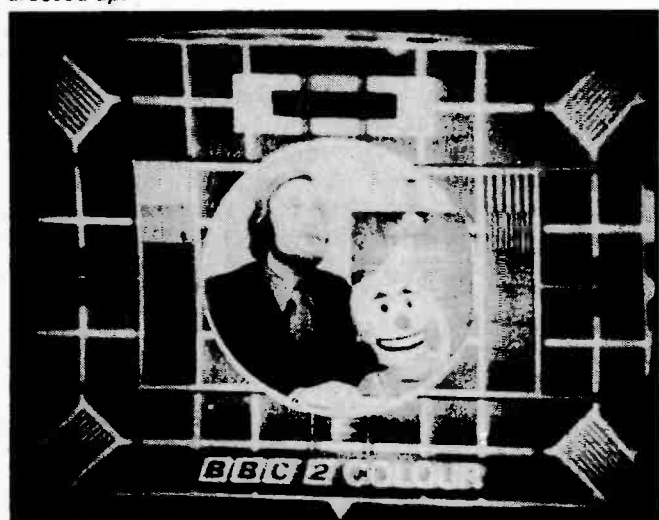
Fig. 5: The BBC-2 test card F was transmitted on BBC-1 during the programme Nationwide.

The first photograph (Fig. 5) was taken in 1974, off BBC-1's "Nationwide", in which aerial erectors were under investigation and examples of poor installations were given. Test Card F has been interfered with in this fashion on several occasions. Digressing for a moment, when the SABC/SAUK Television Service began in South Africa two top comedians tore through the electronically generated PM5544 test pattern, something which had to be seen to be believed!

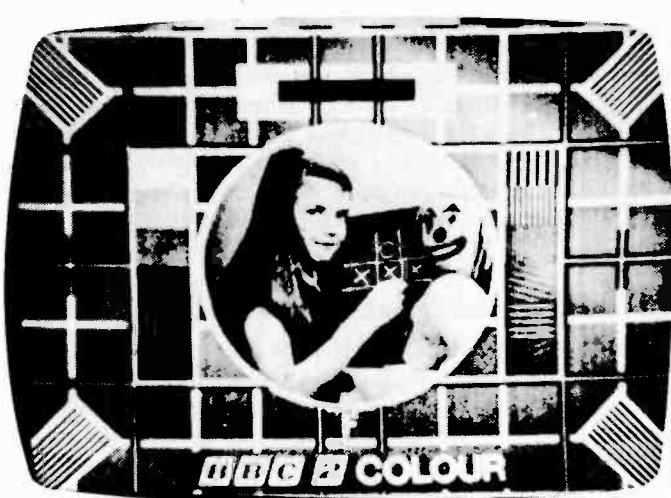
Fig. 6: A slightly modified test card F, with two electronically superimposed crosses to complete the game!

Returning to Test Card F however, the final photograph (Fig. 6) may at first sight appear to be as normal but on close inspection it will be noticed that the dream of many a television service engineer has been enacted by someone at the BBC Television Centre in London. For ten years Carol has been sitting there with her toy and blackboard. And now, finally, the game of noughts and crosses has been completed!! The photograph was taken on Christmas Eve, 1977, and it's open to conjecture as to whether the engineers in charge had been at the orange squash bottle. The two extra crosses were transmitted for only five minutes, so we were fortunate to capture the event on film!

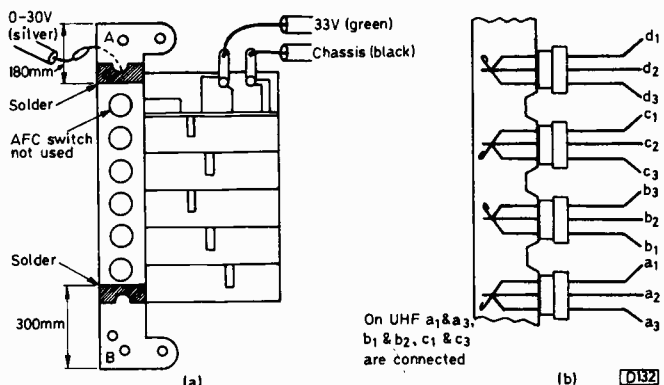
Fig. 1: Fitting a Manor Supplies push-button channel selector unit in a Combi colour receiver. (a) Cut the two fixing brackets A and B from the Combi unit and solder them on to the new unit in the positions shown. The five buttons and a.f.c. switch will then fit through the plastic front escutcheon, leaving the bottom hole unused – this can be blanked off. (b) The band switches on the rear of the Combi unit. Since u.h.f. only is required, disconnect all the wires, then connect a1, a3 and b2 together, and c1 and c3 together: a2 and c2 should be cut off short and sleeved – they are not used.
