THE NEWSPAPER FOR
THE HOBBYIST OF VINTAGE
ELECTRONICS AND SOUND

THE HORN SPEAKER

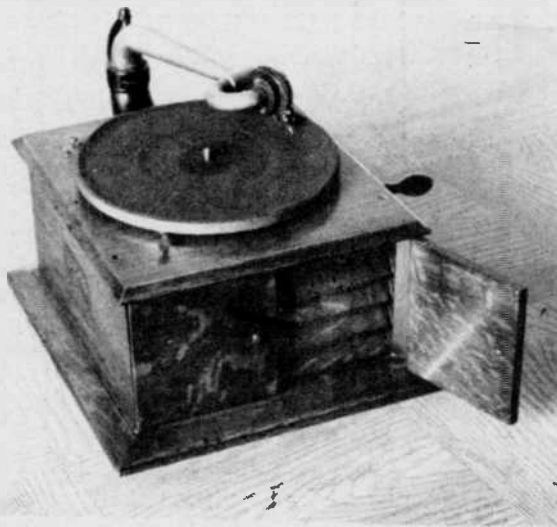
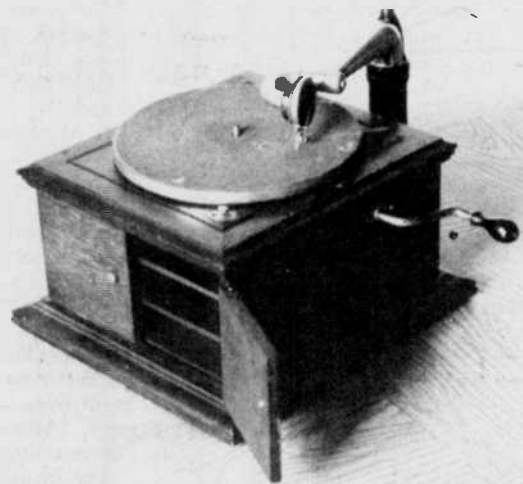
Fig. 4: IVA

Construction of the Victrola 1-1, successor to the VV-IV and shown in Figure 5, is obviously cheaper than that of the VV-IV. The tone arm was altered to eliminate one part, the doors and louvers were eliminated and replaced by a slotted front to the cabinet, and there is no bottom cover (the information tag is pasted on the bottom of the horn). The cabinet of the Victrola 1-1 pictured is mahogany, whereas all the VV-IV I have seen are oak.
