RADIO
Retailing

SERVICE ENGINEER

Radio, Television and Audio Servicing

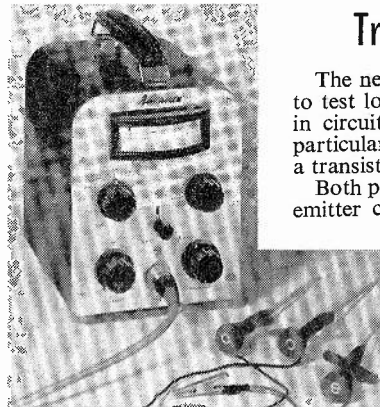
Transistors Tested in Circuit

The new Advance TT1 has been specially designed to test low and medium power transistors while still in circuit, eliminating the risk of physical damage, particularly to printed circuit boards, when removing a transistor for testing.

Both p-n-p and n-p-n types can be tested. Grounded emitter current gain may be measured in or out of circuit and leakage current (grounded emitter) with transistors out of circuit.

Leakage current measurement (grounded emitter 1 μ co) 0-1mA and 0-100 μ A with transistor out of circuit. The circuit is protected so that the maximum battery drain is 110mA and the meter is protected for overloads of greater than 500%.

The probes are a feature of the tester and their design was the result of a special user research by electronic engineers. Provision is made for checking the condition of the batteries. Retractable legs are fitted to the front of the instrument for bench working.

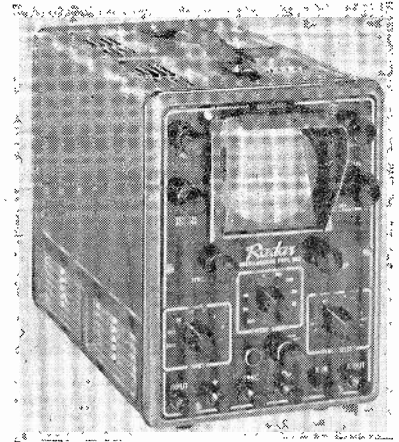
Portable Oscilloscope

THE Radar Type 303 represents an oscilloscope that will never be without a job long enough to collect dust, whether its home be in the laboratory or radio and television service department. Simplicity of operation, coupled with remarkable versatility and portable make-up, put it in the sphere of an instrument long awaited for by the service technician in particular.

The 3 in. screen is faced by a ruled graticule, allowing measurement of pulse amplitude, etc., and in front of this can be slipped an optional polarising filter, which completely prevents light being reflected from the tube face whilst allowing the displayed trace to pass through without loss of illumination.

This combination truly provides excellent linearity of trace and solid synchronising under almost all conditions. The expand control is tied to the paraphase coupling circuit. An inbuilt integrator circuit permits synchronisation from the frame pulse of a television receiver.

In view of the particularly rugged construction of the instrument, it can be expected to withstand a fair amount of rough handling, and van use, without damage. The overall dimensions are:—height 9 in., width $6\frac{1}{2}$ in. and depth 13 in. The steel case, which is finished in hammer stove enamel, is complete with carrying handle and adjustable tilting stand. The weight is 20 lb.

All the controls work perfectly smoothly in relation to the trace without backlash effects or juddering. The sync performance is such that even very small amplitude signals are locked solidly without fuss or bother. The frame integrator circuit was found extremely useful when dealing with television signal and pulse waveforms.

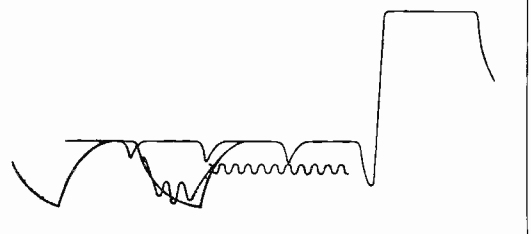
Fig. 1. A section of a line of Test Card C, as displayed on the Radar 303 with trace expansion.

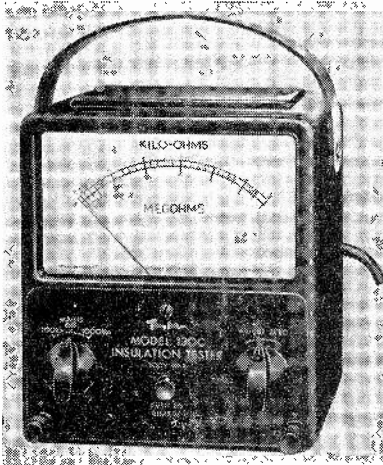
Taylor 130C

The latest addition to the range of Taylor Electrical instruments is the Model 130C insulation tester. Total resistance measurements covered are from 20Ω to $1,000 \text{M}\Omega$ and for insula-

tion measurements a test voltage of 500V d.c. at infinity is applied to the component under test via a safety push-button switch.

Measurements are made on a clear 5-in. scale, the meter movement being of the centre-pole design with a sensitivity of $37.5 \mu\text{A}$. The movement has sprung jewels to withstand rough handling. The instrument is designed to

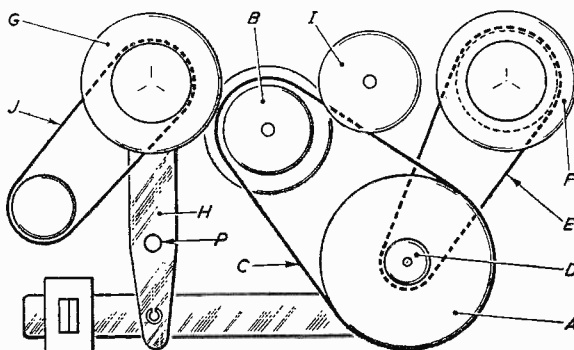
★
Fig. 1. Diagram showing the motor and drive system as used in the Grundig models TK20 and TK25. The belt sections are circular. See text for explanation of reference letters.
★

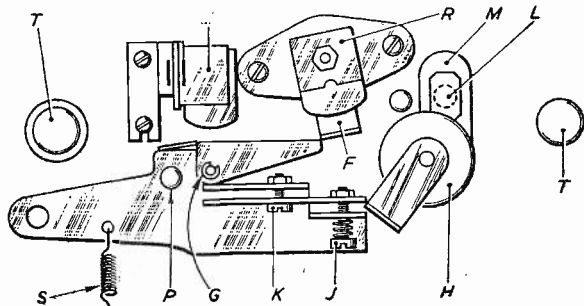
★
Fig. 2. Diagram showing the head assembly of the Grundig models TK20 and TK25 with the mechanisms of the pressure and spacing controls. For references, see text.
★

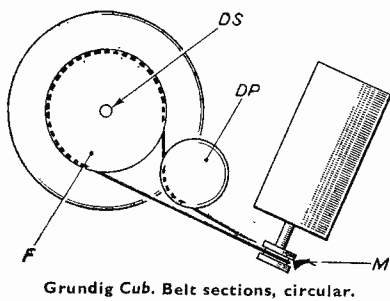
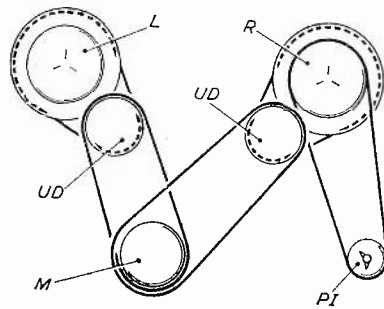
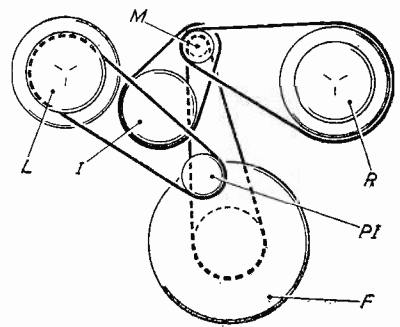
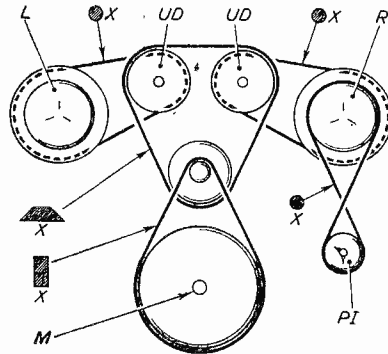
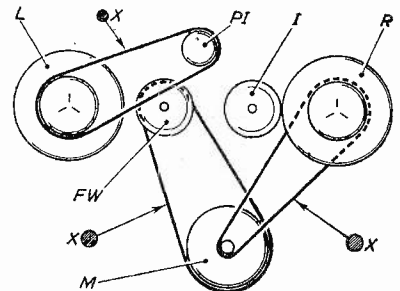
Above: Models TK819, TK820 and TK830.
Below: Models TK9 and TK12.

Above: Models TK30, TK35, TK55, TK60 and TM60. Below: Models TK5 and TK8.

Fig. 3. Diagrams of the various drive systems used in Grundig tape recorders from the simple Cub to the complex TK9 and TK12.

- L—Left-hand spool.
- R—Right-hand spool.
- M—Motor spindle.
- I—Idler pulley.
- DP—Drive pulley.
- DS—Drive spindle.
- FW—Fast Wind pulley.
- PI—Position indicator.
- UD—Unidirectional pulley.
- X—Belt sections.
