ELECTRONIC SERVICING

MAY
1958 • 50¢

shop hints and service notes

Looking for Trouble?

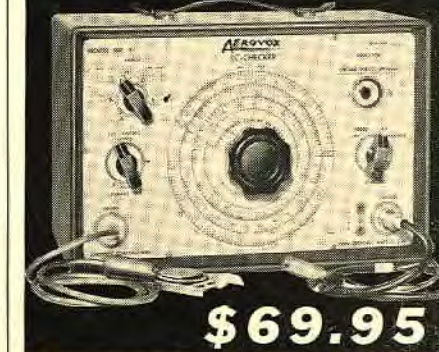
ALL-NEW MODEL 97 AEROVOX LC-CHECKER

The all-new Model 97 LC-Checker represents the ultimate in r-f circuit and component testing. In a single instrument it covers the widest range of checking functions. It's the only instrument that will test for capacitance without disconnecting capacitors from the circuit. Incorporates latest printed-circuit techniques.

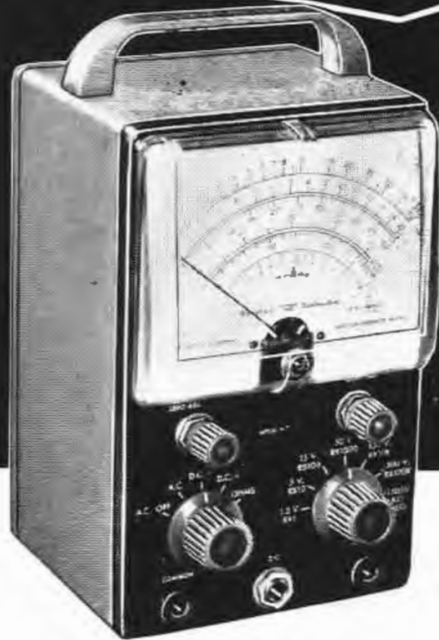
The famous model V-7A Vacuum-Tube-Voltmeter is a perfect example of the high-quality instruments available from Heath at 1/2 the price you would expect to pay! Complete, only **\$24⁵⁰**

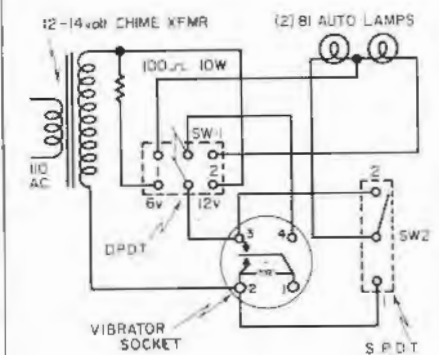
Either 6 or 12 volt vibrators may be tested with the circuit, shown above. Switch SW-1 in position #1 is for 6 volts and in position #2, which uses the full secondary voltage, is for 12 volt vibrators. Switch SW-2 in position #1 will light the auto lamps using the transformer voltage. One bulb lights in the 6 volt position and both in the 12 volt position of SW-1. When SW-2 is in position #2 the lamps are lighted through the vibrator action. If the vibrator is in good condition the lamps will light with the same intensity as in position #1. A weak vibrator will cause a fluctuating light while a defective vibrator will prevent the lamps from lighting at all.

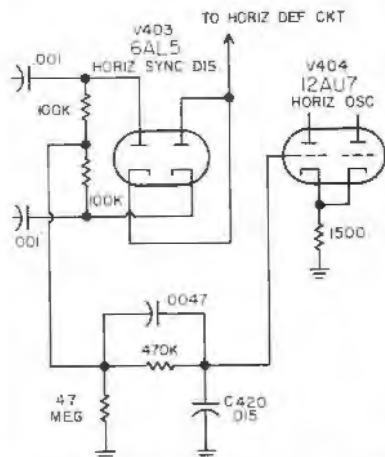
Fig. 3—Increased value of C120 improves noise immunity.

I have an Admiral chassis 18XP4BZ which worked fine in the original location. When the customer uses it at his resort bungalow it develops a horizontal jitter. I appreciate that the receiver is being operated in a weak signal area and therefore may not work as well as in the city but he would like to use it at the bungalow and therefore wants to improve its weak signal performance. The noise in the area is high as he is just off a heavily traveled highway. The ignition noise seems to particularly affect

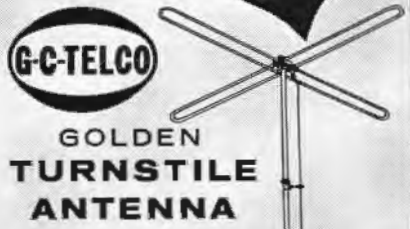
FULL RANGE FM RECEPTION!

Completely Preambled
Non-rusting gold anodized aluminum elements snap into place. Everything is furnished; there is nothing else to buy. You get perfect reception up to 50 miles from transmitters.

COMPLETE KIT NO. A-125
(shown above) List \$18.95
TURNSTILE KIT NO. A-124
standard aluminum elements List \$15.95

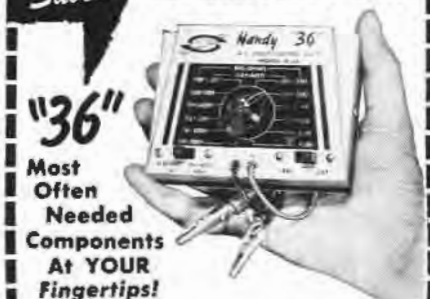
SENCORE Handy "36" R-C Substitution Unit

Most Often Needed Components At YOUR Fingertips!
3 pole, 12 position switch individually selects one of the "36" components for direct substitution.
Contains:
★ 12-1 watt 10% resistors from 10 ohms to 5600 ohms
★ 12-1/2 watt 10% resistors from 10K ohms to 5.6 megohms
★ 10-600 volt capacitors from 100-mfd. to .5-mfd.
★ 1-10mfd., 450V Electrolytic
★ 1-40mfd., 450V Electrolytic
★ For Shop, Lab, or outside service AVAILABLE AT ALL PARTS DISTRIBUTORS!
