# Techni-talk

on AM, FM, TV Servicing

**CONVERSIONS—  
 10-INCH AND**

**PROJECTION TYPE TO USE LARGER PICTURE TUBE**

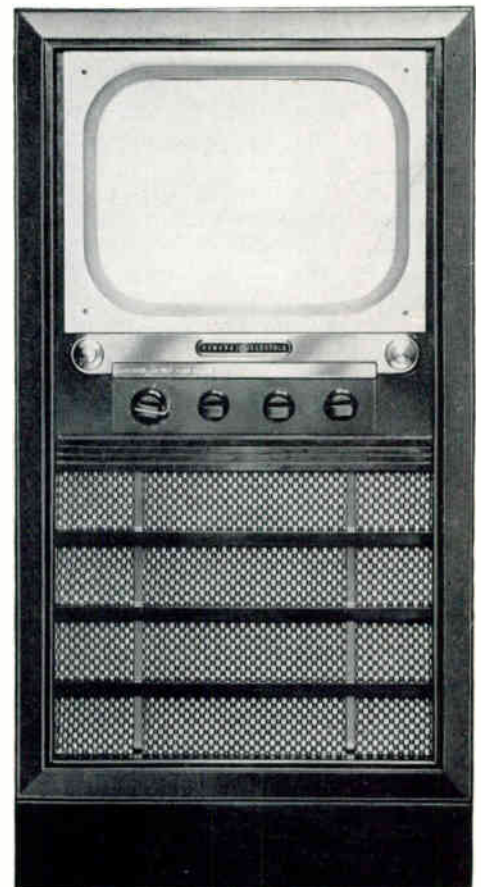
Fig. 2. General Electric Model 10C101 after it has been converted to use a fourteen inch picture tube.

The General Electric Model 10C101 shown in Fig. 1 was originally a ten inch TV receiver. This was converted to use a General Electric 14CP4 picture tube which was the largest size that could be used in the original cabinet. The completed conversion is shown in Fig. 2.

The plastic picture tube mask was then drilled in each corner and fastened to the front panel with brass screws as shown in Fig. 2. At this point the receiver was reassembled and the conversion was complete.

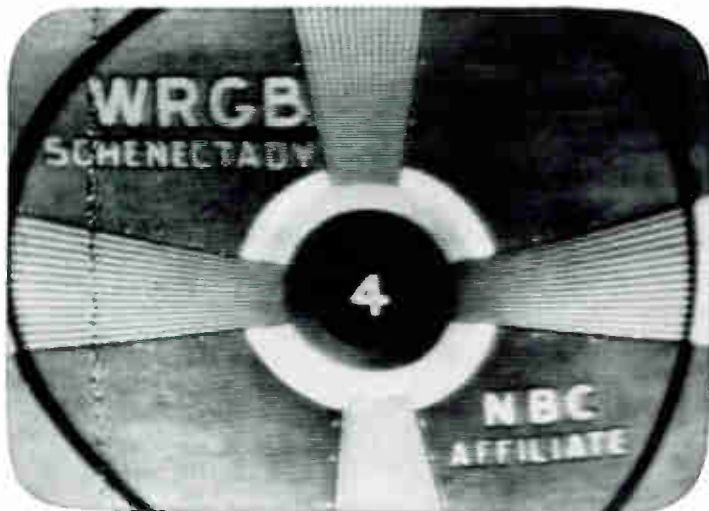
Tele-Clue No. E93. The vertical black lines were due to a slight arc developing at the solder connection to the plate of the 1B3-GT high voltage rectifier. This is similar in appearance to Barkhausen oscillation. The similarity is probably due to the various frequencies developed by the arc falling in the same range as Barkhausen oscillation.

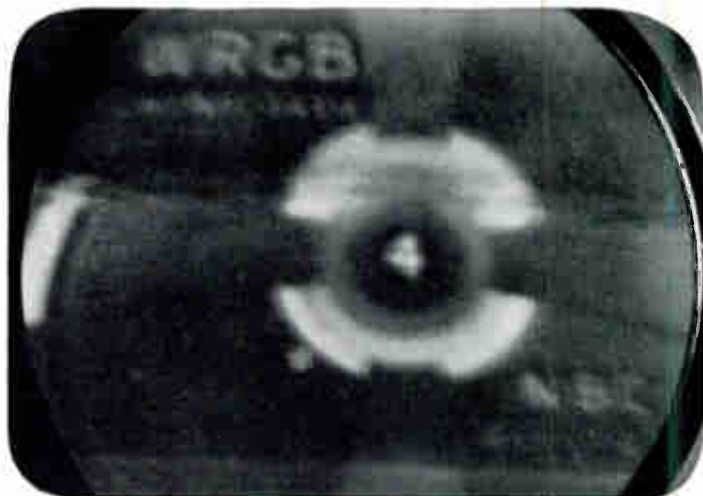
Tele-Clue E94. The increase in horizontal and vertical size as well as the loss in brightness indicates a loss of high voltage. This was caused by a poor connection which developed an arc under the rubber cover at the anode of the picture tube.

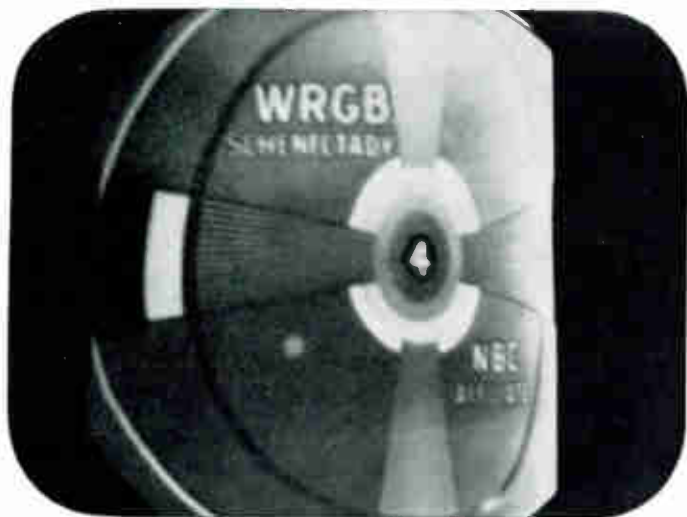
Tele-Clue No. E95. The dim picture with poor horizontal linearity, insufficient width and excessive height was caused by an open in the .5 mfd capacitor C 377 in Fig. 2. This condition is a result of placing a high impedance in series with the horizontal deflection circuit and is caused by an open or very low capacity value of the series capacitor, C 377, to the horizontal deflection coils. This reduces current to the horizontal deflection coils; however, the shunting resistor R 377, passes some current to the coils when capacitor C 377 is open, thus permitting some sweep but with reduced picture tube anode voltage. In some receivers, resistor R 377 will overheat upon opening of capacitor C 377 because of excessive current. High leakage in capacitors C 373 or C 374 will produce similar results except that the linearity will be better.

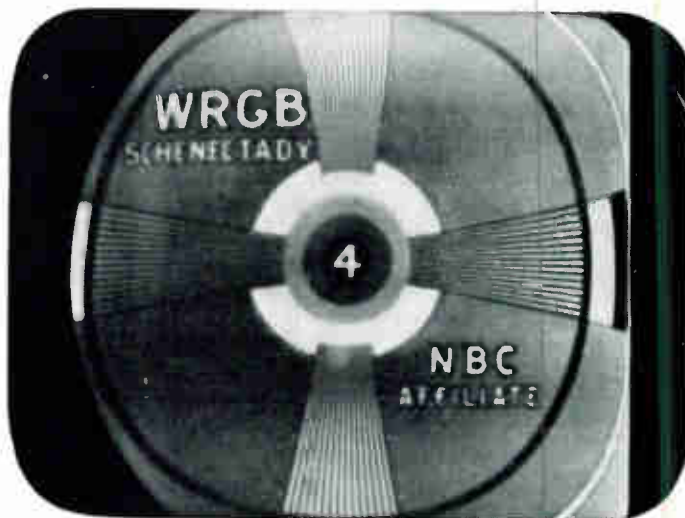
Tele-Clue No. E96. The displacement to the left shows the effect of shorting out the .5 mfd capacitor C 377 in Fig. 2. This condition is the result of additional d-c flowing through the horizontal deflection coils. If this capacitor shorts out it may be impossible to center the picture.
