SYLVANIA NEWS

TECHNICAL

JANUARY-FEBRUARY, 1941

Vol. 9, No. 1

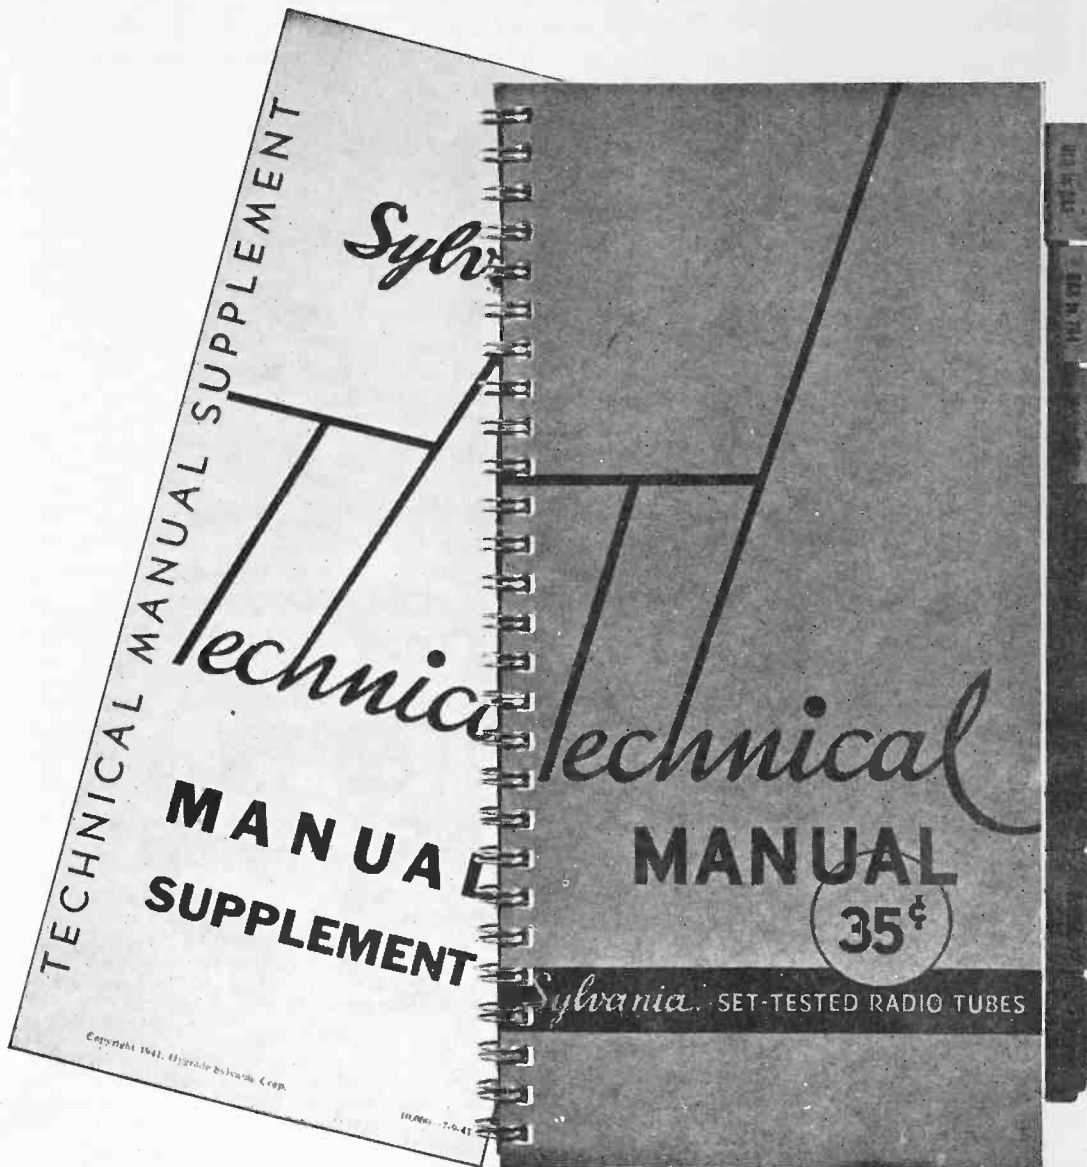
TUBE DATA UP-TO-DATE

Owners of the latest edition of the Sylvania Technical Manual can bring Sylvania Tube characteristics up to date by adding the free Supplement shown above. The tubes listed are those that have been announced to the trade since the latest printing of the Manual.

Wherever possible cross references have been made so that the large number of tube types is shown in a minimum of space. Base views and characteristics are referred to equivalent types, and where this is impossible, base views and operating characteristics are given.
