- Short-Circuiting Those CB Thieves
- The Ear Doctor:  
CB Servicing Case Histories

March/April 1977

# Short-Circuiting Those CB Thieves

by James Crudup, C.E.T.

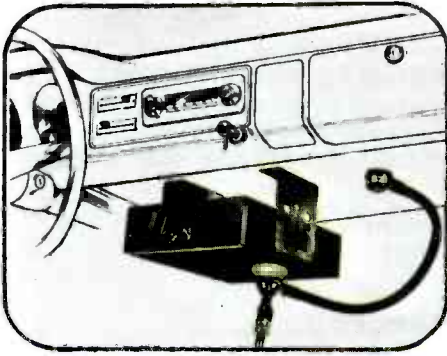
FIGURE 1. CB RADIO CABLE LOCK

with a lock such as shown in Fig.1, fits into a connector at the radio. A key is used to unlock the mechanism which releases the cable so the radio can be removed. By the way, the cable is advertised as cut-proof and the lock is said to be pick-proof.

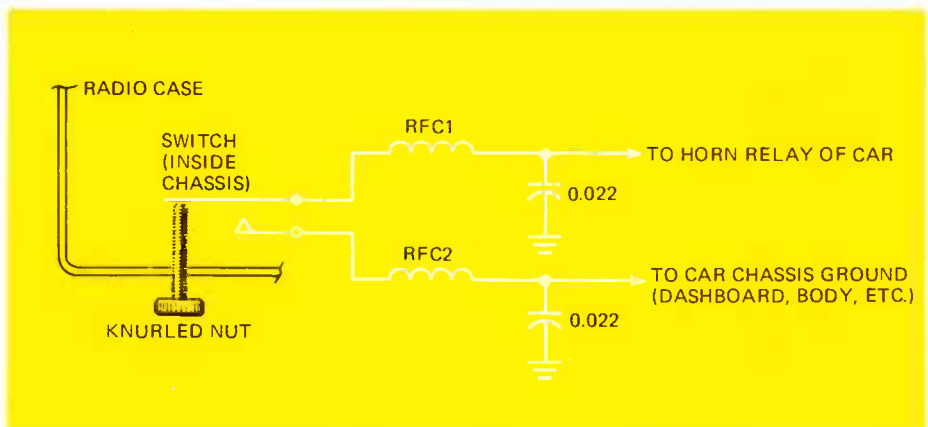
FIGURE 2. A SIMPLE CERAMIC BUBBLER ALARM CIRCUIT

Before we talk about the more expensive alarms, let's take a brief look at the simple alarm in Fig.2. As you can see, the system consists of two capacitors, two inductors, a relay, and some lamp cord. These parts can be purchased at any Radio Shack or Lafayette store. The way it works is simple. The knurl nut has to be unscrewed to remove the CB radio. Of course, unscrewing the nut closes the relay and the horn goes off. When you want to remove the radio without sounding the horn, simply disconnect the ground or the hot lead to the horn.

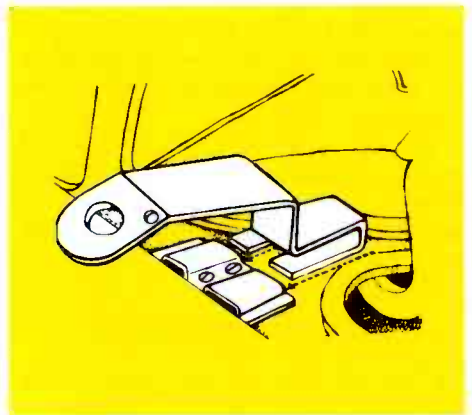
FIGURE 3 AN ANTENNA FOLD DOWN BRACKET

Another cheaper, but probably just as effective, solution is to use a detachable or fold-down antenna mounting bracket as shown in Fig.3. When you leave the car, simply raise the trunk lid, disconnect the antenna from the bracket, and leave it in the trunk. Thieves assume you don't have a rig when your antenna is not visible.

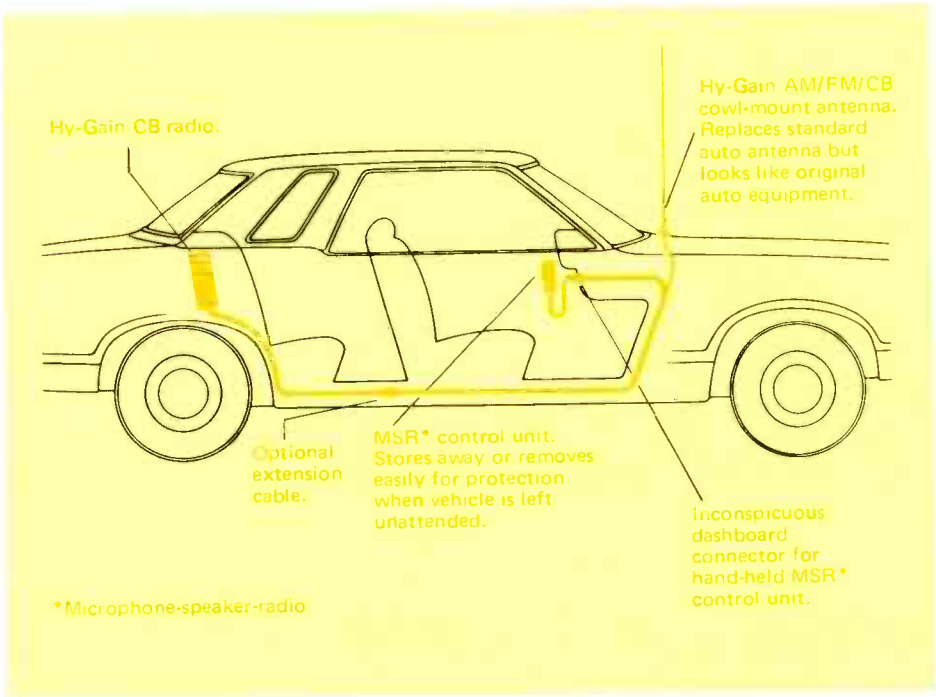
FIGURE 4. CB RADIO SAFELY MOUNTED IN CAR TRUNK

Fig.4. The channel selector is built into the microphone as well as the rig's on/off switch, speaker, and squelch control. A quick-disconnect connector mounted on the car dash allows speedy removal of the microphone for concealment in the glove compartment. To thieves who peer through your car window, you're clean and they are disappointed because there is no radio to steal.

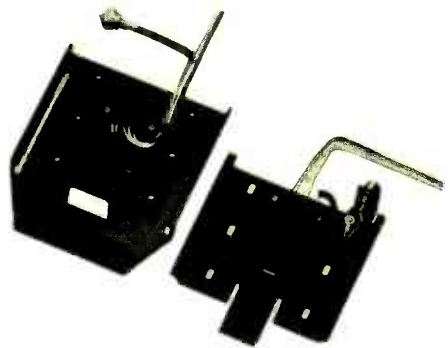
FIGURE 5. A UNIVERSAL SLIDE MOUNT

your rig in the car with relative ease. The essential wires from the radio can be soldered to contacts on a contact plate which is permanently mounted to the bottom of your radio. The other part of the universal mount is permanently mounted in the car. Connections from the power and antenna lines are made to it. The plate on the bottom of the radio mates with the universal mount in the

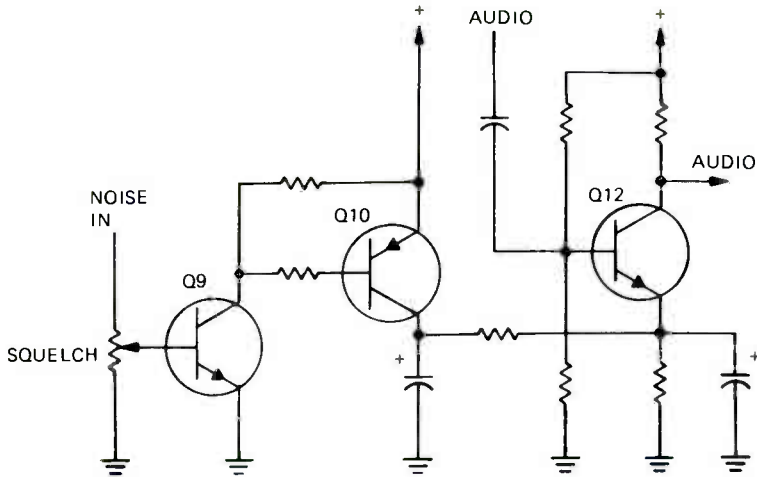
FIGURE 1 SQUELCH CIRCUIT OF SURVEYOR 2400

So, I decided to check the squelch transistors Q9 and Q10. I removed Q10 from the circuit first and checked it. It was okay. Next I removed Q9 from the circuit and found it was definitely bad (emitter to collector short).

The reason the audio had been alright during the transmit condition was because when the transmitter is keyed, the voltage is removed from the squelch transistor. Therefore, the positive voltage is not there to cut off the audio transistor.

SK series of replacements and found an SK3122 which I thought would work okay. Installation of the SK3122 restored sound to the receiver and the squelch control also worked properly.

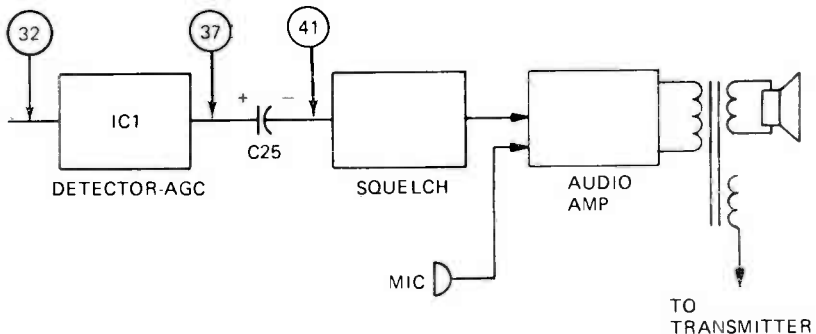
FIGURE 2. OPEN COUPLING CAPACITOR IN KRIS 99ER

So, I decided to check the transmitter to make sure it was modulating properly. It was. Next, I decided to go to signal tracing through the receiver audio path

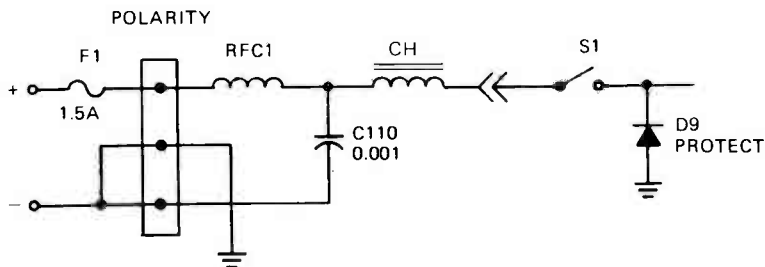
FIGURE 6. HB 525 POWER CIRCUIT

The first thing I noticed when I opened the set, shown in Fig.6, was that RFC1 had burned up before. Someone had placed a wire jumper across it, and had done a messy job, so the first thing I did was to clean that mess up! I then turned the radio over to examine the foil side

This was in the hot side between where RFC1 previously was and the iron core choke. I bridged this burned spot and then connected my ohmmeter across the power leads (noting the polarity). Now, there was a dead short across the power leads when the on/off switch was on.

Looking beyond the on/off switch, the first thing I saw was the protection diode. This is always a prime suspect when the polarity has been reversed. I removed the diode and sure enough, it was shorted. I checked the resistance across the power leads with the diode removed and the short was definitely gone. Replacing the diode restored the radio to service. I used an HEPI70 replacement diode. My charge was \$1 for the diode and \$16 for labor.

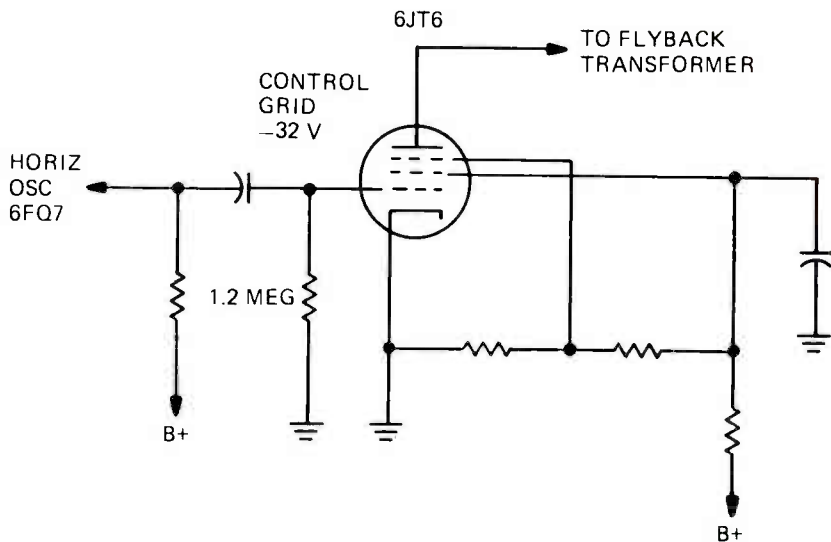
FIGURE 1. INPUT CIRCUIT OF THE HORIZONTAL AMPLIFIER.

I turned the set off and disconnected the coupling capacitor feeding drive signal from the oscillator to the 6JT6 control grid. If the capacitor were leaky, it would account for the positive control-grid voltage and when disconnected the positive voltage would disappear (see Figure 1). The 6JT6 control grid was still positive with the coupling capacitor out of the circuit. I turned the set off again and measured the resistance from the control grid to the chassis. It measured only about 10,000 ohms, while when previously measured from the top of the socket (tube removed) it was 1.2 megohms, which is about what you would expect. I disconnected the 1.2-megohm grid resistor and still got the same reading. A quick check showed that this was the same resistance as measured from the 6JT6 suppressor grid to the chassis. Then

the light dawned. There was a control-grid-to-suppressor-grid short in the 6JT6 tube. With the parts reconnected and the 6JT6 tube out of the socket, the control-grid-to-chassis resistance was 1.2 megohms as expected.
