SERVICING

FEBRUARY
1958 • 50¢

Servicing Transistor Radios
110 Degree Picture Tubes
Looking For Trouble?

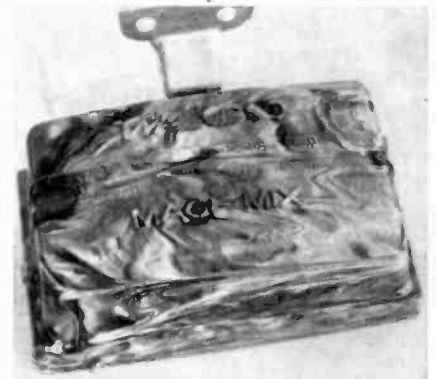
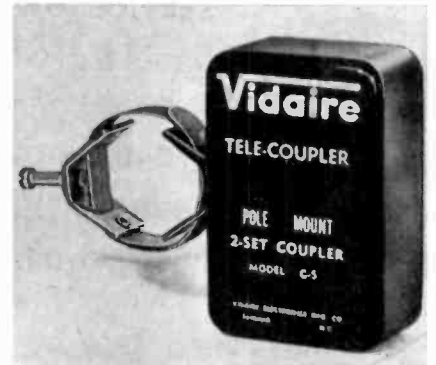
Fig. 5—Two typical couplers designed for outdoor use.

Some manufacturers produce couplers such as these shown in Fig. 5. These units are designed specifically for outdoor use and their containers are usually tapered to shed water and prevent moisture condensation. They should also have a cover which overhangs below the terminal board so that the terminals are properly protected. Furthermore, they are so designed that any downward pull by the hanging transmission line will not cause damage.

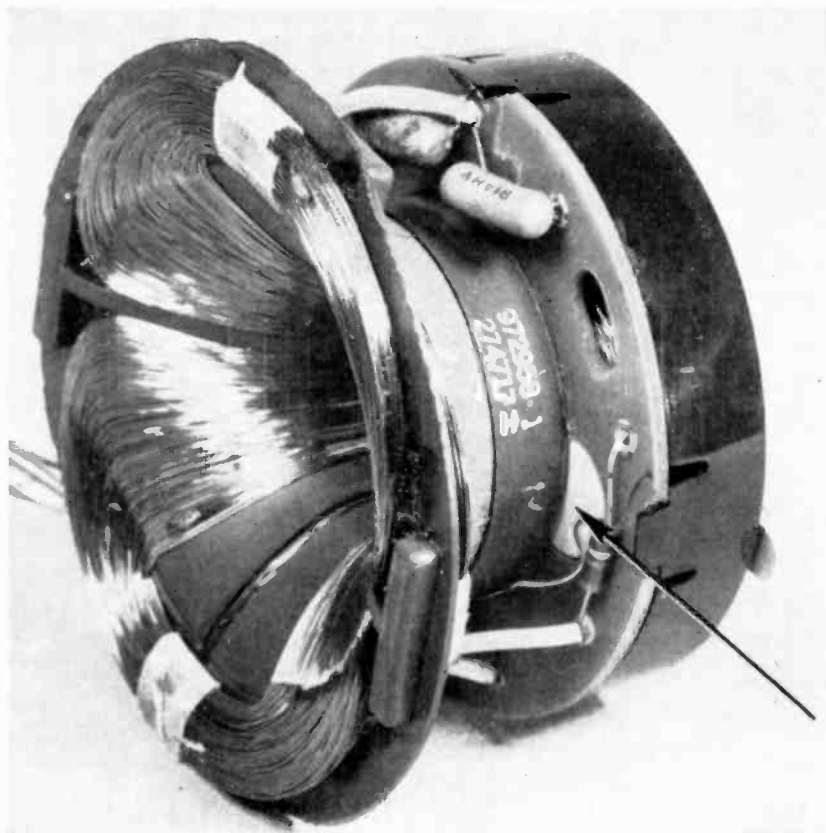
Fig. 1—Typical 110° deflection yoke. The arrow points to a thermistor, R133. Note magnets used to minimize pincushioning.

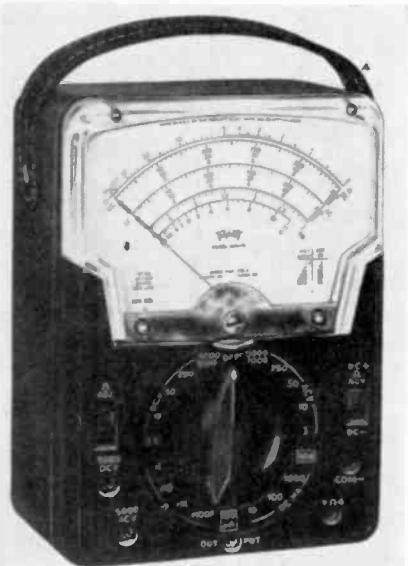
The Triplet Instrument Company has made available two new volt-ohm-milliammeters, models 630 PL and 630 APL. Both meters feature a single selector switch for function and range with an off position for shorting out the meter. They also provide a polarity reversal switch. The *dc* voltages range from 2.5 volt scale to 5000 volts at 20,000 ohms per volt. The *ac* scales range from 3 to 5000 volts at 5,000 ohms per volt. The ohmmeter reads from .1 of an ohm to 100 meg-ohms in four scales. The current range is from 10 *ma* to 10 amperes. Model APL features a mirror backed scale for elimination of parallax error and also 1/2% precision resistors.

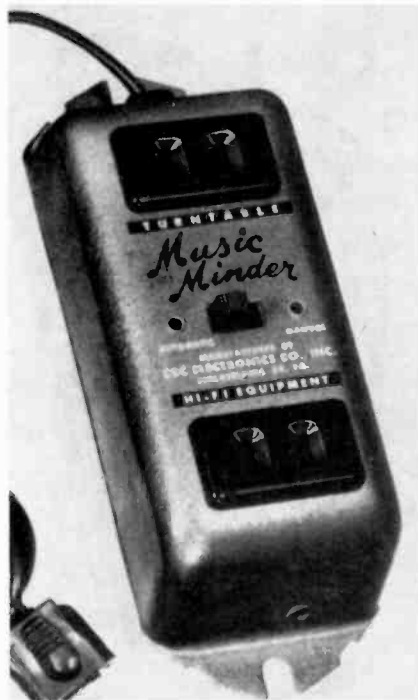
The new "Music Minder" Switch, featuring automatic shut-off of the entire high fidelity system after the last record is played, is now being marketed by CBC Electronics Co., 2601 N. Howard Street, Philadelphia, Pa. This new unit makes it possible for the listener to place a stack of records on the record changer and leave the system completely unattended. At the conclusion of the last record, a relay is actuated and the entire system is shut off. Music lovers, who enjoy listening to music after retiring at night, can now do so without fear of falling asleep or having to get out of bed to turn off the high fidelity system. Should the user not wish to use the automatic feature, the

switch can be set on the "manual" position. In this position the automatic feature is inoperative.

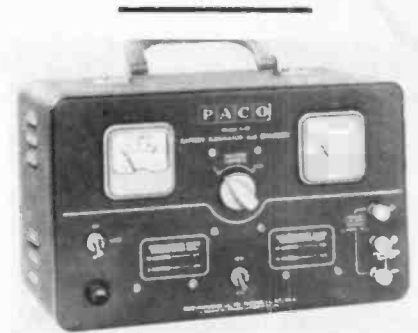
A new battery eliminator in kit form has been announced by the Paco Electronics Company, Inc., a newly formed division of the Precision Apparatus Company, now celebrating its 25th anniversary. The unit features a self-contained, special low-ripple L-C filter output (0.3% maximum ripple) designed to power modern transistor circuits. The Paco Model B-10 battery eliminator kit features both 6 and 12 volt outputs, automatic overload protection, continuously variable voltage output, a heavy-duty, louvred steel cabinet and a two color panel. It doubles as an ideal battery charger. Detailed information on the entire Paco line may be obtained from Paco Electronics Co., Inc., a division of Precision Apparatus Co., Inc., 70-31 84th Street, Glendale 27, L.I., N.Y.

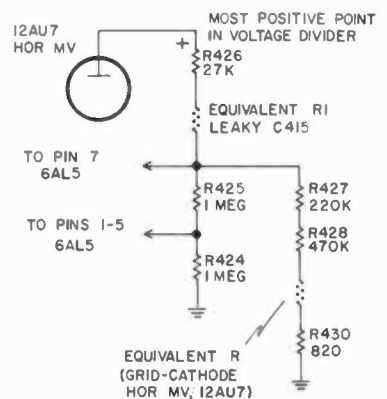
Fig. 4—Equivalent plate circuit when $C415$ is leaky.

ing the trouble (see Fig. 4). The lower positive voltage now measured at pins 1-5 (junction of $R424$ and $R425$) compared to the voltage at pin 7 (junction of $R425$ and $C415$) showed the direct current path was from ground through $R424$, $R425$, a leaky $C415$ and $R426$ to the plate of the horizontal oscillator. The voltage divider also includes a parallel path as shown in Fig. 4.

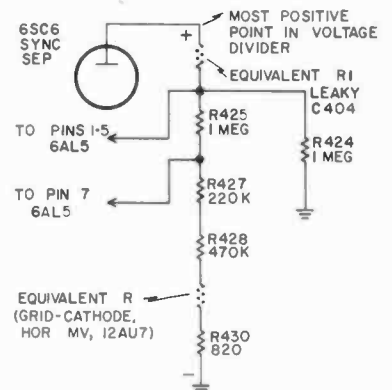
Fig. 5—Equivalent plate circuit when $C404$ is leaky.

A leaky $C404$ would cause a lower positive dc voltage on pin 7 as compared to pins 1-5 with the tube out. The horizontal oscillator grid (pin 2) would draw current and there would be a current path from ground through the cathode-grid circuit of the tube, $R428$, $R427$, $R425$ and the leaky $C404$. The voltage at pin 7 (junction of $R427$ and $R425$) would be closer to ground (less positive) than the voltage at pins 1-5 (junction of $R425$ and $C404$) as shown in Fig. 5. The

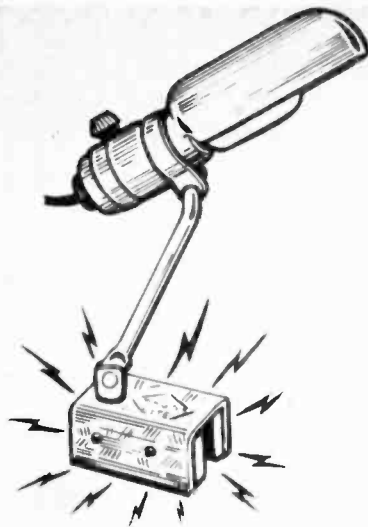
A help to the TV and Radio Serviceman is the new Magna-Lite, recently developed by R-Columbia Products Co., Inc., Highwood, Ill. This firm known for its Serviceman-Designed Products has long felt that a new and different type of service light was needed by the trade. They feel that their new Magna-Lite answers this need. The magnetic base allows this light to be placed on any metal surface without danger of falling and the specially designed flexible-joint arm gets the light where you want it, even under its own base. Available in two models, Model 300 with Standard Shade and Plug and Bulb, and Model 350 with Flood Shade and Standard Plug (less Bulb), this new product can be had for \$3.95 Dealer Net. Write manufacturer for further information.

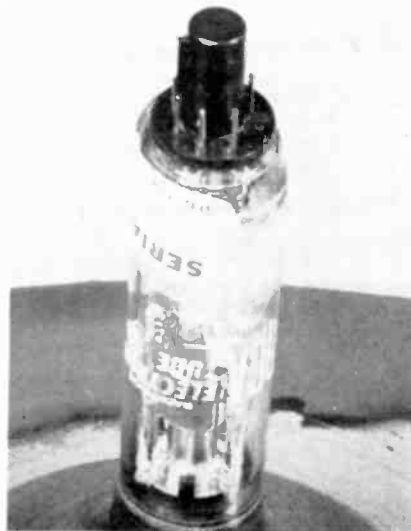
Fig. 3—Base of 110° kinescope showing straight thru pins and indexing plug.
