Practical TELEVISION

NOVEMBER 1965

UHF TEST OSCILLATOR

A NEW DESIGN
FOR THE HOME
CONSTRUCTOR

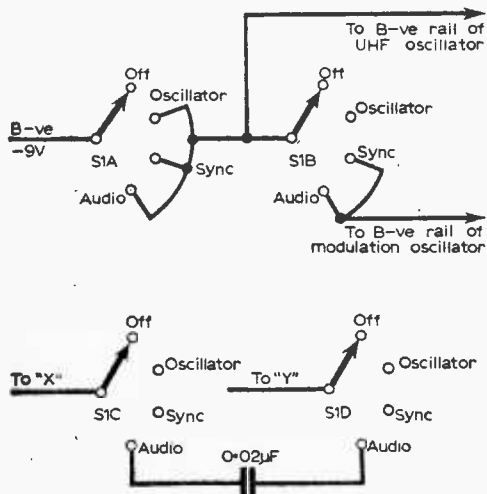
Fig. 1—Details of function switch.

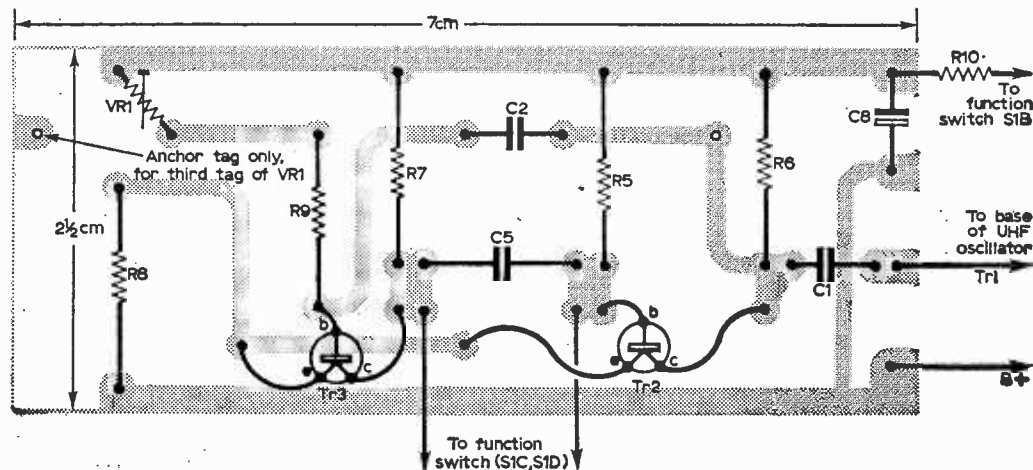
Fig. 5—Printed circuit for modulator.

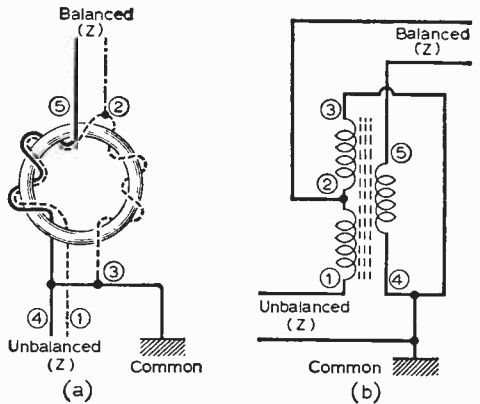
Fig. 6—Details of a constant impedance balun, suitable for aerial applications.

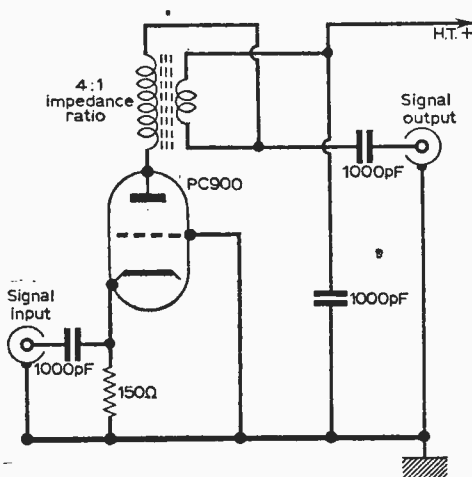
Fig. 8—A wideband single-stage valve amplifier circuit employing a 4:1 ratio impedance transformer.

A wideband amplifier circuit employing a transformer of this kind is given in Fig. 8. The valve is an r.f. triode of high slope (gm equals 14.5mA/V) arranged in the earthed grid mode with the input signal applied to the cathode. Now if the impedance at the signal output socket is equal to (or near) the impedance at the cathode there will be a power gain of about four times (6dB).

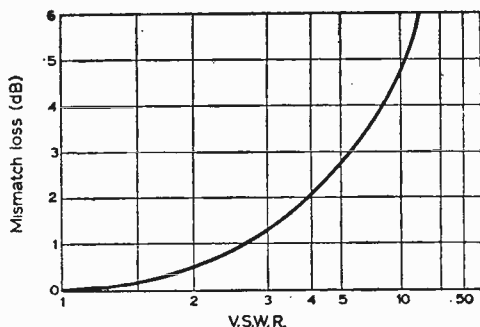
Fig. 2—This curve reveals the amount of loss arising from mismatches at the aerial end of a coaxial cable, the mismatch here being in terms of voltage standing wave ratio, as explained in the text.

There are times, however, when the matching at the aerial may be reasonable but the matching at the set poor. The mismatch curve in Fig. 2 applies only at the aerial end. The combined effect
