## ALSO: SERVICE NOTEBOOK TRANSISTOR IF PREAMPLIFIER ASSESSING COLOUR PERFORMANCE

SERVICING · CONSTRUCTION · COLOUR · DEVELOPMENTS

VOL 23 No 7

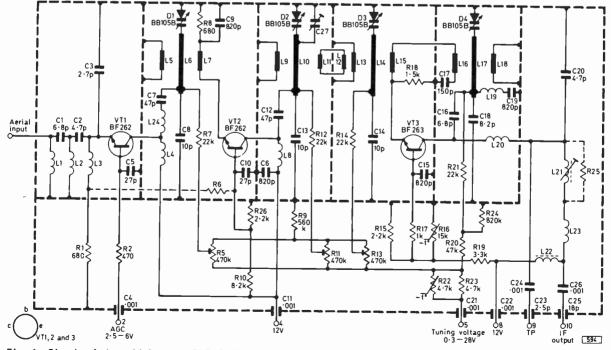
Fig. 1: Circuit of the widely used ELC1043 varicap tuner. The ELC1043/05 is similar except for the transistor types used.

There are two r.f. amplifier transistors, VT1 and VT2, the third transistor VT3 being the oscillator/ mixer. Each of the four half-wave tuned lines (L6, L10, L14 and L17) is terminated at one end by a fixed capacitor and tuned at the other end by a BB105B varicap diode. Tuning is effected by varying the voltage applied to pin 5 between 0.3-28V. The tuning voltage is obtained from an external bank of switched potentiometers (see Fig. 3).

For optimum noise performance the input circuit is untuned, the input being fed to VT1 emitter via a two-stage high-pass filter. The first stage output is developed across L6 and inductively coupled by L7 to the second stage. The bandpass circuit L10/D2and L14/D3 is coupled to the mixer/oscillator stage

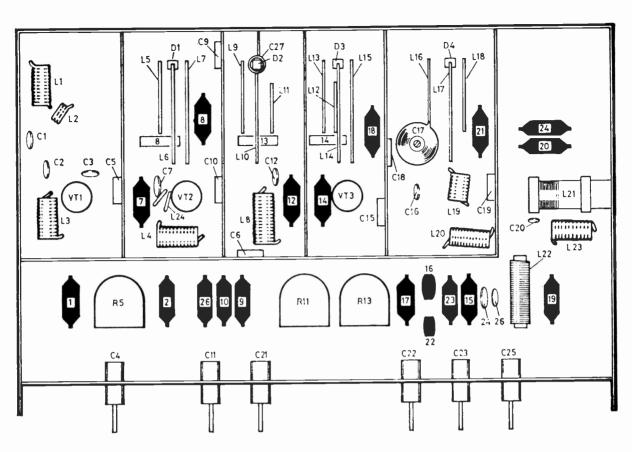
Fig. 2: Layout-of the ELC1043 varicap tuner. Resistors shown black, capacitors white.

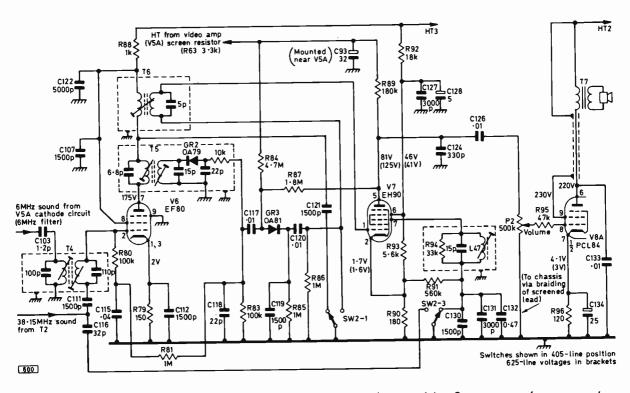
Fig. 1: (a) Sound channel on v.h.f.; (b) sound channel on u.h.f. using the intercarrier system.

A BLOCK diagram of the sound signal path in a typical 405-line only model is shown in Fig. 1(a). The sound and vision i.f. signals from the tuner unit are amplified in a common i.f. stage after which the signals split to go to their respective channels. After further amplification the 38.15MHz sound signal is detected by a diode and is then usually passed via a diode interference limiter and the volume control to a triode-pentode audio amplifier such as a PCL82 or PCL86 which provides adequate amplification to load the loudspeaker. This is conventional amplitude-modulated sound detection and amplification.

For 625-line reception a different arrangement is used as shown in Fig. 1(b). The sound signal is of course frequency modulated and a system known as intercarrier sound is employed. This technique is used mainly to overcome the problem of sound drift in the u.h.f. tuner. All tuners suffer to some extent from drift but on the 405-line channels this is not a serious problem and can be overcome by careful design. On the higher frequency 625-line channels however the problem is very much greater and the drift can be so great as to cause loss of signal. The tuner output consists of the vision i.f. signal at 39.4MHz (in the models we are considering this month) and the sound i.f. signal at 33.4MHz. The point of the arrangement is that the 6MHz difference between them remains constant; the vision signal is a.m. Both signals are amplified in the common i.f. channel and pass to the vision detector which rectifies the vision signal and passes it to the video amplifier. In addition to doing this the diode detector, being a non-linear device, intermodulates the

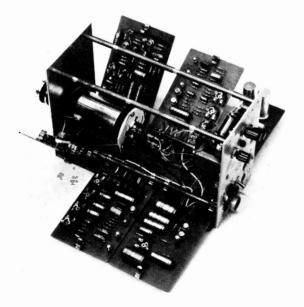
Internal layout of the camera.

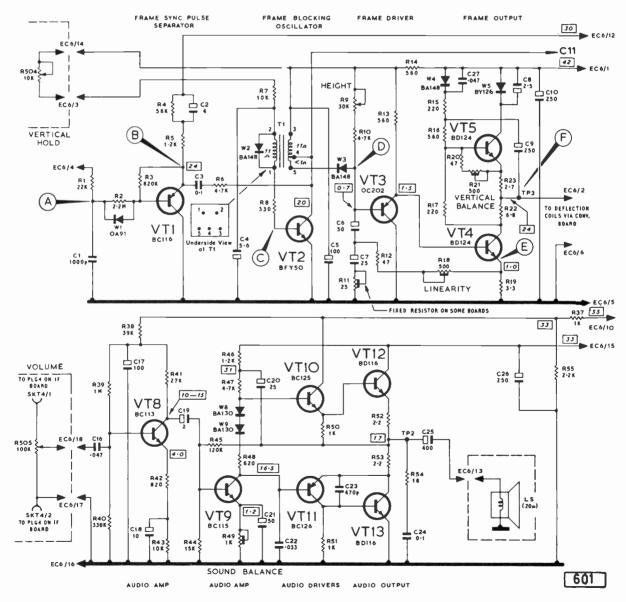
Fig. 8: The field timebase and audio circuits are on the same board. See also Fig. 10.

With earlier boards field collapse is often due to W4 (OA5) going open-circuit: the BA148 used on later boards is a much more reliable replacement. Failure of VT3 gives the same symptom. The only other common frame fault is reduced height with bottom cramping in which case leap for the bootstrap

electrolytic C9. The frame output pair VT4/5 are very reliable whereas the audio output pair VT12/13 are just the opposite. No sound however can also be due to the clip leads having been pulled off the loudspeaker tags or an open-circuit loudspeaker.

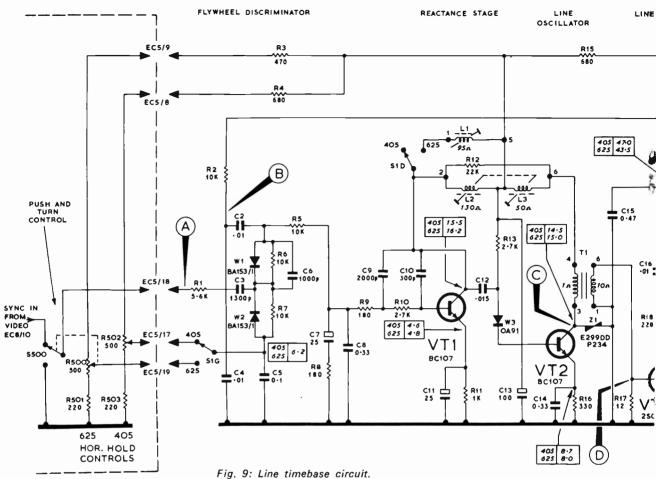
rig. 5. Line timebase circuit

The line timebase circuit is shown in Fig. 9 and consists of a reactance controlled Hartley oscillator, a driver and output pair with transformer coupling throughout. The driver transformer T2 has two isolated secondary windings which drive the cascaded output transistors VT4/5 and a third winding which drives the separate e.h.t. board. The three transformers are extremely reliable. Faults which do occur are failure of the flywheel sync diodes W1/2 giving unstable line lock (separate diodes can be used for replacement) or change in the value of R3 or R15 which upsets line lock. The oscillator coil  $L_2/3$  sometimes pulls away from the track: if the "ears" on its former are cut off it will seat better on the board. VT1 and VT2 are reliable but VT3 fails. Be thankful if you find you have the earlier square D1418 line output transistors fitted since these seem much more reliable than the R1039 fitted later.

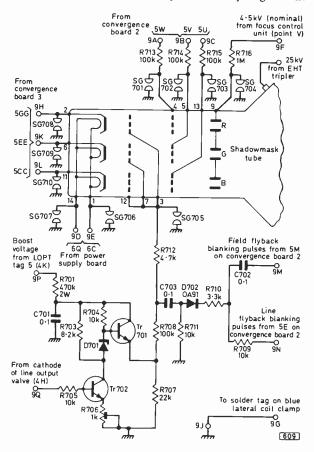
Fig. 1: C.R.T. base circuit, including the beam limiter.

C703 acts as a feed capacitor for the line and field blanking signals and as a d.c. block from the bias supply for the grids.

The grid bias originates from the receiver's boost rail. The approximately 800V applied to 9P is reduced to about 33V by the potential divider action of the circuit. This potential is fed to the tube grids via the series transistor Tr701 and the current limiter R708. R708 also prevents any significant

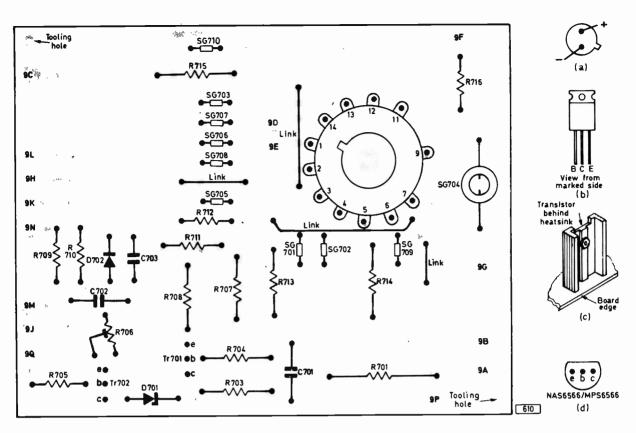
Fig. 2 (above left): Layout of the tube base board: the c.r.t. base is mounted on the board from the copper side. The board size is  $5\frac{1}{8}$  in. x 4in. View is from the copper side.

Fig. 3 (right): (a) Correct TAA550 connections. (b) Correct 2N5492 connections. (c) Method suggested by reader A. M. Melville for mounting the 2N5492: the heatsink is mounted vertically between the transistor mounting holes and the edge of the board with the transistor behind. (d) NAS6566/MPS6566 connections, from below.

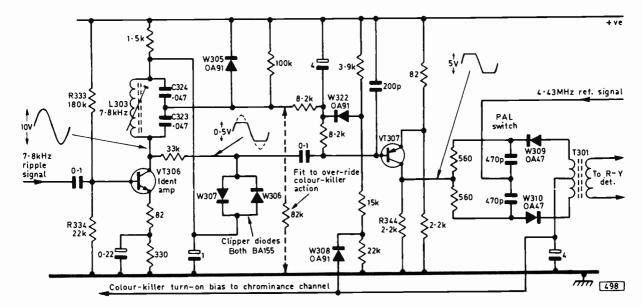
Fig. 1: The ident/PAL switch circuit used in the BRC 3000 chassis. The numerous diodes in this circuit can be confusing. W305 rectifies the ident signal to provide a turn-on bias (negative with respect to h.t.) for the switching waveform amplifier VT307. W307 and W306 clip the positive and negative peaks of the ident signal to generate the squarewave signal required to drive the PAL switch. W309 and W310 form the PAL switch in conjunction with T301. W322 clamps VT307 base bias, preventing it falling below the voltage at W322 anode. W308 also acts to stabilise VT307's base bias: if VT307's collector voltage rises beyond a certain point W308 begins to conduct, stabilising the bias through feedback action.

THE complaint with a set fitted with the BRC 3000 chassis was no colour. With this fault the best action in any colour set is first to override the action of the colour killer—to ensure that the chrominance channel is operative. In many colour sets this can be done simply by connecting a resistor of about

$22k\Omega$  between the l.t. rail and the base of the colourkiller-controlled stage in the chrominance channel. BRC's recommendation with their 3000 chassis however is to connect an  $82k\Omega$  resistor between the junction of C323/C324 (Fig. 1) and chassis. These two series-connected capacitors tune the collector coil of the ident amplifier VT306 the output from which on colour drives the PAL switch driver stage VT307. Standing bias for VT307 is obtained on colour by W305 which rectifies the signal feed to its base. As a result VT307 is non-conductive on monochrome but on colour when the ident signal is present it is brought into conduction and an average voltage of 27V appears across its collector load resistor R344. The colour-killer turn-on bias is produced in the PAL switch circuit when VT307 comes into operation.
