RADIO SERVICE NEWS

VOLUME XVI, No. 2

RCA TUBE DEPARTMENT, HARRISON, NEW JERSEY

April-May, 1951

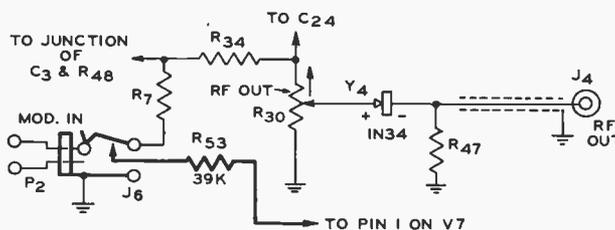
The wide-band modulator in some of the early models of the RCA WR-39B (code numbers 450 and 1149) could not be disabled. After the open-circuit jack is replaced with a closed-circuit type and resistor R53 is connected as shown in the schematic diagram, the wide-band modulator will be disabled until a plug is inserted into the MOD IN jack, J6. When making this conversion, check the polarity of the 1N34; the negative terminal should be connected to the RF OUT jack, J4.

Disabling of the 1N34 mixer is accomplished by providing it with a dc bias so that the diode is continuously

conductive. This is accomplished in the WR-39B (except early models with code numbers 450 and 1149) whenever the phone plug is removed from the MOD IN jack, thereby closing the jack contacts to their normally-closed position.*

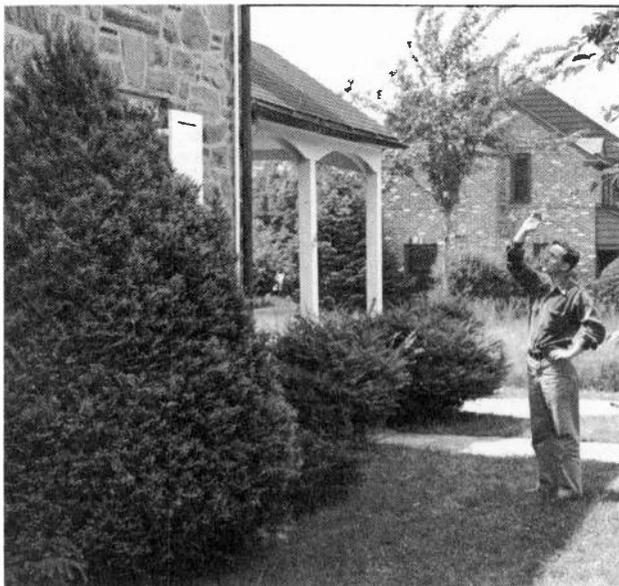
Determine the antenna location.

Observe all sides of the house and roof for antenna mounting possibilities. Give consideration to transmission-line run, point of entry, height above ground, obstructions, nearby antennas, and appearance. Bear in mind that, in general, the

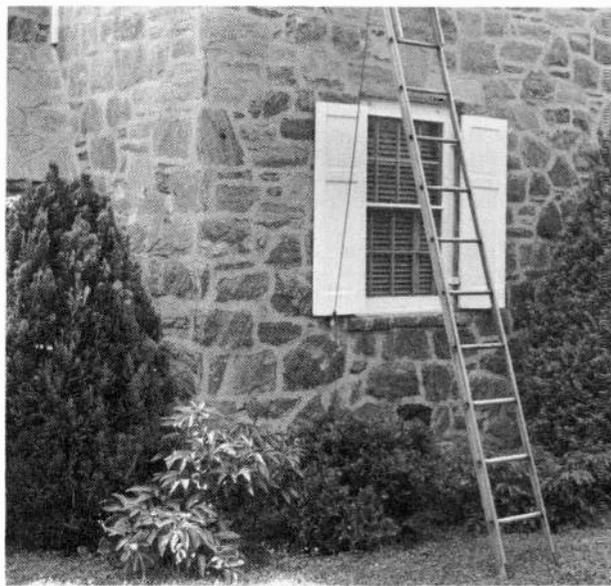
Do not set up the ladder directly in front of a window.

Before erecting the extension ladder at the chosen location, check its general condition. For safety, the extension ladder should be equipped with SAFE-HI ladder shoes, which are used in accordance with existing conditions, i.e., spiked ends down-

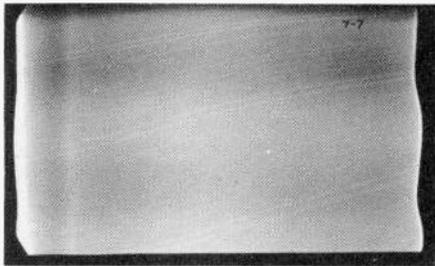
Fig. 1. Two cycles of change in width, and two cycles of change in brightness (hum bars) between the top and bottom of the raster (vertical oscillator running at 60 cycles). The two cycles occur in 1/60th second, indicating that the hum trouble is 120 cycles and that it originates in the B supply. The trouble was caused by open B+ filter capacitors, which resulted in excessive 120-cycle ripple in the B voltage, changing the width and brightness of the raster at a 120-cycle rate. Figures 2 to 9 show examples of 60-cycle hum trouble caused by heater-cathode leakage.

*A hum bar is a change in brightness between the top and bottom of the picture or raster. See Fig. 1.

If there is only one cycle of hum bars, and/or one cycle of horizontal pulling, between the top and bottom of the picture, the trouble is caused by 60-cycle hum (usually caused by heater-cathode leakage). If there are two cycles of hum bars, and/or two

cycles of horizontal pulling, between the top and bottom of the picture, the trouble is caused by 120-cycle hum (usually caused by trouble in the B-supply circuits).

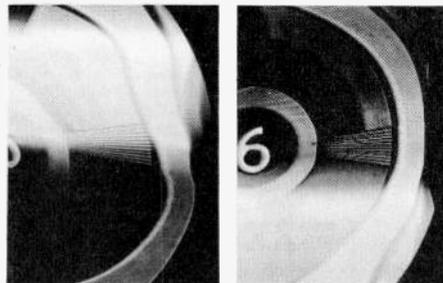
Fig. 2. One cycle of change in brightness (60-cycle hum bars) and one cycle of horizontal pulling, between top and bottom of picture, indicates heater-cathode leakage in the rf, if, or video amplifiers. The trouble in this example was caused by a defective tube in the picture-if amplifier. The 60-cycle leakage current flows through the cathode resistor and modulates the TV signal. The position of the hum symptoms is shifted, as shown above at left and right by reversing the power-cord plug.

In the case of 60-cycle hum symptoms, a simple and positive check can be made by reversing the power-cord plug. If the 60-cycle hum bars or horizontal pulling are caused by internal hum trouble, such as heater-cathode leakage, the hum symptoms will shift in position by about one-half of the height of the picture whenever the plug is reversed. Reversal of the plug has no effect on the position of "hum symptoms" resulting from external interference.

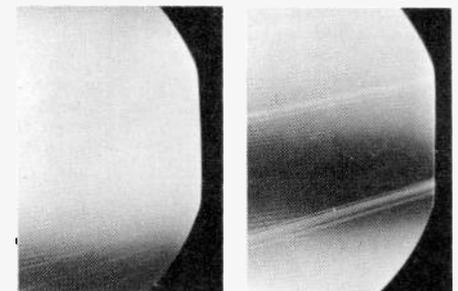
Fig. 3. The presence of 60-cycle hum bars on the raster alone (without TV or other signal) indicates heater-cathode leakage in the video amplifier section, which includes the 2nd detector, dc restorer, and kinescope. Normally, the vertical oscillator tends to sync on the leading edge of the dark bar, as shown above at left. The entire dark bar may be brought into view by adjusting the vertical hold control, as shown above at right. The leakage in this example was simulated by connecting a 1000-ohm resistor from the cathode to the ungrounded heater terminal in a video stage that has a 330-ohm cathode resistor. (Refer to Fig. 5.)

When a tube with heater-cathode leakage is used in the video amplifier, which has good response at 60-cycles, the hum voltage passes through the amplifier and appears on the kinescope, regardless of whether a signal is passing through the receiver.

3. If 60-cycle hum bars remain present on the raster when the picture signal is killed, it generally indicates heater-cathode leakage in the video amplifier. In very rare cases, an exception may be found in the presence of a strong 60-cycle ac field from a power transformer located too close to the socket-end of the kinescope. An example of this rare effect is shown on K-3 in the RCA Television Pict-O-Guide* (Vol. 1).

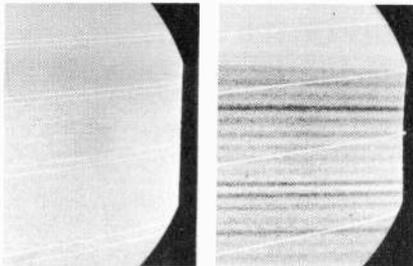
Fig. 4. Heater-cathode leakage in a tube in the rf or picture-if amplifier modulates any signal passing through these amplifiers, including "grain noise" or "snow" signals, as shown at left, or FM signals, as shown at right. Note that in each case the top portion of the raster is devoid of signal. The leakage current reduces the gain of the stage during the time corresponding to the blank portion.

60-cycle hum voltage, produced by heater-cathode leakage in an rf or picture-if tube, cannot by itself pass through these amplifiers which respond only to rf or if signals. However, such hum voltage, can and does act to modulate any rf or if signal that is passing through the amplifiers. For this reason, the effects of heater-cathode leakage in the rf or if amplifiers do not appear on the kinescope unless a signal is being received. The signal does not have to be from a TV station. It can be "grain noise," FM, or other signals, as shown in *Fig. 4*.

The same effect is evident at the center of *Fig. 6*, and the top and bottom of *Fig. 7*. Like many other troubles in electronic equipment, heater-cathode leakage can be intermittent, starting or stopping as the tube warms up. The particular tube used when these photographs were made had intermittent heater-cathode leakage.

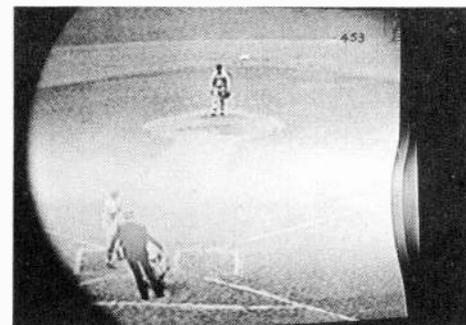
Fig. 6. In addition to 60-cycle change in picture brightness, heater-cathode leakage in the rf, if, or video amplifiers may also produce 60-cycle horizontal pulling in the picture. Both effects are evident in this example, which was produced by heater-cathode leakage in a tube in the picture-if amplifier (Refer to Fig. 7 and the note at the end of the caption for Fig. 9.)

The effects of hum voltage due to heater-cathode leakage in a tube in the rf, if, or video amplifiers may produce both 60-cycle hum bars and 60-cycle horizontal pulling. The presence of the 60-cycle hum bars indicates that the trouble is ahead of the kinescope (in the rf, if, or video amplifiers). The procedure for localizing the faulty tube is, therefore, the same as given previously under item 1 for "60-cycle hum bars."

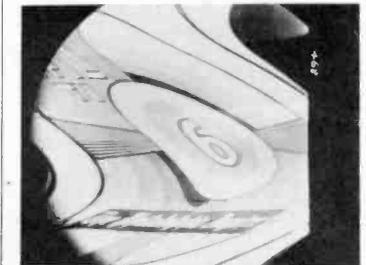
Fig. 9. Severe 60-cycle horizontal picture pulling produced by heater-cathode leakage in a horizontal-afc discriminator. Horizontal picture pulling results from variation in horizontal sync phasing. (Note—In making the photographs for Figures 6, 7, 8 and 9, the picture on the kinescope was intentionally moved toward the left in order to bring the right-hand edge of the raster into view to show that the edge of the raster is straight; horizontal picture pulling does not affect the shape of the raster.)

When 60-cycle horizontal picture pulling occurs, without accompanying 60-cycle hum bars, as shown in *Figures 8 and 9*, the trouble is most likely to be found in the horizontal-afc and oscillator sections, or in the sync-separator section. Heater-cathode leakage in these sections may produce 60-cycle variation in horizontal-sync phasing, which appears as 60-cycle horizontal picture pulling. The pulling is present only on the picture, not on the raster, and it disappears when the TV signal is removed. The remedy is to try new tubes in these sections.
