# Techni-talk

## on AM, FM, TV Servicing

### CONVERSION OF 10- AND 12-INCH

### RECEIVERS TO USE LARGER SIZE PICTURE TUBES

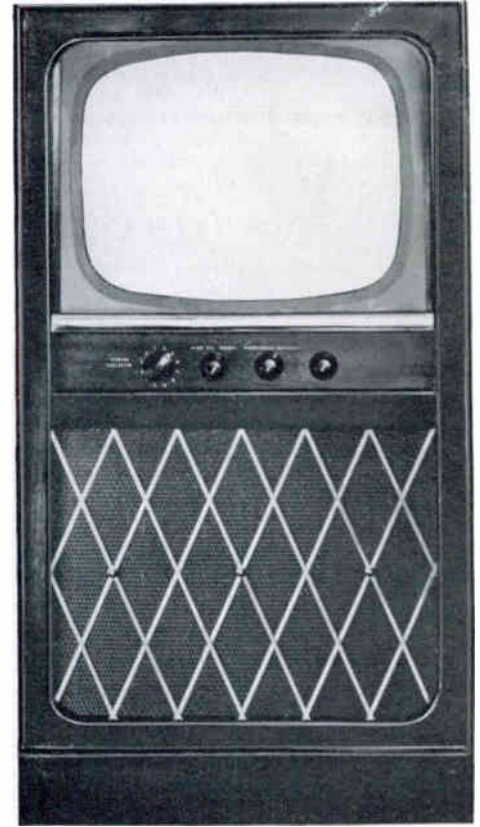
Fig. 1A General Electric Model 809 receiver before conversion. Fig. 1B is the same receiver converted to use a 16KP4 rectangular picture tube. Fig. 1C is the same receiver converted to use a 17BP4-A rectangular picture tube.

The first receiver converted was a General Electric Model 809 shown before conversion in Fig. 1A. This is a series filament type receiver using a 10FP4 picture tube. The cabinet is somewhat unusual in that the chassis is mounted on an angle with the top of the front

A 16-inch rectangular mask measuring 12" x 15 $\frac{1}{2}$ " was placed flush with the front panel. This type of mask is manufactured by both the Deitz Miracle Lens Co. and the Tele-Plastics Co. The panel area which showed on either side of the mask was lighter in color than the rest of the cabinet so this area was varnished with a walnut varnish stain. When this dried the mask was inserted into the recessed top section and held in place by the brass bar using the four original screws. The rubber strip was removed from the bottom of the safety glass panel and placed between the mask and the brass bar with the open end down. This held the bottom of the mask securely between the front of the panel and the brass bar. A  $\frac{3}{8}$ " rubber grommet was inserted from the back between each top corner and the wooden panel. This held the mask in place and when the chassis was placed in the cabinet, the faceplate of the picture tube was practically flush with the inside of the mask. Any small variation between the mask and picture tube faceplate may be corrected by slightly shifting the mask or chassis before the final assembly. The finished conversion is shown in Fig. 1B.

If a 17BP4-A picture tube were used the same type mask as shown in Fig. 1B except in the seventeen-inch size may be used. A somewhat different effect can be obtained at a slightly reduced cost by using a mask designed for use in back of a safety glass. A seventeen-inch conversion using this type mask is shown in Fig. 1C. These masks are made of a thin plastic and are available in a light or dark royalite

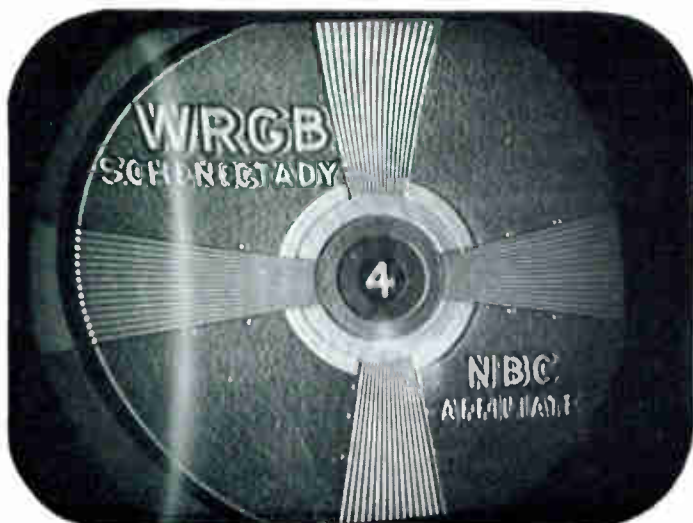
Fig. 1. The faint vertical white line at the left may be due to a defect in the damping circuit. The fine tuning control was adjusted to accentuate the whites.

Most technicians have also been troubled at one time or another by horizontal retrace lines which may appear as vertical white lines similar to Fig. 1. This type of line is due to improper damping and when the horizontal hold control is adjusted it will move in the opposite direction from the direction in which the picture moves. A defect at the transmitter will also result in

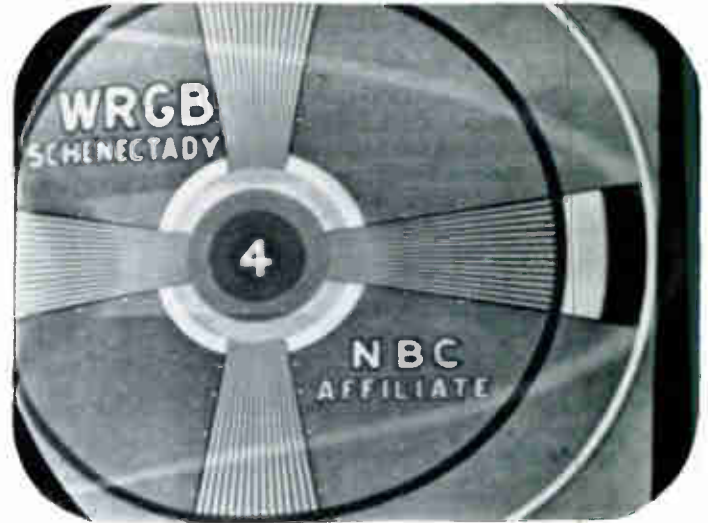
Fig. 2. Horizontal fold-over usually caused by the horizontal retrace being too slow.

this same condition. The fold-over shown in Fig. 2 is usually caused by the horizontal retrace being too slow. This condition is frequently encountered when a capacitance is placed across the secondary of the horizontal sweep transformer to increase the picture size. Both of these defects will disappear if the horizontal retrace is completely blanked out.

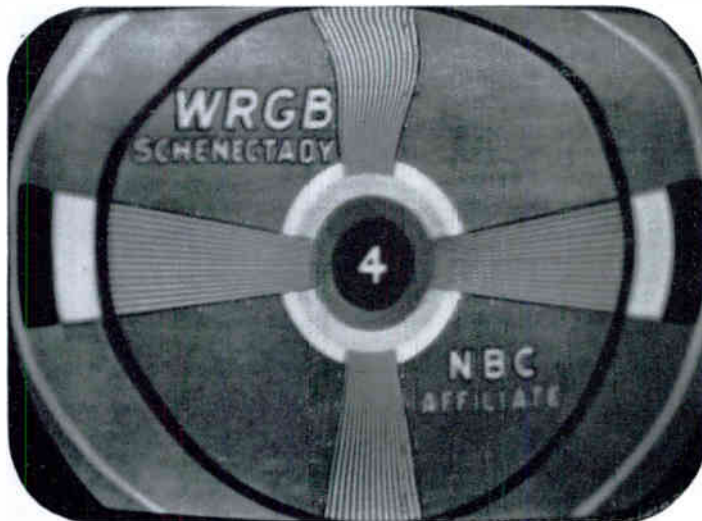
**Tele-Clue No. E-59**—The curve and waviness which appears only at the top of the picture may be due in the General Electric Model 810 line of receivers to the resistance of R98 in Fig. 1 being too low. When replacing use a 56000-ohm resistor.

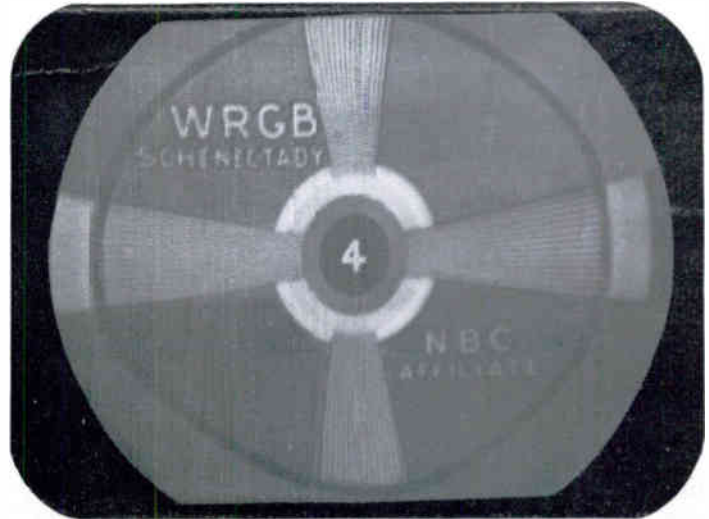
**Tele-Clue No. H-60**—A washed out picture may be due to a low emission or "soft" picture tube. This same type picture will result when the voltage on the No. 2 grid of the picture tube is reduced by leakage to ground.

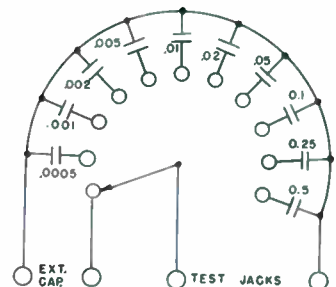
Fig. 3. Circuit diagram for high capacitance substitution box. The capacities are shown in mfd.
