Television Service Tips

Volume XIX
Issue 1
March 15, 1968

Prepared and Distributed by RCA Sales Corporation, Product Performance
600 N. Sherman Drive, Indianapolis, Indiana 46201

"Safety"-Back Retaining Nut
Models—AJ 095, 153, 157—Chassis KCS 158

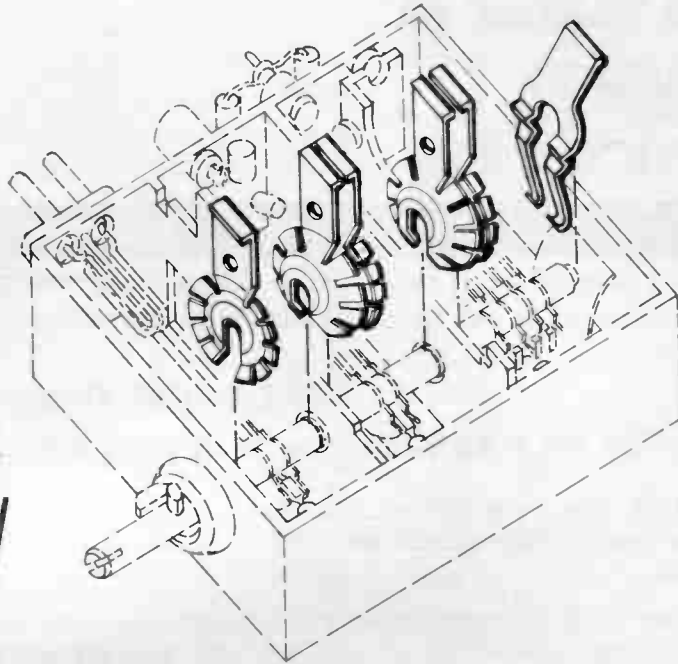
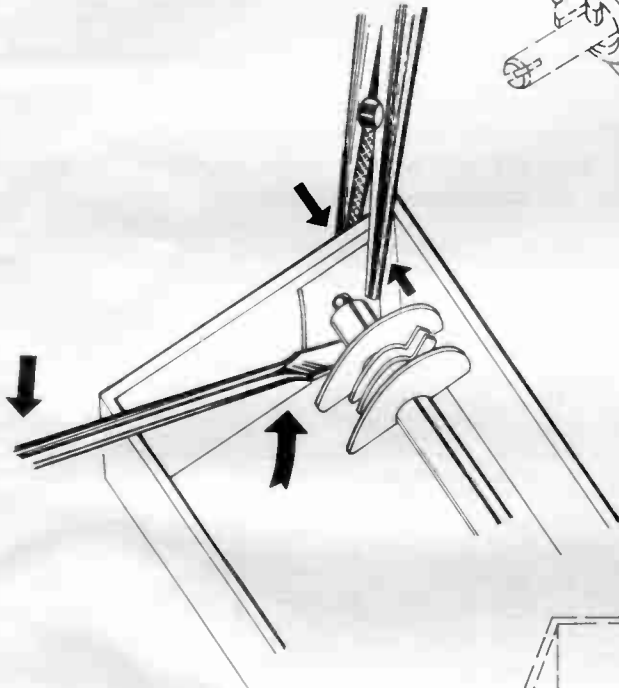
Step 2

A noisy UHF tuner may indicate insufficient wiper tension on the rotor shaft. To correct this condition, the Rotor Bearing Spring and the Wipers should be replaced following the procedure outlined in this publication.

Rotate the shaft fully clockwise (plates unmeshed). Depress the rotor shaft bearing spring with long pliers and apply pressure under the shaft with small screwdriver to force the rear end of the shaft out of the spring detent.
