# ACTUAL TROUBLES IN COMMERCIAL RADIO RECEIVERS

1927 — 1934

**BERTRAM M. FREED**

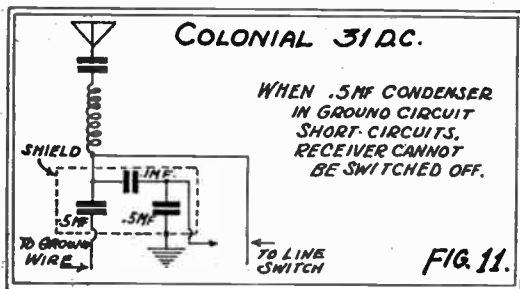
The condition may be encountered where the receiver cannot be switched off with the line switch until the ground wire is disconnected from the ground binding post. The cause for this situation lies with a short circuited .5 mf. condenser in the ground circuit. This condenser is one of three contained in a common block and connected as shown in Figure 11. Although it is good procedure to replace the entire block, a good .5 mf. condenser may be connected in series with the ground post lead, in the event a replacement block cannot be secured easily.

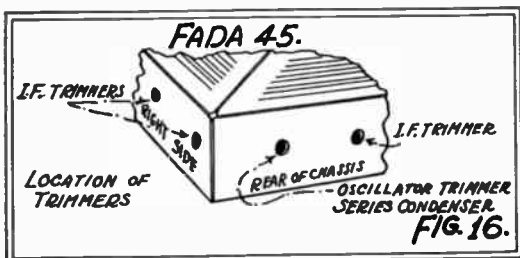
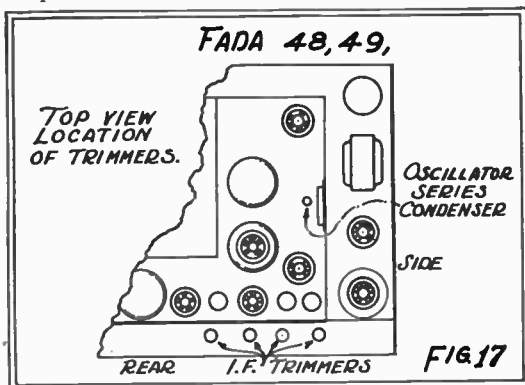
Alignment of these receivers is often confusing because of the different location or position of the alignment condensers. The I.F. trimmers in the model 45 are located in the rear right-hand corner of the chassis as shown in Figure 16. Due to the fact that the primary of the second intermediate transformer is not tuned, there are only three condensers to be adjusted at the intermediate frequency the fourth trimmer being the oscillator series condenser, which is aligned at 600 K.C. The model 48 and 49 receivers have four I.F. compensating condensers lo-

cated at the rear of the chassis as shown in Figure 17. The oscillator series condenser, which is adjusted at 600

K.C. while "rocking" the tuning gang is accessible from the top of the chassis and is located to the right of the

second detector socket. The tuning gang is aligned by adjustment of the compensators on top of each section.

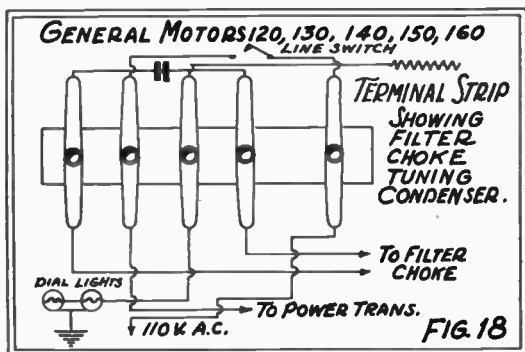
The condition of an abnormal hum has often been found caused by a short-circuited .1 mf. "tuning" con-

denser connected across the filter choke. This condenser is connected across two lugs on the A.C. terminal strip and located beneath the strip as shown in Figure 18.

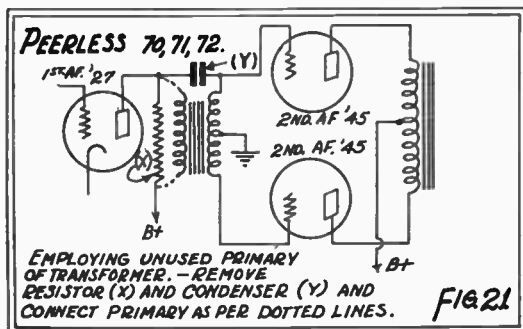
Where an open-circuited or shorted .06 mf. condenser, coupling the first audio stage to the output tubes, is found, the unused primary of the audio transformer whose secondary only is employed, may be utilized. The coupling condenser should be removed and the primary, not shown in the schematic of this receiver, connected in place of the 20,000 ohm carbon plate resistor as shown in Figure 21. This procedure will result in greater volume and slightly lower hum level.

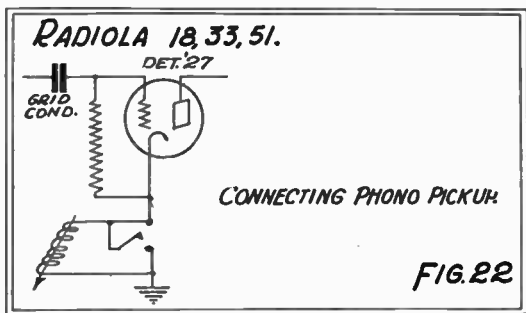
Connecting a phono pickup to these receivers often presents a number of difficulties. If a high impedance pickup is connected from the grid to cathode of the detector tube, the long leads will cause unstable operation and an audio howl. In order to obtain the added ampli-

fication of the detector tube and resulting greater volume, the pickup should be inserted in the cathode circuit of the detector tube as shown in Figure 22.

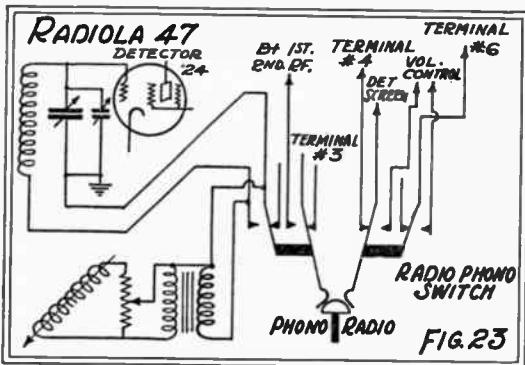
model 47. The condition of intermittent reception on this model, however, with the symptoms of no screen or plate voltages obtained on the R.F. tubes has been traced

to badly corroded contacts of the radio-phonograph transfer switch. These contacts may be easily cleaned by the insertion of a small strip of fine sandpaper or a small magnetite file, after the switch has been removed. The connections to the switch are shown in Figure 23.

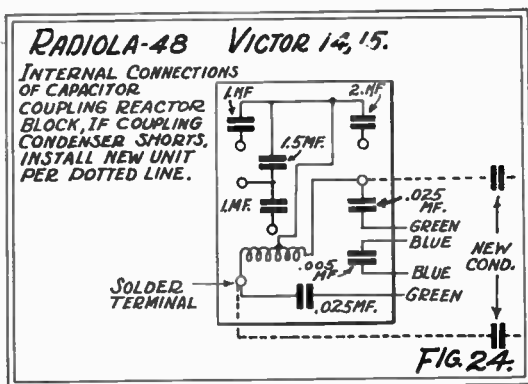
The symptoms of muffled, distorted reproduction, and hum which will clear up when one of the 45 tubes is removed, has invariably been traced to a shorted .025 mf. condenser coupling the detector tube to the power amplifiers. This condition will be made evident by the high plate current and positive grid bias reading obtained on the 45 in whose grid circuit the shorted condenser is connected. Although these condensers are located in the capacitor and coupling reactor block, it is not necessary to replace the entire unit when one of these condensers short-circuits. A new condenser may be installed in series with

the green lead connecting to the grid of the 45, or the green lead may be disconnected and the new unit installed

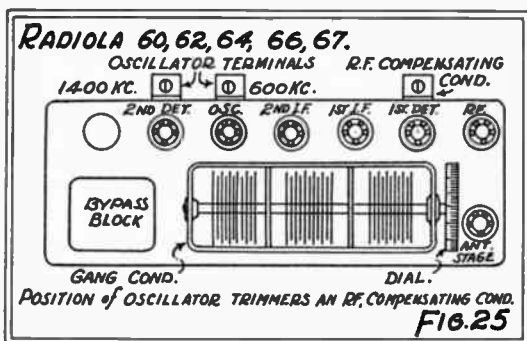
Poor sensitivity at either the high or low frequencies may be due to the oscillator trimmers being out of adjustment. These trimmers are located to the right of the chassis (facing the rear) as shown in Figure 25. The trimmer on the right should be adjusted for maximum response with the receiver tuned to a 1400 K.C. signal generated by an oscillator. The left trimmer is properly adjusted for maximum response with the receiver tuned to a 600 K.C. signal. An insensitive condition may also be caused by the poor adjustment of the R.F. compensator condenser, located at the extreme left as shown in Figure 25, which should be adjusted in the following manner. Tighten the adjusting screw clockwise until the tuning of any station will produce a whistle or oscillation. With the receiver tuned to some station at approximately 1000

K.C. turn the adjusting screw back beyond the point of oscillation. Now tune the set at different points on the dial to observe the presence of oscillation. If this is found, turn the compensating condenser screw back slightly.

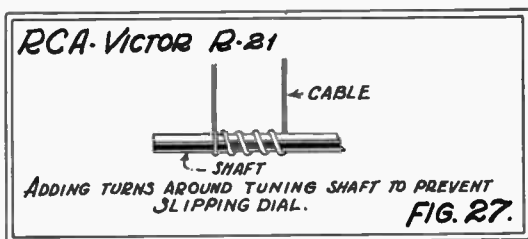
A slipping tuning dial on the Model 21 may be repaired by taking another turn or two around the tuning shaft with the drive cable as shown in Figure 27. To accomplish this, the tension spring must be released so that the turn may be made with the loose cable. When the dial is removed to gain access to the tension spring, its position should be carefully noted so that it may be re-installed without disturbing the dial settings.

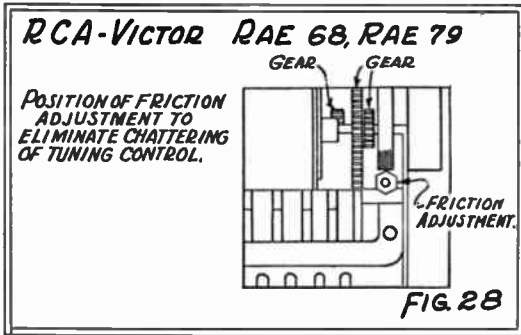
Chattering of the tuning control when one of the sta-

tion selector buttons is pressed, may be eliminated by adjustment of the friction screw whose location is shown in Figure 28. It should not be adjusted too loosely.

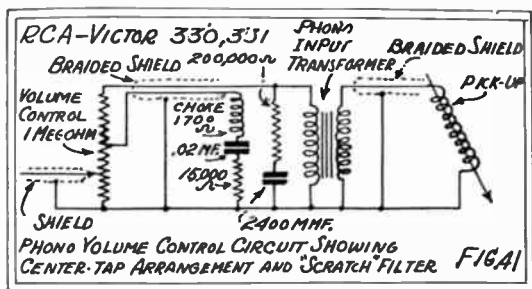
A common complaint with this model is poor control of record volume. A sharp drop in volume is usually obtained when the phono volume control is turned to the middle of its range. This trouble may be remedied by disconnecting the lead to the center-tap on the volume control resistance element. This center-tap on the volume control is employed in conjunction with a choke-condenser-resistor combination as shown in Figure 41, to reduce the high frequency response so as to reduce "needle

scratch." In all cases, however, where the center-tap has been disconnected, the increase in "needle scratch" has been negligible, not interfering with the quality of record reproduction. In the event such condition results, the tone control of the receiver may be used to lower the high frequency response.

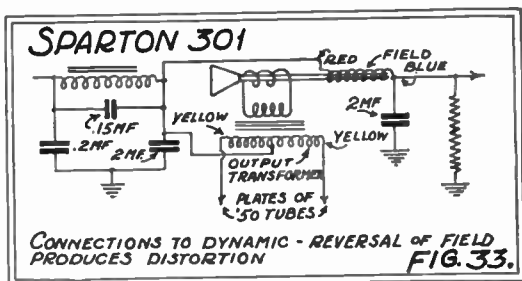
The symptoms of low volume and distorted reproduction are sometimes due to reversed connections to the dynamic speaker field coil. This condition will be disclosed with a set analyzer by low plate voltages obtained on the output tubes. Since the center-tap of the output transformer primary is tied to one side of the field coil, as shown in Figure 33, reversal will cause this trouble.

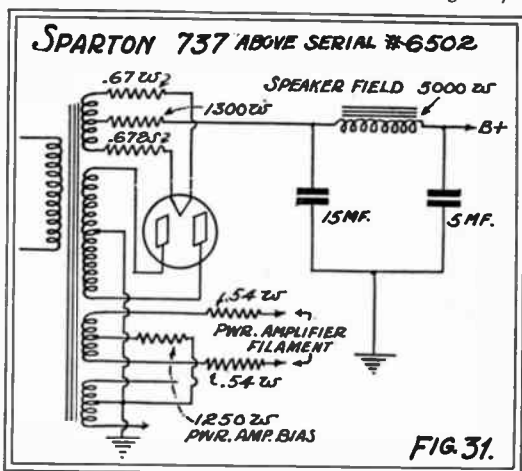
An inoperative receiver is often caused by an open 1300 ohm wire-wound resistor located alongside the 80 rectifier socket. This unit serves to reduce the voltage output of the larger power transformer which was originally in-

tended and designed for use in the Model 301 receiver. It is connected as shown in Figure 31.

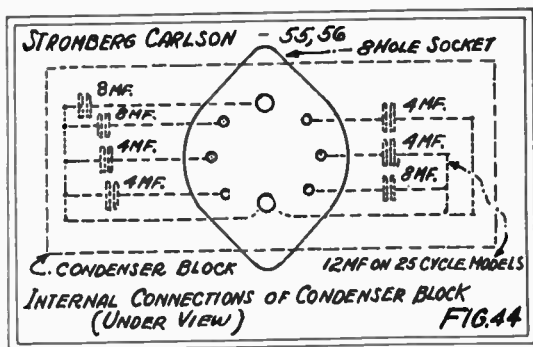
tion has been traced to leakage of and *between* sections of the filter condenser block. This block, whose internal connections are shown in Figure 44, is fastened to the chassis by four screws and is equipped with an 8 prong plug which fits into an 8 hole socket on the chassis. At

times, the leakage will show up only during operation of the receiver, and for this reason is difficult to check with an ordinary ohmmeter of limited range. If a voltmeter is employed in conjunction with a source of high voltage, locating the leaky section is made easier. Another method commonly employed by most service men is that of disconnecting each condenser, in turn, and substituting a unit of similar characteristics. Replacement of the entire block is unnecessary once the path of leakage is found. Those sections causing the trouble may be disconnected from the circuit and new condensers installed beneath the chassis.

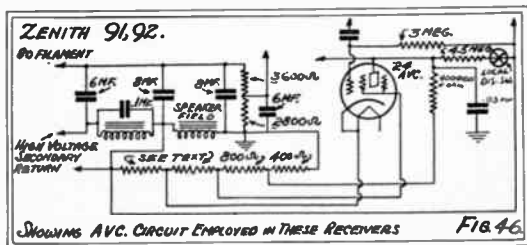
A great many of the troubles associated with these receivers originate in some portion of the A.V.C. circuit and are due to the failure of some component therein. The fact that these models appeared with three different versions of the A.V.C. circuit makes trouble-shooting more difficult and involves procedure. In the first, the volume control was placed in the voltage divider system of the A.V.C. 24 tube which varied the cathode bias on this tube, as shown in Figure 45. A local-distance switch was also employed which shunted a resistor from the plate to the cathode of the A.V.C. tube when the switch was in the local position, thus impressing a constant bias on the R.F. first detector and I.F. stages. This serves to retard the A.V.C. action and reduce inter-station noise. A second revised circuit soon appeared as shown in Figure 46, with the manual volume control in

the grid circuit of the first A.F. stage. A tapped resistor was substituted in place of the volume control in the A.V.C. circuit shown in Fig. 45. This revision permitted the reading of the tuning meter to remain constant regardless of the position of the volume control because the A.V.C. tube operated at full efficiency. A further change was made, wherein the local-distance switch and the 4½ megohm resistor in series with it,

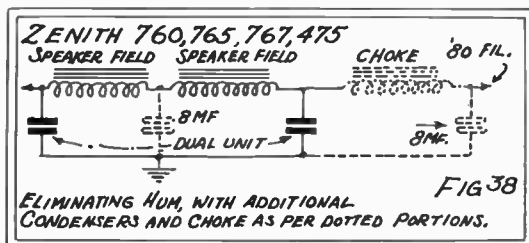
The complaint of hum may be eliminated in most instances by the addition of an 8 mf. electrolytic filter condenser connected after the first speaker field (both speaker fields used as chokes) to chassis, as shown in Figure 38. If this procedure proves ineffectual, then another

filter choke must be provided, as described with the models 715, 755 etc., between the 80 filament and the first speaker field. Further reduction in the hum level may be accomplished by connecting an 8 mf. filter condenser from the filament to chassis.
