TELEVISION SERVICE TIPS

SERVICE DATA - Chassis CTC16X 1965 No. T6

The PW700 Solid Copper Circuit Component Assembly Board on page 34, 1965 No. T6, shows a seven pin tube instead of a nine pin tube for V702. The correct phantom view of PW700 is shown below.

SERVICE HINTS AND PARTS AVAILABILITY FOR CTP 10F, G REMOTE CONTROL MOTOR

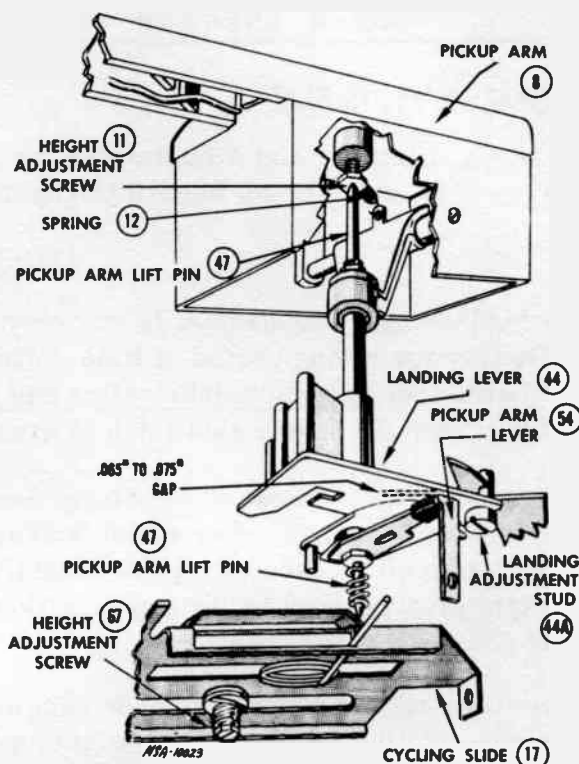
Two height adjustments are necessary. One is to provide a "clutch" clearance which controls the horizontal movement of the pickup arm, and the second adjusts the vertical lift of the pickup arm to clear a stack of records. They are adjusted as follows:

- 1 - Rotate the turntable until the mechanism is completely "Out of Cycle".
- 2 - Adjust the height adjustment screw (67) to obtain a clearance between the pickup arm lever (54) and landing lever (44) of 0.070" to 0.085" (about the thickness of a penny).
- 3 - Trip mechanism and rotate turntable, until pickup arm has completed its inward travel and is just ready to descend.
- 4 - Adjust height adjustment screw (11) so that the stylus is $1 \frac{3}{16}$ " above the surface of the turntable mat.
