# Service Talk

FROM  
TELEVISION RECEIVER PRODUCT SERVICE  
ELECTRONICS PARK SYRACUSE, N. Y.

FEBRUARY 1960

## SPECIAL COMPONENTS IN TELEVISION RECEIVERS

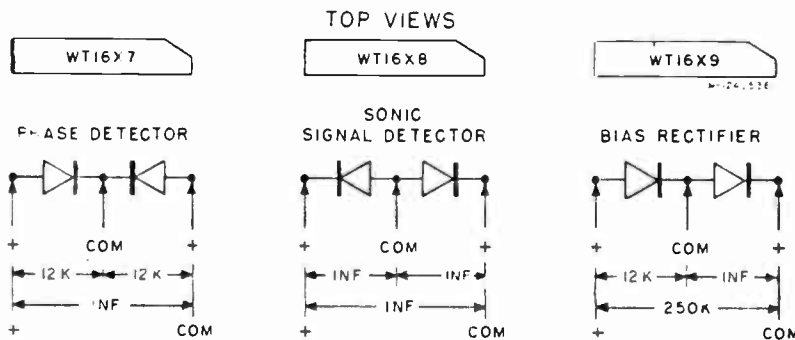
SIMPSON 260 METER SET FOR HIGH OHMS (RX 10,000)

The new line of General Electric television receivers employs three dual diode combinations. One is employed as the horizontal phase detector (WT16X7). Two are used in the Sonic Remote Receiver Circuitry, the first as a Signal Detector (WT16X8) and the other as a Bias Rectifier (WT16X9). Physically these diodes appear to be much the same but electrically they differ greatly. The Phase Detector has common anodes, and the Bias Rectifier is series connected. While each diode is plainly marked, a simple ohmmeter check can eliminate any confusion with these components.

The diagram below shows the measurements taken with a Simpson 260 meter. A VTVM may be used and the polarities of conduction shown will remain the same; however, the values may differ with meters as is the case of using other VOM types.

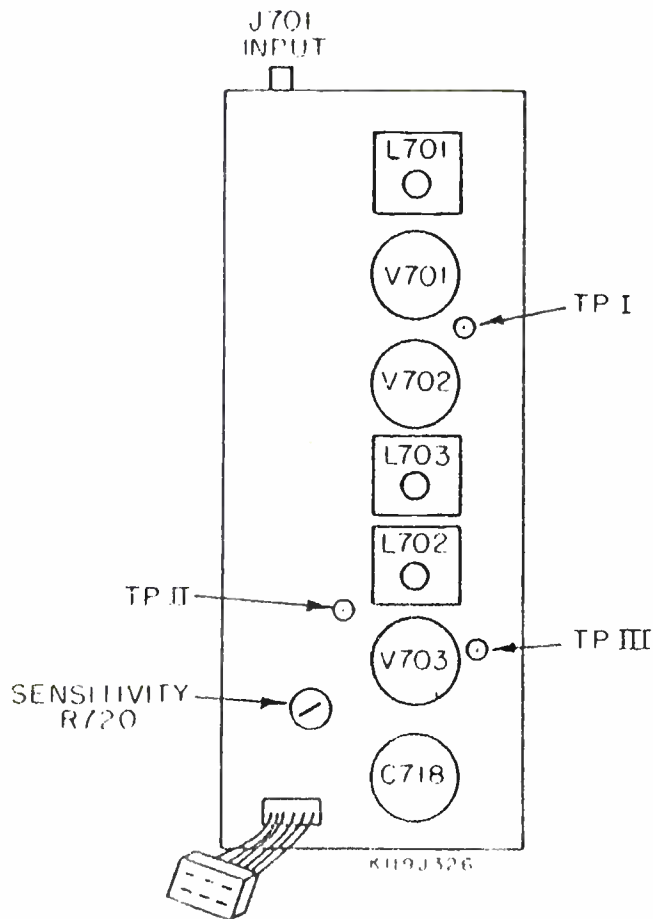
SONIC REMOTE RECEIVER

These corrections and additions to the sonic remote control system alignment, covered in the M6 preliminary 32-2000-60 should be noted. The receiver adjustment location view Figure 20 on Page 13 should be changed to show the positions of L702 and L703 reversed with L703 located above L702.

The sensitivity control R720 should be set to provide proper operation of each push button function under the noise conditions of the location of final installation. In most cases this control may be set to provide a static bias voltage at test points II or III of -6.5 to -8 volts.

- Reset the sensitivity control on the receiver (R720) to provide proper operation of each push button function under the noise conditions of the location of final installation. In most cases this control may be set to provide a static bias voltage at Test Point II or III of -6.5 to -8 volts. Under some noise conditions (intermittent bells or chimes) a bias slightly higher than normal should be used.

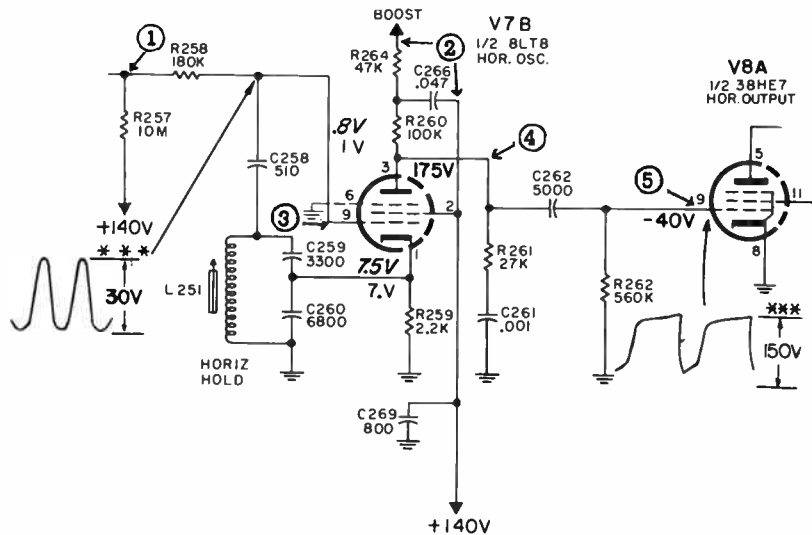
The partial schematic diagram below shows the oscillator circuitry with circled numbers identifying areas referred to in the step-by-step procedure. In actual troubleshooting, the DB (or other chassis) main-chassis schematic diagram should be used, and common-sense troubleshooting practice followed; for example, in the event of a failure in the horizontal or high-voltage area, a preliminary visual inspection and a check of circuit voltages may furnish immediate clues to the trouble source.

1. Connect a jumper between chassis ground and the junction of R257-R258. If high voltage becomes operative as shown by the raster, it can be assumed that the difficulty is in the

phase detector or another stage on that side of the oscillator. In this case, normal troubleshooting practices should be applied beginning with the phase detector output and working back.

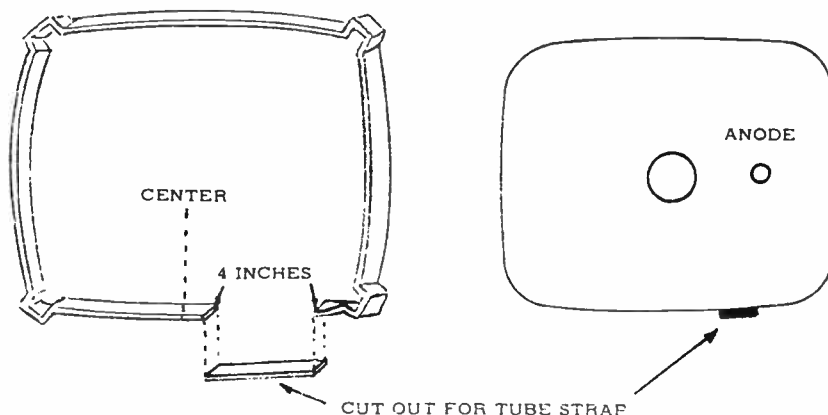
Replace the above tubes with Type 16BYP4. This tube is equipped with tension band implosion protection. Use of this tube requires a minor alteration to the plastic cabinet.

To alter the cabinet, remove approximately 4 inches of the plastic rib which surrounds the picture tube. This allows the clamp on the tension band to fit properly into the cabinet. The illustration below shows the area to be cut out and the dimension. The plastic can be easily snapped out with side cutters.

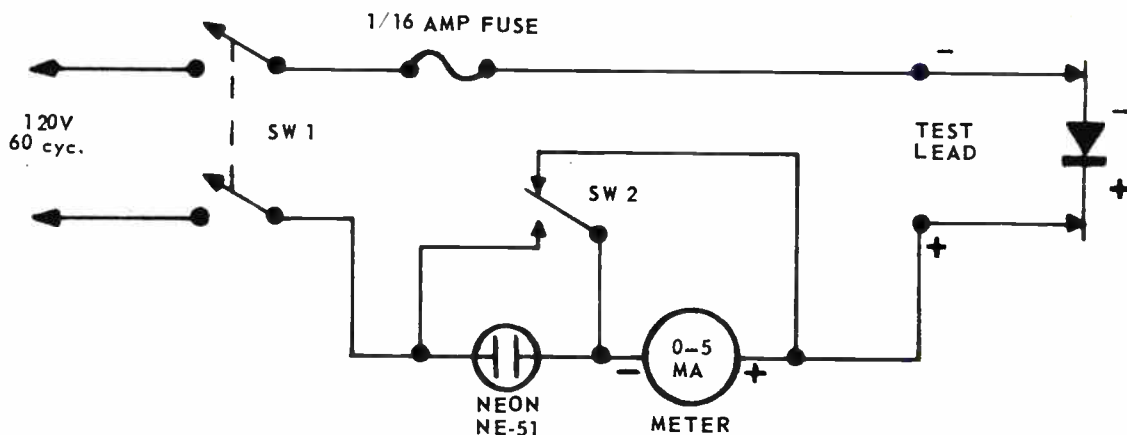
Since it has been difficult to determine which semi-conductor H.V. rectifier is responsible for the loss of HV, many good rectifiers are being swapped.

The following simple test circuit has been developed to permit accurate testing of these units.

The test unit may be enclosed in a small metal box with the meter. Sw. 1 should be a spring return, to assure an open circuit during hook-up. Sw. 2 is for meter protection in the event of excessive leakage and should also be spring return. The neon bulb should be mounted in an enclosed neon light assembly similar to Allied 7E852 (has no built-in resistor).

Since the unit is connected to the power line, it should either be operated through an isolation transformer or have a 1 to 1 transformer built in to the case.

2. Connect test leads of unit to rectifier, observing proper polarity.
3. Depress Sw. 1 and observe neon lamp. Proper rectifier action will produce DC and light only one element of the neon lamp. If both elements light, AC is indicated and the rectifier is defective.
4. Assuming proper neon indication is obtained, depress Sw. 2 (Sw. 1 also remains closed), the meter should read over 0.5MA for a good rectifier. Readings of 0.5MA or less indicate a defective rectifier.

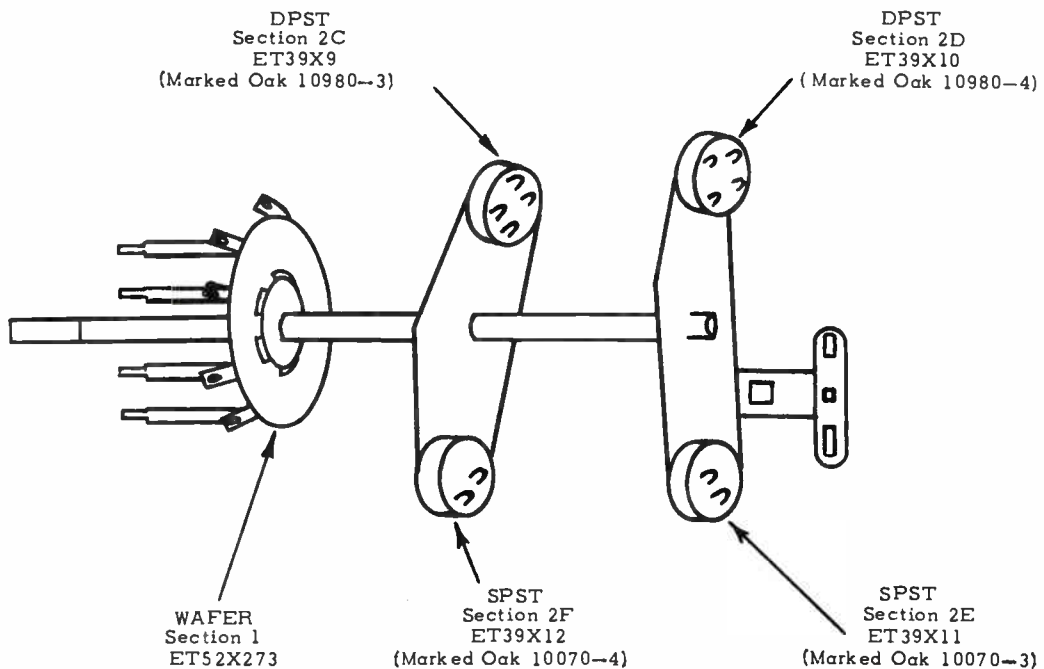
Nearly all defective switch assemblies can be repaired by replacing the faulty switch section or sections.

The illustration identifies the various individual switch

section Catalog Numbers which are the same for all models listed below.

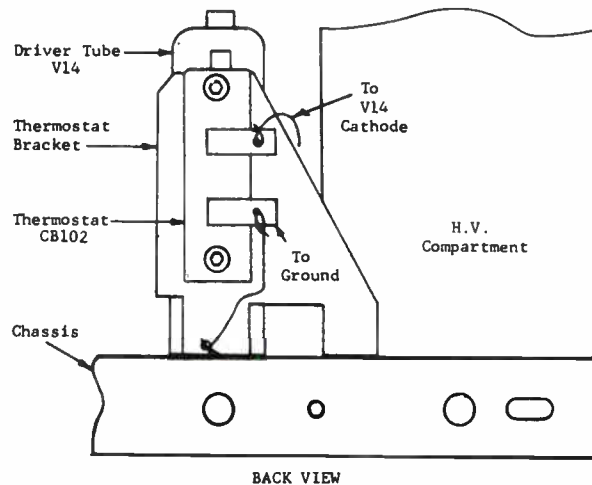
The thermostat CB102 is mounted adjacent to the glass envelope of the horizontal output tube V14 and directly above the rear apron as illustrated.

The thermostat is connected in series with the grounded cathode lead of V14. The cathode is connected to the top terminal of CB102 and the bottom terminal is connected to chassis ground.

Abnormal heat from the glass envelope of V14 will cause the thermostat to open and V14 will become inoperative due to its open cathode circuit. Abnormal heat would be due to excessive plate and/or screen current which in turn could be caused by either a failure of V14 itself or a malfunction in its input or output circuits such as loss of grid drive from the horizontal oscillator, a defective regulator tube, sweep transformer, etc.
