# Tele-Clues

**Tele-Clue K-274**

**Receiver:** G-E "U-4" line (See "U-4" Tele-Clue Schematic).  
**Component:** C254, 5000 mmfd, 450 volt capacitor, temperature range 10° - 105° C - SHORTED.  
**Circuit:** Grid circuit of V8 Clipper tube.  
**Symptom:** Soft sync, horizontal side lock and possible audio buzz.

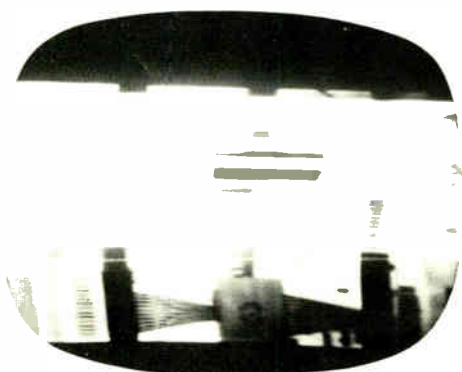
**Tele-Clue D-275**

**Receiver:** G-E "U-4" line.  
**Component:** C301, .015 mfd, 600 volt capacitor - LEAKY (1 meg).  
**Circuit:** Grid circuit of V9A vertical oscillator.  
**Symptom:** Top fold over, poor vertical sync.

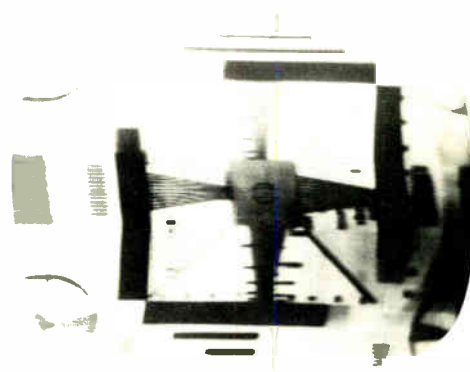
**Tele-Clue D-278**

**Receiver:** G-E "U-4" line.  
**Component:** V9 tube, 3,000 ohm heater-cathode leakage.  
**Circuit:** Vertical oscillator and output.  
**Symptom:** Very poor vertical interlace. Vertical may lock-in too high or too low.

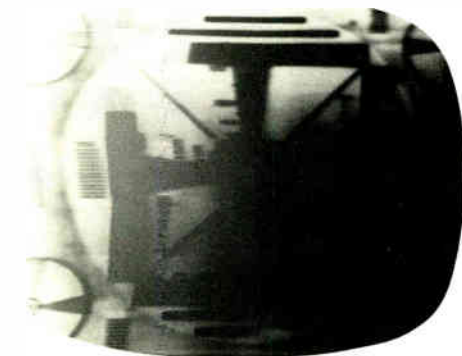
**Tele-Clue D-276**

**Receiver:** G-E "U-4" line.  
**Component:** C-307, .0082 mfd, 1600 volt capacitor-OPEN.  
**Circuit:** Vertical blanking charging capacitor in cathode circuit of picture tube.  
**Symptom:** Dim raster with shading on right.

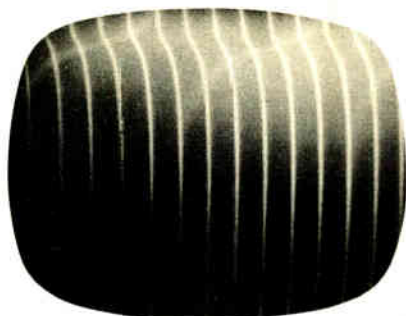
**Tele-Clue F-241**

**Receiver:** Any with Full-Wave Rectifier Tube.  
**Component:** Rectifier tube with one open plate connection.  
**Symptom:** (1) shading of picture. (2) One plate in tube may turn pink. (3) Tube could test "ok" on tube testers that tie plates together.

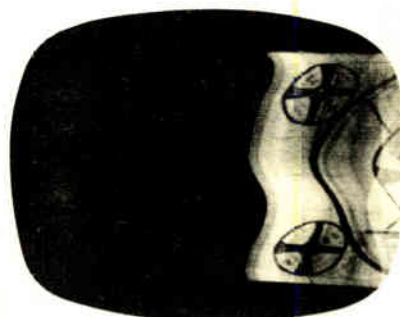
**Tele-Clue F-244**

**Receiver:** G-E "M-4" line.  
**Component:** C401B, 100 mfd, 350 v, output filter capacitor — OPEN.  
**Circuit:** Heater circuit of low voltage rectifier.  
**Symptom:** (1) Distorted raster reduced in size. (2) Horizontal off frequency. (3) Hum in audio.

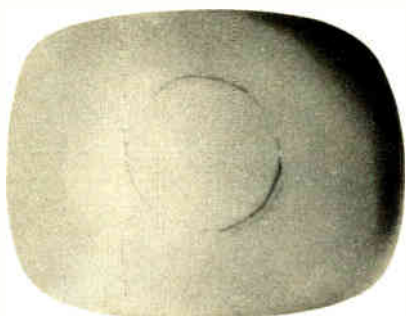
**Tele-Clue G-242**

**Receiver:** Any 21" with flat safety glass.  
**Component:** Faceplate of picture tube and safety glass.  
**Symptom:** Ring of dust precipitated at edge of a circular area where safety glass and picture tube faceplate are in close proximity.  
**Cause:** Electrostatic charge developing between safety glass and faceplate.

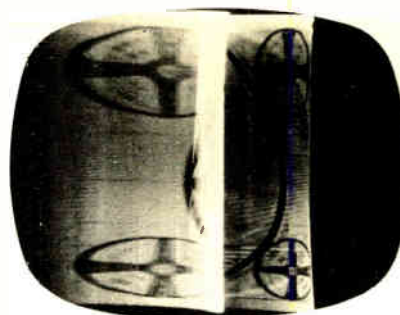
**Tele-Clue F-245**

**Receiver:** G-E "M-4" line.  
**Component:** C-260, 40 mfd, 400 volt, B+ to B+ "boost" capacitor — OPEN.  
**Circuit:** Plate circuit of damper tube.  
**Symptom:** (1) Reduced size. (2) Horizontal foldover at center of picture.

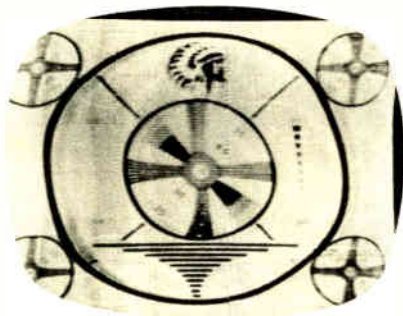
**Tele-Clue F-243**

**Receiver:** G-E "M-4" line (see M-4 Tele-Clue Schematic in Vol. 10, No. 5 issue).  
**Component:** C401A, 60 mfd, 350 v, input filter capacitor — OPEN.  
**Circuit:** Heater circuit of low voltage rectifier.  
**Symptom:** (1) Curl at edge of raster. (2) Reduced size. (3) Horizontal pulling.  
**Cause:** Reduced B+ voltage with increased hum level.

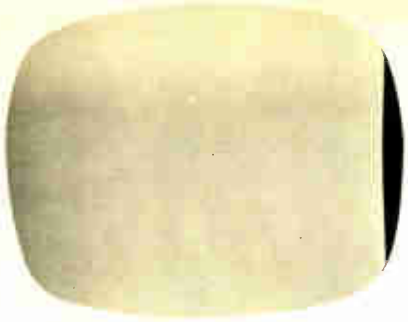
**Tele-Clue R-246**

Receiver: G-E "M-4" line.

Circuit: Cathode circuit of audio output tube.

Symptom: (1) Blank raster. (2) Reduced width. (3) No audio. (4) Resistor R314 burns.

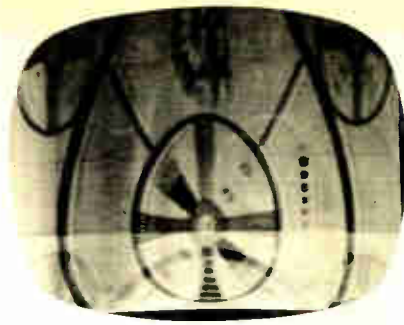
**Tele-Clue D-249**

Receiver: G-E "M-4" line.

Component: C209-.027 mfd, 500 volt, temperature compensated ceramic capacitor — LEAKY (1 megohm).

Circuit: Grid (pin 1) circuit of vertical output tube.

Symptom: Bottom foldover and top stretch.

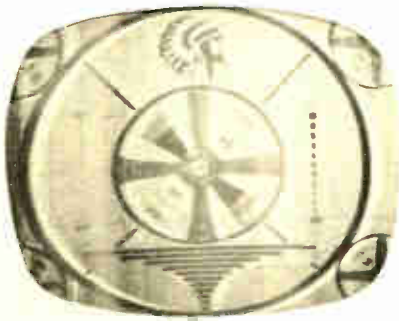
**Tele-Clue G-247**

Receiver: G-E "M-4" line.

Circuit: G2 (pin 3) circuit of picture tube.

Symptom: Dim picture and raster.

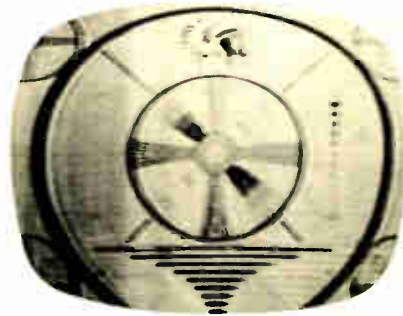
**Tele-Clue D-250**

Receiver: G-E "M-4" line.

Circuit: Grid (pin 1) circuit of vertical output tube.

Symptom: Top compression and bottom stretch.

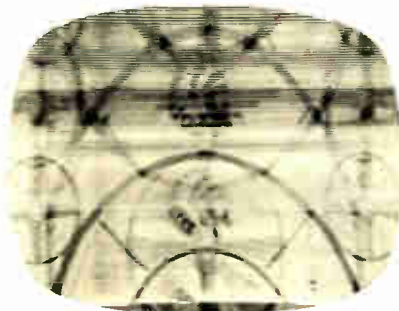
**Tele-Clue D-248**

Receiver: G-E "M-4" line.

Component: C204-.0039, 1000 volt capacitor — LEAKY (200 K ohms).

Circuit: Grid (pin 4) circuit of vertical oscillator tube.

Symptom: (1) Top stretch. (2) Vertical roll. (3) Vertical hold control ineffective.

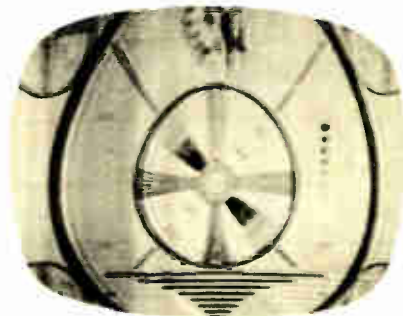
**Tele-Clue D-251**

Receiver: G-E "M-4" line.

Component: C205-.033 mfd, 200 volt tubular capacitor — LEAKY (2.2 meg).

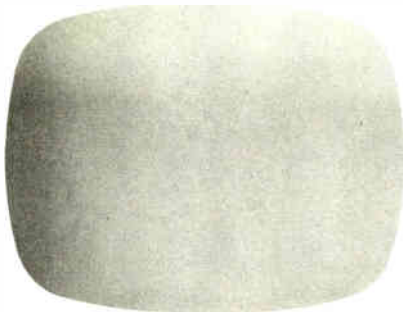
**Tele-Clue M-285**

**Receiver:** G-E "U-4" line (See "U-4" Tele-Clue Schematic).

**Circuit:** V6B Keyer grid voltage divider.

**Symptom:** Blank raster due to AGC overload which blocked out both video and audio.

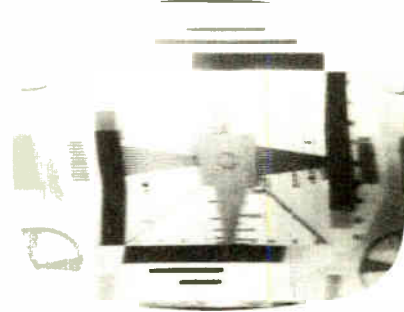
**Tele-Clue D-288**

**Receiver:** G-E "U-4" line.

**Circuit:** Vertical oscillator, V9A, plate circuit.

**Symptom:** Shrinkage at both top and bottom.

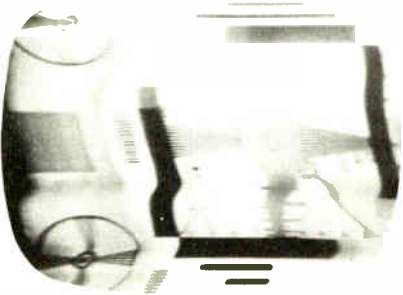
**Tele-Clue M-286**

**Receiver:** G-E "U-4" line.

**Circuit:** AGC filter in plate circuit of V15A AGC clamp tube.

**Symptom:** Horizontal hunting, horizontal distortion when stabilized and some horizontal shading.

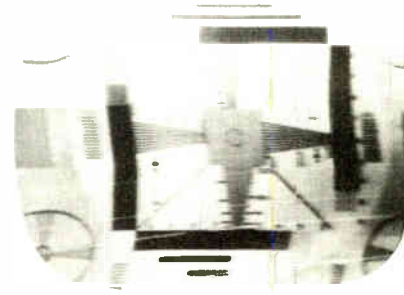
**Tele-Clue D-289**

**Receiver:** G-E "U-4" line.

**Circuit:** Vertical blanking circuit to cathode of picture tube.

**Symptom:** Visible vertical retrace lines.

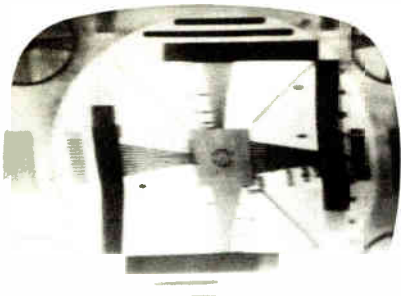
**Tele-Clue D-290**

**Receiver:** G-E "U-4" line.

**Circuit:** Vertical blanking circuit to cathode of picture tube.

**Symptom:** Slight horizontal shrinkage and shading at top.

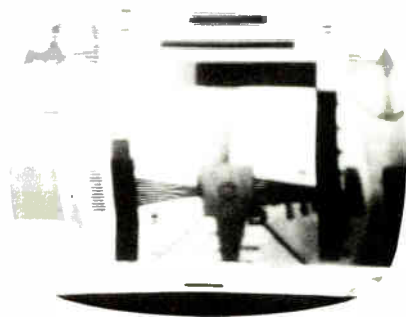
**Tele-Clue D-294**

**Receiver:** G-E "U-4" line.

**Component:** C-303, .1 mfd, 20%, 600 volt, molded capacitor — LEAKY (1 megohm).

**Circuit:** Coupling capacitor between plate (pin 5) of vertical oscillator tube, V9A, and grid (pin 1) of vertical output tube, V9B.

**Symptom:** Top stretch with bottom foldover.

**Receiver:** G-E "U-4" line.  
**Component:** C-303, .1 mfd, 20%, 600 volt, molded capacitor — LEAKY (1 megohm).  
**Circuit:** Coupling capacitor between plate (pin 5) of vertical oscillator tube, V9A, and grid (pin 1) of vertical output tube, V9B.  
**Symptom:** Top stretch with bottom foldover.

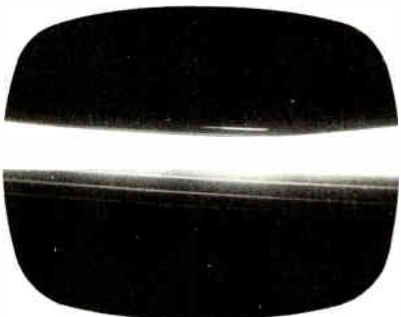
**Tele-Clue D-292**

**Receiver:** G-E "U-4" line.

**Circuit:** Vertical linearity shaping capacitor in grid (pin 1) circuit of vertical output tube, V9B.

**Symptom:** Loss of vertical size which expands when sync is present.

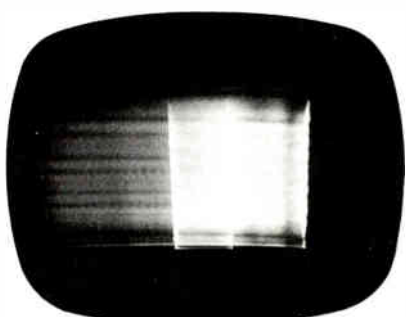
**Tele-Clue F-295**

**Receiver:** G-E "U-4" line.

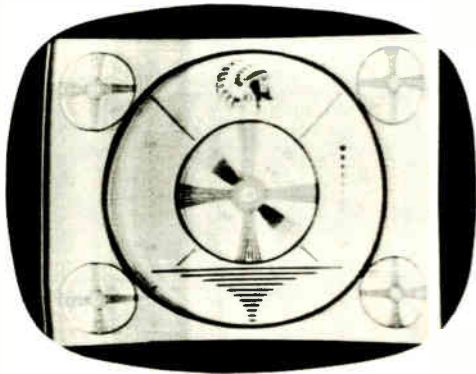
*Tele-Clue E-263*

Receiver: G-E "M-4" (See M-4 Tele-Clue Schematic)  
Component: C-263, 280 mmfd, 4 KV ceramic capacitor—OPEN.  
Circuit: Cathode (pin 3) and Plate (pin 5) of damper.  
Symptom: Small picture with increased H.V.

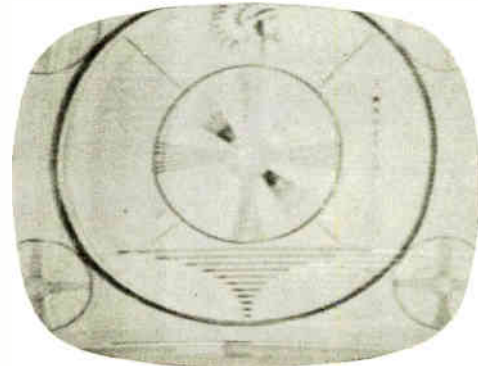
*Tele-Clue C-266*

Receiver: G-E "M-4" line.  
Component: C165, .047 mfd., 200 volt tubular capacitor—OPEN.  
Circuit: Grid circuit of video amplifier tube.  
Symptom: Weak picture, vertical sync in hole.

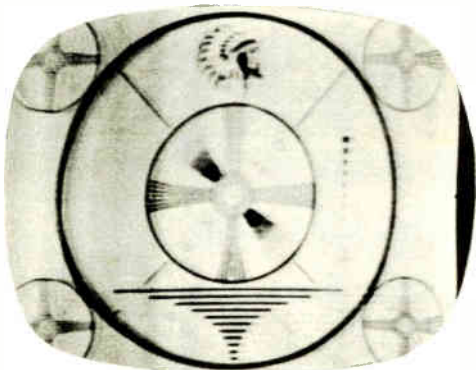
*Tele-Clue E-264*

Receiver: G-E "M-4" line.  
Component: C-261, 0.1 mfd., 600 volt, (.047 mfd. late production) molded capacitor—OPEN.  
Circuit: Screen (pin 4) of horizontal output tube.  
Symptom: Shrinkage on right side and reduced H.V.

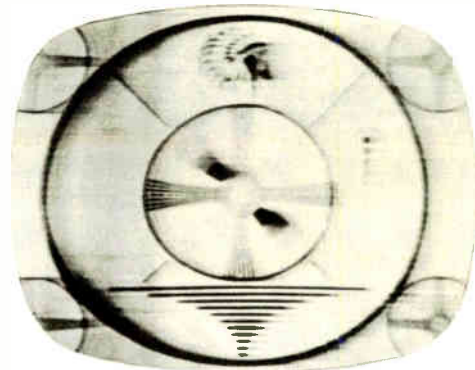
*Tele-Clue C-267*

Receiver: G-E "M-4" line.  
Component: R-181, 17" Contrast Control 17,000 ohms with stop at 15,000. R-185, 21" Contrast Control with stop at 22,000 and tap at 8750 ohms—OPEN.  
Circuit: Plate circuit of video amplifier tube.  
Symptom: Smear, varies with contrast control setting.

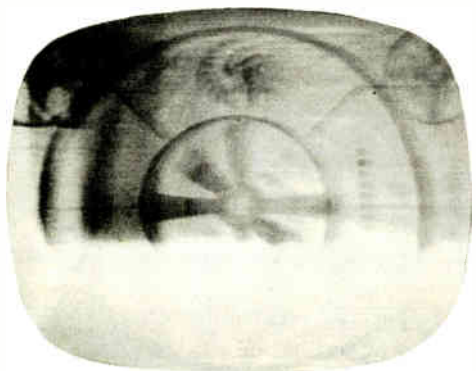
*Tele-Clue C-265*

Receiver: G-E "M-4" line.  
Component: L-158, 560 microhenry choke—OPEN.  
Circuit: Video detector peaking coil.  
Symptom: Weak picture, overload when tuning and sync compression.

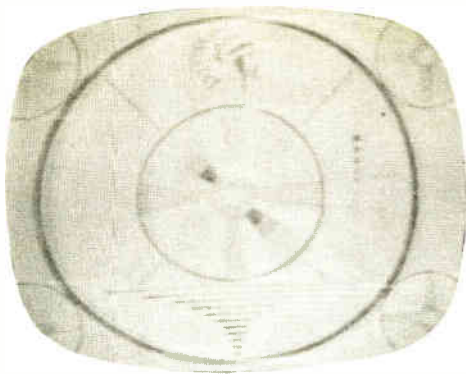
**Tele-Clue C-268**

Receiver: G-E "M-4" line.  
 Component: C-170, .1 mfd., 600 volt tubular capacitor—OPEN.  
 Circuit: Plate circuit of video amplifier tube.  
 Symptom: Weak picture.

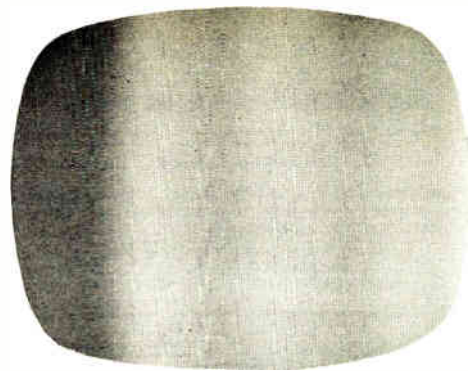
**Tele-Clue D-271**

Receiver: G-E "M-4" line.  
 Component: C-211, .01 mfd., 1000 volt tubular capacitor—OPEN.  
 Circuit: Vertical retrace blanking circuit to grid (pin 2) of picture tube.  
 Symptom: Left side darkened. Picture shading is not too noticeable except on blank channel as shown.

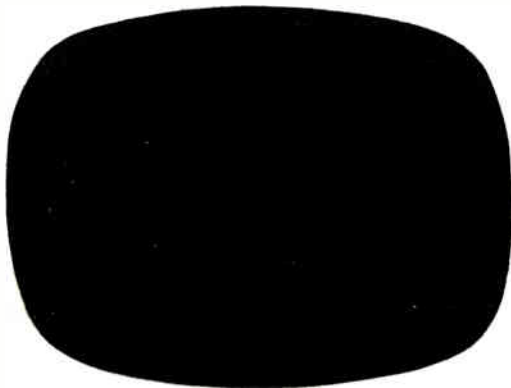
**Tele-Clue C-269**

Receiver: G-E "M-4" line.  
 Component: C-170, .1 mfd., 600 volt capacitor—SHORTED.  
 Circuit: Plate circuit of video detector.  
 Symptom: No raster, H.V. and video signal normal.

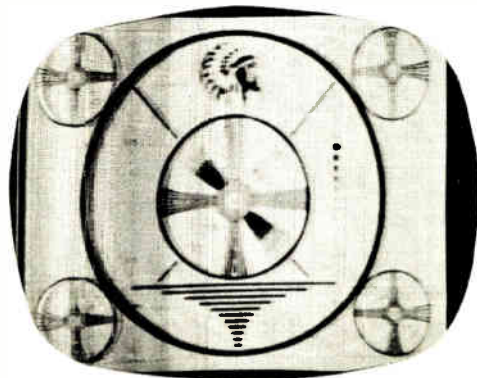
**Tele-Clue D-272**

Receiver: G-E "M-4" line.  
 Component: C-211, .01 mfd., 1000 volt tubular capacitor—SHORTED.  
 Circuit: Vertical retrace blanking circuit to grid (pin 2) of picture tube.  
 Symptom: Small size raster, low H.V., resistor R219 burns.

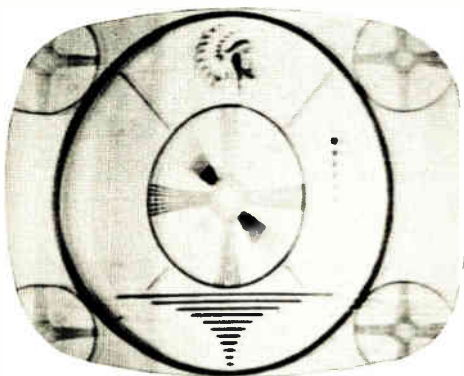
**Tele-Clue A-270**

Receiver: G-E "M-4" line.  
 Component: C-262, .056 mfd., 600 volt tubular capacitor.  
 Circuit: Horizontal yoke.  
 Symptom: Sectional horizontal compression.

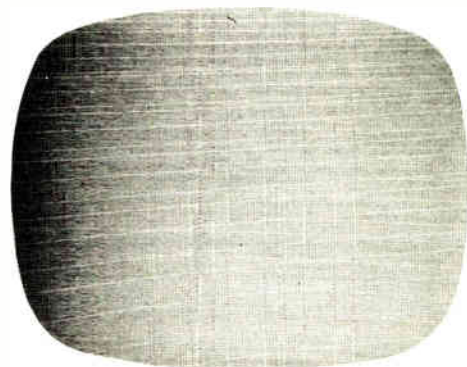
**Tele-Clue D-273**

Receiver: G-E "M-4" line.  
 Component: C212, .018 mfd., 1000 volt tubular capacitor—OPEN.  
 Circuit: Vertical retrace blanking circuit to grid (pin 2) of picture tube.  
 Symptom: Vertical retrace lines visible only on dim picture. Clearly visible on blank raster.

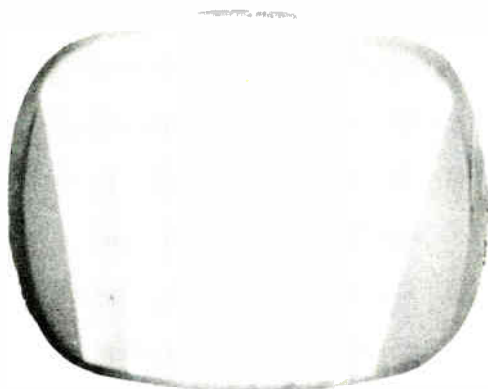
**Tele-Clue E-252**

**Receiver:** Arvin Model 21-551TM.  
**Component:** Horizontal output transformer—winding between plate of horizontal output tube and HV rectifier—OPEN.  
**Symptom:** Pleated raster.

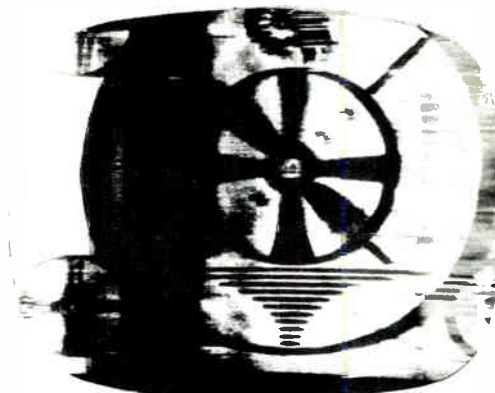
**Tele-Clue M-255**

**Receiver:** G-E "M-4" line.  
**Component:** C167, 5000 mmfd, 450 volt ceramic capacitor. (pin 2)—OPEN.  
**Circuit:** Grid circuit of clipper tube.  
**Symptom:** Overload, low AGC voltage, horizontal pulling and vertical roll.

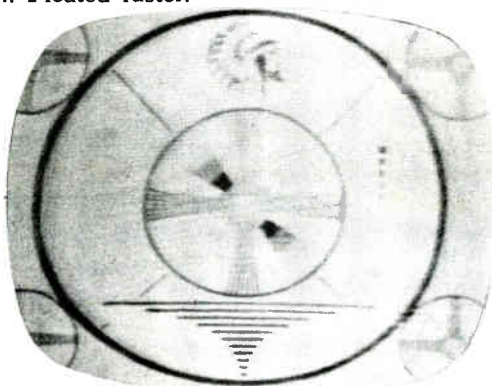
**Tele-Clue M-253**

**Receiver:** G-E "M-4" line (see M-4 Tele-Clue Schematic in Vol. 10 No. 5 issue).  
**Component:** R-161—12 Megohm, 1/2 watt resistor—OPEN.  
**Circuit:** Plate (pin 6) circuit of AGC clamp tube.  
**Symptom:** Weak picture on low and medium signals.

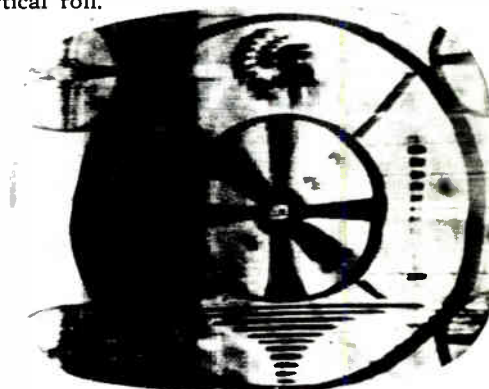
**Tele-Clue M-256**

**Receiver:** G-E "M-4" line.  
**Component:** C167, 5000 mmfd, 450 volt, ceramic capacitor—SHORTED.  
**Circuit:** Grid (pin 2) circuit of clipper tube.  
**Symptom:** Same as Tele-Clue M-255, but may be somewhat worse.

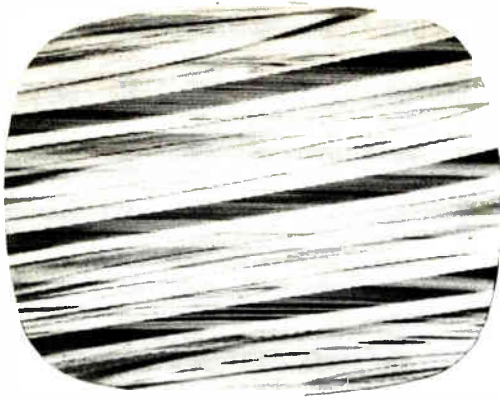
**Tele-Clue E-257**

Receiver: G-E "M-4" line.  
 Component: C257, .0068 mfd, 600 volt capacitor—SHORTED.  
 Circuit: Plate (pin 1) circuit of horizontal multivibrator,  
 C257 is connected across horizontal stabilizer coil.  
 Symptom: Poor horizontal hold and pull in.

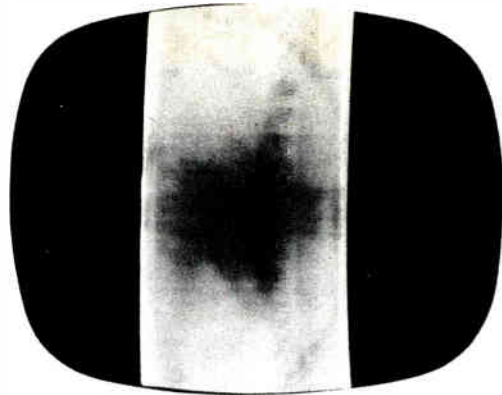
**Tele-Clue E-260**

Receiver: G-E "M-4" line.  
 Component: C258, 820 mmfd, 500 volt ceramic capacitor—  
 OPEN.  
 Circuit: Plate (pin 6) circuit of horizontal multivibrator.  
 Symptom: Very short horizontal sweep, low H.V., horizontal  
 off frequency.

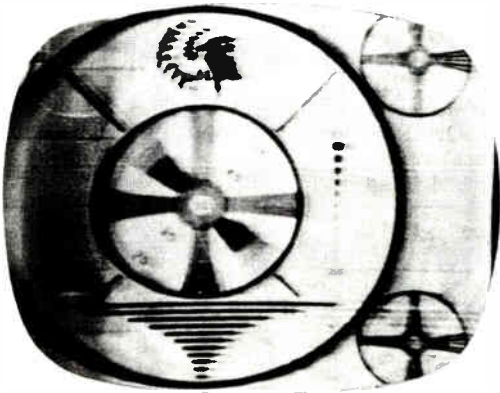
**Tele-Clue E-258**

Receiver: G-E "M-4" line.  
 Component: C253, 820 mmfd, 500 volt ceramic capacitor—  
 OPEN.  
 Circuit: Grid (pin 2) circuit of horizontal multivibrator.  
 Symptom: Phase shift, no horizontal pull in.

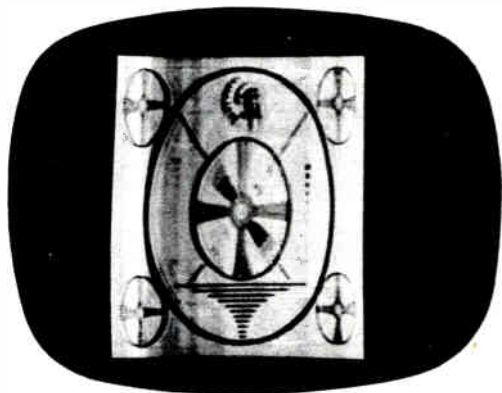
**Tele-Clue E-261**

Receiver: G-E "M-4" line.  
 Component: C258, 820 mmfd, 500 volt ceramic capacitor—  
 LEAKY (33 K ohms).  
 Circuit: Plate (pin 6) circuit of horizontal multivibrator.  
 Symptom: Small dim picture.

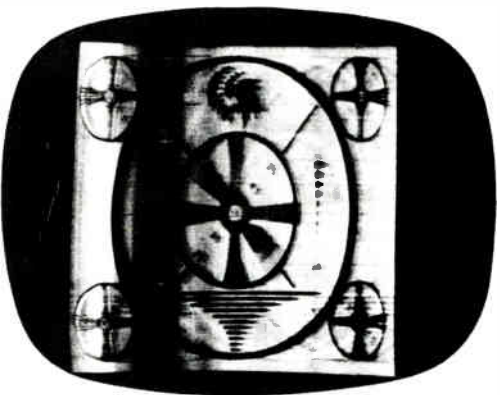
**Tele-Clue E-259**

Receiver: G-E "M-4" line.  
 Component: C253, 820 mmfd, 500 volt ceramic capacitor  
 LEAKY (22 K ohms).  
 Circuit: Grid (pin 2) circuit of horizontal multivibrator.  
 Symptom: Small size, reduced H.V.

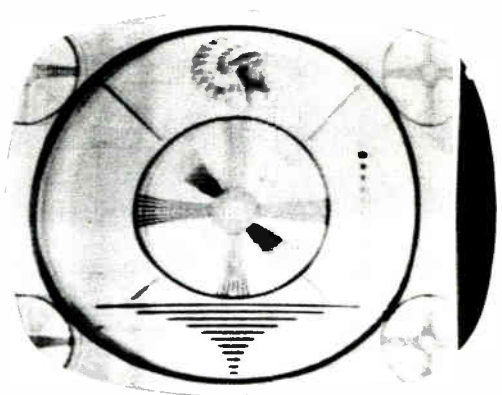
**Tele-Clue E-262**

Receiver: G-E "M-4" line.  
 Component: C259, 5000 mmfd, 450 volt ceramic capacitor—  
 LEAKY (200 K ohms)  
 Circuit: Plate (pin 6) circuit of horizontal multivibrator.  
 Symptom: Right-hand compression and fold over.

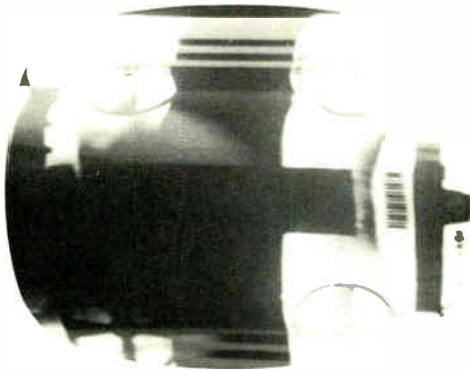
**Tele-Clue K-274**

**Receiver:** G-E "U-4" line (See "U-4" Tele-Clue Schematic).  
**Component:** C254, 5000 mmfd, 450 volt capacitor, temperature range 10° - 105°C - SHORTED.  
**Circuit:** Grid circuit of V8 Clipper tube.  
**Symptom:** Soft sync, horizontal side lock and possible audio buzz.

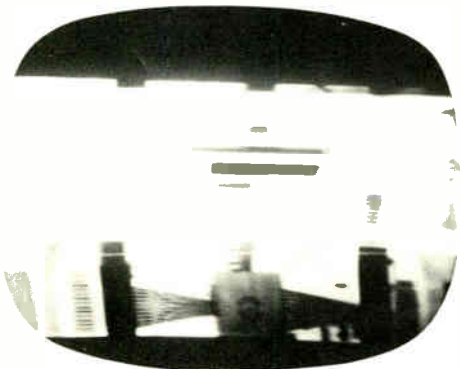
**Tele-Clue D-275**

**Receiver:** G-E "U-4" line.  
**Component:** C301, .015 mfd, 600 volt capacitor - LEAKY (1 meg).  
**Circuit:** Grid circuit of V9A vertical oscillator.  
**Symptom:** Top fold over, poor vertical sync.

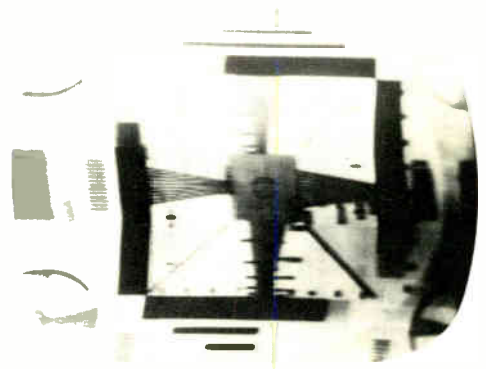
**Tele-Clue D-278**

**Receiver:** G-E "U-4" line.  
**Component:** V9 tube, 3,000 ohm heater-cathode leakage.  
**Circuit:** Vertical oscillator and output.  
**Symptom:** Very poor vertical interlace. Vertical may lock-in too high or too low.

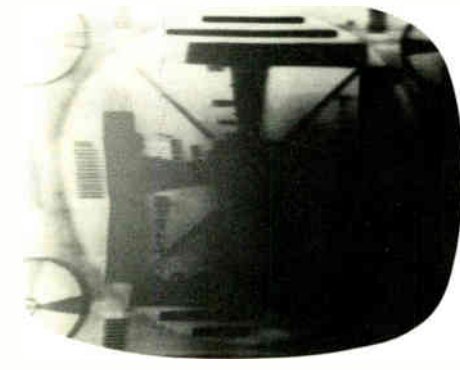
**Tele-Clue D-276**

**Receiver:** G-E "U-4" line.  
**Component:** C-307, .0082 mfd, 1600 volt capacitor-OPEN.  
**Circuit:** Vertical blanking charging capacitor in cathode circuit of picture tube.  
**Symptom:** Dim raster with shading on right.

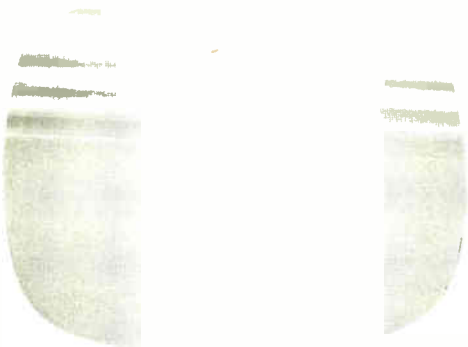
**Tele-Clue M-279**

**Receiver:** G-E "U-4" line.  
**Component:** C250, 800 mmfd, 500 volt HiK capacitor — OPEN.  
**Circuit:** Cathode bypass capacitor in V6B keyer.  
**Symptom:** Partial blanking of screen and loss of sync which may appear to be corrected by change of AGC (R-254) control setting.

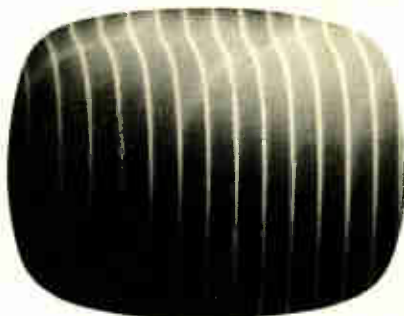
**Tele-Clue F-241**

**Receiver:** Any with Full-Wave Rectifier Tube.  
**Component:** Rectifier tube with one open plate connection.  
**Symptom:** (1) shading of picture. (2) One plate in tube may turn pink. (3) Tube could test "ok" on tube testers that tie plates together.

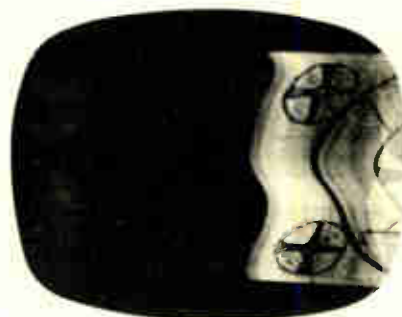
**Tele-Clue F-244**

**Receiver:** G-E "M-4" line.  
**Component:** C401B, 100 mfd, 350 v, output filter capacitor — OPEN.  
**Circuit:** Heater circuit of low voltage rectifier.  
**Symptom:** (1) Distorted raster reduced in size. (2) Horizontal off frequency. (3) Hum in audio.

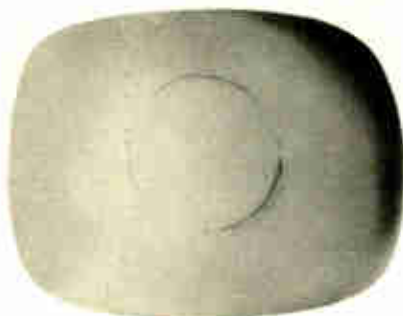
**Tele-Clue G-242**

**Receiver:** Any 21" with flat safety glass.  
**Component:** Faceplate of picture tube and safety glass.  
**Symptom:** Ring of dust precipitated at edge of a circular area where safety glass and picture tube faceplate are in close proximity.  
**Cause:** Electrostatic charge developing between safety glass and faceplate.

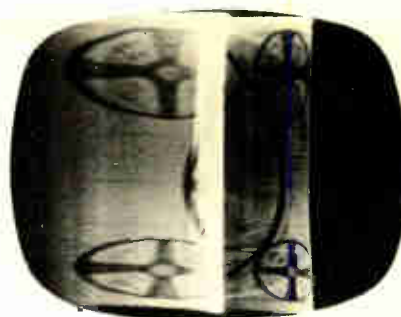
**Tele-Clue F-245**

**Receiver:** G-E "M-4" line.  
**Component:** C-260, 40 mfd, 400 volt, B+ to B+ "boost" capacitor — OPEN.  
**Circuit:** Plate circuit of damper tube.  
**Symptom:** (1) Reduced size. (2) Horizontal foldover at center of picture.

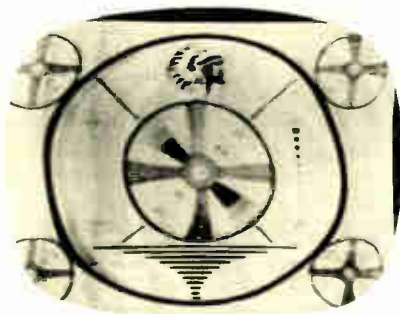
**Tele-Clue F-243**

**Receiver:** G-E "M-4" line (see M-4 Tele-Clue Schematic in Vol. 10, No. 5 issue).  
**Component:** C401A, 60 mfd, 350 v, input filter capacitor — OPEN.  
**Circuit:** Heater circuit of low voltage rectifier.  
**Symptom:** (1) Curl at edge of raster. (2) Reduced size. (3) Horizontal pulling.  
**Cause:** Reduced B+ voltage with increased hum level.

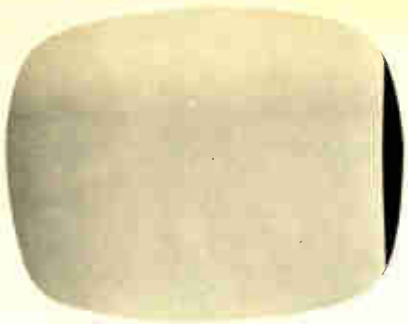
**Tele-Clue R-246**

Receiver: G-E "M-4" line.

Circuit: Cathode circuit of audio output tube.

Symptom: (1) Blank raster. (2) Reduced width. (3) No audio. (4) Resistor R314 burns.

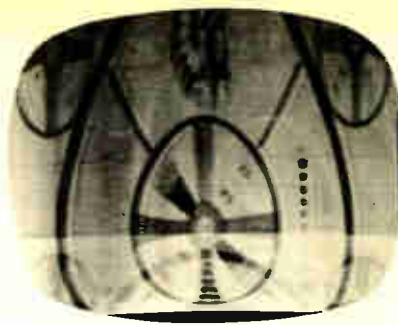
**Tele-Clue D-249**

Receiver: G-E "M-4" line.

Component: C209-.027 mfd, 500 volt, temperature compensated ceramic capacitor — LEAKY (1 megohm).

Circuit: Grid (pin 1) circuit of vertical output tube.

Symptom: Bottom foldover and top stretch.

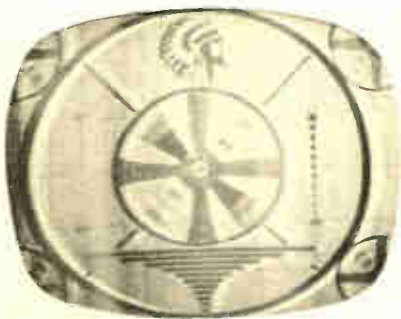
**Tele-Clue G-247**

Receiver: G-E "M-4" line.

Circuit: G2 (pin 3) circuit of picture tube.

Symptom: Dim picture and raster.

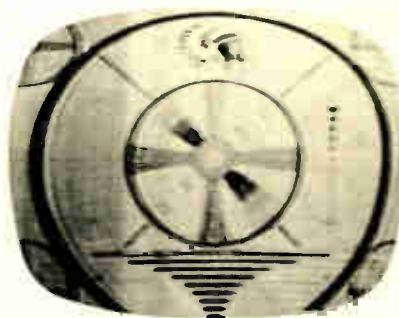
**Tele-Clue D-250**

Receiver: G-E "M-4" line.

Circuit: Grid (pin 1) circuit of vertical output tube.

Symptom: Top compression and bottom stretch.

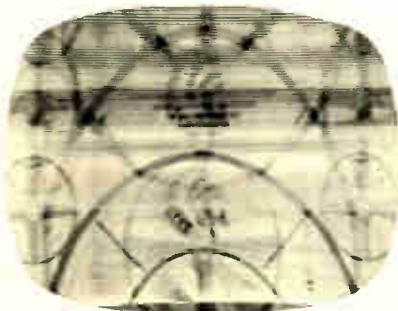
**Tele-Clue D-248**

Receiver: G-E "M-4" line.

Component: C204-.0039, 1000 volt capacitor — LEAKY (200 K ohms).

Circuit: Grid (pin 4) circuit of vertical oscillator tube.

Symptom: (1) Top stretch. (2) Vertical roll. (3) Vertical hold control ineffective.

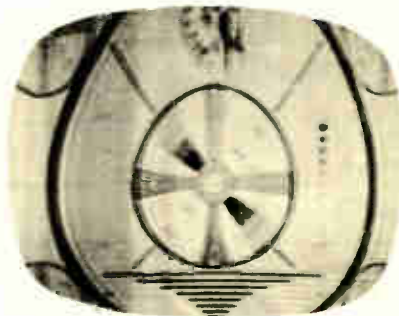
**Tele-Clue D-251**

Receiver: G-E "M-4" line.

Component: C205-.033 mfd, 200 volt tubular capacitor — LEAKY (2.2 meg).

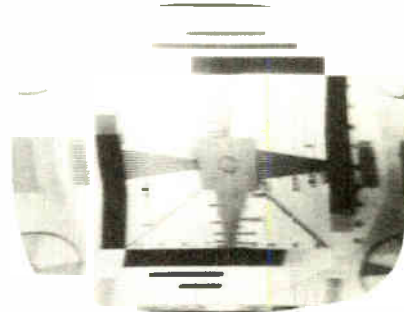
**Tele-Clue D-288**

**Receiver:** G-E "U-4" line.

**Circuit:** Vertical oscillator, V9A, plate circuit.

**Symptom:** Shrinkage at both top and bottom.

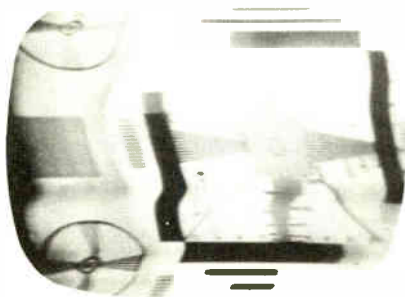
**Tele-Clue M-286**

**Receiver:** G-E "U-4" line.

**Circuit:** AGC filter in plate circuit of V15A AGC clamp tube.

**Symptom:** Horizontal hunting, horizontal distortion when stabilized and some horizontal shading.

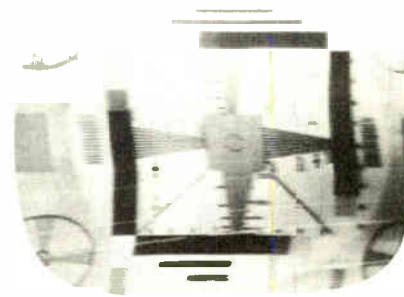
**Tele-Clue D-289**

**Receiver:** G-E "U-4" line.

**Circuit:** Vertical blanking circuit to cathode of picture tube.

**Symptom:** Visible vertical retrace lines.

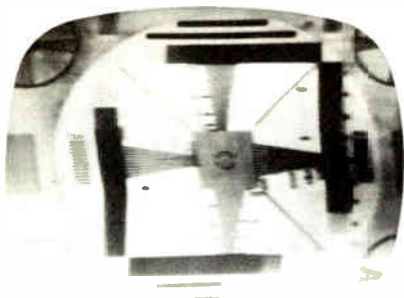
**Tele-Clue D-290**

**Receiver:** G-E "U-4" line.  
**Component:** C-306, .022 mfd, 20%, 1000 volt molded capacitor — SHORTED.  
**Circuit:** Vertical blanking circuit to cathode of picture tube.  
**Symptom:** Slight horizontal shrinkage and shading at top.

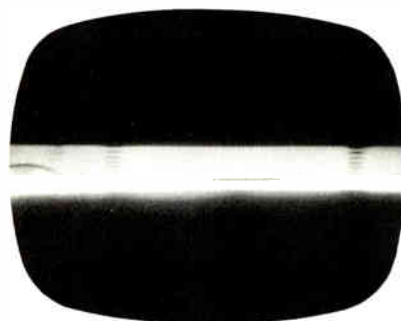
**Tele-Clue D-293**

**Receiver:** G-E "U-4" line.  
**Component:** C-304, .033 mfd, 10%, 400 volt, molded capacitor — SHORTED.  
**Circuit:** Vertical linearity shaping capacitor in grid (pin 1) circuit of vertical output tube, V9B.  
**Symptom:** Loss of vertical height with top stretch and bottom foldover.

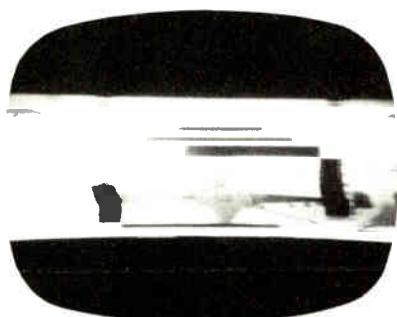
**Tele-Clue D-291**

**Receiver:** G-E "U-4" line.  
**Component:** C-506D, 40 mfd, 75 volt, part of 4 section can type electrolytic capacitor — OPEN.  
**Circuit:** Cathode bypass in vertical output tube, V9B.  
**Symptom:** Loss of vertical size with possible fold-over at bottom.

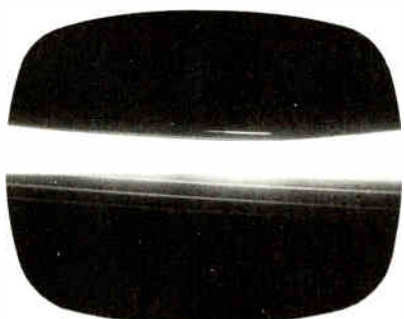
**Tele-Clue D-292**

**Receiver:** G-E "U-4" line.  
**Component:** C-304, .033 mfd, 10%, 400 volt molded capacitor — OPEN.  
**Circuit:** Vertical linearity shaping capacitor in grid (pin 1) circuit of vertical output tube, V9B.  
**Symptom:** Loss of vertical size which expands when sync is present.

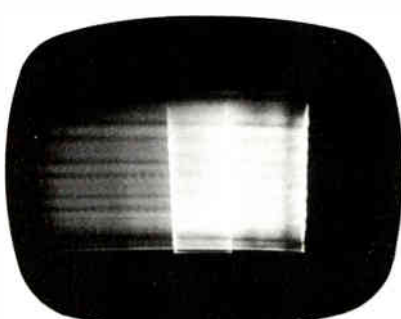
**Tele-Clue F-295**

**Receiver:** G-E "U-4" line.  
**Component:** C-363, 40 mfd, 450 volt, electrolytic capacitor — OPEN.  
**Circuit:** B+ "boost" capacitor between plate (pin 5) of damper tube, V12, and pin 3 of the picture tube.  
**Symptom:** Horizontal foldover near center and partial blanking of picture.

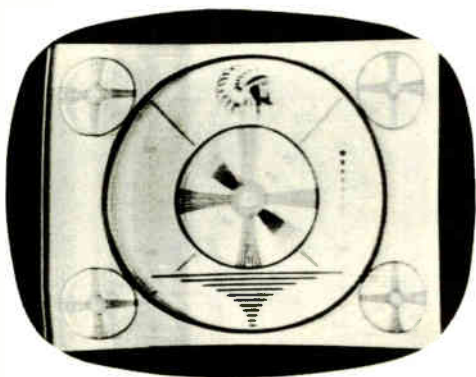
*Tele-Clue E-263*

Receiver: G-E "M-4" (See M-4 Tele-Clue Schematic)  
Component: C-263, 280 mmfd, 4 KV ceramic capacitor—OPEN.  
Circuit: Cathode (pin 3) and Plate (pin 5) of damper.  
Symptom: Small picture with increased H.V.

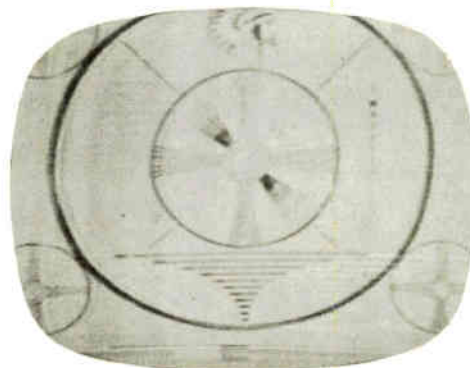
*Tele-Clue C-266*

Receiver: G-E "M-4" line.  
Component: C165, .047 mfd., 200 volt tubular capacitor—OPEN.  
Circuit: Grid circuit of video amplifier tube.  
Symptom: Weak picture, vertical sync in hole.

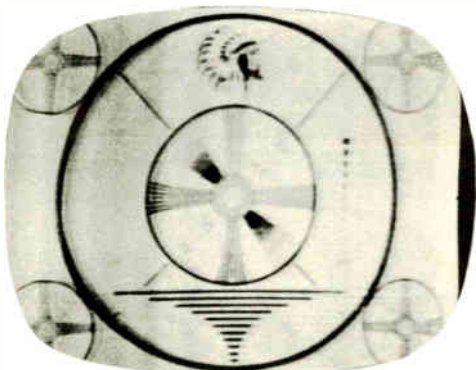
*Tele-Clue E-264*

Receiver: G-E "M-4" line.  
Component: C-261, 0.1 mfd., 600 volt, (.047 mfd. late production) molded capacitor—OPEN.  
Circuit: Screen (pin 4) of horizontal output tube.  
Symptom: Shrinkage on right side and reduced H.V.

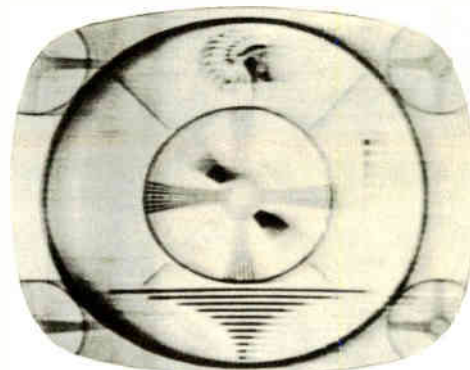
*Tele-Clue C-267*

Receiver: G-E "M-4" line.  
Component: R-181, 17" Contrast Control 17,000 ohms with stop at 15,000. R-185, 21" Contrast Control with stop at 22,000 and tap at 8750 ohms—OPEN.  
Circuit: Plate circuit of video amplifier tube.  
Symptom: Smear, varies with contrast control setting.

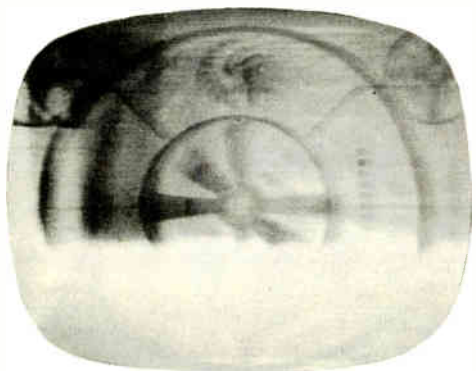
*Tele-Clue C-265*

Receiver: G-E "M-4" line.  
Component: L-158, 560 microhenry choke—OPEN.  
Circuit: Video detector peaking coil.  
Symptom: Weak picture, overload when tuning and sync compression.

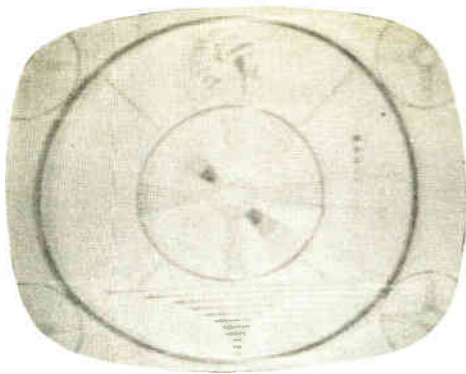
**Tele-Clue C-268**

Receiver: G-E "M-4" line.  
 Component: C-170, .1 mfd., 600 volt tubular capacitor—OPEN.  
 Circuit: Plate circuit of video amplifier tube.  
 Symptom: Weak picture.

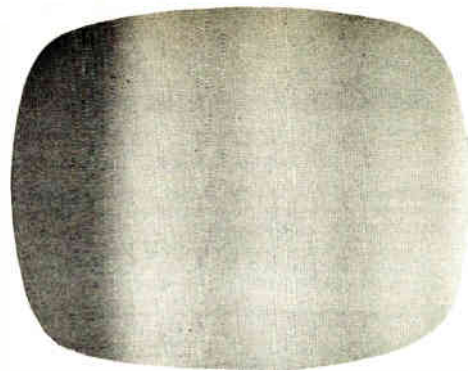
**Tele-Clue D-271**

Receiver: G-E "M-4" line.  
 Component: C-211, .01 mfd., 1000 volt tubular capacitor—OPEN.  
 Circuit: Vertical retrace blanking circuit to grid (pin 2) of picture tube.  
 Symptom: Left side darkened. Picture shading is not too noticeable except on blank channel as shown.

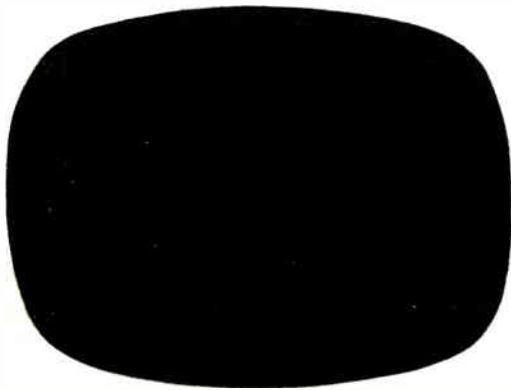
**Tele-Clue C-269**

Receiver: G-E "M-4" line.  
 Component: C-170, .1 mfd., 600 volt capacitor—SHORTED.  
 Circuit: Plate circuit of video detector.  
 Symptom: No raster, H.V. and video signal normal.

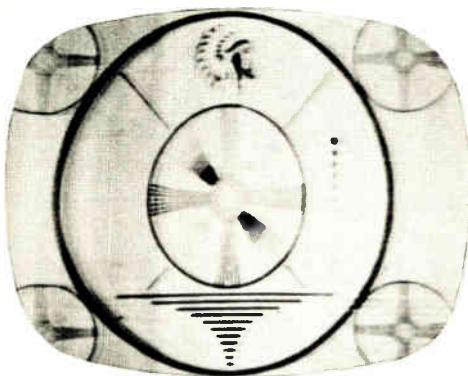
**Tele-Clue A-270**

Receiver: G-E "M-4" line.  
 Component: C-262, .056 mfd., 600 volt tubular capacitor.  
 Circuit: Horizontal yoke.  
 Symptom: Sectional horizontal compression.

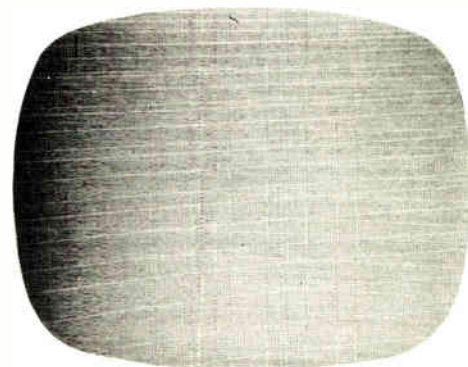
**Tele-Clue D-273**

Receiver: G-E "M-4" line.  
 Component: C212, .018 mfd., 1000 volt tubular capacitor—OPEN.  
 Circuit: Vertical retrace blanking circuit to grid (pin 2) of picture tube.  
 Symptom: Vertical retrace lines visible only on dim picture. Clearly visible on blank raster.

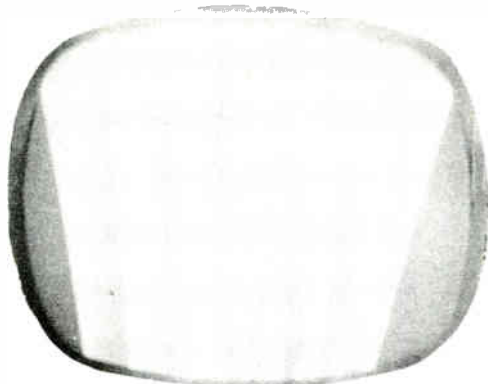
**Tele-Clue E-252**

**Receiver:** Arvin Model 21-551TM.

**Component:** Horizontal output transformer—winding between plate of horizontal output tube and HV rectifier—OPEN.

**Symptom:** Pleated raster.

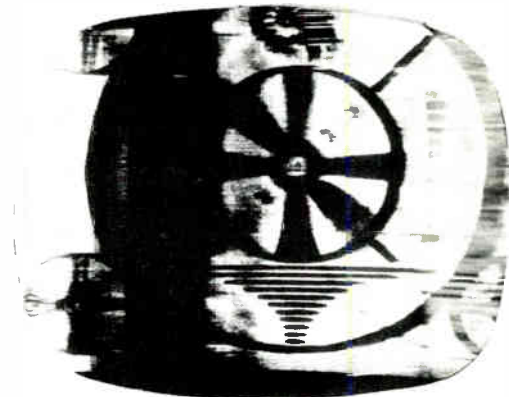
**Tele-Clue M-255**

**Receiver:** G-E "M-4" line.

**Circuit:** Grid circuit of clipper tube.

**Symptom:** Overload, low AGC voltage, horizontal pulling and vertical roll.

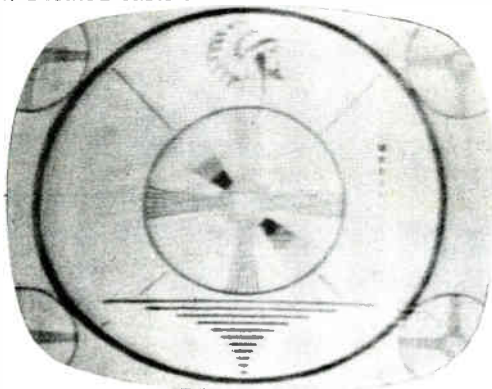
**Tele-Clue M-253**

**Receiver:** G-E "M-4" line (see M-4 Tele-Clue Schematic in Vol. 10 No. 5 issue).

**Circuit:** Plate (pin 6) circuit of AGC clamp tube.

**Symptom:** Weak picture on low and medium signals.

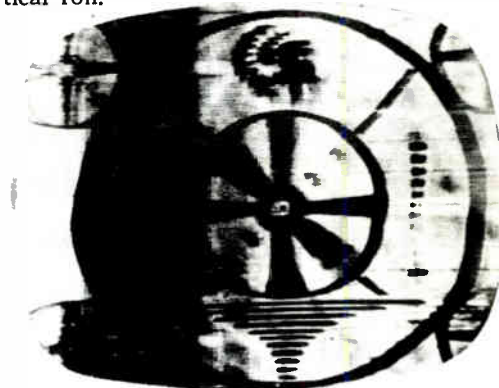
**Tele-Clue M-256**

**Receiver:** G-E "M-4" line.

**Circuit:** Grid (pin 2) circuit of clipper tube.

**Symptom:** Same as Tele-Clue M-255, but may be somewhat worse.

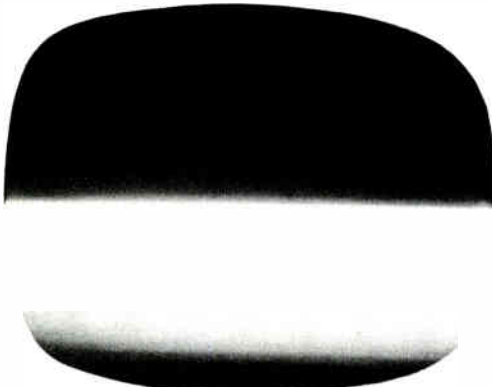
**Tele-Clue M-254**

**Receiver:** G-E "M-4" line.

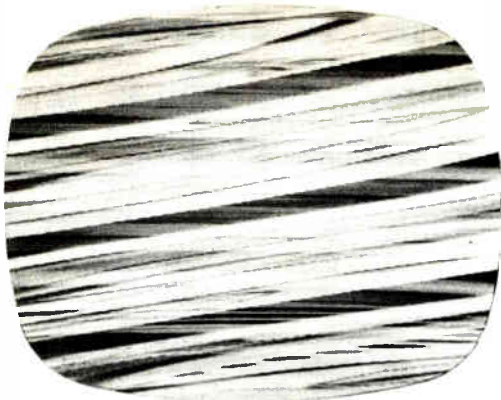
**Tele-Clue E-257**

Receiver: G-E "M-4" line.  
 Component: C257, .0068 mfd, 600 volt capacitor—SHORTED.  
 Circuit: Plate (pin 1) circuit of horizontal multivibrator,  
 C257 is connected across horizontal stabilizer coil.  
 Symptom: Poor horizontal hold and pull in.

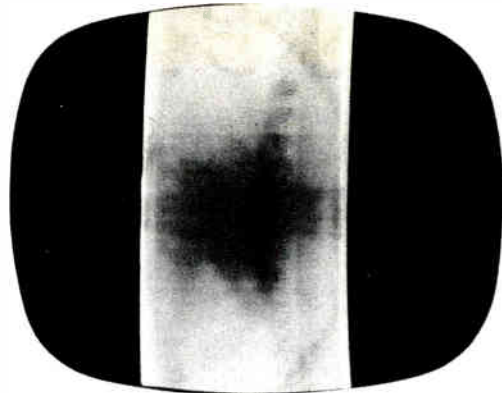
**Tele-Clue E-260**

Receiver: G-E "M-4" line.  
 Component: C258, 820 mmfd, 500 volt ceramic capacitor—OPEN.  
 Circuit: Plate (pin 6) circuit of horizontal multivibrator.  
 Symptom: Very short horizontal sweep, low H.V., horizontal off frequency.

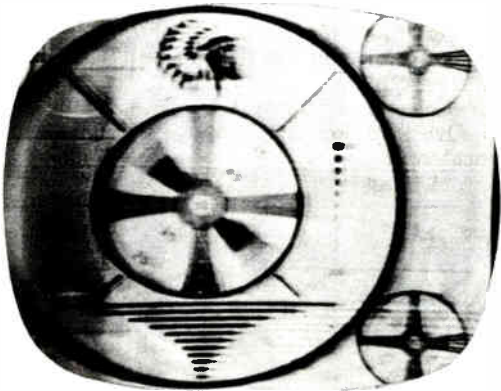
**Tele-Clue E-258**

Receiver: G-E "M-4" line.  
 Component: C253, 820 mmfd, 500 volt ceramic capacitor—OPEN.  
 Circuit: Grid (pin 2) circuit of horizontal multivibrator.  
 Symptom: Phase shift, no horizontal pull in.

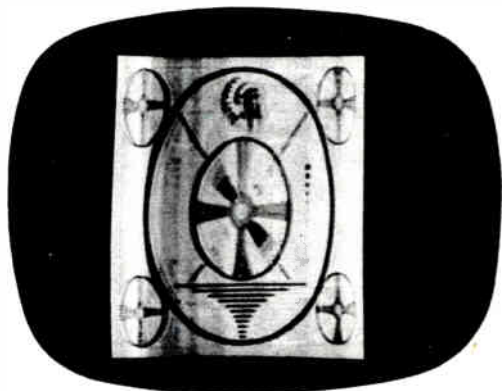
**Tele-Clue E-261**

Receiver: G-E "M-4" line.  
 Component: C258, 820 mmfd, 500 volt ceramic capacitor—LEAKY (33 K ohms).  
 Circuit: Plate (pin 6) circuit of horizontal multivibrator.  
 Symptom: Small dim picture.

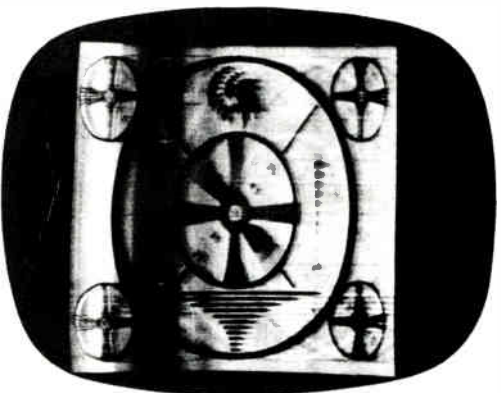
**Tele-Clue E-259**

Receiver: G-E "M-4" line.  
 Component: C253, 820 mmfd, 500 volt ceramic capacitor LEAKY (22 K ohms).  
 Circuit: Grid (pin 2) circuit of horizontal multivibrator.  
 Symptom: Small size, reduced H.V.

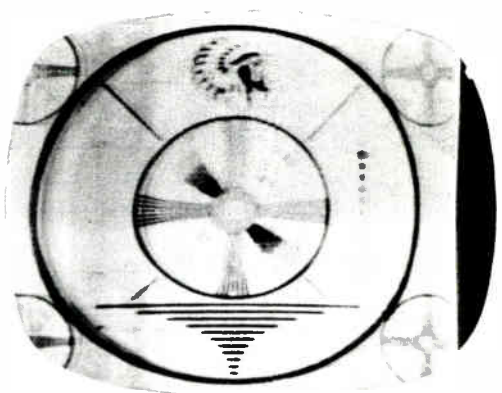
**Tele-Clue E-262**

Receiver: G-E "M-4" line.  
 Component: C259, 5000 mmfd, 450 volt ceramic capacitor—LEAKY (200 K ohms)  
 Circuit: Plate (pin 6) circuit of horizontal multivibrator.  
 Symptom: Right-hand compression and fold over.

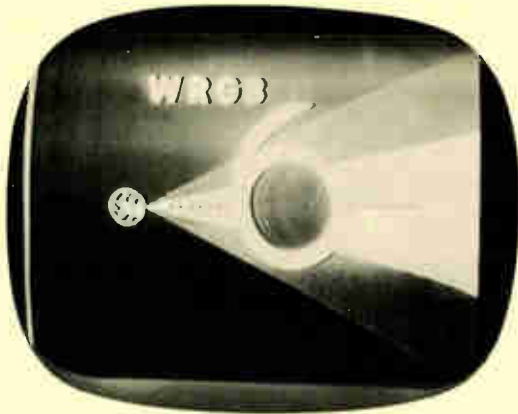
**Tele-Clue E-236**  
Open C-262 in Damper Circuit

The reduction in both width and height was caused by an open capacitor, C-262, in a General Electric "U-2" receiver. This capacitor is encircled in Fig. 1. Inasmuch as several different lines of General Electric receivers use similar circuits, this Tele-Clue should be considered as representative of an open capacitor across the cathode and plate of the damper tube in any of these circuits.

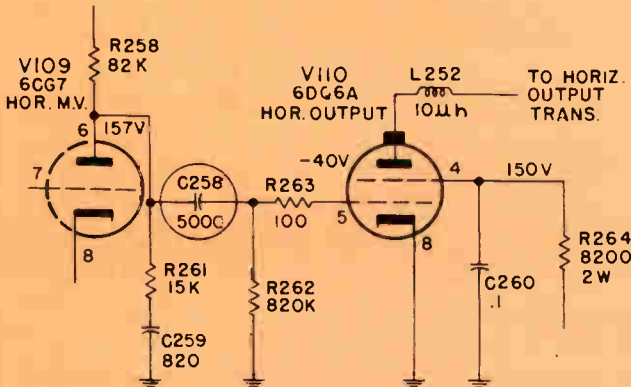
**Fig. 2. Horizontal output circuit used in "U2" line of General Electric receivers which included Models 21T1540, 1, 2, 3, 4, 21C1548, 9, 50, 51, 2, 3, 4, 5 and 6.**

The horizontal foldover on the right side of this Tele-Clue was caused by leakage in coupling capacitor C258 shown encircled in Fig. 2. Since this leakage reduces bias on the output tube it causes the sawtooth to be "rounded off" at the peak resulting in squeezing on the right side of raster.

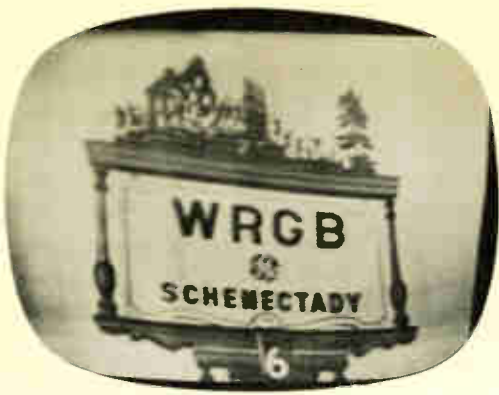
**Tele-Clue D-238**

**Defective C-310 — 14, 16 and 17-inch G-E Receivers**

The loss of height as well as the slight keystone effect was due to a defective capacitor C-310, shown in Figs. 3 and 4. The function of this capacitor is to prevent the vertical output waveform from feeding into the horizontal circuit. When this capacitor is defective, the size as well as the vertical edges of the raster may be affected. It was also impossible to get a full size picture without stretching at the top and foldover at the bottom. Due to the location of C-310, it may be necessary to remove the picture tube when making a replacement.

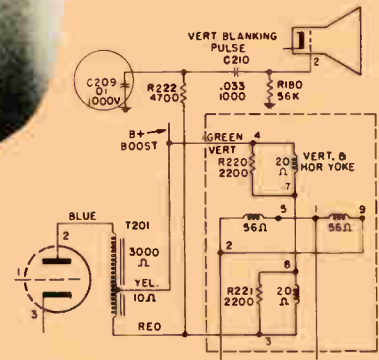
**Fig. 5. Vertical retrace blanking circuit used in General Electric "U-2" receivers.**

The vertical striations shown above were caused by an open capacitor, C-209, in a General Electric "U-2" receiver. This capacitor is encircled in Fig. 5. Inasmuch as several different lines of General Electric receivers use similar circuits, this Tele-Clue should be considered as representative of this particular capacitor being open in any of these circuits.

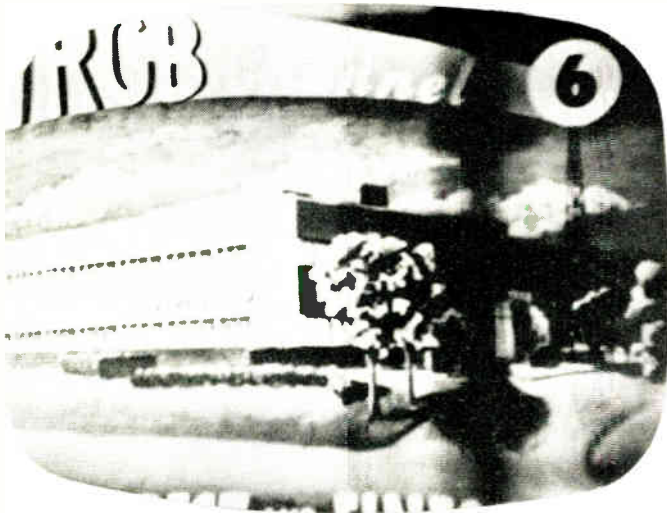
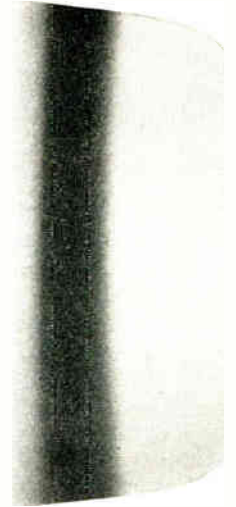
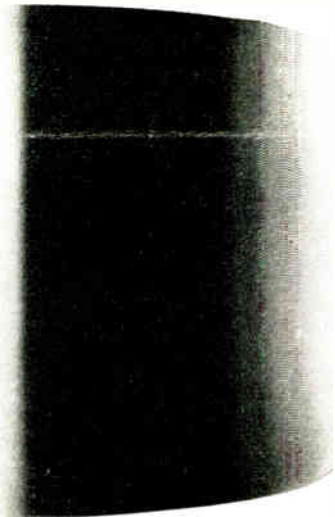
## TELE-CLUES E-229, 230 AND 231

The vertical dark stripe on the right side of the above photographs was caused by a change in the value of resistors R287 and R288 shown encircled in Fig. 1. R287 had changed to about 2K and R288 to about 10K. If R288 is reduced to about 6K it produces the wider black bar

shown in Tele-Clue E-231. As the resistance of R288 is decreased the bar increases in width spreading toward the left side of the screen. Should only one resistor change in value it causes only a slight shading rather than a black bar.
