# Tele-Clues

**Tele-Clue K-274**

**Receiver:** G-E "U-4" line (See "U-4" Tele-Clue Schematic).  
**Component:** C254, 5000 mmfd, 450 volt capacitor, temperature range 10° - 105° C - SHORTED.  
**Circuit:** Grid circuit of V8 Clipper tube.  
**Symptom:** Soft sync, horizontal side lock and possible audio buzz.

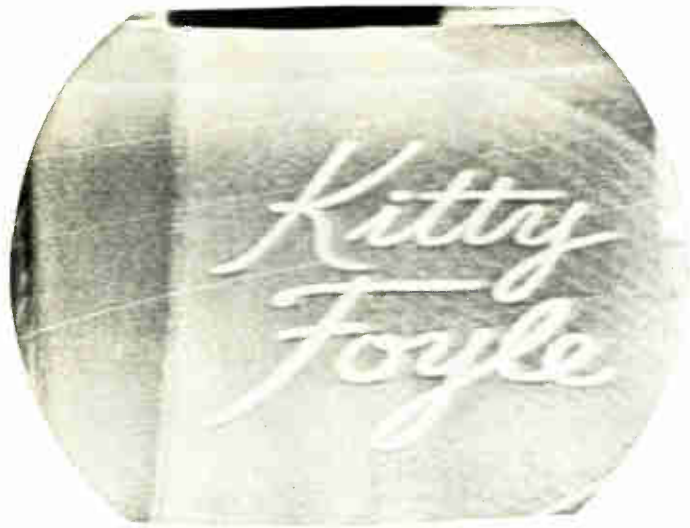
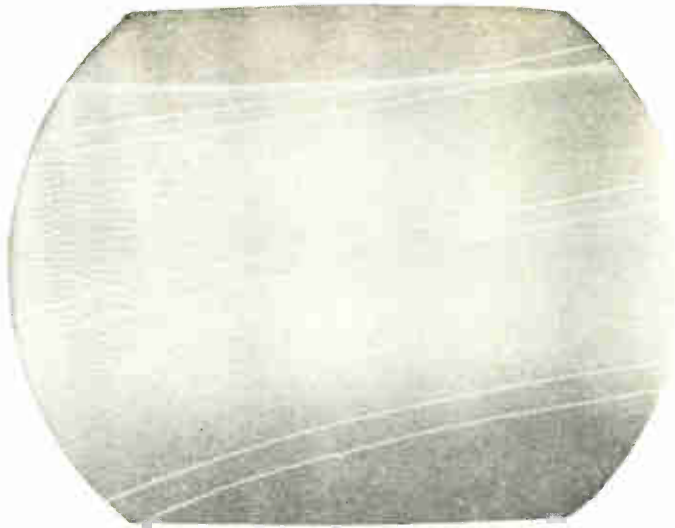
**TELE-CLUES D-232 AND 233**  
Defective 6K6-GT Vertical Output Tube

The white horizontal line near the top of the above Tele-Clues was caused by a defective 6K6-GT vertical output tube. This particular condition has been termed "Albino Gechi" and is caused by a momen-

tary slowing down of the vertical sweep as it approaches the top of the screen. This slowing down of the sweep causes several "scan" lines to be bunched and produces the white line.

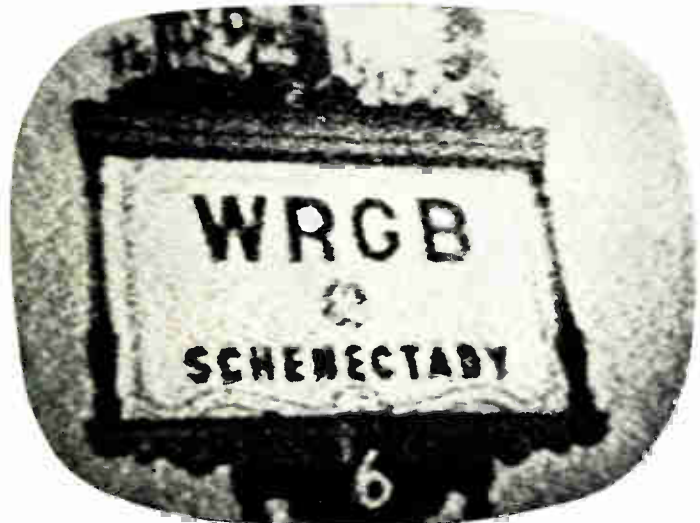
**TELE-CLUE M-234**  
R175 "open" or increased in value

The "snow" shown here was caused by an increase in the resistance of R175 (20 meg.) shown encircled in Fig. 2. This resistor establishes the delay bias on the r-f amplifier and when it increases in value or is "open" the negative bias voltage is increased and cuts off the 6B58 r-f amplifier tube. In some cases a new 6B58 will temporarily improve the condition, however in a few weeks or months the "snow" will begin to appear. The only permanent cure is to check and replace R175. The receiver used for this photograph was a U-2 model although the same circuit is also used in a great many other General Electric models.

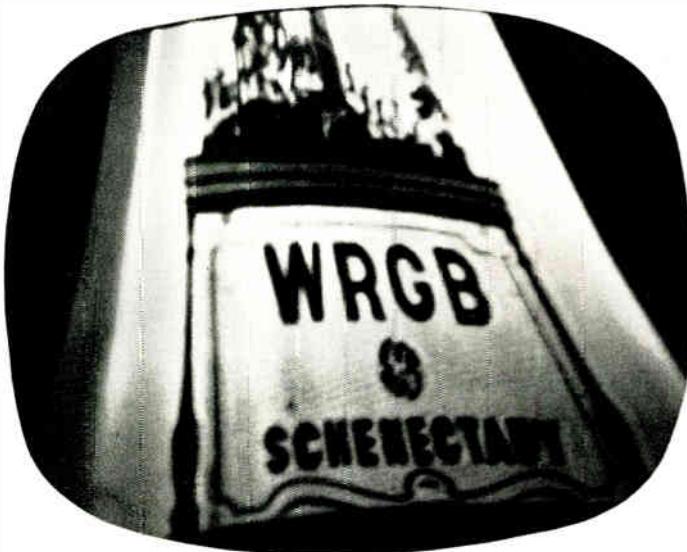
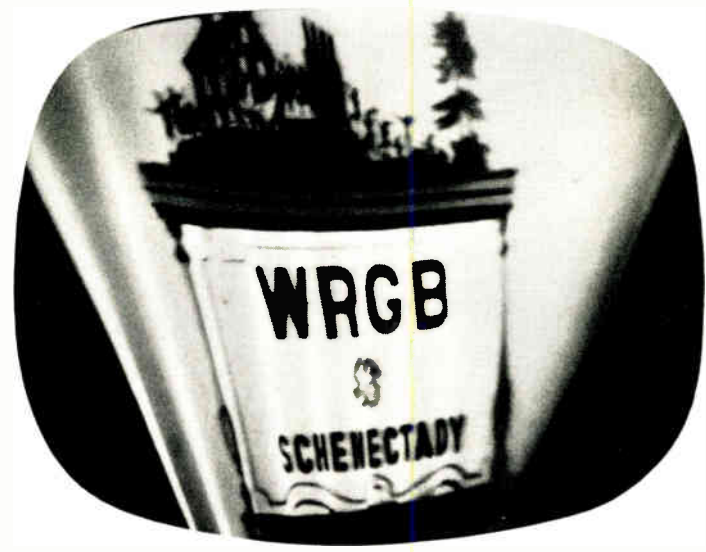
TELE-CLUES A-224 AND A-225

The above condition was due to an "open" in one side of the deflection yoke in a General Electric receiver using the "U-2" chassis. Inasmuch as the two horizontal deflection coils are connected in parallel, as

shown in Fig. 1, an "open" in one coil will produce a picture as shown at the left, whereas an "open" in the other coil will produce the condition shown on the right. Check connections before replacing yoke.

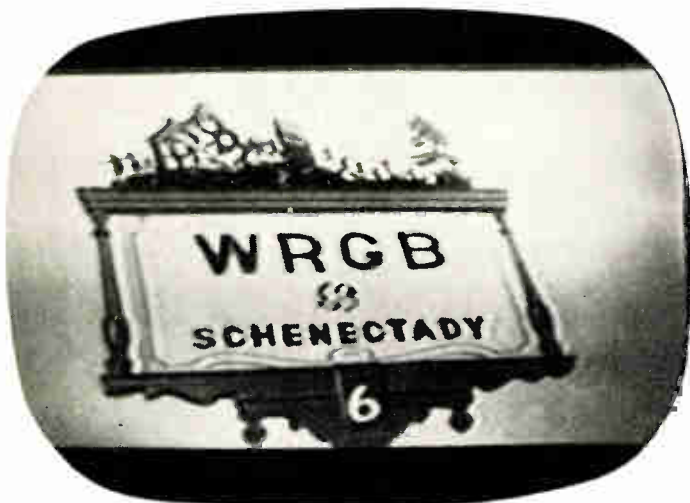
TELE-CLUE F-226

The loss of vertical height was due to a poor connection between the heater winding ground rivet and chassis. Another defect due to this same condition was shown in Tele-Clue F-220 which appeared in the last issue. It is impossible to predict just what circuit or circuits will be affected and a considerable amount of time can be spent checking circuit components. One indication that resistance has developed is the appearance of the chassis around the ground rivet. Due to electrolysis, the area surrounding this rivet may be discolored. The location of this rivet was shown with Tele-Clue F-220. Tele-Clues E-227 and E-228 illustrate another condition caused by resistance in a ground rivet.

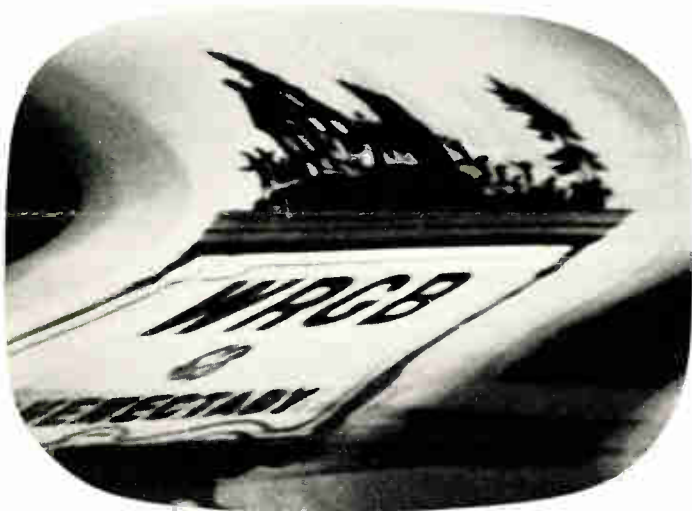
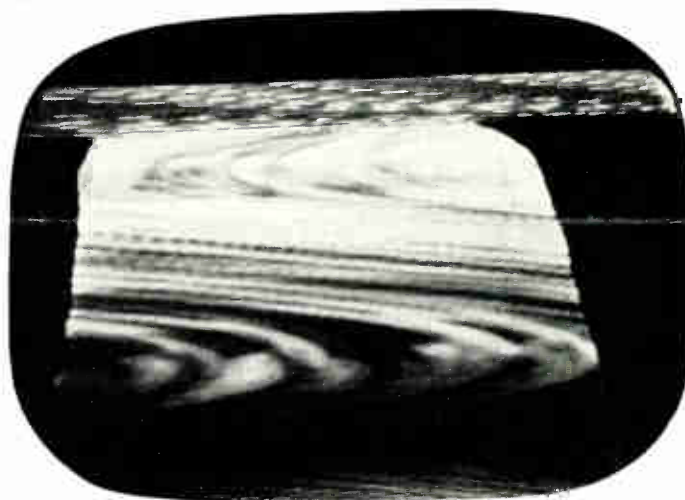
TELE-CLUES E-227 AND E-228

The condition shown here is somewhat different in appearance than Tele-Clues F-220 and F-226. It was caused by the development of resistance in a ground rivet on a General Electric "O" type receiver. In this case, however, the rivet provided the ground connection for the picture tube heater as well as capacitor C-257 in the "anti-hunt" portion of the horizontal oscillator circuit. This circuit is shown in Fig. 2. The difference between the picture on the right and the one on the left was due to the amount of resistance. Low resistance produced Tele-Clue E-227 and high resistance produced E-228.

There are two ways of curing the trouble:

- (1) Solder the ground rivet to the chassis. Use a sufficiently hot iron so a good bond is made.
- (2) Remove the filament lead from this particular rivet and connect it to some other ground rivet nearby.

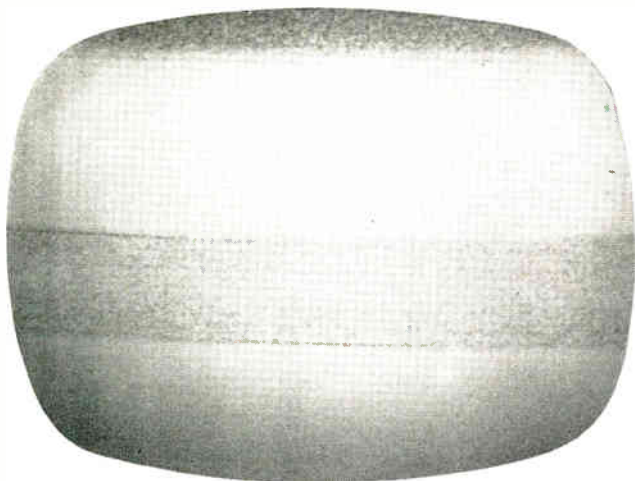
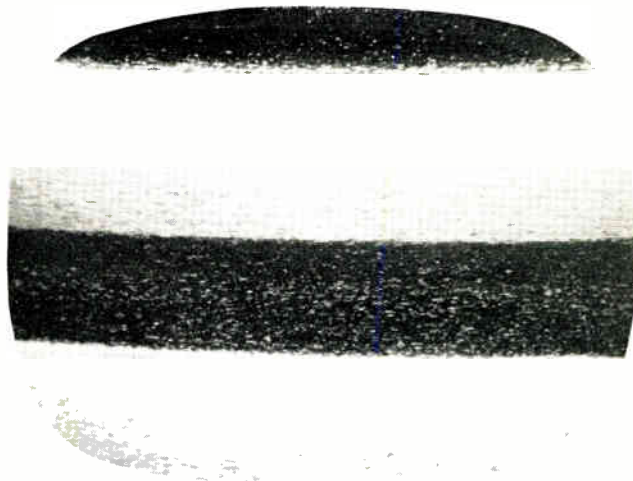
**TELE-CLUES F-214 & F-215:** The 120-cycle bars seen in Tele-Clues F-214 and F-215 were caused by a gassy 5U4G rectifier tube. These bars could also be seen in the background on some stations, but varied in intensity on different stations.

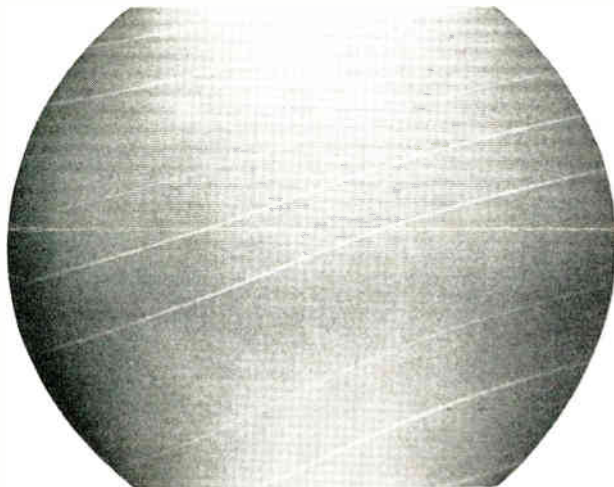
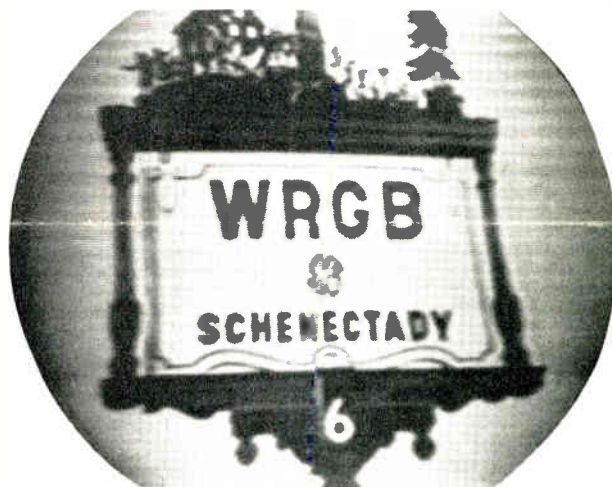
**TELE-CLUES D-216 & D-217:** The horizontal striations shown above may be caused by an open damping resistor across the vertical deflection yoke coils. It may also be caused by spurious oscillation in the vertical blocking oscillator transformer or a change in the time constants in the vertical charging capacitor circuit.

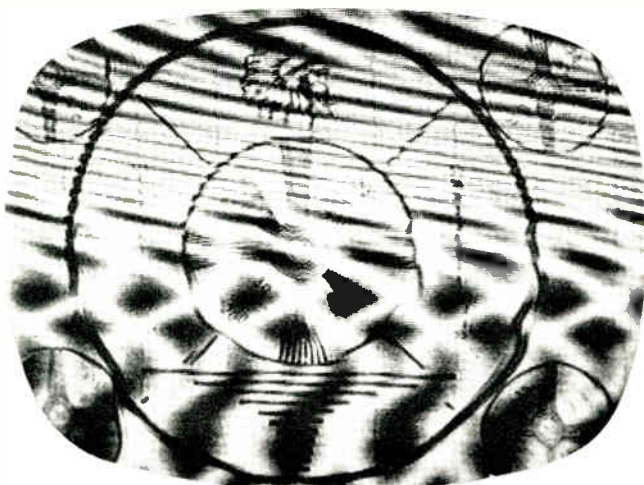
**TELE-CLUE O-218:** The r-f interference shown here was due to radiation from the 6AF4-A UHF oscillator tube. In this case, the shield was left off, but similar radiation could result from a loose or poorly grounded shield.

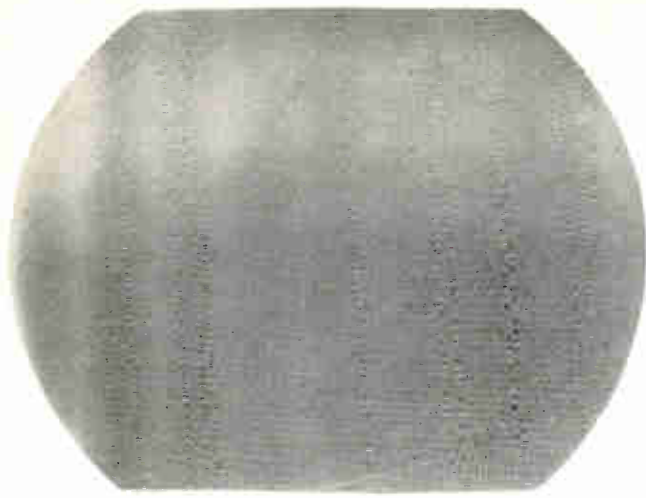
**TELE-CLUE E-219:** The vertical striations were caused by a slight mismatch in the horizontal windings of the deflection yoke. Some universal replacement yokes may produce this type of defect. If this condition appears after replacing the yoke, it might be advisable to obtain a direct replacement from the receiver manufacturer.

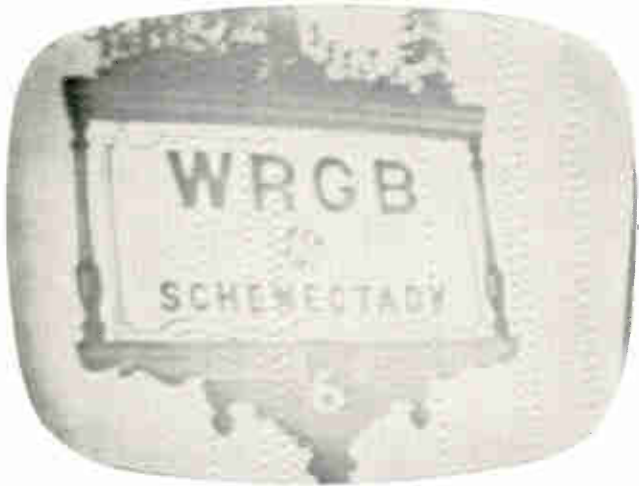
**TELE-CLUE F-220:** The light or "washed-out" picture was caused by a poor connection between the heater winding ground rivet and chassis on an "S" type General Electric receiver. The ground side of the heater winding is connected to a rivet located near the 5U4-GA socket as shown in Fig. 1. The resistance between this rivet and chassis could hardly be measured since it was only about 0.2 ohms. The total heater current of 9.15 amperes, however, caused a voltage drop ( $E = I \times R$ ) of almost 2 volts. Since the tube heaters seemed to have normal brilliance, a considerable amount of time could be spent checking other components. The above condition is not the only one that may occur due to resistance at the ground rivets. There are several other visual indications and these will be included in the next issue.

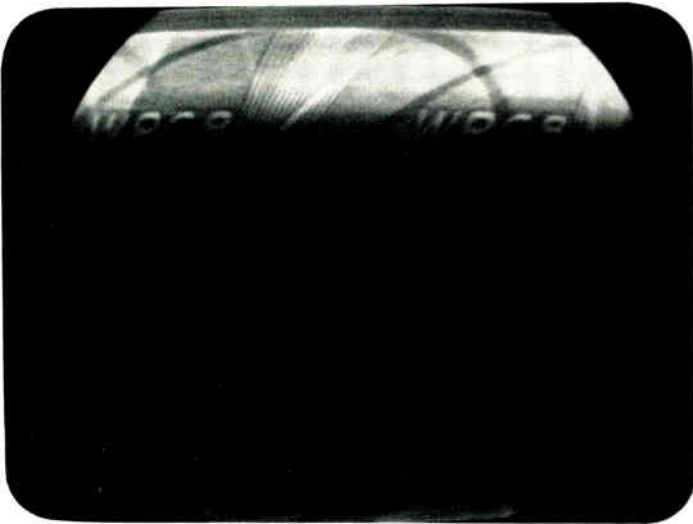
**Tele-Clue No. C-73**—Short between filament and cathode (terminals 8 and 9) on 12AT7 video amplifier in 12T3 receiver.

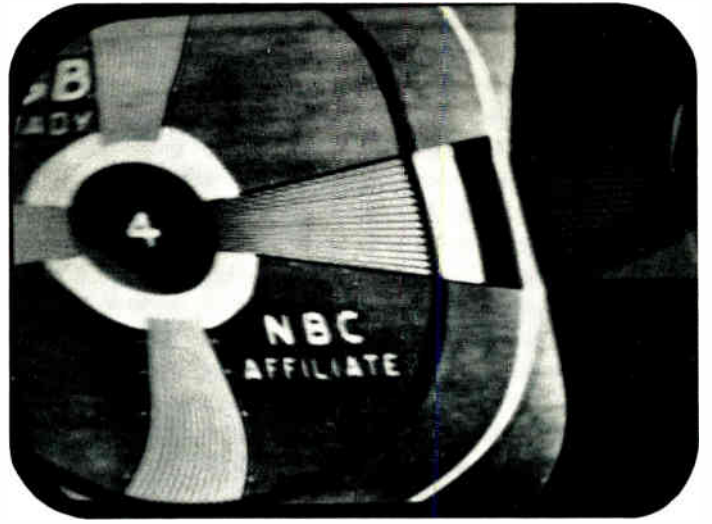
**Tele-Clue No. K-74**—A short between the cathode and heater in the 6SL7-GT Sync Amplifier and clipper tube used in a large number of General Electric chassis will result in a picture similar to either Tele-Clue No. 74 or 75. The contrast control has little or no effect. Horizontal synchronization is extremely critical with a horizontal jitter or weaving present most of the time.

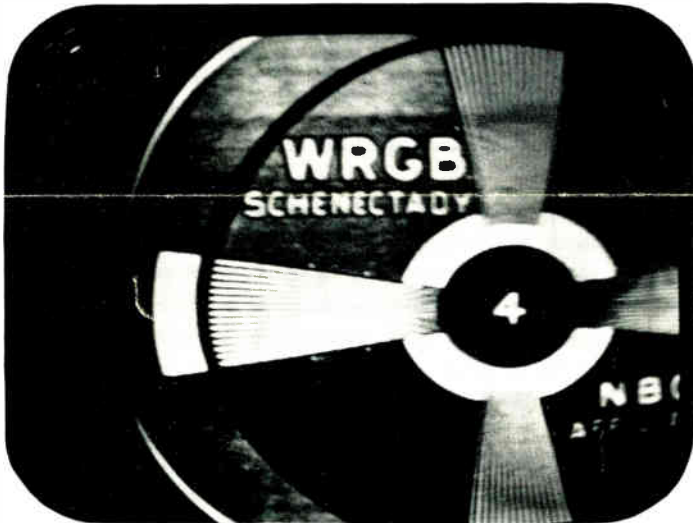
**Tele-Clue No. K-75**—This is also the result of a short between cathode and heater in the 6SL7-GT Sync Amplifier and clipper tube and the same explanation as given for Tele-Clue No. 74 will apply here. The only difference is that horizontal synchronization occurs so that the black border can be seen at the left instead of at the right of the picture tube.

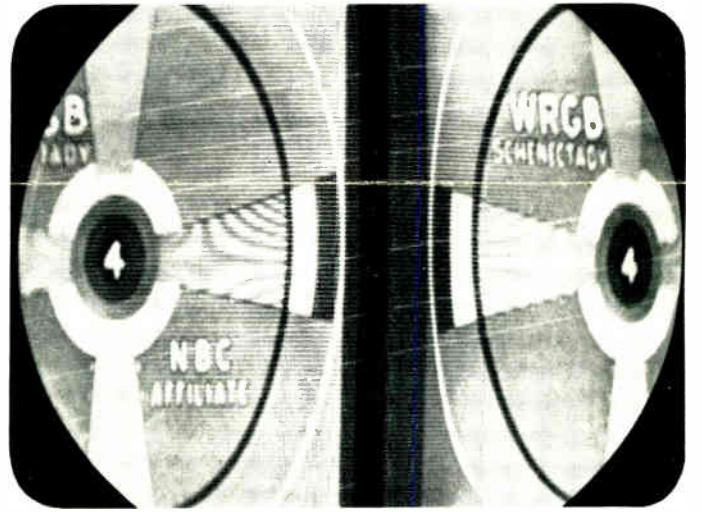
**Tele-Clue No. E-76**—This defect in horizontal synchronization which was the only point where horizontal sync would occur indicates a phase shift in the horizontal oscillator circuit shown in Fig. 1. This circuit is used in the Westinghouse Model H-606K12. A similar circuit, however, is used in a considerable number of TV receivers. This defect was caused by a change in the value of R453 from 220,000 ohms to 8000 ohms.

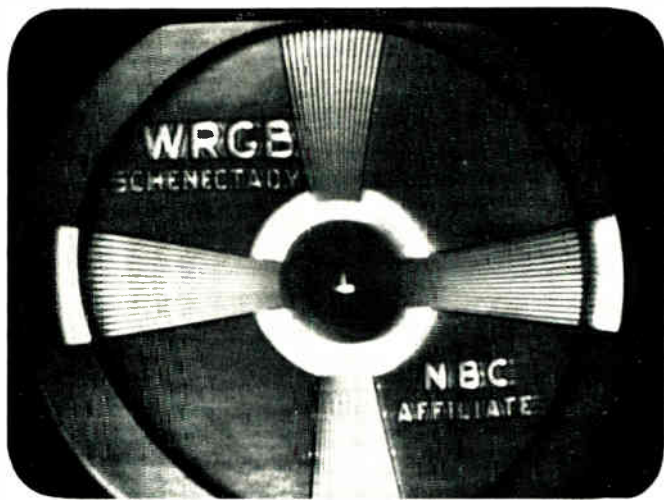
**Tele-Clue No. H-77**—This photograph and the one shown in Tele-Clue No. 78 illustrate the effect of low emission in a picture tube. The picture with the brightness and contrast controls adjusted for correct balance between the blacks and whites was very dull and had a washed-out appearance similar to Tele-Clue No. H-60. When the contrast control was advanced the color gradation between black and white practically disappeared as shown above.

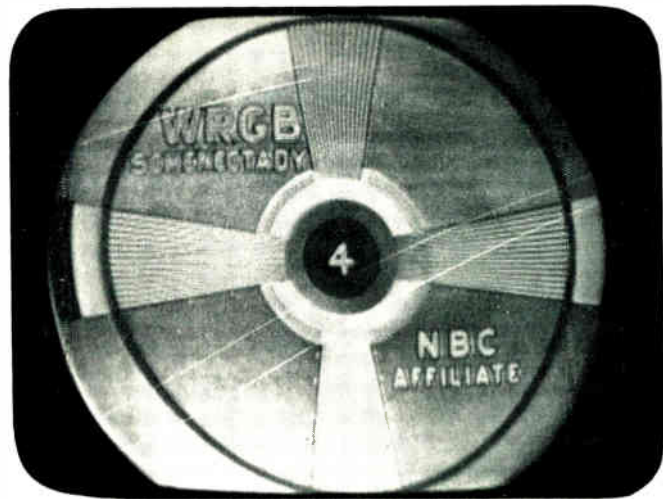
**Tele-Clue No. H-78**—This photograph shows the result of advancing the brightness control on the same tube used in Tele-Clue No. 77. The contrast control was returned to normal. The five shading rings around number 4 should vary in shading from black in the center to white on the outside. In the above photograph the outer ring is darker than the next inner ring. This is just the reverse of the normal shading sequence.

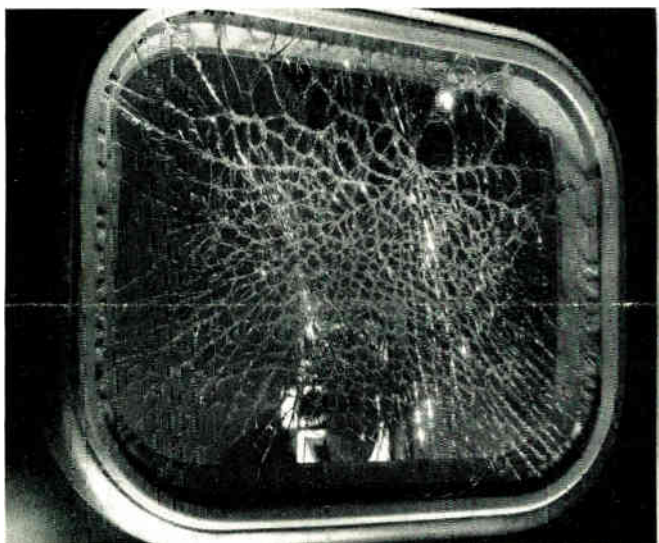
**G-79**

**Tele-Clue No. G-79 & 80**—These photographs illustrate the result of a fourteen inch picture tube which imploded while in its cabinet. The tremendous force released is apparent from the condition of the safety glass in these photographs. Fortunately this type of glass breakage, which obviously was due to the fracture occurring first in the faceplate, does not occur very often. In one case this did happen sometime during the night to a receiver not in its cabinet. Pieces of glass were scattered all over the service shop and were found imbedded in the walls about twenty feet away.

These photographs illustrate that if an implosion occurs while the set is in the cabinet, damage would result only to the receiver. However, utmost care should be exercised when removing, transporting or repairing a receiver outside of its cabinet. The potential danger is great since a scratch or defect in the glass of the tube may cause an implosion of any time. Therefore it is advisable to use every precaution including the wearing of safety glasses while working around exposed picture tubes.

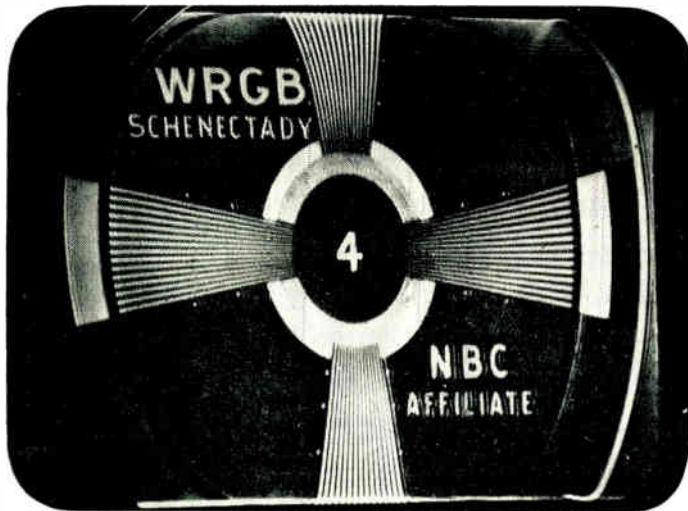
**Tele-Clue A81.** The vertical foldover which can be seen at the right side both top and bottom was due to a defect in the vertical windings of the deflection yoke on a General Electric Model 802. Several vertical retrace lines were visible near the top and extended about one-inch down from the top. These could not be eliminated by adjusting the vertical hold, vertical linearity or height controls. Ordinarily a short in the vertical coils will result in a keystone effect similar to Tele-Clue No. A-21. This effect was not noticeable in this photograph, however a new yoke corrected the defect.

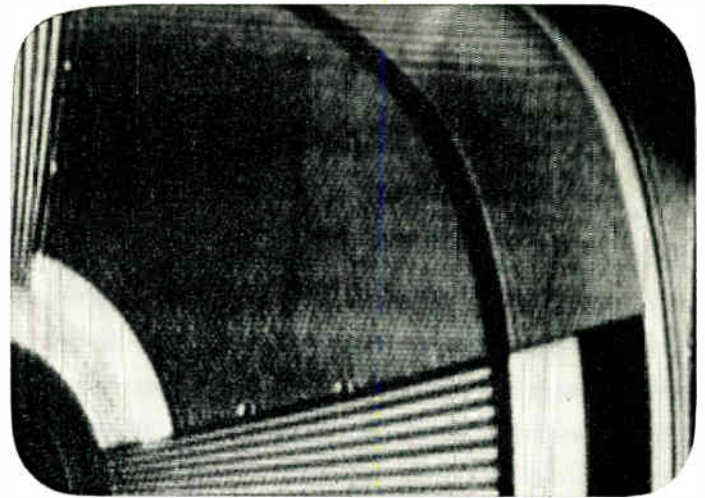
**Tele-Clue A82.** This is an enlarged view of the top right hand corner of Tele-Clue No. A81 which shows the foldover and vertical retrace lines which could not be eliminated.

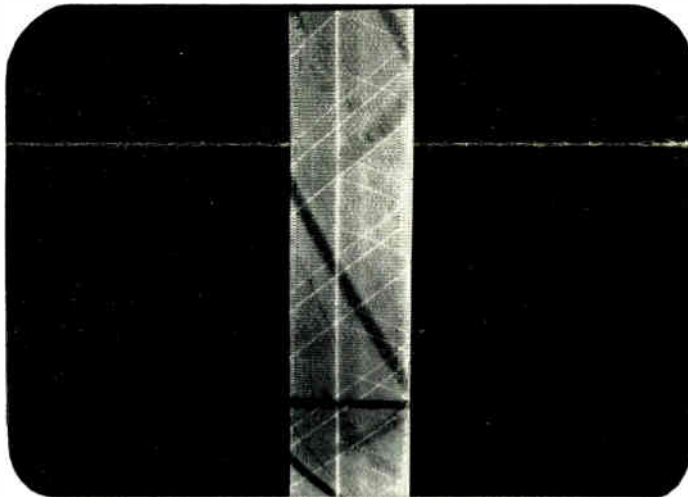
B 107

**Tele-Clue No. A83.** This illustrates another unusual defect in the deflection yoke. In this case the width is reduced and again without any noticeable keystone effect. This photograph was taken of a Westinghouse Model 619T12 chassis V2150-176. This same chassis is also used in Model 617T12. The horizontal output circuit for this receiver is shown in Fig. 1.

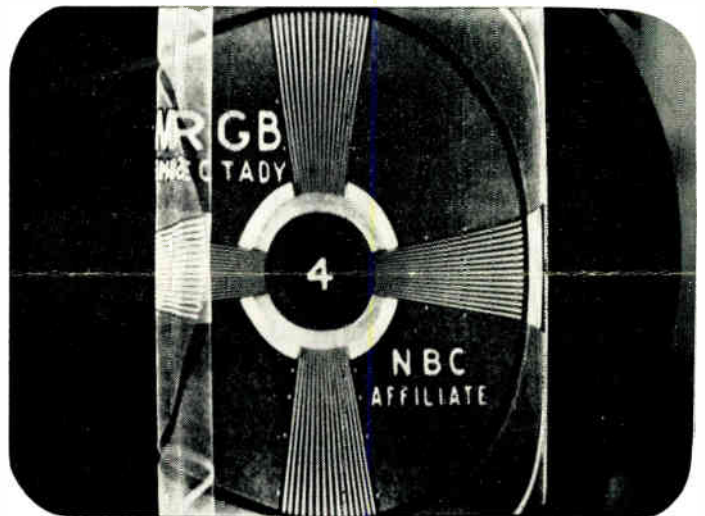
**Tele-Clue No. E84.** This shows the effect of removing the 6W4-GT damper tube in the circuit shown in Fig. 1. Ordinarily the removal of the damper tube results in a reduction of the high voltage to a point where little or no illumination of the screen is visible. In this circuit however, the high voltage was not noticeably reduced and there was a gradual change which took place during a two minute period after the damper tube was removed. After this period the test pattern appeared like Tele-Clue No. E85.

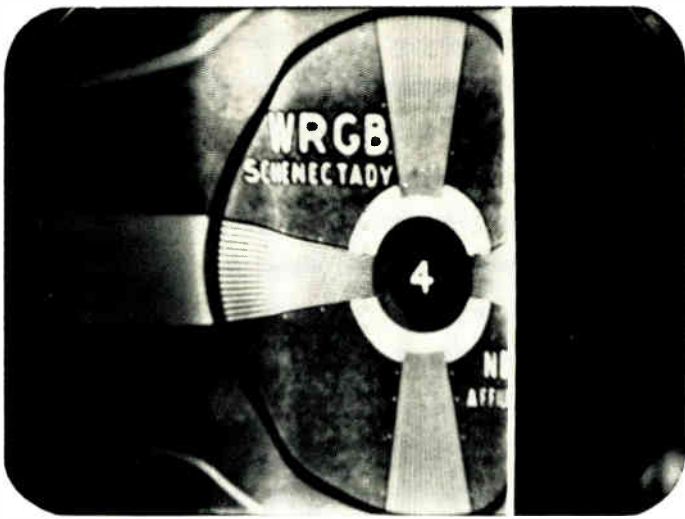
**Tele-Clue No. E85.** This photograph was taken about two minutes after Tele-Clue No. E84. There was a gradual change to each side of the test pattern until it looked like the above photograph. The test pattern looked like this as long as the damper tube was out of the circuit.

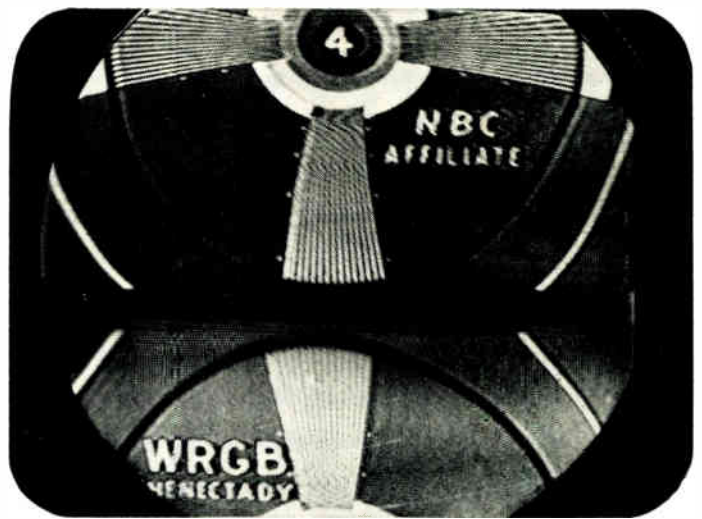
**Tele-Clue No. C86.** This is a somewhat unusual defect which could take a considerable amount of time to run down. The picture was very dark and looked as if the contrast control was advanced too far. This control however, had no noticeable effect on the picture. The horizontal sync was critical and the vertical would jump a frame quite frequently. This condition was caused by a leaky capacitor C290 in Fig. 2. Because of this a positive voltage (50 V.) appeared on the picture tube grid. This circuit was used in the following General Electric TV receivers:

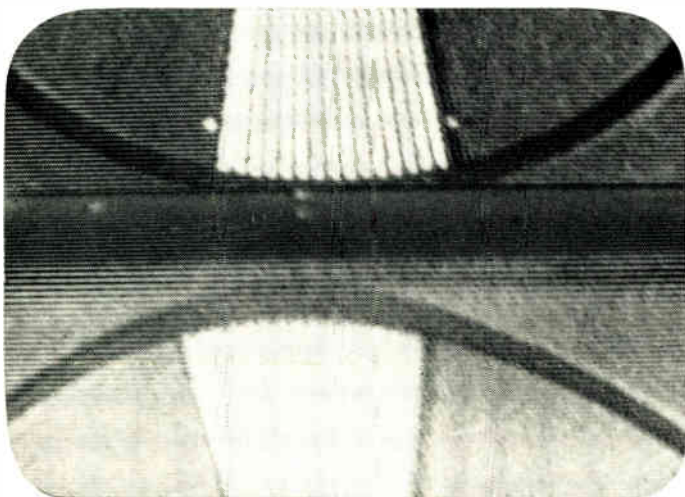
**Tele-Clue No. C87.** This is an enlarged view of the area between the frames shown in Tele-Clue No. C86. The vertical sync pulse has disappeared completely. This area should appear like that shown in Tele-Clue No. C88.

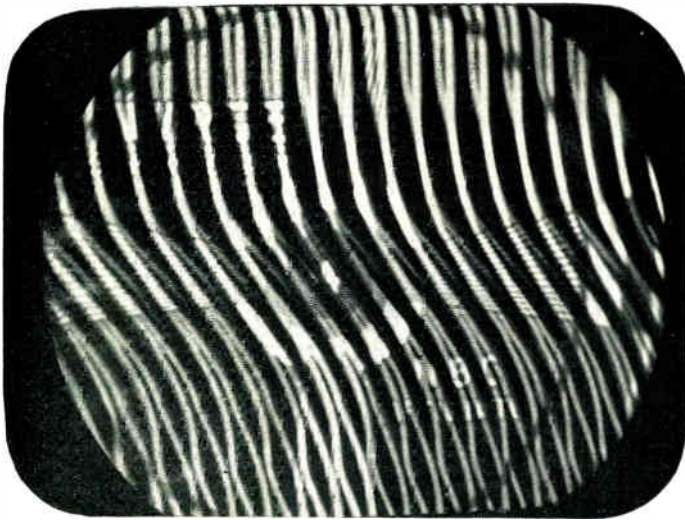
**Tele-Clue No. J89.** This condition was caused by spurious oscillation in the 6C4 HF oscillator used in a Westinghouse Model H-604T10. The frequency which is indicated by the number of vertical or diagonal lines, could be varied by adjusting the fine tuning control. The lowest frequency appears above and the highest frequency is shown in Tele-Clue No. J90. The shield over this tube had no apparent effect, however, another 6C4 tube entirely eliminated this defect.

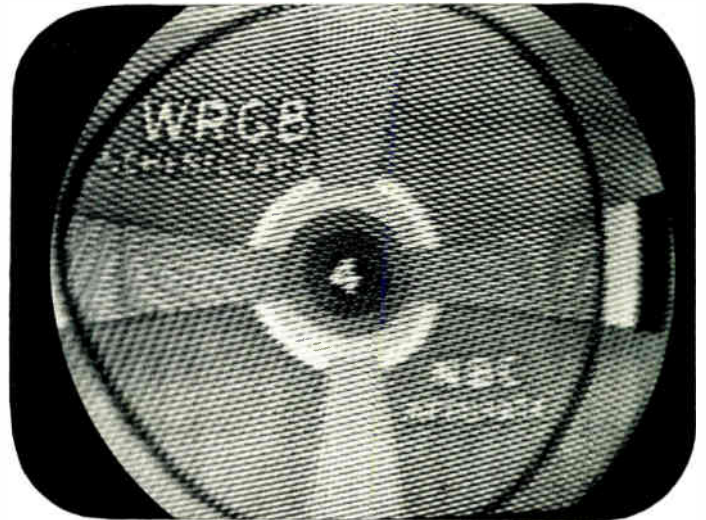
**Tele-Clue No. J90.** This is the same defect shown in Tele-Clue No. J89 except at a different setting of the fine-tuning control. A similar effect may be caused by any RF getting through to the grid of the picture tube. The interference shown above could be varied by adjusting the fine tuning control which indicated that the HF oscillator was at fault.

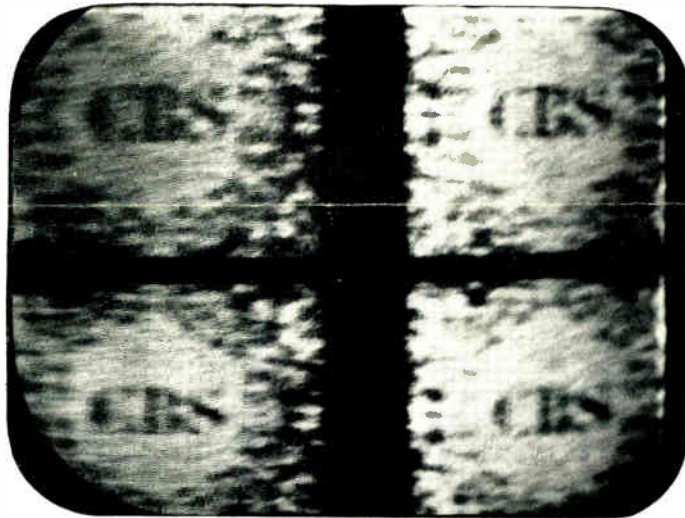
**Tele-Clue No. L91.** This is a photograph of a CBS color transmission which was received from New York City a distance of about 160 miles. If your area should receive color programs using the CBS color system, a considerable number of people will probably believe their sets are defective since adjustment of the horizontal and vertical hold controls will only produce a picture similar to that shown above.

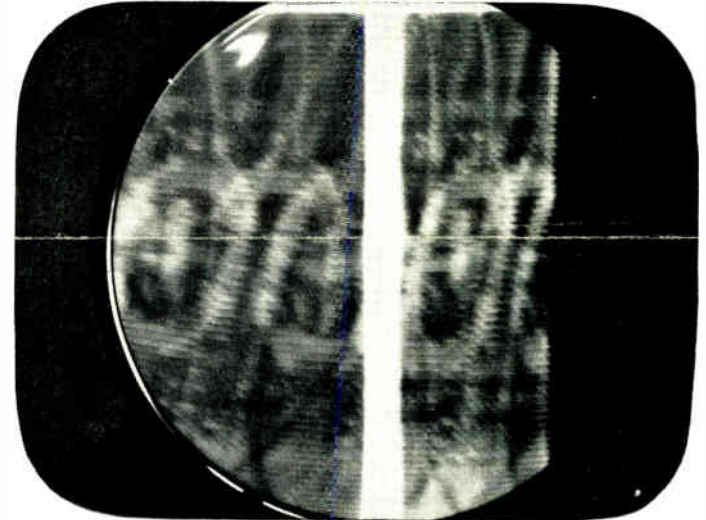
**Tele-Clue No. E92.** The bright vertical bar and loss of horizontal synchronization was caused by C363 in Fig. 1 being open. This condition is the result of blocking the horizontal sweep generator. It usually is brought about by improper operating bias on the horizontal sweep oscillator tube caused by open, leaky, or shorted components in the grid bias circuit. A ready check to determine whether this is the source of the trouble is to observe the waveshape with an oscilloscope across the sine-wave oscillator tank circuit of tube V12B. If the amplitude and waveshape do not check with published data, the components R 366 or C 365 should be checked.

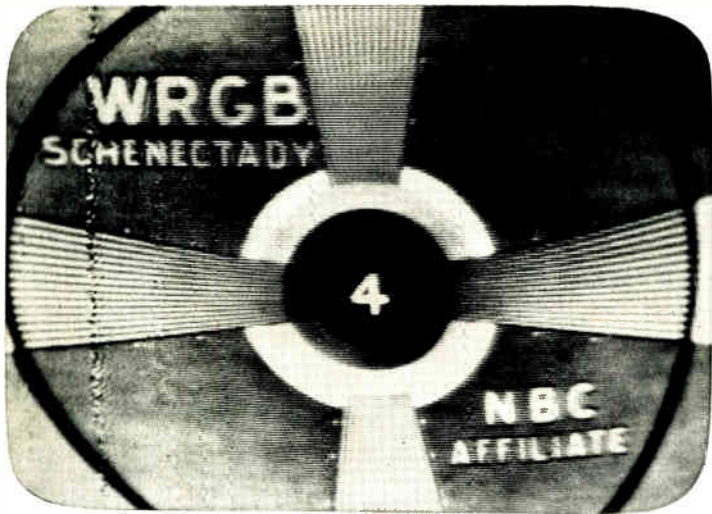
**Tele-Clue No. E93.** The vertical black lines were due to a slight arc developing at the solder connection to the plate of the 183-GT high voltage rectifier. This is similar in appearance to Barkhausen oscillation. The similarity is probably due to the various frequencies developed by the arc falling in the same range as Barkhausen oscillation.

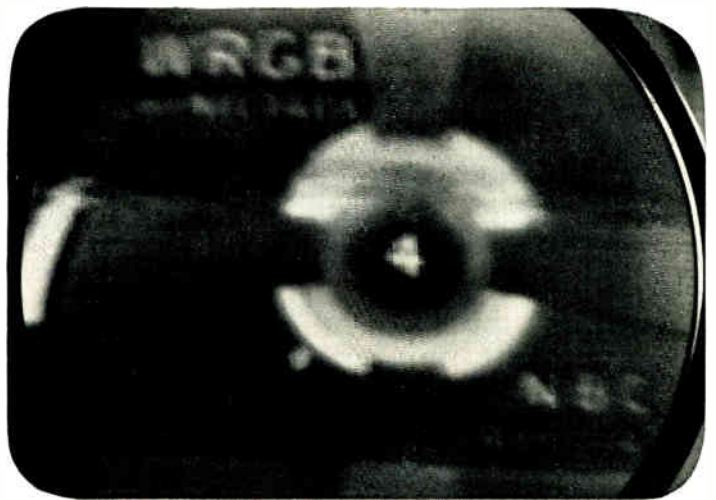
**Tele-Clue E94.** The increase in horizontal and vertical size as well as the loss in brightness indicates a loss of high voltage. This was caused by a poor connection which developed an arc under the rubber cover at the anode of the picture tube.

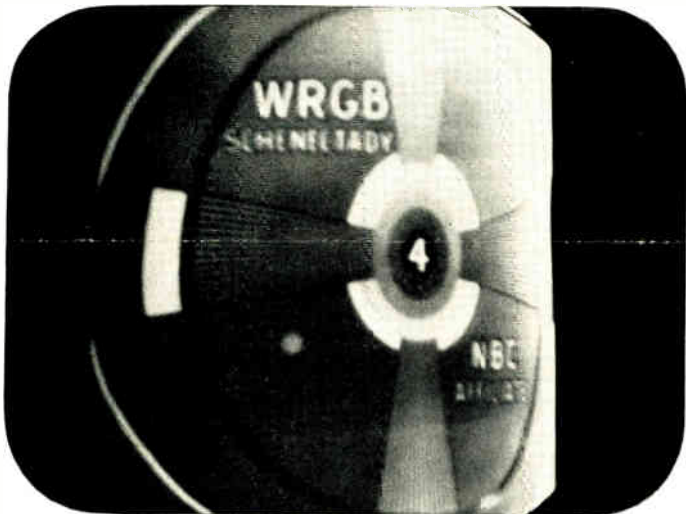
**Tele-Clue No. E95.** The dim picture with poor horizontal linearity, insufficient width and excessive height was caused by an open in the .5 mfd capacitor C 377 in Fig. 2. This condition is a result of placing a high impedance in series with the horizontal deflection circuit and is caused by an open or very low capacity value of the series capacitor, C 377, to the horizontal deflection coils. This reduces current to the horizontal deflection coils; however, the shunting resistor R 377, passes some current to the coils when capacitor C 377 is open, thus permitting some sweep but with reduced picture tube anode voltage. In some receivers, resistor R 377 will overheat upon opening of capacitor C 377 because of excessive current. High leakage in capacitors C 373 or C 374 will produce similar results except that the linearity will be better.

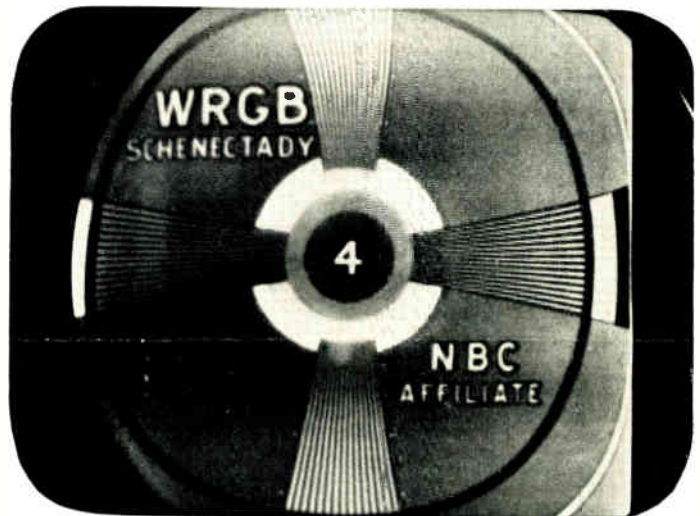
**Tele-Clue No. E96.** The displacement to the left shows the effect of shorting out the .5 mfd capacitor C 377 in Fig. 2. This condition is the result of additional d-c flowing through the horizontal deflection coils. If this capacitor shorts out it may be impossible to center the picture.

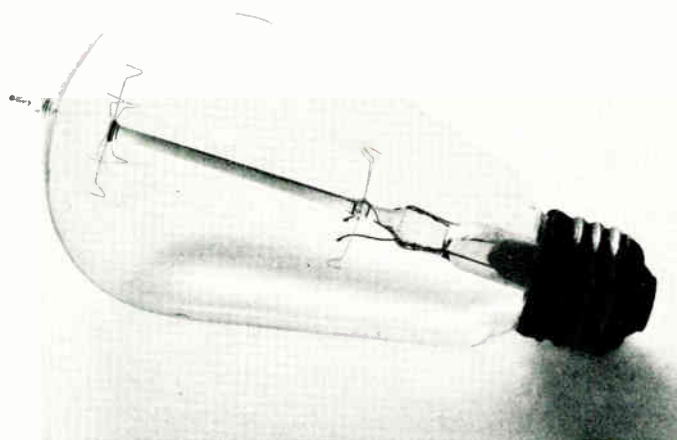
**Tele-Clue No. J97.** This is a photograph of a typical straight wire incandescent lamp, which may cause interference in the 60 to 70 megacycle frequencies (Channels 2, 3 and 4). Lamps of this type have not been manufactured since about 1925, however, a considerable number are still in use in such places as attics, fruit cellars, closets, etc. It is very rare for a modern General Electric lamp to cause interference; however, the type shown above may produce a high frequency oscillation. The main points of identification are the filament shape, the clear glass bulb and the tip.

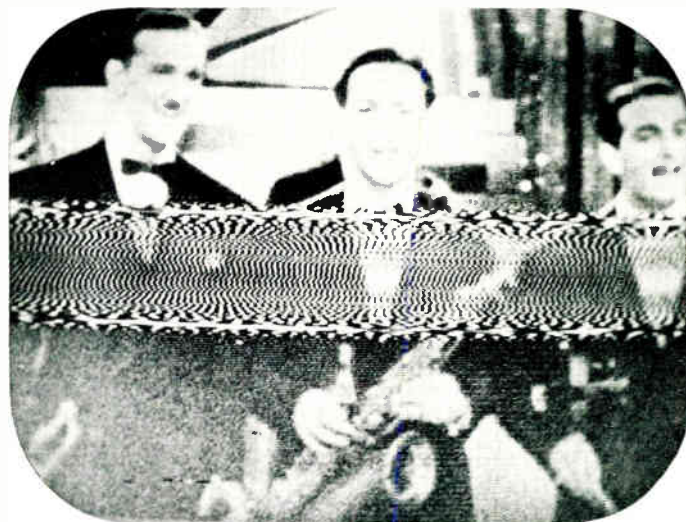
**Tele-Clue No. J98.** This shows one type of interference pattern produced by the lamp shown in Tele-Clue No. J97. Due to these lamps being used intermittently in such places as porch lights, closets, etc., they may be rather difficult to locate. Another factor is that this type of interference may cover a radius equivalent to two city blocks, particularly in low signal areas. In some cases the interference pattern may move either up or down on the screen until it is no longer visible. The radiation from a lamp of this type can be shielded or dissipated by use of metal reflectors but no one recommendation will apply to all installations. Therefore, the simplest remedy is to find and replace the guilty lamp.

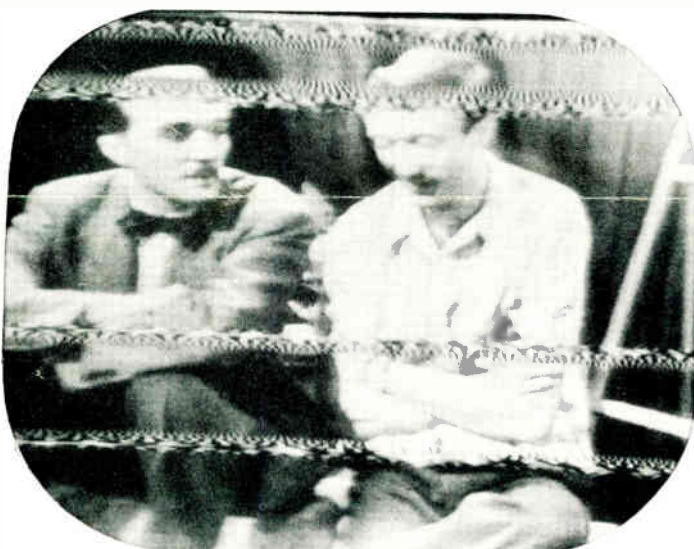
**Tele-Clue Nos. J99 and J100.** Two more interference patterns produced by the type of lamp shown above. The black bands in the photograph on the right are the result of operating the lamp close to the receiver.

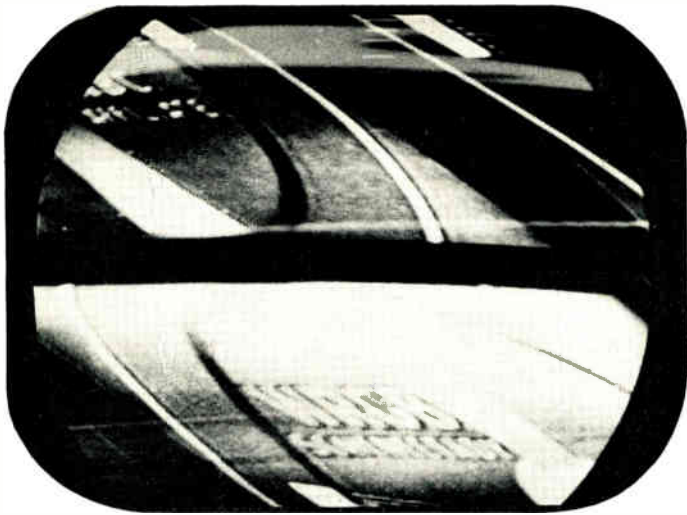
**Tele-Clue No. K101.** The above photo illustrates the effect of losing both horizontal and vertical synchronization. This defect was due to an open C-354 in Figure 1. However, it could be due to any of the following:

1. C351 open.
2. Defective V10A or V10B.
3. Loss of plate voltage on V10A or V10B.
4. Incorrect value of R354.
5. Insufficient amplitude of composite signal applied to sync amplifier from video amplifier, check video amplifier circuit. A scope will prove invaluable when used as a signal tracer in this circuit. The wave form and amplitude should be compared with the manufacturer's service notes.

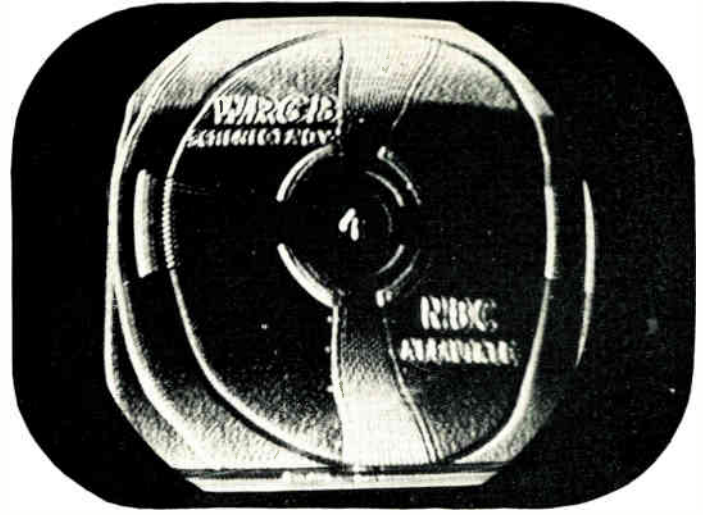
**Tele-Clue No. M102.** This condition is typical when a component fails in the AGC circuit. It may result in the contrast control having little or no effect on the picture. If the contrast control has little control, it may be due to leakage in one of the capacitors such as a C261 or C251. Since the impedance of the circuit is high, leakage in the order of 1 megohm or less may cause trouble. A completely inoperative control may be the result of a shorted capacitor or a ground in the AGC system. This was caused by a shorted C251 in Figure 2, however, a short in C261 or an open in L258 may result in a similar condition.

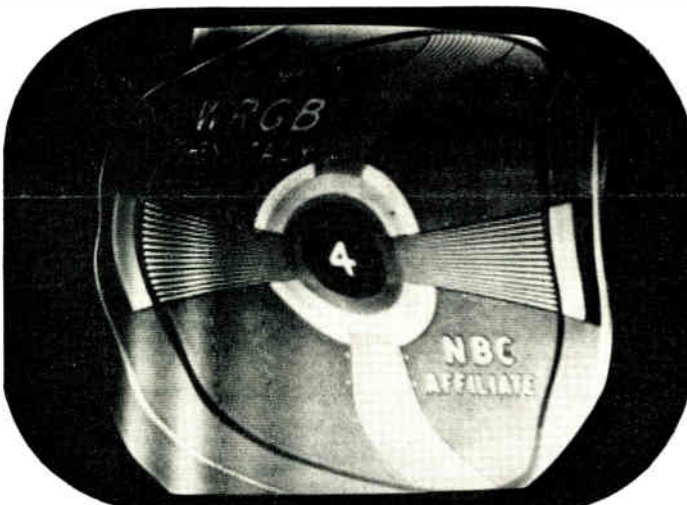
**Tele-Clue No. F103.** This photo indicates a defective component which reduces the output B+ voltage. This reduced B+ voltage will affect both horizontal and vertical sweep and will also give reduced picture brilliance. The ripple and shadow through the picture is due to inadequate filtering of the "B" supply. This was caused by an open C452 in Figure 2.

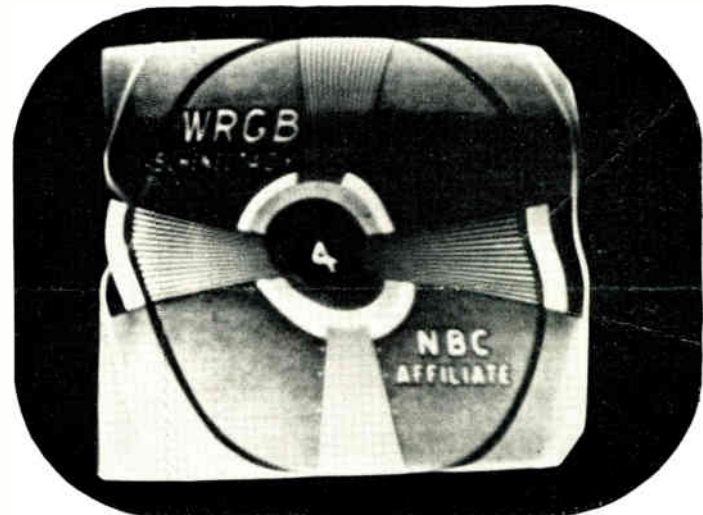
**Tele-Clue No. F104.** This illustrates another defect due to inadequate filtering. The dark shaded bar is caused by hum in the picture tube grid circuit, while the waviness in the raster edge is the result of hum in the horizontal deflection circuit. This was caused by an open C453 in Figure 2.

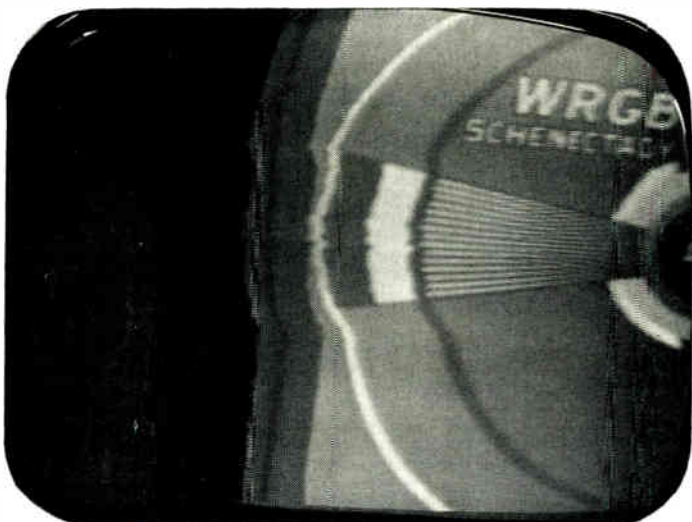
Tele-Clue No. F-105. This defect was due to an open developing in the 10 mfd capacitor C379-A in Fig. 1. The vertical hold was unstable and synced in slightly above normal. The horizontal hold was also unstable and would only sync in with the blanking bar either at the left as shown above or at the right as shown in Tele-Clue No. F-106.

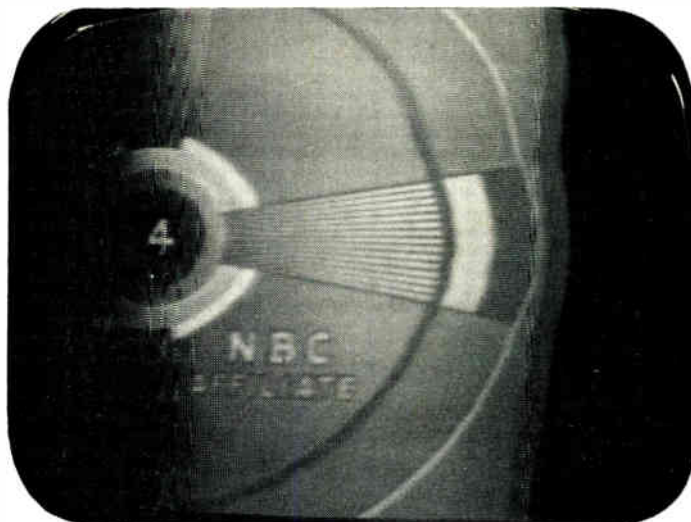
Tele-Clue No. F-106. This is the same defect as shown in Tele-Clue No. F-105 with the hold control adjusted so that the blanking bar syncs at the right.

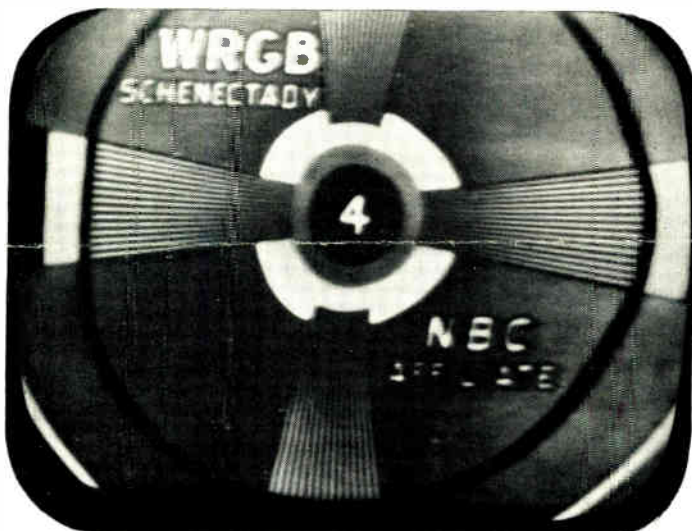
Tele-Clue No. K-107. The above photograph was taken with the contrast control set at minimum (counterclockwise). The defect shown here was due to 50K ohms leakage across C-354 in Fig. 1. Incidentally, if this capacitor is completely shorted, horizontal oscillation is "killed," resulting in complete loss of any illumination on the picture tube. The vertical syncs slightly above normal as can be seen in the above photograph. If C351 is leaky the picture will appear practically the same as the above except that the vertical will sync at the normal point.

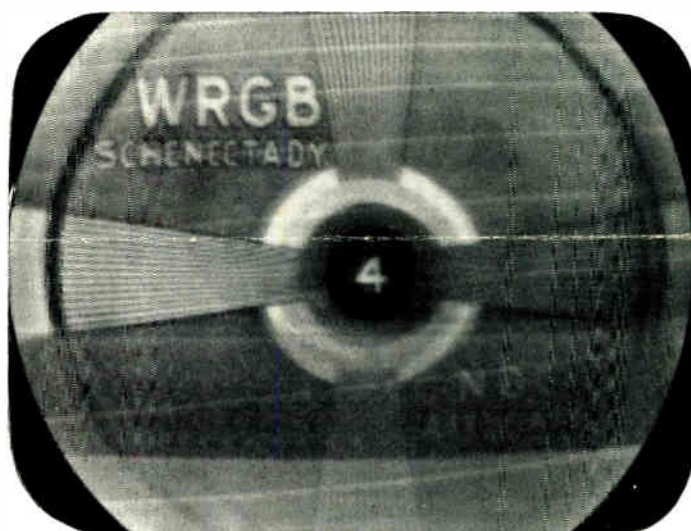
Tele-Clue No. C-108. This photograph shows the effect of oscillation in the video amplifier of a General Electric 10T1 receiver. This defect can be caused by an open in either one of the 6800-ohm resistors R-233 or R-234 which are connected in parallel with the video compensating chokes L-255 and L-268 in Fig. 2. Both of these chokes are wound on resistors and may be difficult to locate unless the resistor is checked separately. This same type circuit is used in a number of General Electric models.
