# Tele-Clues

**Tele-Clue K-274**

**Receiver:** G-E "U-4" line (See "U-4" Tele-Clue Schematic).  
**Component:** C254, 5000 mmfd, 450 volt capacitor, temperature range 10° - 105° C - SHORTED.  
**Circuit:** Grid circuit of V8 Clipper tube.  
**Symptom:** Soft sync, horizontal side lock and possible audio buzz.

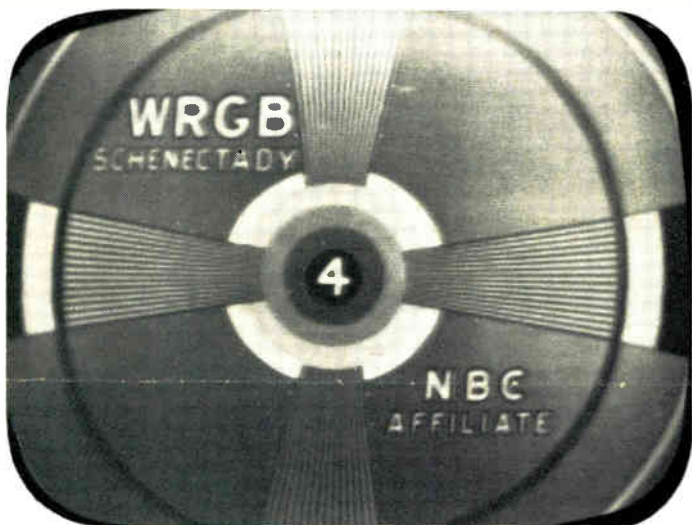
**Tele-Clue No. F-109.** Line voltage variations will affect the over-all operation of a TV receiver. The height, width and focus are all affected as can be seen by comparing the four Tele-Clues shown on this page. The above photograph was taken after the TV receiver was adjusted for proper operation at a line voltage of 120 volts.

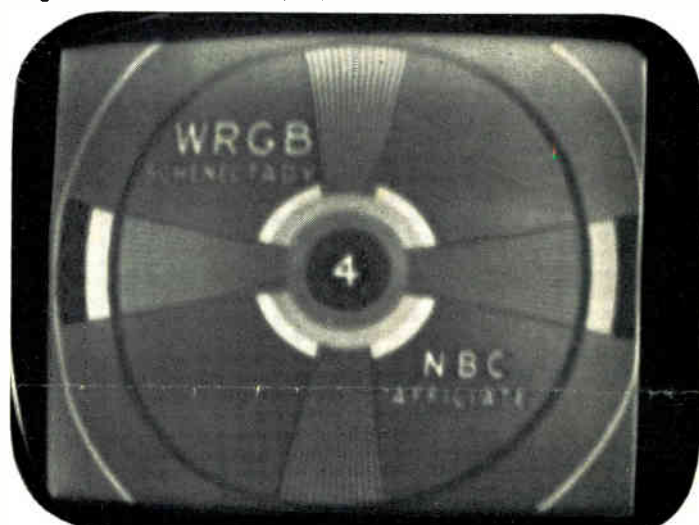
**Tele-Clue No. F-112.** This is similar to Tele-Clue No. F-111 but with the same defects more pronounced since the line voltage has been reduced to 100 volts.

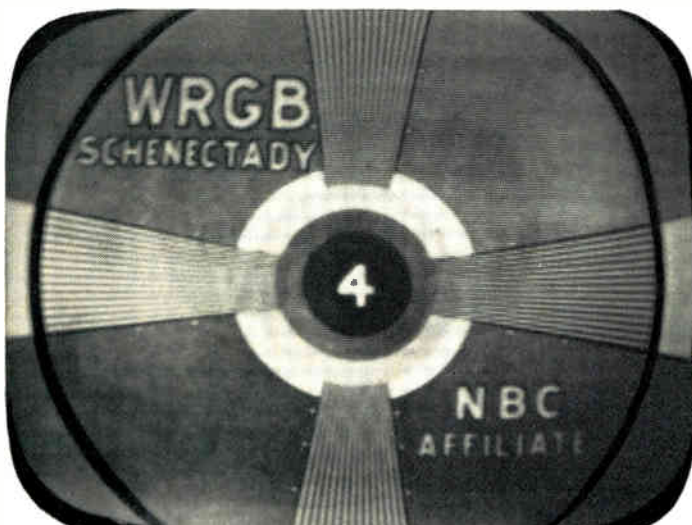
**Tele-Clue No. F-110.** This photograph was taken of the same receiver with the line voltage increased to 130 volts. No other adjustments were made. The width and height have increased and the black portions of the test pattern are darker. The definition of the vertical wedges is reduced near the center of the picture which could have been corrected by adjusting the focus control.

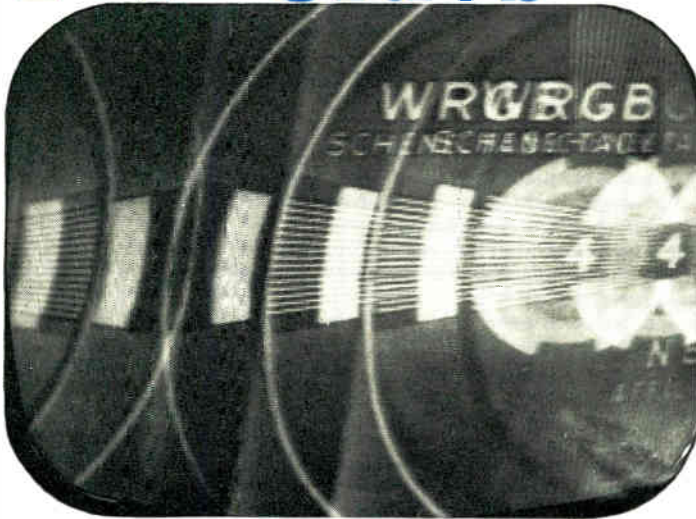
**Tele-Clue E-113.** The horizontal shifting shown here was due to an open capacitor C356 in Fig. 1. This capacitor feeds the horizontal sync pulses to V12. If this capacitor is open the control voltage ordinarily developed across resistor R356 and R357 and applied to the grid of V13A will obviously be incorrect.

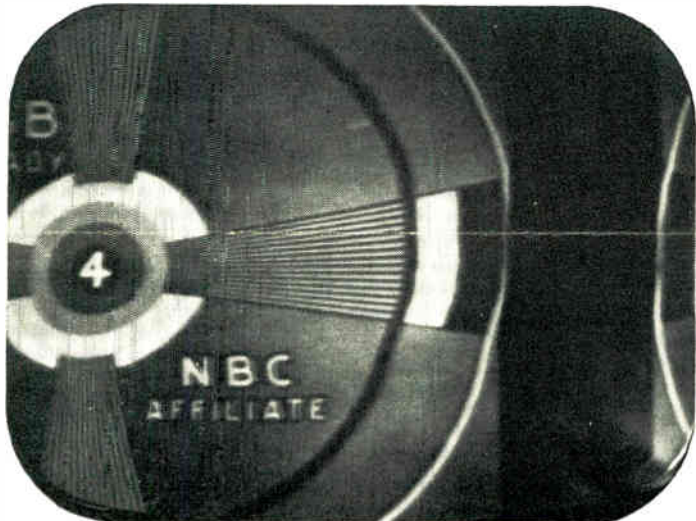
**Tele-Clue E-115.** This condition was caused by an open capacitor C358 in Fig. 1. The picture weaves horizontally and can only be stabilized with the horizontal blanking bar at the right as shown or with a number of horizontal lines tearing the picture as shown in Tele-Clue E-116. A similar type defect will also appear if R359, R360 or C357 is open.

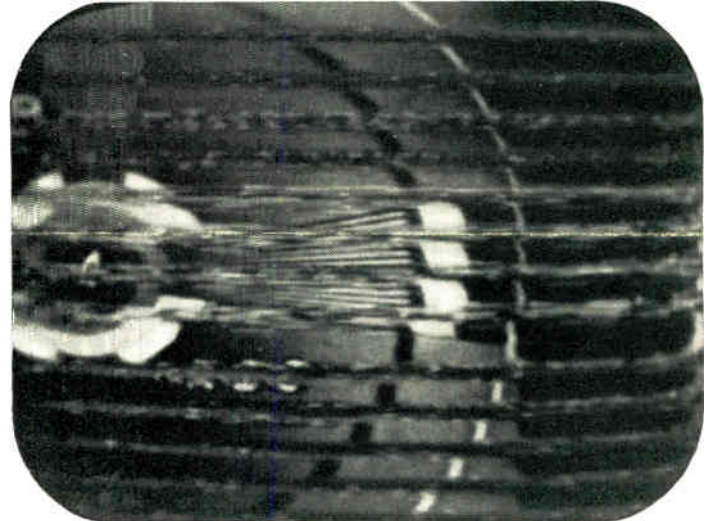
**Tele-Clue E-116.** This defect was caused by the same defect as Tele-Clue E-115 but at a different setting of the hold control. The number of horizontal lines which appear will also vary with the control setting.

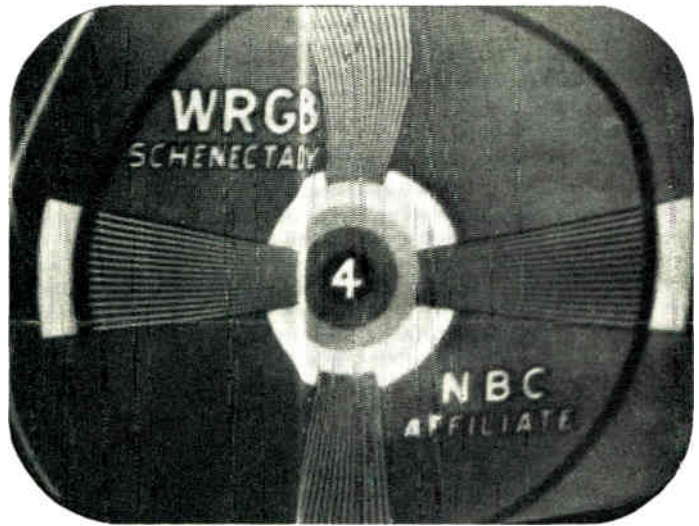
**Tele-Clue E-119.** Leakage across capacitor C366 in Fig. 1 will cause a vertical white line to appear near the center of the picture and there is pulling at the top. This defect also causes a slight reduction in the width.

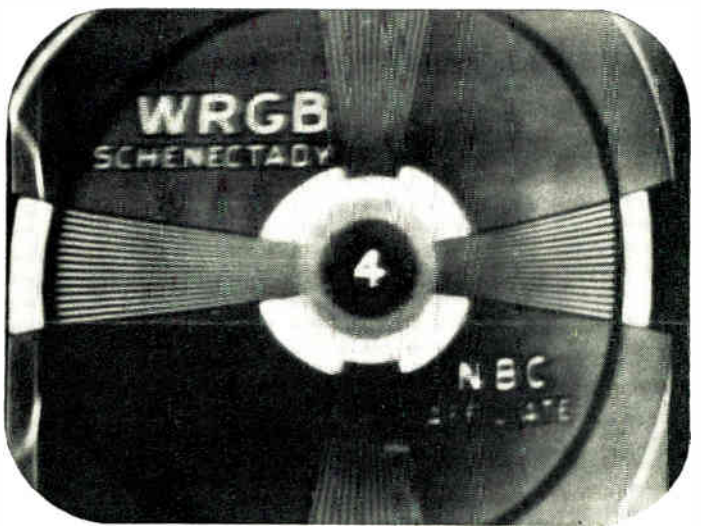
**Tele-Clue E-120.** Leakage across capacitor C368 (100K) in Fig. 1 will cause the width to be reduced with a slight foldover on the left side as shown in the above photograph.

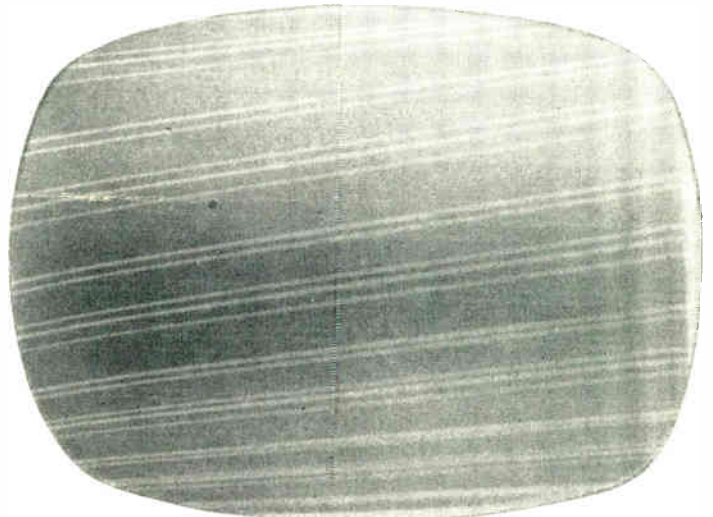
**Tele-Clue No. C-124.** Loss of both sound and picture but with a raster on the picture tube showing vertical retrace lines not stabilized as shown above. This indicates that the trouble is between the antenna terminals and the point where the sound is taken off. In an intercarrier receiver, such as shown in Fig. 2, the defect should be found in the tubes or circuits shown as V1, V2, V3, V4, V5, V6 or Y1. In a conventional receiver such as that shown in Fig. 3, the defect should be found in either the R-F unit or the first video i-f amplifier.

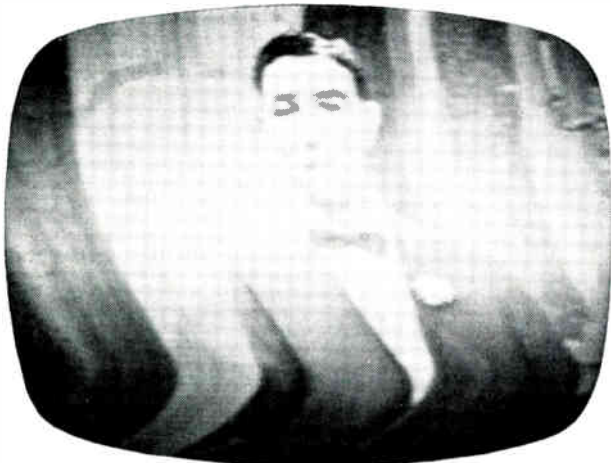
**Tele-Clue No. F131.** This Tele-Clue illustrates one effect of excessive a-c voltage in TV receiver circuits. In this instance the result is a combination of the two conditions shown in Tele-Clues C132 and E133. This defect is reasonably common since it may be caused by either a defective filter capacitor or a heater-cathode short. A heater-cathode short would have to be in one of the signal amplifying stages before the point where the sync pulses are taken off.

The light and dark areas are caused by a-c modulating the video signal at the input to the picture tube. The horizontal pulling is caused by a-c modulating the sync pulses which in turn modulate the horizontal oscillator. This condition could be caused by a defective filter capacitor which would allow a higher than normal level of a-c to be fed to the signal amplifying stages as well as the horizontal circuit. A check as indicated in Tele-Clue No. F130 would determine whether the filter network is at fault.

Another reason for the same type of picture distortion would be heater-cathode leakage in any signal amplifying stage before the sync pulses are taken off. A quick check for this condition would be to place the scope probe at either the cathode or plate of each stage. Heater-cathode leakage would be indicated by an a-c voltage greater in amplitude than that present at the B+ output of the power supply.

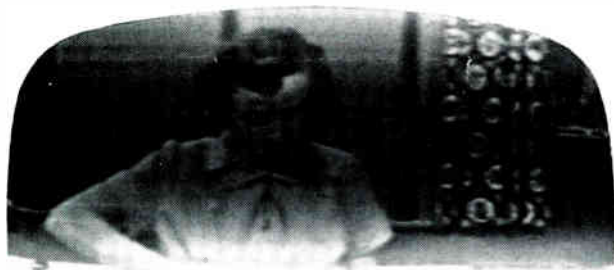
**Tele-Clue No. C132.** The shading in the above picture is caused by modulation of the video signal by 60 cycle a-c. This modulation causes a portion of each frame to extend into the black or darker than normal level and another portion of the frame to extend into the white or lighter than normal level. This effect can be readily understood when the normal video signal waveform on the left is compared with the modulated waveform on the right. The scope probe was placed on the grid of the picture tube and the sweep frequency set to sync at 60 cycles per sec. Notice that there is no

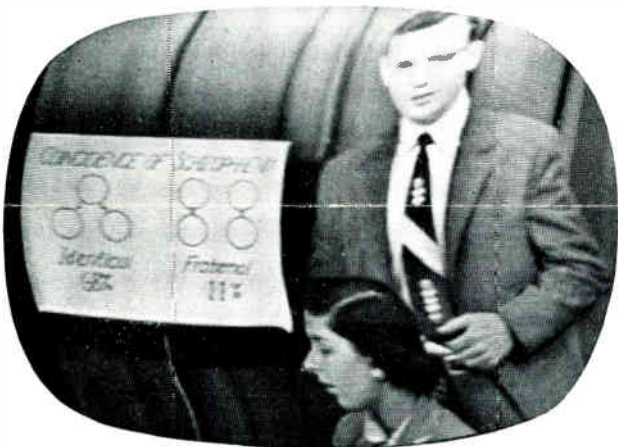
**Tele-Clue K-135.** Leakage in capacitor C-302 shown encircled in Fig. 1 will cause waviness in the picture due to a distortion of the sync pulses plus some of the video signal getting into the sync circuits. In the normal waveform shown on the left, vertical sync pulses appear as light ver-

tical streaks at the left and at the right of the waveform. The area in between these two vertical sync pulses is filled with horizontal sync pulses. The portion of these sync pulses which are visible at point "A" represents only the tips due to the action of the "clipper" tube. Due to the bias change on the clipper tube caused by leakage in C-302, video information as well as most of the complete vertical sync pulse is getting through the clipper tube as shown in the waveform on the right. The amplitude of this waveform is about 110 volts whereas the normal waveform is about 60 volts.

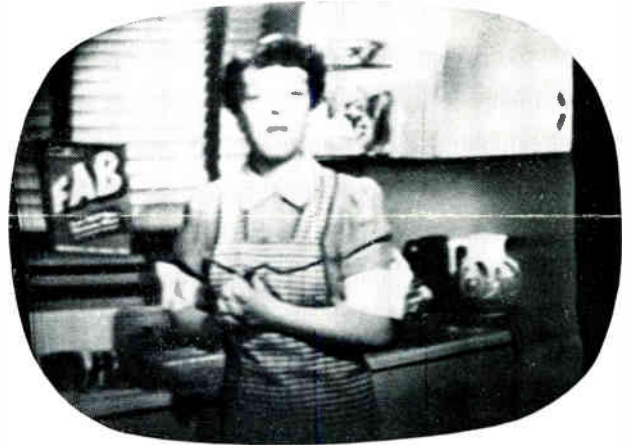
**Tele-Clue K-136.** If Capacitor C-303 also encircled in Fig. 1 is open, the picture is moved slightly to the left and has a wavy edge. The width control was adjusted so the waviness on the right edge could be seen. The

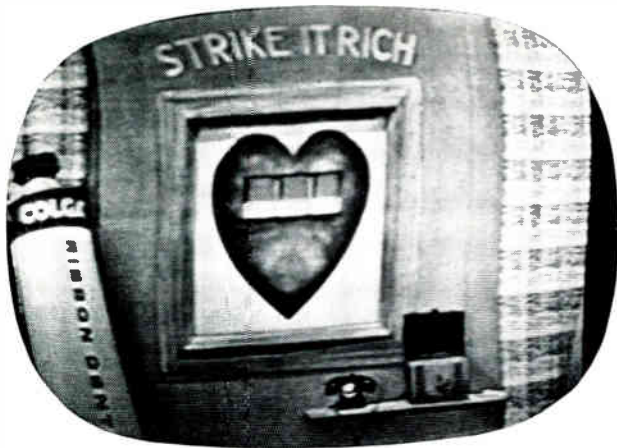
**Tele-Clue K-137.** Leakage (20K) in capacitor C-301 also caused a displacement to the left. In addition, the picture has more of a weave than Tele-Clue K-136. The waveform on pin 1 of V116A appeared practically the same as that shown under Tele-Clue K-136. Both horizontal and vertical sync were slightly unstable due to the change in bias on the noise inverter tube. This bias change caused the noise inverter tube to act as a clipper which prevented proper clipping action by the clipper tube.

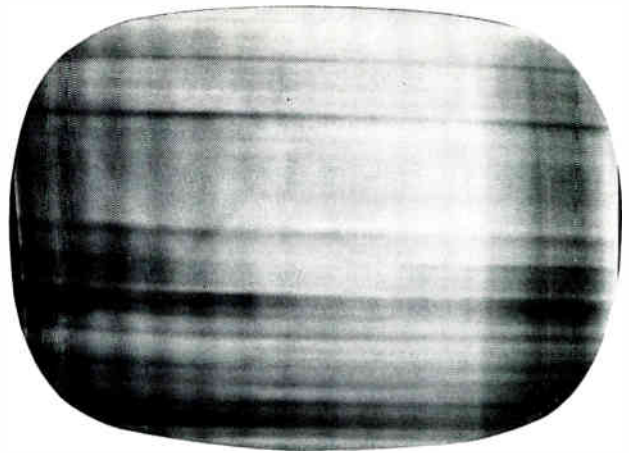
**Tele-Clue K-139.** If the 15K resistor R-301 in Fig. 1 is reduced in value to 200 ohms or less the picture will be practically lost as shown above. The waveform at point "A" will appear like that shown below. This has eliminated practically all of the horizontal sync pulse amplitude and only

the vertical pulse can be identified. This defect would seldom occur unless considerable current should be drawn through R-301. Since C-301 is connected between the lower end of L-167 and the cathode of V113B, a reduction in the value of R-301 will in effect ground one end of C-301. This would by-pass all frequencies except those very low in frequency.

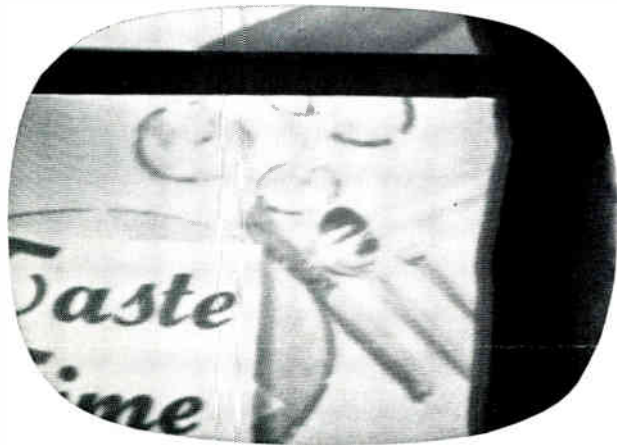
**Tele-Clue K-138.** A short in capacitor C-301 in Fig. 1 produced the picture shown above. The waveform at pin 1 of V116A point "A" appeared as shown below. Both the horizontal and vertical sync pulses have practically

disappeared. This caused the picture to sync slightly below normal vertically and to weave and sync with the blanking bar near the center horizontally. The shape of the area between the vertical sync pulses will change with the picture content.

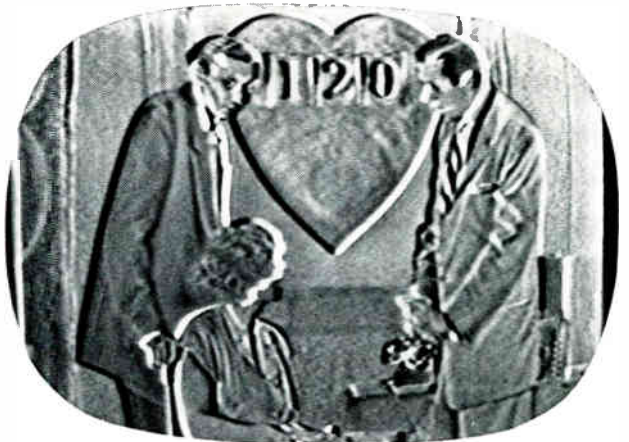
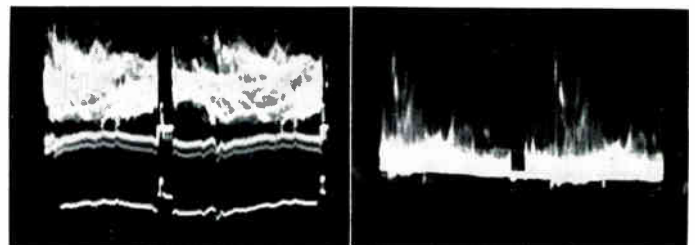
**Tele-Clue K-140.** A short in capacitor C-169 in Fig. 1 caused a loss of the low frequencies and trailing whites. A normal waveform at the output of the video detector point "B" in Fig. 1 will appear as shown in the

waveform on the left. A short in C-169 will cause this waveform to change as shown on the right. In every waveform photograph, the scope was synced at one-half the vertical frequency.

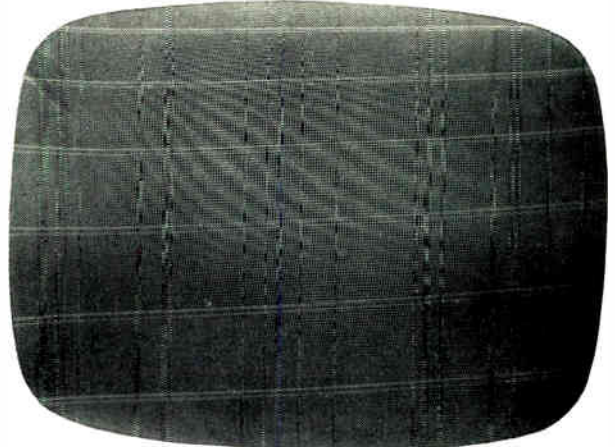
Tele-Clue No. M-143. An open in the grid circuit of V117 in Fig. 1 will cause the picture to appear the same as Tele-Clue M-141. An open in the grid circuit of V113 in Fig. 2 will cause a complete loss of the video signal as shown above.

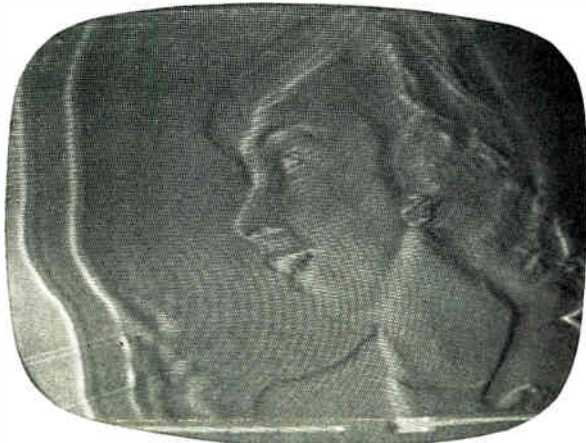
Tele-Clue No. M-141. Keyed AGC circuits have caused technicians considerable trouble because the effect on the picture is often misleading. If the AGC keyer tube V117 in Fig. 1 is inoperative due to an open filament, low emission, an open AGC winding on the width coil, or some other defect, the AGC voltage will be very low. This low voltage causes one or more of the video i-f or video amplifier tubes to be overloaded which results in a negative picture plus erratic horizontal and vertical synchronization as shown above. The above defect was caused by an open filament in the 6AU6 keyer tube.

If it should be necessary to replace the width coil T503, be sure the leads are connected correctly. If either side is reversed, the polarity of the waveform will also be reversed. This will produce the same condition shown in the above photograph.

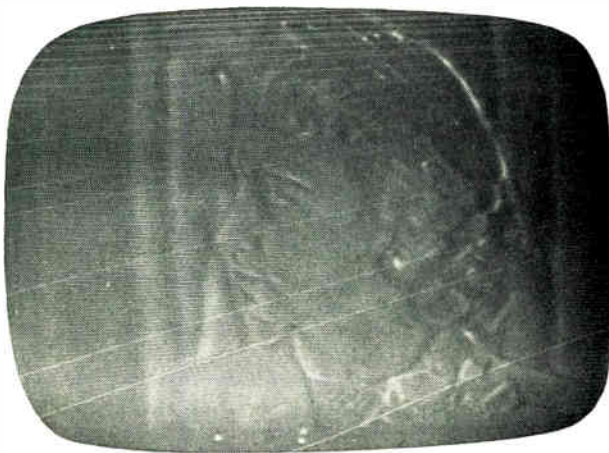
caused by an open filament in the 6AU6 keyer tube in the Fig. 2 circuit. The condition shown occurred with a good level of signal. If the signal level is low, the picture may appear normal at high contrast control settings even with the keyer tube inoperative.

Tele-Clue No. M-142. Somewhat different picture conditions are caused when defects occur in the slightly different AGC circuit shown in Fig. 2. As an example, when the 6AU6 tube is inoperative due to an open filament or an open in the AGC winding on the width coil, the picture is affected but not as much as in the Fig. 1 circuit. The above picture was

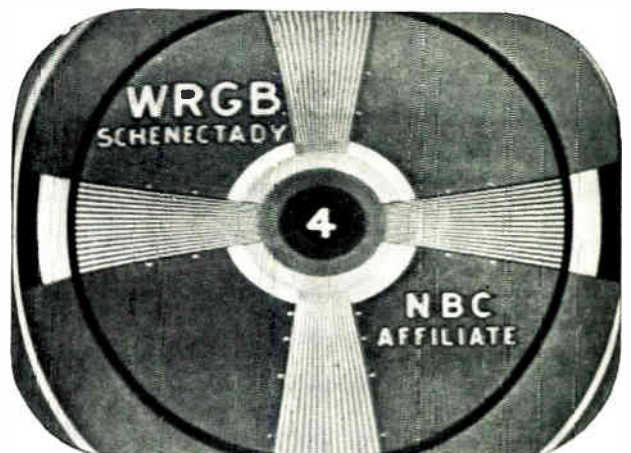
Tele-Clue No. M-144. An open in capacitor C405 in Fig. 1 will cause a loss of vertical interlace. When this capacitor opens, it allows horizontal pulses to appear on the AGC line as shown in the wave form on Page 4. Normally only d-c is present at this point. These horizontal pulses upset normal vertical synchronization which caused the side wedge to fan out

near the center as shown. The vertical would not interlace at any setting of the vertical hold control, otherwise it seemed to operate over the normal range.

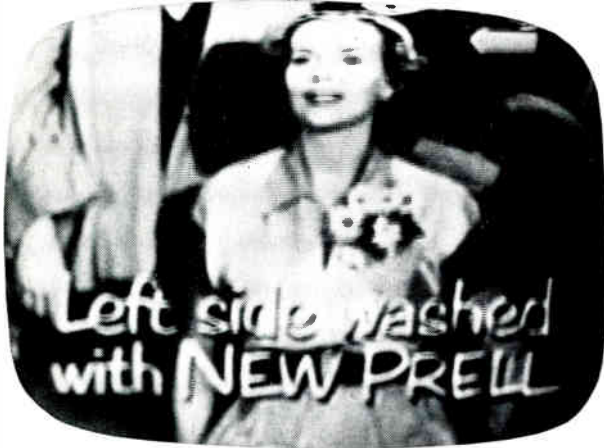
**Tele-Clue No. M-145.** An open in capacitor C251 in Fig. 2 will also cause poor interlace, but in addition the vertical will jitter as shown above. The vertical hold control was very limited in range.

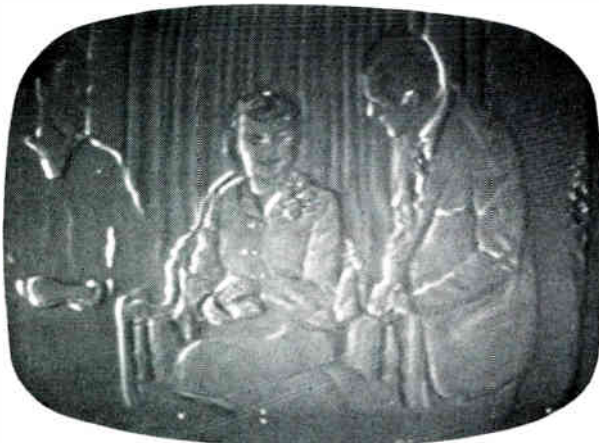
**Tele-Clue No. F-146.** The condition shown above is quite similar to that shown in Tele-Clue M-141. This condition, however, was caused by a low emission 5U4-G rectifier tube V129 in Fig. 3. Since this is the tube which supplies the B+ for the horizontal sweep output tube, a reduction in the B+ voltage will result in a reduction of the amplitude of the pulse applied to the plate of the keyer tube shown in Fig. 1. In addition, the normal operating voltages for this keyer tube are also changed. This

reduces the AGC voltage and causes overloading similar to Tele-Clue M-141. The normal amplitude of the waveform at the plate of the keyer tube was about 600 volts peak to peak. The low output 5U4-G caused this voltage to be reduced to about 400 volts peak to peak. The AGC circuit shown in Fig. 2 was not affected by the low output rectifier tube. The only noticeable change was a reduction in size.

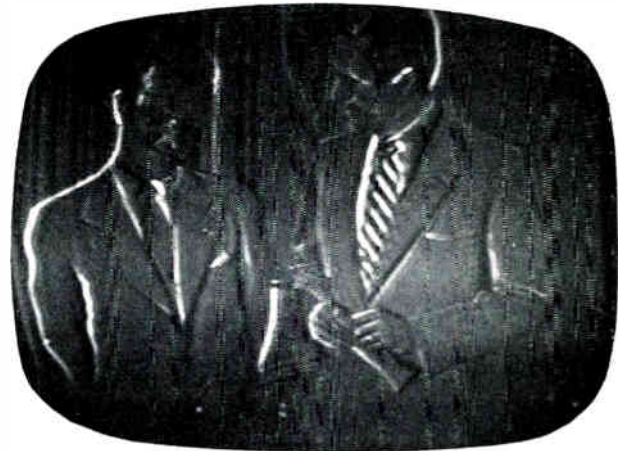
**Tele-Clue No. F-147.** The above condition was caused by an open input filter capacitor C600A shown in Fig. 3. This caused practically the same type of picture as Tele-Clue M-141. The amplitude of the waveform at the plate of the keyer tube in Fig. 1 was about two thirds of the normal amplitude. The AGC circuit shown in Fig. 2 was not affected by an open filter. The only change in the picture was a reduction in size and horizontal hum bars.

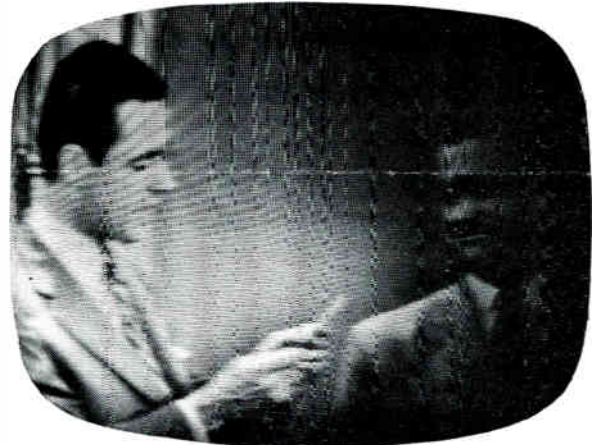
**Tele-Clue No. F-148.** If the output capacitor C602A in Fig. 3 is open, the AGC voltage is not affected and the only noticeable change to the picture is a slight shading on the right side as shown above. The amplitude of the waveform at the plate of the keyer tube in Fig. 1 was reduced about ten percent but this was not enough to affect the picture quality. The AGC circuit in Fig. 2 was not affected by an open filter capacitor.

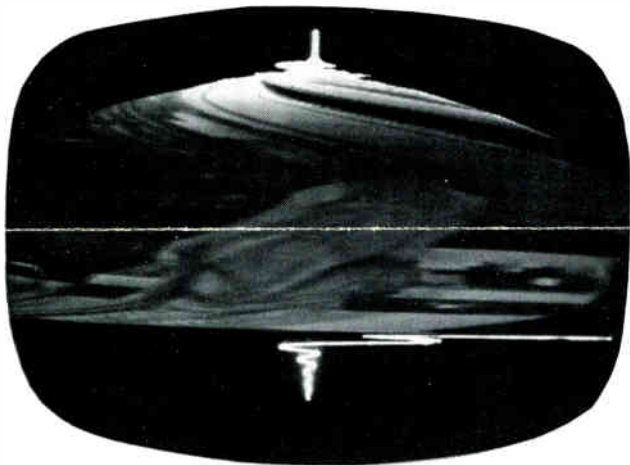
**TELE-CLUE E-149.** A heater-cathode short in V117A in Fig. 1 will cause the picture to be distorted as shown above. This caused the cathode to be modulated by a 60-cycle a-c voltage which cuts off the horizontal oscillator at the top and bottom of the picture tube screen.

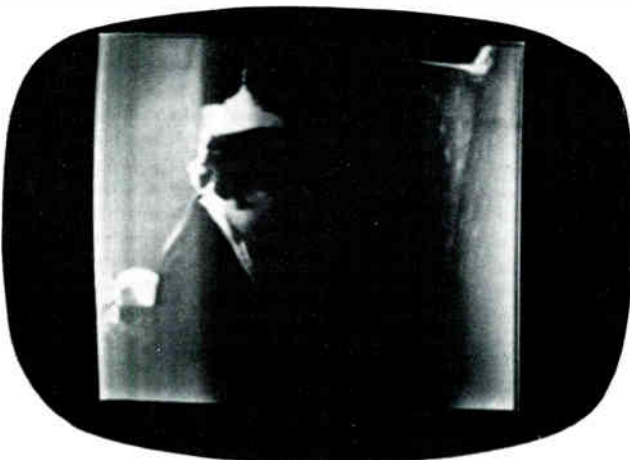
**TELE-CLUE E-150.** An open capacitor C-371 in Fig. 1 produces the defect shown above. When this capacitor is open the critical balance across

the horizontal transformer is changed. This affects the shape of the waveform fed to the horizontal blanking tube and causes the center portion of the picture to be blanked out. The reduction in width and height was due to a lower B+ boost voltage which also resulted from the open capacitor C-371. If C-371 shorts, it completely blanks out the raster.

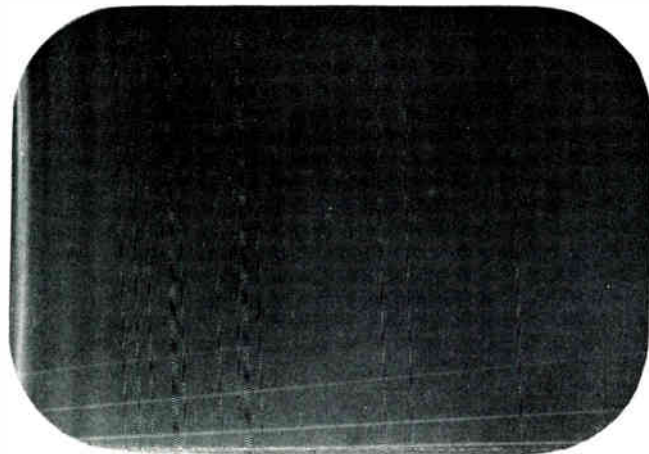
**TELE-CLUE M-152.** Stewart Warner Models 9120A, B, C, D, E and F. A complete loss of video information with a reduction of high voltage results if the resistance of R-258 in Fig. 2 is reduced in value. This defect may be misleading since a check of the video signal at the output of the video detector is normal in appearance. The amplitude, however, is about ten times the normal amplitude of 1.7 V peak-to-peak. This produces enough bias on the grid of the first video amplifier (V12) to cut it off completely. Since the AGC voltage depends upon the frequency and amplitude of the waveform in the horizontal output transformer, this defect in the horizontal multivibrator will cause a reduction in the AGC voltage as well as the HV anode voltage.

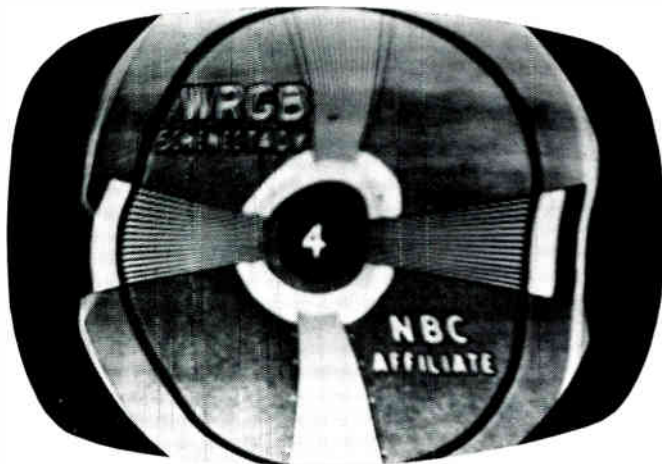
**TELE-CLUE K-153.** The waviness in the picture together with the displacement to the left resulted from an open C-353 in Fig. 3. Since this capacitor has to pass the horizontal sync pulse, when it is open, the sync pulse will be integrated through the resistor, R-353. This integrated pulse causes a delay in the sync which shifts the picture to the left. With the weakened horizontal sync pulse, the sync is influenced by the black transmission of the picture that causes the wavy edge to the picture. It appears as though the "black" transmissions pull the picture out of shape.

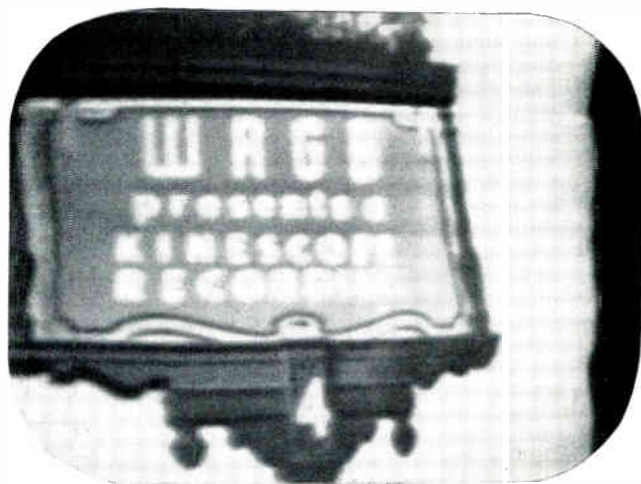
**TELE-CLUE E-154.** An open circuit between the graphite coating on the picture tube and chassis is another cause for waviness in the raster edges. This was the cause of the waviness shown in the above photograph. Note that the darker areas in the picture cause deeper indentations in the edge than lighter areas. Since the aquadag coating on the picture tube acts as a HV filter capacitor, the same condition could be caused by an open HV capacitor.

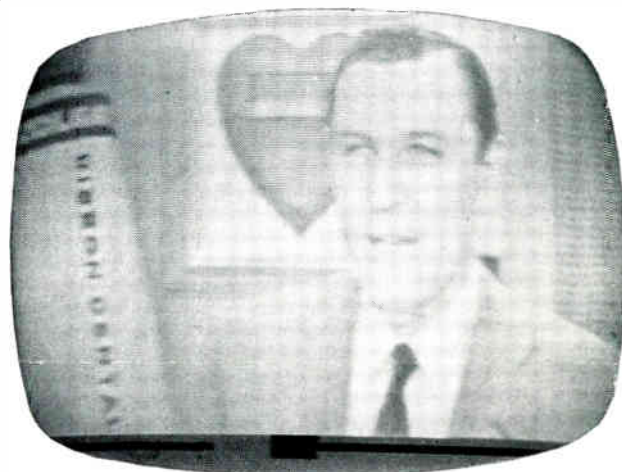
**TELE-CLUE K-155.** The above condition was due to leakage in capacitor C-351 in Fig. 3. In this instance, the picture would sync normally at a low setting of the contrast control. When the contrast control was advanced to produce a picture with normal contrast, the vertical would jump to the position shown above. If this capacitor is shorted, the picture will be too dark and the contrast control will have very little if any effect.

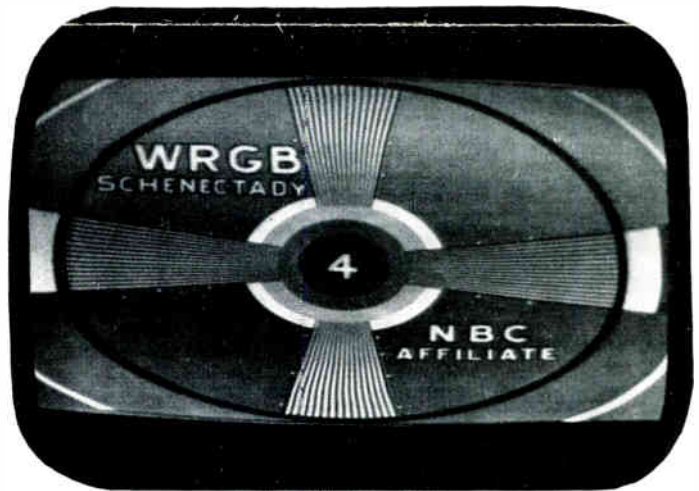
**TELE-CLUE D-157.** The reduction in height on General Electric Models 17C110 and -111 was caused by C-304 in Fig. 2 overheating. This can be corrected by extending the leads so this capacitor is about one-half inch away from the chassis. The picture is usually normal when the receiver is first turned on, but as it heats up both the height and vertical linearity may be affected.

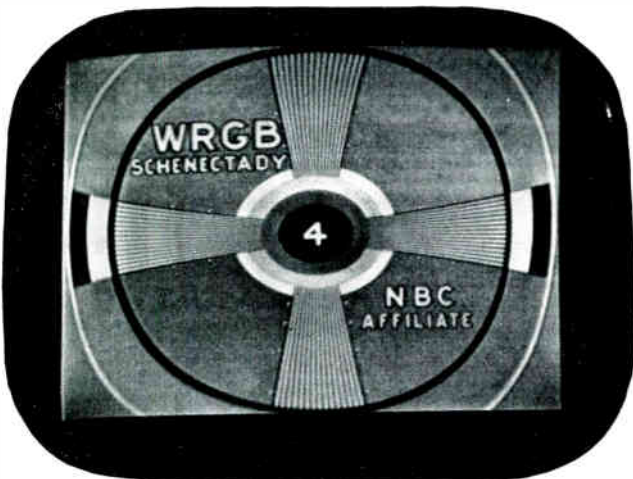
**TELE-CLUE F-156.** A reduction in both height and width may be caused by increased resistance in Globar Resistor R-454 in Fig. 1. Since an increase in this resistance will reduce the filament voltage on all the tubes, the picture quality and brightness may also be affected.

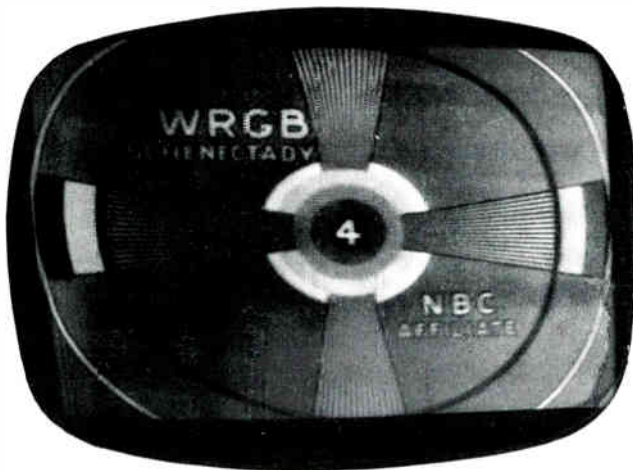
**TELE-CLUE E-158.** The use of ferrite cores in deflection yokes has resulted in increased yoke efficiency. This ferrite core is in the form of a two- or four-segment collar fastened around the yoke windings. One or more of these segments may loosen slightly, and if this happens either or both height and width may be affected. The condition shown above was produced by placing a paper collar between the ferrite core and the yoke windings in a General Electric Stratopower receiver.

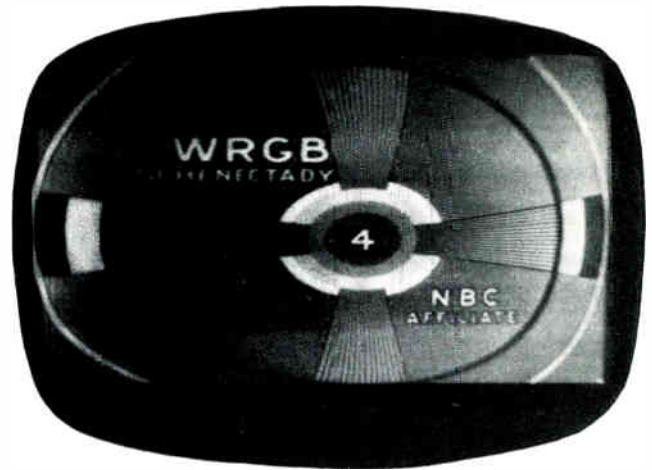
**TELE-CLUE E-161.** When one half of the ferrite core is used the picture is somewhat wider but still stretched at the top. This is due to the position of the ferrite core section.

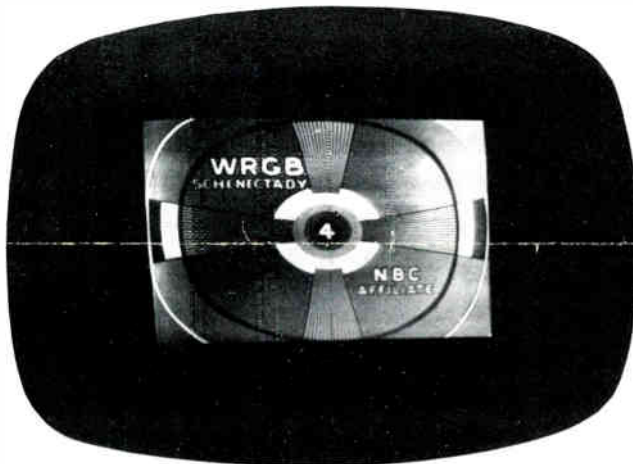
**TELE-CLUE E-159.** This photograph illustrates the effectiveness of the ferrite core. The loss of both height and width resulted when the entire ferrite core was removed from the deflection yoke.

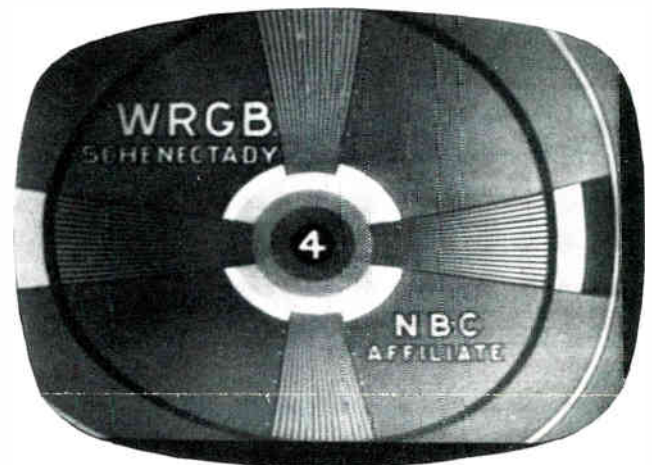
**TELE-CLUE E-162.** When three quarters of the ferrite core is used most of the picture assumes normal proportions. One portion will however be reduced in size depending on the position of the missing core section. In the above photograph the top right quarter is slightly compressed.

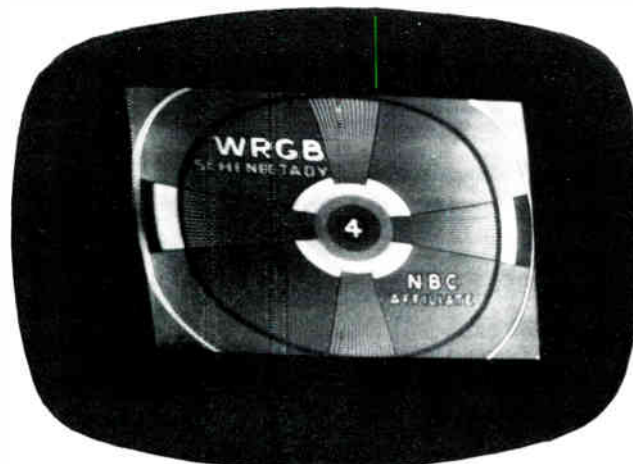
**TELE-CLUE E-160.** If only one quarter of the ferrite core is used the size is slightly increased from Tele-Clue E-159. This portion of the ferrite core increased the efficiency of only one of the four yoke windings and caused the top quarter to be stretched more than the other three quarters.

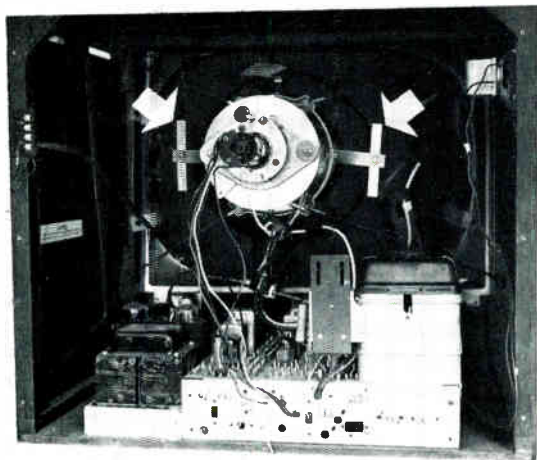
**TELE-CLUE G-163.** The two bars shown at each side of the above photograph are known as "picture straightener" magnets. When these are not used the raster sides may be slightly bowed as shown in Tele-Clues G-164, 165 and 166.

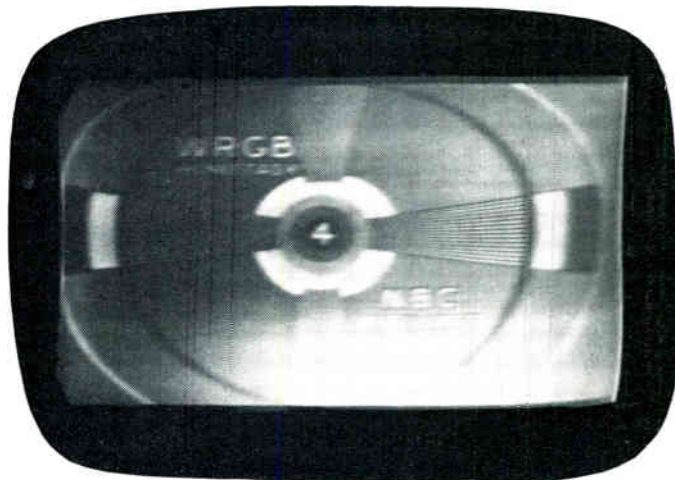
**TELE-CLUE G-166:** Misadjustment of the picture straightener magnets may cause an "S" curve on the raster edge as shown above. This could be mistaken for hum in the horizontal circuits. The correct adjustment is in the position where all sides of the raster are practically square.

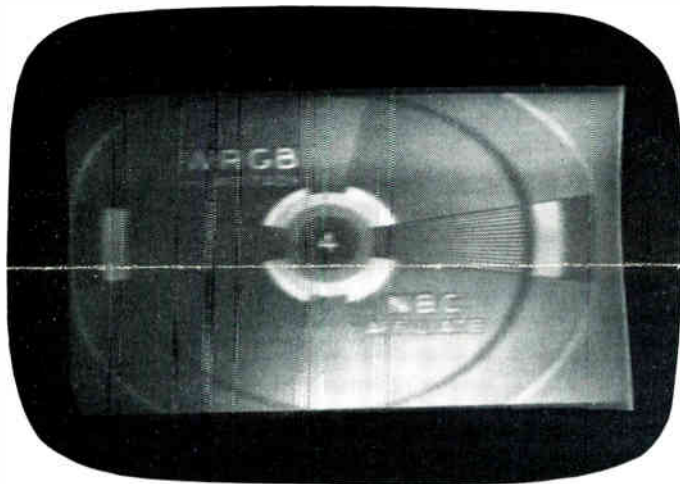
**TELE-CLUE G-164:** The bowed side of the test pattern was due to the removal of the picture straightener magnet on that side. Both the height and width had to be reduced so the edge of the raster could be seen.

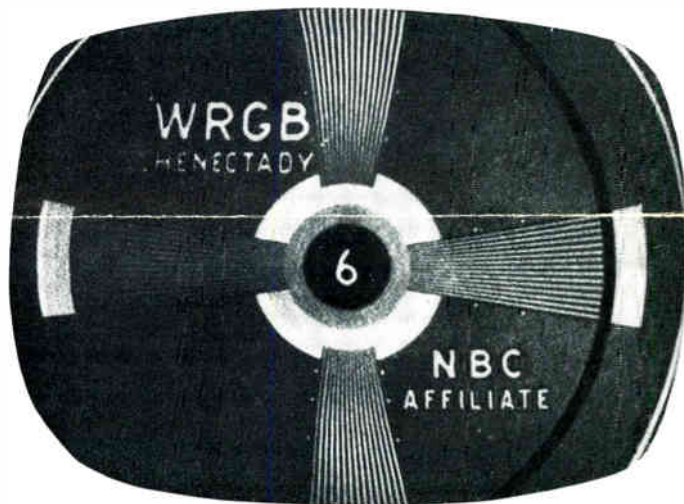
**TELE-CLUE G-167:** Loss of brightness may be caused by a reduction in the strength of the ion-trap magnet. The above picture indicates the maximum brightness that could be obtained with an ion-trap magnet which had lost some of its magnetism. A similar condition may be caused by an incorrect adjustment of the ion-trap magnet or incorrect voltages on the picture tube.

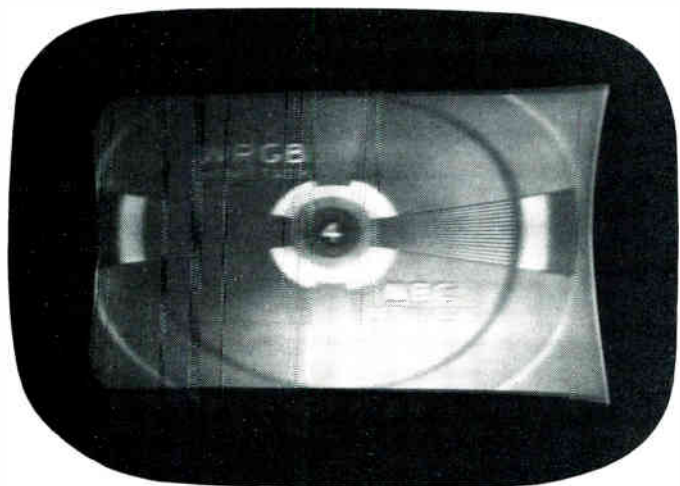
**TELE-CLUE G-165:** If the picture straightener magnets are incorrectly adjusted, the picture may be somewhat worse than if they were not used at all. The bow or "pincushion" effect in the above photograph was caused by a misadjustment of these magnets.

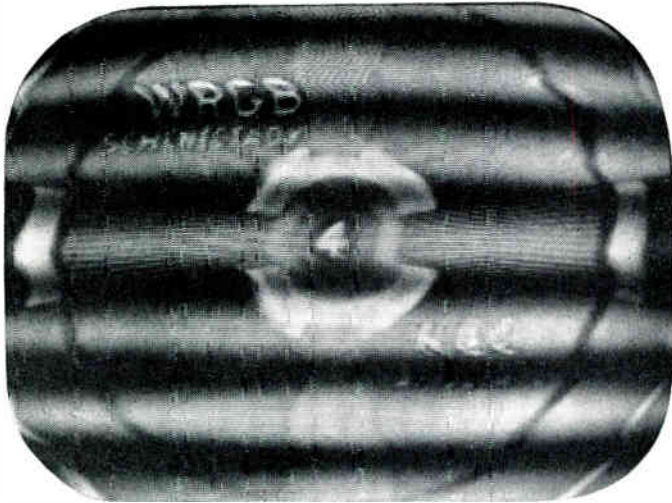
**TELE-CLUE N-168:** The sound bars shown here may be caused by several different conditions. Misadjustment of the fine tuning control or in-

correct i-f alignment can place the audio carrier too high on the alignment curve. A normal alignment curve is shown at the top and a curve with the sound carrier too high is shown at the bottom. The sound carrier is on the right side of both curves.

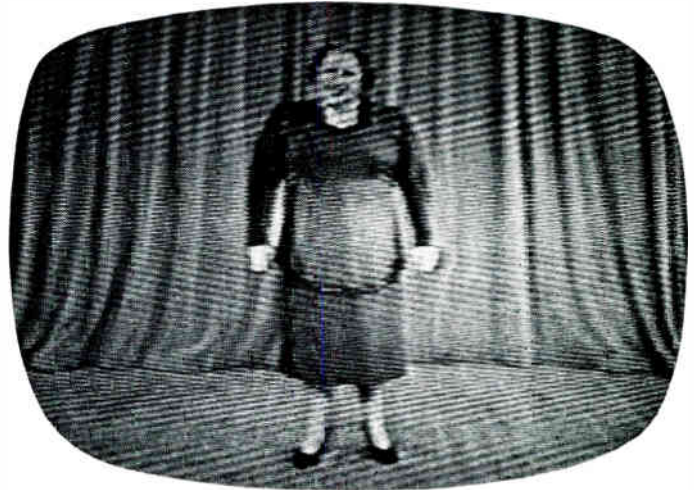
**TELE-CLUE J-169:** This type of interference may be caused by the oscillator in a UHF converter. It is the result of interaction between the oscillator in the converter and the oscillator in the receiver. In most cases it can be corrected by adjusting the fine-tuning control on the receiver. If this control does not have sufficient range to eliminate the interference, try adjusting the oscillator slug.

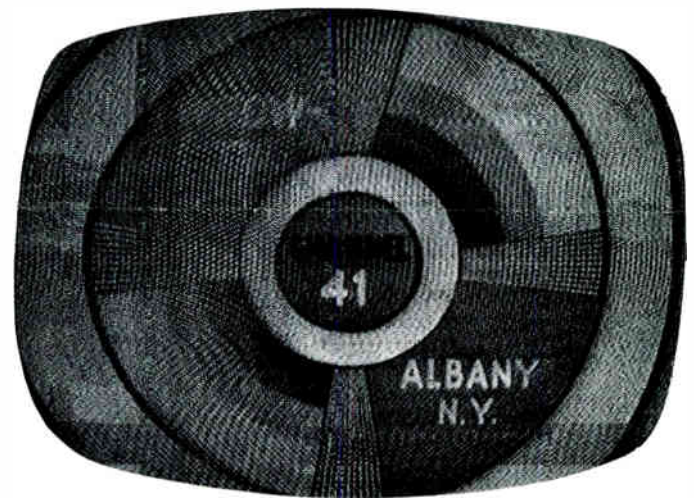
**TELE-CLUE J-170:** A VHF station may interfere with a UHF station in areas where the VHF station is on a channel adjacent to the converted UHF channel. The above picture was caused by a VHF station on channel 5 interfering with a UHF station which had been converted to channel 6. This condition can usually be improved by reducing the oscillator frequency on channel 5. The lead between the converter and the receiver should be shortened as much as possible to avoid VHF signal pick-up. In some cases it may be necessary to change the input channel to channel 4. If this is done the i-f stage in the converter should be realigned to the channel 4 frequency.

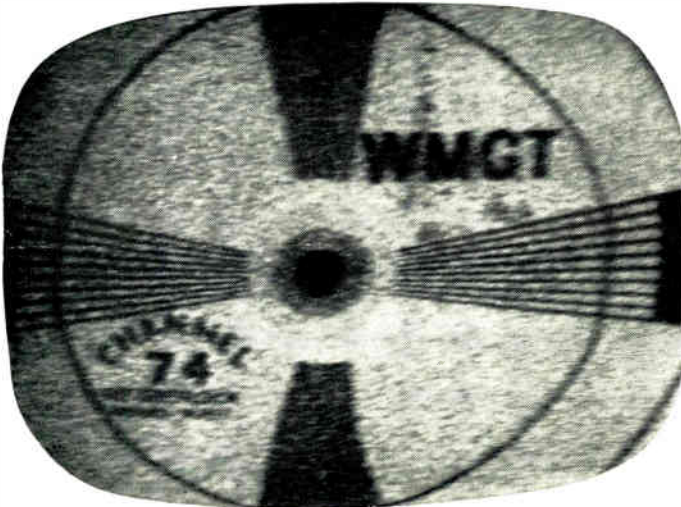
**TELE-CLUE O-172.** Cascode type UHF Converter with the poorest signal-to-noise appearance.

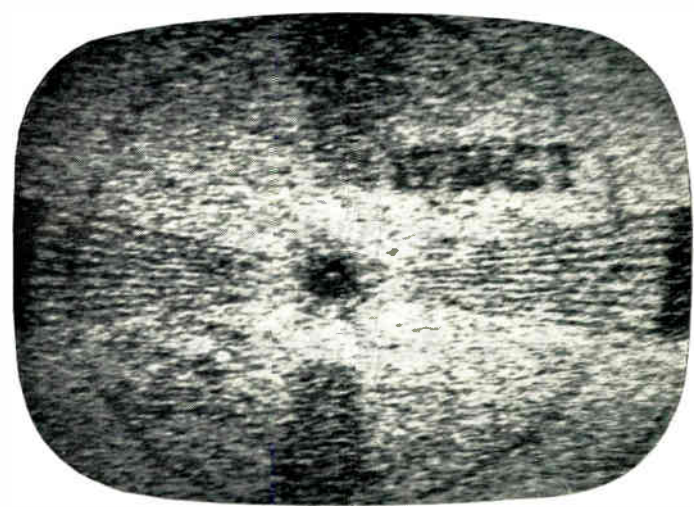
**TELE-CLUE O-174.** Pentode type UHF Converter with the poorest signal-to-noise ratio.

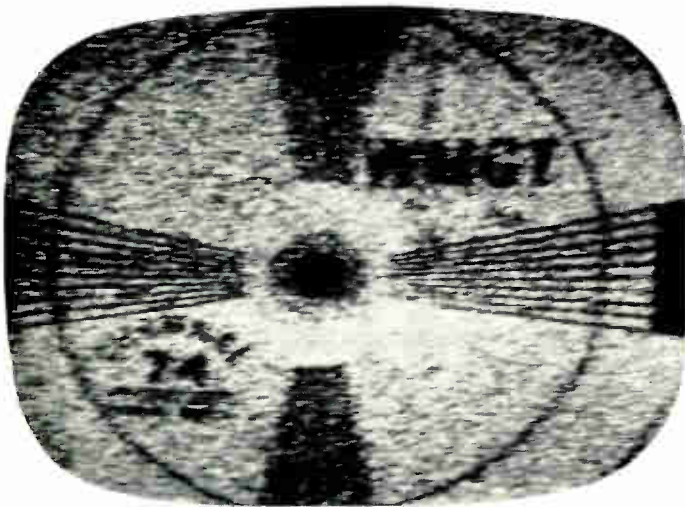
**TELE-CLUE O-175.** The same converter used in Tele-Clue O-174 but with the antenna tuned. A piece of tin foil was wrapped around the UHF antenna lead and moved along the lead until the best picture was received. The improvement was not perceptible in most of the other converters.

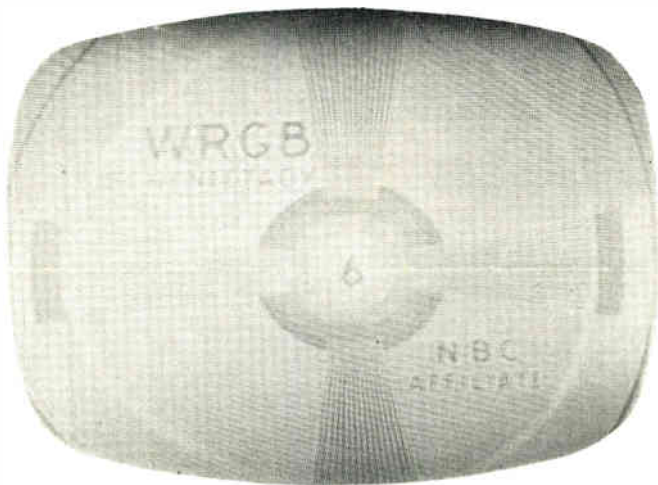
**TELE-CLUE C-189.** An open video choke in the plate supply circuit will produce a negative picture. This picture was caused by an open L-164 in Fig. 1. Since the sync signals were taken off the detector in this receiver synchronization was not affected. An open in L-162 would produce a similar condition.

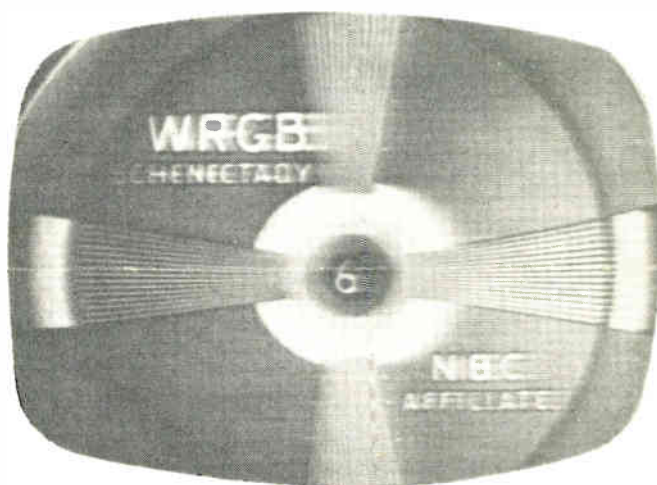
**TELE-CLUE C-190.** An open choke when a resistor is in series may cause a smear. This picture was caused by an open L-155 in Fig. 1. An open in L-161 would produce a similar condition.

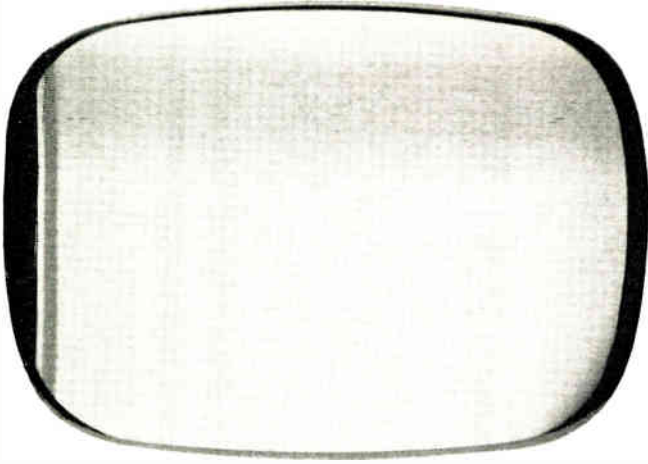
**TELE CLUE E-191.** The dark vertical lines at the left are known as "Diode-hausen" and are produced in the high voltage rectifier tube. "Diode-hausen" is a radiation phenomenon and is more pronounced when an indoor or built-in antenna is used. General Electric 1B3-GT tubes will not produce Diode-hausen.
