# Tele-Clues

**Tele-Clue K-274**

**Receiver:** G-E "U-4" line (See "U-4" Tele-Clue Schematic).  
**Component:** C254, 5000 mmfd, 450 volt capacitor, temperature range 10° - 105° C - SHORTED.  
**Circuit:** Grid circuit of V8 Clipper tube.  
**Symptom:** Soft sync, horizontal side lock and possible audio buzz.

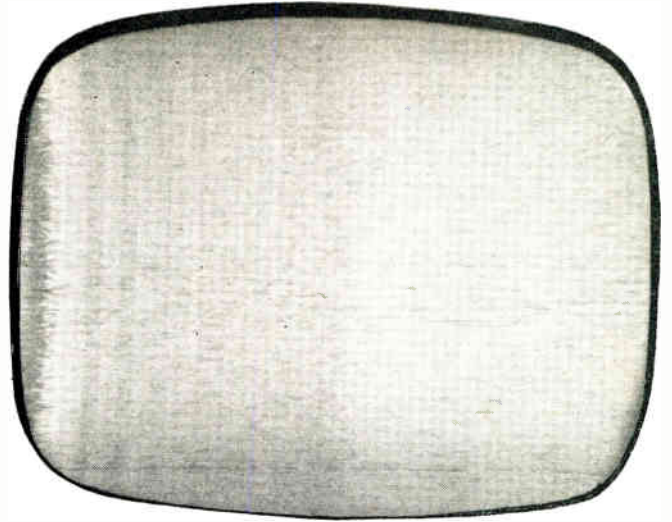
**TELE CLUE E-192.** The jagged dark vertical line on the left is known as "spook." This is similar in location and appearance to "Diode-hausen" as shown in Tele Clue number E-191. The vertical lines produced by "spook" are usually more jagged than "Diode-hausen." "Spook" is produced in the damping diode circuit and is a radiation phenomenon. This condition can be eliminated in most receivers either by replacing the damper tube or adding r-f filters in the plate and cathode leads of the damper tube.

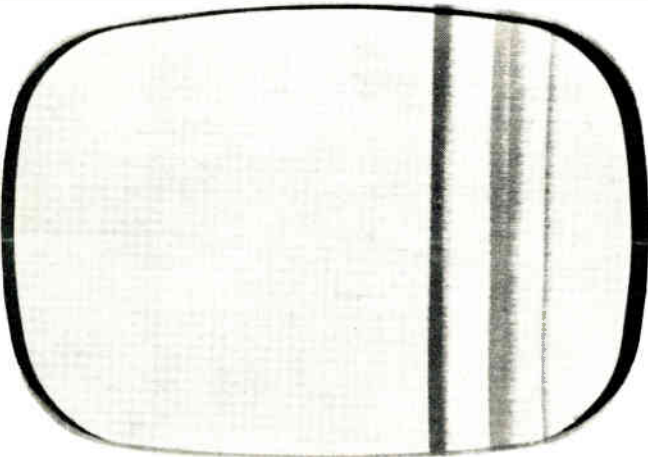
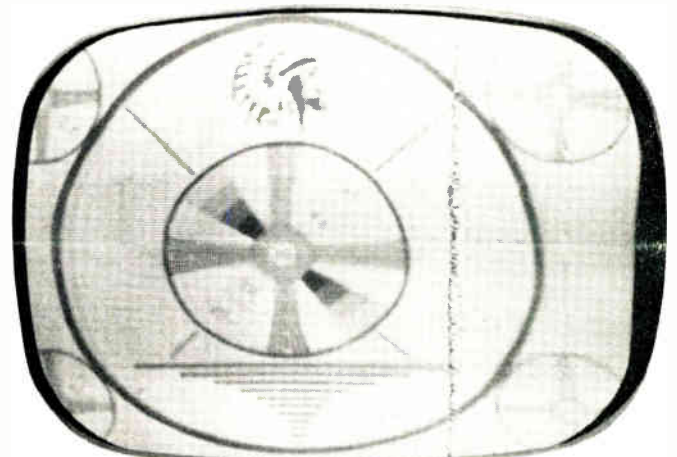
**TELE CLUE E-193 AND 194.** The dark vertical lines at the right are known as "snivets." This condition may be due to the design of the horizontal circuit in which a particular horizontal output tube is used. A horizontal output tube which produces "snivets" is usually characterized by a sharp dip in the  $E_b$ - $I_b$  curve at or near the "knee." A tube with this characteristic may operate satisfactorily in some receivers but not in others. Snivets like "spook" and "Diode-hausen" is a radiation problem which is worse when an indoor or built-in antenna is used. This condition may appear on either UHF or VHF or both. E-193 shows "snivets" on a blank raster and E-194 with a video signal.

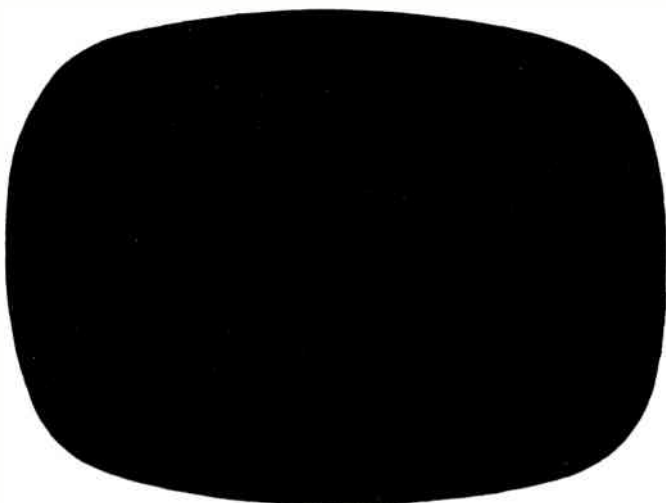
**TELE-CLUE F-195:** The black screen shown here was caused by an open C 400 A—20 Mfd, 450 V capacitor in the "N" series chassis. A schematic of this chassis was included in the Vol. 7 No. 1 issue of *Techni-Talk* as a Tele-Clue Schematic. C 400 A is part of a dual-unit capacitor located under the chassis. This capacitor is connected between the B+ side of the vertical output transformer and ground. The blanked out screen was due to the reduction in B+ boost voltage from about 400 V to 240 V. The B+ boost voltage developed across this capacitor can be measured from the red wire on the yoke plug to chassis. The regular B+ voltage is not affected by this capacitor. No increase in audio buzz is noticeable when this capacitor is open.

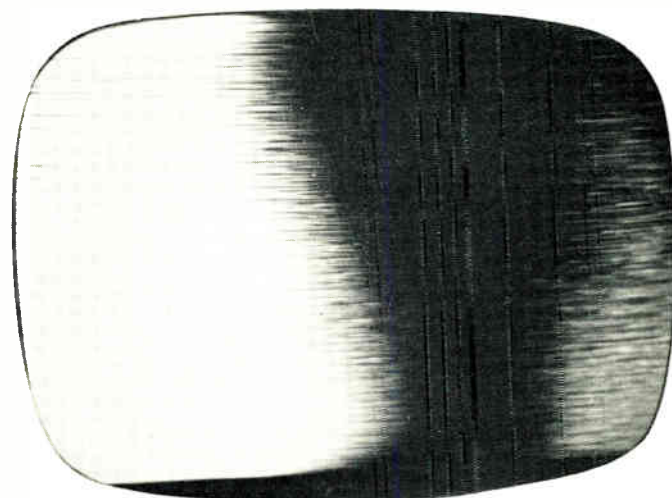
**TELE-CLUE F-197:** The picture shown here resulted from an open C 403 A—200 Mfd, 250-volt capacitor in the "N" chassis. This is one section of a dual unit located on the front apron of the chassis. When this capacitor is open B+ is not affected but the horizontal cannot be brought into sync and the vertical sync is critical. A slight audio buzz is also present.

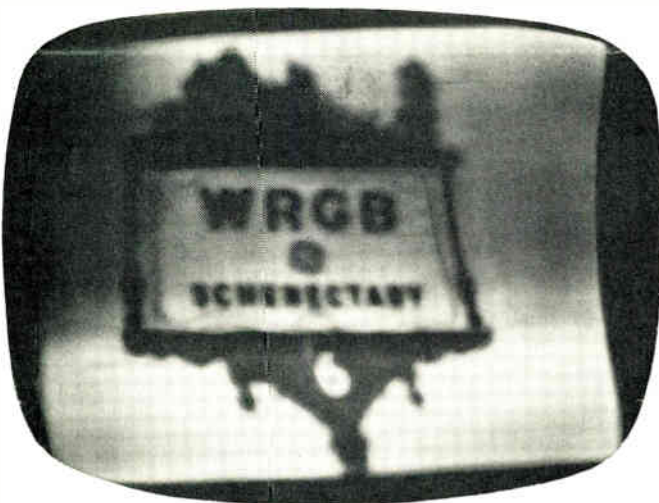
**TELE-CLUE F-196:** The dim picture shown here was caused by an open C 400 B—150 Mfd, 250 V capacitor in the "N" chassis. This is a dual-unit capacitor located under the chassis. When this capacitor is open the B+ voltage drops from the normal 215 V to 120 V. Audio buzz increases to an objectionable level and does not vary with volume control settings. The effect of increased hum can be seen in the curvature and shading of the picture. Vertical sync is normal but the picture is reduced in size and is out of focus.

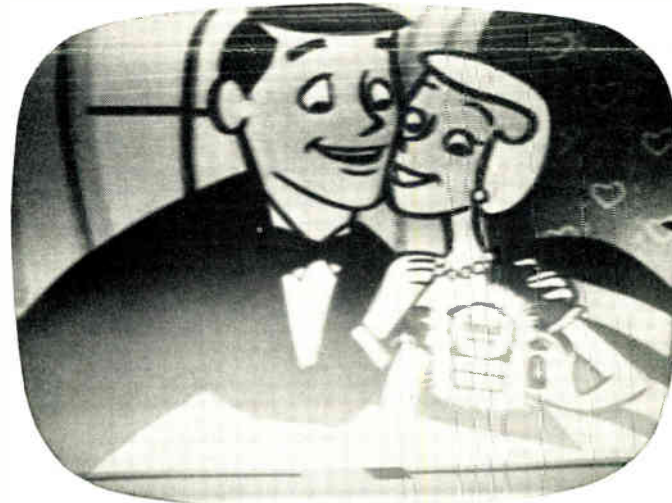
**TELE-CLUE F-198:** If the same capacitor (C 403 A) used for Tele-Clue F-197 loses some of its capacitance the vertical sync becomes "soft." The hum voltage causes both curvature and shading as shown in this Tele-Clue.

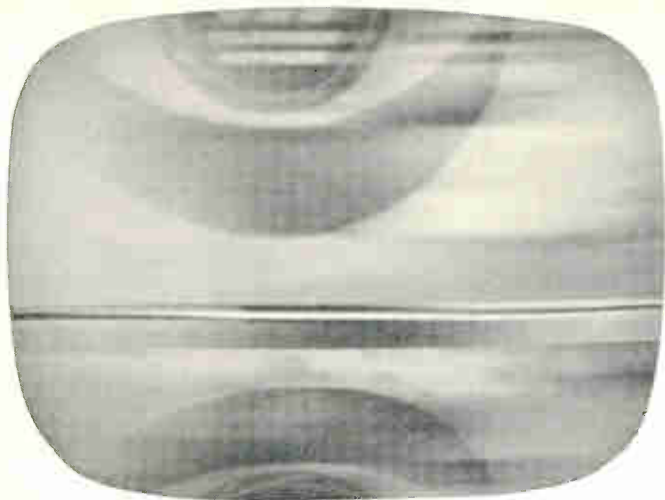
**TELE-CLUE F-199:** If the other half of capacitor C 403 in the "N" chassis is open the low-frequency response is affected. C 403 B is a 15 Mfd, 250-volt capacitor also located on the front apron of the chassis. When this capacitor is open the picture may tend to "bounce" and usually syncs with the blanking bar visible. Notice the streaking in the picture as well as the appearance of the blanking bar.

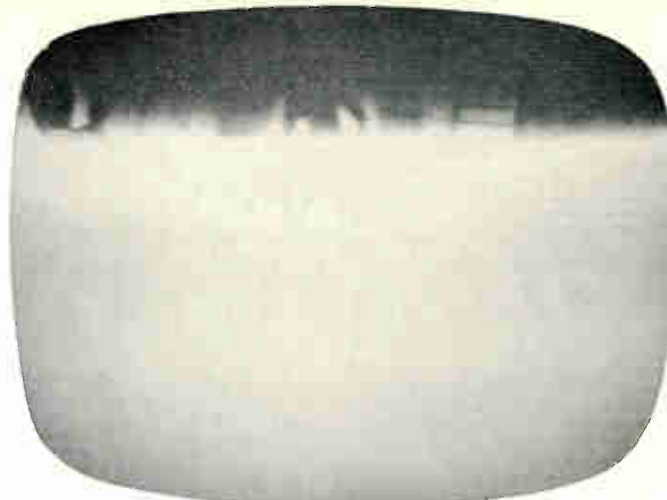
**TELE-CLUE M-202:** This defect is the same as Tele-Clue M-201 but at a different setting of the vertical hold control.

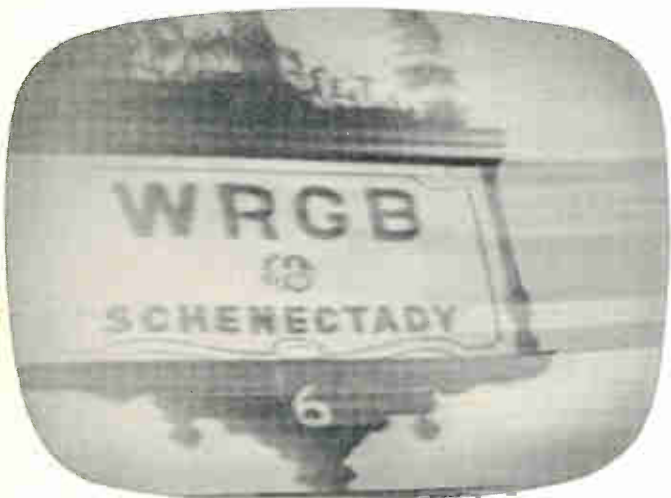
**TELE-CLUE F-200:** This is another photograph of the same defect shown in Tele-Clue F-199. This shows the streaking in the picture and blanking bar as well as the washed-out appearance at the left side of the picture.

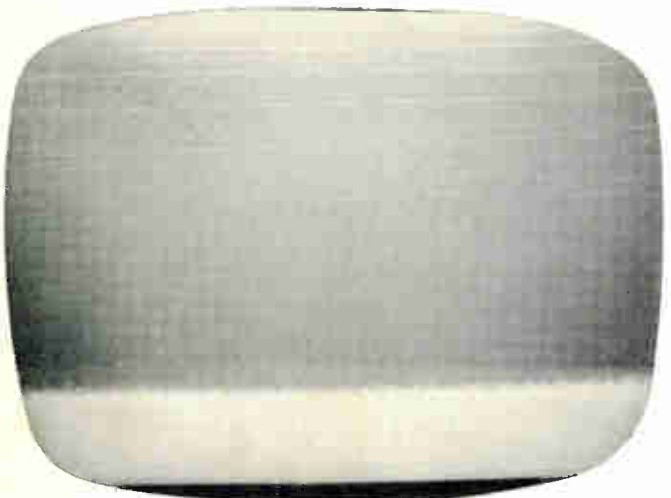
**TELE-CLUE M-201:** The defect shown was caused by an open AGC capacitor C161 in the "N" chassis between the 12BH7 socket and the 3AU6 1st i-f amplifier socket. A high-level audio buzz was present which varied with the volume control setting. The video and audio defects were due to about 3 volts of 60 cycles a-c which appeared on the AGC line when C161 was open.

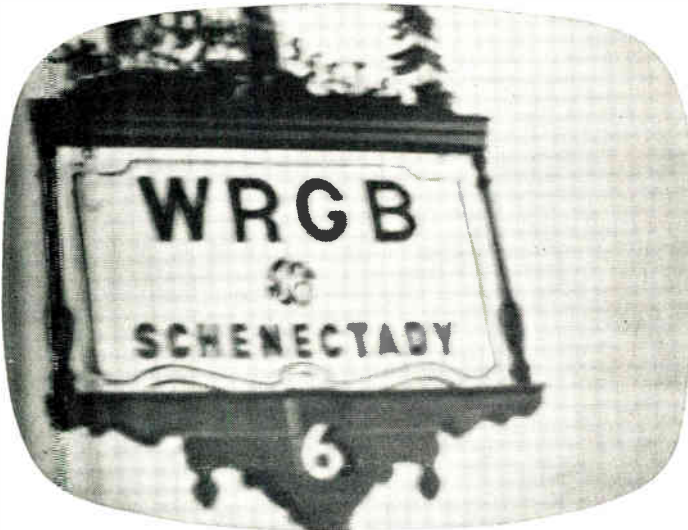
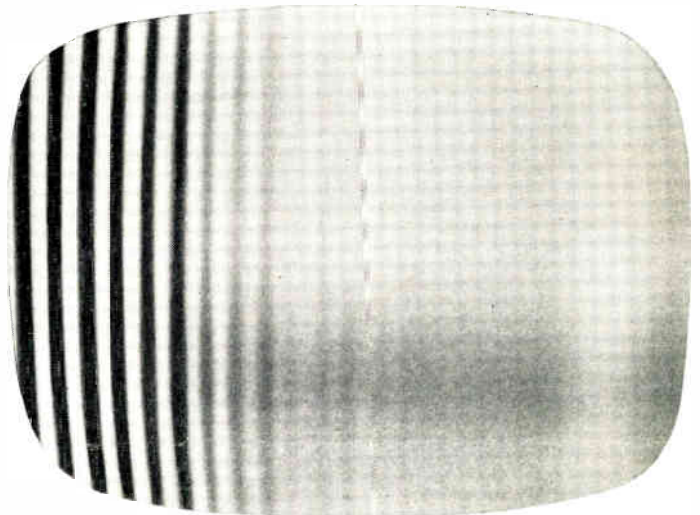
**TELE-CLUE F-203 and 204**—The vertical striations were caused by a defective C-464 capacitor in a 21T4 type General Electric receiver. The electrical location of this capacitor is shown in Fig. 1 and the physical location in Fig. 2. This capacitor checked OK on a capacitor checker, but it had apparently lost its effectiveness at higher frequencies as indicated in the waveform photographs. The first waveform was taken with the oscilloscope connected to the grid of the picture tube. The second and third waveforms were taken with the oscilloscope connected across a 10-ohm resistor in the B+ side of the horizontal yoke winding. The oscilloscope was synced at one-half the horizontal frequency. The first and second waveforms indicate that spurious frequencies are present in both the video signal and the horizontal sweep current. A new C-464 capacitor removed these spurious frequencies as shown in the third waveform. It was also found that a .25 or .5 mfd 600-volt capacitor connected across the original C-464 or a 1000-ohm resistor in series with the B+ lead to the head end was effective in eliminating the vertical striations. Similar visible striations have been noticed on other General Electric models. These were also due to defective filter capacitors.

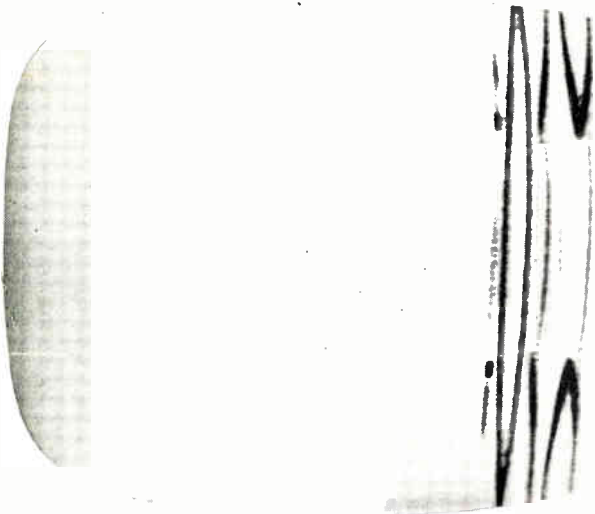
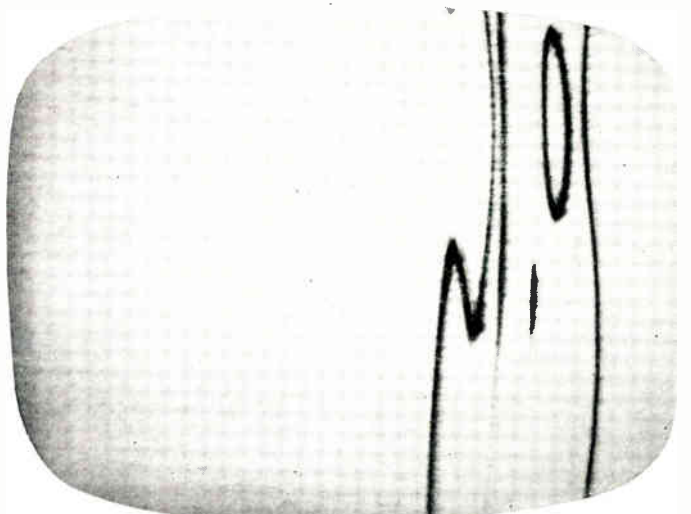
Tele-Clues E-205, 6, and 7 show fairly typical "snivets" which are spontaneous, spurious oscillations generated within the horizontal output tube. The frequency is dependent upon geometric configuration and applied potentials. It is also affected by magnetic fields (which can be thought of as changing the geometric configuration). Because of the slight change in geometry necessary to alter the frequency, the snivet characteristics of sweep tubes vary between tubes of the same manufacture but generally more between manufacturers. Likewise, the voltage conditions vary between sets so that some sets of the same manufacture are more prone to snivet than others and some manufacturers' sets are more prone to snivet than others.

**TELE-CLUE E-205 AND 206**—These dark patterns on the right side of these two photographs are due to "snivets." This condition was previously described and illustrated in Tele-Clues E-193 and 194. The "snivets" shown above appeared only when a separate UHF converter was used. The pattern changed as the frequency of the converter was changed and at some settings the raster was "clean."

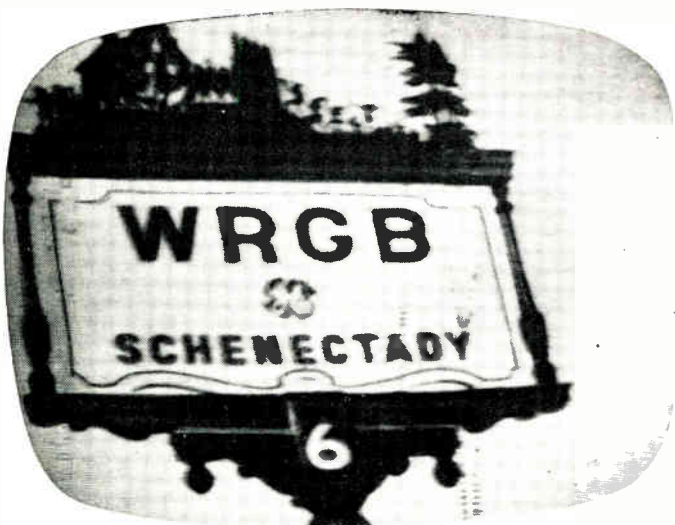
**TELE-CLUE E-207**—This shows the effect of "snivets" when a picture is received. A different horizontal output tube may eliminate the "snivets" entirely or change the frequency so the picture is "clean." Another method which may be used is to place an ion-trap magnet over the horizontal output tube as shown in the photographs on the right. The ion-trap is then slowly turned until the "snivets" disappear.

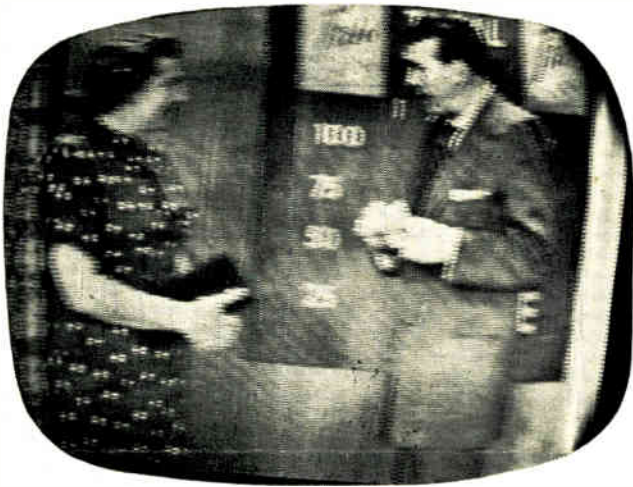
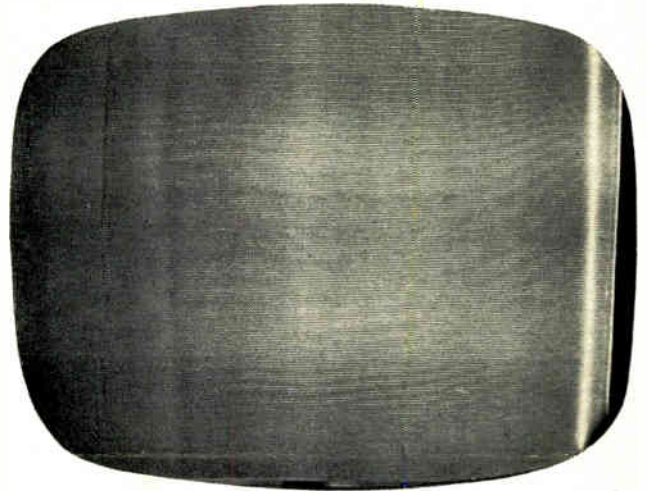
**TELE-CLUE E-208 AND 209**—The reduction in width plus horizontal displacement of alternate fields was caused by a leaky 680 mmf capacitor (C260) in the General Electric "N" series receiver. This capacitor is connected in series with a 12K resistor between pin 5 on the 12 BQ6-GA horizontal output tube and chassis. This defect also produced a white vertical line which can be seen in Tele-Clue No. E-209 on the right. Refer to "N" Tele-Clue schematic.

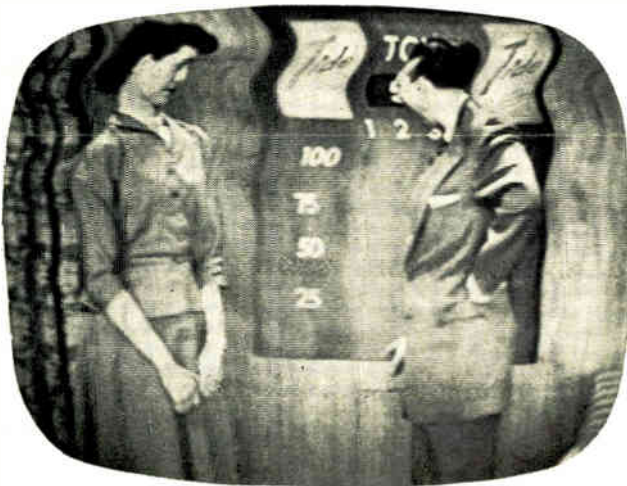
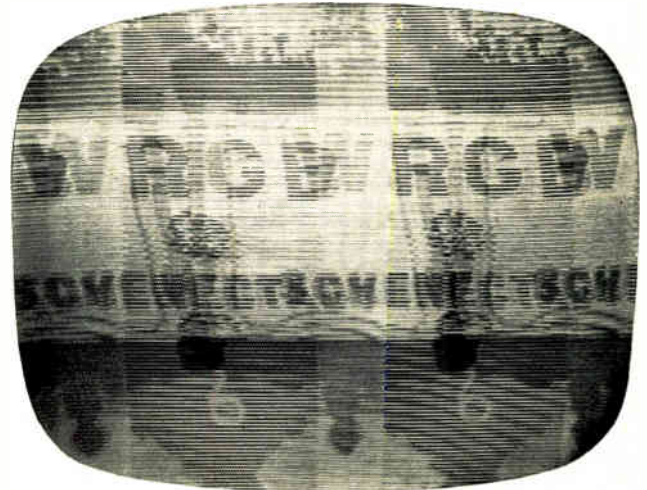
**TELE-CLUE E-210**—An open .2 mfd capacitor C255 in "N" series General Electric chassis will cause the defect shown above. This capacitor is connected in series with a 27K resistor between pin 1 of the 6SN7GTB (V109) horizontal multivibrator and ground. The waviness produced by an open in the anti-hunt circuit is less pronounced in this chassis than in some other models. A comparison can be made between the above Tele-Clue and Tele-Clue E-26. Refer to "N" Tele-Clue schematic.

**TELE-CLUE E-211**—If the horizontal multivibrator (V109) cathode resistor in the General Electric "N" chassis changes value the horizontal frequency will be affected. This resistor R262 was changed from 1.2K to 600 ohms.

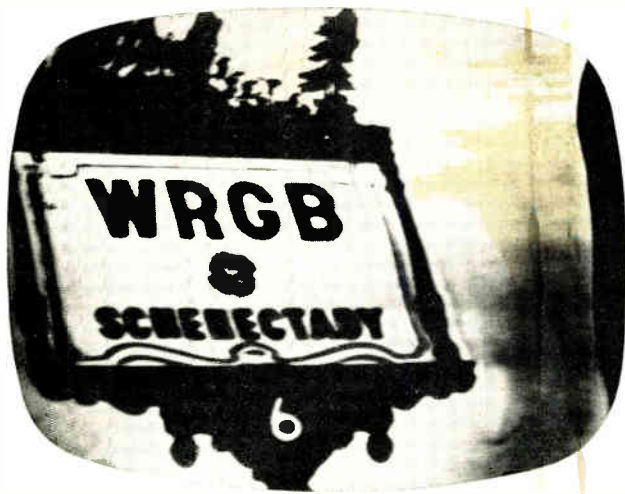
**TELE-CLUE M-212**—The distortion shown here was caused by a 6BC5 tube with grid emission in a General Electric Model 1711 receiver. The receiver would operate normally for about ten minutes. The contrast would then slowly increase until the contrast control had little or no effect on the picture. If any one of the AGC controlled tubes are leaky, gassy or have grid emission, the picture will be affected. V2, 4, 5, and 6 are AGC controlled in the chassis layout shown in Fig. 1. Due to the shield on V6 this tube runs hotter than the others and may, therefore, be more susceptible to this defect. Tele-Clue M-102 describes other components which may produce a similar condition.

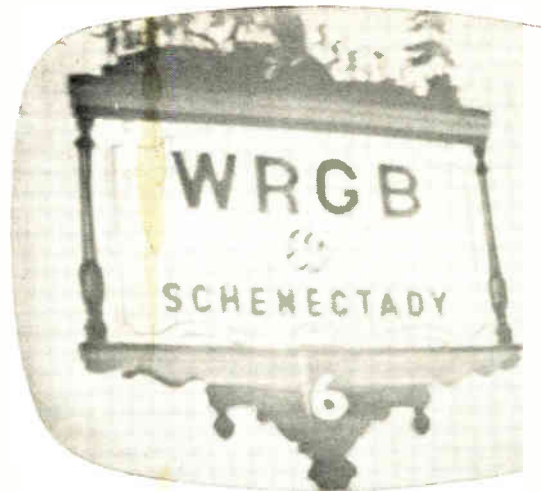
**TELE-CLUE Q-213**—The above photograph shows the effect of too much brightness which could not be reduced beyond the level shown. A heater-cathode short in the picture tube will cause this condition. This type of short can be cured sometimes by gently tapping on tube neck. Another defect which may develop in General Electric receivers such as model 1711 is an increase in the value of resistor R274 encircled in Fig. 2. This resistor is located above the chassis on the terminal board near capacitor C-451 in Fig. 1.

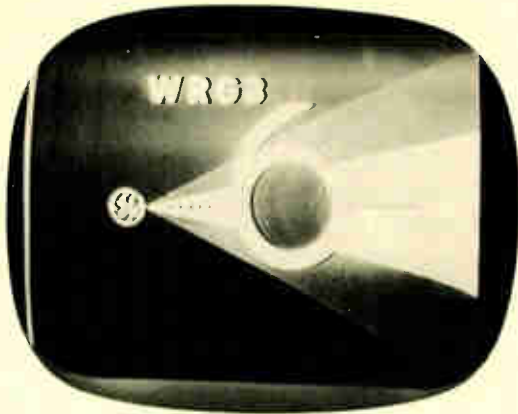
**Tele-Clue E-236**  
Open C-262 in Damper Circuit

The reduction in both width and height was caused by an open capacitor, C-262, in a General Electric "U-2" receiver. This capacitor is encircled in Fig. 1. Inasmuch as several different lines of General Electric receivers use similar circuits, this Tele-Clue should be considered as representative of an open capacitor across the cathode and plate of the damper tube in any of these circuits.

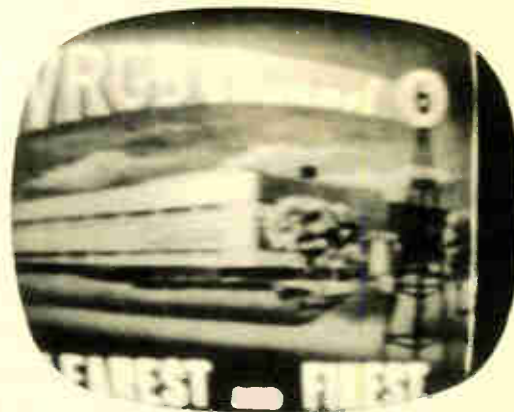
**Tele Clue E-237**  
Leakage in C258-"U-2" Chassis

The horizontal foldover on the right side of this Tele-Clue was caused by leakage in coupling capacitor C258 shown encircled in Fig. 2. Since this leakage reduces bias on the output tube it causes the sawtooth to be "rounded off" at the peak resulting in squeezing on the right side of raster.

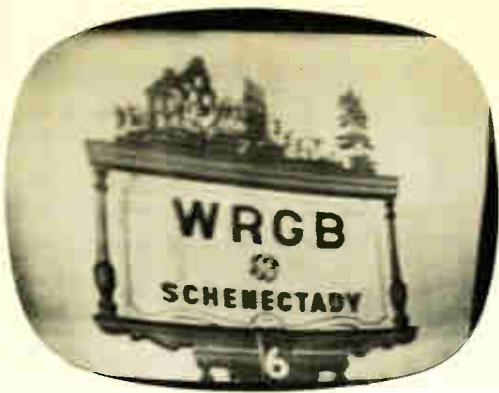
Tele-Clue D-238

Defective C-310 — 14, 16 and 17-inch G-E Receivers

The loss of height as well as the slight keystone effect was due to a defective capacitor C-310, shown in Figs. 3 and 4. The function of this capacitor is to prevent the vertical output waveform from feeding into the horizontal circuit. When this capacitor is defective, the size as well as the vertical edges of the raster may be affected. It was also impossible to get a full size picture without stretching at the top and foldover at the bottom. Due to the location of C-310, it may be necessary to remove the picture tube when making a replacement.

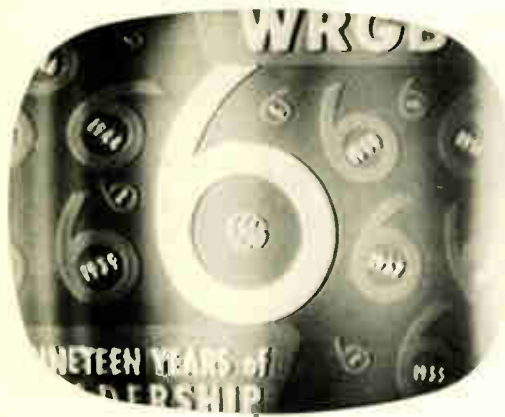
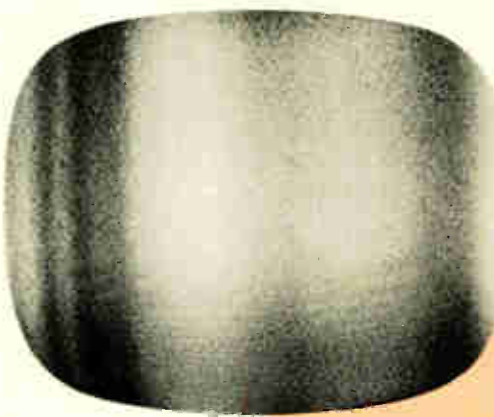
Tele-Clue D-239 and 240  
Open C-209 in Vertical Blanking Circuit

The vertical striations shown above were caused by an open capacitor, C-209, in a General Electric "U-2" receiver. This capacitor is encircled in Fig. 5. Inasmuch as several different lines of General Electric receivers use similar circuits, this Tele-Clue should be considered as representative of this particular capacitor being open in any of these circuits.

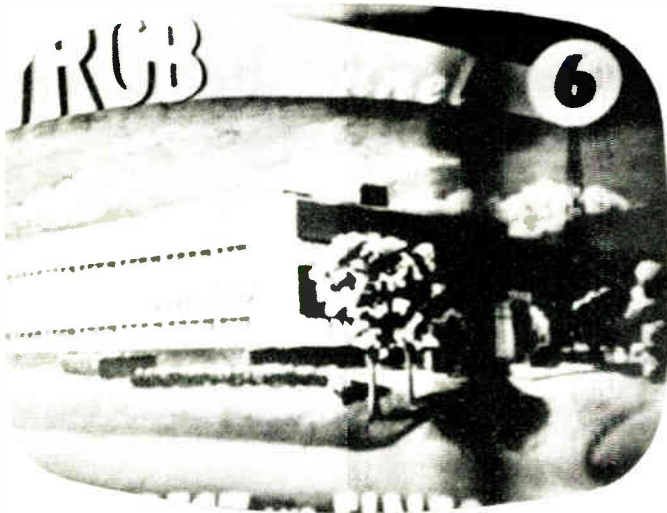
Tele-Clue E-229

The vertical dark stripe on the right side of the above photographs was caused by a change in the value of resistors R287 and R288 shown encircled in Fig. 1. R287 had changed to about 2K and R288 to about 10K. If R288 is reduced to about 6K it produces the wider black bar

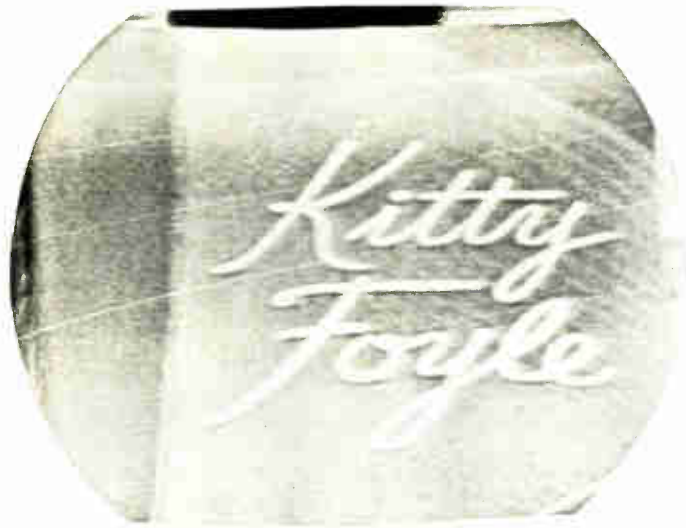
**TELE-CLUES D-232 AND 233**  
**Defective 6K6-GT Vertical Output Tube**

The white horizontal line near the top of the above Tele-Clues was caused by a defective 6K6-GT vertical output tube. This particular condition has been termed "Albino Gechi" and is caused by a momen-

tary slowing down of the vertical sweep as it approaches the top of the screen. This slowing down of the sweep causes several "scan" lines to be bunched and produces the white line.

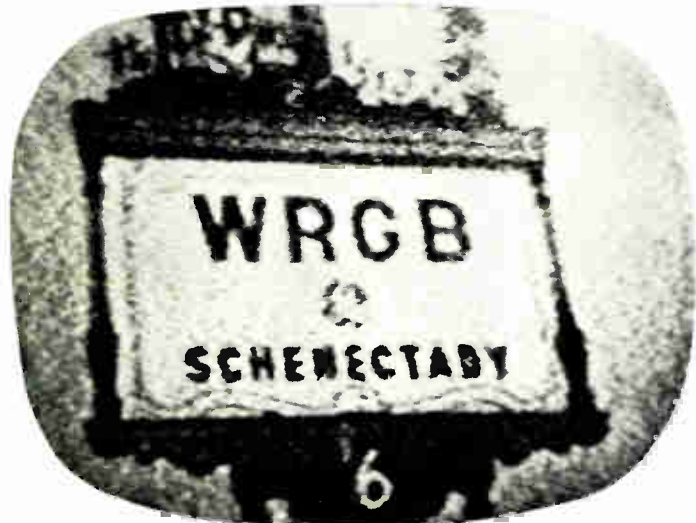
**TELE-CLUE M-234**  
**R175 "open" or increased in value**

The "snow" shown here was caused by an increase in the resistance of R175 (20 meg.) shown encircled in Fig. 2. This resistor establishes the delay bias on the r-f amplifier and when it increases in value or is "open" the negative bias voltage is increased and cuts off the 6B58 r-f amplifier tube. In some cases a new 6B58 will temporarily improve the condition, however in a few weeks or months the "snow" will begin to appear. The only permanent cure is to check and replace R175. The receiver used for this photograph was a U-2 model although the same circuit is also used in a great many other General Electric models.

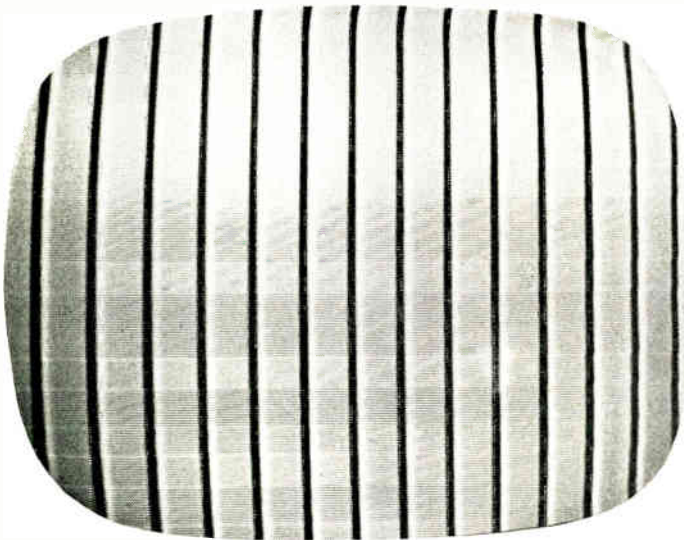
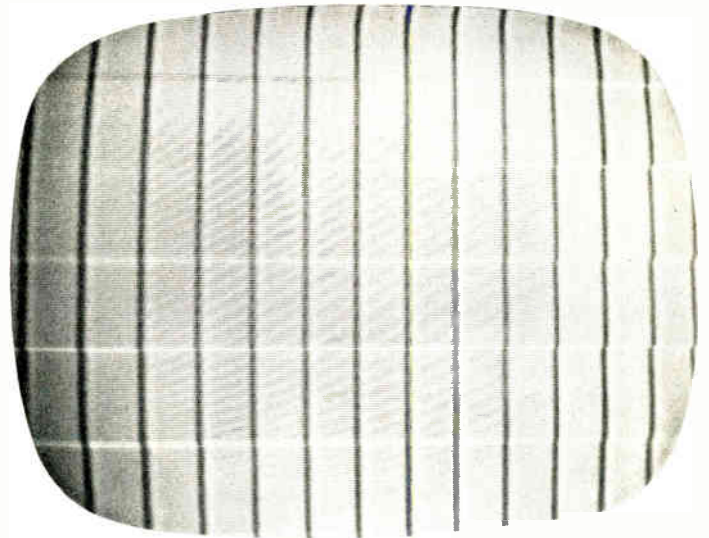
TELE-CLUES G-222 AND G-223

The defect shown above was due to what is known as a "singing" picture tube. In this instance, it was a 24ALP4 which is a 110" tube. Photographs do not clearly indicate the condition because it appeared as a constantly changing horizontal wiggle mostly on the right side of the picture. Since the Tele-Clue on the left did not show the condition at the normal vertical frequency, the vertical hold was adjusted to produce the picture shown on the right.

The reason this type of defect produces "singing" is due to an arcing either outside or inside the picture tube. Outside arcing (or singing) usually occurs at the point of contact between the outside conductive coating and the grounding spring. Internal arcing usually occurs at the

point of contact where the spacing clips on the high-voltage anode cylinder of the electron gun assembly make contact with the internal conductive coating. The electron gun was shown in considerable detail in the Vol. 4, No. 5 issue of Techni-talk.

External arcing can usually be corrected by changing the point of contact. The grounding spring may also be changed slightly in shape to provide a larger area of contact. A piece of tape can also be applied to hold the spring in contact with the conductive coating. Obviously, there is very little that can be done by the service technician to correct internal arcing.

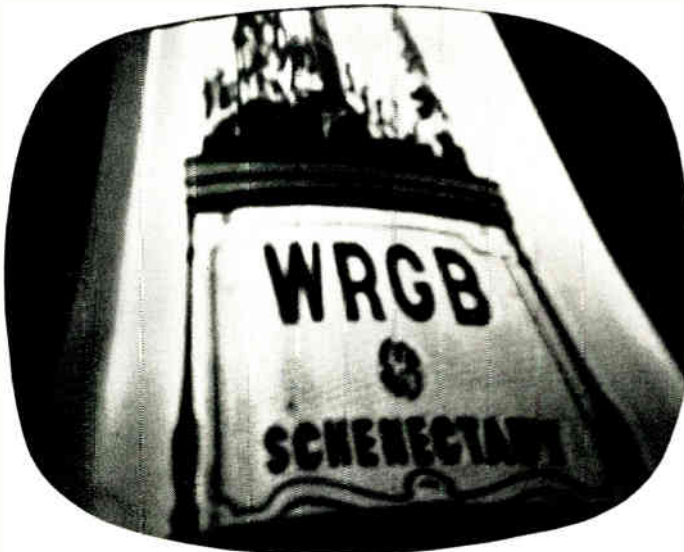
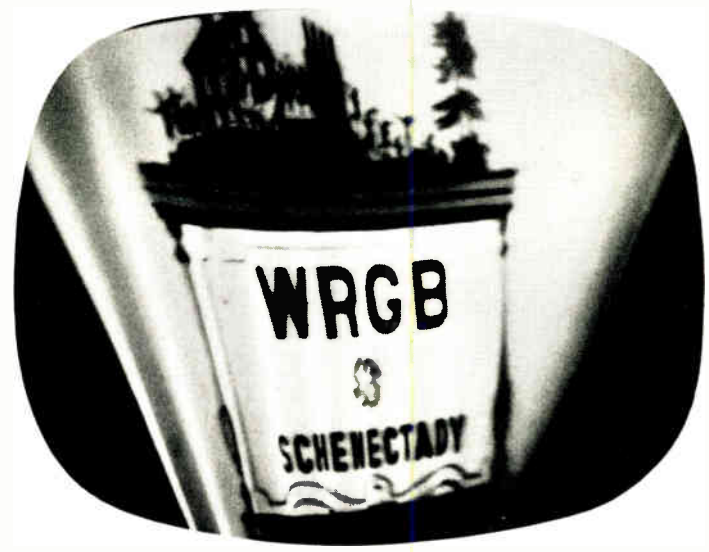
TELE-CLUES A-224 AND A-225

The above condition was due to an "open" in one side of the deflection yoke in a General Electric receiver using the "U-2" chassis. Inasmuch as the two horizontal deflection coils are connected in parallel, as

shown in Fig. 1, an "open" in one coil will produce a picture as shown at the left, whereas an "open" in the other coil will produce the condition shown on the right. Check connections before replacing yoke.

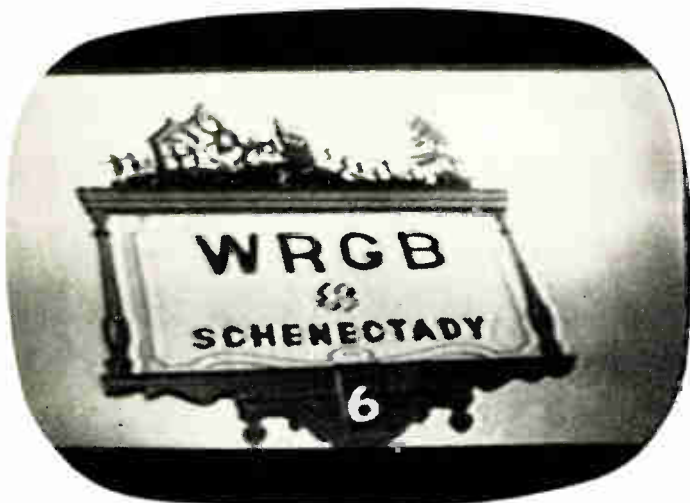
TELE-CLUE F-226

The loss of vertical height was due to a poor connection between the heater winding ground rivet and chassis. Another defect due to this same condition was shown in Tele-Clue F-220 which appeared in the last issue. It is impossible to predict just what circuit or circuits will be affected and a considerable amount of time can be spent checking circuit components. One indication that resistance has developed is the appearance of the chassis around the ground rivet. Due to electrolysis, the area surrounding this rivet may be discolored. The location of this rivet was shown with Tele-Clue F-220. Tele-Clues E-227 and E-228 illustrate another condition caused by resistance in a ground rivet.

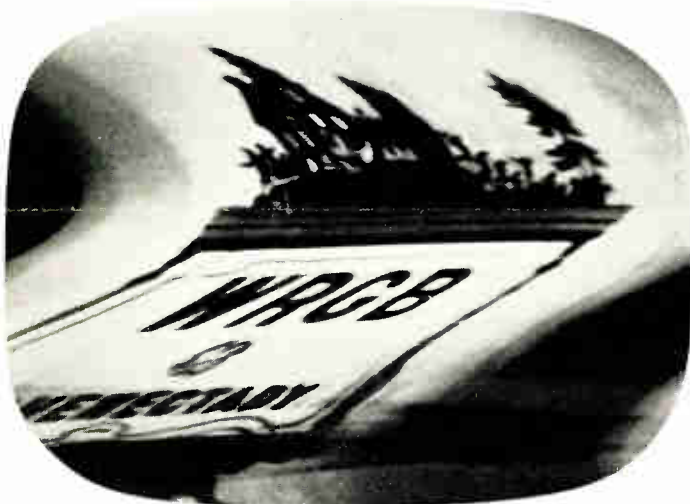
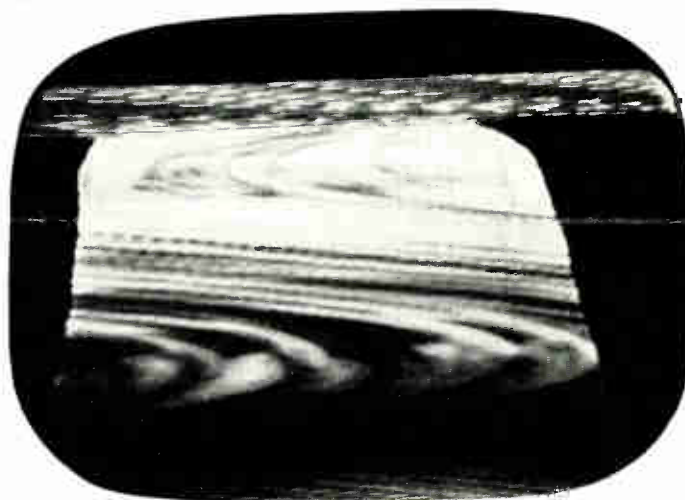
TELE-CLUES E-227 AND E-228

The condition shown here is somewhat different in appearance than Tele-Clues F-220 and F-226. It was caused by the development of resistance in a ground rivet on a General Electric "O" type receiver. In this case, however, the rivet provided the ground connection for the picture tube heater as well as capacitor C-257 in the "anti-hunt" portion of the horizontal oscillator circuit. This circuit is shown in Fig. 2. The difference between the picture on the right and the one on the left was due to the amount of resistance. Low resistance produced Tele-Clue E-227 and high resistance produced E-228.

There are two ways of curing the trouble:

- (1) Solder the ground rivet to the chassis. Use a sufficiently hot iron so a good bond is made.
- (2) Remove the filament lead from this particular rivet and connect it to some other ground rivet nearby.

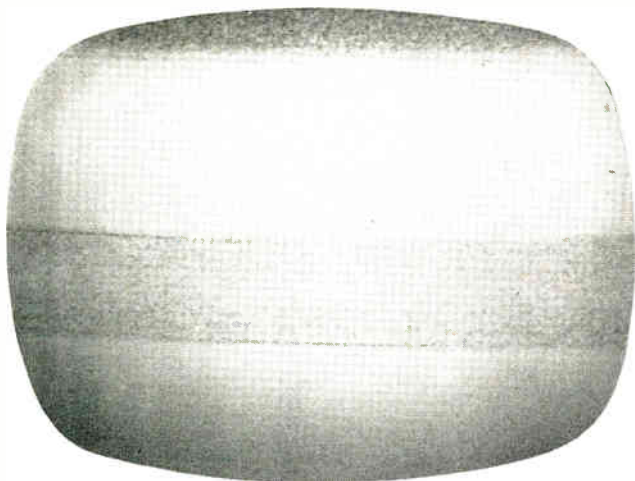
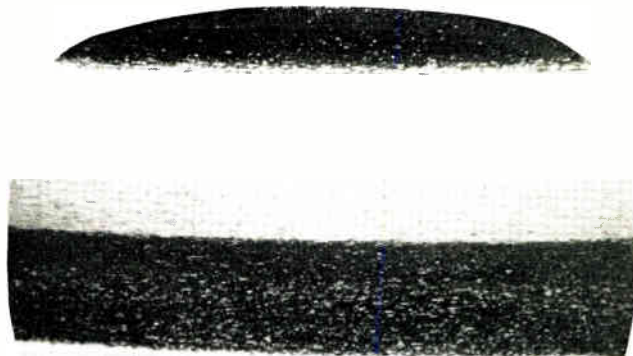
**TELE-CLUES F-214 & F-215:** The 120-cycle bars seen in Tele-Clues F-214 and F-215 were caused by a gassy 5U4G rectifier tube. These bars could also be seen in the background on some stations, but varied in intensity on different stations.

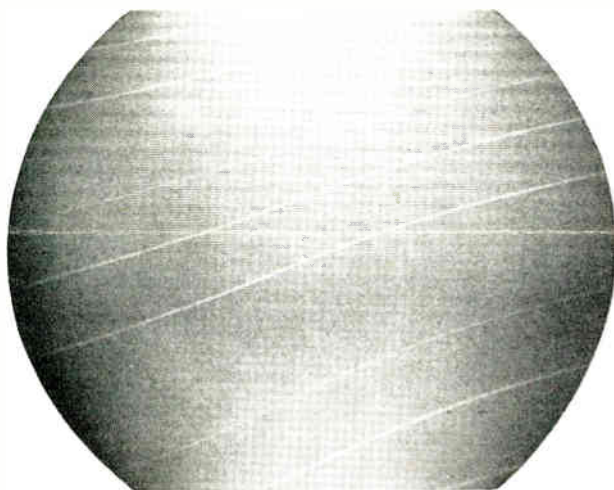
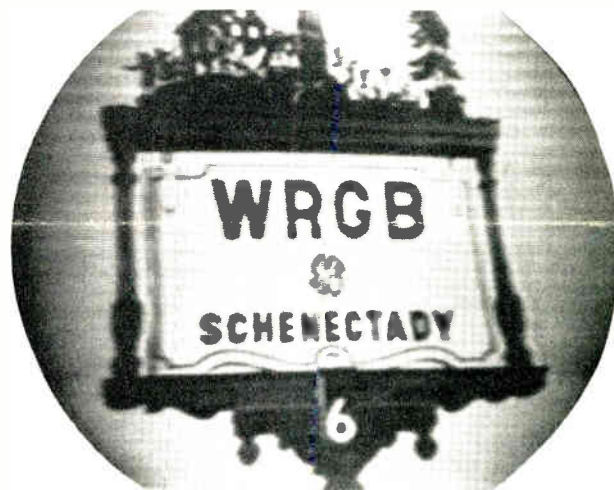
**TELE-CLUES D-216 & D-217:** The horizontal striations shown above may be caused by an open damping resistor across the vertical deflection yoke coils. It may also be caused by spurious oscillation in the vertical blocking oscillator transformer or a change in the time constants in the vertical charging capacitor circuit.

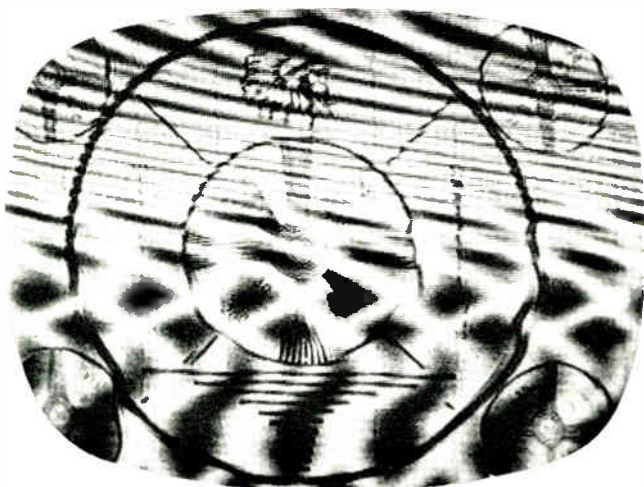
**TELE-CLUE O-218:** The r-f interference shown here was due to radiation from the 6AF4-A UHF oscillator tube. In this case, the shield was left off, but similar radiation could result from a loose or poorly grounded shield.

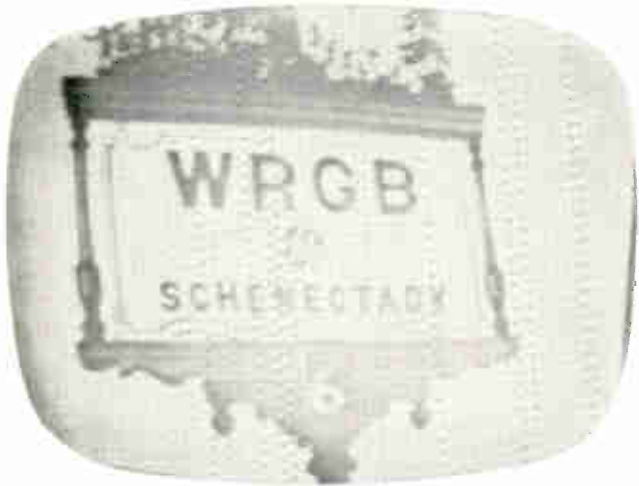
**TELE-CLUE F-220:** The light or "washed-out" picture was caused by a poor connection between the heater winding ground rivet and chassis on an "S" type General Electric receiver. The ground side of the heater winding is connected to a rivet located near the 5U4-GA socket as shown in Fig. 1. The resistance between this rivet and chassis could hardly be measured since it was only about 0.2 ohms. The total heater current of 9.15 amperes, however, caused a voltage drop ( $E = I \times R$ ) of almost 2 volts. Since the tube heaters seemed to have normal brilliance, a considerable amount of time could be spent checking other components. The above condition is not the only one that may occur due to resistance at the ground rivets. There are several other visual indications and these will be included in the next issue.

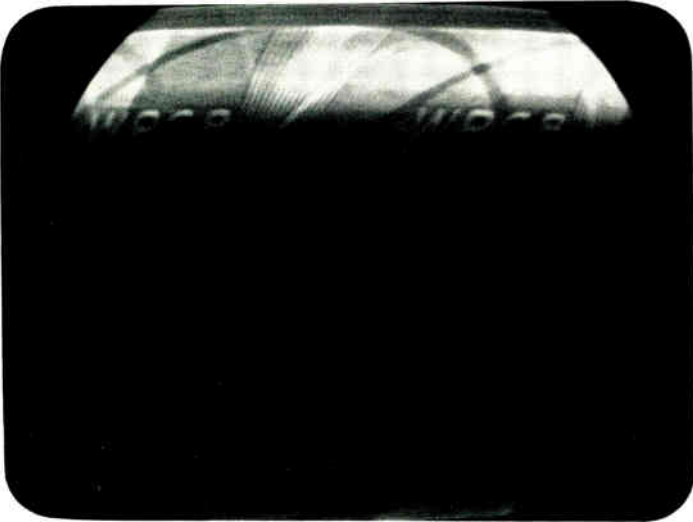
**Tele-Clue No. C-73**—Short between filament and cathode (terminals 8 and 9) on 12AT7 video amplifier in 12T3 receiver.

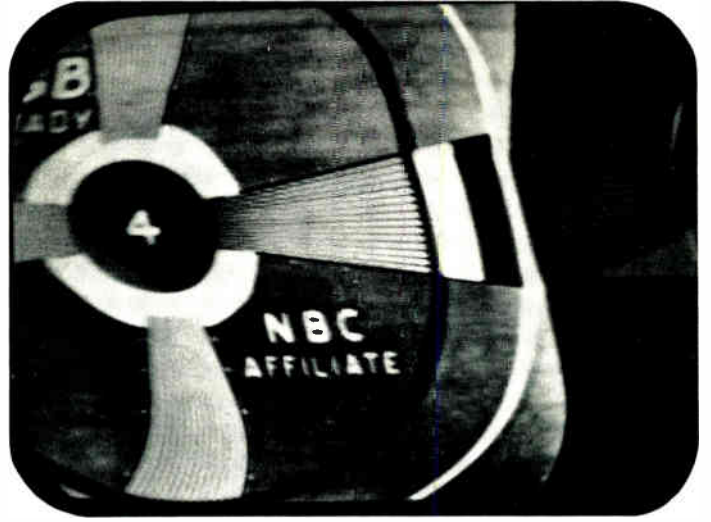
**Tele-Clue No. K-74**—A short between the cathode and heater in the 6SL7-GT Sync Amplifier and clipper tube used in a large number of General Electric chassis will result in a picture similar to either Tele-Clue No. 74 or 75. The contrast control has little or no effect. Horizontal synchronization is extremely critical with a horizontal jitter or weaving present most of the time.

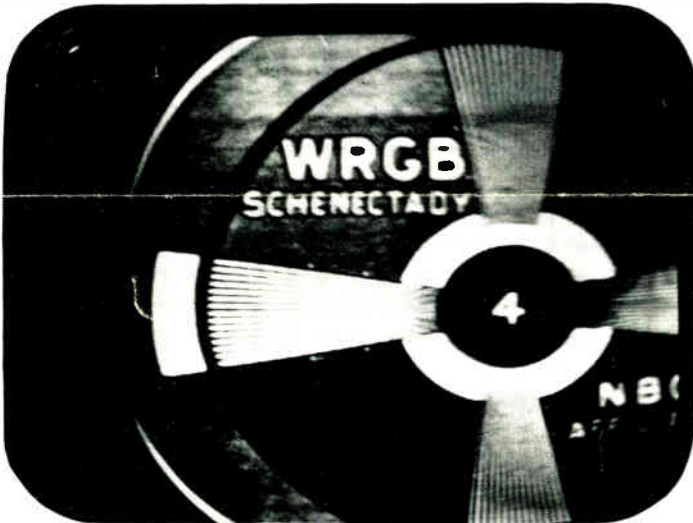
**Tele-Clue No. K-75**—This is also the result of a short between cathode and heater in the 6SL7-GT Sync Amplifier and clipper tube and the same explanation as given for Tele-Clue No. 74 will apply here. The only difference is that horizontal synchronization occurs so that the black border can be seen at the left instead of at the right of the picture tube.

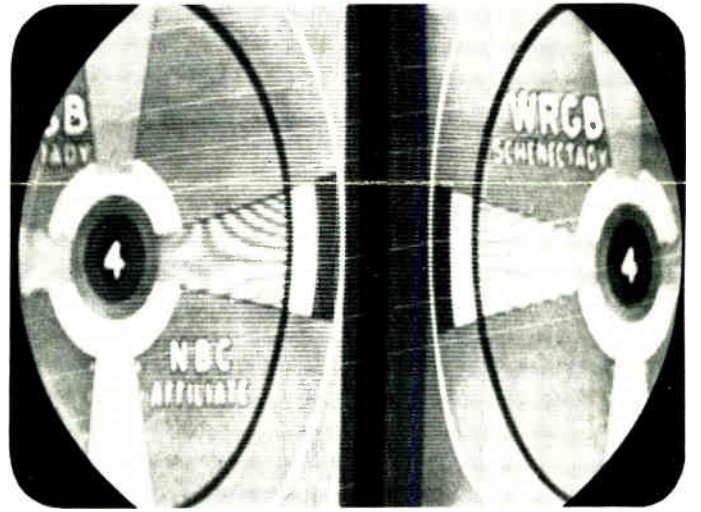
**Tele-Clue No. E-76**—This defect in horizontal synchronization which was the only point where horizontal sync would occur indicates a phase shift in the horizontal oscillator circuit shown in Fig. 1. This circuit is used in the Westinghouse Model H-606K12. A similar circuit, however, is used in a considerable number of TV receivers. This defect was caused by a change in the value of R453 from 220,000 ohms to 8000 ohms.

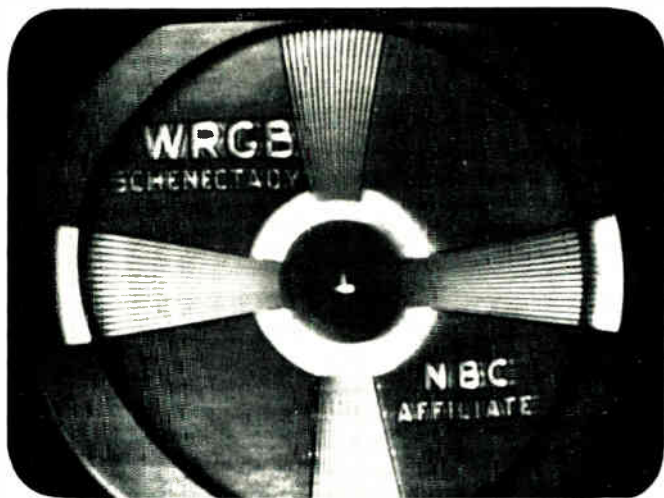
**Tele-Clue No. H-77**—This photograph and the one shown in Tele-Clue No. 78 illustrate the effect of low emission in a picture tube. The picture with the brightness and contrast controls adjusted for correct balance between the blacks and whites was very dull and had a washed-out appearance similar to Tele-Clue No. H-60. When the contrast control was advanced the color gradation between black and white practically disappeared as shown above.

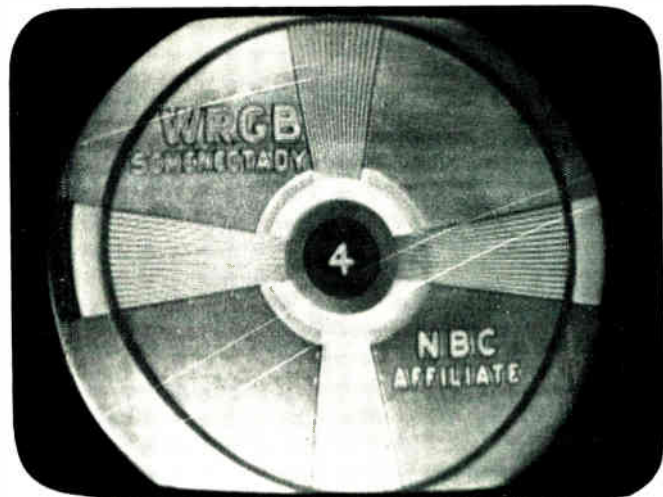
**Tele-Clue No. H-78**—This photograph shows the result of advancing the brightness control on the same tube used in Tele-Clue No. 77. The contrast control was returned to normal. The five shading rings around number 4 should vary in shading from black in the center to white on the outside. In the above photograph the outer ring is darker than the next inner ring. This is just the reverse of the normal shading sequence.

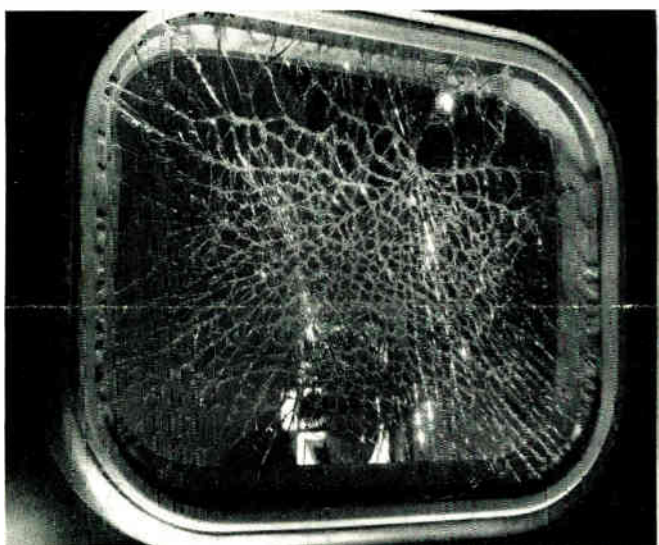
**Tele-Clue No. G-79 & 80**—These photographs illustrate the result of a fourteen inch picture tube which imploded while in its cabinet. The tremendous force released is apparent from the condition of the safety glass in these photographs. Fortunately this type of glass breakage, which obviously was due to the fracture occurring first in the faceplate, does not occur very often. In one case this did happen sometime during the night to a receiver not in its cabinet. Pieces of glass were scattered all over the service shop and were found imbedded in the walls about twenty feet away.

These photographs illustrate that if an implosion occurs while the set is in the cabinet, damage would result only to the receiver. However, utmost care should be exercised when removing, transporting or repairing a receiver outside of its cabinet. The potential danger is great since a scratch or defect in the glass of the tube may cause an implosion at any time. Therefore it is advisable to use every precaution including the wearing of safety glasses while working around exposed picture tubes.

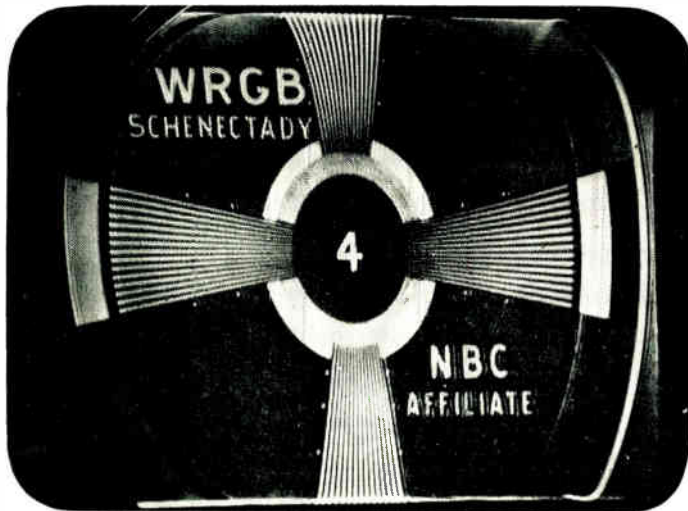
**Tele-Clue A81.** The vertical foldover which can be seen at the right side both top and bottom was due to a defect in the vertical windings of the deflection yoke on a General Electric Model 802. Several vertical retrace lines were visible near the top and extended about one-inch down from the top. These could not be eliminated by adjusting the vertical hold, vertical linearity or height controls. Ordinarily a short in the vertical coils will result in a keystone effect similar to Tele-Clue No. A-21. This effect was not noticeable in this photograph, however a new yoke corrected the defect.
