# Tele-Clues

**Tele-Clue K-274**

**Receiver:** G-E "U-4" line (See "U-4" Tele-Clue Schematic).  
**Component:** C254, 5000 mmfd, 450 volt capacitor, temperature range 10° - 105° C - SHORTED.  
**Circuit:** Grid circuit of V8 Clipper tube.  
**Symptom:** Soft sync, horizontal side lock and possible audio buzz.

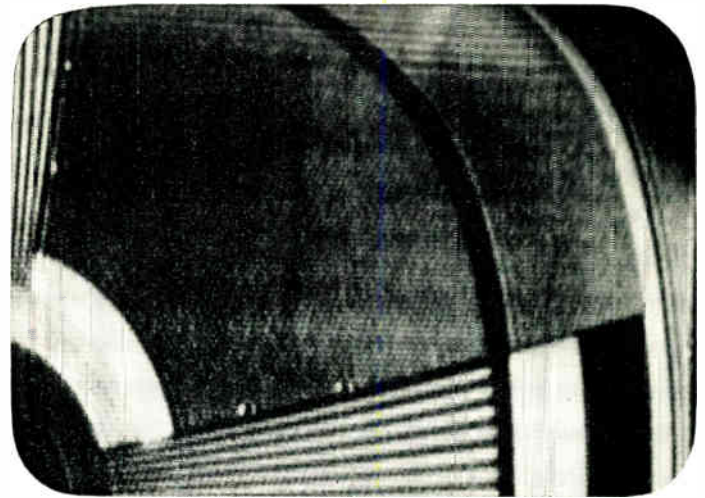
**Tele-Clue A82.** This is an enlarged view of the top right hand corner of Tele-Clue No. A81 which shows the foldover and vertical retrace lines which could not be eliminated.

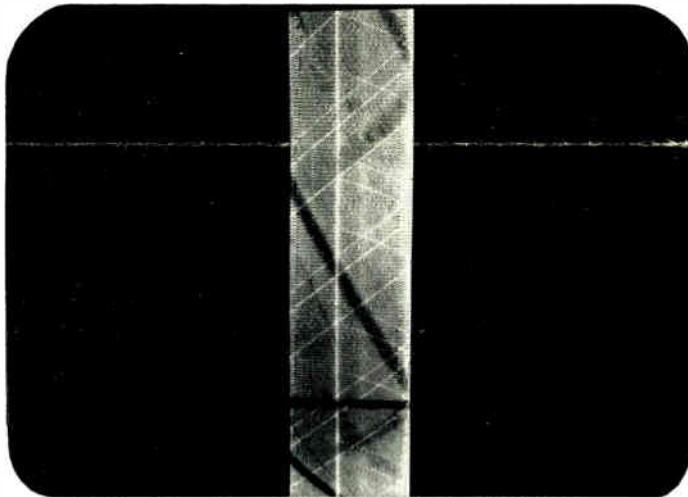
**Tele-Clue No. A83.** This illustrates another unusual defect in the deflection yoke. In this case the width is reduced and again without any noticeable keystone effect. This photograph was taken of a Westinghouse Model 619T12 chassis V2150-176. This same chassis is also used in Model 617T12. The horizontal output circuit for this receiver is shown in Fig. 1.

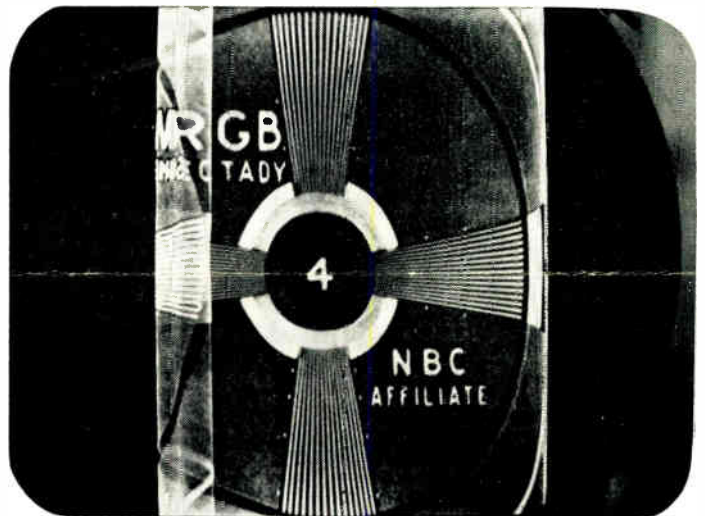
**Tele-Clue No. E84.** This shows the effect of removing the 6W4-GT damper tube in the circuit shown in Fig. 1. Ordinarily the removal of the damper tube results in a reduction of the high voltage to a point where little or no illumination of the screen is visible. In this circuit however, the high voltage was not noticeably reduced and there was a gradual change which took place during a two minute period after the damper tube was removed. After this period the test pattern appeared like Tele-Clue No. E85.

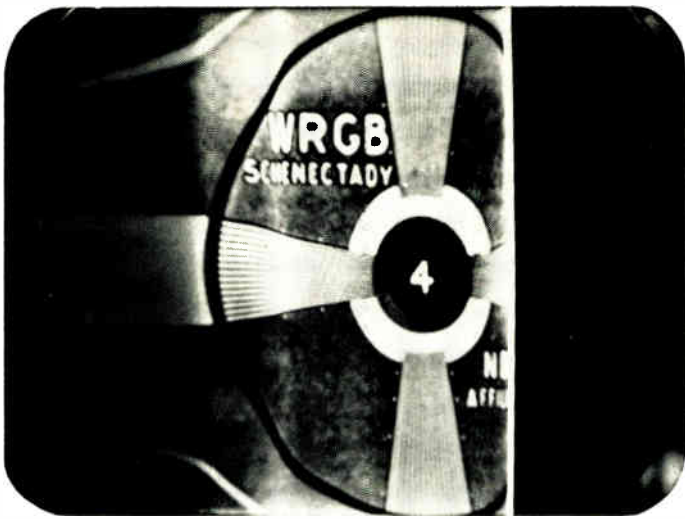
**Tele-Clue No. E85.** This photograph was taken about two minutes after Tele-Clue No. E84. There was a gradual change to each side of the test pattern until it looked like the above photograph. The test pattern looked like this as long as the damper tube was out of the circuit.

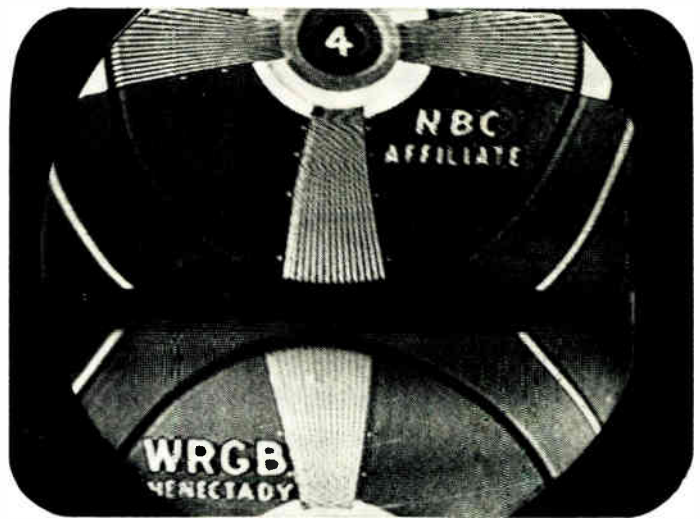
**Tele-Clue No. C86.** This is a somewhat unusual defect which could take a considerable amount of time to run down. The picture was very dark and looked as if the contrast control was advanced too far. This control however, had no noticeable effect on the picture. The horizontal sync was critical and the vertical would jump a frame quite frequently. This condition was caused by a leaky capacitor C290 in Fig. 2. Because of this a positive voltage (50 V.) appeared on the picture tube grid. This circuit was used in the following General Electric TV receivers:

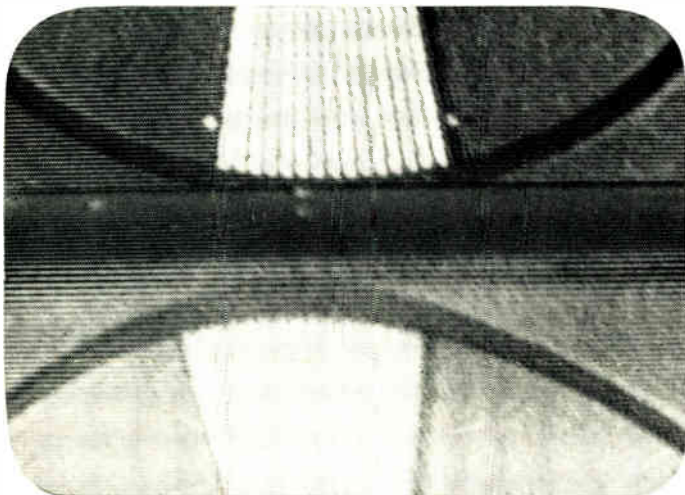
**Tele-Clue No. C87.** This is an enlarged view of the area between the frames shown in Tele-Clue No. C86. The vertical sync pulse has disappeared completely. This area should appear like that shown in Tele-Clue No. C88.

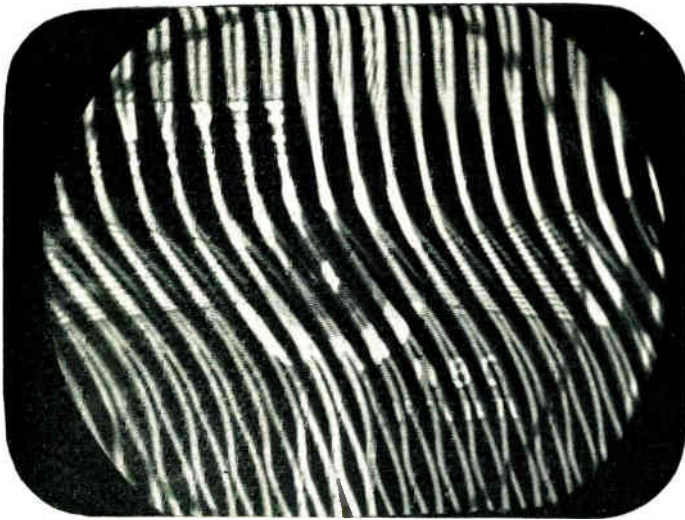
Tele-Clue No. J89. This condition was caused by spurious oscillation in the 6C4 HF oscillator used in a Westinghouse Model H-604T10. The frequency which is indicated by the number of vertical or diagonal lines, could be varied by adjusting the fine tuning control. The lowest frequency appears above and the highest frequency is shown in Tele-Clue No. J90. The shield over this tube had no apparent effect, however, another 6C4 tube entirely eliminated this defect.

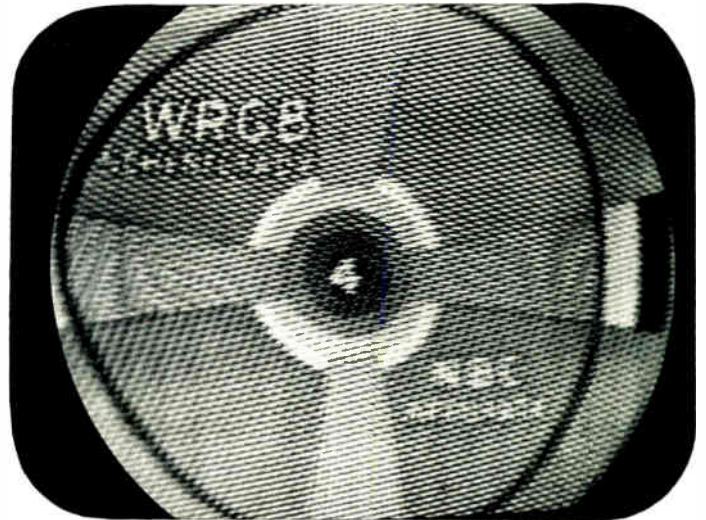
Tele-Clue No. J90. This is the same defect shown in Tele-Clue No. J89 except at a different setting of the fine-tuning control. A similar effect may be caused by any RF getting through to the grid of the picture tube. The interference shown above could be varied by adjusting the fine tuning control which indicated that the HF oscillator was at fault.

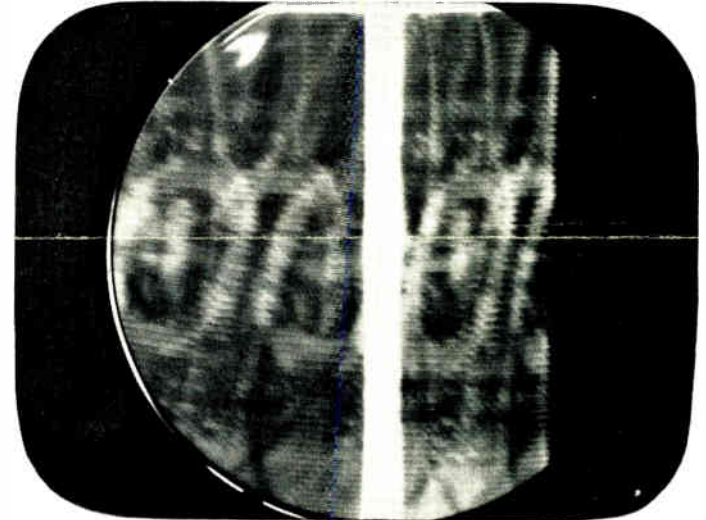
Tele-Clue No. E92. The bright vertical bar and loss of horizontal synchronization was caused by C363 in Fig. 1 being open. This condition is the result of blocking the horizontal sweep generator. It usually is brought about by improper operating bias on the horizontal sweep oscillator tube caused by open, leaky, or shorted components in the grid bias circuit. A ready check to determine whether this is the source of the trouble is to observe the waveshape with an oscilloscope across the sine-wave oscillator tank circuit of tube V12B. If the amplitude and waveshape do not check with published data, the components R 366 or C 365 should be checked.

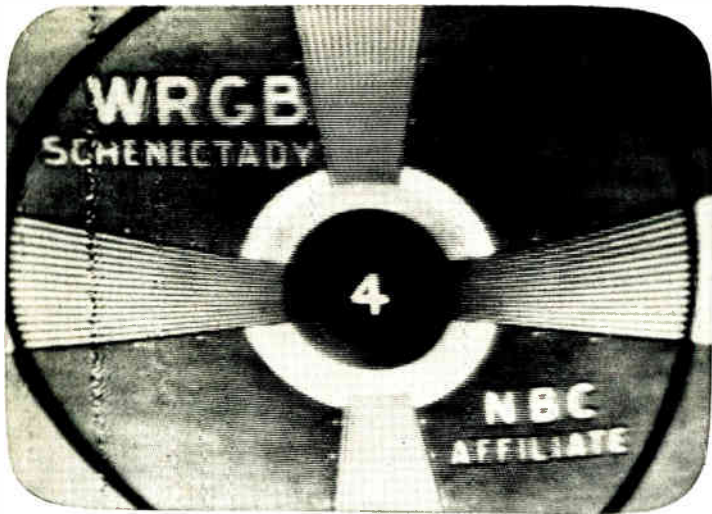
Tele-Clue No. E93. The vertical black lines were due to a slight arc developing at the solder connection to the plate of the 183-GT high voltage rectifier. This is similar in appearance to Barkhausen oscillation. The similarity is probably due to the various frequencies developed by the arc falling in the same range as Barkhausen oscillation.

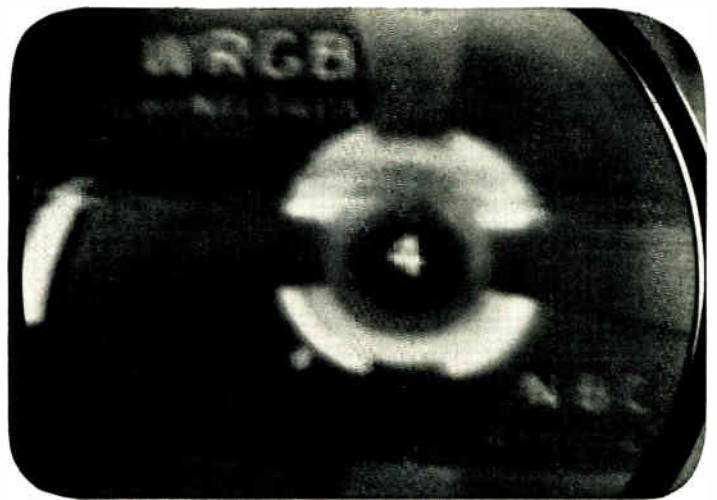
Tele-Clue E94. The increase in horizontal and vertical size as well as the loss in brightness indicates a loss of high voltage. This was caused by a poor connection which developed an arc under the rubber cover at the anode of the picture tube.

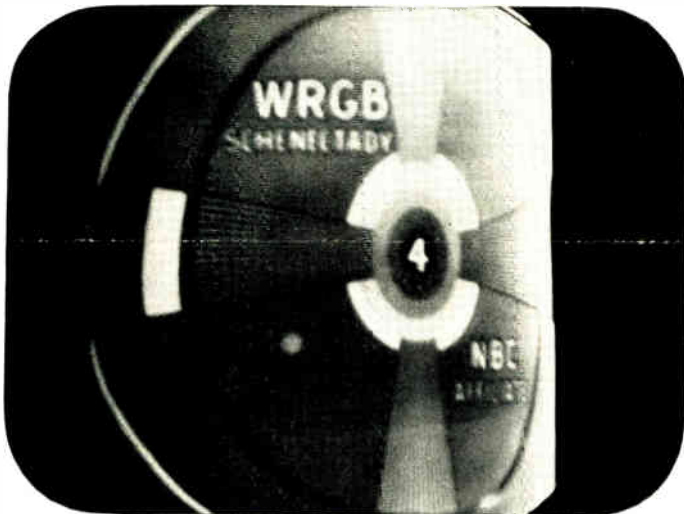
Tele-Clue No. E95. The dim picture with poor horizontal linearity, insufficient width and excessive height was caused by an open in the .5 mfd capacitor C 377 in Fig. 2. This condition is a result of placing a high impedance in series with the horizontal deflection circuit and is caused by an open or very low capacity value of the series capacitor, C 377, to the horizontal deflection coils. This reduces current to the horizontal deflection coils; however, the shunting resistor R 377, passes some current to the coils when capacitor C 377 is open, thus permitting some sweep but with reduced picture tube anode voltage. In some receivers, resistor R 377 will overheat upon opening of capacitor C 377 because of excessive current. High leakage in capacitors C 373 or C 374 will produce similar results except that the linearity will be better.

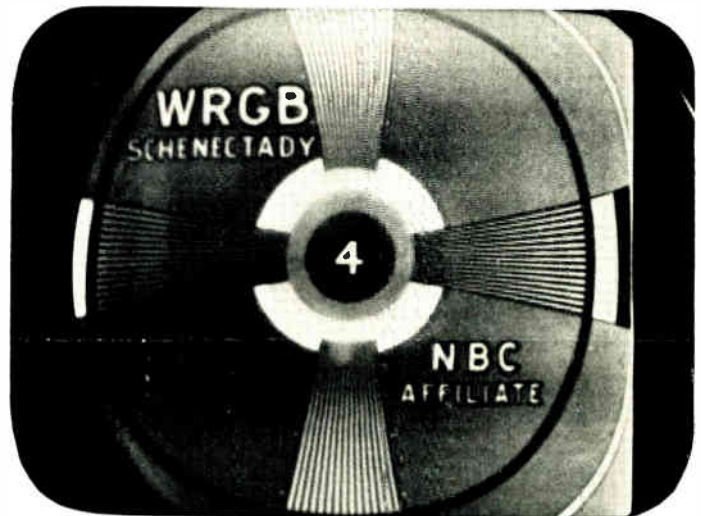
Tele-Clue No. E96. The displacement to the left shows the effect of shorting out the .5 mfd capacitor C 377 in Fig. 2. This condition is the result of additional d-c flowing through the horizontal deflection coils. If this capacitor shorts out it may be impossible to center the picture.

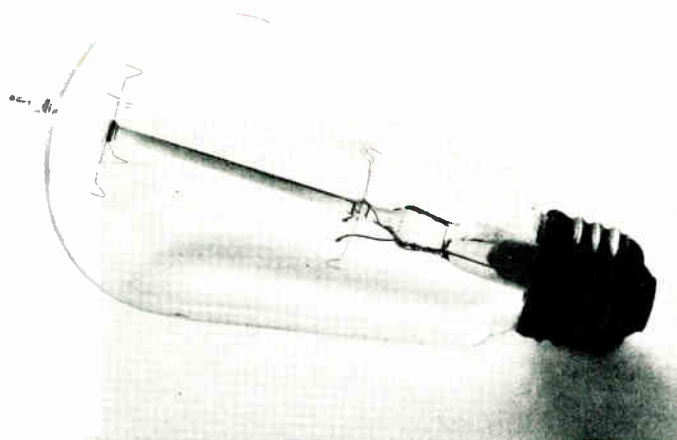
**Tele-Clue No. J97.** This is a photograph of a typical straight wire incandescent lamp, which may cause interference in the 60 to 70 megacycle frequencies (Channels 2, 3 and 4). Lamps of this type have not been manufactured since about 1925, however, a considerable number are still in use in such places as attics, fruit cellars, closets, etc. It is very rare for a modern General Electric lamp to cause interference; however, the type shown above may produce a high frequency oscillation. The main points of identification are the filament shape, the clear glass bulb and the tip.

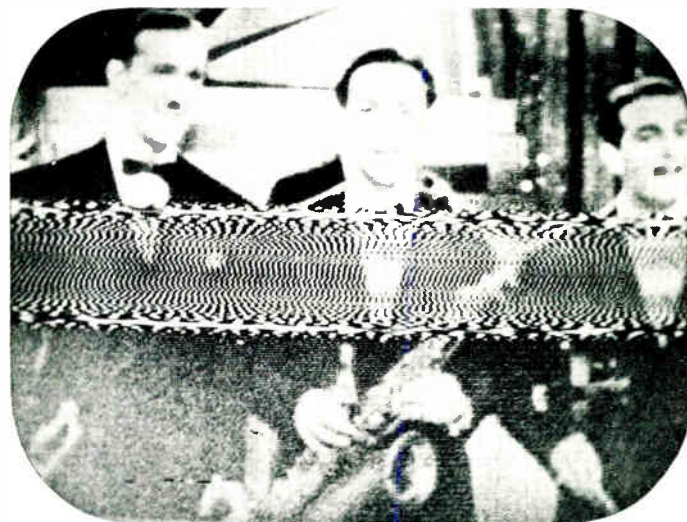
**Tele-Clue No. J98.** This shows one type of interference pattern produced by the lamp shown in Tele-Clue No. J97. Due to these lamps being used intermittently in such places as porch lights, closets, etc., they may be rather difficult to locate. Another factor is that this type of interference may cover a radius equivalent to two city blocks, particularly in low signal areas. In some cases the interference pattern may move either up or down on the screen until it is no longer visible. The radiation from a lamp of this type can be shielded or dissipated by use of metal reflectors but no one recommendation will apply to all installations. Therefore, the simplest remedy is to find and replace the guilty lamp.

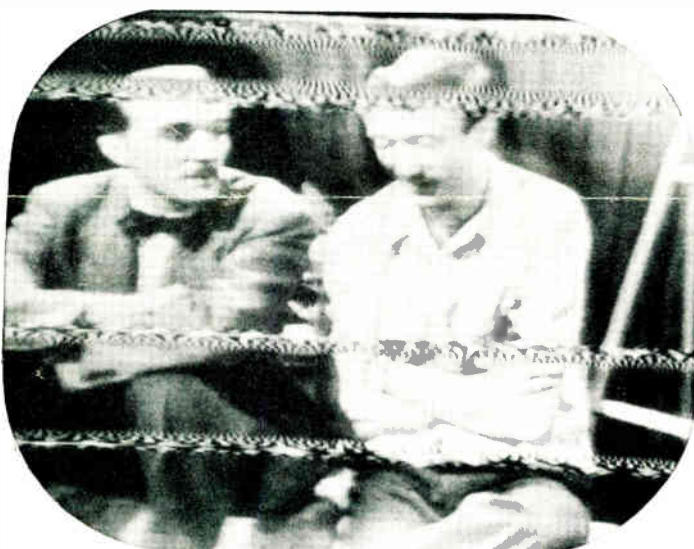
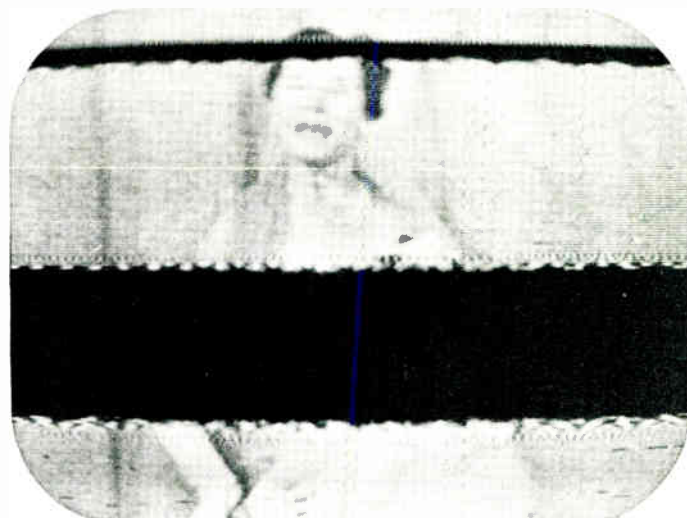
**Tele-Clue Nos. J99 and J100.** Two more interference patterns produced by the type of lamp shown above. The black bands in the photograph on the right are the result of operating the lamp close to the receiver.

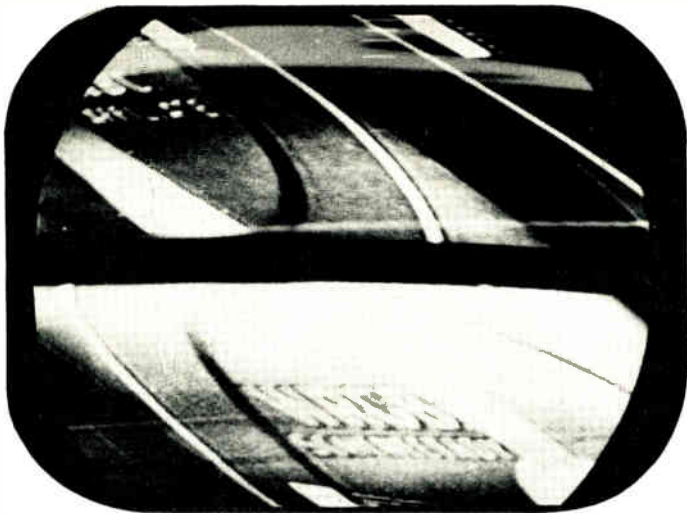
**Tele-Clue No. K101.** The above photo illustrates the effect of losing both horizontal and vertical synchronization. This defect was due to an open C-354 in Figure 1. However, it could be due to any of the following:

1. C351 open.
2. Defective V10A or V10B.
3. Loss of plate voltage on V10A or V10B.
4. Incorrect value of R354.
5. Insufficient amplitude of composite signal applied to sync amplifier from video amplifier, check video amplifier circuit. A scope will prove invaluable when used as a signal tracer in this circuit. The wave form and amplitude should be compared with the manufacturer's service notes.

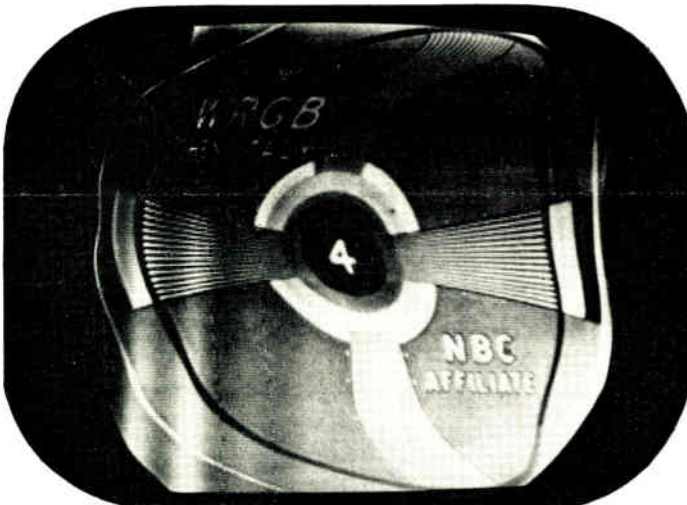
**Tele-Clue No. F103.** This photo indicates a defective component which reduces the output B+ voltage. This reduced B+ voltage will affect both horizontal and vertical sweep and will also give reduced picture brilliance. The ripple and shadow through the picture is due to inadequate filtering of the "B" supply. This was caused by an open C452 in Figure 2.

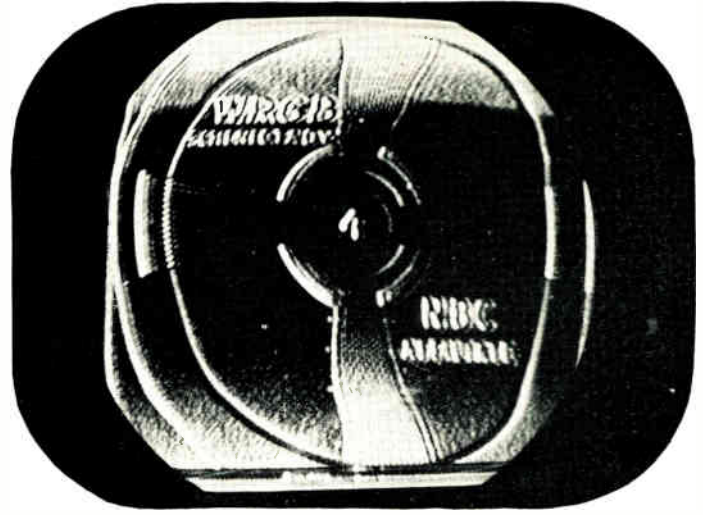
**Tele-Clue No. M102.** This condition is typical when a component falls in the AGC circuit. It may result in the contrast control having little or no effect on the picture. If the contrast control has little control, it may be due to leakage in one of the capacitors such as a C261 or C251. Since the impedance of the circuit is high, leakage in the order of 1 megohm or less may cause trouble. A completely inoperative control may be the result of a shorted capacitor or a ground in the AGC system. This was caused by a shorted C251 in Figure 2, however, a short in C261 or an open in L258 may result in a similar condition.

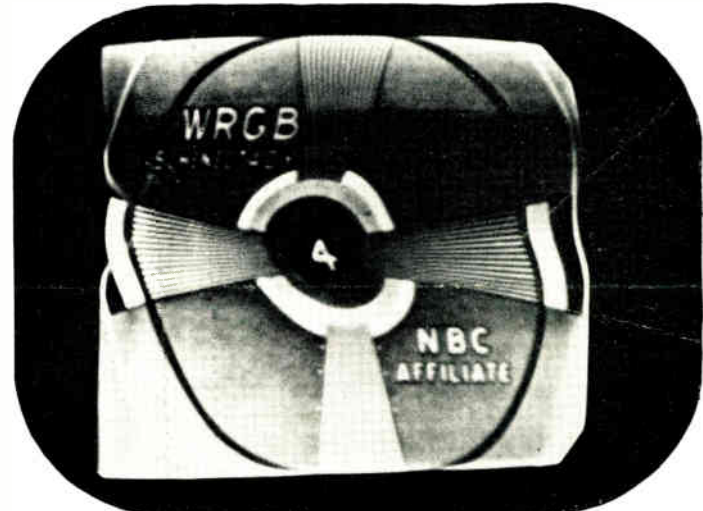
**Tele-Clue No. F104.** This illustrates another defect due to inadequate filtering. The dark shaded bar is caused by hum in the picture tube grid circuit, while the waviness in the raster edge is the result of hum in the horizontal deflection circuit. This was caused by an open C453 in Figure 2.

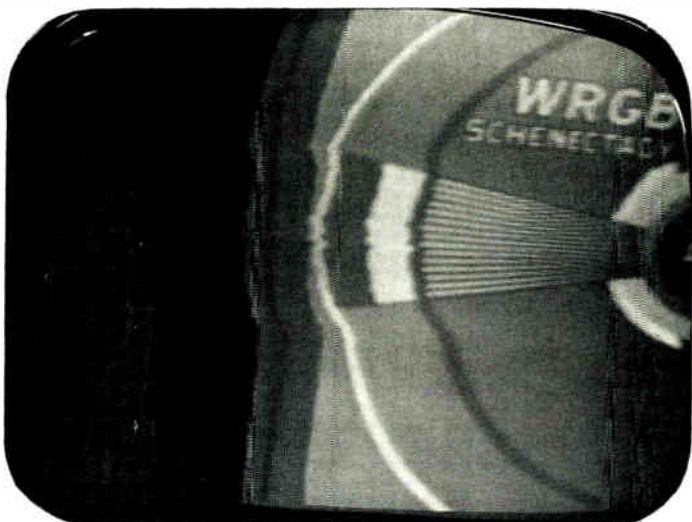
Tele-Clue No. F-105. This defect was due to an open developing in the 10 mfd capacitor C379-A in Fig. 1. The vertical hold was unstable and synced in slightly above normal. The horizontal hold was also unstable and would only sync in with the blanking bar either at the left as shown above or at the right as shown in Tele-Clue No. F-106.

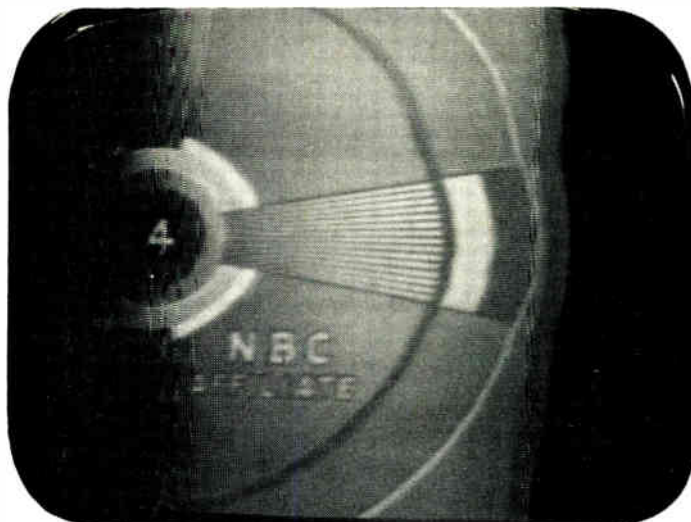
Tele-Clue No. F-106. This is the same defect as shown in Tele-Clue No. F-105 with the hold control adjusted so that the blanking bar syncs at the right.

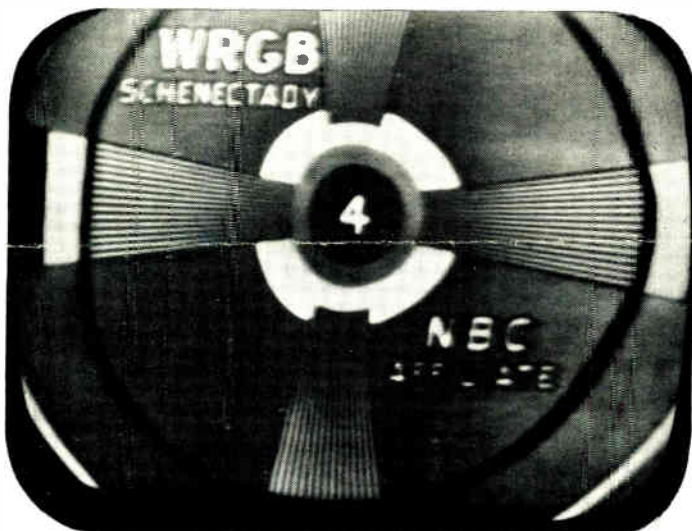
Tele-Clue No. K-107. The above photograph was taken with the contrast control set at minimum (counterclockwise). The defect shown here was due to 50K ohms leakage across C-354 in Fig. 1. Incidentally, if this capacitor is completely shorted, horizontal oscillation is "killed," resulting in complete loss of any illumination on the picture tube. The vertical syncs slightly above normal as can be seen in the above photograph. If C351 is leaky the picture will appear practically the same as the above except that the vertical will sync at the normal point.

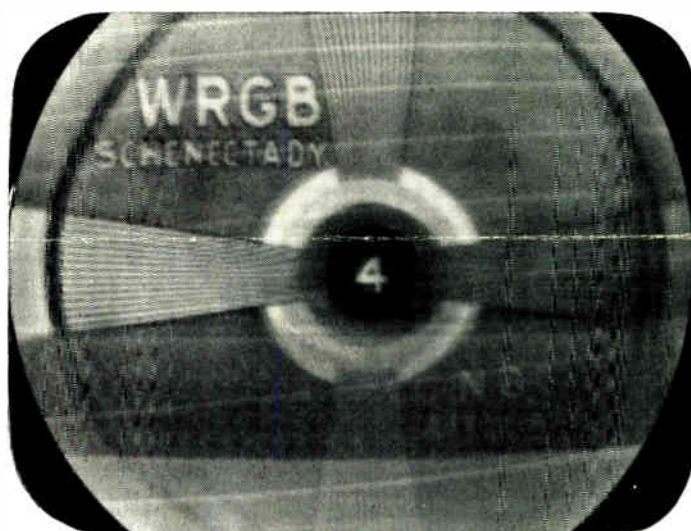
Tele-Clue No. C-108. This photograph shows the effect of oscillation in the video amplifier of a General Electric 10T1 receiver. This defect can be caused by an open in either one of the 6800-ohm resistors R-233 or R-234 which are connected in parallel with the video compensating chokes L-255 and L-268 in Fig. 2. Both of these chokes are wound on resistors and may be difficult to locate unless the resistor is checked separately. This same type circuit is used in a number of General Electric models.

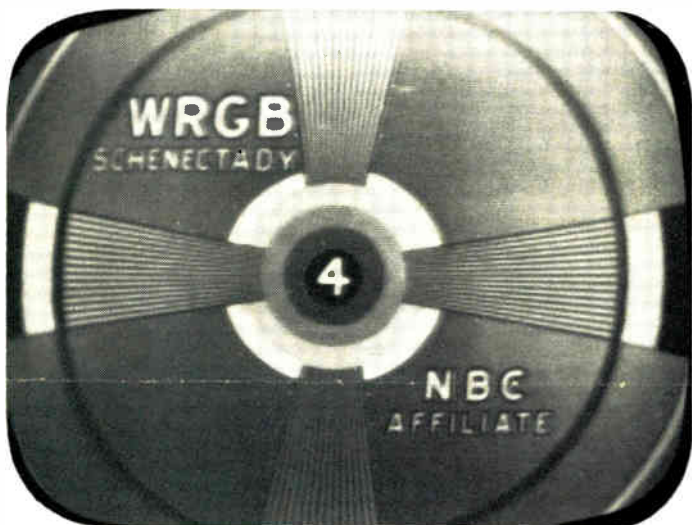
Tele-Clue No. F-109. Line voltage variations will affect the over-all operation of a TV receiver. The height, width and focus are all affected as can be seen by comparing the four Tele-Clues shown on this page. The above photograph was taken after the TV receiver was adjusted for proper operation at a line voltage of 120 volts.

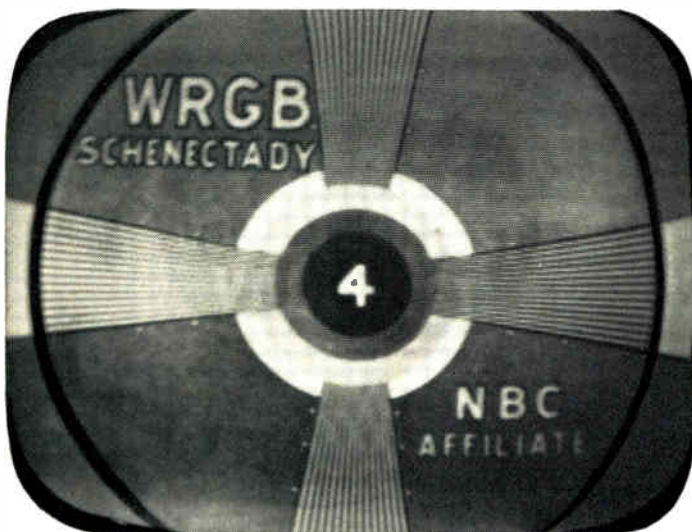
Tele-Clue No. F-110. This photograph was taken of the same receiver with the line voltage increased to 130 volts. No other adjustments were made. The width and height have increased and the black portions of the test pattern are darker. The definition of the vertical wedges is reduced near the center of the picture which could have been corrected by adjusting the focus control.

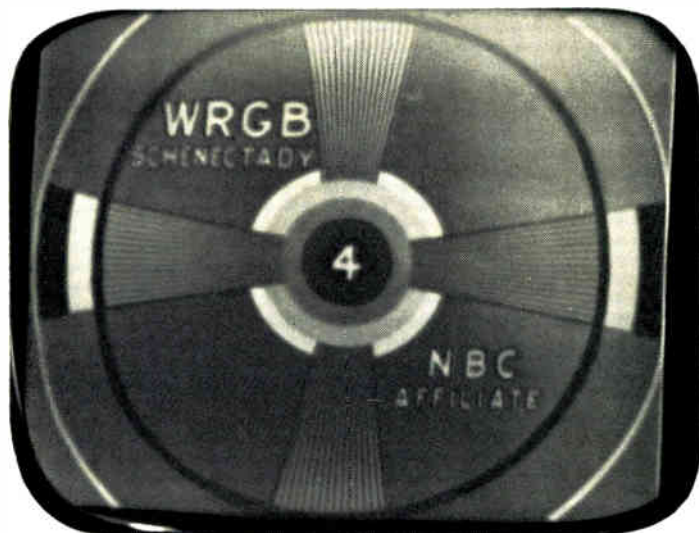
Tele-Clue No. F-111. This photograph illustrates the effect of reducing the line voltage to 110 volts on the same receiver. The height, width, focus and brightness have all been reduced.

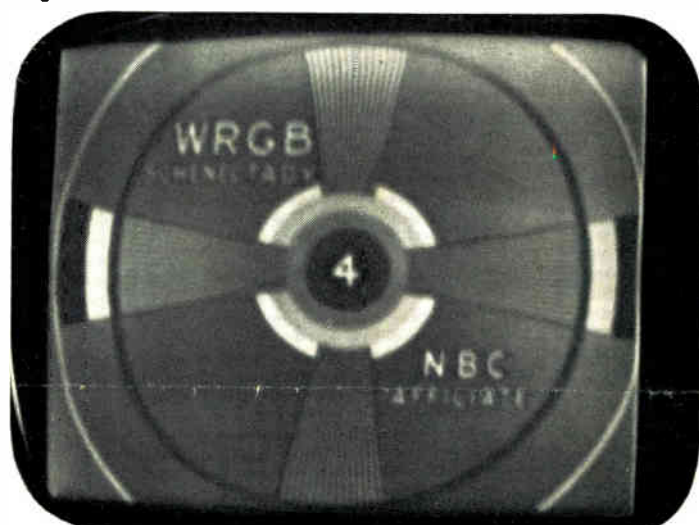
Tele-Clue No. F-112. This is similar to Tele-Clue No. F-111 but with the same defects more pronounced since the line voltage has been reduced to 100 volts.

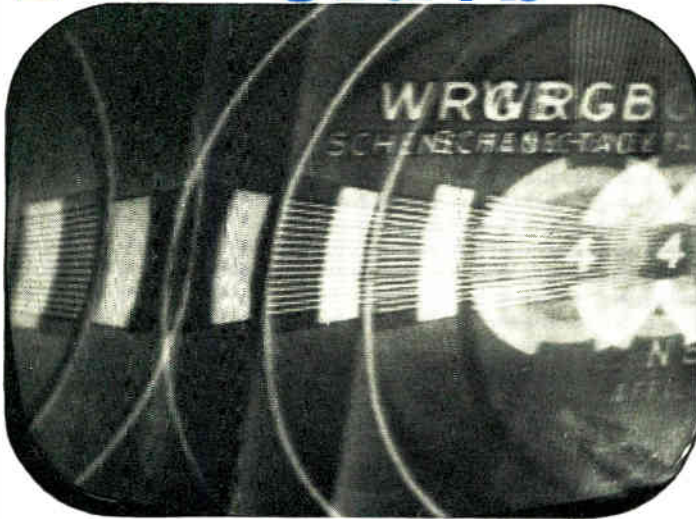
**Tele-Clue E-113.** The horizontal shifting shown here was due to an open capacitor C356 in Fig. 1. This capacitor feeds the horizontal sync pulses to V12. If this capacitor is open the control voltage ordinarily developed across resistor R356 and R357 and applied to the grid of V13A will obviously be incorrect.

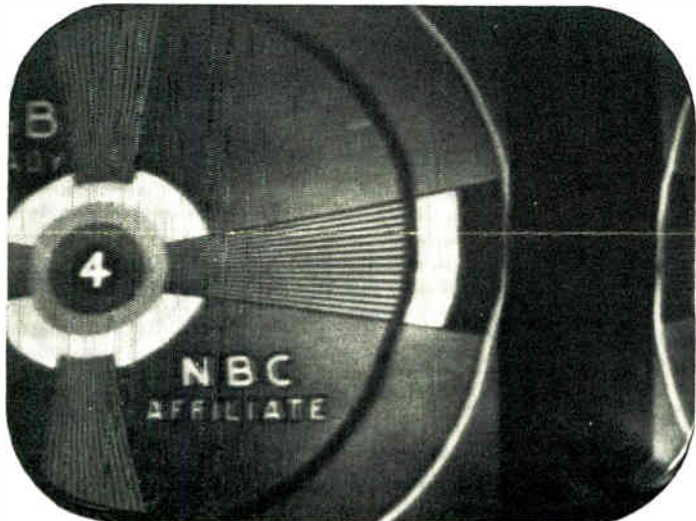
**Tele-Clue E-115.** This condition was caused by an open capacitor C358 in Fig. 1. The picture weaves horizontally and can only be stabilized with the horizontal blanking bar at the right as shown or with a number of horizontal lines tearing the picture as shown in Tele-Clue E-116. A similar type defect will also appear if R359, R360 or C357 is open.

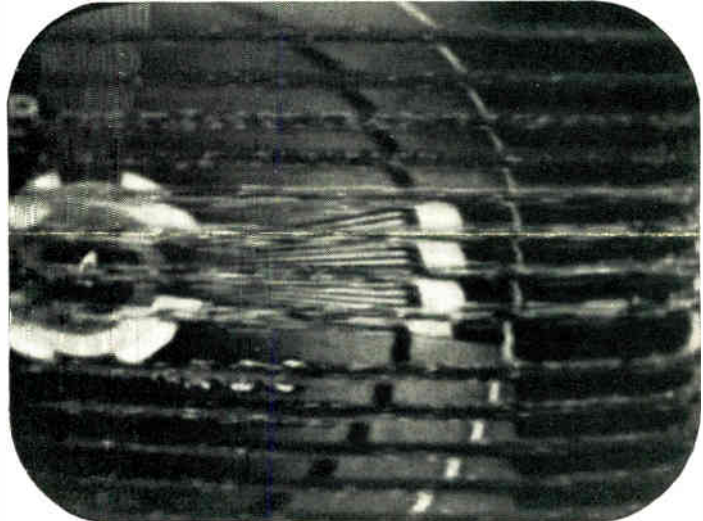
**Tele-Clue E-116.** This defect was caused by the same defect as Tele-Clue E-115 but at a different setting of the hold control. The number of horizontal lines which appear will also vary with the control setting.

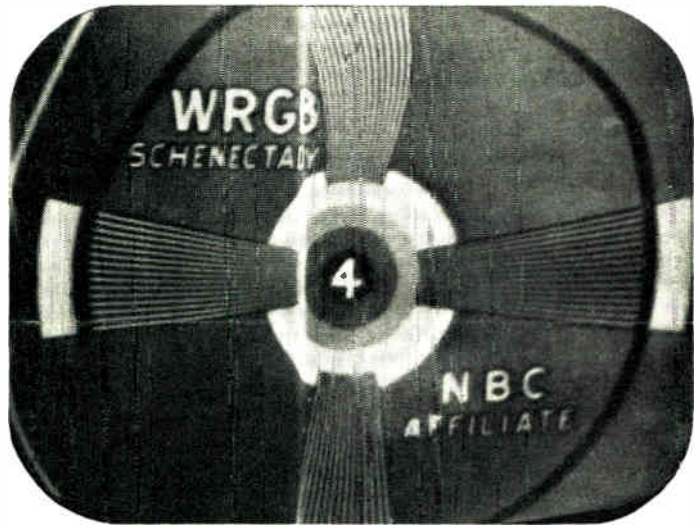
**Tele-Clue E-119.** Leakage across capacitor C366 in Fig. 1 will cause a vertical white line to appear near the center of the picture and there is pulling at the top. This defect also causes a slight reduction in the width.

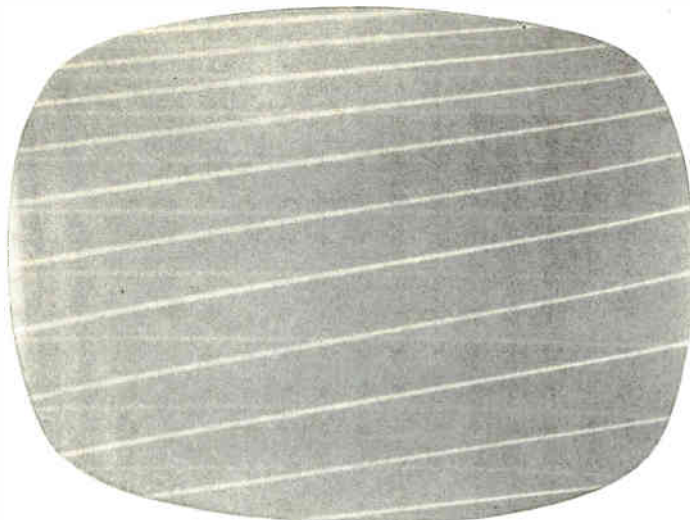
**Tele-Clue No. C-126.** Loss of picture only with normal sound and vertical retrace lines stabilized, indicates that the trouble is between the point where the sync pulses are taken off and the picture tube. In either the intercarrier receiver shown in Fig. 2 or the conventional receiver shown in Fig. 3, the defect is pinpointed to the last video coupling circuit and the picture tube.

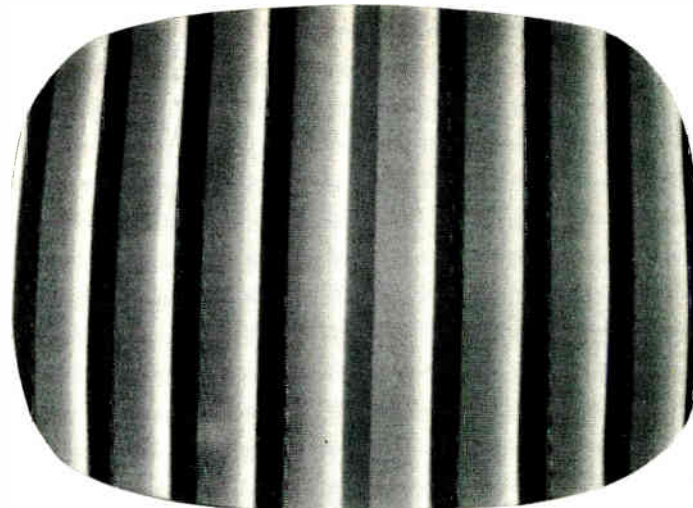
**Tele-Clue No. C-127.** A quick way of checking for the loss of video signal is with an ordinary AM signal generator. If the signal is lost between the video detector and the picture tube, connect the output of the generator to the output of the video detector through a .01 mfd 600 volt capacitor. The frequency should be set at some harmonic of 15,750 cycles with the audio modulation turned off. The tenth harmonic or 157.5 kc will produce a pattern similar to the above photograph. If this type of pattern appears on the picture tube, it indicates that the circuit between this point and the picture tube is operating. If no pattern appears on the picture tube, the output of the signal generator should be connected first to the grid, and then to the plate of each video amplifier tube, and then to the grid of the picture tube or until the point is found where the signal appears. The circuit can then be checked for the defective component. Due to the amplification of the video amplifier tubes, the amplitude of the signal and therefore the darkness of the horizontal bars will decrease as the point of injection is moved closer to the grid of the picture tube.

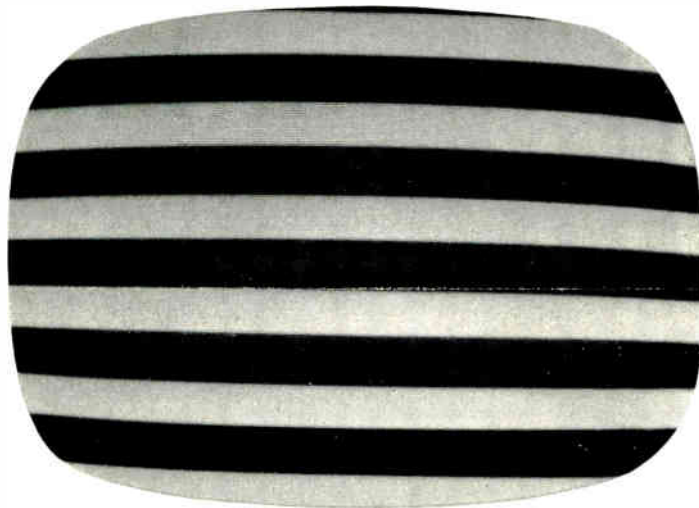
**Tele-Clue No. C-128.** If the signal is getting through from the output of the video detector, the point of injection should be moved to the video detector input. The frequency of the signal generator will have to be changed to approximately the center of the i-f pass-band. The pattern which should appear on the picture tube screen will be similar to the above photograph. The point of injection should then be moved to the plate and grid of each video i-f amplifier tube or until the point is reached where the signal disappears. This circuit can then be checked for the defective component.

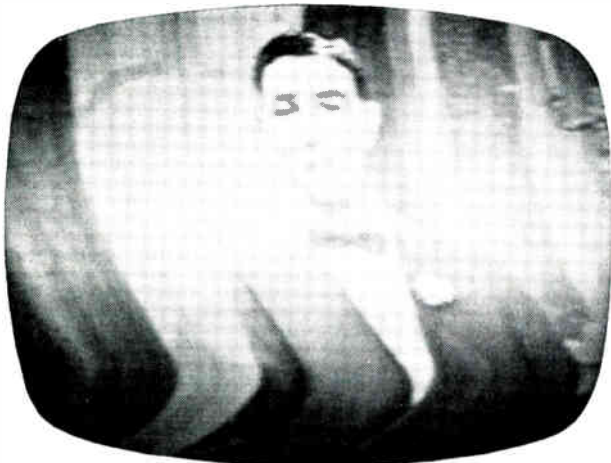
**Tele-Clue No. F131.** This Tele-Clue illustrates one effect of excessive a-c voltage in TV receiver circuits. In this instance the result is a combination of the two conditions shown in Tele-Clues C132 and E133. This defect is reasonably common since it may be caused by either a defective filter capacitor or a heater-cathode short. A heater-cathode short would have to be in one of the signal amplifying stages before the point where the sync pulses are taken off.

The light and dark areas are caused by a-c modulating the video signal at the input to the picture tube. The horizontal pulling is caused by a-c modulating the sync pulses which in turn modulate the horizontal oscillator. This condition could be caused by a defective filter capacitor which would allow a higher than normal level of a-c to be fed to the signal amplifying stages as well as the horizontal circuit. A check as indicated in Tele-Clue No. F130 would determine whether the filter network is at fault.

Another reason for the same type of picture distortion would be heater-cathode leakage in any signal amplifying stage before the sync pulses are taken off. A quick check for this condition would be to place the scope probe at either the cathode or plate of each stage. Heater-cathode leakage would be indicated by an a-c voltage greater in amplitude than that present at the B+ output of the power supply.

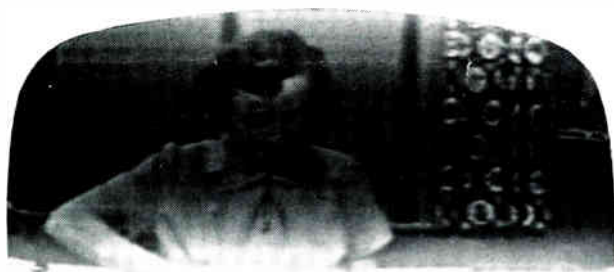
**Tele-Clue No. C132.** The shading in the above picture is caused by modulation of the video signal by 60 cycle a-c. This modulation causes a portion of each frame to extend into the black or darker than normal level and another portion of the frame to extend into the white or lighter than normal level. This effect can be readily understood when the normal video signal waveform on the left is compared with the modulated waveform on the right. The scope probe was placed on the grid of the picture tube and the sweep frequency set to sync at 60 cycles per sec. Notice that there is no

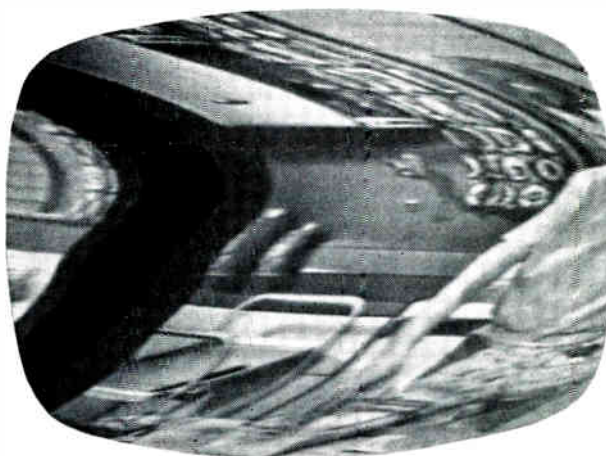
**Tele-Clue No. E133.** This shows the effect of a-c modulating the horizontal sync signal which in turn modulates the horizontal reactance tube. Since the reactance tube controls the horizontal oscillator, portions of the picture will be shifted due to the a-c modulation. Notice that the shading of the picture is not affected since this condition was caused by leakage between the cathode pin 8 and the heater of V117A in Fig. 3. A similar condition will appear if leakage occurs between the cathode pin 8 and the heater in V118B.

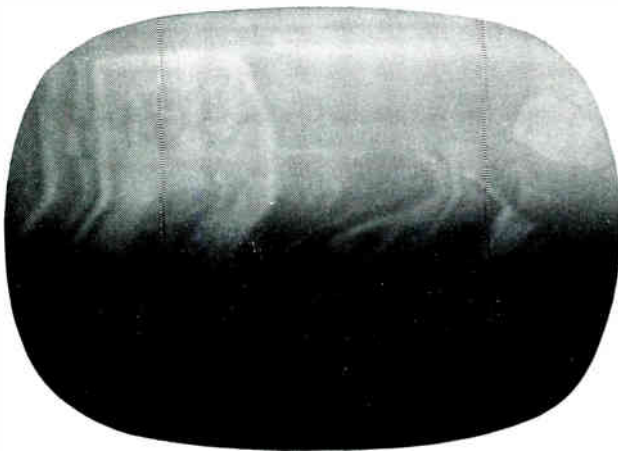
**Tele-Clue K-134.** Leakage (about 40K) between the cathode (pin 3) and the heater in the 12A7 (V113B) shown in Fig. 1 will result in a picture similar to that shown above. The appearance of the picture is similar to heater-cathode leakage in any of the video signal amplifying tubes and affects both the picture shading and horizontal sync. This is due to the a-c on pin 3 feeding back into the output of the video detector through C-301 and L-167. A short between these two tube elements will produce alternate white and black areas with a complete loss of video information. Ordinarily this tube might not be suspected since it is not one of the video amplifying tubes.

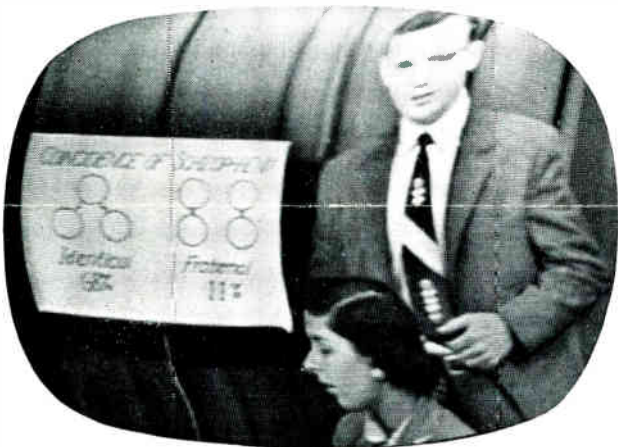
**Tele-Clue K-135.** Leakage in capacitor C-302 shown encircled in Fig. 1 will cause waviness in the picture due to a distortion of the sync pulses plus some of the video signal getting into the sync circuits. In the normal waveform shown on the left, vertical sync pulses appear as light ver-

tical streaks at the left and at the right of the waveform. The area in between these two vertical sync pulses is filled with horizontal sync pulses. The portion of these sync pulses which are visible at point "A" represents only the tips due to the action of the "clipper" tube. Due to the bias change on the clipper tube caused by leakage in C-302, video information as well as most of the complete vertical sync pulse is getting through the clipper tube as shown in the waveform on the right. The amplitude of this waveform is about 110 volts whereas the normal waveform is about 60 volts.

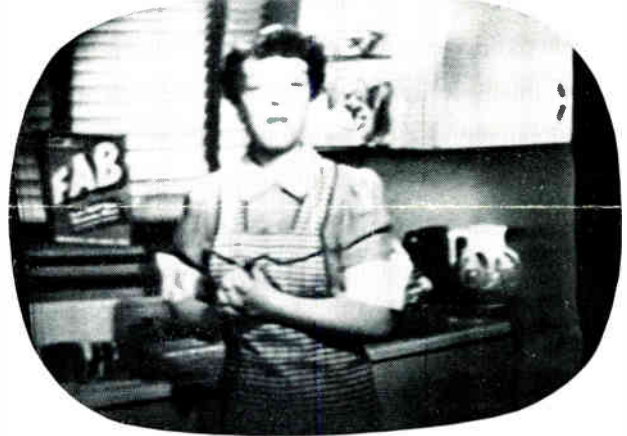
**Tele-Clue K-136.** If Capacitor C-303 also encircled in Fig. 1 is open, the picture is moved slightly to the left and has a wavy edge. The width control was adjusted so the waviness on the right edge could be seen. The

important change here is the displacement to the left which will ordinarily make centering difficult. The waveform at point "A" in Fig. 1 will appear similar to that shown above. Note that both vertical sync pulses are much broader than the normal waveform shown under Tele-Clue K-135.

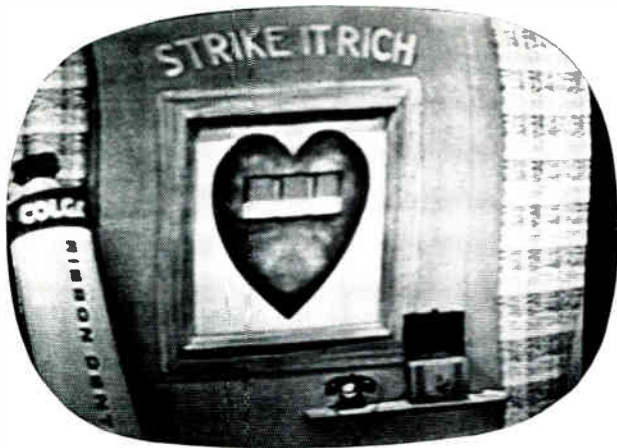
**Tele-Clue K-137.** Leakage (20K) in capacitor C-301 also caused a displacement to the left. In addition, the picture has more of a weave than Tele-Clue K-136. The waveform on pin 1 of V116A appeared practically the same as that shown under Tele-Clue K-136. Both horizontal and vertical sync were slightly unstable due to the change in bias on the noise inverter tube. This bias change caused the noise inverter tube to act as a clipper which prevented proper clipping action by the clipper tube.

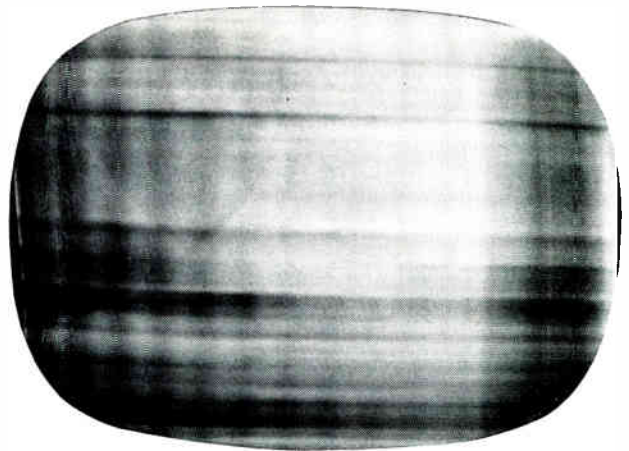
**Tele-Clue K-139.** If the 15K resistor R-301 in Fig. 1 is reduced in value to 200 ohms or less the picture will be practically lost as shown above. The waveform at point "A" will appear like that shown below. This has eliminated practically all of the horizontal sync pulse amplitude and only

the vertical pulse can be identified. This defect would seldom occur unless considerable current should be drawn through R-301. Since C-301 is connected between the lower end of L-167 and the cathode of V113B, a reduction in the value of R-301 will in effect ground one end of C-301. This would by-pass all frequencies except those very low in frequency.

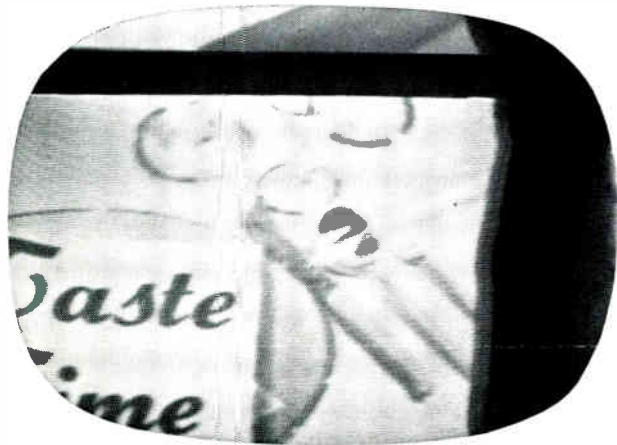
**Tele-Clue K-138.** A short in capacitor C-301 in Fig. 1 produced the picture shown above. The waveform at pin 1 of V116A point "A" appeared as shown below. Both the horizontal and vertical sync pulses have practically

disappeared. This caused the picture to sync slightly below normal vertically and to weave and sync with the blanking bar near the center horizontally. The shape of the area between the vertical sync pulses will change with the picture content.

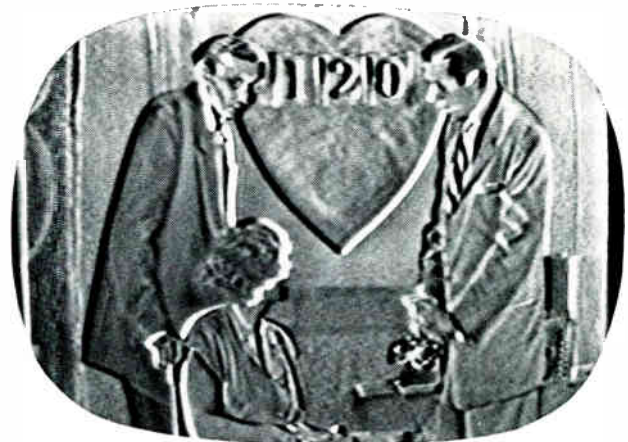
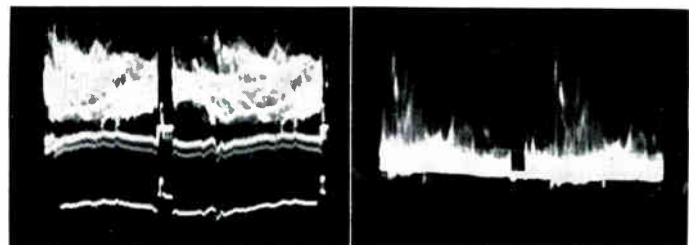
**Tele-Clue K-140.** A short in capacitor C-169 in Fig. 1 caused a loss of the low frequencies and trailing whites. A normal waveform at the output of the video detector point "B" in Fig. 1 will appear as shown in the

waveform on the left. A short in C-169 will cause this waveform to change as shown on the right. In every waveform photograph, the scope was synced at one-half the vertical frequency.

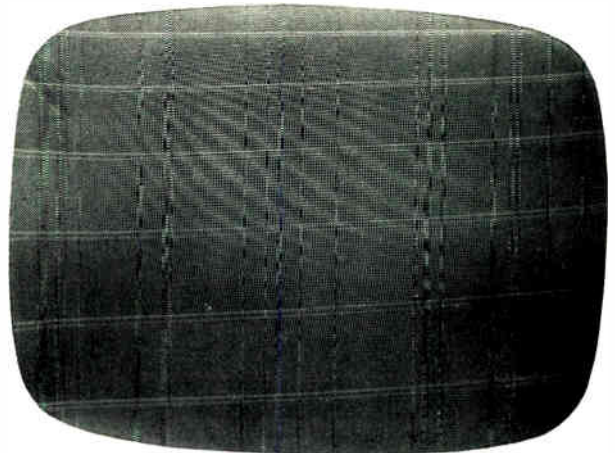
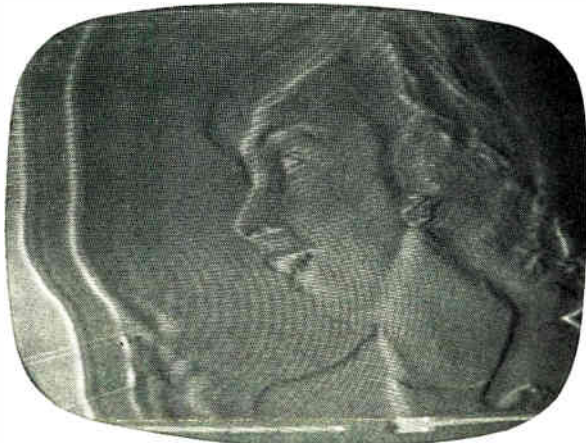
Tele-Clue No. M-143. An open in the grid circuit of V117 in Fig. 1 will cause the picture to appear the same as Tele-Clue M-141. An open in the grid circuit of V113 in Fig. 2 will cause a complete loss of the video signal as shown above.

Tele-Clue No. M-141. Keyed AGC circuits have caused technicians considerable trouble because the effect on the picture is often misleading. If the AGC keyer tube V117 in Fig. 1 is inoperative due to an open filament, low emission, an open AGC winding on the width coil, or some other defect, the AGC voltage will be very low. This low voltage causes one or more of the video i-f or video amplifier tubes to be overloaded which results in a negative picture plus erratic horizontal and vertical synchronization as shown above. The above defect was caused by an open filament in the 6AU6 keyer tube.

If it should be necessary to replace the width coil T503, be sure the leads are connected correctly. If either side is reversed, the polarity of the waveform will also be reversed. This will produce the same condition shown in the above photograph.
