# Tele-Clues

**Tele-Clue K-274**

**Receiver:** G-E "U-4" line (See "U-4" Tele-Clue Schematic).  
**Component:** C254, 5000 mmfd, 450 volt capacitor, temperature range 10° - 105° C - SHORTED.  
**Circuit:** Grid circuit of V8 Clipper tube.  
**Symptom:** Soft sync, horizontal side lock and possible audio buzz.

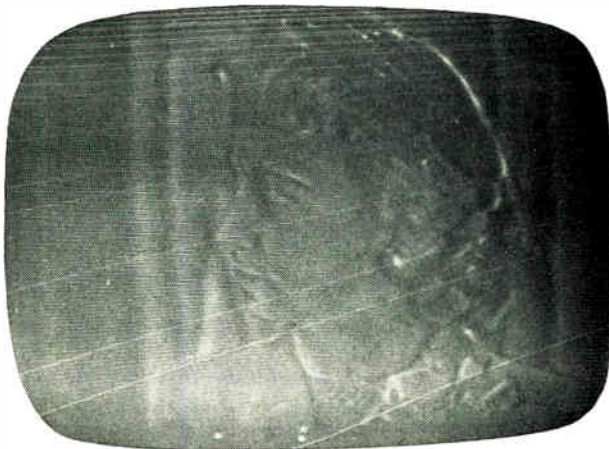
caused by an open filament in the 6AU6 keyer tube in the Fig. 2 circuit. The condition shown occurred with a good level of signal. If the signal level is low, the picture may appear normal at high contrast control settings even with the keyer tube inoperative.

Tele-Clue No. M-142. Somewhat different picture conditions are caused when defects occur in the slightly different AGC circuit shown in Fig. 2. As an example, when the 6AU6 tube is inoperative due to an open filament or an open in the AGC winding on the width coil, the picture is affected but not as much as in the Fig. 1 circuit. The above picture was

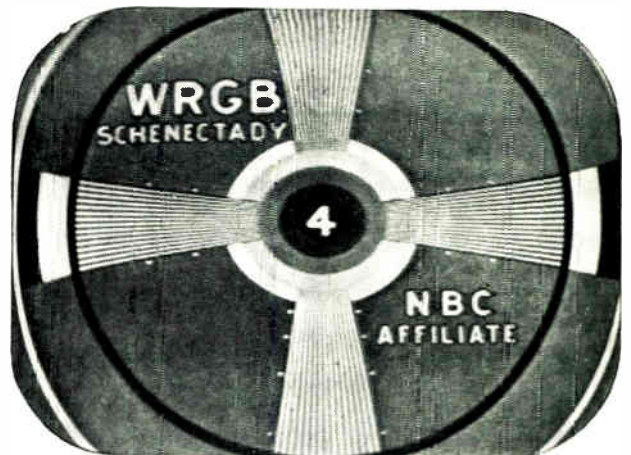
Tele-Clue No. M-144. An open in capacitor C405 in Fig. 1 will cause a loss of vertical interlace. When this capacitor opens, it allows horizontal pulses to appear on the AGC line as shown in the waveform on Page 4. Normally only d-c is present at this point. These horizontal pulses upset normal vertical synchronization which caused the side wedge to fan out

near the center as shown. The vertical would not interlace at any setting of the vertical hold control, otherwise it seemed to operate over the normal range.

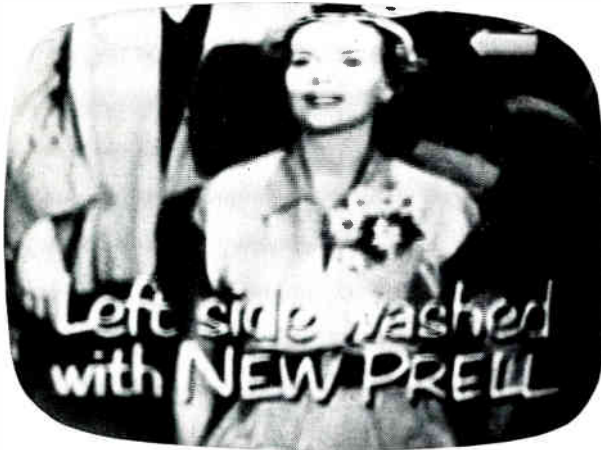
**Tele-Clue No. M-145.** An open in capacitor C251 in Fig. 2 will also cause poor interlace, but in addition the vertical will jitter as shown above. The vertical hold control was very limited in range.

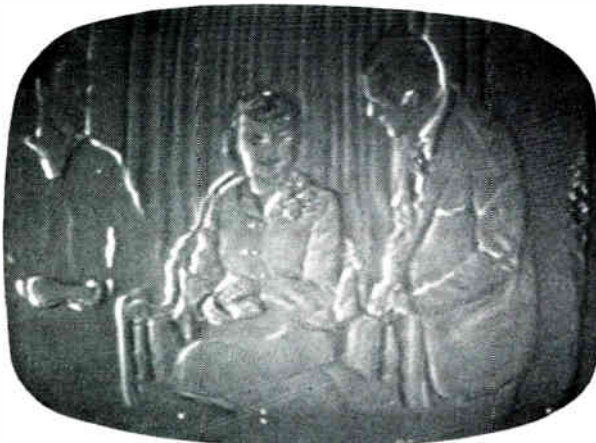
**Tele-Clue No. F-146.** The condition shown above is quite similar to that shown in Tele-Clue M-141. This condition, however, was caused by a low emission 5U4-G rectifier tube V129 in Fig. 3. Since this is the tube which supplies the B+ for the horizontal sweep output tube, a reduction in the B+ voltage will result in a reduction of the amplitude of the pulse applied to the plate of the keyer tube shown in Fig. 1. In addition, the normal operating voltages for this keyer tube are also changed. This

reduces the AGC voltage and causes overloading similar to Tele-Clue M-141. The normal amplitude of the waveform at the plate of the keyer tube was about 600 volts peak to peak. The low output 5U4-G caused this voltage to be reduced to about 400 volts peak to peak. The AGC circuit shown in Fig. 2 was not affected by the low output rectifier tube. The only noticeable change was a reduction in size.

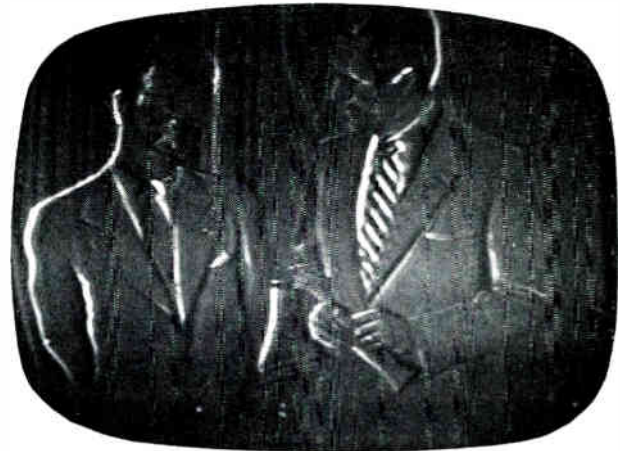
**Tele-Clue No. F-147.** The above condition was caused by an open input filter capacitor C600A shown in Fig. 3. This caused practically the same type of picture as Tele-Clue M-141. The amplitude of the waveform at the plate of the keyer tube in Fig. 1 was about two thirds of the normal amplitude. The AGC circuit shown in Fig. 2 was not affected by an open filter. The only change in the picture was a reduction in size and horizontal hum bars.

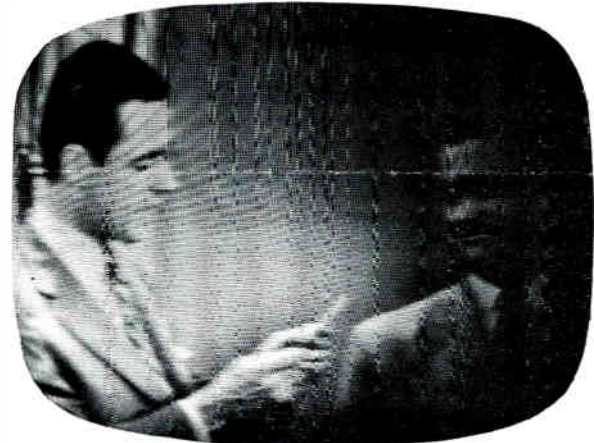
**Tele-Clue No. F-148.** If the output capacitor C602A in Fig. 3 is open, the AGC voltage is not affected and the only noticeable change to the picture is a slight shading on the right side as shown above. The amplitude of the waveform at the plate of the keyer tube in Fig. 1 was reduced about ten percent but this was not enough to affect the picture quality. The AGC circuit in Fig. 2 was not affected by an open filter capacitor.

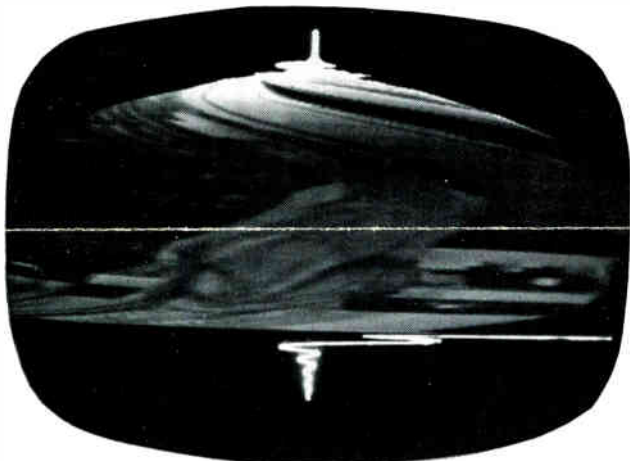
**TELE-CLUE E-149.** A heater-cathode short in V117A in Fig. 1 will cause the picture to be distorted as shown above. This caused the cathode to be modulated by a 60-cycle a-c voltage which cuts off the horizontal oscillator at the top and bottom of the picture tube screen.

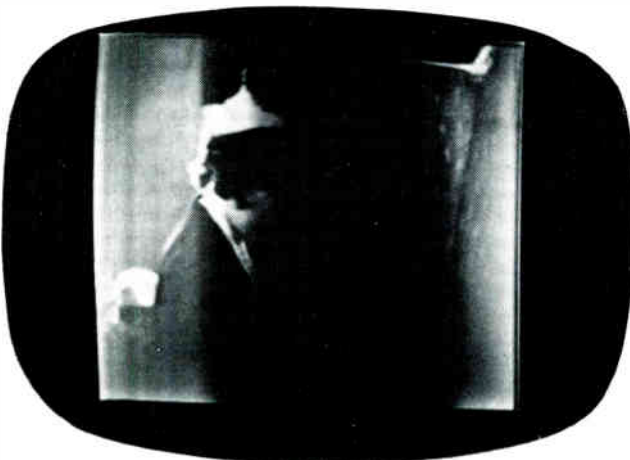
**TELE-CLUE E-150.** An open capacitor C-371 in Fig. 1 produces the defect shown above. When this capacitor is open the critical balance across

the horizontal transformer is changed. This affects the shape of the waveform fed to the horizontal blanking tube and causes the center portion of the picture to be blanked out. The reduction in width and height was due to a lower B+ boost voltage which also resulted from the open capacitor C-371. If C-371 shorts, it completely blanks out the raster.

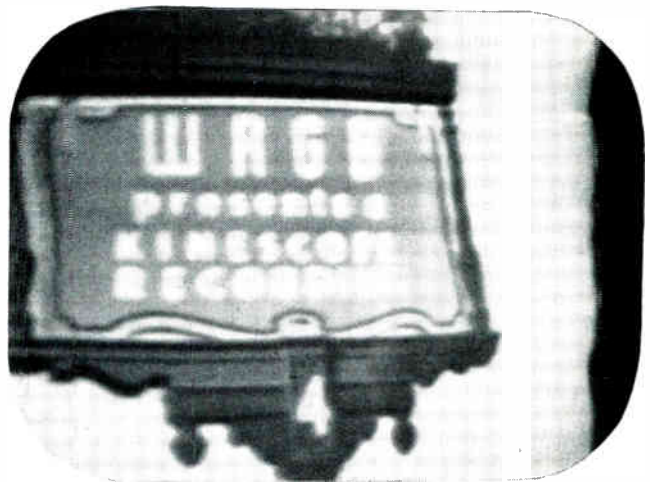
**TELE-CLUE E-154.** An open circuit between the graphite coating on the picture tube and chassis is another cause for waviness in the raster edges. This was the cause of the waviness shown in the above photograph. Note that the darker areas in the picture cause deeper indentations in the edge than lighter areas. Since the aquadag coating on the picture tube acts as a HV capacitor, the same condition could be caused by an open HV capacitor.

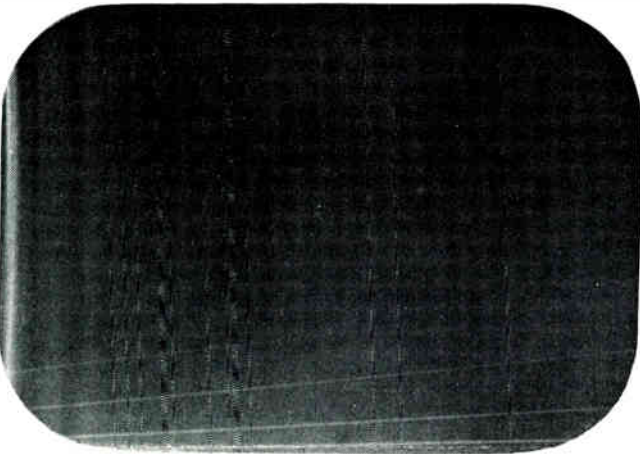
**TELE-CLUE M-152.** Stewart Warner Models 9120A, B, C, D, E and F. A complete loss of video information with a reduction of high voltage results if the resistance of R-258 in Fig. 2 is reduced in value. This defect may be misleading since a check of the video signal at the output of the video detector is normal in appearance. The amplitude, however, is about ten times the normal amplitude of 1.7 V peak-to-peak. This produces enough bias on the grid of the first video amplifier (V12) to cut it off completely. Since the AGC voltage depends upon the frequency and amplitude of the waveform in the horizontal output transformer, this defect in the horizontal multivibrator will cause a reduction in the AGC voltage as well as the HV anode voltage.

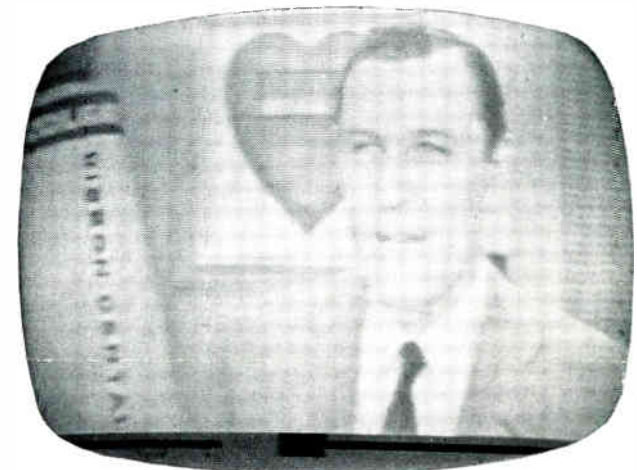
**TELE-CLUE K-155.** The above condition was due to leakage in capacitor C-351 in Fig. 3. In this instance, the picture would sync normally at a low setting of the contrast control. When the contrast control was advanced to produce a picture with normal contrast, the vertical would jump to the position shown above. If this capacitor is shorted, the picture will be too dark and the contrast control will have very little if any effect.

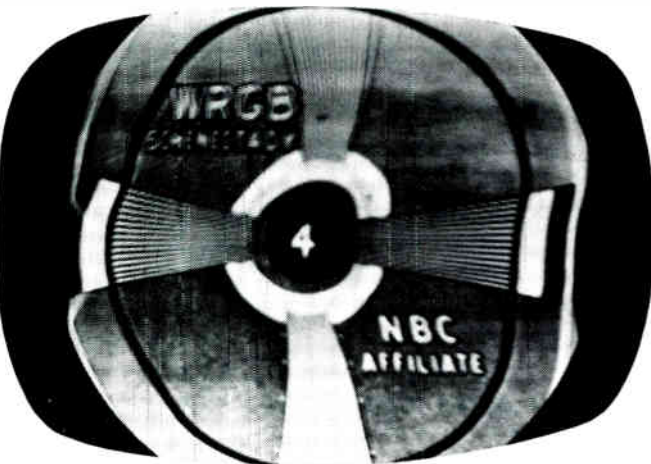
**TELE-CLUE K-153.** The waviness in the picture together with the displacement to the left resulted from an open C-353 in Fig. 3. Since this capacitor has to pass the horizontal sync pulse, when it is open, the sync pulse will be integrated through the resistor, R-353. This integrated pulse causes a delay in the sync which shifts the picture to the left. With the weakened horizontal sync pulse, the sync is influenced by the black transmission of the picture that causes the wavy edge to the picture. It appears as though the "black" transmissions pull the picture out of shape.

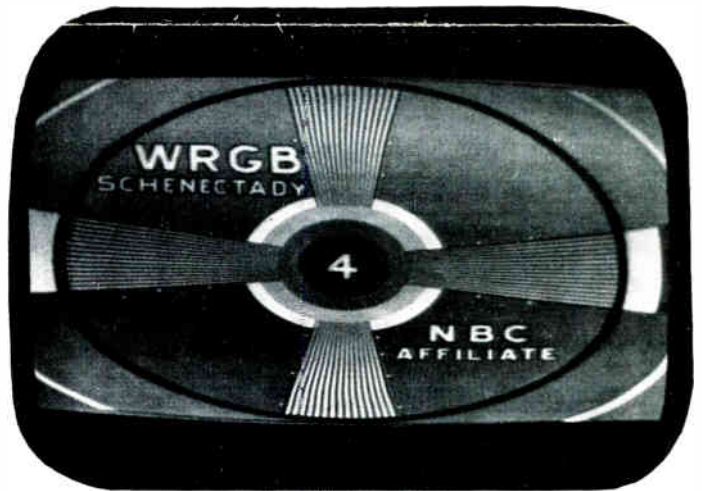
**TELE-CLUE D-157.** The reduction in height on General Electric Models 17C110 and -111 was caused by C-304 in Fig. 2 overheating. This can be corrected by extending the leads so this capacitor is about one-half inch away from the chassis. The picture is usually normal when the receiver is first turned on, but as it heats up both the height and vertical linearity may be affected.

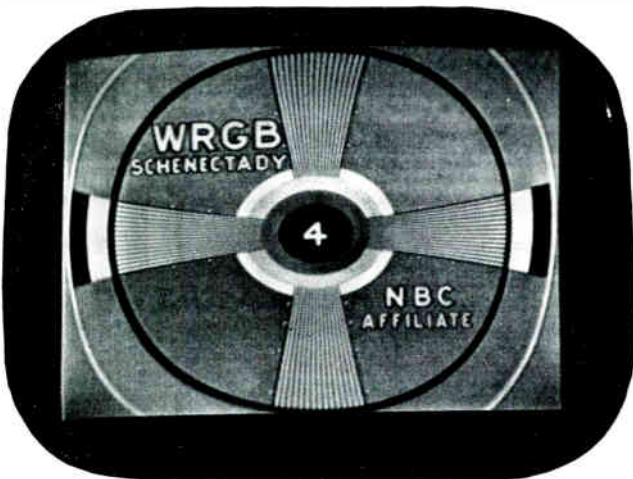
**TELE-CLUE F-156.** A reduction in both height and width may be caused by increased resistance in Globar Resistor R-454 in Fig. 1. Since an increase in this resistance will reduce the filament voltage on all the tubes, the picture quality and brightness may also be affected.

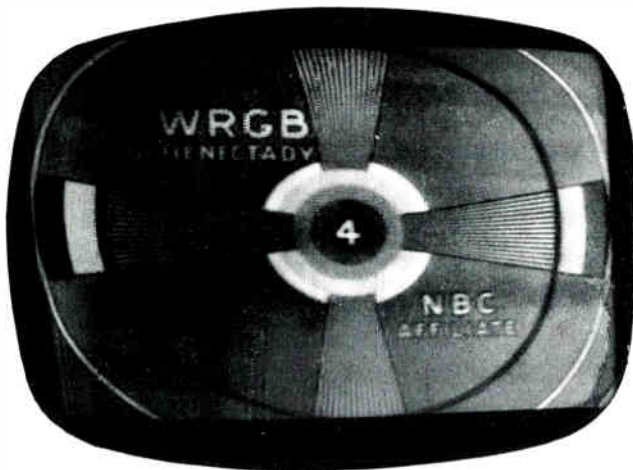
**TELE-CLUE E-158.** The use of ferrite cores in deflection yokes has resulted in increased yoke efficiency. This ferrite core is in the form of a two- or four-segment collar fastened around the yoke windings. One or more of these segments may loosen slightly, and if this happens either or both height and width may be affected. The condition shown above was produced by placing a paper collar between the ferrite core and the yoke windings in a General Electric Stratopower receiver.

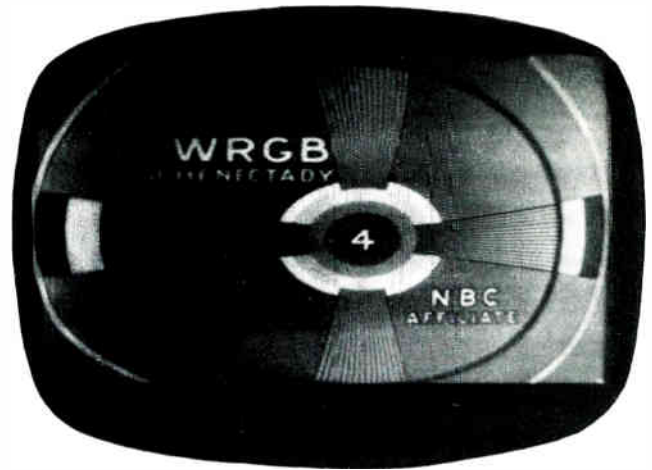
**TELE-CLUE E-161.** When one half of the ferrite core is used the picture is somewhat wider but still stretched at the top. This is due to the position of the ferrite core section.

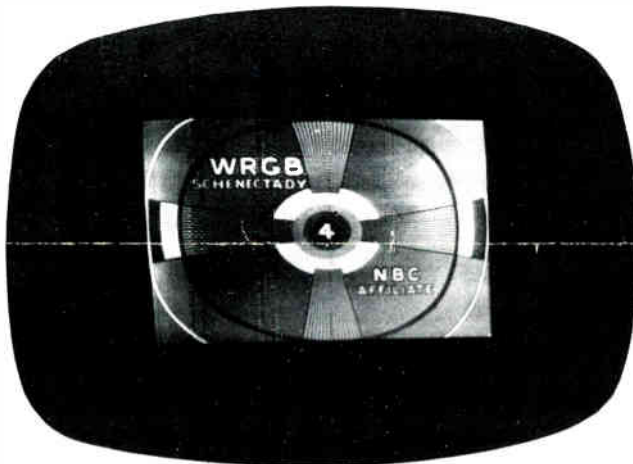
**TELE-CLUE E-159.** This photograph illustrates the effectiveness of the ferrite core. The loss of both height and width resulted when the entire ferrite core was removed from the deflection yoke.

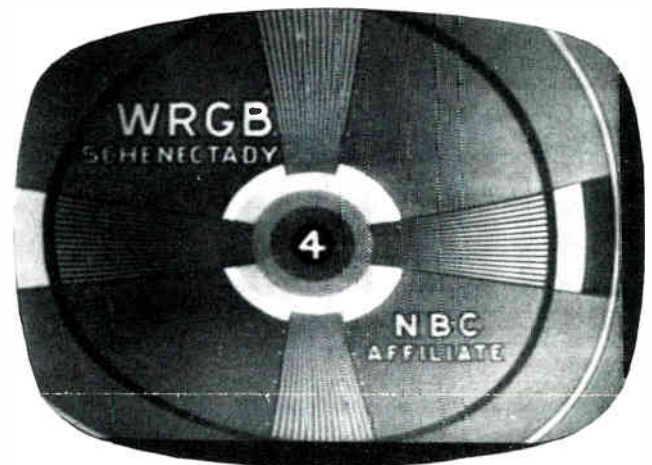
**TELE-CLUE E-162.** When three quarters of the ferrite core is used most of the picture assumes normal proportions. One portion will however be reduced in size depending on the position of the missing core section. In the above photograph the top right quarter is slightly compressed.

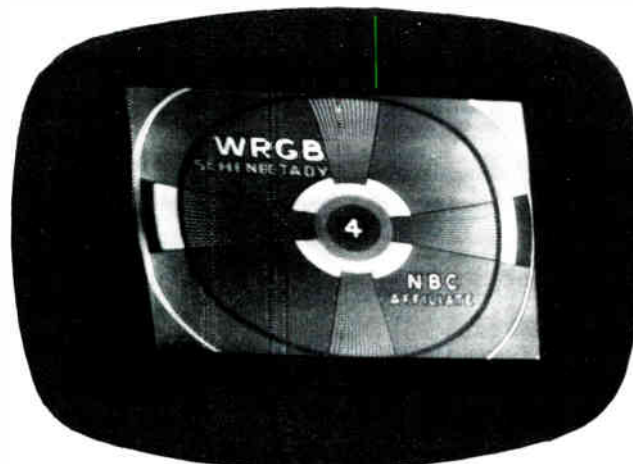
**TELE-CLUE E-160.** If only one quarter of the ferrite core is used the size is slightly increased from Tele-Clue E-159. This portion of the ferrite core increased the efficiency of only one of the four yoke windings and caused the top quarter to be stretched more than the other three quarters.

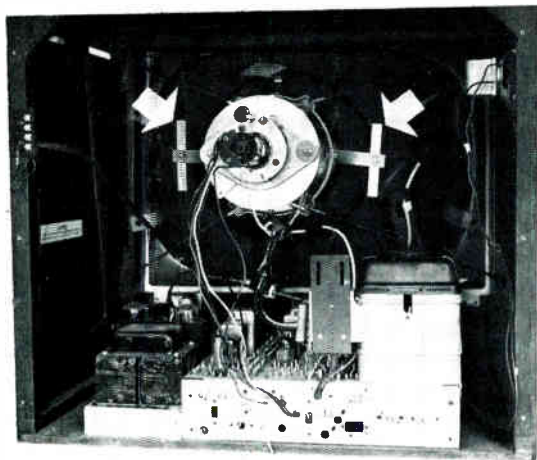
**TELE-CLUE G-163.** The two bars shown at each side of the above photograph are known as "picture straightener" magnets. When these are not used the raster sides may be slightly bowed as shown in Tele-Clues G-164, 165 and 166.

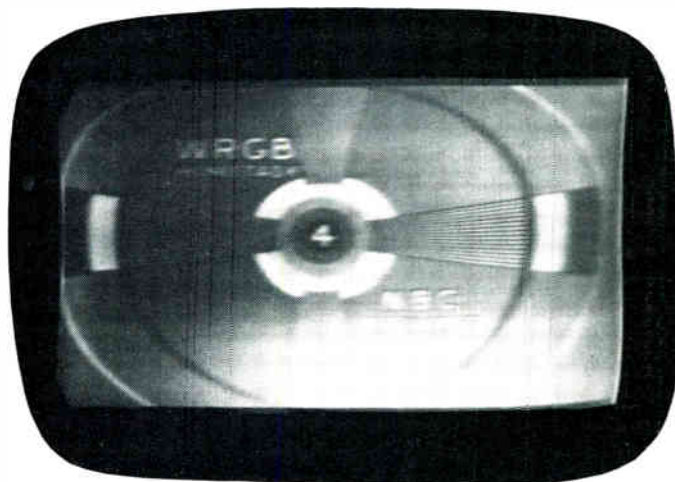
**TELE-CLUE G-166:** Misadjustment of the picture straightener magnets may cause an "S" curve on the raster edge as shown above. This could be mistaken for hum in the horizontal circuits. The correct adjustment is in the position where all sides of the raster are practically square.

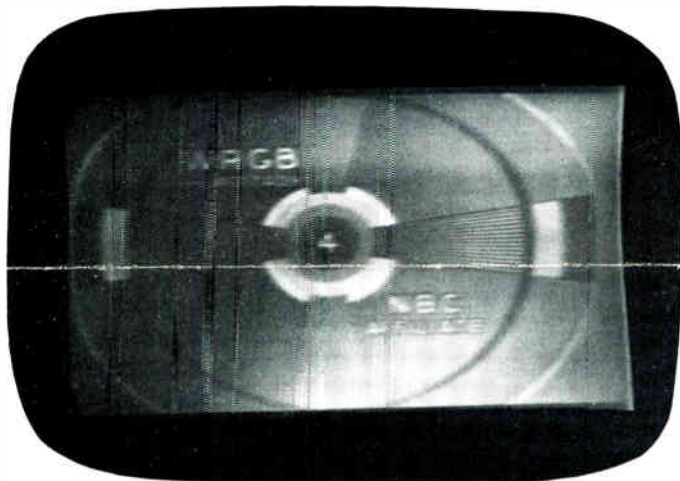
**TELE-CLUE G-164:** The bowed side of the test pattern was due to the removal of the picture straightener magnet on that side. Both the height and width had to be reduced so the edge of the raster could be seen.

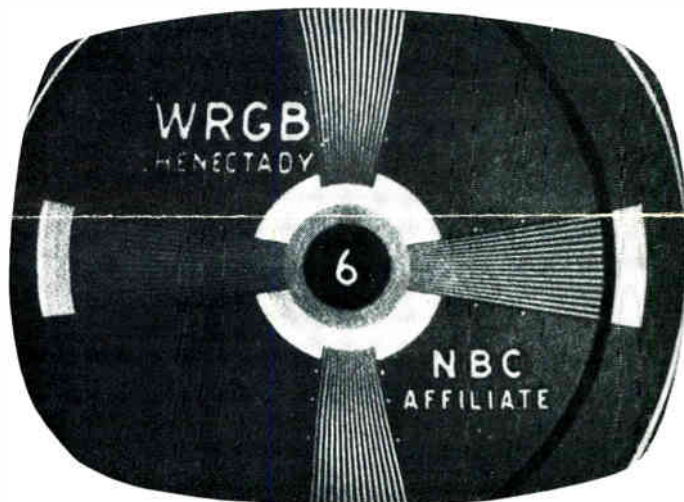
**TELE-CLUE G-167:** Loss of brightness may be caused by a reduction in the strength of the ion-trap magnet. The above picture indicates the maximum brightness that could be obtained with an ion-trap magnet which had lost some of its magnetism. A similar condition may be caused by an incorrect adjustment of the ion-trap magnet or incorrect voltages on the picture tube.

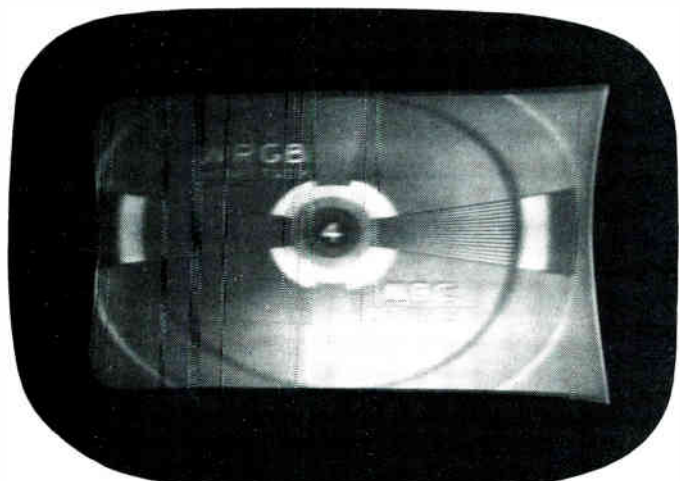
**TELE-CLUE G-165:** If the picture straightener magnets are incorrectly adjusted, the picture may be somewhat worse than if they were not used at all. The bow or "pincushion" effect in the above photograph was caused by a misadjustment of these magnets.

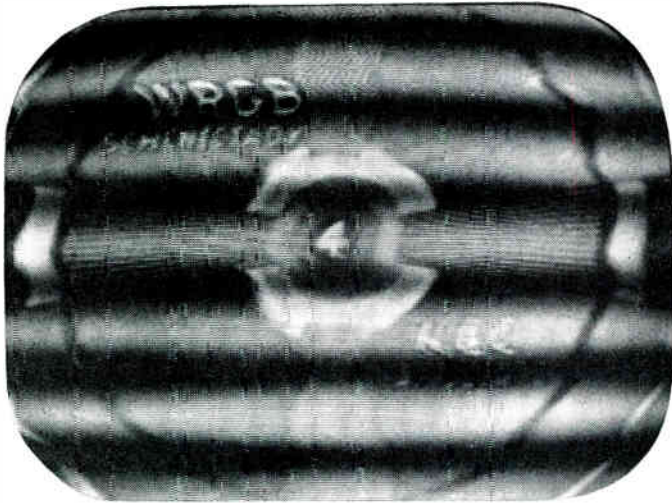
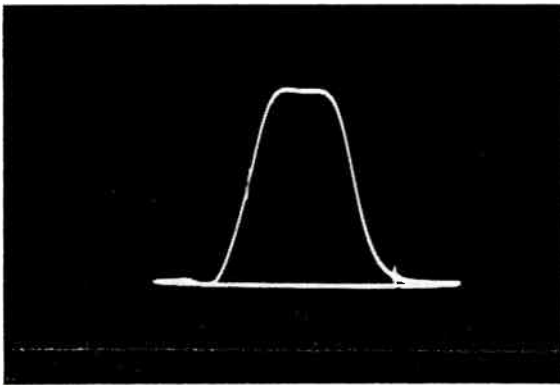
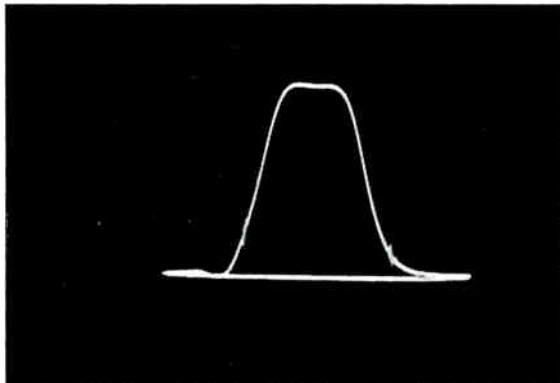
**TELE-CLUE N-168:** The sound bars shown here may be caused by several different conditions. Misadjustment of the fine tuning control or in-

correct i-f alignment can place the audio carrier too high on the alignment curve. A normal alignment curve is shown at the top and a curve with the sound carrier too high is shown at the bottom. The sound carrier is on the right side of both curves.

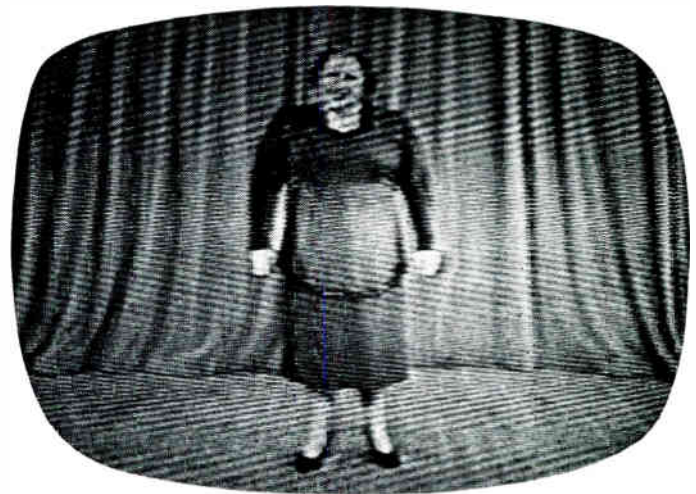
**TELE-CLUE J-169:** This type of interference may be caused by the oscillator in a UHF converter. It is the result of interaction between the oscillator in the converter and the oscillator in the receiver. In most cases it can be corrected by adjusting the fine-tuning control on the receiver. If this control does not have sufficient range to eliminate the interference, try adjusting the oscillator slug.

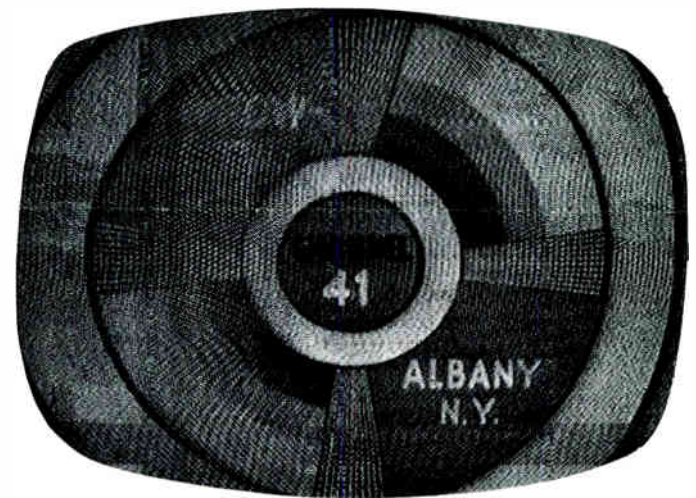
**TELE-CLUE J-170:** A VHF station may interfere with a UHF station in areas where the VHF station is on a channel adjacent to the converted UHF channel. The above picture was caused by a VHF station on channel 5 interfering with a UHF station which had been converted to channel 6. This condition can usually be improved by reducing the oscillator frequency on channel 5. The lead between the converter and the receiver should be shortened as much as possible to avoid VHF signal pick-up. In some cases it may be necessary to change the input channel to channel 4. If this is done the i-f stage in the converter should be realigned to the channel 4 frequency.

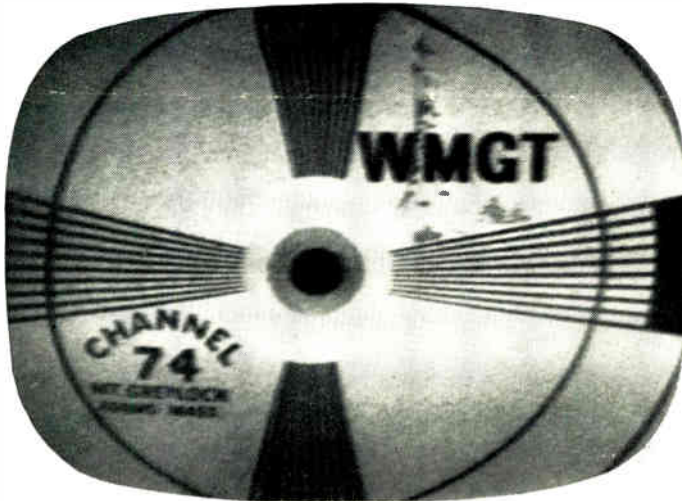
**TELE-CLUE O-171.** Cascade type UHF Converter with the best signal-to-noise appearance.

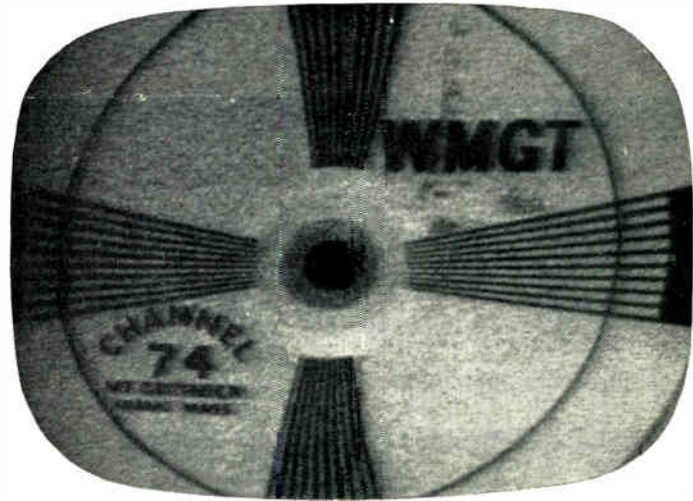
**TELE-CLUE O-173.** Pentode type UHF Converter with the best signal-to-noise appearance.

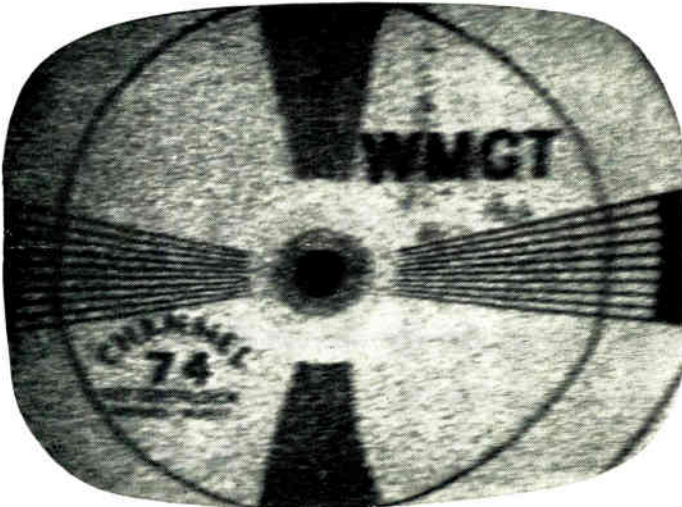
**TELE-CLUE O-172.** Cascade type UHF Converter with the poorest signal-to-noise appearance.

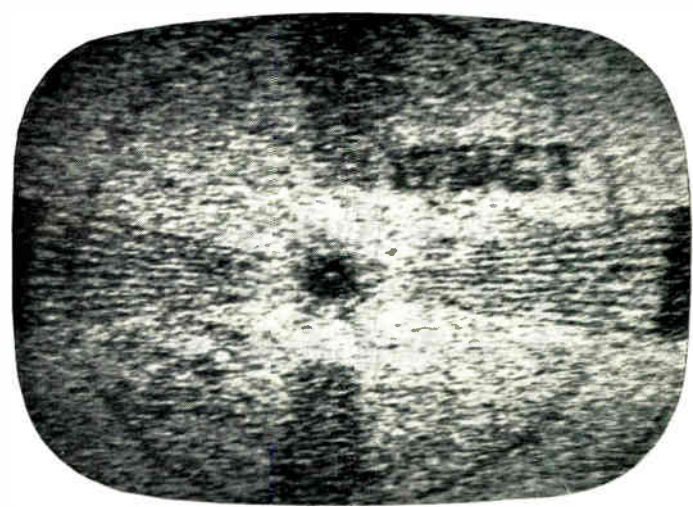
**TELE-CLUE O-174.** Pentode type UHF Converter with the poorest signal-to-noise ratio.

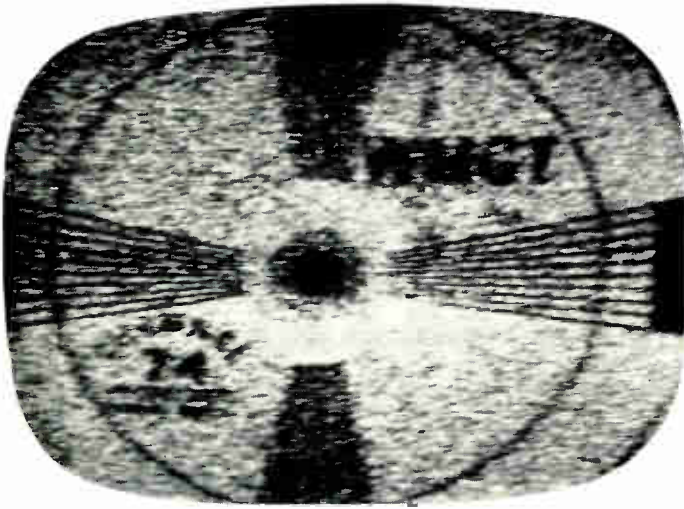
**TELE-CLUE O-175.** The same converter used in Tele-Clue O-174 but with the antenna tuned. A piece of tin foil was wrapped around the UHF antenna lead and moved along the lead until the best picture was received. The improvement was not perceptible in most of the other converters.

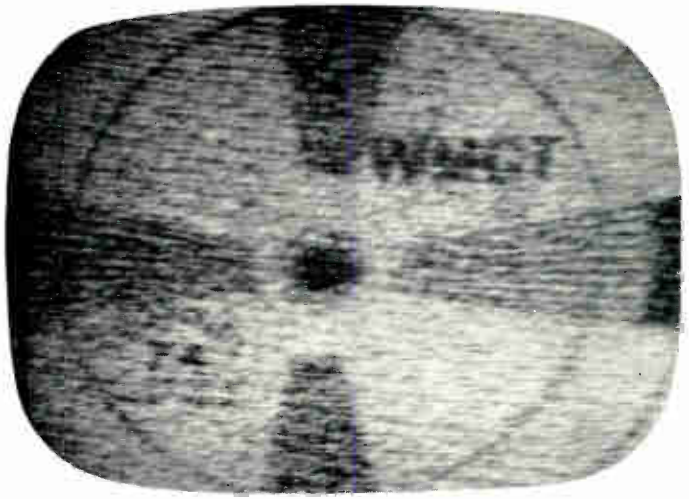
**TELE-CLUE O-178.** Single tube type UHF Converter (no i-f stage).

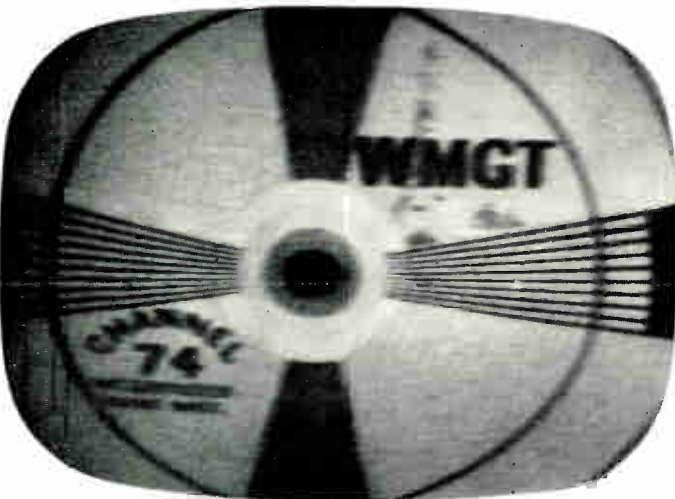
**TELE-CLUE O-176.** Grounded-grid type UHF Converter.

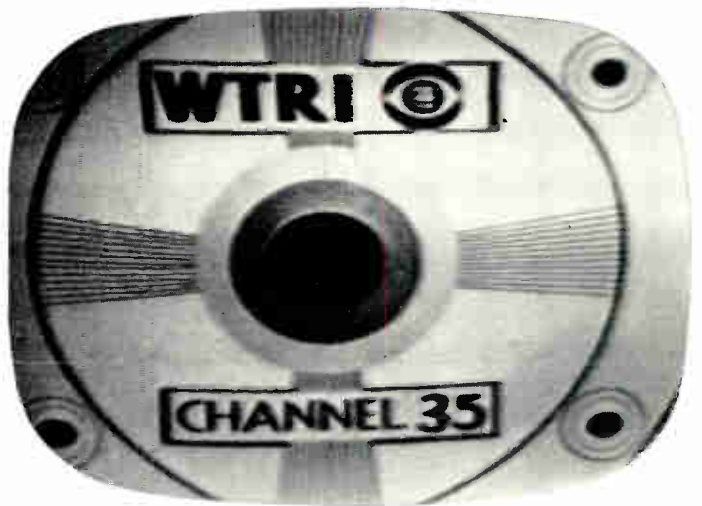
**TELE-CLUE O-179.** Just about every UHF Converter produced a usable picture from the local station. If a sufficient signal level is present the signal-to-noise ratio of the converter has little importance. The converter used in Tele-Clue O-171 produced the above picture from the local station located about fifteen miles away.

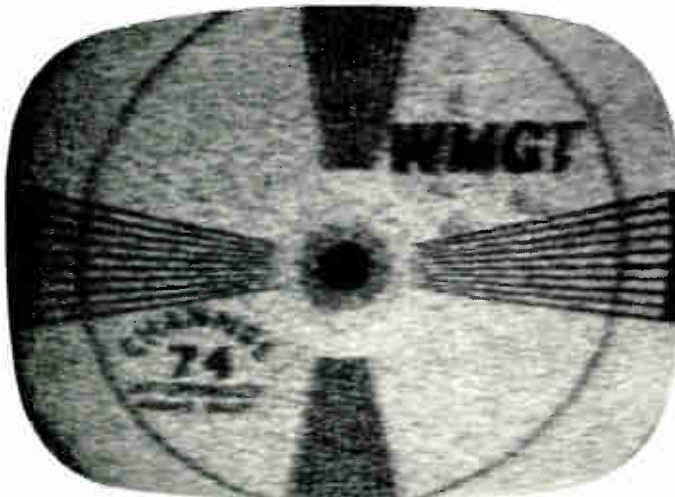
**TELE-CLUE O-177.** Channel 74 strip in the same receiver (cascode type head-end).

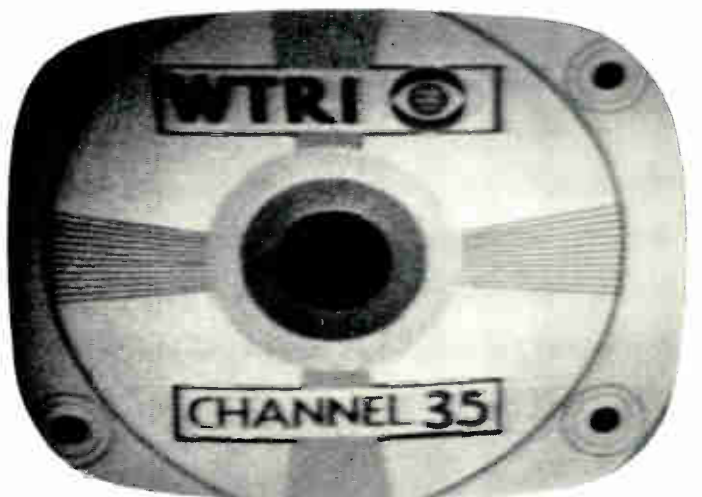
**TELE-CLUE O-180.** The Converter used in Tele-Clue O-178 produced the above picture from the same local station.

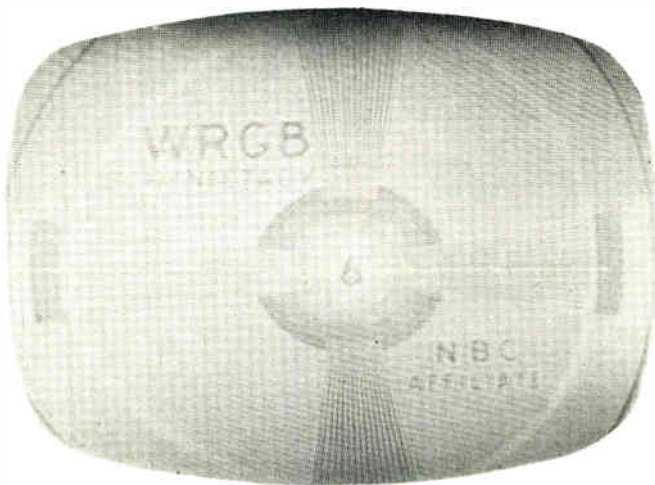
**TELE-CLUE C-189.** An open video choke in the plate supply circuit will produce a negative picture. This picture was caused by an open L-164 in Fig. 1. Since the sync signals were taken off the detector in this receiver synchronization was not affected. An open in L-162 would produce a similar condition.

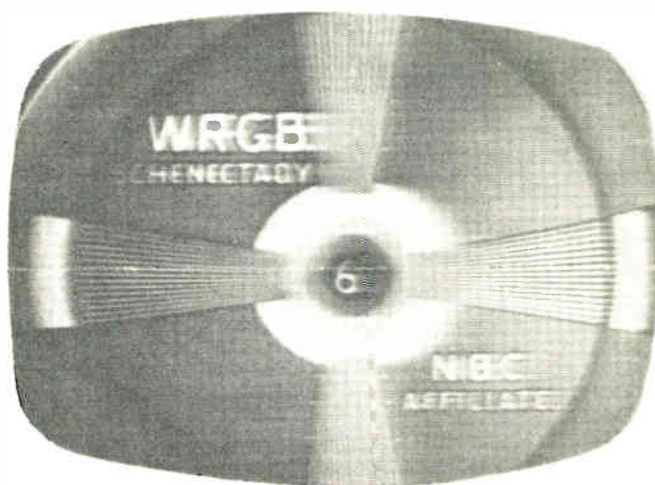
**TELE-CLUE C-190.** An open choke when a resistor is in series may cause a smear. This picture was caused by an open L-155 in Fig. 1. An open in L-161 would produce a similar condition.

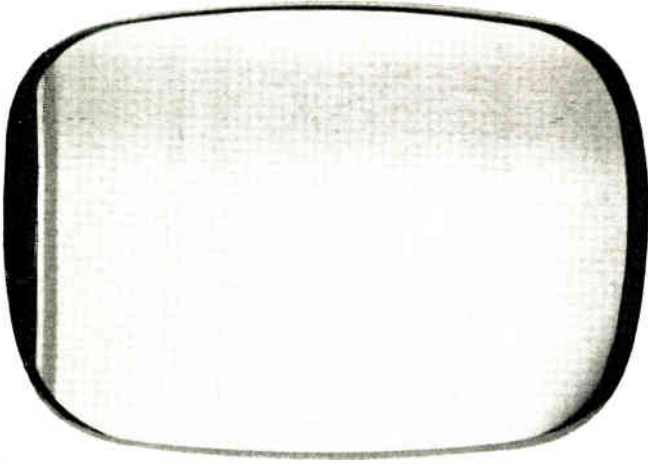
**TELE CLUE E-191.** The dark vertical lines at the left are known as "Diode-hausen" and are produced in the high voltage rectifier tube. "Diode-hausen" is a radiation phenomenon and is more pronounced when an indoor or built-in antenna is used. General Electric 1B3-GT tubes will not produce Diode-hausen.

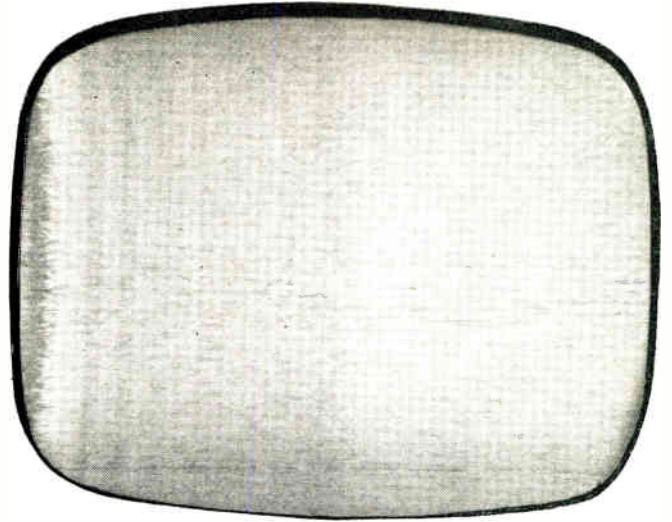
**TELE CLUE E-192.** The jagged dark vertical line on the left is known as "spook." This is similar in location and appearance to "Diode-hausen" as shown in Tele Clue number E-191. The vertical lines produced by "spook" are usually more jagged than "Diode-hausen." "Spook" is produced in the damping diode circuit and is a radiation phenomenon. This condition can be eliminated in most receivers either by replacing the damper tube or adding r-f filters in the plate and cathode leads of the damper tube.

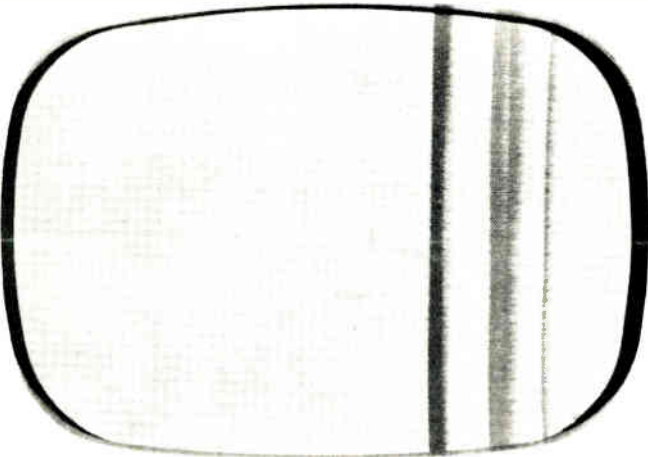
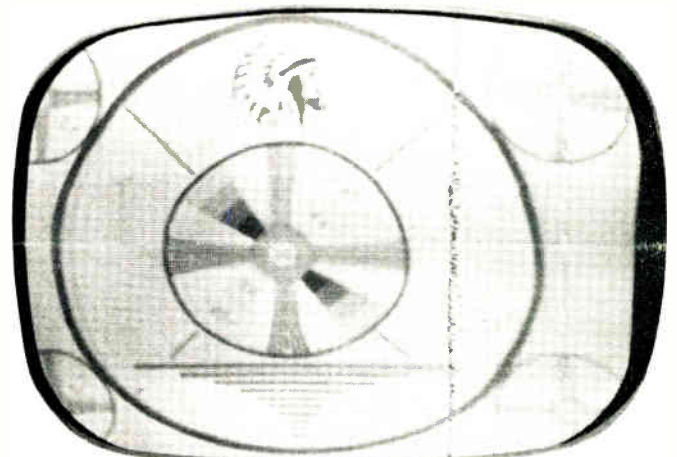
**TELE CLUE E-193 AND 194.** The dark vertical lines at the right are known as "snivets." This condition may be due to the design of the horizontal circuit in which a particular horizontal output tube is used. A horizontal output tube which produces "snivets" is usually characterized by a sharp dig in the  $E_b$ - $I_o$  curve at or near the "knee." A tube with this characteristic may operate satisfactorily in some receivers but not in others. Snivets like "spook" and "Diode-hausen" is a radiation problem which is worse when an indoor or built-in antenna is used. This condition may appear on either UHF or VHF or both. E-193 shows "snivets" on a blank raster and E-194 with a video signal.

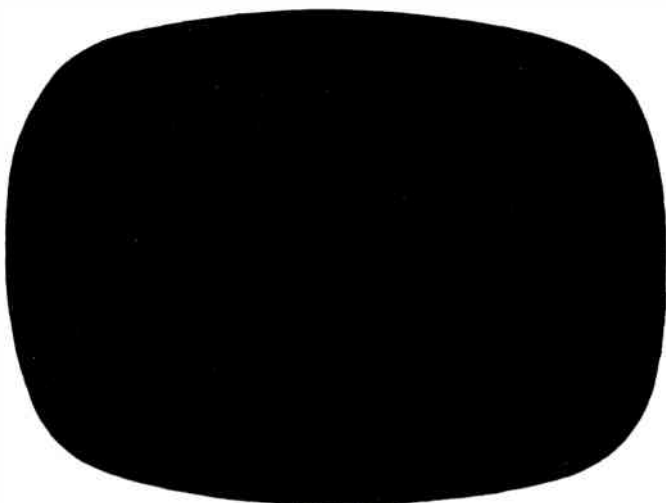
**TELE-CLUE F-195:** The black screen shown here was caused by an open C 400 A—20 Mfd, 450 V capacitor in the "N" series chassis. A schematic of this chassis was included in the Vol. 7 No. 1 issue of *Techni-Talk* as a Tele-Clue Schematic. C 400 A is part of a dual-unit capacitor located under the chassis. This capacitor is connected between the B+ side of the vertical output transformer and ground. The blanked out screen was due to the reduction in B+ boost voltage from about 400 V to 240 V. The B+ boost voltage developed across this capacitor can be measured from the red wire on the yoke plug to chassis. The regular B+ voltage is not affected by this capacitor. No increase in audio buzz is noticeable when this capacitor is open.

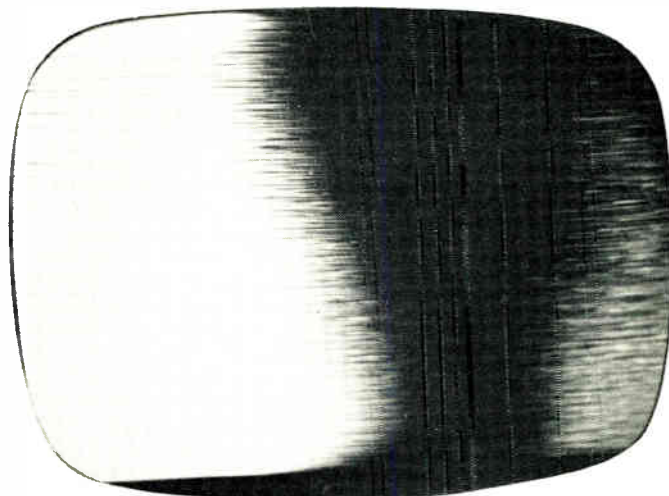
**TELE-CLUE F-197:** The picture shown here resulted from an open C 403 A—200 Mfd, 250-volt capacitor in the "N" chassis. This is one section of a dual unit located on the front apron of the chassis. When this capacitor is open B+ is not affected but the horizontal cannot be brought into sync and the vertical sync is critical. A slight audio buzz is also present.

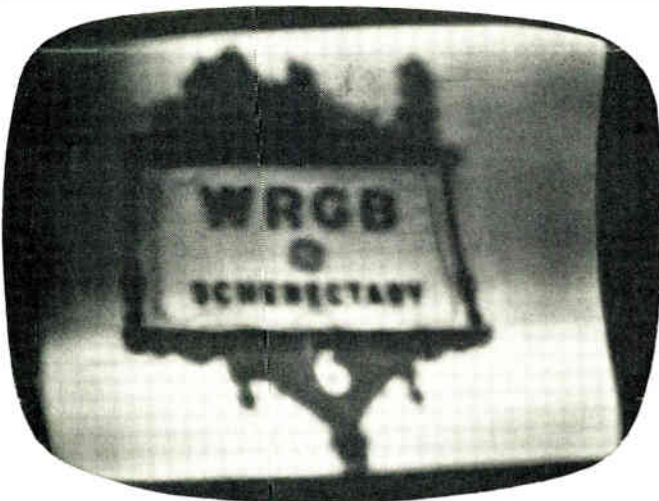
**TELE-CLUE F-196:** The dim picture shown here was caused by an open C 400 B—150 Mfd, 250 V capacitor in the "N" chassis. This is a dual-unit capacitor located under the chassis. When this capacitor is open the B+ voltage drops from the normal 215 V to 120 V. Audio buzz increases to an objectionable level and does not vary with volume control settings. The effect of increased hum can be seen in the curvature and shading of the picture. Vertical sync is normal but the picture is reduced in size and is out of focus.

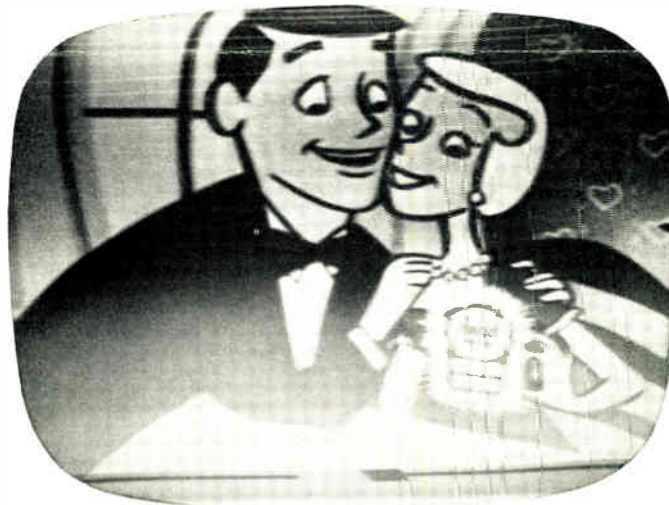
**TELE-CLUE F-198:** If the same capacitor (C 403 A) used for Tele-Clue F-197 loses some of its capacitance the vertical sync becomes "soft." The hum voltage causes both curvature and shading as shown in this Tele-Clue.

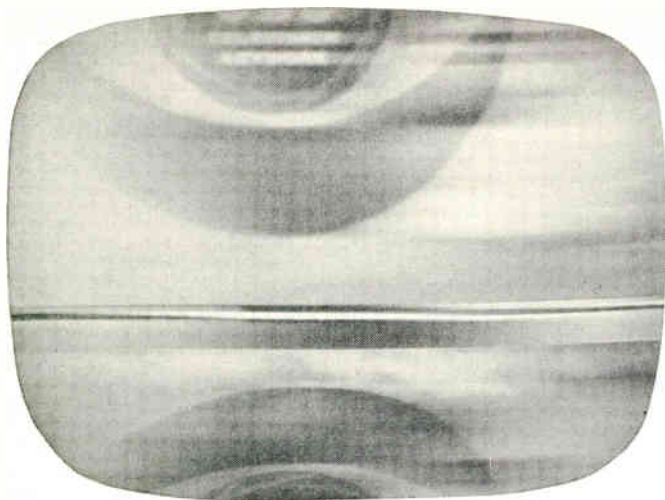
**TELE-CLUE F-199:** If the other half of capacitor C 403 in the "N" chassis is open the low-frequency response is affected. C 403 B is a 15 Mfd, 250-volt capacitor also located on the front apron of the chassis. When this capacitor is open the picture may tend to "bounce" and usually syncs with the blanking bar visible. Notice the streaking in the picture as well as the appearance of the blanking bar.

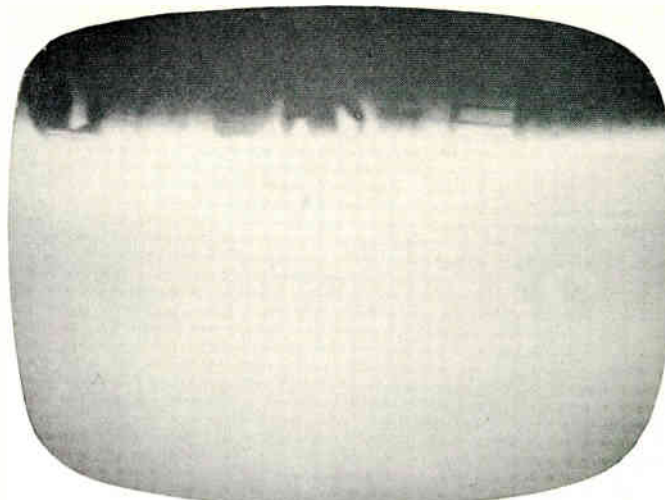
**TELE-CLUE M-202:** This defect is the same as Tele-Clue M-201 but at a different setting of the vertical hold control.

**TELE-CLUE M-201:** The defect shown was caused by an open AGC capacitor C161 in the "N" chassis between the 12BH7 socket and the 3AU6 1st i-f amplifier socket. A high-level audio buzz was present which varied with the volume control setting. The video and audio defects were due to about 3 volts of 60 cycles a-c which appeared on the AGC line when C161 was open.

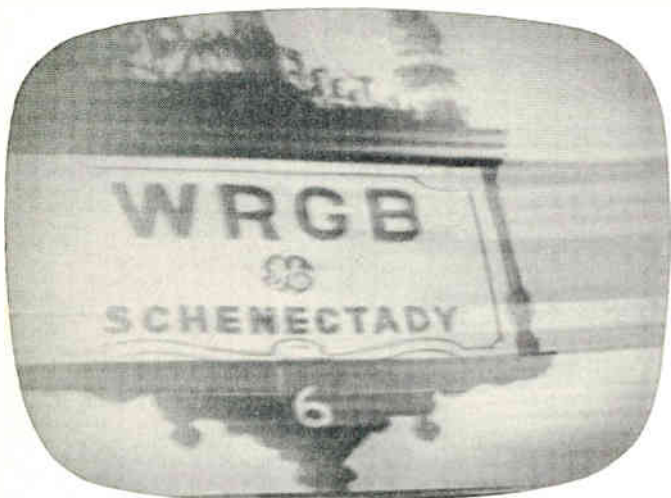
**TELE-CLUE F-200:** This is another photograph of the same defect shown in Tele-Clue F-199. This shows the streaking in the picture and blanking bar as well as the washed-out appearance at the left side of the picture.

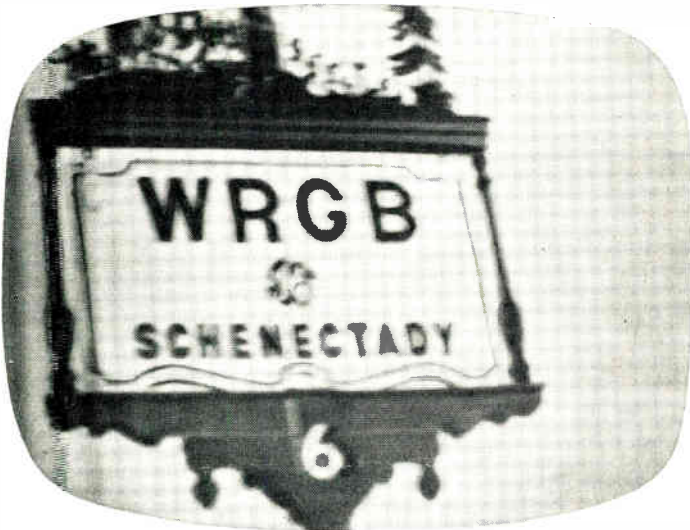
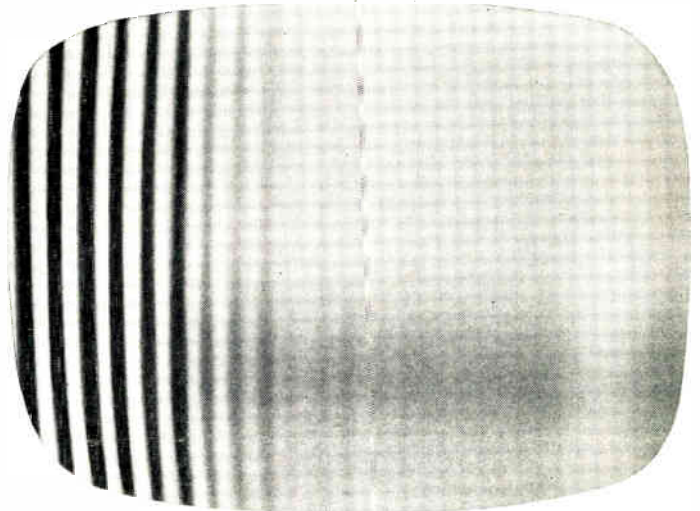
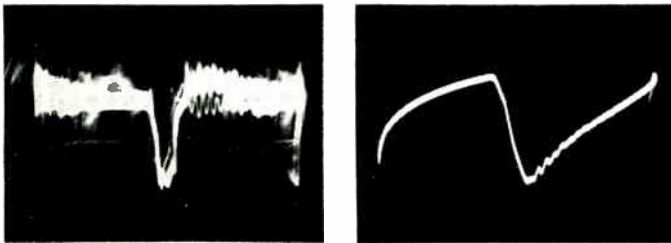
**TELE-CLUE F-203 and 204**—The vertical striations were caused by a defective C-464 capacitor in a 21T4 type General Electric receiver. The electrical location of this capacitor is shown in Fig. 1 and the physical location in Fig. 2. This capacitor checked OK on a capacitor checker, but it had apparently lost its effectiveness at higher frequencies as indicated in the waveform photographs. The first waveform was taken with the oscilloscope connected to the grid of the picture tube. The second and third waveforms were taken with the oscilloscope connected across a 10-ohm resistor in the B+ side of the horizontal yoke winding. The oscilloscope was synced at one-half the horizontal frequency. The first and second waveforms indicate that spurious frequencies are present in both the video signal and the horizontal sweep current. A new C-464 capacitor removed these spurious frequencies as shown in the third waveform. It was also found that a .25 or .5 mfd 600-volt capacitor connected across the original C-464 or a 1000-ohm resistor in series with the B+ lead to the head end was effective in eliminating the vertical striations. Similar visible striations have been noticed on other General Electric models. These were also due to defective filter capacitors.
