# Tele-Clues

**Tele-Clue K-274**

**Receiver:** G-E "U-4" line (See "U-4" Tele-Clue Schematic).  
**Component:** C254, 5000 mmfd, 450 volt capacitor, temperature range 10° - 105° C - SHORTED.  
**Circuit:** Grid circuit of V8 Clipper tube.  
**Symptom:** Soft sync, horizontal side lock and possible audio buzz.

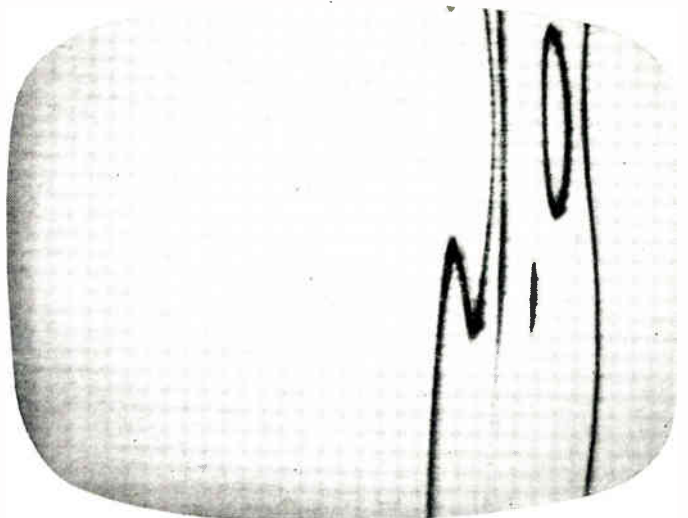
Tele-Clues E-205, 6, and 7 show fairly typical "snivets" which are spontaneous, spurious oscillations generated within the horizontal output tube. The frequency is dependent upon geometric configuration and applied potentials. It is also affected by magnetic fields (which can be thought of as changing the geometric configuration). Because of the slight change in geometry necessary to alter the frequency, the snivet characteristics of sweep tubes vary between tubes of the same manufacture but generally more between manufacturers. Likewise, the voltage conditions vary between sets so that some sets of the same manufacture are more prone to snivet than others and some manufacturers' sets are more prone to snivet than others.

**TELE-CLUE E-205 AND 206**—These dark patterns on the right side of these two photographs are due to "snivets." This condition was previously described and illustrated in Tele-Clues E-193 and 194. The "snivets" shown above appeared only when a separate UHF converter was used. The pattern changed as the frequency of the converter was changed and at some settings the raster was "clean."

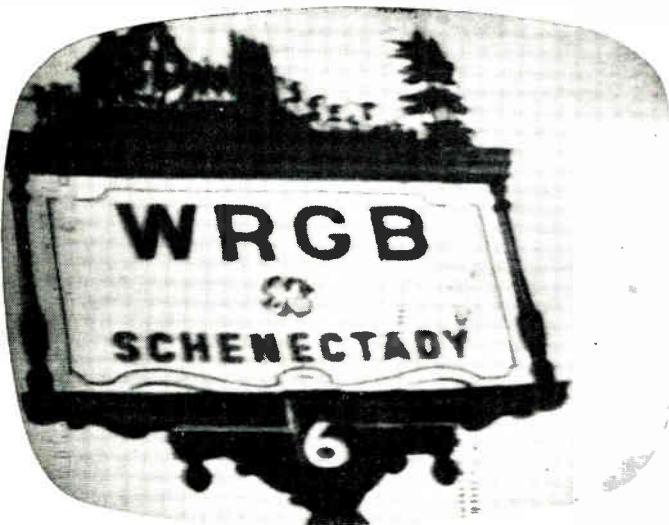
**TELE-CLUE E-207**—This shows the effect of "snivets" when a picture is received. A different horizontal output tube may eliminate the "snivets" entirely or change the frequency so the picture is "clean." Another method which may be used is to place an ion-trap magnet over the horizontal output tube as shown in the photographs on the right. The ion-trap is then slowly turned until the "snivets" disappear.

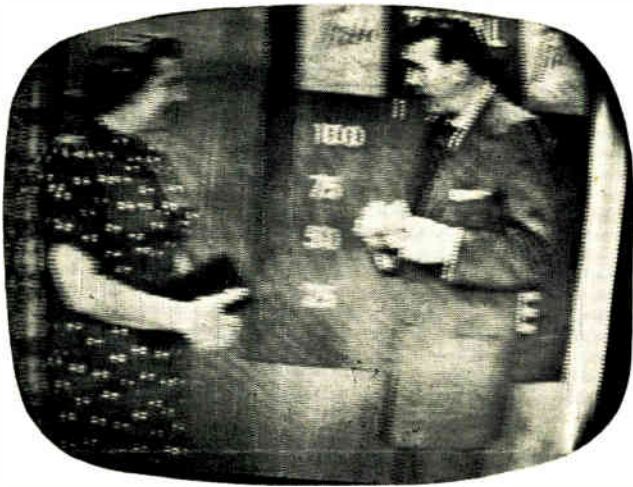
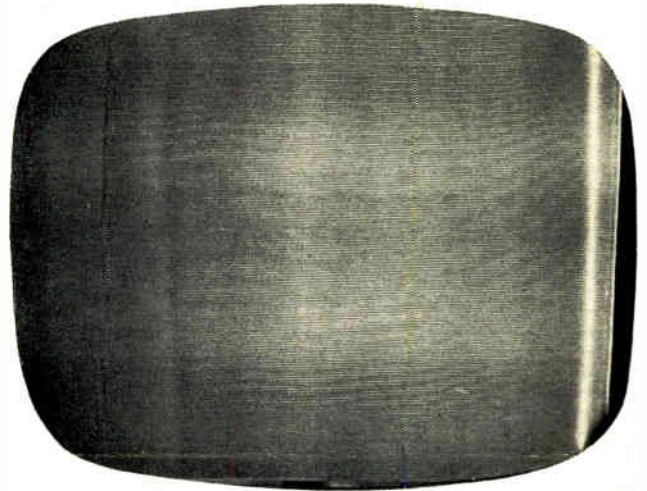
**TELE-CLUE E-208 AND 209**—The reduction in width plus horizontal displacement of alternate fields was caused by a leaky 680 mmf capacitor (C260) in the General Electric "N" series receiver. This capacitor is connected in series with a 12K resistor between pin 5 on the 12 BQ6-GA horizontal output tube and chassis. This defect also produced a white vertical line which can be seen in Tele-Clue No. E-209 on the right. Refer to "N" Tele-Clue schematic.

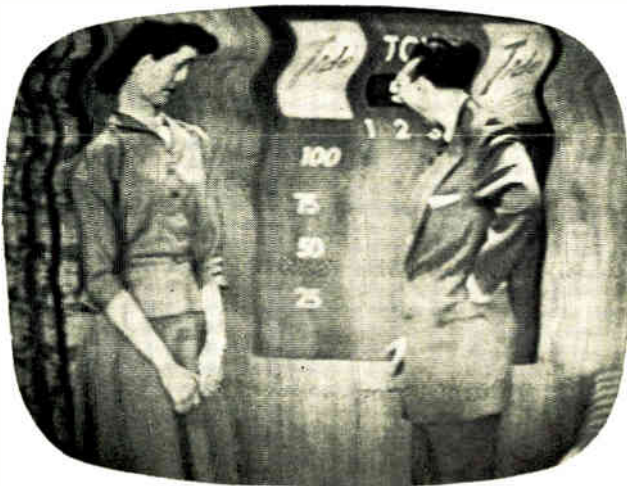
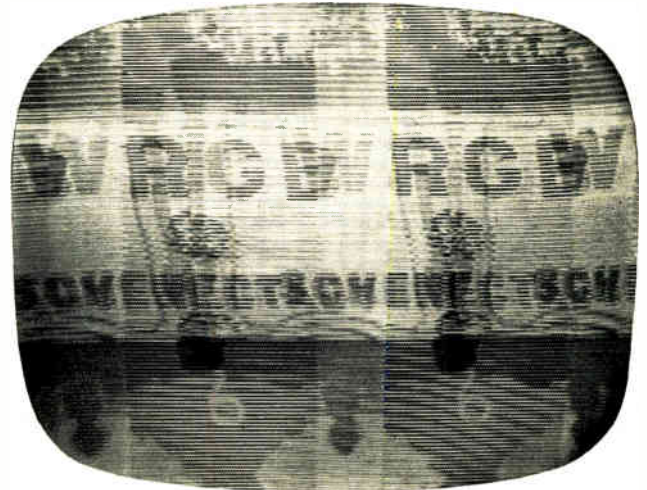
**TELE-CLUE E-210**—An open .2 mfd capacitor C255 in "N" series General Electric chassis will cause the defect shown above. This capacitor is connected in series with a 27K resistor between pin 1 of the 6SN7GTB (V109) horizontal multivibrator and ground. The waviness produced by an open in the anti-hunt circuit is less pronounced in this chassis than in some other models. A comparison can be made between the above Tele-Clue and Tele-Clue E-26. Refer to "N" Tele-Clue schematic.

**TELE-CLUE E-211**—If the horizontal multivibrator (V109) cathode resistor in the General Electric "N" chassis changes value the horizontal frequency will be affected. This resistor R262 was changed from 1.2K to 600 ohms.

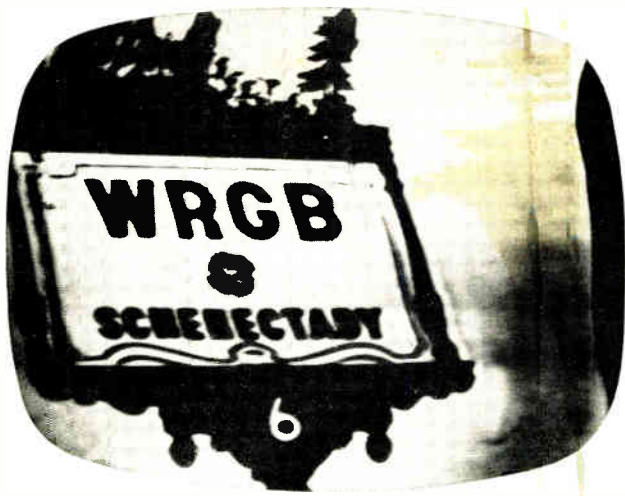
**TELE-CLUE M-212**—The distortion shown here was caused by a 6BC5 tube with grid emission in a General Electric Model 17T1 receiver. The receiver would operate normally for about ten minutes. The contrast would then slowly increase until the contrast control had little or no effect on the picture. If any one of the AGC controlled tubes are leaky, gassy or have grid emission, the picture will be affected. V2, 4, 5, and 6 are AGC controlled in the chassis layout shown in Fig. 1. Due to the shield on V6 this tube runs hotter than the others and may, therefore, be more susceptible to this defect. Tele-Clue M-102 describes other components which may produce a similar condition.

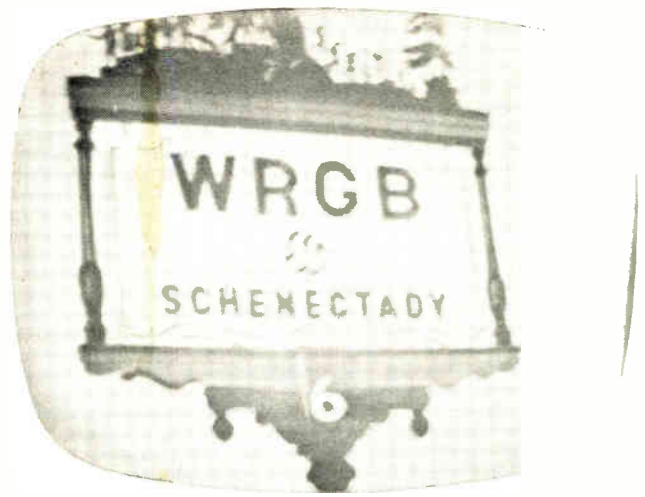
**TELE-CLUE Q-213**—The above photograph shows the effect of too much brightness which could not be reduced beyond the level shown. A heater-cathode short in the picture tube will cause this condition. This type of short can be cured sometimes by gently topping on tube neck. Another defect which may develop in General Electric receivers such as model 17T1 is an increase in the value of resistor R274 encircled in Fig. 2. This resistor is located above the chassis on the terminal board near capacitor C-451 in Fig. 1.
