**COLOR TV**

**FACTBOOK**

**-Problems & Solutions**

By the Editors of Electronic Technician/Dealer

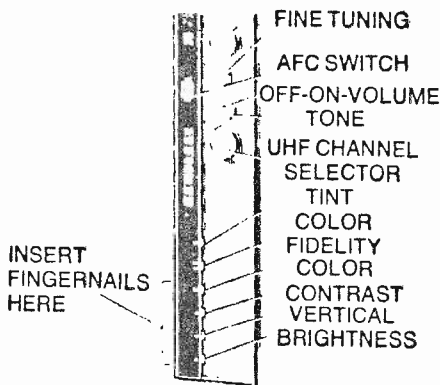
In models using the NC2570-1, -2, -51 and NC2596-1 tuner clusters, removal of the auxiliary control cluster

can be simplified by snapping out the lower portion of the long narrow plastic crystal that covers the knobs (see illustration). Insert fingernails under the left edge of the crystal at the bottom; press toward the right and pull upward. Lift the crystal far enough to permit removal of color fidelity knob. Then proceed with cluster removal from the back by taking out the two mounting screws, disconnecting the leads and working the assembly out past the escutcheon boss and the CRT.

When reassembling, replace knob then insert right edge of crystal carefully to avoid damage to escutcheon, then snap in left edge.

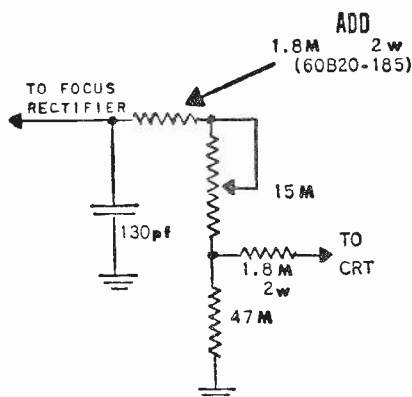
### CURRENT PRODUCTION

The focus control, in present production of H10 and H12 series color chassis, is wired as a rheostat instead

of a potentiometer. A 1.8M resistor has also been added. This change has

been made to improve reliability. It is suggested that you make this modification whenever you replace the focus control in a G11, G13 H10 or H12 chassis. If the set does not have adequate focus range after modification, try a lower value resistor (1M for instance) but keep the value as high as possible.

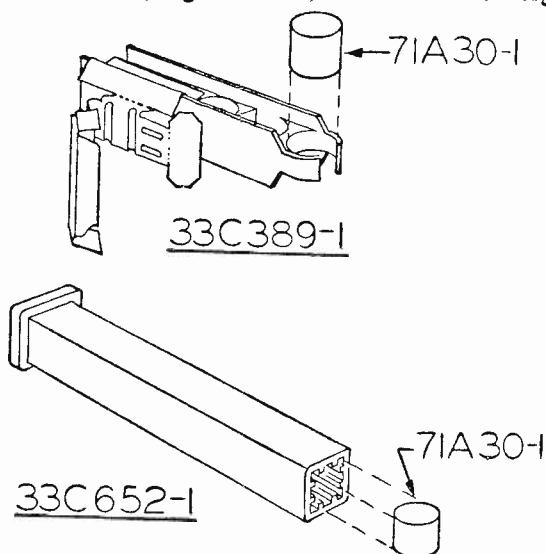
The replacement parts pictured are available to replace the nylon slider (magnet holder) used on the convergence

assembly of earlier color TV models. Order the type shown in the drawing. The magnet (71A30-1) is not included with either type. The mounting clip shown with 33C389-1 is included.

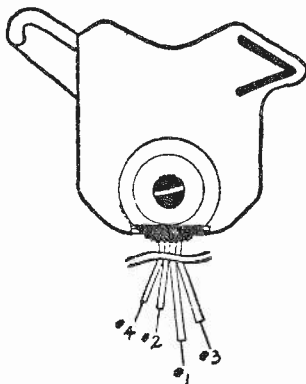
The cable from these convergence coil assemblies consists of four color coded wires bonded together as a flat conductor cable. The inside wires of the cable are connected to the vertical coils; the outside wires are connected to the horizontal coils.

The color coding of the replacement may differ from that of the original either in color or sequence or both. We suggest that you compare the replacement with the original before you remove the original. If they differ in any way, ignore the color coding when wiring the replacement. Connect the wires in the same physical sequence as the original (be sure that you view both original and replacement from the same side).

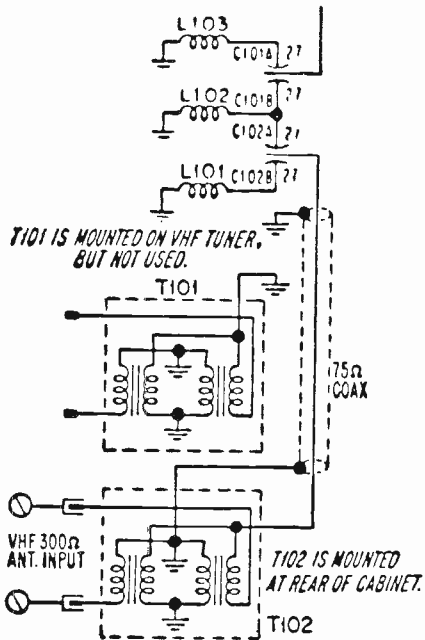
If you do not make this correction on the replacement tuner when an external balun is used, you will cause partial loss of signal and ghosting.

When you replace the above tuners in 1971 color TV sets, check the antenna terminal board on the cabinet back. If it has a VHF Balun attached, you must disconnect and ground the Balun on the replacement tuner. Then connect the 75Ω coax from the terminal board to the replacement tuner in the same manner as the original tuner was connected. The schematic shows this arrangement.

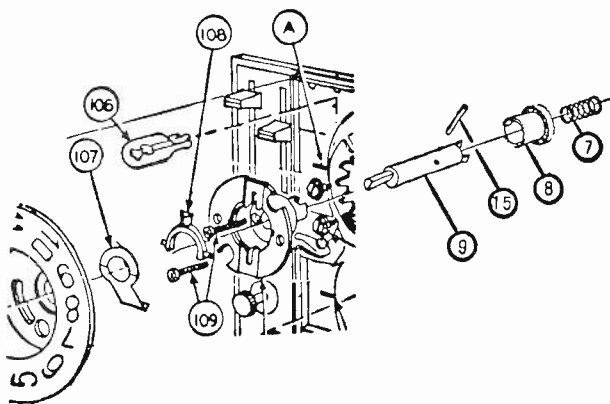
After early production models, the following changes were made to eliminate the possibility of the VHF tuner and the channel indicator disc getting one-half turn out of step.

- Spring No. 107 was changed from 19A384-1 to a heavier spring No. 19A384-2 (or two 19A384-1). See illustration.

- Compression spring No. 7 in the VHF fine tuning shaft was changed from 19A248-2 to a heavier spring, 19A248-1. This spring is already in sets using the 94C381-5 VHF tuner.

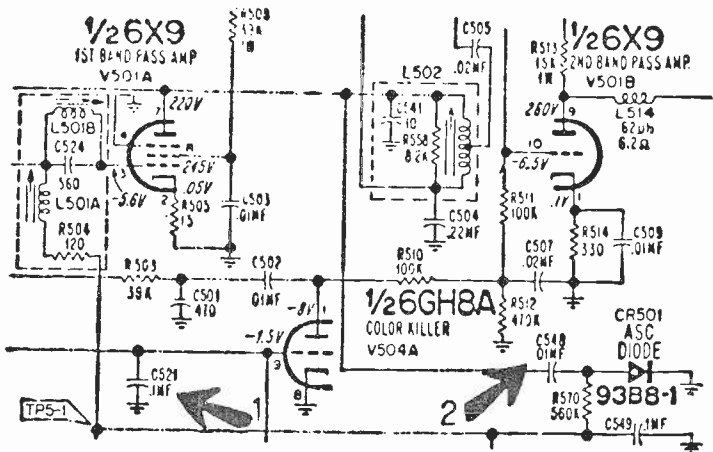
## Color-TV Chassis G11/G13/H10/H12/K15/K16 Series—Weak Or No Color

A weak or no color complaint can be caused by defective capacitor C521.

Failure of this capacitor permits a negative voltage to be produced at the plate (Pin 1) of the color killer tube, which will bias off the second bandpass amplifier. Check

this capacitor by substitution since measuring it with an ohmmeter may not reveal a defective capacitor. Replace it with a 0.1  $\mu$ f of higher working voltage capacitor such as a

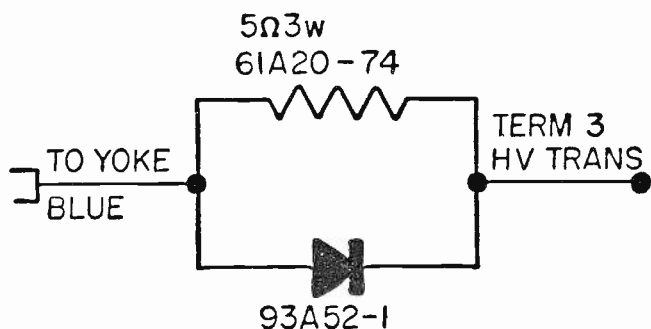
When you install a 98A131-5 replacement HV transformer kit (79A148-1 transformer) in the G11 chassis, you may find some sets which require horizontal centering.

Horizontal centering can be accomplished by adding a diode, with parallel resistor, in series with the blue lead to the deflection yoke at Terminal 3 of the transformer.

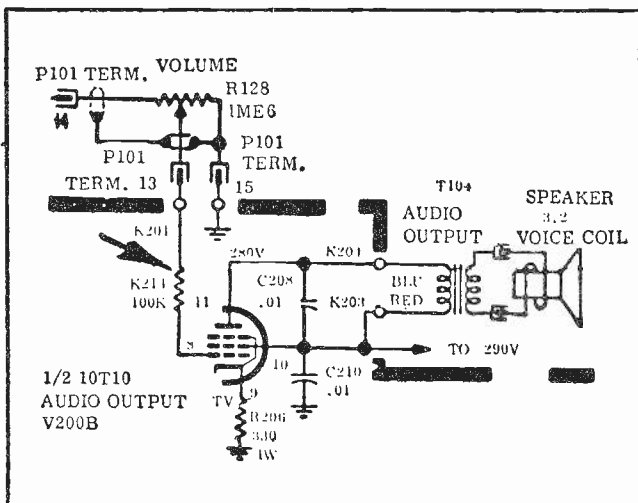
## Color-TV Chassis K-19—Defective VOLUME Control

Occasional failure of the VOLUME control on the K19 color-TV chassis has been traced to an arc in the 10T10 audio detector and output tube as a possible cause.

Damage to the control may be eliminated by adding a 100K, 1/2w resistor between pin 8 of the 10T10 tube socket and the wiper of the control, which connects to pin 13 of P101.

Also when installing this resistor, it must be placed at the circuit board. Because of the capacity of the audio cable, if the resistor were installed at the control, it would level at minimum setting of the VOLUME control. Remove the foil pattern between pin 8 of the 10T10 tube socket and K201 on the circuit board. Keep the resistor leads short and make a good mechanical connection, then solder. Check the cathode resistor R206 because it may have been overheated. The 180 $\Omega$ , 1/2 w resistor may be replaced with a 330 $\Omega$ , 1w resistor as used in later production.

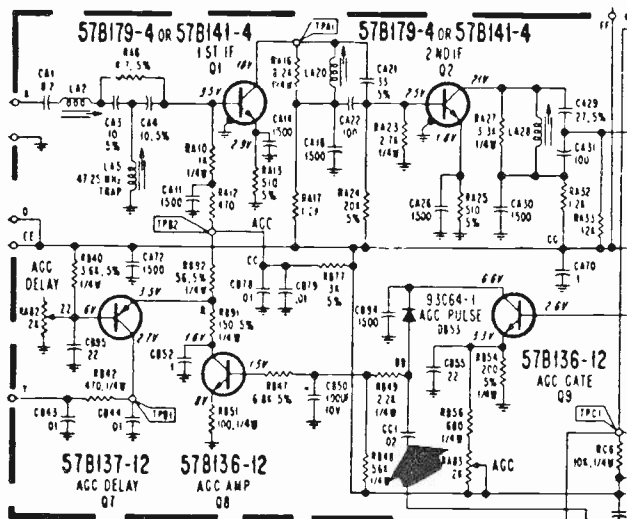
Color TV Chassis T15K10/T41K10 Series—Intermittent or No Video and No Sound with White Raster

One possible cause for this problem is a leaky or shorted CC1 capacitor (.02 $\mu$ f); replace with Admiral Part No. 65A422-203-3.

Intermittent failure of this capacitor has been reported in cases in which the set operated for a few minutes or a few hours before the loss of picture and sound occurred. When the AGC section malfunctions, the AGC voltage to the base of the 1st IF transistor increases, shutting off the transistor.

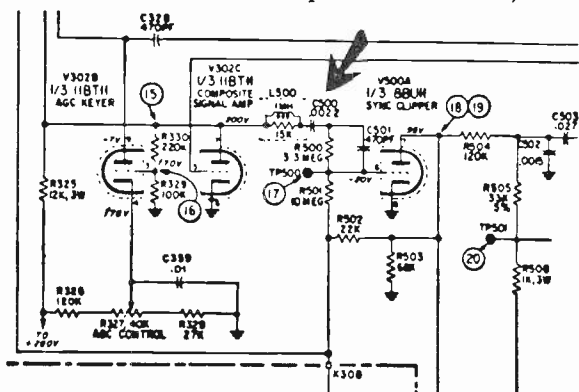
SECTION OF K18 SCHEMATIC SHOWING C500 AND SYNC CLIPPER

## Color TV Chassis K18, K19 Series—Horizontal Bending or Pulling in Picture

This condition may be caused by a leaky capacitor, C500, .0022mfd. When this capacitor is defective, the effect

on the picture may be similar to another problem which caused bending in the picture and which was corrected by redressing the orange lead away from the delay line. This problem is similar—video in the sync circuits—but with capacitor C500 defective, the condition can be more severe.

Observe the waveform at the plate (pin 7) of the sync clipper tube. If any video information appears with the sync information, capacitor C500 is probably defective; replace it with 65A417-222-1.

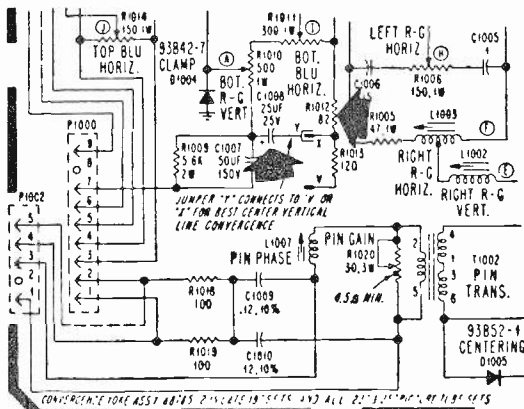
SECTION OF 3K19 CONVERGENCE BOARD SCHEMATIC

If you encounter a symptom of insufficient or no vertical sweep, resistor R1012 overheated, and capacitor C1008 with the end blown out, the possible cause is as follows:

You will likely find filament-to-cathode leakage in the 10GF7A vertical-output tube. (Output section; pin 3 to pins 4 and 5).

With filament-to-cathode leakage in this tube, AC voltage is connected into the convergence assembly.

Replace the 10GF7A tube, resistor R1012 (82 ohm, 1/2 w) and capacitor C1008 (25 mfd, 25 v). The replacement should be made with Part No. 67A200-250-7.

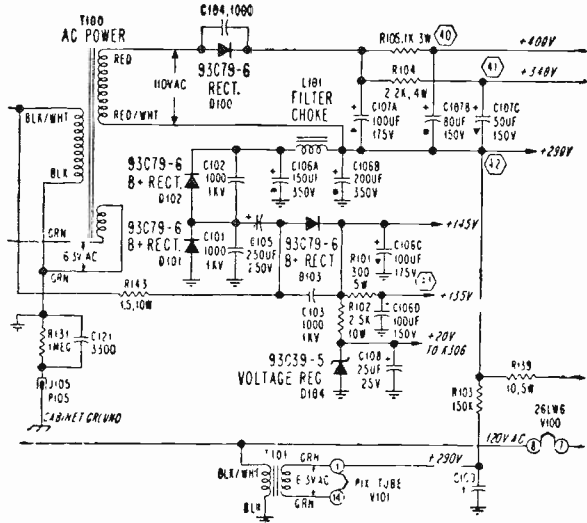
## Color TV Chassis K19 Series—Hum Bar in Picture at 60 Hz Rate

The possible cause of an hum bar in the picture can be

an open electrolytic capacitor on the 20v B+ supply—Part No. 67A200-250-4.

If you encounter a set with this problem, the ripple on the higher B+ supplies will appear normal. Checking the waveform at the plate (pin 2) of the Video Amplifier tube, 11CH11, will confirm the defective capacitor; you will observe 60 Hz on the video signal.

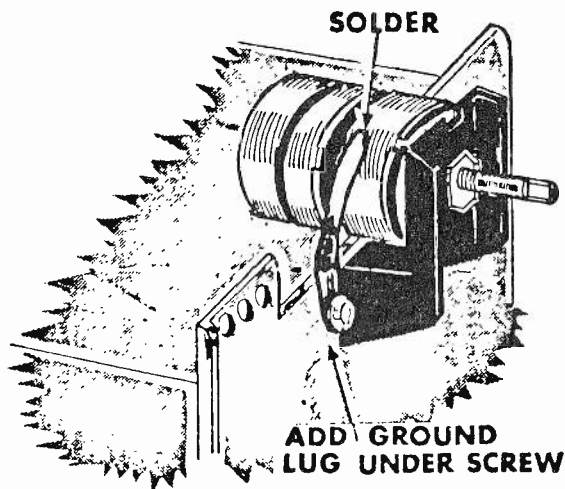
There has been a few reports of loss of sound in color TV Models 5L5851, 5L5853 and 5L5855 which are equipped with the 8T9A, 8-track tape player. The TV sound signal in these models is amplified by the left channel amplifier of the tape player, so component failure in the audio section of the tape player can also cause loss of TV sound.

Investigation of these reports showed that the sets were,

in most cases, being operated in carpeted rooms and that a static discharge was noted as the controls were touched.

Component failures that may occur as a result of a strong static discharge include one or more of the following transistors: Q7, Q9, Q11, Q13 or the equivalent right-channel parts.

In the 5L5850 series models, the on/off/volume control is mounted to the tuner by a plastic bracket. We recommend grounding the control case to eliminate this problem.

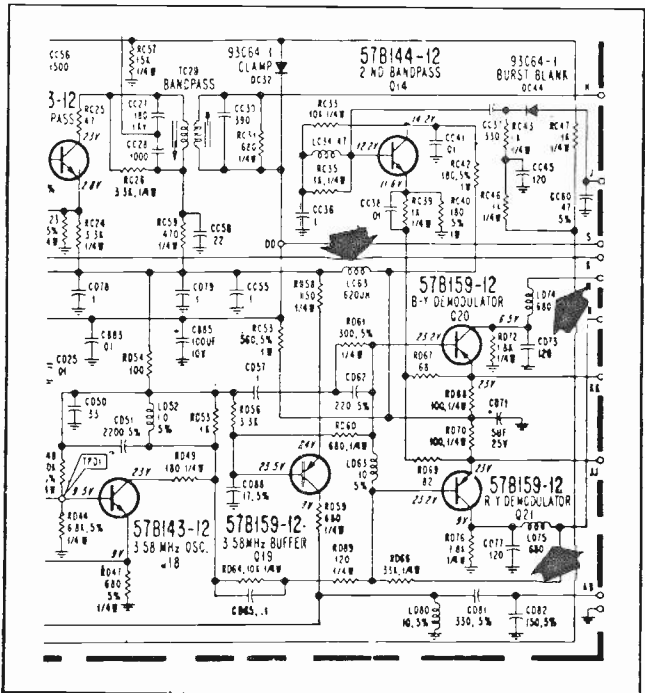
## Color TV Chassis K10—No Color

A problem of no color can possibly be caused by an open coil, LC63 (620 mh). If this coil is open, we will

not have voltage at the collector of the 2nd Bandpass transistor, Q14. Replace the defective coil with Part No. 73A55-48.

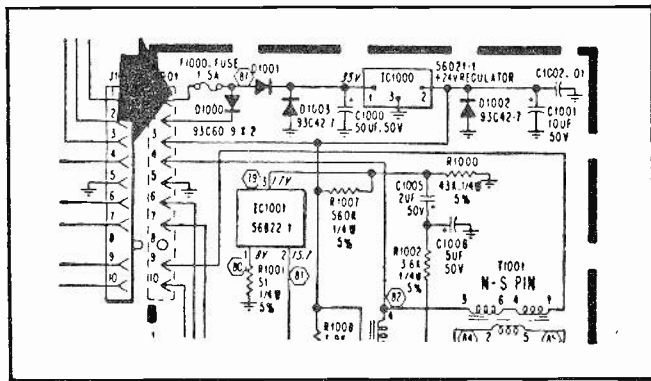
If the symptom is no vertical sweep (thin line across) and a raspy coming from the high voltage section of the chassis, the probable cause a open F1000 fuse (1.5a, 84A-7).

This fuse is located on the component side of the Pincushion board.

As noted in the circuit diagram, the B+ 33 volt and 24 volt supplies are fused by F1000. When the fuse is open, the

lack of source voltages will result in no vertical sweep and no sound, except for the buzz mentioned above.

You may find that replacement of the fuse restores operation and that there is no apparent problem in the Pincushion board. In some cases the manufacturer found that the blown fuse was caused by excessive current in the vertical output transistors. If you find this condition, check resistor R632 on the M600 Vertical Module; if it is 75 ohms, replace it with 61A172-560 (56 ohms, 5%, 1/4 watt). In some early chassis, you may find that R632 is 39 ohms; 56 ohms is the ideal value. Also note that the R632 symbol may not appear on early M600 boards — look for D603. A diode originally

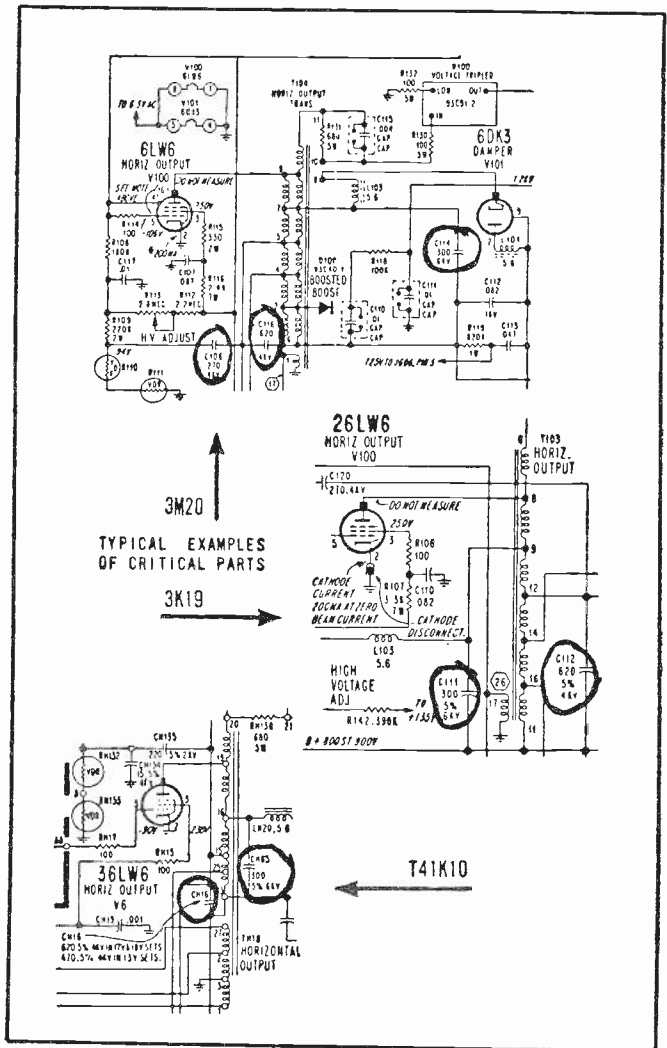
## Color TV Chassis 3M20/3K19/T41K10 — Overheating Replacement HV Capacitor

If you find that after replacing a high voltage capacitor and it begins to overheat, the possible cause may be that it was not replaced with the exact replacement part.

The manufacturer received several complaints of overheating replacement capacitors in the high voltage section — usually a part mounted on the high voltage transformer.

Investigation of these complaints has revealed that, in almost every case, the culprit was a general replacement capacitor which did not have the proper temperature coefficient specified for that function.

The manufacturer strongly urges the use of exact Admiral replacement parts. Refer to the service manual for the model being serviced to be sure that you get the correct replacement part.

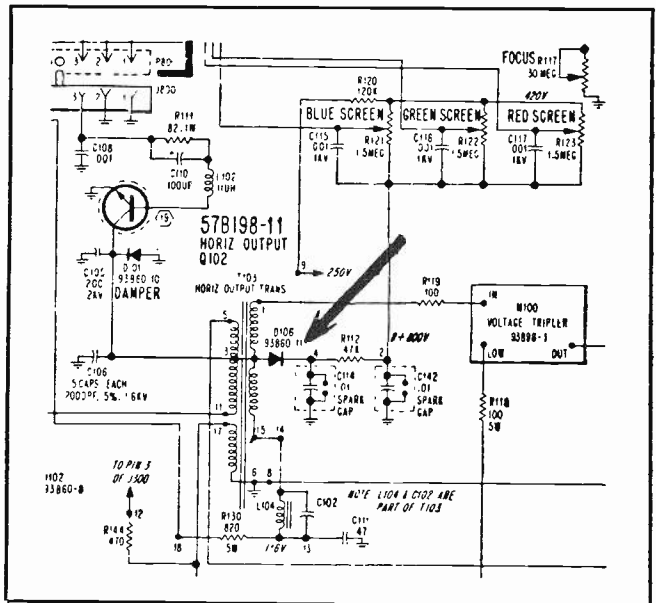
A symptom of low brightness, video smear and the screen controls may work backwards, can be caused by a defective diode in the horizontal output section of the chassis.

A defective D106 diode, located on the high voltage transformer, can cause the 800 volt supply to the high side of screen controls to read low.

Since these same symptoms, low brightness and video smear, could be caused by a defect in the RGB module, check for the failure of diode D106 by measuring the 800 volt supply. Diode D106 provides the 800 volts by rectifying the horizontal pulses.

If the diode is defective, you will measure some B+ on the high side of the screen controls, usually between 130 volts and 250 volts, depending on whether the diode is open or shorted. The screen controls will have no effect if the diode is completely open. If it is not completely open, the screen intensity will decrease as the control is increased—the reverse of normal operation.

The schematic shown is for the 1M30. If you are servicing the other solid state chassis mentioned, refer to the appropriate service manuals; the terminal numbers for the diode and the 800 volt test point are not the same.

Replace the defective diode with the exact Admiral replacement Part No. 93A60-11.

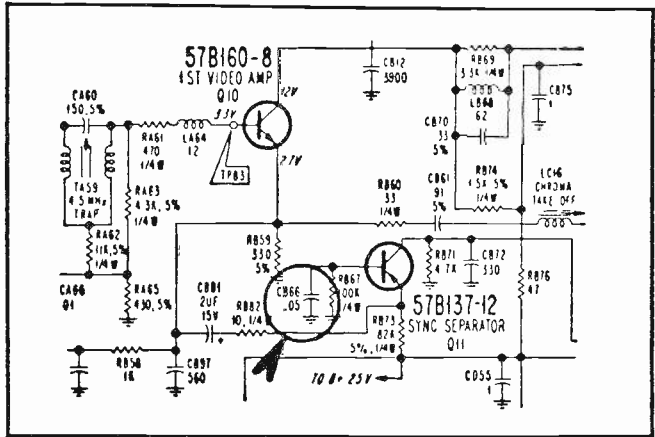
A symptom of no vertical or horizontal sync, or horizontal weave in the picture can be caused by a defective CB66 capacitor (.05 mfd, 50 v).

In some cases, the sync problem may only appear when the set is first turned on; as the set warms up, the sync improves.

To correct the problem replace capacitor CB66, .05 mfd ceramic disc, with a .047 polyester film capacitor, part number 64A43-11 as used in later production models.

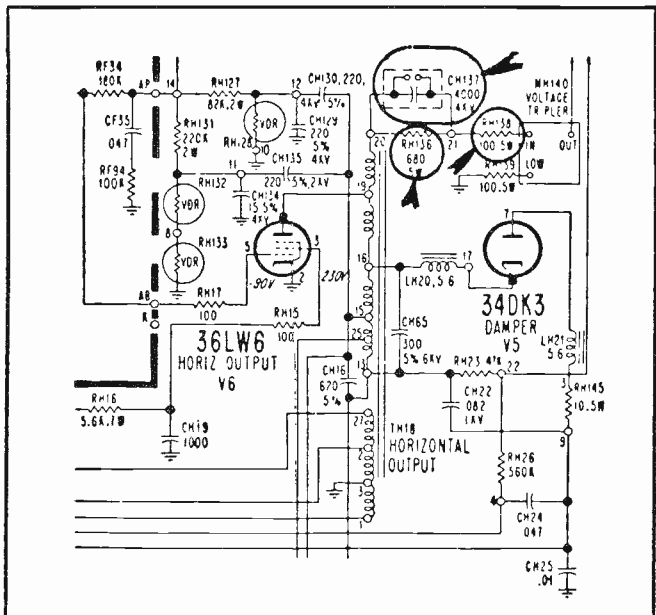
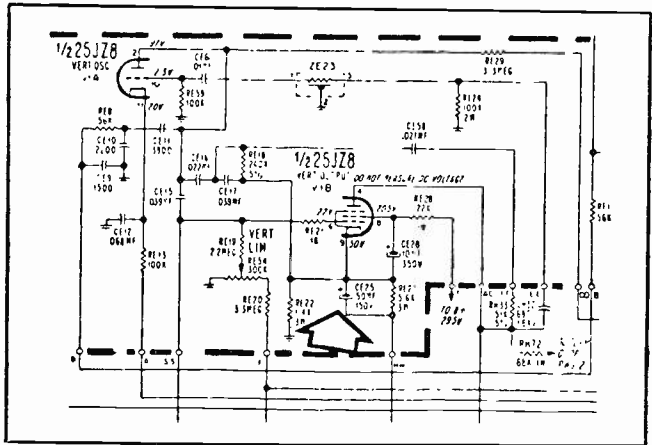
## Color TV Chassis T40K10 Series—Horizontal Tearing And/Or Poor Sync

A symptom of horizontal tearing and/or poor horizontal sync can be caused by improper second anode lead dress.

The second anode lead can be dressed too near to the components on the high voltage transformer; namely, resistors RH136 and RH138, and capacitor CH137.

The set may lock in satisfactorily on a strong signal but

not on a weaker channel—the horizontal oscillator may be off frequency.

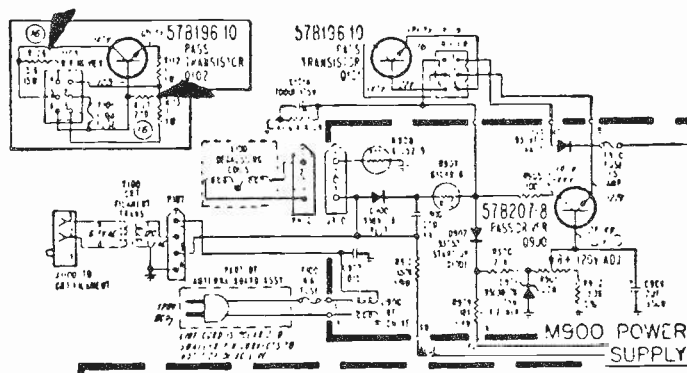
A symptom of high voltage shutdown circuit triggering, which causes pulsating audio and flashing (on-off) of the raster at a once per second rate, can possibly be caused by increased 120 volt B+ line voltage. The increase can be possibly caused by a defective pass transistor Q101 and/or Q102. The above problem can be confirmed by measuring the regulated 120 volt B+ supply line at fuse F900. This voltage is adjustable by the B+ 120 volt *Adjust* control, R901, on the power supply board. You should be able to vary it slightly above and below 120 volts. Leaky or shorted pass transistors can cause this voltage to increase to 140 or 150 volts. If you have too much voltage on the 120 volt line, the problem is in the power supply. Increased B+ will result in the horizontal system trying to produce excessive high voltage and the high voltage shutdown circuit will activate.

If the set continues to operate with high B+ voltage, F900 (120 volt B+ fuse) and F101 (1/16 amp fuse) in the pass transistor circuit may open. This may be the result of the horizontal output transistor Q103 failing. If transistor Q103 shorts, it will cause F900 to open immediately when the TV set turned on. This transistor can be temporarily removed if suspected of being defective.

The 120 volt B+ supply can be operated with F900 removed for checking or repairing that supply (with no load, the voltage will increase by 2 to 3 volts.)

Be sure to discharge the power supply through a resistor to ground before installing the fuse (use a 10 K, 1 watt

resistor). Grounding direct to the chassis will blow the 1/16 amp fuse, F101. Discharge both sides of the fuse holder because the capacitors in circuits beyond the fuse may be charged.

Be sure to adjust the B+ 120 volt supply adjustment to exactly 120 volts when the repairs have been completed.

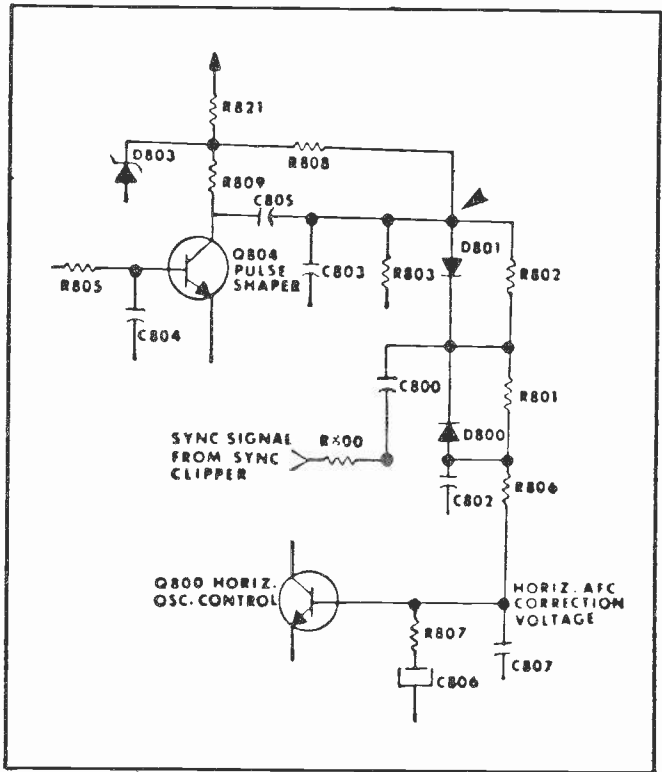
This new procedure differs from the original adjustment found in the M10 service manual, S1349, primarily in the "point" that is to be temporarily grounded during the adjustment. This procedure will insure a better setting of the Horizontal Hold Control.

- 1) Check the horizontal hold *pull-in* and *locking* by switching from station to station. If at first the picture has several slanted bars and takes several seconds to *lock in*, it requires adjustment.
- 2) The *Horizontal Hold* adjustment is available at the back of the cabinet. A limited range of horizontal frequency is available without removing the cabinet back. If this is inadequate, proceed to step 3.
- 3) Remove the cabinet back. Attach a short clip-on jumper from the junction of R803 and D801 as shown in illustration (in the middle of the chassis, behind the *green bias* control) to chassis ground, the T800 horizontal shield can.
- 4) This connection should aggravate the out of sync condition; the slanted lines should change angle or increase in number.

5) Bend the tabs of the horizontal oscillator coil top shield and pull the adjustment rod out slightly to permit full rotation. 6) Slowly turn the adjustment rod to produce a picture that is as close to stationary as possible. 7) Remove the temporary jumper installed in step 3. 8) Push the horizontal oscillator adjustment rod back in to its original position and bend the tabs down to hold it in place.

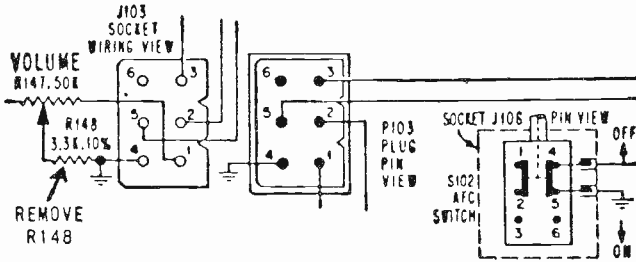
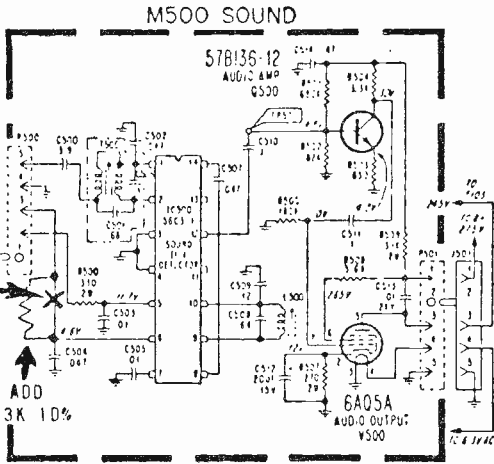
#### Color TV Chassis 3M20—Failure Of Sound IC

Failure of the Sound IC (56A3-1) during an electrical storm can be prevented from occurring again by making the following corrections.

Remove resistor R148 from the tuner cluster and ground the wiper of the *volume control* R147. Cut the foil between Pin 3 of P500 and terminal 6 of the IC on the A8911-1 sound board (M500). Add a 3.3K resistor across the gap you have created. Capacitor C504 is to be placed on the terminal 6 side of the added resistor. Keep the resistor leads short. Make good mechanical and electrical solder connections.

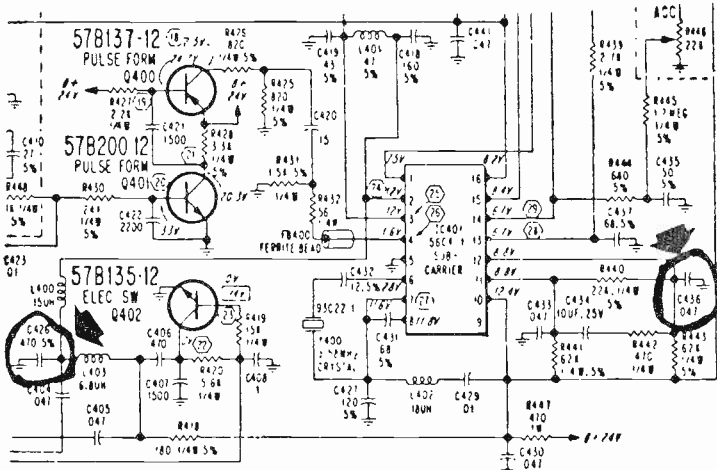
## Color TV Chassis M10—No Or Poor Color Sync

A symptom of no or poor color sync can be caused by a defective capacitor C426 or C436. Also, try substituting IC400 and/or IC401.

When servicing this chassis for color or color sync problems, check the 24-volt regulated supply. This supply is a scan-derived B+ voltage developed by D1001 and regulated by IC1000 (found on the Pincushion module). If this voltage is low, substitute the Pincushion module. Other likely causes of reduced voltage would be a leaky capacitor or other component on the 24-volt regulated line.

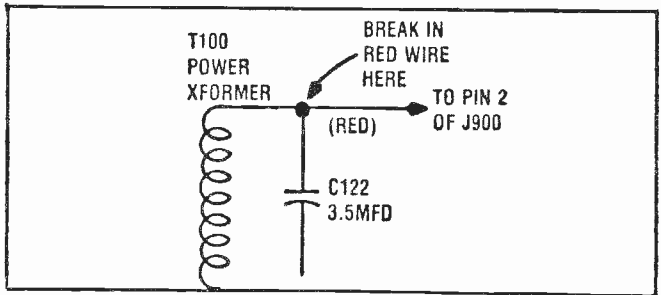
**CHASSIS:** Admiral 1M30B

**TROUBLE SYMPTOM:** Raster pulls in from both sides as brightness is increased.

**CAUSE:** Break in small red wire in power transformer circuit at the point where capacitor C122 connects to it. This red wire, which is dressed in a bundle of other wires, connects C122 to pin 2 of J900. A break in this wire causes the regulated 130V B+ supply to decrease below 130V as the brightness level is increased.

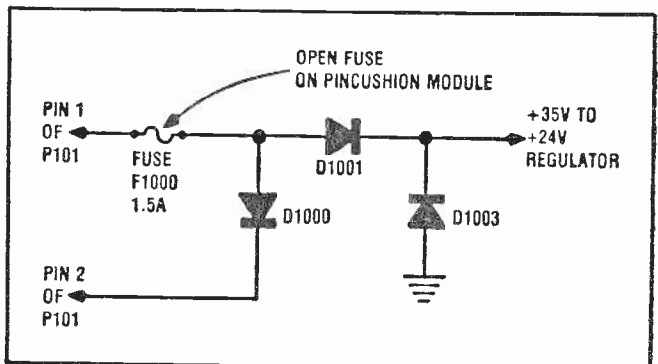
**CHASSIS:** Admiral M10

**TROUBLE SYMPTOM:** Vertical sweep and sound missing (only a thin horizontal line displayed on screen) and a "raspy" buzz emanating from the high-voltage section of the chassis.

**CAUSE:** Open fuse F1000 (1.5A) on A8954-3 pincushion module. Opening of this fuse eliminates the 33- and 24-volt supplies, disabling the vertical sweep and sound sections. In some cases there is no apparent cause for the opening of fuse F1000 (Admiral part No. 84-A4-7), and replacing it restores both vertical sweep and sound. In other documented cases involving earlier runs of the M10 Chassis, the opening of fuse F1000 has been found to be caused by excessive current in the vertical output transistors, which is cured by replacing 75-ohm resistor R632, on the M600 vertical module, with a 56-ohm, 5%, ½-W type (Admiral part No. 61A172-560). (In some early runs of this chassis series, R632 is 39 ohms, but still should be replaced with the 56-ohm type. Also, the callout "R632" is not printed on some early versions of the M600 module because the resistor replaced a diode (D603) which originally had been planned for this location on the module; consequently, if you cannot find a resistor designated "R632," look for one with a callout "D603" and replace it with a 56-ohm type.

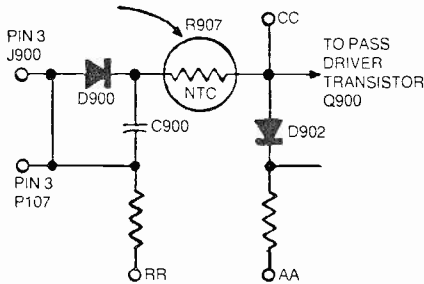
**CHASSIS:** Admiral M10 Series

**TROUBLE SYMPTOM:** No raster or sound.

**CAUSE:** Open negative-temperature-coefficient (NTC) resistor R907 on the M900 power supply board. Two versions of this resistor were used in production runs of this chassis series; both were assigned an Admiral part number (61C49-6), but the color of one version is aqua (bluish) and that of the other is black. The aqua-colored version has a higher-than-normal failure rate. Admiral has requested that when any M10 series chassis is serviced, the color of resistor R907 be checked. If an aqua version is found, it should be replaced with a new black version of this resistor, Admiral part 61C49-7.

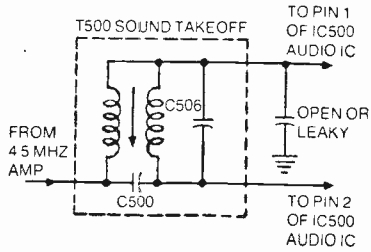
**CHASSIS:** Admiral M10 Series

**TROUBLE SYMPTOM:** Hissing or buzz-type noise in sound which is not changed by varying the volume control setting.

**CAUSE:** Open or leaky capacitor C507, which is connected to pin 1 of audio stage, IC500.

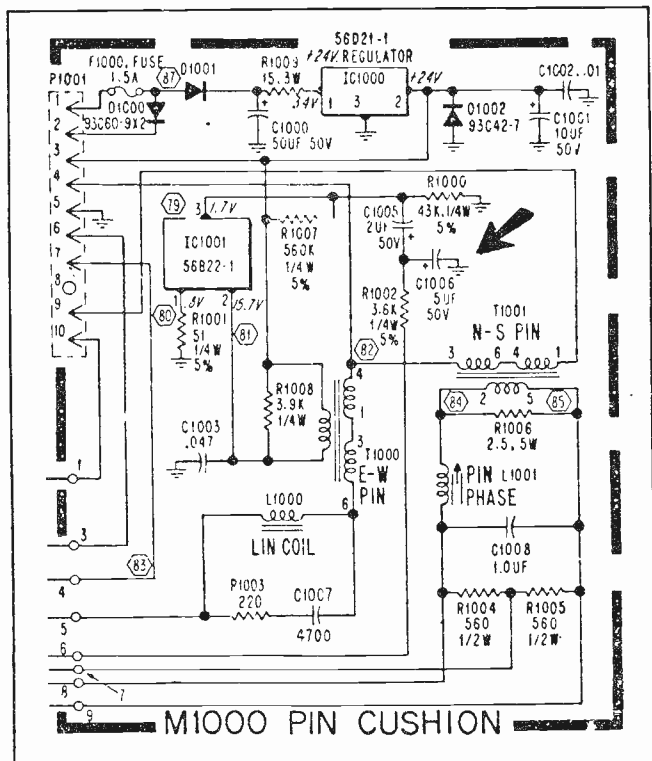
## Color TV Chassis M10—No side pincushion correction & raster pulled in at sides

The possible cause of this symptom is a defective electrolytic capacitor (C1006, 5mfd, 50V), that is mounted on the pincushion board. Replace with Admiral part number 67A200-479-7 (4.7mfd, 50V).

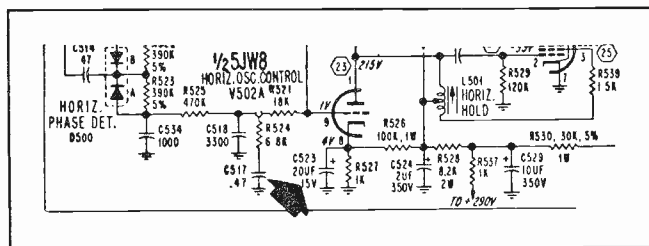
## Color TV Chassis 3K19—Horizontal frequency drift

The possible cause of this drift is a defective electrolytic capacitor, C523 (20mfd, 15V). Replace with Admiral part no. 67A4-71.

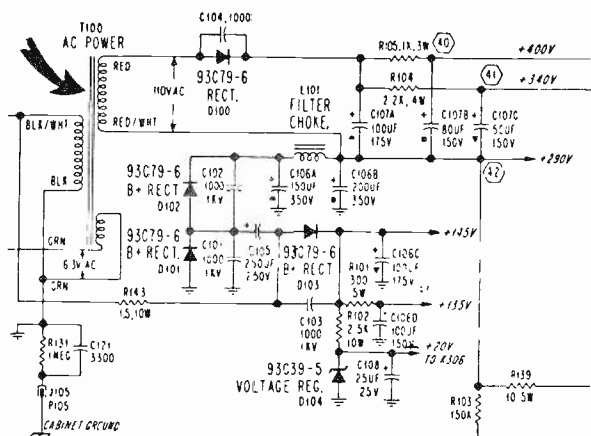
### Color TV Chassis 3K19—Weak video, vertical retrace lines & very little or no control of brightness.

The possible cause of this condition is an open secondary winding on the T100 power transformer (110VAC winding for 400V B+ supply.)

In this condition, the 400V B+ supply will be low, and you'll find the following supply voltages: 400V will measure 310V (low); 340V will measure 300V (low); and 290V will measure correct at 290V. The reduced B+ voltage to the plate (pin 2) of the 11CH11 video amplifier tube upsets the picture tube cathode bias. And the open winding may also cause failure of the C107 electrolytic capacitor. To correct, replace the power transformer with Admiral part number 80A116-3.

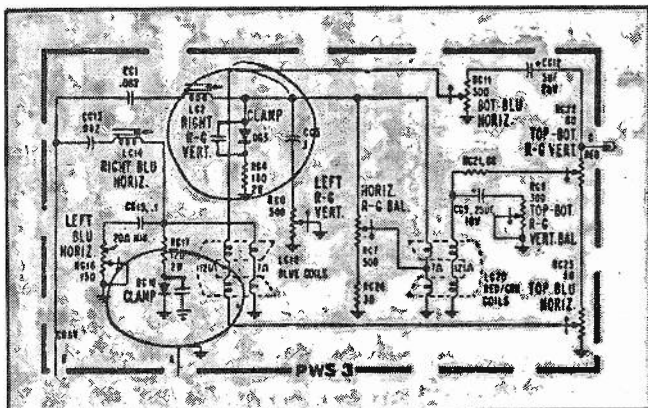
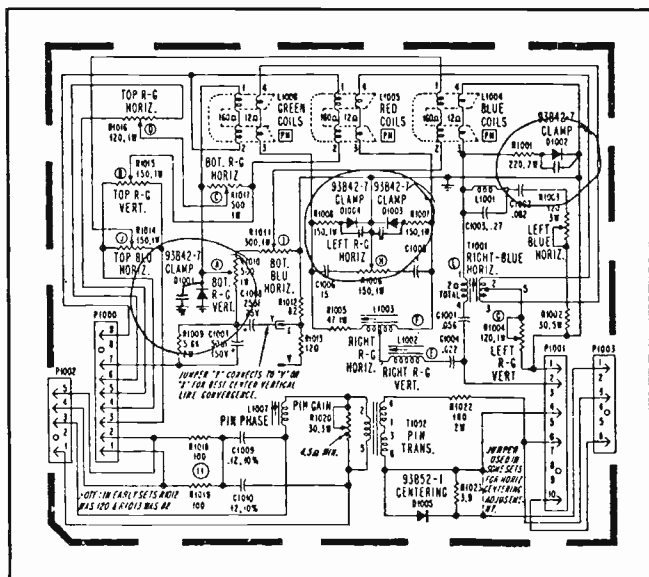
### Color TV Chassis K10 & K19—One or two thin, dark, vertical interference bars from left to center of picture

These bars, which are more prevalent on the low VHF channels, may only be noticeable on weak signals or when using a built-in antenna. The position of the bars changes when the horizontal dynamic controls on the convergence board are adjusted. This is not the same as 'snivets' which are caused by the horizontal output tube during UHF operation. The problem can be corrected by adding a 680pf 500V capacitor across each of the clamp diodes on the convergence assembly, as shown in drawings below. The top diagram is for the K10 chassis, and the bottom diagram for the K19 chassis. Keep the leads short.

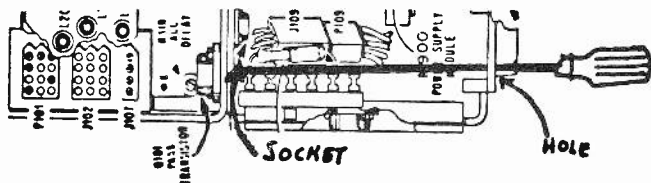
## Color TV Chassis M10—Service Hint for Replacing Transistor Q101

When replacing the forward pass transistor Q101 the transistor socket may slip out of its retainer while inserting the new transistor. Improper installation could be the result with failure, then, of Q101, blown fuses, etc. To avoid this problem, insert a blunt rod or tool through the lower of the two holes in the bottom left rear of the chassis shown below, and to the left of the power supply panel. Pressure can then be applied to hold the socket in its retainer while removing and inserting the new transistor.

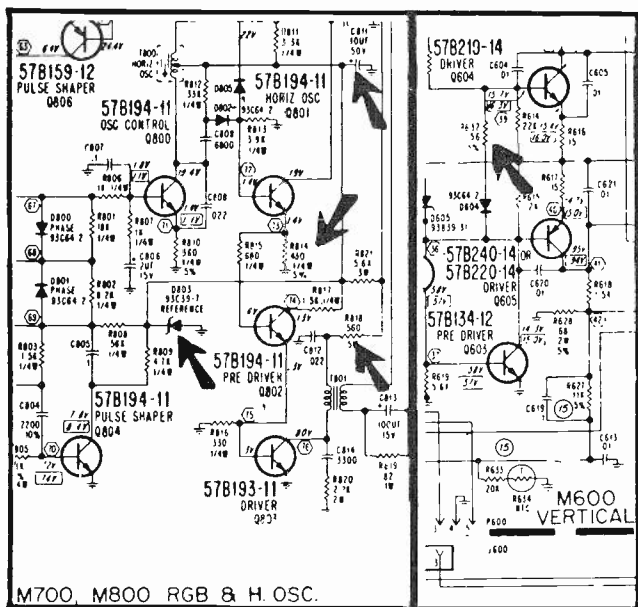
## Color TV Chassis 3M10/4M10—For all symptoms listed see diagram below

*Symptom*—Slow start up of horizontal oscillator.

Check electrolytic capacitor, C811, 10mfd, 25V. It could be leaky.

*Symptom*—The horizontal scan line in the center of the picture is missing.

Check the value of R632. It should be 56 ohms, 5%, 1/4W.

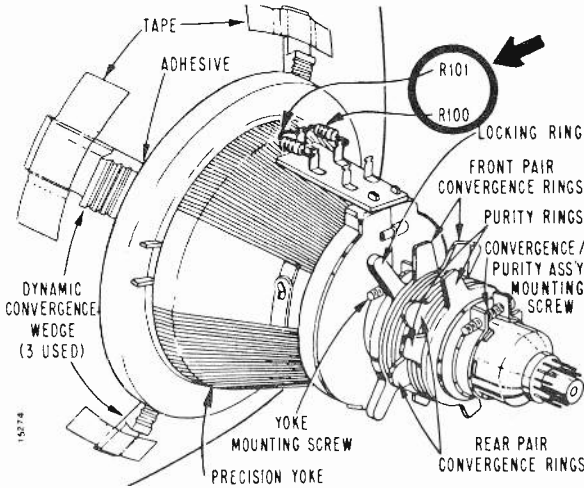
## Color TV Chassis M45—Picture tube and/or deflection yoke replacement

When replacing picture tube and deflection yoke, be sure to remove R100 and R101 from the terminal strip, on the old yoke and solder them in place on the new yoke. These resistors DO NOT come as part of the new yoke assembly.

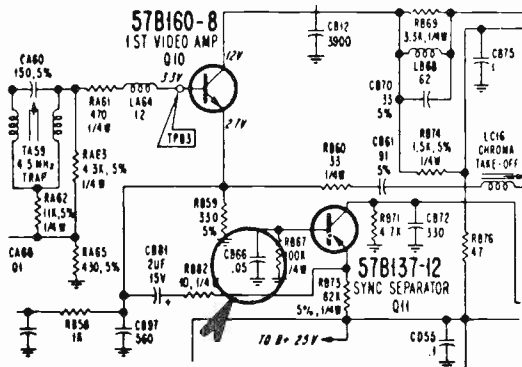
## Color TV Chassis T15K10/16K10— Loss of Vertical or Horizontal Sync

The symptom of no vertical or horizontal sync, or horizontal weave in the picture can be caused by a defective CB66 capacitor (.05 mfd, 50 v). In some cases, the sync problem may only appear when the set is first turned on. Then, as the set warms up, the sync improves.

To correct the problem, replace capacitor CB66, .05 mfd ceramic disc, with a .047 polyester film capacitor, part number 64A43-11 as used in later production models.

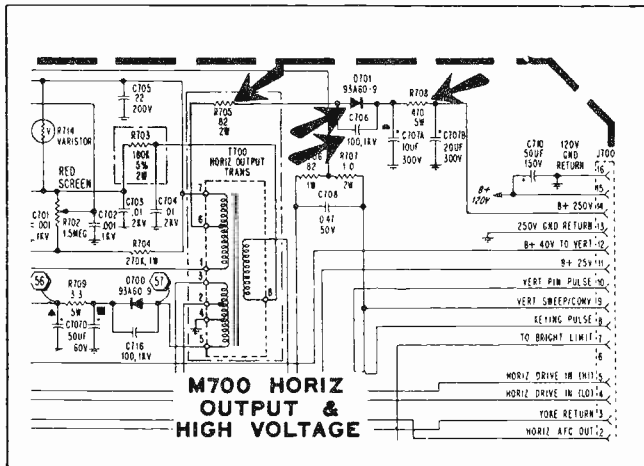
**Color Chassis 9M50—Loss of picture, no control of brightness, retrace lines, and loss of 250v Scan B+.** Probable causes are: (a) open R705 (820Ω, 2 watt), (b) open R708 (740 Ω, 5 watt), (c) Shorted or leaky C706, 100 pfd 1kv, (d) shorted D701.

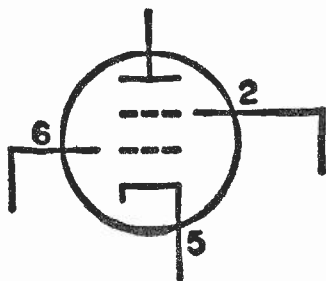
BASE DIAGRAM AS  
SHOWN IN SCHEMATIC

The 6EF4 regulator tube has been shown in the M678 schematic with this base diagram. A technician would assume that this is a tetrode, but this is incorrect.

Tube element 2 is not a grid, but rather a high voltage shield. The shield

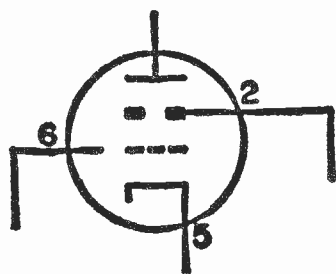
CORRECT BASE DIAGRAM

is used to minimize the effects of a momentary arc within the tube. The correct base diagram is shown here.

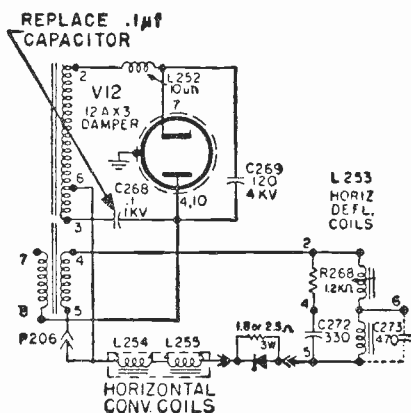
## Color TV Chassis M663—Vertical Green and Purple Stripes

Failure of C268 (.1 $\mu$ f 1kV - open) causes the appearance of a vertical green line approximately 1/4 in. wide

displaced from the left edge of the screen by roughly 1 1/2 in. Approximately in the center of the screen a faint purple line will also be seen.

This effect is more readily noticeable on a blank channel with the color control fully clockwise. This fault will also cause poor color rendition because of an improperly shaped flyback pulse appearing at the grid of the burst gate tube.

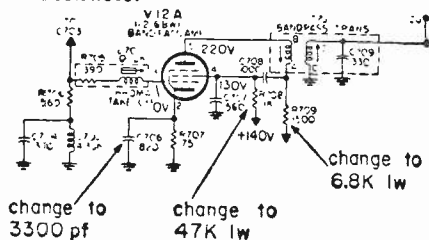
## Increasing Chroma Gain on Canadian G-E M678/M679 Color Chassis

There may be instances, in some locations, where additional chroma gain is desirable.

The following modification has been developed which provides considerable additional chroma gain.

1. Change bandpass V12A cathode bypass capacitor, C706, 820pf to a 3300pf (ET22X127).

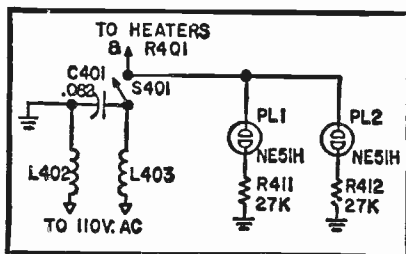
## Replacing Incandescent Bulb With Neon Bulb in Canadian G-E Chassis

The "Portacolor" chassis has been slightly modified to use a standard

neon bulb, NE51H, in place of the currently used incandescent bulb, G-E #756. The circuit changes are only in the pilot light circuit of chassis code "V."

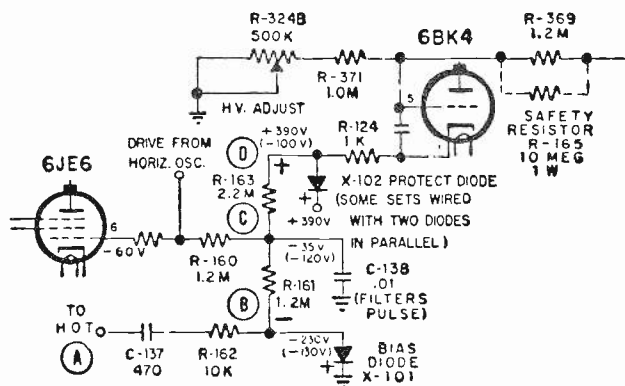
To provide even more protection, the models using chassis 120957 and 120958, Triangle Code "A" and up, are wired with a "Fail-Safe" circuit in the high voltage system. The purpose of this circuit is twofold: (1) to prevent the high voltage from rising above safe limits in the event of failure of the shunt regulator tube, and (2) to limit the maximum high voltage obtained by adjustment of the high voltage adjust control.

In the event of failure of the shunt regulator tube, this circuit develops a negative voltage which is applied to the grid of the horizontal output tube. This increased bias cuts down the output of the tube, which in turn reduces the high voltage.

Referring to the schematic, point "A" is connected to "FC" of the horizontal output transformer and couples a positive going pulse to the anode of Bias Diode X-101,

which develops a negative voltage at point "B." When the shunt regulator is operating normally, safety Diode X-102 is a low impedance device in the cathode circuit so that the voltage at point "D" is virtually the same as the supply voltage, 390 volts. Should the shunt regulator fail, X-102 appears as a high impedance, isolating point "D" from the B+ supply.

In normal operation, the resultant voltage at point "C" is determined by the relative values of positive voltage at "D" and the negative voltage at "B." This voltage is applied to the grid of the horizontal output tube through R-160 in addition to the normal grid-leak bias already present. The circuit is designed to maintain normal bias when the shunt voltage at "B" then increases the bias applied to the horizontal output tube.

The action of the fail-safe circuit results in visual indications similar to those normally associated with a very weak horizontal output tube. The picture is very dim, focus is poor and width is insufficient. The picture may be too dim to see the sides of the raster and the high voltage reads about 12kv.

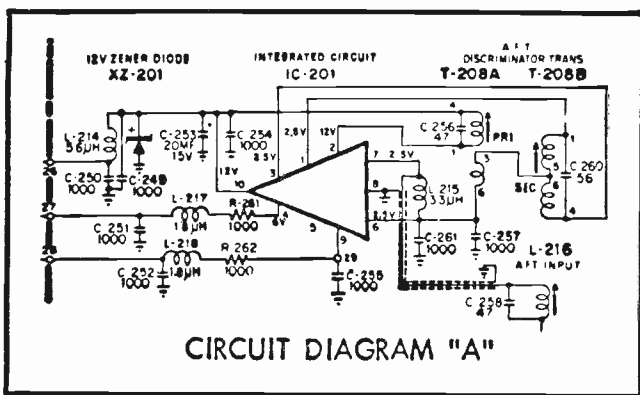
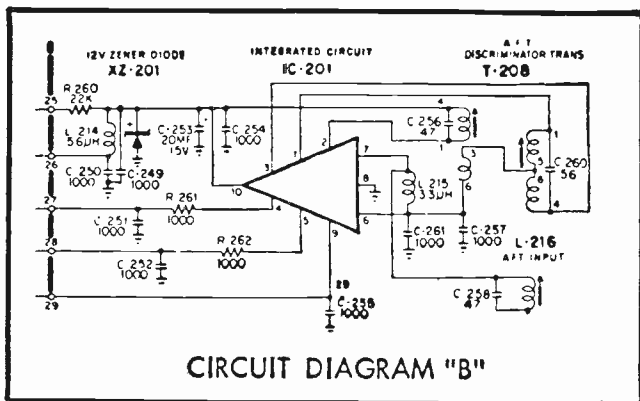
The AFT integrated circuit, Part No. 815215, has been redesigned and will no longer have a Pin 9 terminal. In the sets which use parallel filaments, the new version of IC 815215 is directly interchangeable with the old one.

In the chassis with series filaments, it will be necessary to check the printed board circuitry connected to the IC; and if the printed board wiring to Pin 5 is open, it will be necessary to connect a jumper between Pins 5 and 9 of the IC (see circuit diagram "A").

The new version of the IC 815215 can be used without modification if Pin 5 of the IC is connected to the AFT circuitry (see circuit diagram "B").

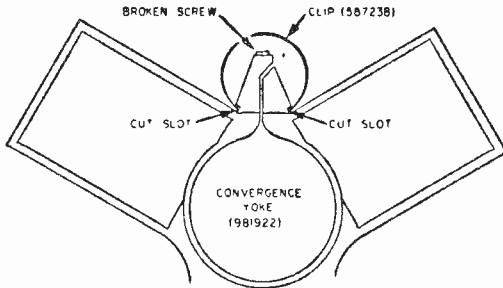
Many Part No. 981922 convergence yokes have been replaced because of a broken plastic screw on the yoke

clamp. A spring clip, Part No. 587238, is now available so that these yokes may be repaired as shown in the illustration.

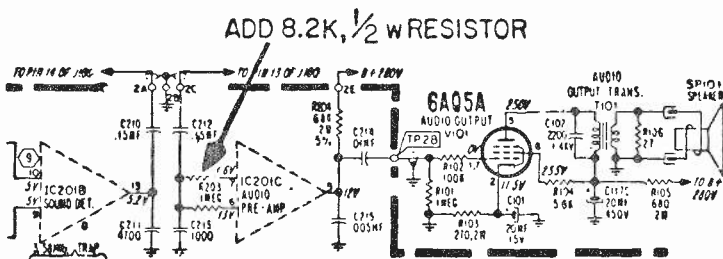
If failure of the sound IC in the K20 chassis is encountered, check the wiring of capacitor C134, .022 $\mu$ f. This capacitor should be connected to the shield braid of the leads going to the VOLUME control. If C134 is found to be grounded to the control bracket, it should be disconnected from the bracket and connected to the shield braid ground.

The production change now being incorporated in the K20 chassis protects the sound IC by connecting an 8.2K,  $\frac{1}{2}$ w resistor between Pin 7 of the IC and the junction of capacitors C212 and C213 and resistor R203, as shown in the partial schematic. If the 8.2K resistor is installed in the field, it is necessary to cut the foil pattern and to keep the leads short.

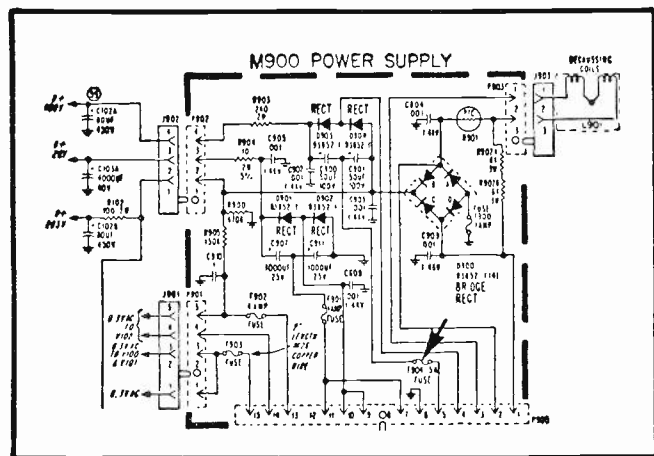
There have been reports of an unusual condition in the M20 chassis which can result from failure of a fuse in the low-voltage power supply module. You would not expect an open fuse to cause this condition, but it does.

The problem can be caused by open fuse F904 which has a ½a pigtail, Part No. 84A7-16 on the power-supply module. The F904 fuse is in the secondary of the power transformer, supplying ac to the 400v B+ circuit. Because of the power supply design, 285v still remains on the 400v B+ line when the fuse opens. The reduction of B+ voltage to the cathodes of the picture tube will result in excessive brightness and no control of brightness.

Check the circuits supplied by the 400v B+ and associated components. When repairs have been made, replace the open fuse.
