**COLOR TV**

**FACTBOOK**

**-Problems & Solutions**

By the Editors of Electronic Technician/Dealer

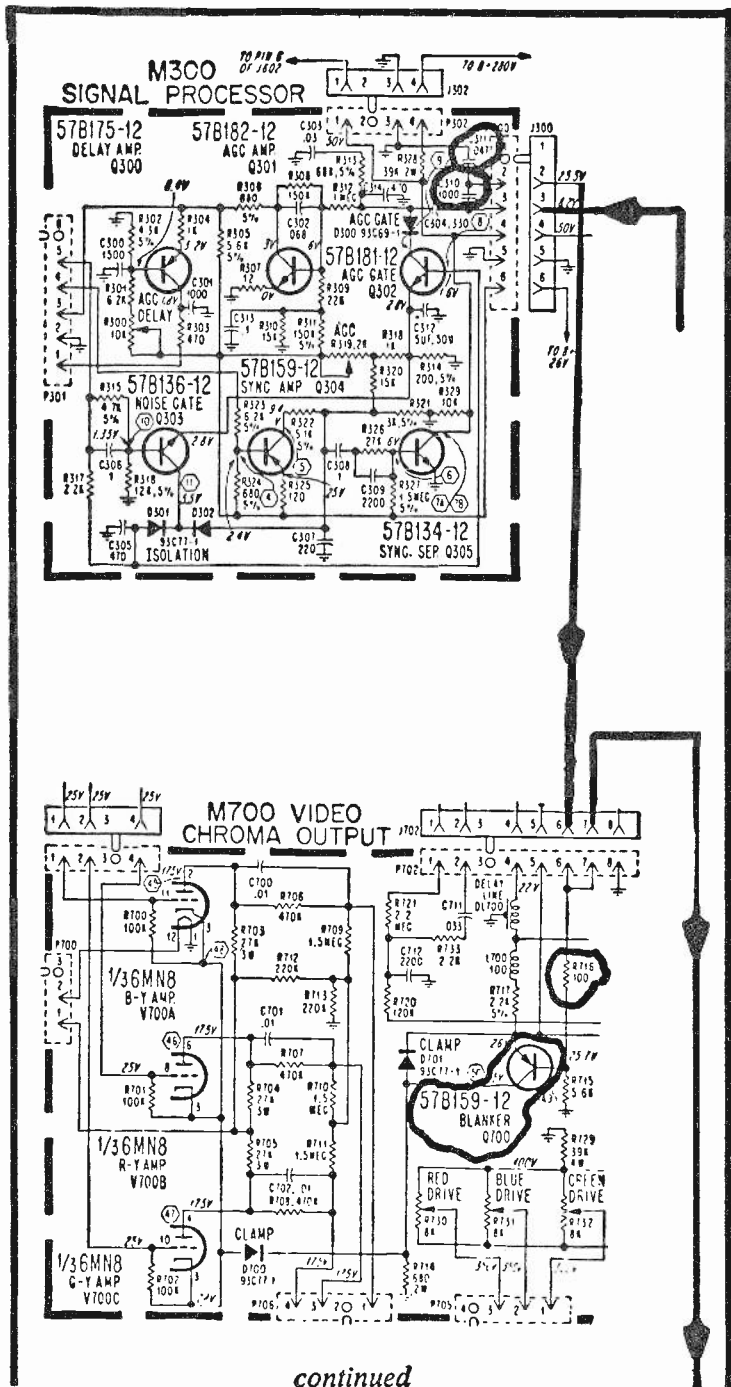
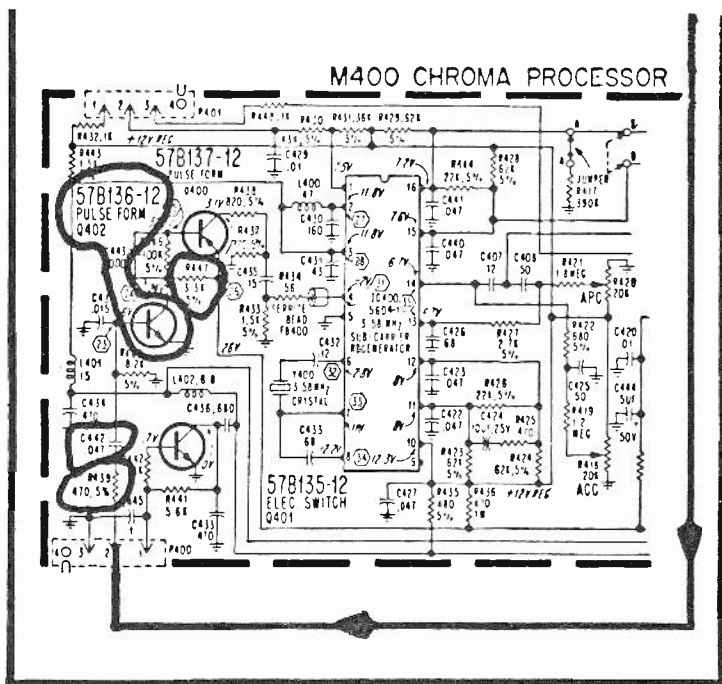
Examination of the M400 chroma processor module and/or M700 video chroma output shows burnt or damaged components. When either or both modules are replaced, the same components in the replacement module are immediately damaged.

Normally module problems are contained in the specific module showing a problem. However, in this instance, the fault is due to a defective component in an associated module. Capacitor C310 in the M300 signal processor module is shorted causing a much higher than normal horizontal pulse to be applied to the M400 chroma processor and the M700 video output module.

When capacitor C310 shorts, a much higher than normal horizontal pulse is also fed to resistor R716, causing it to burn to an almost open condition and blanker transistor Q700 to split apart.

When capacitor C310 shorts, a much higher than normal horizontal pulse is fed also to module M400, causing resistor R439 to burn, capacitor C442 to short, and transistor Q402 to turn ON very hard and conduct heavily, resulting in damage to resistor R447.

Repair the M300 signal processor, the M400 chroma processor, and the M700 video chroma output module as shown in the chain reaction information.

Replace capacitor C310 and open capacitor C311.

Replace burnt resistor R716 and damaged transistor Q700.

Replace burnt resistor R439, shorted capacitor C442 and damaged resistor R447.

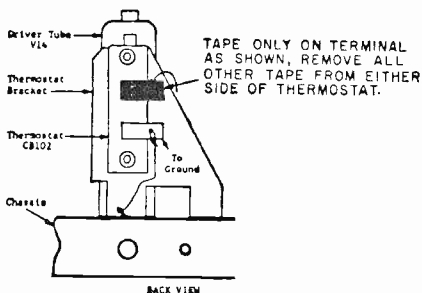
This tape should be removed, since it may result in cutout tripping when there is no problem in the set. The only tape required is around the top terminal, as illustrated, to prevent shock. The top terminal is at B+ potential when the cutout is open.

the following: (1) Is there any tape on either side of the cutout? (2) Space between the thermostat and a properly seated horizontal output tube V14 should be  $\frac{3}{4} \pm \frac{1}{8}$  in.

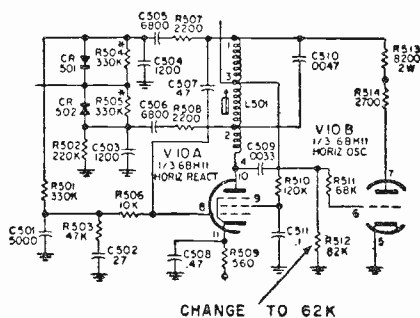
**Correcting Horizontal Foldover.** Change R512 from 82K to 62K. This is most easily done by shunting a 240K 1/2w across the existing 82K

resistor. The extra resistor may be added to the underside of the circuit board. Following this change, the horizontal oscillator should be re-adjusted for proper operation. This is not intended as an instruction to rework sets, but is used as a correction if this complaint is encountered.

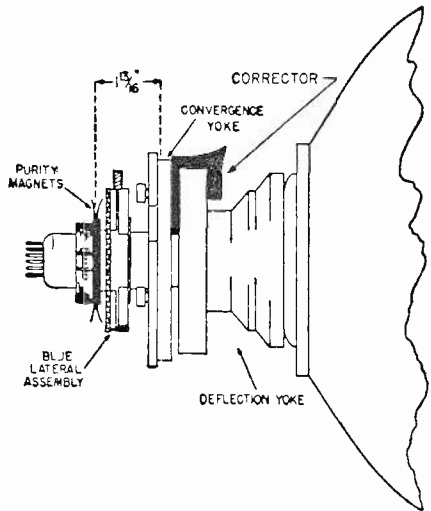
**Using the Wide Blue Convergence Corrector (ET42X59).** If a wide blue raster exists, we now have available a unit to correct this condition.

Before any correctors are installed, it should be determined that a wide blue problem actually exists. This is identified as follows:

1. Adjust for proper center convergence.
2. Observe the vertical lines of a cross-hatch pattern. If blue fringing shows mainly on the outside as illustrated in drawing, this is defined as a wide blue raster.

2. If wide blue condition still exists, install corrector ET42X59 as follows: (a) Slide the corrector down vertically over the rear face of the deflection

yoke as shown in illustration. This is to be positioned directly above the blue gun and the top clip is to be pressed down firmly on the yoke body for the entire length of the clip. (b) If excessive correction is encountered (narrow blue), the clip should be raised slightly above the yoke body.

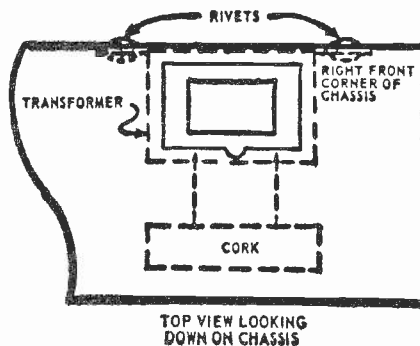
A few cases of low-volume buzz have been traced to the vertical output transformer.

This problem may be easily solved

by inserting a piece of cork gasket or other soft non-perishable packing between the vertical transformer core frame and the underside of the chassis as shown here.

Only those sets having a complaint of low volume buzz should have the packing added.

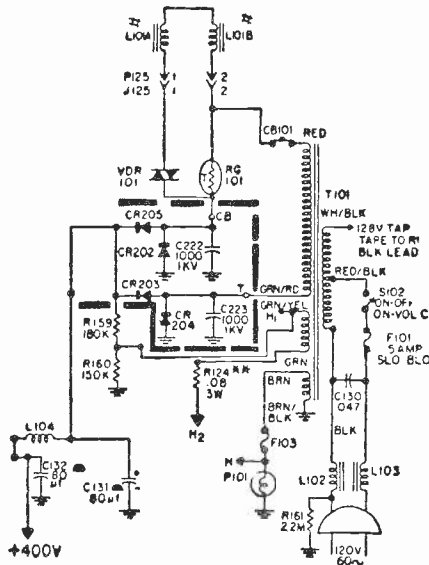
It has been determined, through recent tests, that for maximum reliability and minimum service, the high line voltage tap should be used whenever either of the following conditions exist.

1. Average line voltage equals or exceeds 123v.
2. Line voltage equals or exceeds 128v for a period of 15 minutes or more during normal viewing hours (even though the average may be less than 123v).

Whenever a KC chassis is serviced for any reason, measure the line voltage and change the primary tap if either of the above conditions exist.

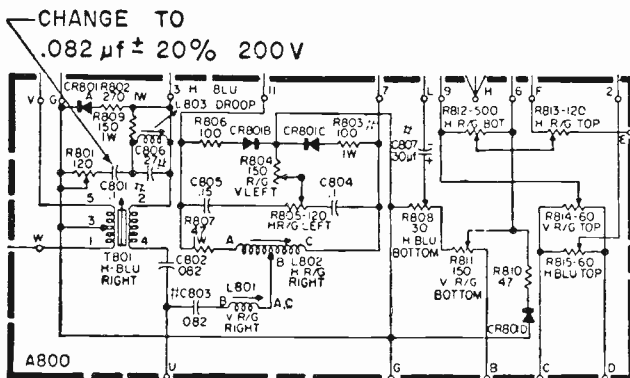
**Failure of R801 Blue-Left Convergence Potentiometer.** Failure of this component will probably be caused by overloading which may occur in rare cases because of tolerance building up in other circuit components.

**Correction:** When replacing R801, change value of C801 from .1 to  $0.082 \mu f \pm 20\%$ , 200v. This corrects tolerance build up and will reduce current through R801. **Insufficient Width:** Measure the horizontal output tube, V14, grid voltage. This is normally about  $-67v \pm 20\%$ . If it reads higher than normal, sometimes as high as  $-100v$ , output will be substantially reduced. **Correction:** Disconnect R517, 3.6M and measure its value. If it is not correct, sometimes as high as 6M, it must be replaced. While disconnected, also check the value of R518 which should be 2.2M. Replace with correct value. **Excess Stiffness or Drag in Fine Tuning of ET86X263 and ET86X274 VHF Tuners.** If fine tuning shows excessive stiffness, item No. 22 and 23 in the exploded view, these items require lubrication. **Correction:** Apply

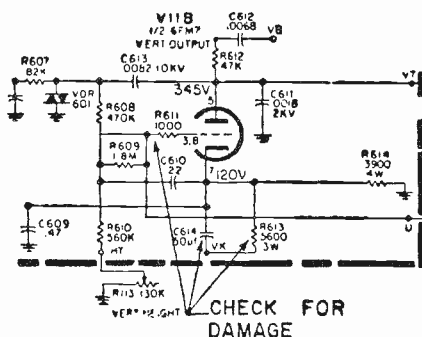
You should be aware of secondary

component damage which may occur in a color set when a 6FM7

vertical tube fails. The extent and nature of the secondary damage will vary, depending on the nature of the tube failure.

In addition, it should be noted the CRT phosphor may be damaged in 3-4min. if the set is operated at high brightness without vertical sweep.

In case of a 6FM7 failure, the following components should be checked for damage and replaced if necessary.

1. R130, 680 may be overheated.
2. R611, 1K may be overheated.
3. R613, 5.6K may be overheated.
4. C614, 50  $\mu f$  may be showing leakage at lugs.

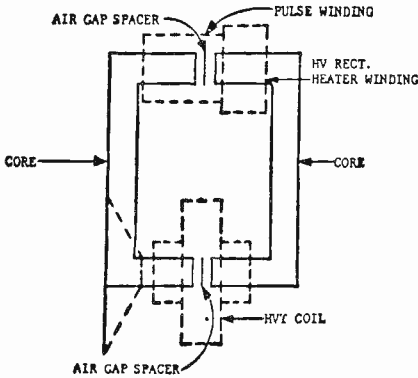
If the horizontal output transformer T104 becomes defective, the correct service procedure is to separate the ferrite core halves and replace the defective coil instead of replacing the

Tighten the mounting nuts securely, so the sides of the transformer core make good contact with the sides of the metal compartment (make sure the grease is applied). This dissipates the heat efficiently to the outside.

Finally, make a good ground connection to the ground end of the pulse winding T104A. If this connection is not made, there is a possibility of excessive high voltage if the HV regulator tube V17 should become defective.

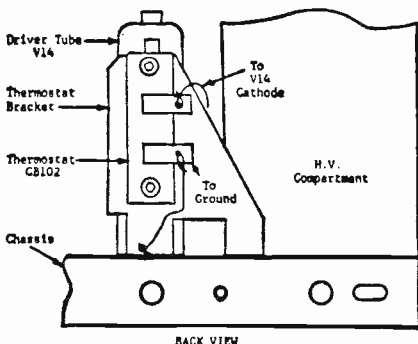
2. If an operating chassis is tipped up on its front edge, the thermostat will open since it will be oriented hori-

zontally above V14 and receiving its full heat, even on a correctly operating chassis. When this happens, clip a jumper lead across the thermostat terminals to activate the horizontal circuit. Make sure the clip lead is removed after completing work.

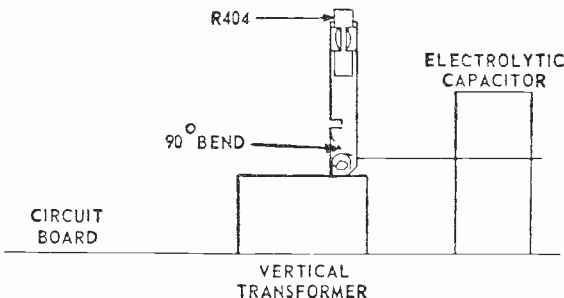
Vertical buzz can be caused by the heat from resistor R404, causing the temperature of the vertical output transformer to rise sufficiently to soften the transformer wax. This allows the transformer laminations to vibrate, causing buzz.

To correct the problem remove resistor R404 from its bracket. Remove one screw and disassemble the bracket from the transformer and electrolytic capacitor. Then bend bracket 90° as shown in illustration and reassemble bracket and resistor. Allow transformer about one hour to cool off before applying power. This allows the wax to harden.

Maintain the following dimensions for the indicated receiver: In the SF1600 Series receivers, slide resistor R404 down in the clip to create at least a 1/2-in. space between it and the bottom of the VHF tuner cover. In the SF2200 Series receivers, maintain at least a 1-in. space between the resistor and the antenna terminal assembly.

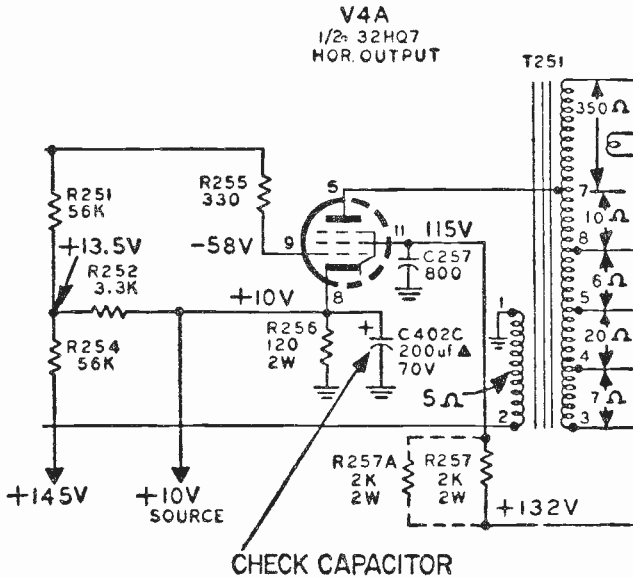
develop: picture contrast may vary from left to right (left being washed out, right being high contrast). Hori-

zontal tearing, vertical jitter and singing horizontal output transformers may also occur.

The troubleshooting procedure can be either waveform analysis using an oscilloscope, or bridging of the 10v line with a known good 200 $\mu$ f electrolytic. The VHF tuner 10v input terminal is a convenient test point. The oscilloscope pattern of a good electrolytic will show a 0.5v neg spike with a repetition rate of 15.75kHz. A defective unit will show something resembling a distorted 15.75kHz sinewave. As little as 0.3v P-P of this 15.75kHz sinewave component can cause problems in the picture. It is a good practice to bridge the replacement capacitor (ES31X7) into the circuit before removing the original unit to make sure the new unit will function satisfactorily.

Replacement with a new electrolytic capacitor will normally cure the problem.

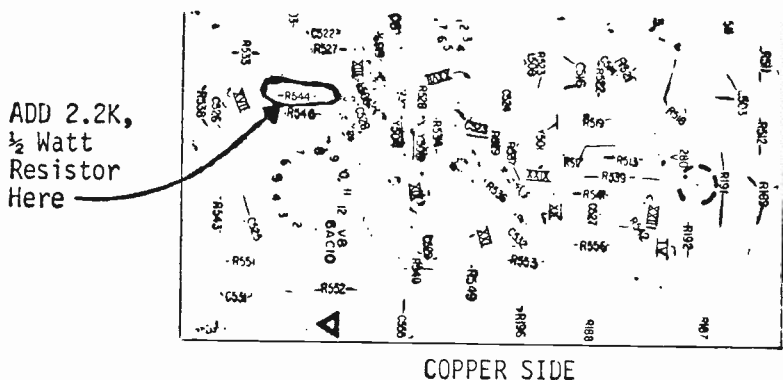
A change has been incorporated in late production C-1 chassis receivers to reduce chroma noise in weak signal locations. The value of the matrix resistor, 4R544, has been changed

from 2.7K to 1.2K to improve the signal-to-noise ratio in the G-Y color difference amplifier. If needed, this improvement can be incorporated in early production receivers by paralleling the 2.7K resistor with a 2.2K, 1/1w resistor. The 2.2K resistor can be placed on the bottom of the circuit board.

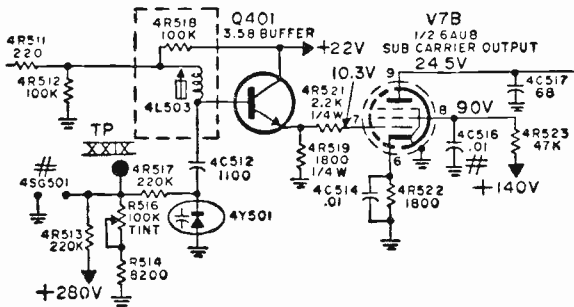
Symptom: Intermittent or weak color. Cause: Shorted  
3.58 Buffer Transistor Q401.

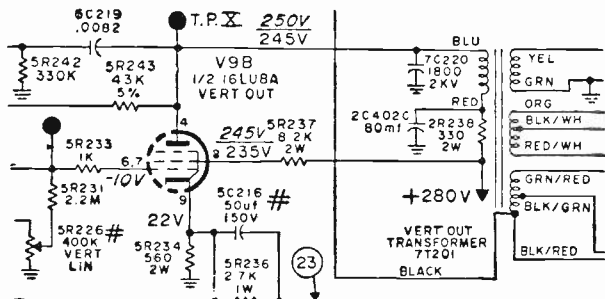
Symptom: No vertical sweep. Cause: Resistor 2R238  
open. Check load side of resistor for short.

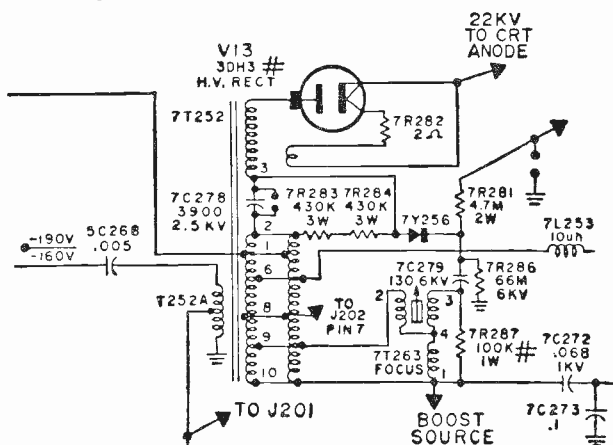
Symptom: Arcing in focus tracking network. Cause: Defective capacitor 7C278.

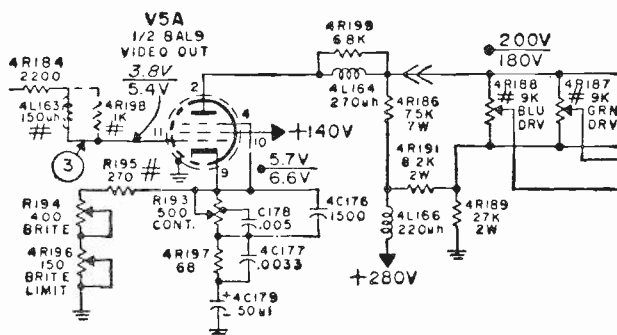
Symptom: Arcing in focus tracking network. Excessive CRT beam current creates a large voltage drop across focus tracking resistors, 7R283, 7R284, causing the protective spark-gap capacitor, 7C278 to arc continuously. Possible Causes: Video output tube 8AL9 shorted. Electrolytic capacitor 4C179 shorted. CONTRAST or BRIGHTNESS

control wiring or terminal shorted to ground. The second video transistor Q304 shorted. The first video transistor Q301 shorted.

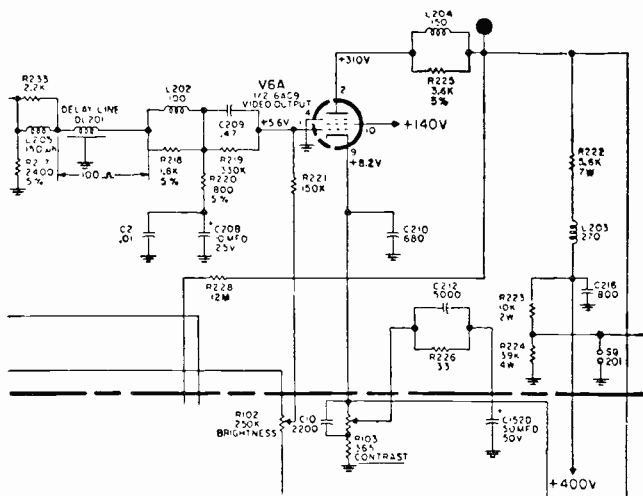
In the KE and KE-II chassis there is a 6AG9 video amplifier tube (V6A) which upon failing can produce excessive cathode current. This may burn a spot on the CONTRAST control (R103) changing its resistance to 200Ω and 300Ω with a corresponding reduction in cathode bias.

Past practice has been to change only the 6AG9, since control R103 was not suspected of being defective. When only the 6AG9 is changed, the picture will bloom and pull in at the sides at maximum brightness and contrast—even

with the picture tube bias at minimum. The pull-in is caused by the loss of high-voltage regulation. Even under these conditions, a reasonably good picture usually can be attained by readjusting the picture-tube bias and gray scale, but the adjustments are critical.

One possible cause of 6AG9 tube failure is the position of a wire support. A stiff steel wire support extends upward from the KE circuit board near Pin 12 of the 6AG9. This steel wire has a loop at the top which supports an insulated lead. In many cases the steel wire support touches the glass envelope of the 6AG9 and causes an extremely small hole in the glass, resulting in loss of vacuum. This type of failure may account for the excessive current through the 6AG9 and the burned spot on the CONTRAST control.

The correct procedure, when replacing the 6AG9 video amplifier tube, is to measure the value of the CONTRAST control (R103), replacing the control if it measures 290 $\Omega$  or lower.

Whenever you service a KE color-TV chassis or replace a 6AG9, bend the steel wire support away from the 6AG9 so that no part of the support touches the glass envelope.

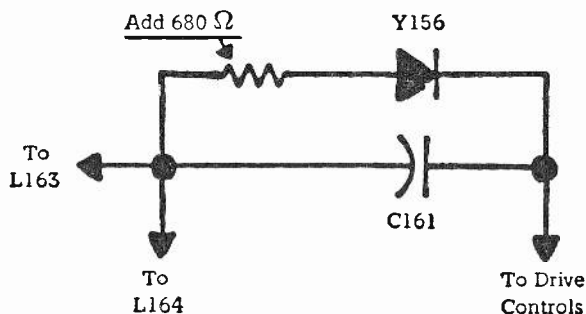
Y156 and insert the assembly into the circuit board where Y156 was removed. This will correct the problem, which is basically caused by internal arcing in the picture tube.

When either diode Y155 or Y156 fails, add a 680 $\Omega$ , 1/2 w, 10% resistor in series with the anode side of Y156, as shown in illustration. Splice the resistor to the anode side of

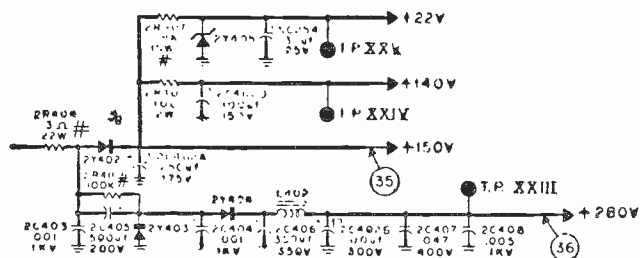
Symptoms of no raster or sound can be caused by an open resistor (2R406 or 2R404). In early production

models replace the 2Ω, 10w resistor with a 2Ω, 15w resistor, Part No. EP14X9. In later production models, replace the 3Ω, 15w resistor with a 3Ω, 22w resistor, Part No. EP14X24.

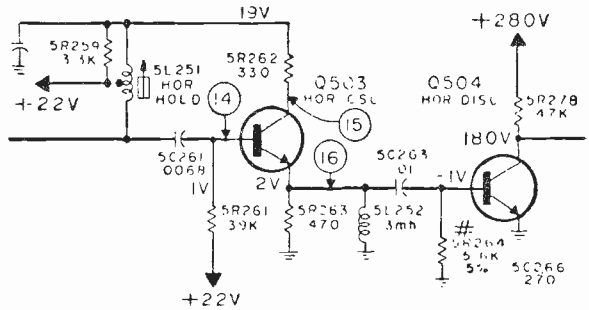
Other no raster symptoms can be caused by a shorted horizontal oscillator transistor, Q503, or a shorted hori-

zontal discharge transistor, Q504. The shorted transistors will cause the 26HU5 tube to run hot and the circuit breaker will trip.

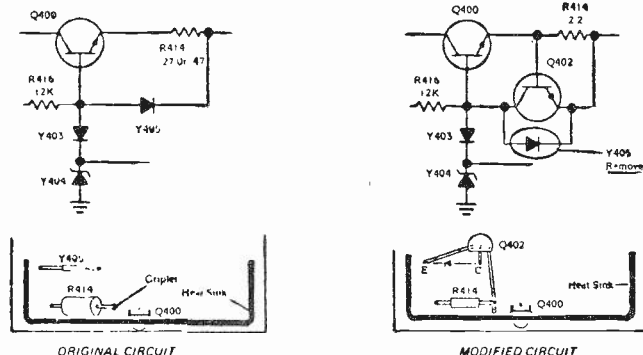
Low-brightness and overload with a strong signal symptom is often caused by the scan rectified 22v source not regulating properly. A possible correction to the problem is to modify the 22v regulator circuit in the following manner:

Remove diode Y405, resistor R414 and the griplet shown in the original simplified schematic. Replace, as shown in the modified circuit, resistor R414 with a 2.2Ω ½ w resistor.

Replace diode Y405 with a Q402 transistor (EP15X1). A Q402 transistor and a  $2.2\Omega$ ,  $\frac{1}{2}$  w resistor are supplied with Q400 replacement transistors (EP15X11).

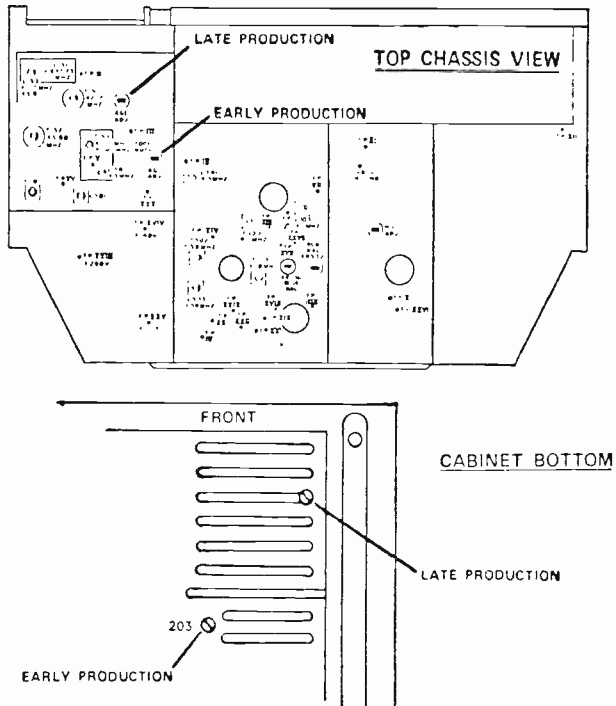
A definite increase in color gain and contrast can be achieved by setting the AGC control, R203, as high as possible without overload. Sets produced after December 1, 1972 (5Z1N) were factory adjusted to the higher AGC setting. Sets prior to this date can, in most cases, be improved by this AGC level increase.

If the set has been in service for a time, it may be advisable to check the 8CB11, 3rd IF tube. In some rare

On C chassis sets, the AGC control can be adjusted through a hole in the bottom of the early production TV sets, and through a cabinet bottom slot in later models. An insulated screw driver less than  $\frac{1}{8}$ -in. in diameter is required. An excellent tool for this purpose is an EP69X32 HORIZONTAL HOLD control shaft that can be sharpened to a screw driver point. See illustrations for the AGC control location on early and late production models.

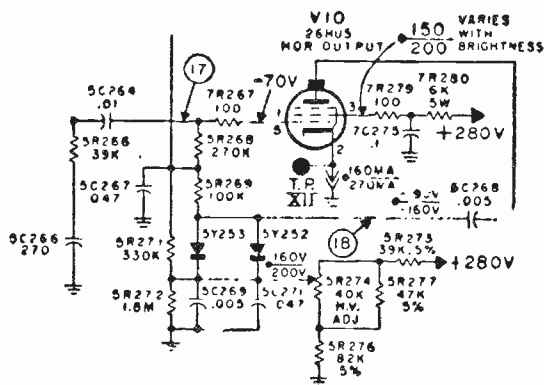
When encountering a dim raster symptom, capacitor

5C271 may be shorted. Replace this capacitor with one that is 400v rated, Part No. EP25X4.

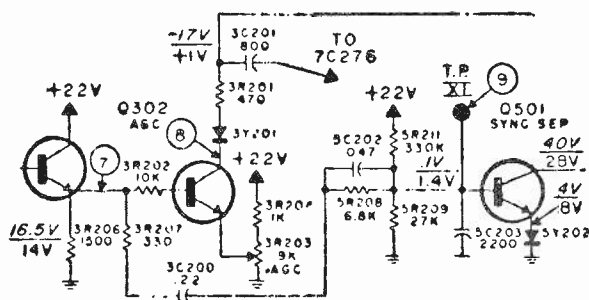
A no AGC symptom can be caused by open diode 5Y201.

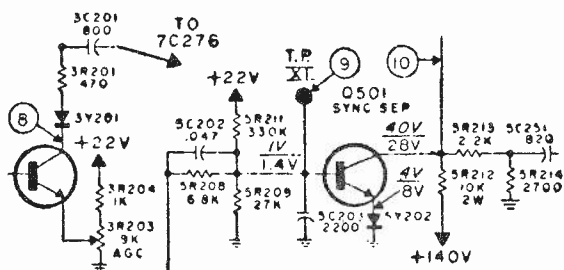
A symptom of no horizontal or vertical sync can be caused by a shorted diode 5Y202.

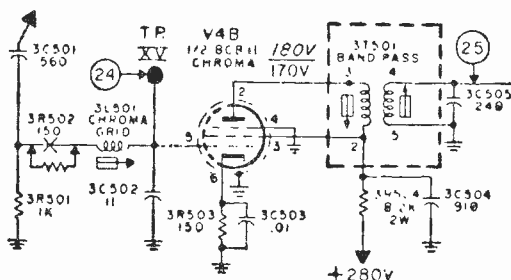
An intermittent color or no color can be caused by a burned resistor, R504, after its leads short to the bandpass transformer can.

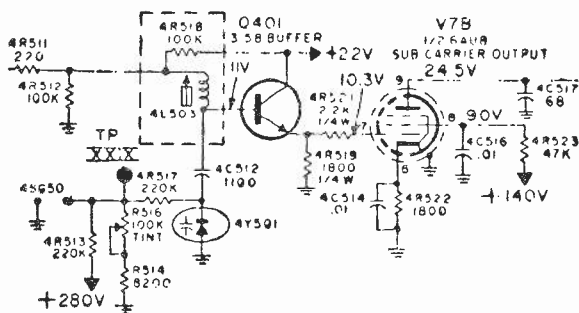
Intermittent or weak color can also be caused by a shorted buffer transistor, Q401.

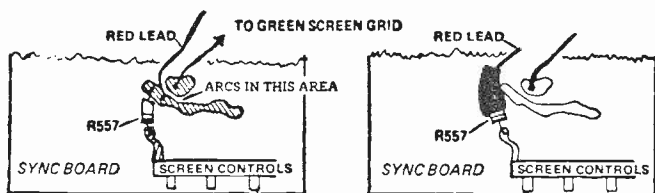
Repeated failure of power supply diodes Y402, Y403, Y404 and Y405 may be caused by picture tube arcs, which

are coupled into the B+ circuits through a secondary arc from the picture-tube green-screen-grid copper pad to the

copper pad for the B+ end of resistor R557 (on sync board) as shown in the illustration below.

Remove the B+ end of resistor R557 and the red B+ lead from the board and reconnect by means of a "flying joint" covered with heat-shrinkable tubing (Cat. No. EP90X1).

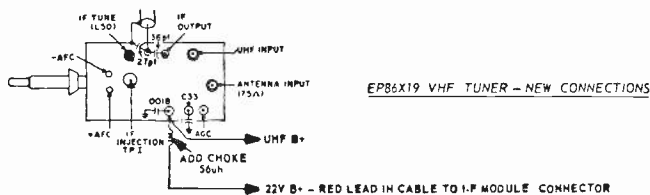
Test the tuner to determine if the MOSFET is shorted. This can be done by unsoldering the AGC lead from the tuner, discharging the AGC tuner terminal to ground and

then measuring the voltage at the open AGC terminal. If the voltage at this terminal is positive by more than a perceptible movement of the meter (the voltage should be zero), the MOSFET is shorted or partially shorted and the tuner should be replaced.

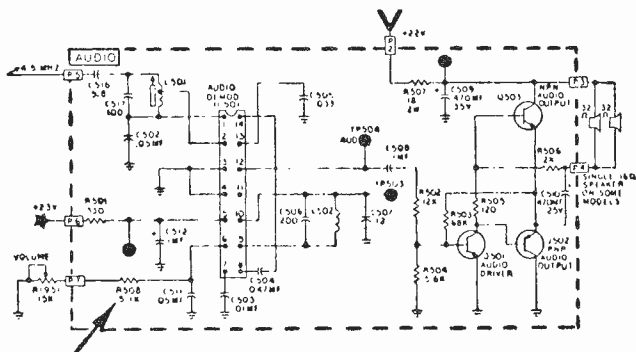
The position of the VOLUME control knob (slider) is determined by the audio output tolerance rating of IC501. With nominal audio output from IC501, the VOLUME control will function through its normal range.

If the audio output from IC501 is near or at its maximum output tolerance rating, then the VOLUME control must be retarded more than usual to attenuate the greater output. This places the slider in a position on the control nearer to the left end, where a larger resistance change occurs over a shorter mechanical path and the control becomes critical to adjust.

On audio modules exhibiting this condition, with Date Code before 5G2P, change resistor R508 from 5100 $\Omega$  to 6200 $\Omega$ . Beginning with Date Code 5G2P, the VOLUME control range has been optimized at the factory.

Increasing the resistance of resistor R508 allows the slider to be repositioned so that the VOLUME control will operate over its normal range.

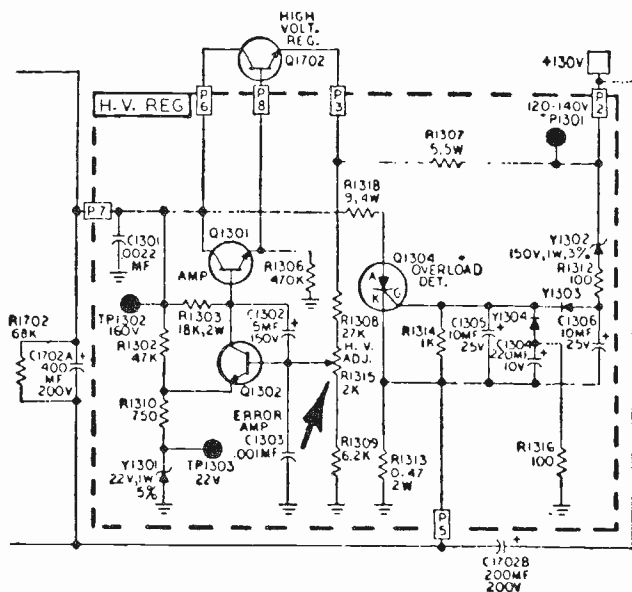
Wait at least 45 sec. before resetting the circuit breaker. By design, resistor R1318 always heats prior to circuit

breaker tripping. Quick resetting or holding the circuit breaker will damage this resistor on the high-voltage regulator module. Tripping can be caused by control misadjustment, allowing the receiver to operate from a few minutes to many hours before tripping.

**High-voltage Setting:** Adjust BRIGHTNESS and CONTRAST controls fully counterclockwise (CCW). Adjust HIGH-VOLTAGE control R1315 on the high-voltage module for 26.5kv at the picture tube anode. This is at minimum beam current (black screen).

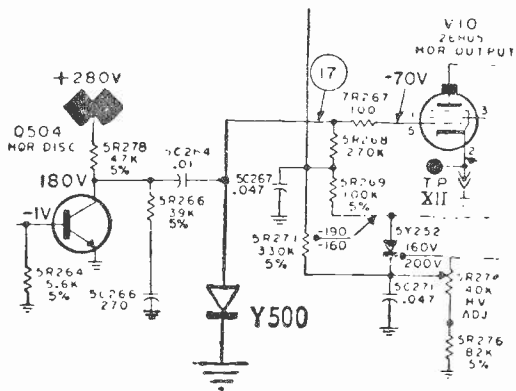
## Color-TV Chassis C1/L1 and C2/L2—Horizontal Discharge Transistor Q504 Failure

After replacement of transistor Q504, add a clamp diode, Y500 (EP57X1), to the copper side of the Sync Cir-

cuit Board as shown in the schematic. The diode is easily added and will protect Q504 from high "turn-on" voltages.

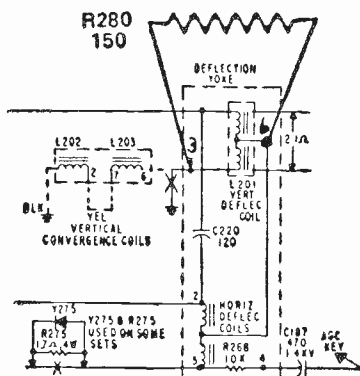
### Color-TV Chassis HE—Striations (Vertical Shaded Lines)

To overcome these symptoms add an R280, 150Ω ½w resistor between terminals 3 and 6 of the yoke as shown in

the diagram. Resistor R280 was added in HE chassis production beginning with Serial Number Code 5L1P.

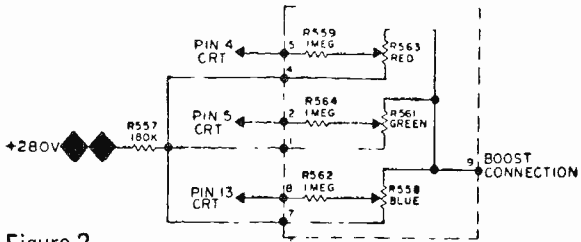
Figure 2

Each section of this triple pot has only two terminal legs which mount into the circuit board. The third leg of each potentiometer section has been removed. Interconnection between control sections is accomplished internally. The boost B+ line connect directly to a separate solder tab on the control. A piece of buss wire is inserted into the circuit board in place of each of the 1 megohm resistors R559, R562, R564, to provide circuit continuity. The electrical circuitry remains the same as in earlier C chassis receivers as shown in Fig. 2.

The catalog number for this new screen control is EP49X247. It should be used in all C chassis sets with serial numbers beginning with 5Z1T-----and later.

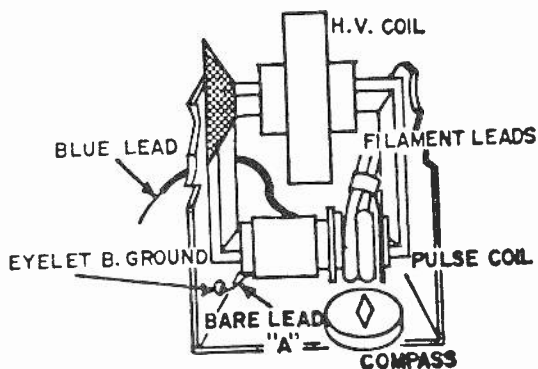
FIGURE 1

Some pulse windings in the above listed assemblies were wound in reverse. Installed in a set, they will create convergence and/or color sync problems because the pulse will be negative going rather than positive going. The assemblies in General Electric's present stock are wound correctly, but you may have one on the shelf which is wound in reverse. Using the following procedure, you can check the coil before installing it in a receiver. Refer to Fig. 1.

- 1) Place a small compass near the filament leads.
- 2) Connect the negative lead of a 1.5 volt battery to the metal frame of the high voltage transformer assembly.
- 3) Touch the blue pulse coil lead to the positive end of the battery.

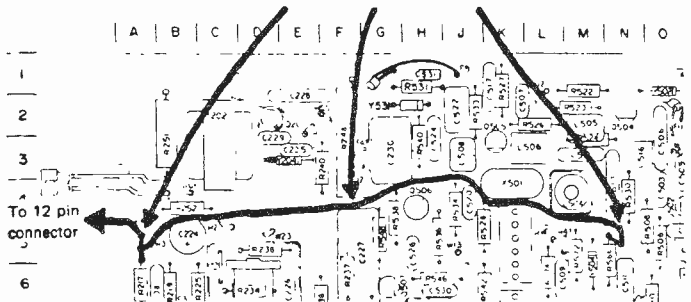
100 v p-p pulse voltage on it, and may not measure shorted with an ohmmeter. But there may be a solder splash, strand of wire, lead dress short, etc. which will arc and cause the coil to overheat when the set is turned on.

Check for shorts at islands and along grey wire.

The best repair procedure is to make a good visual inspection of the grey lead and its connections on the circuit board. The lead from the coil connects to the 12 pin connector near C404. From the connector, it goes to the circuit

board near resistor R217, and then another lead connects it to R566. Be sure to inspect the leads and both sides of the circuit board for foreign material, or dress shorts. The diagram shows the location of the leads on the circuit board.

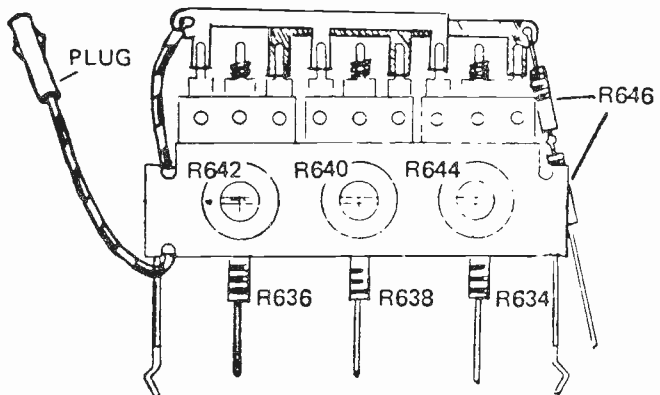
A symptom of vertical retrace lines at all brightness levels can be caused by resistor R646 increasing in value. In late production receivers, R646 consists of two 200 K resistors in series. Check the value of both resistors.

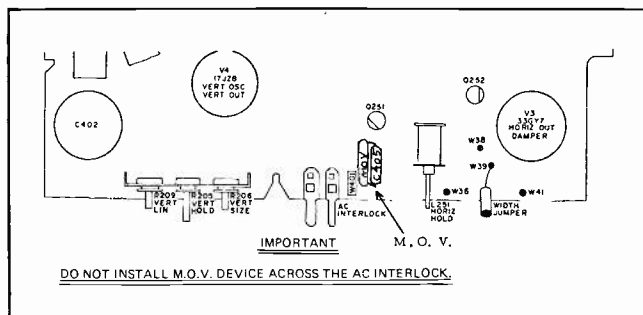
Due to high line transients in certain areas of the country, usually caused by frequent lightening storms, it may be desirable to protect the power supply from a repetitive failure by installing a BE 750 M.O.V. device.

In the SF chassis, the M.O.V. may be installed across C405 (diagram below) by carefully wrapping and soldering the leads around the legs of 405. Dress the M.O.V. close to the capacitor on top of the circuit board. But do not install M.O.V. across the AC interlock.

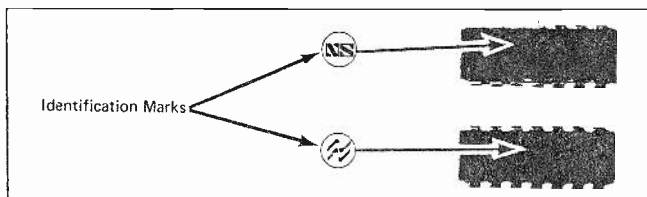
### YM Chassis—Audio Hum

Some YM chassis sets manufactured between June and October 1977 can have an audio hum because of a peculiarity of certain audio IC's (IC190). These are shown below:

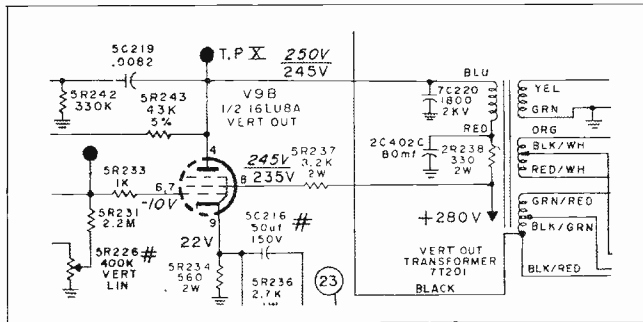
**Color TV Chassis C1/L1—No vertical sweep, or insufficient sweep.**

Check for intermittent short in 16LU8, or an open 5R234, or open 5R237, or open 2R238 (check the load side for short), or an open 5C216. (see diagram below).

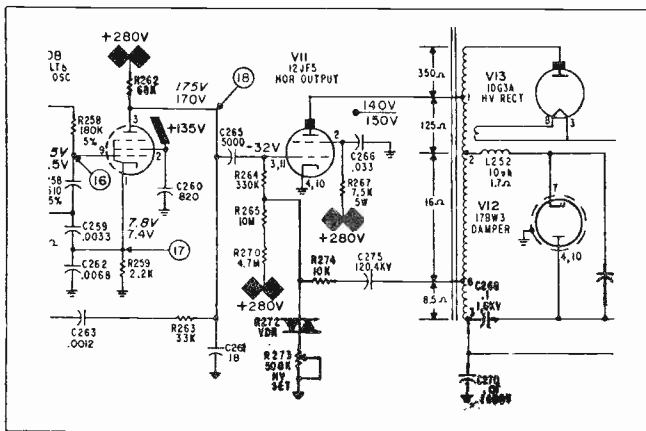
Resistor R264 in horizontal output stage is probably changing value. It should read greater than 150K ohms. Replace with 330K, 1/2W, carbon resistor.

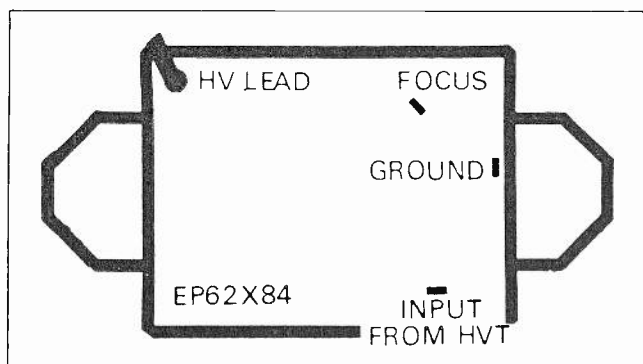
## Color TV Chassis MB-2—New high voltage multiplier (EP62X84).

The new multiplier is a replacement for EP62X41, but, the terminal placement is slightly different and it doesn't have a connection diagram printed on the side. Connections should be made as shown below.

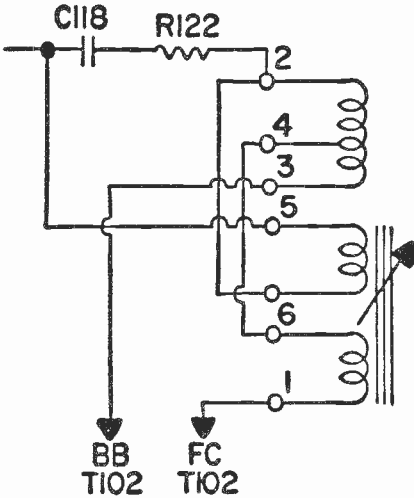
T920 and T931 color TV chassis uses a new type focus transformer part No.

361306-1. The 361306-1 can be used as a replacement for the earlier transformer (361240-3); however, because of physical differences between the two, the connections are not the same.

Terminal identification and the correct wiring for the 361306-1 transformer are shown in illustration.

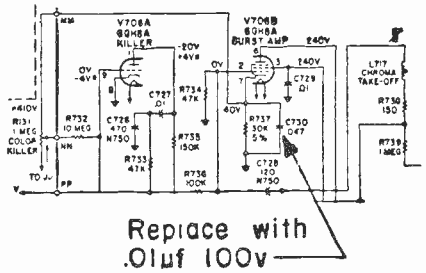
3.58MHz oscillator to operate on a more linear curve which improves the "hold-in" range of the color sync circuit. Changes 3 and 4 provide an increase in the burst signal amplitude which increases the control voltage applied from the phase detector diodes to the reactance control circuit.

1. Remove C755 (10pf NPO) and replace it with a 15pf NPO.
  2. Remove C756 (82pf NPO) and replace it with a 100pf NPO.
  3. If C730 is a 0.047μf. replace it with a 0.01μf 100v.
  4. If the burst amplifier tube is a 6GH8, replace it with a 6KE8.
  5. Perform AFPC adjustment as outlined in the service manual.
- The first two changes permit the

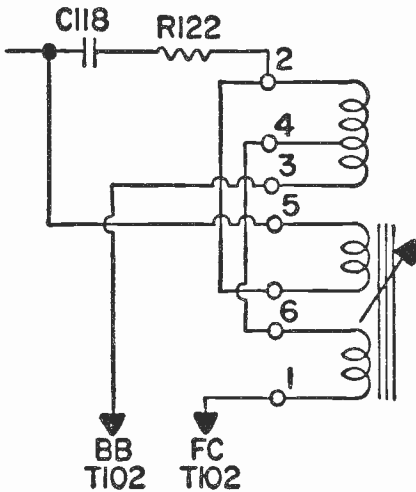
361306-1. The 361306-1 can be used as a replacement for the earlier transformer (361240-3); however, because of physical differences between the two, the connections are not the same.

Terminal identification and the correct wiring for the 361306-1 transformer are shown in illustration.

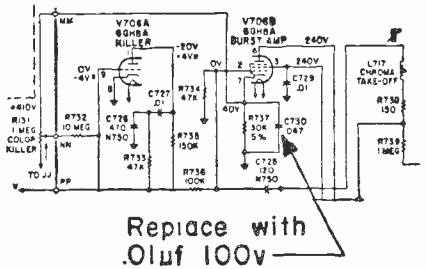
3.58MHz oscillator to operate on a more linear curve which improves the "hold-in" range of the color sync circuit. Changes 3 and 4 provide an increase in the burst signal amplitude which increases the control voltage applied from the phase detector diodes to the reactance control diodes.

1. Remove C755 (10pf NPO) and replace it with a 15pf NPO.
2. Remove C756 (82pf NPO) and replace it with a 100pf NPO.
3. If C730 is a 0.047μf. replace it with a 0.01μf 100v.
4. If the burst amplifier tube is a 6GH8, replace it with a 6KE8.
5. Perform AFPC adjustment as outlined in the service manual.

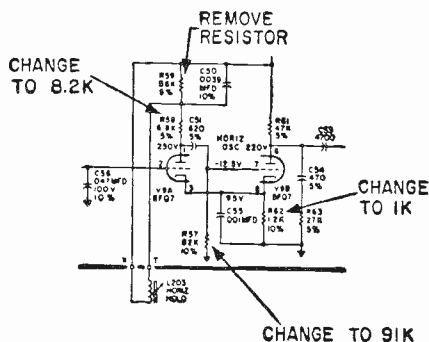
## TV Chassis T927 — Christmas Tree Effect

There have been reports of horizontal oscillator instability resulting in a symptom sometimes called

"Christmas tree effect." A production change has been made in the T927 chassis to eliminate this tendency. In this change R59 is deleted, R58 is changed from 6.8K to 8.2K, R57 from 82K to 91K and R62 from 1.2K to 1K.

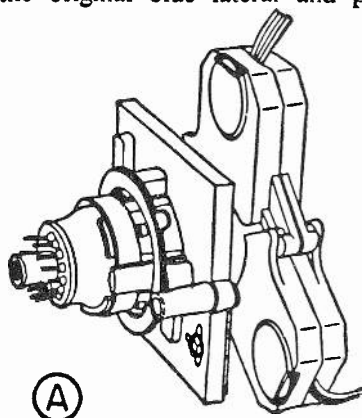
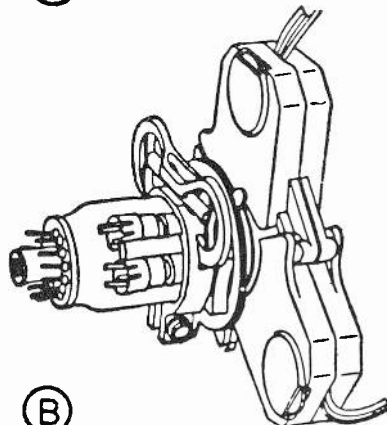
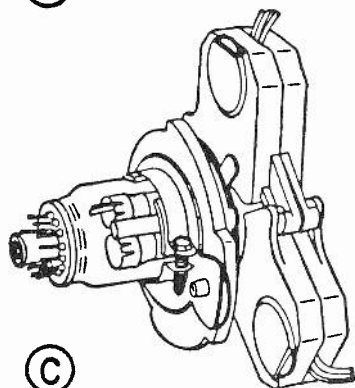
This new combination device (Part No. 361292-1) is now being stocked at all Magnavox parts depots. It is suggested that where poor purity is experienced as a result of "spot-tail-

ing" this can be corrected by replacing the original blue lateral and purity

device with part No. 361292-1.

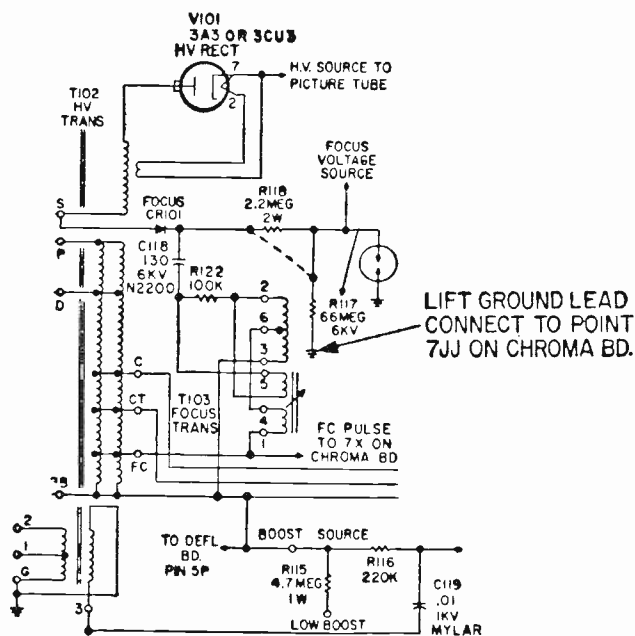
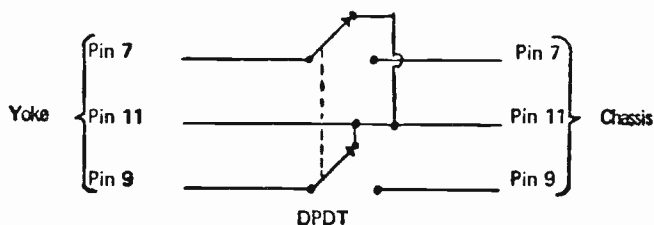
## Color TV Chassis T924—Modification of Color Test Fixture

Refer to Service Manual 7297, Sections 4.1 and 2. The test fixture yoke is wired as shown on the schematic for

the T924-03, 07 and 09 versions. These chassis are directly adaptable to the test fixture. However, the vertical yoke windings are connected internally in the T924-01, 02, 05, 06, 08 and 10 versions. These versions will have no vertical sweep when used with the fixture. A DPDT switch,

such as part No. 160370-5, can be inserted in the yoke extension cable as shown to enable the fixture to be used with all T924 versions.

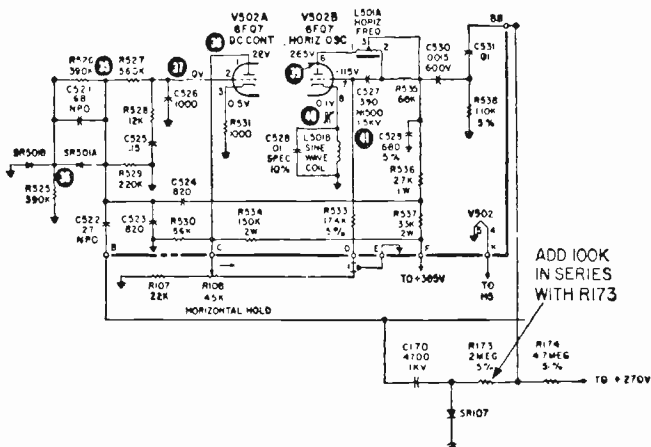
**Color TV Chassis T933—Service Hints**  
**Horizontal Jitter, Low 6BK4 Current, Raster Size Change as**  
**Brightness Control Setting Is Changed**

Resistor R173 (2M, ½ w, 5%) in the grid circuit of the 6JE6 horizontal output tube can cause horizontal jitter, low 6BK4 current and changing raster size as the brightness

Once this circuit modification has been completed the plate/screen supply for V901 will be the 270v source.

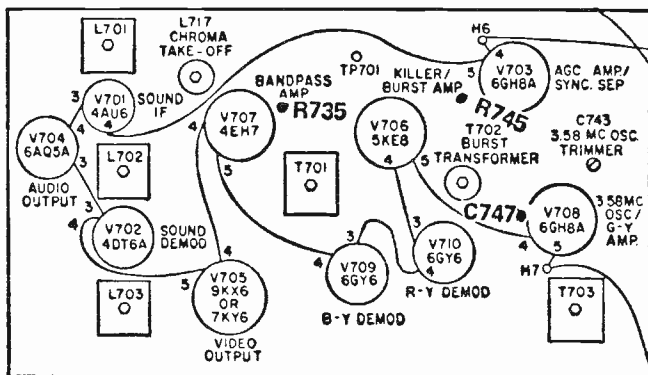
AFPC alignment can be accomplished in the T924 chassis without removing the chassis from the cabinet. The accompanying illustration of the chroma board points out the location of three connecting points (available from the top of the chassis), which are electrically equivalent to the alignment points listed in the service manual. They are

as follows: R735-V706B-Pin 2, R745-V706A-Pin 9, C747-T703-Pin 3.

Procedure: (1) Disconnect the chassis from the power source. (2) Connect a long clip lead to each of the three indicated points. Use leads which are sufficiently long to hang over the back of the chassis without shorting. Identify each lead so that its connecting point can readily be determined. (3) Insert tuning tools into T702 and T703, and leave them in place throughout adjustment procedure. (4) Set a long insulated screwdriver in place on C743. (5) Connect the chassis to the power source through an isolation transformer. (6) Complete the AFPC alignment as described in the service manual, using the installed clip leads as test points. (7) Disconnect the chassis from the power source before removing the clip leads and tuning tools.

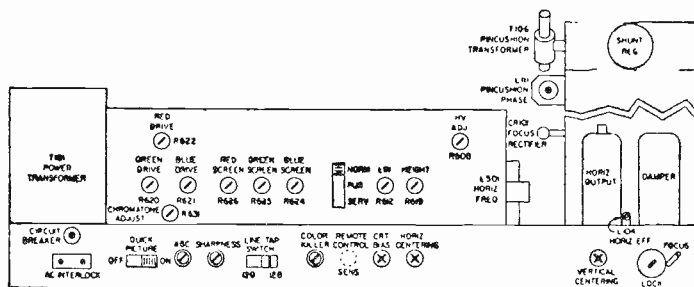
## Color TV Chassis T924—Critical Horizontal Hold or 'Lock-Out'

Horizontal "Lock-Out" is the condition described as follows: The receiver loses horizontal sync when tuned from one channel to another or where tuned off channel and back on channel, and sync can be restored only by adjusting the horizontal hold control. The horizontal hold control may be critical in adjustment but no other symptoms of horizontal troubles are presented.

If a T924 chassis has these symptoms, add a 12M, 1/2w, 10% resistor (part number 230104-263) from Pin 1 to Pin 9 of V703, the sync separator.

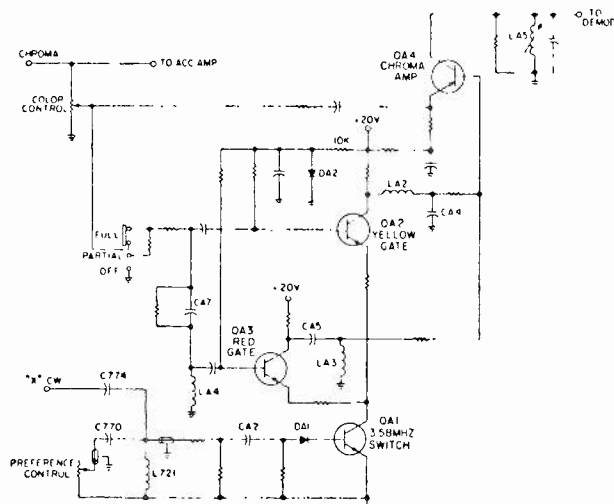
A problem in either the red gate or the yellow gate may be isolated by observing the action of the PREFERENCE control with the ATC switch on FULL. If fleshtones cannot

be shifted to green, the defect is most likely in the red gate circuit. If fleshtones cannot be shifted to magenta, the defect is in the yellow gate circuit.

The gates may be checked for proper operation using a scope and a color bar signal. While scoping the collector of the yellow gate, adjust the PREFERENCE control to obtain maximum amplitude of the first bar following the horizontal blanking interval. Move the scope probe to the collector of the red gate; the third and fourth bars should have approximately equal amplitude. If no waveform is present, check the base signals and the dc voltages.

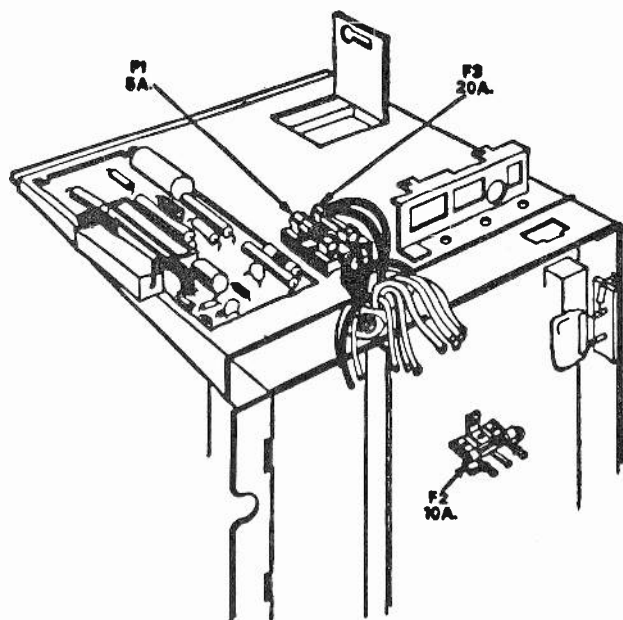
T940 Chassis (bottom view)

On the T940 chassis there are three fuses in addition to the circuit breaker.

F1, a 5a, 125v Slo-Blo fuse (Magnavox Part No. 180157-19) is connected in the 120vac supply line prior to the line choke and power transformer primary winding. This fuse provides additional protection even when the instrument is turned off and in the "Quick-On" position.

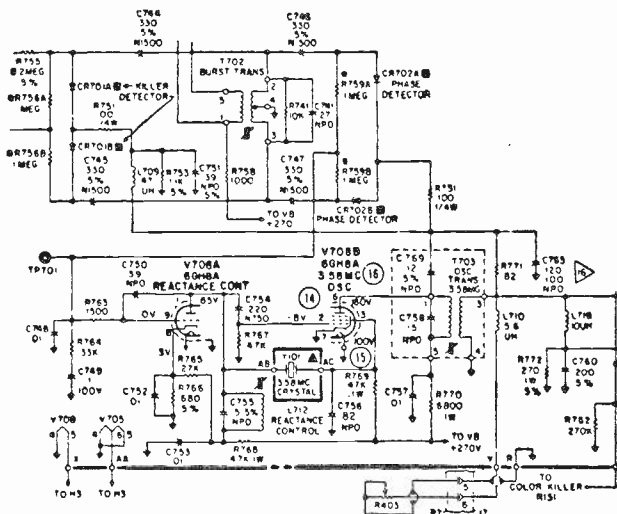
## Color TV Chassis T931/T933/T940—Color Sync Problems

The mentioned chassis as well as earlier chassis—such as the T920, T919, T918 and T911—use a matched pair diodes in the color killer and phase detector circuits. You

are reminded to include these diodes in your troubleshooting checks whenever you are working on a color sync problem. Either the color killer detector diodes (CR701A and CR701B) or the color phase detector diodes (CR702A and CR702B) can be the cause of intermittent loss of color sync, poor color sync or in some cases even loss of color. These diodes are specified as matched pairs, meaning they have identical characteristics. If one of the diodes in these matched pairs should suffer a change in characteristics, operation of the circuit will be impaired. The usual resistance checks will not be satisfactory in determining if the suspected diode has changed characteristics. If you suspect that either the killer detector or phase detector circuits are at fault, the following check is suggested:

Connect a color-bar generator to the receiver and set it for a normal color-bar display. Remove the 3.58MHz Oscillator tube (V708) and ground the junction of R756A and R756B in the color-killer detector circuit. Using a VTVM, measure the dc voltage to ground at each outside terminal of a diode pair—for example, at the anode of diode CR701A and cathode of CR701B. The voltage at the

anode should be negative, while positive at the cathode. The exact value of the voltages measured at these points will vary from set to set and also with the level of the burst signal. (Typical values might be +55v at the cathode and -55v at the anode.) The important point is the difference, if any, between the voltages measured across each of the diode pairs. Under ideal conditions there should be no difference. However, a 10 percent variation is allowable. If a voltage difference in excess of 10 percent exists across either diode pair, replace the pair with a matched pair, Part No. 170733-1.
