**COLOR TV**

**FACTBOOK**

**-Problems & Solutions**

By the Editors of Electronic Technician/Dealer

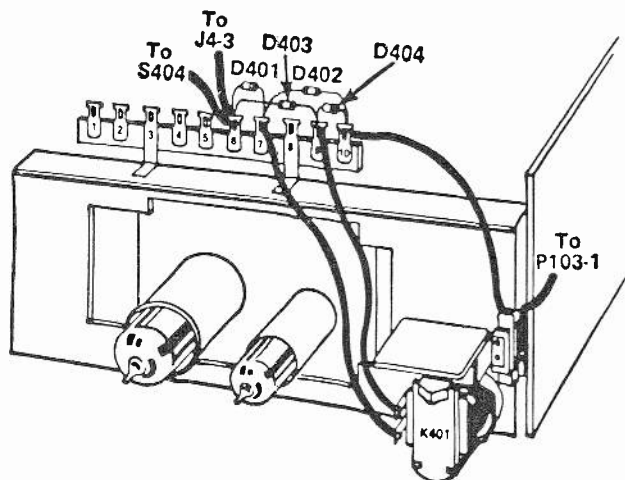
Fig. 1—Tuner assembly removed from cabinet to show component location of early production circuit.

### Color TV Chassis T950 with 704059 Remote Control Receiver— Volume ON/OFF Stepping Relay Circuit Modification

Early production of the T950 chassis equipped with the 704059 Remote Receiver has the Volume ON/OFF relay, K401, connected in the rectifier bridge arrangement. The relay, Part No. 160418-6, and the bridge connected rectifiers, Part No. 530082-4, are physically located on the tuner mounting bracket as shown in the illustration (Fig. 1).

In current production units, the relay circuit has been modified, as shown schematically in the diagram, to provide greater reliability. If it becomes necessary to replace a stepping relay connected in an early production circuit, it is recommended that at the same time the circuit be modified to the later production circuit to reduce the chance of future relay failure. The steps for the field modification are as follows: Fig. 1 illustrates the original parts location and Fig. 2 illustrates the parts location for the field modification. The terminals of the terminal strip have been numbered sequentially, 1 through 10, with terminal 1 nearest the front of the tuner assembly.

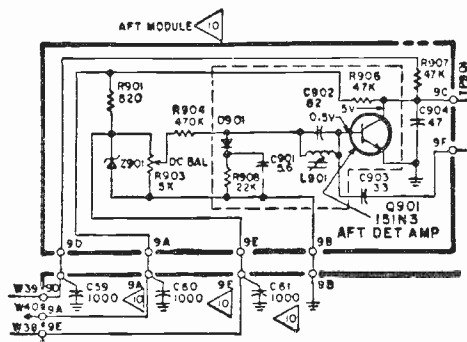
### Color TV Chassis T936—AFT Field Adjustment

When field adjusting the AFT circuit, select a station broadcasting a color program, preferably VHF, adjusting the fine tuning for optimum picture and sound with the

AFT switch in the OFF position. Connect a VTVM across points 9E and 9D of the AFT module and move the AFT switch to ON. Adjust the dc balance control, R903 for 0v.

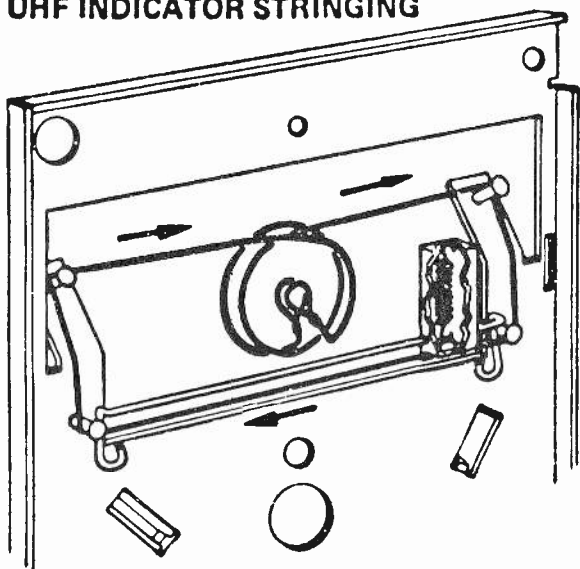
### UHF INDICATOR STRINGING

It has been determined that breakage of the UHF dial cord has in some cases been caused by the dial cord rub-

bing against sharp burrs on the edges of the cord guide flanges of the tuner mounting assembly in the front panel (see illustration).

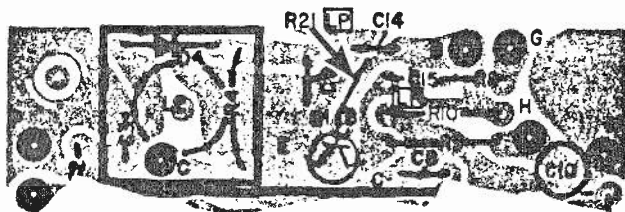
### AUTOMATIC FINE TUNING (AFT) BOARD (EARLY PRODUCTION)

On early production versions of these chassis it is possible that coincidence gate transistor Q1 on the AFT board could be damaged as a result of a high-voltage arc within the chassis. To prevent such damage, a 100 $\Omega$  resistor, R21, was added in series with the base of Q1 in later versions of these chassis.

If transistor Q1 on an early version AFT board should require replacement, a 100 $\Omega$  protective resistor should be added to the circuit at the same time. To accomplish this, cut the copper clad off the AFT board between the base of Q1 and the junction of C14, as shown in the illustration, install a 100 $\Omega$ , 1/2w resistor, R21, in series between the base of Q1 and point B on the AFT board.

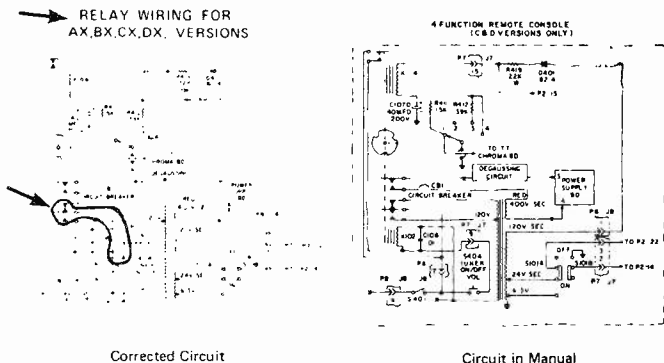
Corrected Circuit

The ON-OFF/VOLUME Stepper circuit for the C and D versions of color-TV receiver chassis T958 was modified to include a second relay, K104. This modification is indicated in Service Manual 7331 Section 4.1 in the block

labeled "Relay Wiring for AX, BX, CX, DX Versions" and in Service Manual 7326 (704059 and 704065 Remote Control Receivers), Page 9 in the block labeled "AX Four-Function Remote-Console Only." The schematic and labeling of these diagrams in both manuals are in error and should be corrected as indicated in the illustrations shown. The arrows in the illustration at the left indicate the areas in need of correction. The illustration on the right indicates the correct wiring for relays K102 and K104. This correction should be noted in both of the indicated service manuals.

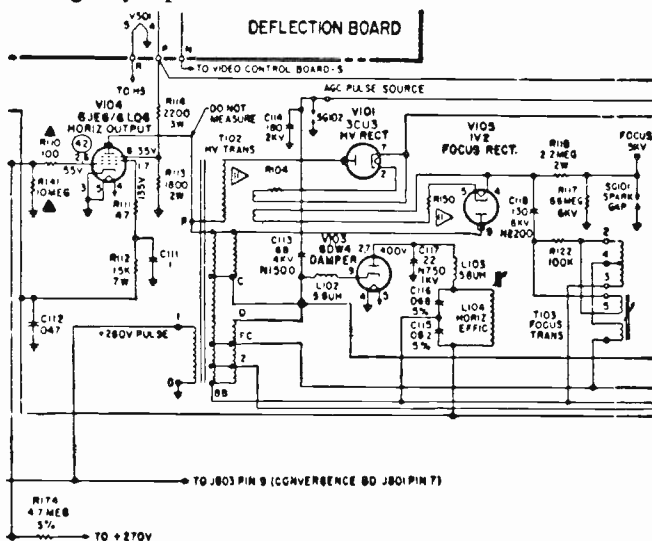
### Color TV Chassis T938—Installing Replacement High-Voltage Transformer 361328-1

The chassis employs a Horizontal Centering circuit (Diode and Resistor with solderless connectors for adjustment). These may not be shown on your copy of the T938 schematic diagram; if so, please add them. Failure to make the proper connection between terminals C and D will result in apparent normal operation, however, the transformer will be operating at excessive temperatures.

Transformer No. 361328-1 is the recommended replacement for the 361241 transformer used in the early production chassis. When installing this transformer, be sure that

terminals C and D on the transformer are connected through a jumper wire.

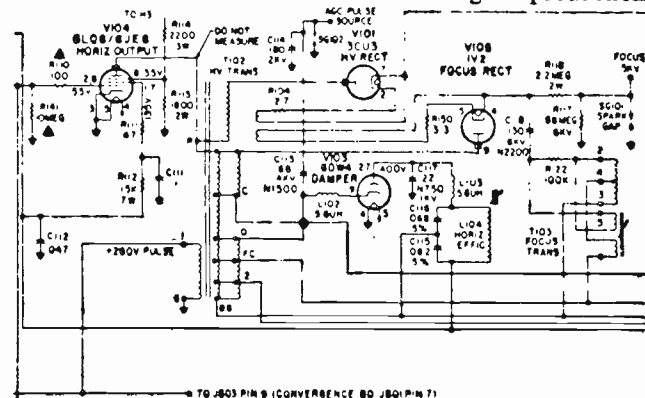
## CIRCUIT WITH HORIZONTAL CENTERING

These connections may not be shown on your copy of the T918 schematic diagram; if so, please add them. Failure to make the proper connection between terminals C and D will result in apparent normal operation, however, the transformer will be operating at excessive temperatures.

chassis. When installing this transformer be sure that terminals C and D on the transformer are connected through either a jumper wire or a 6.8Ω, 1w resistor.

- If the chassis employs a Horizontal Centering circuit (Diode and Resistor with solderless connectors for adjustment) terminals C and D must be connected with a short jumper wire.
- If the chassis does not employ the centering circuit, terminals C and D must be connected through a 6.8Ω, 1w resistor.

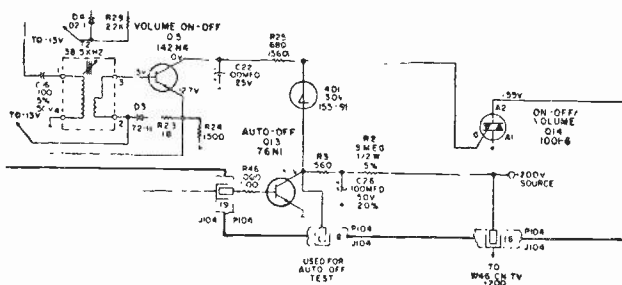
It has been found that an arc in the picture tube of a color-TV set with a 704069-1 remote control receiver can cause a high-amplitude transient pulse to appear at the base circuit of transistor Q13 in this receiver. In some instances, the current produced by such a transient is sufficient to destroy the transistor. Because of this, a current-limiting resistor is installed in series with the base of Q13 in all late production units. If an early production remote control not having such a resistor in series with the base of Q13 is encountered, one should be installed. This can readily be ac-

complished by cutting the foil between the base of Q13 and Pin 19 of the edge connector and then bridging the cut with a 1K resistor.

The exact value of the resistor is not critical. Individual values of 100 $\Omega$  and 1K have been used for this application in production; however, for field modification, the 1K value is preferred.

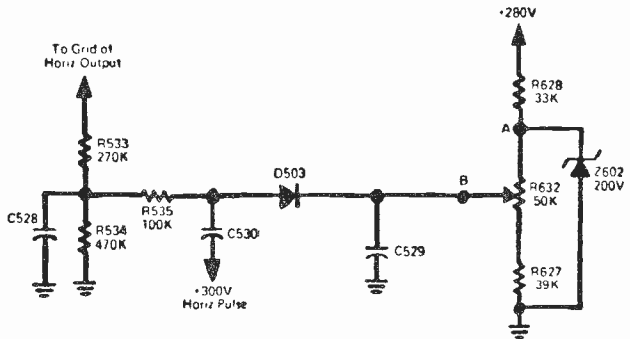
### Color-TV Chassis T924/T939/T950—Reduced High Voltage Caused by Leaky Zener Regulator Diode

A regulated 200v reference potential at the HIGH-VOLTAGE control (point A) is maintained by zener diode Z602—this potential variable over a range from about 88v to the full 200v present at the cathode (point B) of diode D503. The voltages present at the cathode of D503 determines the amount of the negative charge developed at its

anode by capacitor C530 during each horizontal pulse. The resulting negative voltage is divided across resistors R534 and R535, and applied as negative bias to the horizontal output tube grid. The amount of this bias determines the conduction of the tube and as a result the amount of high voltage. As the bias at the horizontal output tube grid becomes more negative, the high voltage reduced and vice versa.

If diode Z602 becomes defective, the high voltage is affected. If the diode opens, the potential at point A rises slightly and results in a very slight increase in high voltage. However, if the diode becomes leaky or shorts, the potential at point A decreases, causing an increase in negative bias at the horizontal output tube grid. An increase in this negative bias results in reduced high voltage, accompanied by decreased screen brightness and a narrower raster. The degree of reduction of high voltage, brightness and raster width can range from very slight to severe, depending on the degree of leakage in diode Z602.

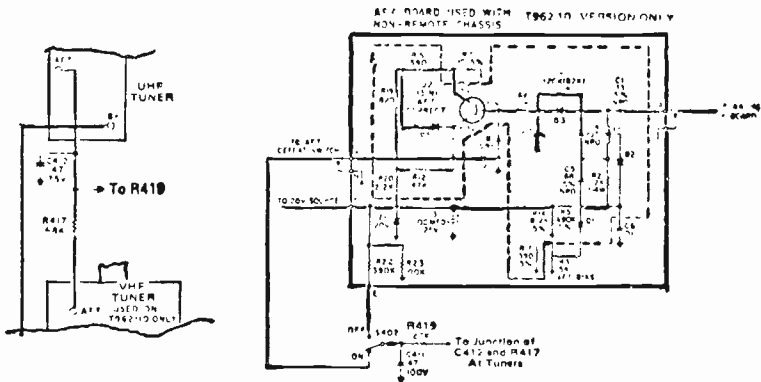
## Color-TV Chassis T962-10—New Tuners and AFT Correction Circuit

The 340193-1 VHF tuner, 340190-2/340191-2 UHF tuner and the AFT board used with the T962-10 version chassis differ from those used with all other T962 chassis

versions. In the tuners, the anodes of the AFT varicaps are connected to ground reference and the AFT correction voltage supplied from the AFT board is centered around +5v, and applied to the cathodes. There is no +20v reference source applied to these tuners. Since the AFT correction voltage required for these tuners is centered around +5v rather than +15v as for the tuners of all other T962 chassis versions, the AFT circuit has been modified to provide the proper voltage range. The illustrations show both the schematic for the new AFT board and the connection of the AFT correction voltage to the tuners for the T962-10 version.

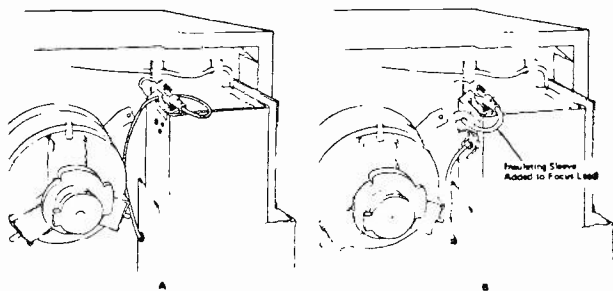
The T939 Color-TV chassis used in both consumer and hotel/motel product lines marketed during 1969 should be inspected for focus-rectifier lead-dress whenever any service is performed.

On some versions of this chassis the focus-rectifier socket is mounted on top of the high-voltage cage. Illustration A shows improper dressing of the focus-rectifier lead, which

could cause arcing between the lead and the high-voltage cage and/or deflection-yoke bracket.

Illustration B shows the recommended method for eliminating this possibility, using materials available without charge from Magnavox. Order Kit No. 171282-1 containing instructions and materials for five modifications from your Magnavox district.

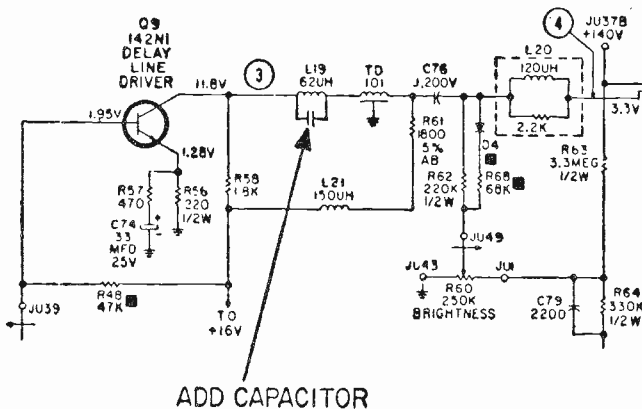
## Color-TV Chassis T952—Elimination of 3.58MHz Beat Pattern

Later versions of the T952 chassis incorporate a 33pf capacitor across L19 in the delay line circuit. This capacitor, which is identified as C75 (Part No. 250508-3305)

can be added to earlier version chassis to improve performance in cases where this beat pattern is noticed.

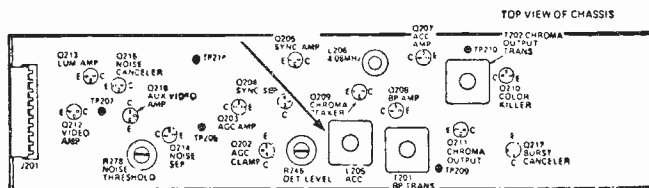
## Color-TV Chassis T974/T936/T956/T957—ACC Servicing Tip

The ACC (Automatic Chroma Control) circuitry used in the T974, T936, T956 and T957 chassis are designed to monitor the station burst signal and compensate for

changes in chroma levels which in theory should proportionately accompany burst level changes. In practice, all stations do not maintain specified burst-chroma level relationships.

If a station transmits too high a burst, too much bias will be placed on the chroma amplifier. This could result in a no color condition on a model utilizing one of the above chassis. Initially, the indication would be saturated reds. When this condition is corrected by use of the COLOR control, the other colors drop out.

The condition can be alleviated by detuning the ACC coil, L205, on the T974 chassis or L23 on the T936, T956 or T957 chassis. The effect of the ACC action is reduced by the amount of detuning. Best performance was ob-

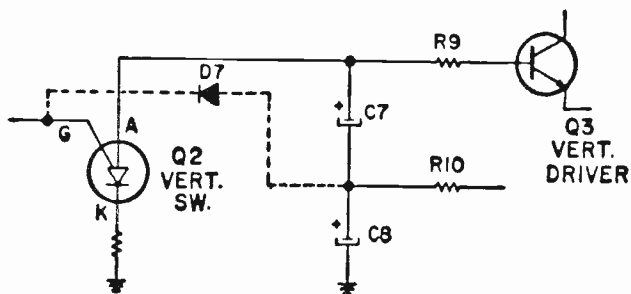
The diode, Part No. 530116-3, is available at the Magnavox Parts Centers and only this silicon device should be used in modifying early production "D" Panels.

This diode has been added on the second issue of the Magnavox factory schematic dated December, 1972.

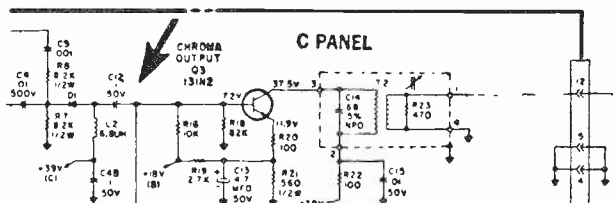
## Color-TV Chassis T979—Failure of C12 on "C" Panel

A condition of weak or no chroma has been traced to leakage in capacitor C12, located on the "C" panel. This

capacitor is used in the input circuit of the chroma output stage to couple the chroma signals from the COLOR control to the base of transistor Q3, while blocking the 39v dc applied to the anode of diode D1.

The suspect capacitor is a  $.1\mu\text{f}/50\text{v}$  unit manufactured by Dielectron and can be readily identified by a letter **D** on its body. Replacement with a  $.1\mu\text{f}/100\text{v}$  should precede any additional troubleshooting as any leakage will alter the operating voltages of transistor Q3.

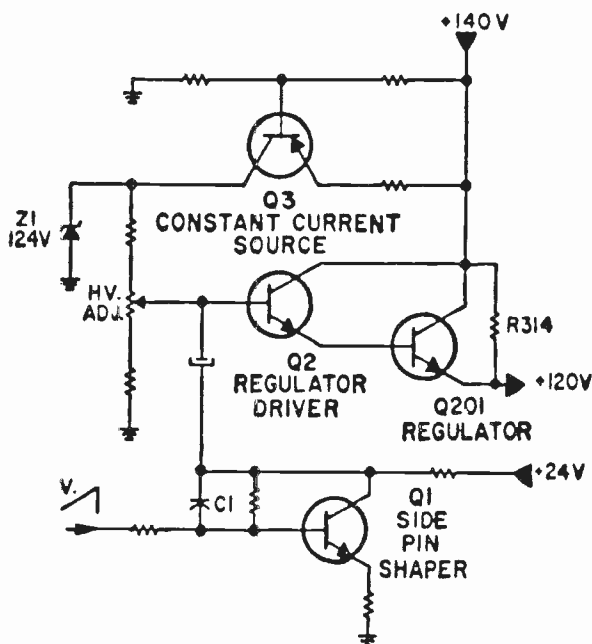
## Color-TV Chassis T989—Troubleshooting the Power Supply

The pilot lamps are important indicators when diagnosing AC problems in the power supply. If the lamps do not light when the AC switch is in the ON position, the following checks should be made:

- 1) Be sure the AC line cord is connected to the wall outlet, then push the circuit breaker reset button.

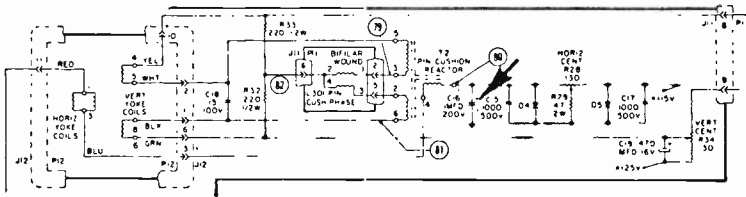
Capacitor C16 at the upper left hand corner of the "D" panel is charged and discharged by the horizontal yoke current. It is a special capacitor and may not be substituted by a general purpose capacitor. It was discovered that a run of these capacitors fell below minimum specifications.

You are requested to help the manufacturer locate and remove these capacitors from service by visually inspecting the unit any time you have occasion to service a T979 chassis. The faulty components are identified by the letters MF on the capacitor body. For example: Pactron, 1.0 $\mu$ f +10%, MF200v.

If you discover one of these capacitors in service, replace the "D" panel. Credit will be issued to you when the panel is returned to the Magnavox Parts Center. Approved capacitors are identified by an MPC, HA or MF (with an accompanying white dot).

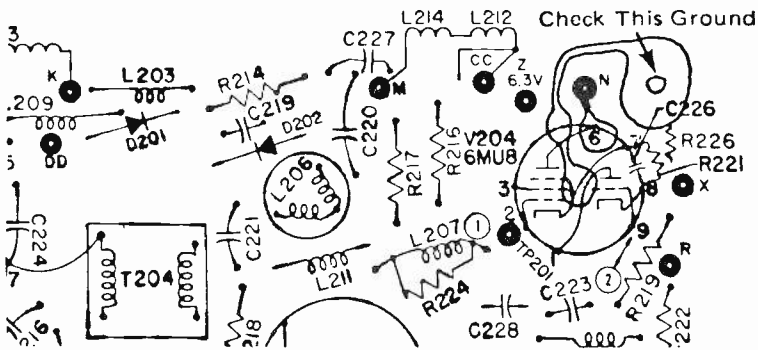
## Color-TV Chassis T958—Hum Bar

A strong hum bar that would occur intermittently on a T958 chassis was traced to a poor solder ground at the filament of V204, 6MU8 on the Video IF board. The SER-

VICE SWITCH in this instance proved to be a valuable service aid when it was noted that the bar was still visible in the PURITY position of the switch. The ground point is shown in the illustration.

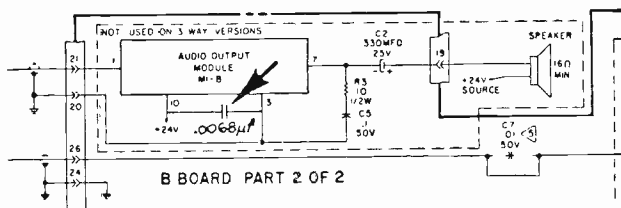
## Audio Output Module 612046-202

A .0068 $\mu$ f capacitor has been bridged from B+ (pin 10) and ground (pin 3) on the module to preclude the possi-

bility of oscillations occurring in the module. In addition, a pigtail is attached on the ground land surface at terminal 3. This lead is to be brought around the board and attached to pin 20 on the chassis.

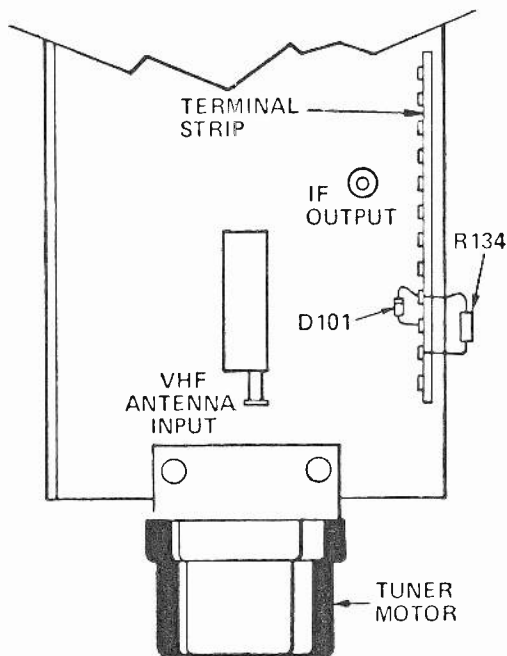
## Color TV Chassis T989—Remote Control UHF AGC Improved

The T989 chassis employing the six-function remote control and digital readout features may exhibit overload symptoms on strong UHF signals. This condition can be

corrected by changing resistor R134 from 150 K, 1/2 w to 270 K, 1/2 w. The change increases the RF, AGC voltage applied to the UHF, RF amplifier in the 340236-1 UHF

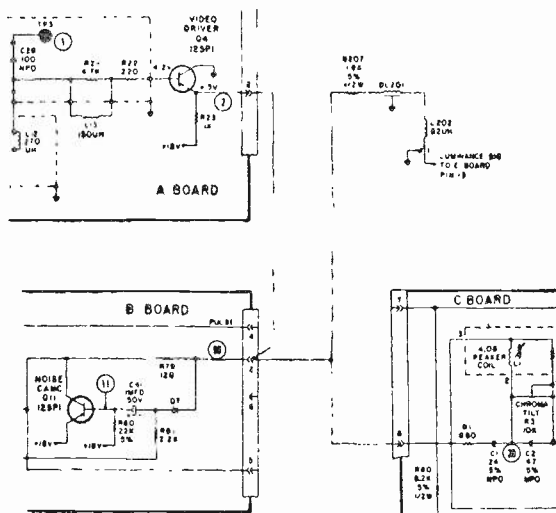
## Color TV Chassis T979—Vertical Line on Left Side of Raster

A narrow vertical line on the left side of the raster has been noticed on a limited number of T979 chassis. The cause has been traced to an error in the wiring from the "B" board. The illustration shows the correct wiring arrangement. The vertical line on the screen is produced when the wire from pin 6 of the "C" board is erroneously connected to pin 3 of the "B" board instead of to pin 2. The result is that the video signal is routed through R79

on the "B" board before being applied to the video stages. R79 introduces a small pulse into the video signal. The solution is to remove this wire from pin 3 of the "B" board and connect it to pin 2.

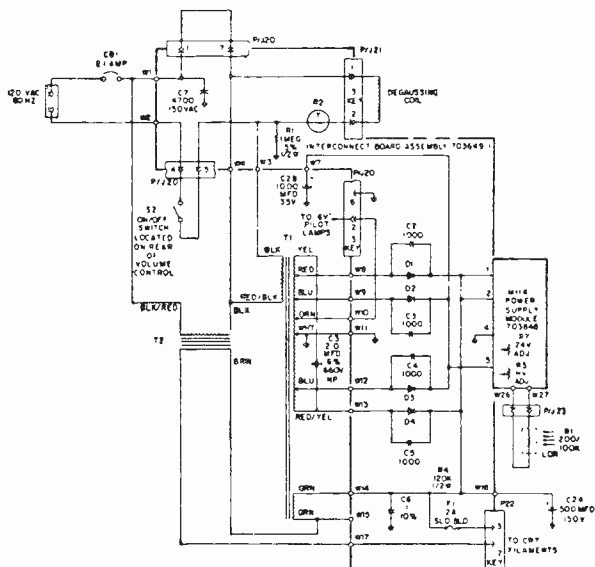
## Color TV Chassis T995—Quick-On Wiring

was originally designed with the Quick-On feature and contains a Quick-On transformer. The function of this transformer is defeated as shown in the illustration. The

jumper wire from pin 1 to 7 on P/J 20 of the Interconnect board shorts out the primary winding of the Quick-On transformer, T2, and disables the Quick-On option. The filament voltage to the picture tube is provided by the bottom winding on the power transformer, T1 (Part No. 300316-1). However, the Quick-On transformer must remain in the circuit because its secondary winding serves as a load in series with the picture tube filaments.

In the near future, transformer T1 will be changed to part number 300316-2. At that time, the filament winding of T1 will be 6.3 v AC and will be connected to terminals W14 and W17 of the Interconnect board. Transformer T2 will be eliminated.

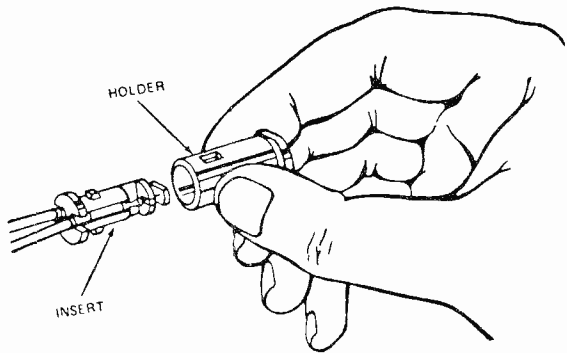
### Videomatic TV Sets—New LDR Holders

A new LDR holder assembly has been developed to minimize the possibility of LDR damage from static discharges. The new assembly is made of two parts—the holder (Part No. 143593-1) and the insert (Part No. 143592-1). The entire assembly is still removable from the front of the instrument as usual, but to separate the holder from the insert the holder must be gripped as shown in illustration and squeezed to unlock it. This new assembly may be used to replace all original holders with the part number 142848 or 143290.

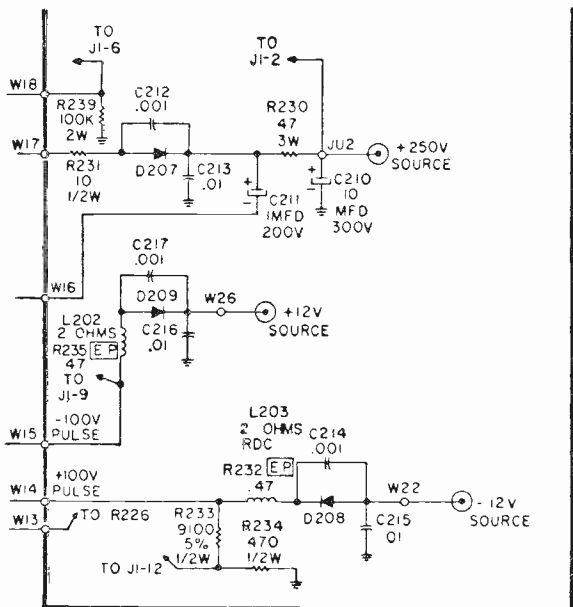
## Color TV Chassis T981/982/987 — Failure of Resistors R232 and R235

Resistors R232 and R235 are .47 - ohm, 1/2w, metal film resistors used in the plus and minus 12v DC vertical power supplies of early production chassis. If either of these resis-

tors fails and replacing the resistor corrects the problem, it is very possible that a previous problem existed and the resistor was overstressed but did not fail at that time. Sometime after the original problem was corrected, the resistor fails.

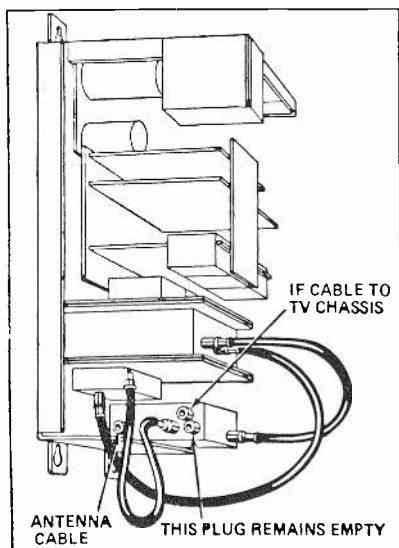
### Star Remote Control — Coax Cable Connections

Replacement of the STAR Tuning Assembly may cause confusion when the coax connectors are reattached to the

VHF tuner. As shown in the illustration, two coax cables connect to the VHF tuner. One is the antenna cable and the other is the IF cable to the TV chassis. Notice that one of the plugs remains empty. If the IF cable is connected to the

empty plug, the results will be a snowy picture or no picture. When installing a replacement STAR Tuning Assembly, be sure to connect the IF cable to the correct plug.

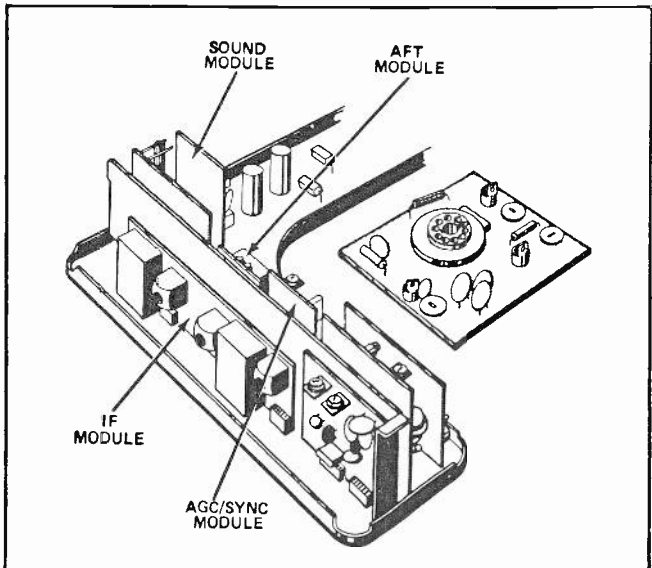
(A) The RF AGC voltage should be about plus 10 volts and the IF AGC voltage should be about plus 4.5 volts. (B) If the voltages are incorrect, replace the AGC/Sync module.

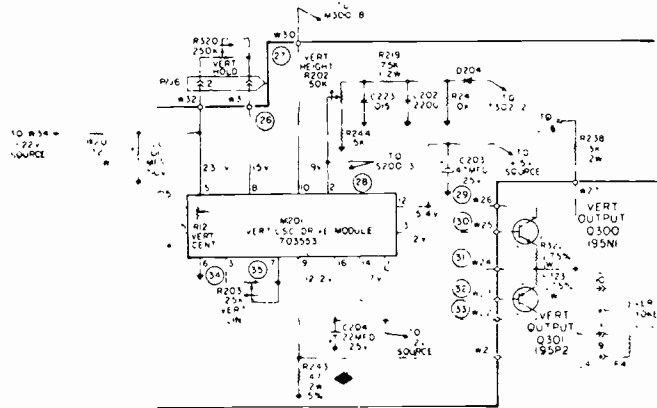
### Color TV Chassis T981/2/7—Keystoned Or Slanted Raster

Capacitors C203 and C204 are the plus and minus 12-volt filter capacitors used in these chassis. When the capacitor fails, it usually causes a small slanted raster with

a keystone effect similar to a shorted yoke. These parts should be replaced with 100 mfd. capacitors @ 25 VDC, Part No. 270109-1225, to prevent the problem from re-occurring.

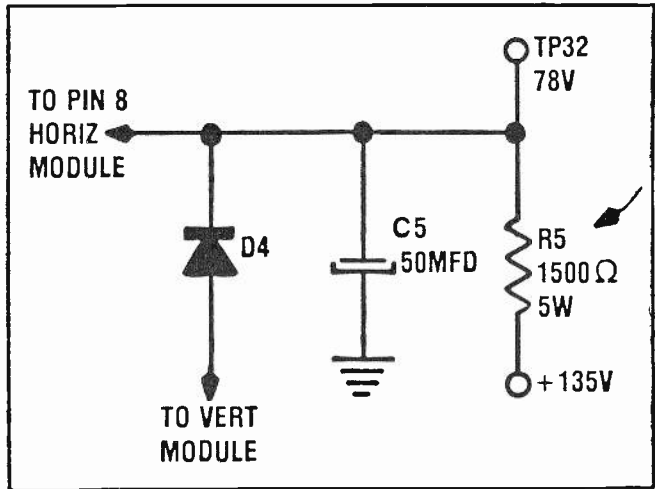
**TROUBLE SYMPTOM:** Incorrect horizontal scan or complete loss of raster (sound unaffected).

**CAUSE:** If cause is traced to a defect on the horizontal module or a defective horizontal output transistor Q1, always check the voltage at TP32 after replacing either the module or Q1. The voltage at TP32 should be about 78 volts. If it is significantly higher, the value of R5 (1500 ohms, 5W) probably has decreased, in which case R5 should be replaced to prevent repeated failure of the horizontal module or transistor Q1.

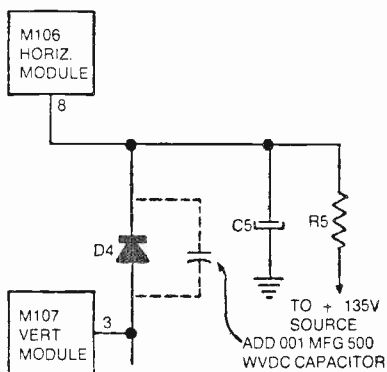
**TROUBLE SYMPTOM:** A white stripe which extends down from the top of the screen about three inches and curves to the left. This video interference occurs only under certain weak signal conditions.

**CAUSE:** Radiation from diode D4, which is electrically connected between pin 3 of the M107 vertical module and pin 8 of the M106 horizontal module. (The physical location of D4 is on the copper side of the "mother" printed-circuit board, near the lower right side of the chassis.) To eliminate this radiation or the possibility of it occurring, add a  $0.001 \mu\text{F}$ , 500V capacitor (Magnavox part 250551-1029) across D4. Place the capacitor as close to the printed-circuit board as possible, but avoid shorting out the adjacent copper lands on the board.

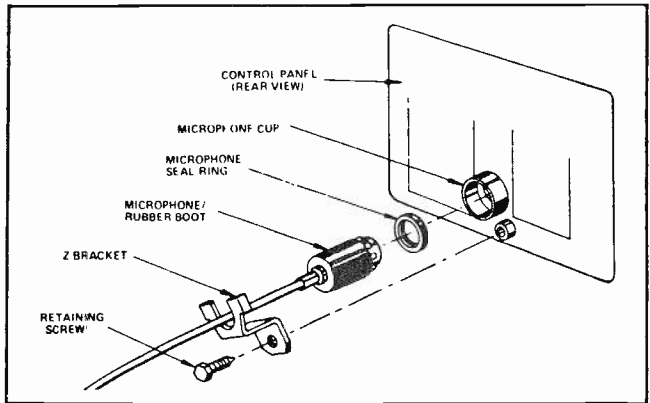
**Videomatic Touch Tune Models—low remote receiver sensitivity**  
Videomatic models equipped with the RG9000 Remote kit can be controlled with the transmitter at distances up to 30 feet. If the set will operate only when the transmitter is within a few feet of the remote receiver microphone, try a known-good transmitter. If the transmitter does not correct

the problem, check the remote receiver microphone for proper installation. The microphone *must* be insulated from the metal control panel. A contact between these assemblies will produce a ground loop and greatly desensitize the remote receiver. When a low sensitivity symptom occurs, remove the microphone from its mounting cup and make the following checks:

- Check that the microphone seal ring is installed in the cup ahead of the microphone.
- Check that the metal microphone housing not covered by the rubber boot is insulated with electrical tape to prevent possible contact with the cup.
- Place the microphone squarely into the cup.
- Install the Z bracket so the ears capture the sides of the boot and the cable connector is centered in the bracket opening.

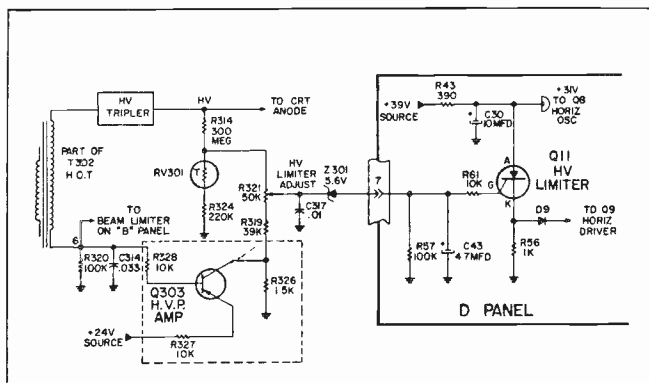
The T989 chassis uses a HV monitoring circuit to sense excessive HV. When the HV exceeds acceptable limits, the circuit kills the horizontal oscillator and shuts down the HV. (See diagram below).

The circuit is preset at the factory and R321 is sealed. Therefore, any readjustment of the circuit requires installation

of a new HV limiter Adjust, R321. If component values in the divider network change, the circuit trip point will be changed. R314 and RV301 are likely suspects. RV301 should measure approximately 750K at 25 degrees C, and approximately 225K at 55 degrees C. Z301 is also a critical circuit component. If it is too leaky, it will allow the circuit to trip prematurely. A specially screened diode must be used for Z301. To replace the diode, order kit P.N. 171383-1. The kit contains a new diode and a new R321.

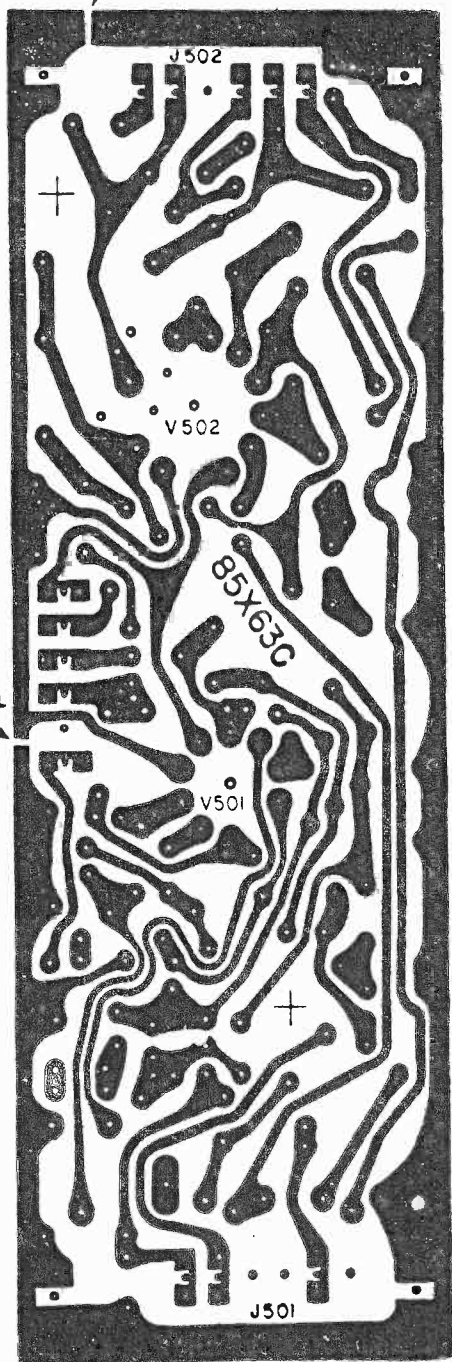
CUT FOIL

There is a possibility of heater ground currents on the PW500 (P156) deflection board, having a common path to ground with the horizontal oscillator automatic phase control circuit returns. This condition can come and go depending upon the contact resistance of the four ground pins on the corners of the boards.

tor in parallel. Change transistor Q501 to an 86X0048-001 transistor. Cut foil on the PW500 board as shown to eliminate a common-ground path between the heater returns and APC circuits.

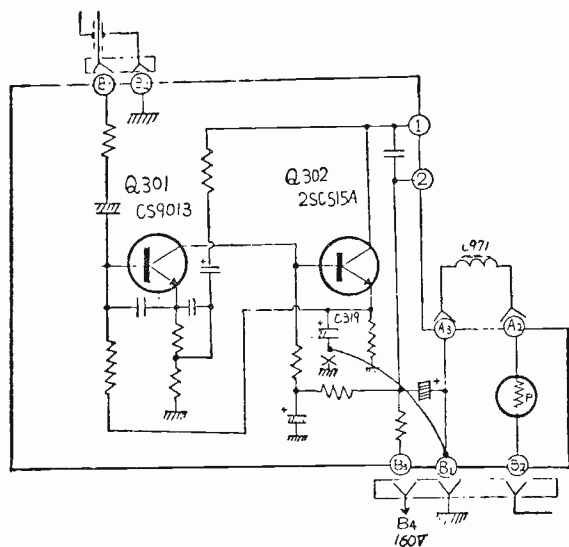
Remove the five-connector plug on the audio board and clean the contacts at ground terminal B4. Using a tuner cleaner that does not attack plastics, clean contact B4. Also, visually inspect and do whatever else is necessary to be absolutely certain that contact B4 is making positive contact.

Add a short piece of new wire from the negative side of C319 to terminal B1 on the PC board.

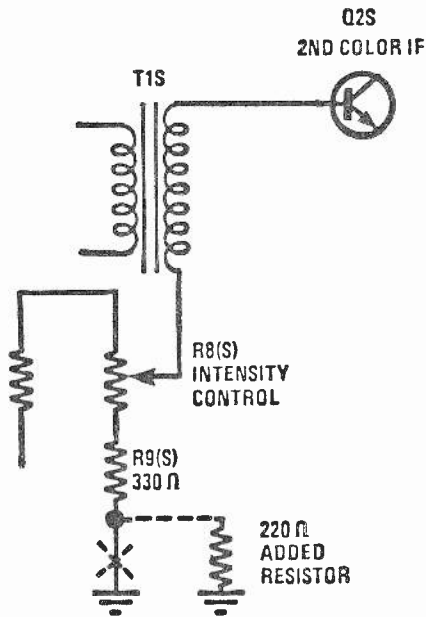
**Vertical Retrace Lines Visible at High Brightness.** Current production sets are designed to operate properly with the G2 controls set to track near the center of their operating range. Tracking the set with the G2 controls at or near maximum setting can pro-

in two ways; electrically, however, the wiring is the same. 2. To effect this change, a 220 resistor is added in series with R9(S) (330 $\Omega$ ) and the intensity control R8(S), to ground. (3) Proceed as follows (refer to photo): A. If the 560 $\Omega$  2w resistor R21(E) is wired to terminal 2, move the wire to terminal 3. B. If the 330 $\Omega$  resistor R9(S) from the intensity control is wired to terminal 3, remove and wire to terminal 2. C. If a jumper wire exists between terminals 2 and 3, remove and discard. D. Add a 220 $\Omega$  1/2w resistor between terminals 2 and 3. 4. Final check: R9(S) 330 $\Omega$  resistor from bottom of intensity control should be wired to terminal 2. Added resistor (220 $\Omega$ ) should be wired from

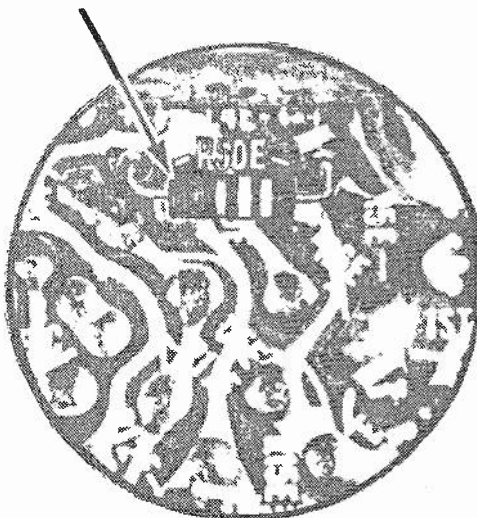
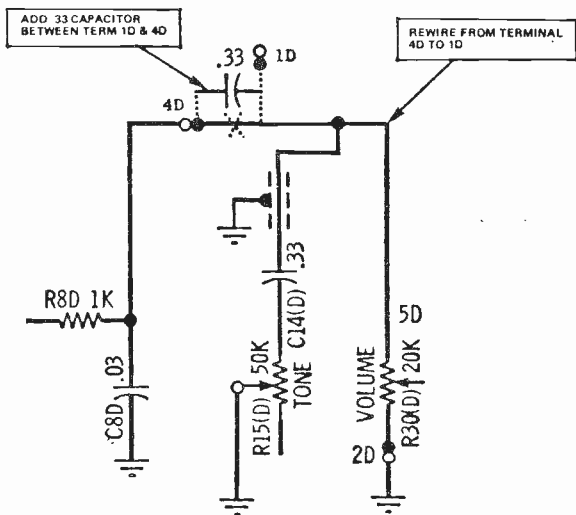
**SOLDER.**

Symptom: Under certain operating conditions, sets with E-14 or E-15 panels may tend to "ring" in the second

video stage and cause either (1) a multiple ghost effect with each ghost spaced about  $\frac{1}{4}$  in. to the right, or (2) a slightly "busy" background.

Solution: For sets using either E-14 or E-15 panels, install a 2.7K  $\frac{1}{2}$ w resistor in the space provided for resistor R50E (see details in the photos). This places the resistor

in parallel with the video peaking coil and prevents ringing. This modification will not be needed for subsequent E panels.

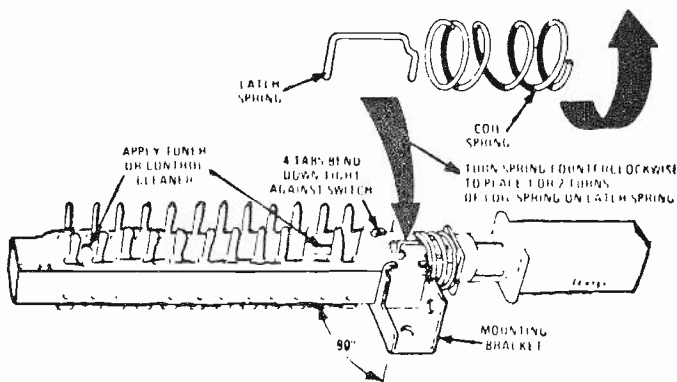
If the INSTA-MATIC switch locks down but will not release or switch will not lock down and there is erratic, mechanical action, make the following corrections:

The switch body may not be properly positioned relative to the mounting bracket. Align the switch body perpendicular to the mounting bracket and tighten the four mounting tabs as

shown in the illustration. Turn the coil spring to place one or two turns over latch spring, whichever obtains the best action. The latch spring may be distorted. If so, replace it with latch spring Part No. 42P63085.

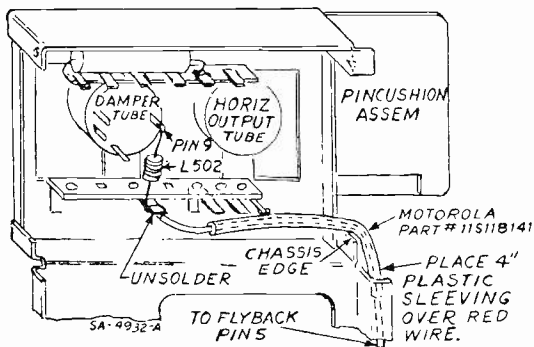
RF radiation may be caused by damaged insulation on the red wire between pin 5 of the high-voltage transformer

and pin 9 of the damper tube. Place plastic sleeving over the wire, to prevent leakage to the chassis edge, as shown in the accompanying illustration.

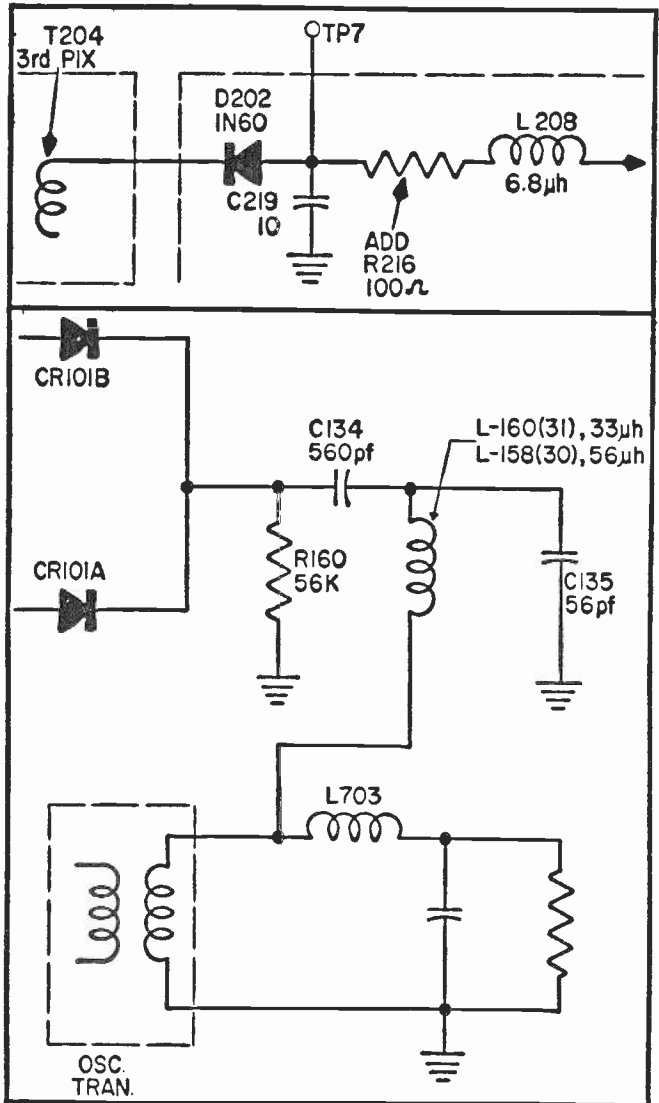
There is an error on the schematic, CTC-30/31, which was supplied with the initial group of production models. This error was not in the wiring of the chassis: (a) Components

R-160 (56K) and C134 (560pf) in the ACC circuits of CTC-30 and 31 should be interchanged. (b) Takeoff to ACC on CTC-30 was shown on wrong side of phase shift coil. Proper connections are shown.

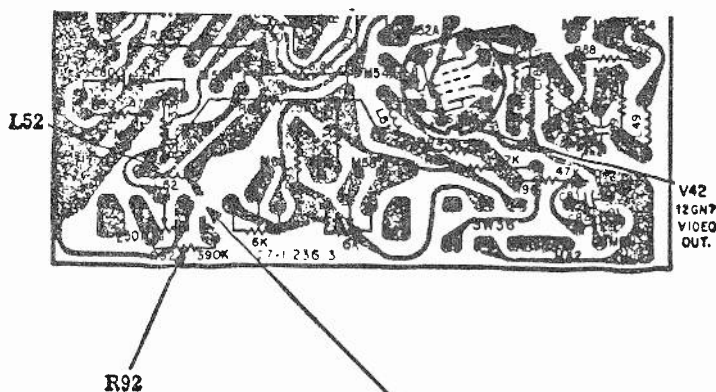
### Color TV Chassis 18QT85/18MT70— Failure of Blue and Green Drive Control

Engineering evaluation has shown that the blue or green drive control can open if arcing appeared between the copper circuitry connecting the drive control and B+.

Open copper at this point  
and connect jumper across

In those instances where a set is removed for replacement of the control or for servicing other than the control, the following change should be made to protect the control from future failure (refer to drawing).

(1) Open the copper strip connecting coil L52 and resistor R92 (390K). (2) Connect an insulated jumper between coil L52 and resistor R92 (390K).

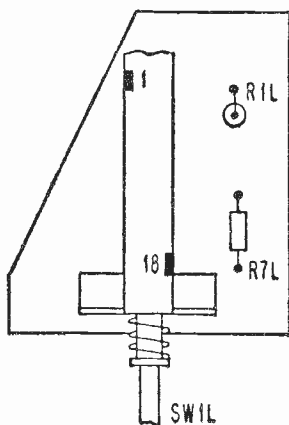
PHILCOMATIC SWITCH/PANEL

Chassis that may exhibit a high contrast level with the CONTRAST control at minimum (full counterclockwise) can be corrected by replacing resistor R1L with a 1.2k 1/2w

resistor and resistor R7L with a 560Ω resistor. These resistors are located on the Philcomatic switch panel as shown.

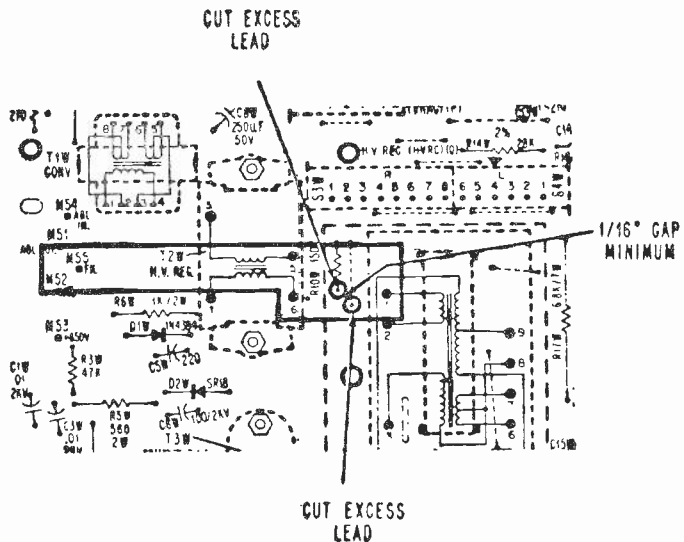
Should an open picture-tube filament be encountered in any of the color modular chassis, a possible cause of failure

may be the closeness of solder points between the picture-tube filament and the 150v point located on the deflection mother board (W). Any leakage or short between these two points could destroy the picture-tube filament.

Upon referring to the drawing you will note that the points in question are between one end of resistor R10W and the copper strip going to pin 6 of the high-voltage regulator transformer, T2W. Check the spacing between these two points. There should be a minimum spacing of 1/16 in. free of foreign material. Also, any excess leads that extend through the two points should be cut off. Therefore, before replacing a picture tube which exhibits an open picture-tube filament, check the two points as indicated.

It is strongly recommended that should any of the subject chassis come in for shop service regardless of reason, check the two points in order to prevent any possible future failure.

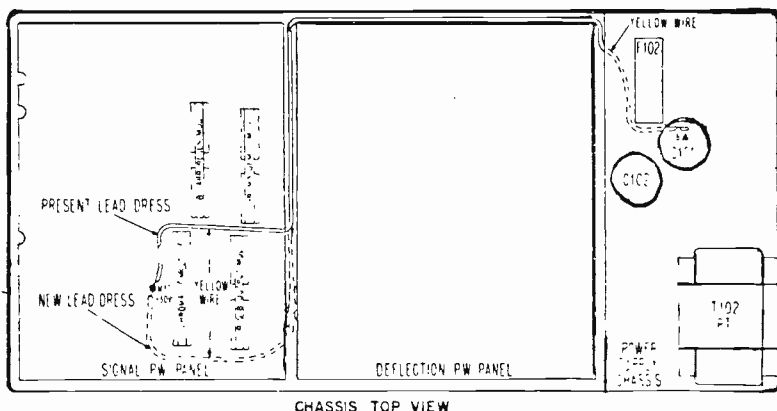
In the event a condition of video ringing (gray bars) is noted on the right side of the raster, a change in lead dress of the 30v line from the power supply to the 30v lug M37 on the signal mother board may help in reducing or eliminating the gray bars.

Refer to the drawing to locate the 30v yellow lead. The lead dress can be performed without removing the chassis or extending the lead length.

It is recommended that when service is required on any of the subject chassis, the 30v lead dress be checked and redressed if required.

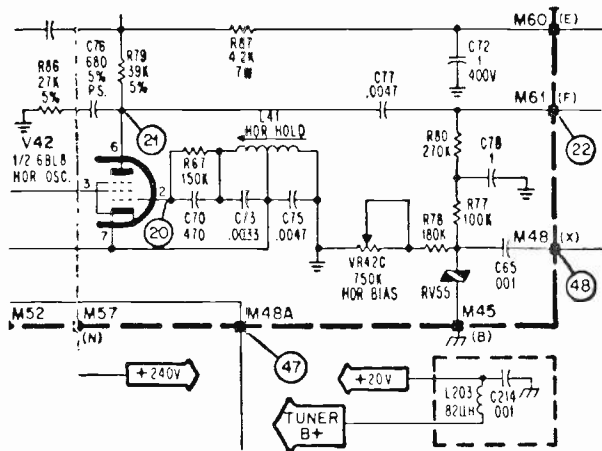
In the event three black vertical bars appear on the left side of the raster—with or without video information—field

reports indicate resistors R77 and R78 may be the cause. It is recommended that resistor R77 be changed to 330K, 1/2w. It is also suggested that resistor R78 be changed to

100K, 1w and be mounted vertically on the panel. Check the HORIZONTAL BIAS ADJUST control which should be set at its maximum high-voltage setting.

For an improvement in performance, resistors R77 and R78 may be changed to these values indicated on all incoming chassis repairs, thereby, possibly eliminating the occurrence of the symptoms described.

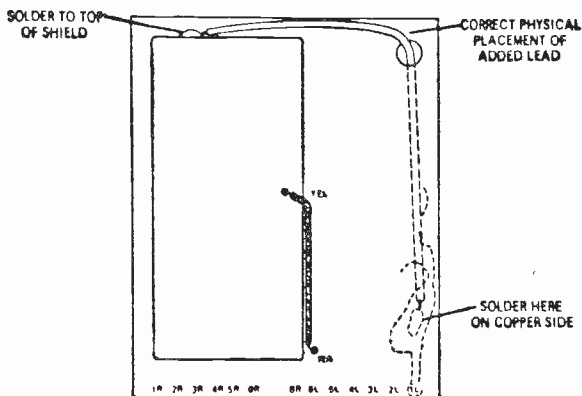
**ACTC (B)**  
TOP COMPONENT VIEW

In the event a condition of video ringing appears in weak or fringe signal areas, the addition of a ground lead to the

ACTC module (B) (Part No. 69-1000), between the top of the shield and terminal (1L) should correct the problem.

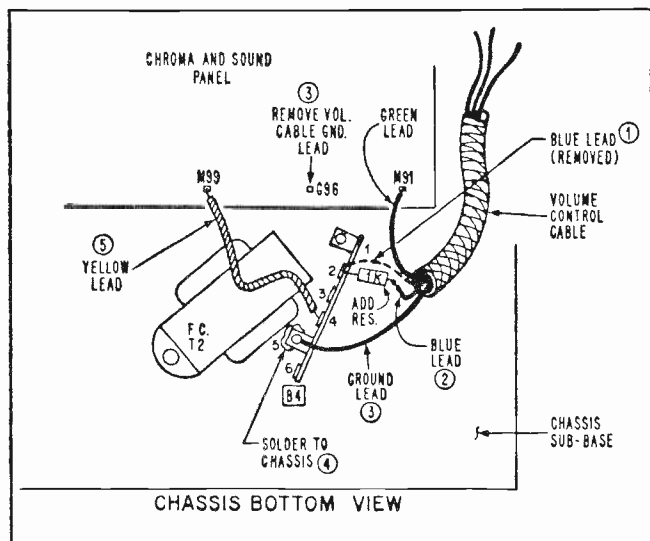
If hum or buzz is encountered at low levels of volume in any of these chassis, the following procedures should remove or reduce the hum or buzz to a point where it will no longer be objectionable:

- 1) Remove the blue lead of the volume control cable

from lug 2 on terminal B4.

- 2) Connect a 1K,  $\frac{1}{2}$ W resistor between lug 2 and the blue lead.
- 3) Remove the ground lead of the volume cable from lug G96 on the PW panel and reconnect it to lug 5 (ground) on terminal B4.
- 4) Securely solder ground lug 5 on terminal B4 to the chassis, for improved mechanical grounding.
- 5) Dress the yellow lead connected between lug M99 (on PW panel) and B4-4 away from filter choke (T2) and at right angles to the choke core, as shown in the accompanying illustration.

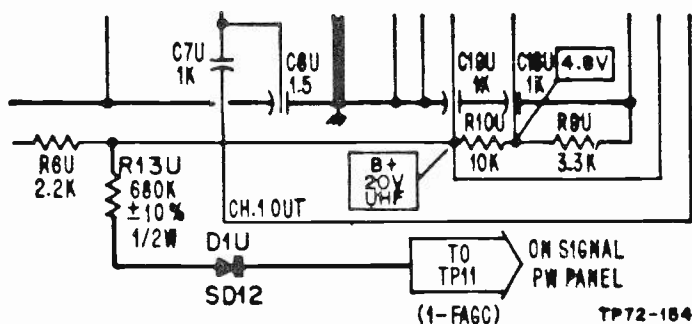
This modification should be made on tuners not already modified if a snowy UHF picture is produced in an area where a nearly snow free picture is possible (assuming no other defect is causing the snowy UHF picture).

diode SD12 (DIU) No. 34-8057-13, and then connecting the cathode of the diode to lug TP11 (1-FAGC) on the Signal PW Panel with an added wire. (Refer to attached illustration for layout of the new parts.)

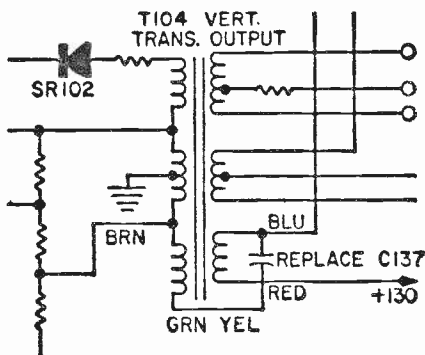
Reports indicate that leakage of C137, a  $0.0033\mu\text{f}$  capacitor, may cause critical vertical hold.

It is recommended that when a replacement is necessary, an RCA stock #120347 capacitor or one with exact specifications, be used. This capacitor is a ceramic  $0.0033\mu\text{f} \pm 10\%$  and rated at 3kv.

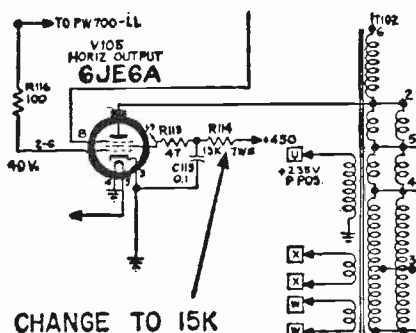
### New Damper Tube in RCA Victor Color Chassis

Effective with November 1966 production, all 25in. color chassis CTC21, 24, 25 and 25X were equipped with a new type damper tube, 6CL3. The tube biasing is identical to the Novar

6DW4. However, the tubes are not interchangeable without circuit modification.

The 6CL3 is said to be more efficient than the 6DW4, requiring an increase in the screen grid load of the horizontal output tube. It will be necessary to change R114 from 13K to 15K if the new damper is used. Horizontal efficiency coil and HV adjustments must be performed after the conversion.

If you encounter a chassis where repeat failures occur — a change from the 6DW4 to the 6CL3 may help.

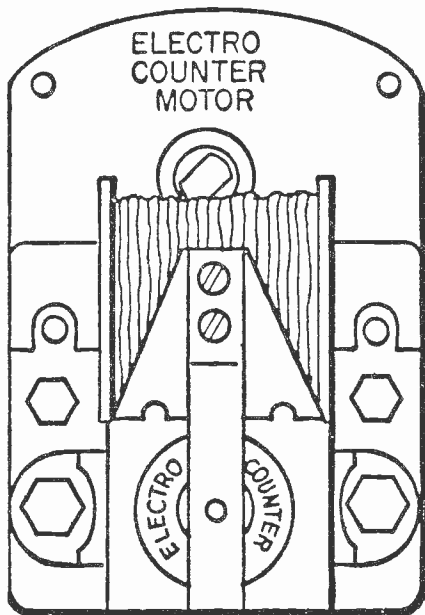
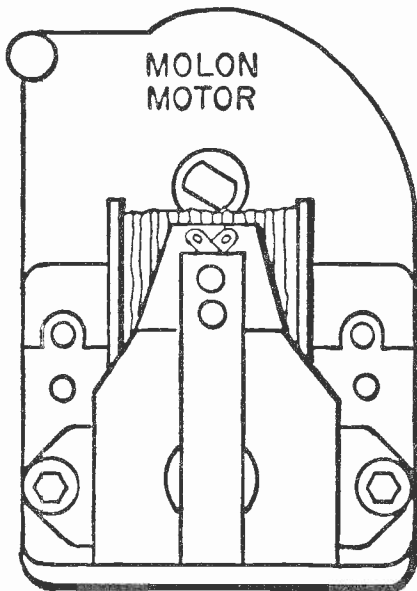
### Non-remote Power Tuning CTC30 Chassis — Channel Skipping

Some models with nonremote power tuning may occasionally skip channels. The following corrective action should clear this problem.

**Condition "A."** Where there is a tendency to skip a VHF channel and an Electro Counter motor is used,

replace "leaf switch" S1002, stock number 115497. **Condition "B."** Where CR1202 diode has failed and

an Electro Counter motor is used: (1) Add  $10\ \mu\text{f}$  capacitor C1201 — if it is missing, stock number 118832. (2) Replace S1002 switch, stock number 115497. (3) Replace CR1202 diode, stock number 116052. **Condition "C"**.

Where there is a tendency to skip a VHF channel or jam and a Molon motor is used, replace motor with Electro Counter motor stock number 119680.
