**COLOR TV**

**FACTBOOK**

**-Problems & Solutions**

By the Editors of Electronic Technician/Dealer

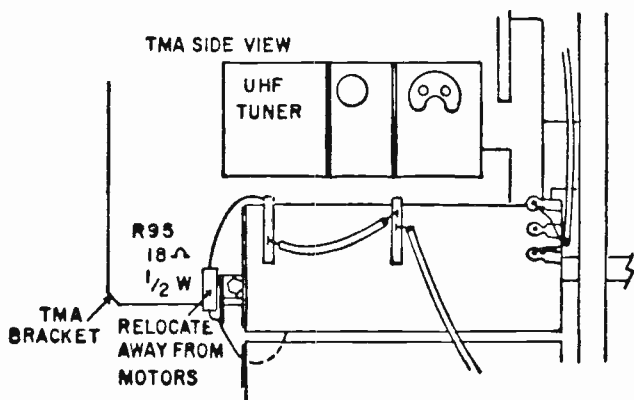
The remote color television receivers referenced to this bulletin use a twin-lead for power to the pilot lamp. In some instances (specifically after normal service operations and during reinstallation of the tuner mounting assembly), the "high" side of the lamp power lead could be accidentally "pinched" between the TMA bracket and chassis "shorting" the lamp to chassis. The following corrective steps are to be performed when the referenced receivers are serviced: (1) Make a visual check of the pilot lamp supply lines (twin lead) to find out if lead has been "pinched" or "shorted" by TMA bracket. (2) If lead has been pinched

or shorted, remove TMA and place a "spaghetti" sleeve over the pilot lamp leads. (3) Check physical location of

pilot lamp series resistor R95 ( $18\Omega$   $\frac{1}{2}w$ ). This resistor, shown in illustration, may be located in close proximity to the color remote motor. Take corrective action necessary (relocate terminal board leads, and/or "body" of resistor) to position body of resistor in a location at least two to three inches away from any of the remote control motors (i.e., color, tint, volume). This action may involve a simple relocation of the terminal board further rearward on the TMA bracket. Resistor R95 is accessible without pulling the TMA or chassis.

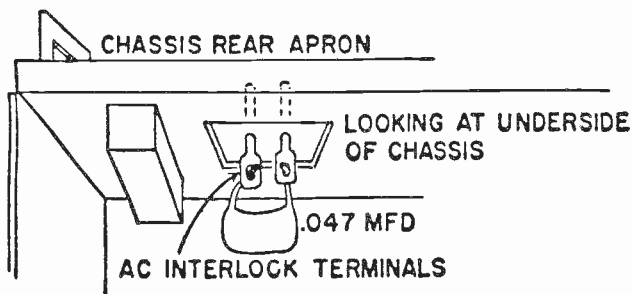
The color television receivers referenced have a  $.047\mu f$  filter capacitor connected across the ac input line. Due to its physical location (wired directly across the ac interlock terminals), the capacitor can easily be checked and/or replaced in the home using the following guidelines and illustration: (1) Remove rear cover and chassis retaining bolts; slide chassis slightly rearward to inspect capacitor across interlock terminals. (2) If the approved capacitor, identified by its white color and stamped with drawing number 90097-221 or 1442487-221 is used, secure chassis and restore receiver operation. No further action is necessary. (3) If the capacitor viewed is brown or reddish-

brown in color, it should be replaced with the approved type. The RCA Stock Number of the approved capacitor is 111286. It is recommended that all service technicians carry this approved type capacitor.

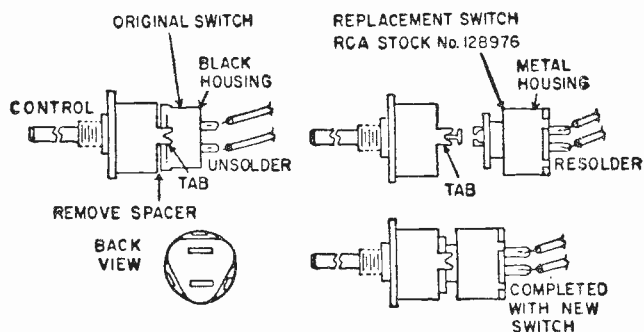
The color television receivers referenced have a pull-on, push-off type switch assembly that may experience premature failure. Original switch assemblies should be removed

and approved replacements installed as outlined: (1) Remove rear cover and identify the type switch in the receiver. If the switch is the same type as the approved replacement, replace rear cover and restore operation. No further action is necessary. (2) If the original type switch is identified, it should be removed and the approved replacement (RCA Stock No. 128976) installed. (3) The switch should be replaced in the home as follows: Loosen

the tuner mounting assembly, unsolder ac leads and remove original switch from the control by bending the three retaining tabs outward. Remove spacer, pull the actuating shaft of the replacement switch to its extended position and slip over the end of the control shaft. Now, secure the switch by bending tabs inward over the switch shoulder. Resolder leads, install TMA and check switch action. Replace rear cover and restore receiver operation with no further action necessary.

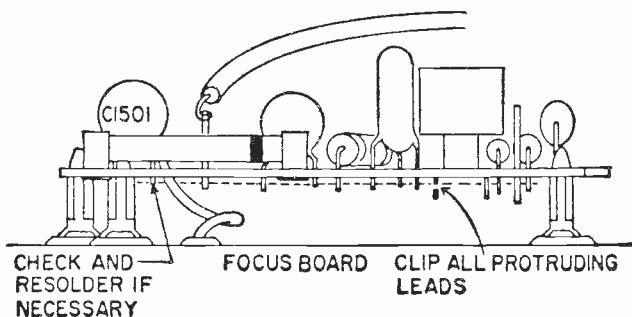
The color TV sets included in this series contain focus boards that could arc to ground. To provide a method of checking and eliminating any arcing in this area, the following procedure should be used: (1) Remove the plastic dust cover from the focus area by unsnapping plastic clips (if the cover is translucent, discard). (2) Unsnap the focus board from the chassis mounting standoff. Use care when unsnapping. (3) Clip off all protruding leads to within 0.1 in. of the board, as illustrated. (4) Inspect the solder connections between C-1501 and the board, resolder if needed. (5) Reinstall the board on its proper chassis standoffs. (6) Install an opaque plastic dust cover, RCA Stock No. 128661, if the original dust cover was discarded. Note: It is recommended that the RCA Stock No. 128661 opaque dust cover be carried by service technicians when making calls to service this chassis.

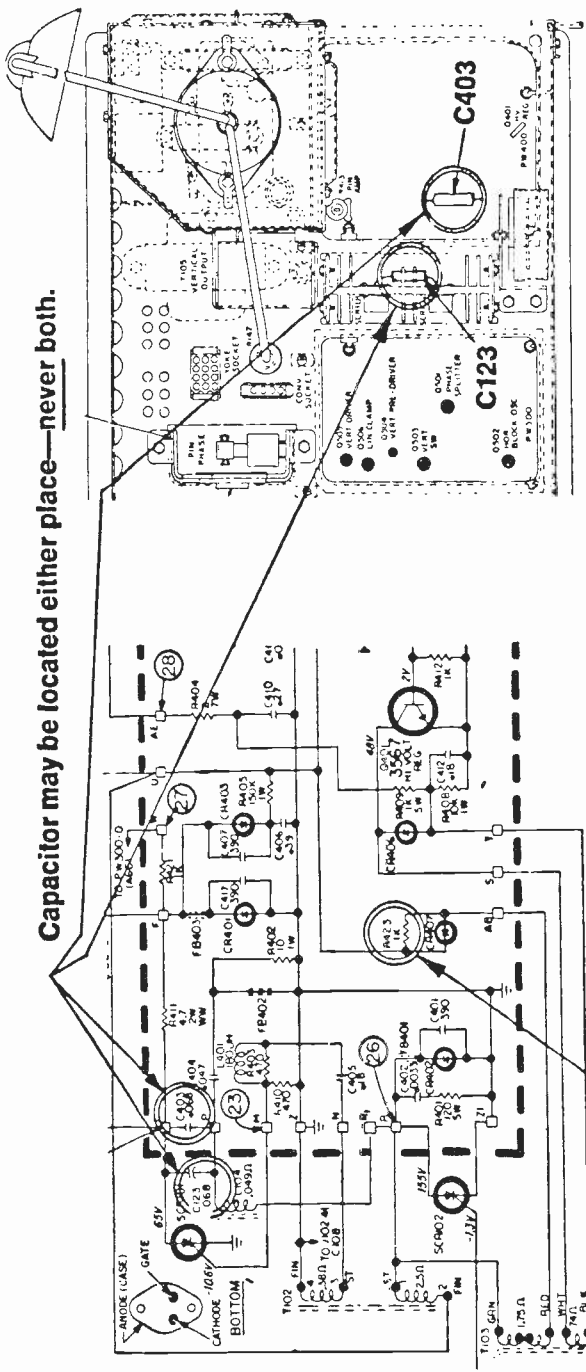
Capacitor may be located either place—never both.

Can cause "piecrust" effect.

A "piecrust" or "geartooth" effect in the raster (scaloped edges) at different brightness levels may be the result of resistor R423 opening. Under these conditions the high voltage and brightness limiter operation appear to be normal, while in some instances the symptom may be accompanied by a high-pitched squeal.

The 0.068 $\mu$ f commutator capacitor used in the horizontal deflection circuit of this chassis is located either on the PW300 board or on a terminal board under the SCR heat sink. Two capacitors in parallel are never used. If the capacitor is on PW400, it is C403; off the board, it is C123. In either case, the capacitor is the same type and the replacement stock number is 165437.

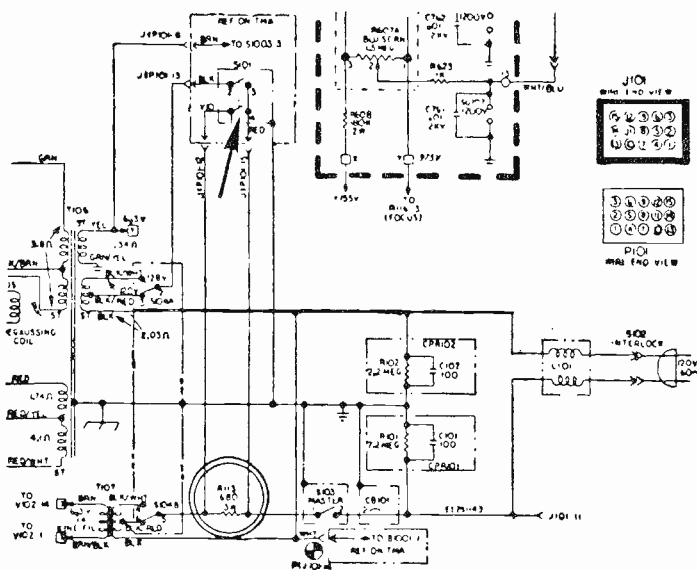
Some color tracking problems in instruments utilizing the CTC40 chassis—which seem to relate to a defective picture tube—may actually be the result of a defective ON/OFF switch. Should the section of the switch used to bypass

the picture tube filament dropping resistor (R113) become intermittent, the filament voltage could vary between 5 (STANDBY) and 6.3v (ON). This can cause variations in color tracking.

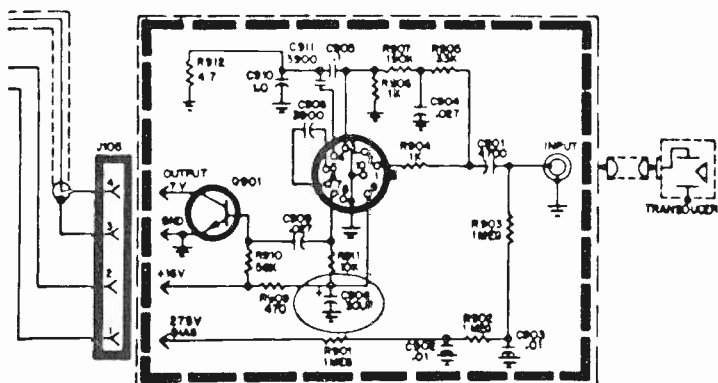
Reduced remote-control sensitivity of instruments utilizing these chassis may be the result of an off-value electrolytic capacitor in the preamplifier. The capacitor is Symbol No. C908, Part No. 128058, a 30 $\mu$ f, 15v electrolytic ca-

capacitor. If replaced, use part No. 132062, a tantalum type  $27\mu\text{f}$ , 15v electrolytic for maximum reliability.

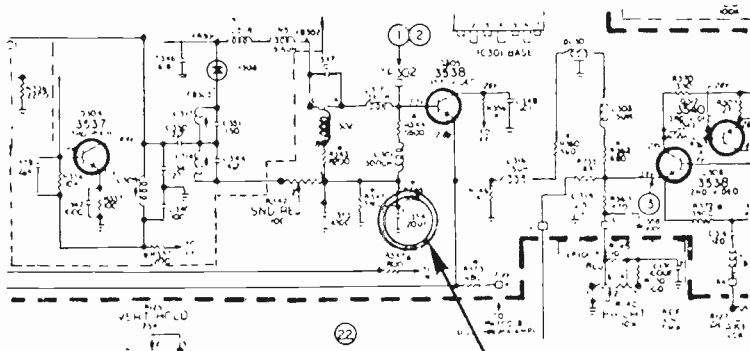
Check Electrolytic

A wide variety of video and/or sync symptoms in these chassis may be the result of an electrolytic capacitor (a

$20\mu\text{f}$  15v electrolytic, RCA stock No. 121995) changing value. Possible symptoms include: video "smear"; video "bends"; unstable sync; or various combinations of these symptoms. In addition, the symptom may vary with the brightness control setting.

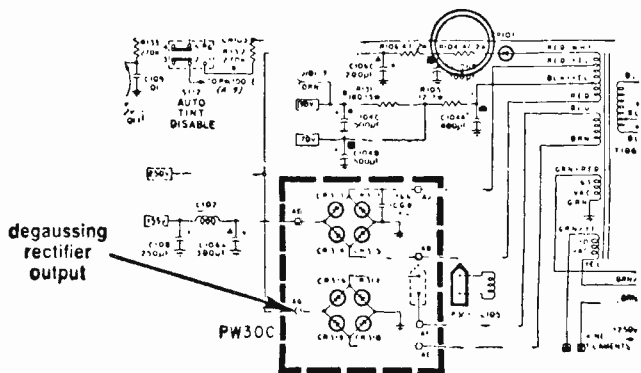
Resistor R104, in the 240v dc supply circuit, is a 47 $\Omega$ , 2w flame retardative (film) type resistor in early-production receivers. In the event this resistor fails, the instrument may continue to operate on the 220v dc supplied by the degaussing bridge rectifier output. Symptoms for R104 failure may include a hum bar and/or degaussing "interference" in the raster.

For a quick check, unplug the degaussing coils and if the video is lost, the 250v dc supply is inoperative. In those specific chassis where resistor R104 fails, replace it with a 47 $\Omega$ , 4w flame retardative type resistor (Stock No. 132879).

Replacement resistor R106 (47 $\Omega$ , 2w film) is Stock No. 132951.

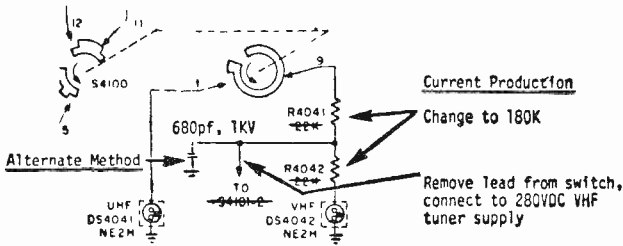
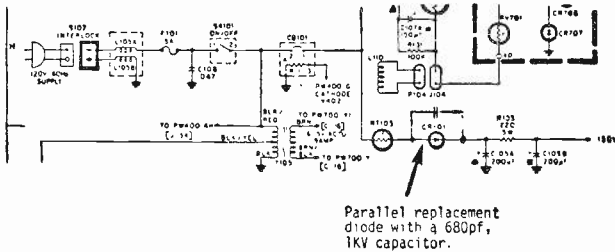
There is the possibility of a hum-bar in the picture on TV sets employing this chassis, when operated in weak signal areas. The interference appears as the "silicon-bar" type normally associated with the power supply rectifiers. In some cases the interference may be from the neon channel indicator bulbs. For TV sets in current production the bulbs are operated on dc, as shown in the partial schematic. An alternate method, which may eliminate the interference on one channel but not another, is to add a capacitor as shown.

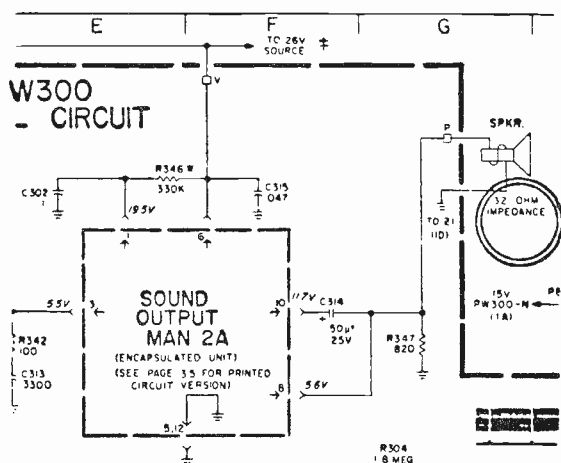
### Color TV Chassis CTC 46 Series—Sound Output Module

The output impedance of the sound output module (MAN) is relatively high (32 to 35 $\Omega$ ) compared to other current color chassis.

In the event bench servicing is required, make certain a lower impedance (4 to 8 $\Omega$ ) test speaker is not used, since this can result in damage to MAN module components.

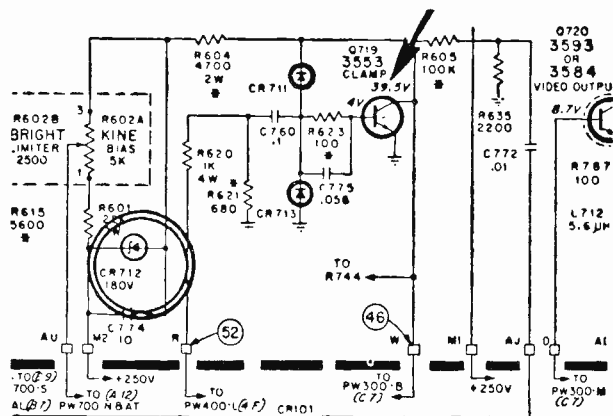
### Color TV Chassis CTC 40, 44, 47—Brightness Problems Caused by Diode CR712

Some brightness symptoms in these chassis, which are generally associated with CRT circuitry, may be caused by a leaky or shorted zener diode, CR712. The symptoms may include—retrace lines in raster—inability to cut off raster with brightness control—not possible to extinguish lines

with screen and/or kine bias controls during color temperature setup procedure. The collector voltage of the clamp transistor, Q719, should read 139.5v.

**schematic correction  
normal reading 139.5V**

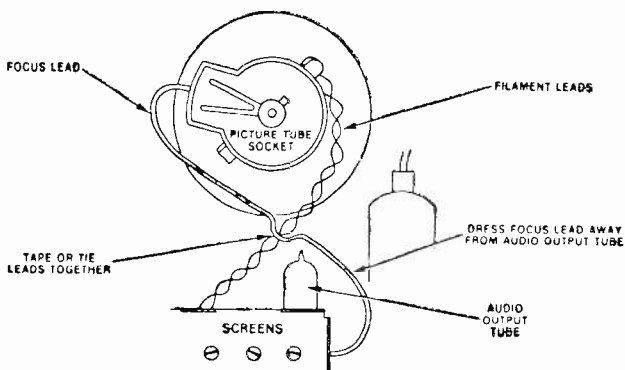
## Color-TV Chassis CTC38/39—Picture Tube Focus Lead

One such possibility concerns the positioning of the focus lead attached to the picture tube socket of the CTC38 and CTC39 chassis. During manufacture, the black focus lead is attached with tape or a tie wire to the two brown filament leads. This lead dress is established to keep the focus lead away from the audio output tube. If this lead dress is not maintained, over a period of time heat from the tube may cause deterioration of the insulation. The result can be an audio output tube failure, due to arcing between the lead and the tube elements.

To insure maximum reliability, this lead dress should be checked whenever the receiver is serviced for any reason.

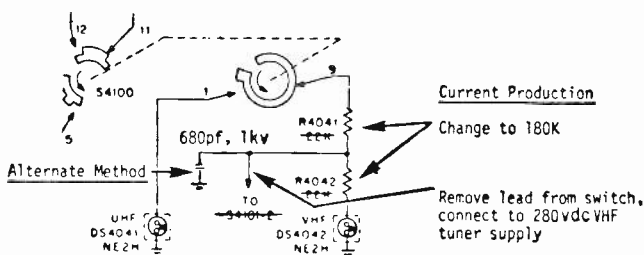
### Color-TV Chassis CTC51 Series—"Hum-Bar" Interference

There is the possibility of a hum-bar in the picture on TV sets employing this chassis when operated in weak-signal areas. The interference appears as the "silicon-bar" type normally associated with the power supply rectifiers. In some cases the interference may be from the neon channel indicator bulbs. In current production the bulbs are operated on

dc as shown in the partial schematic. An alternate method, which may eliminate the interference on one channel but not another, is to add a capacitor as shown.

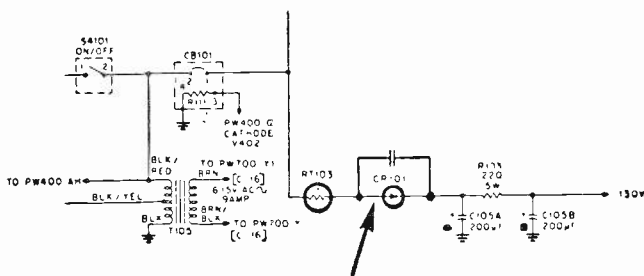
#### Color-TV Chassis CTC51 Series—Diode CR101 Protection

Premature failure of the 130v B+ supply diode (CR101) in early production TV sets using this chassis may in some instances be the result of a picture tube arc damaging the

Parallel replacement diode with a 680pf, 1kv capacitor.

diode. To prevent such failures, make certain a 680pf, 1kv capacitor, Stock No. 113165, is connected in parallel with the diode replacement.

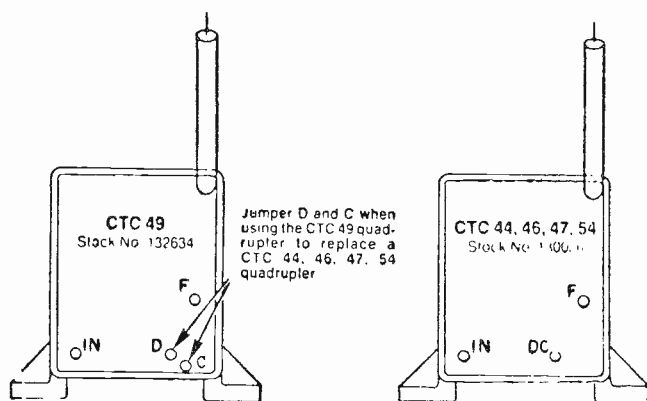
## Color-TV Chassis CTC44/46/47/49/54—High-Voltage Quadrupler Interchangeability

The CTC49 quadrupler (Stock No. 132634) can be used as a direct replacement for the CTC44,46,47,54 quadrupler

(Stock No. 130026) by jumpering quadrupler terminals D and C together and using that point for the DC connection. Stock No. 130026 cannot be used in the CTC49 chassis.

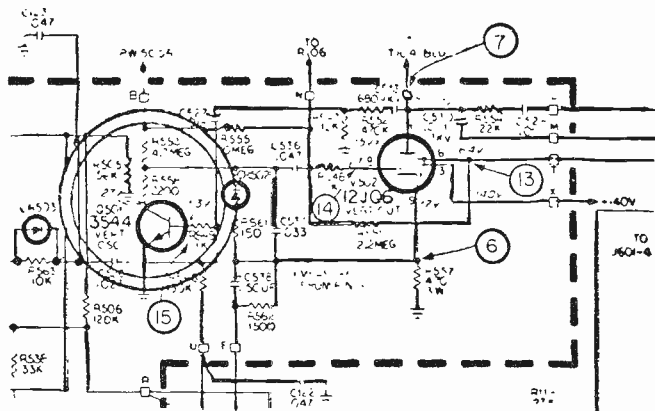
### Color-TV Chassis CTC36—Unstable Vertical Sweep

Loss of vertical sweep in this chassis, when no sync input is present (i.e., during channel changes, when the tuner is on an inactive channel, etc.), may be the result of an off-tolerance vertical oscillator transistor, Q501.

No vertical sweep (oscillator does not restart) under these conditions indicates the possibility of an off-tolerance transistor (Q501). Output components (such as tube V502 and/or cathode resistor R557) may be damaged if the instrument has been operated any length of time without the vertical oscillator running.

To test for this condition: First turn instrument OFF. Then disable the sync input to transistor Q501 by moving

the service switch to the RASTER position and turn the TV set ON again.

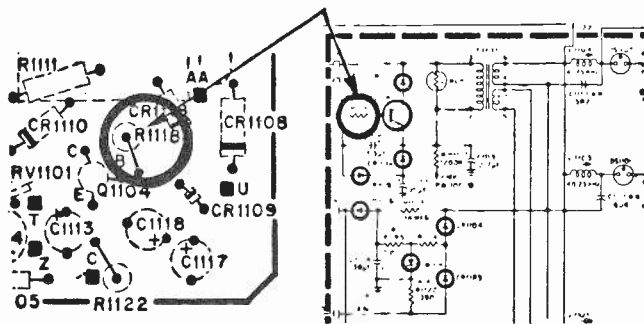
A resistor value change in the noise immunity circuit,

Change to 100Ω

(base of transistor Q1104) as shown in the above illustration, may be helpful in resolving this symptom.

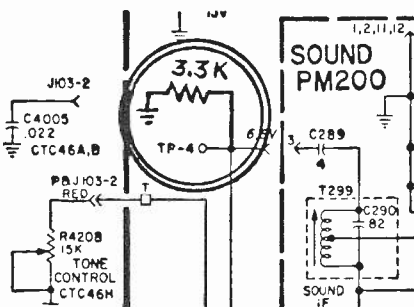
#### Color-TV Chassis CTC46 Series—Hum Modulation

There have been isolated instances of hum modulation in instruments utilizing this chassis. The intensity of the hum is variable with the fine tuning.

Usually the hum can be reduced to an acceptable level by

connecting a 3300Ω resistor from TP4 to ground on the PW400 board. If the hum is still present on strong signals a smaller value resistor may be used. However, do not use a value lower than 2200Ω.

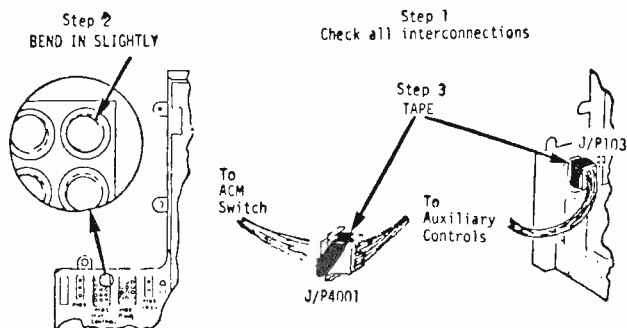
In those instances where intermittent color is encountered as the auxiliary control bin is opened or closed, the following procedures are suggested:

Examine wiring between chassis, auxiliary control assembly and ACM switch (J/P103 and J/P4001) for in-

termittent connections.

Ensure positive plug and jack connections by bending (slightly) the female pins in P103 (auxiliary control assembly-to-chassis) and P4001 (auxiliary control assembly-to-ACM switch).

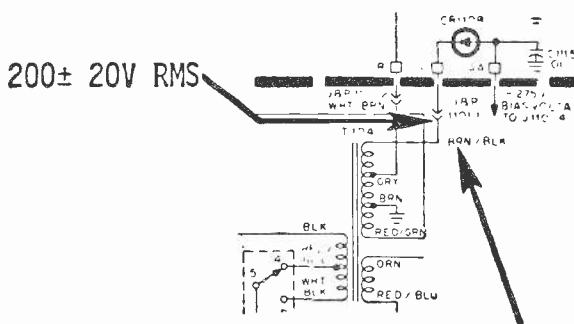
### Color-TV Chassis CTC46 Series—Standby Transformer Replacement

Note color code correction

To insure optimum reliability in those isolated instances where the Standby Transformer (T104) must be replaced, make sure the replacement transformer is connected as

shown in the Basic Service Data and in the partial schematic.

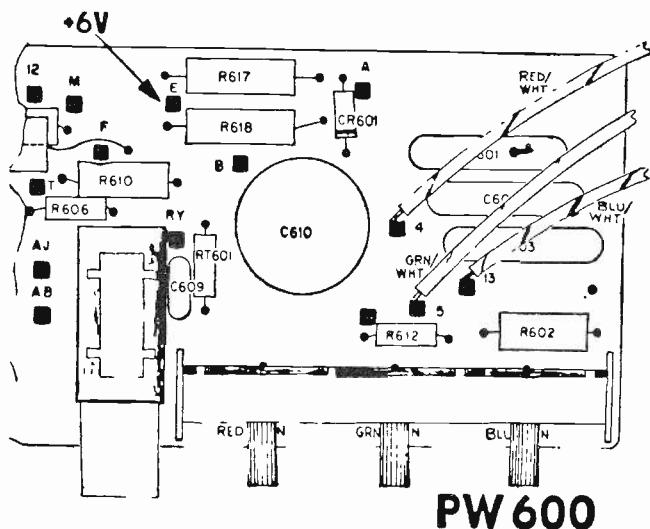
## Color-TV Chassis CTC54 Series—ETA Motor Symptoms/Service

Various symptoms—such as “Motor runs continuously” or “motor does not run,” relating to the motor (B4601) associated with the Electronic Tuning Assembly (ETA 423B)—which are not resolved by the replacement of the

MAT module may be the result of loss of the 6v dc input to the MAP module circuitry. This power supply is located on the PW600 board and consists of diode CR601, electrolytic capacitor C610, and two 15 $\Omega$ , 2w resistors—R617 and R618.

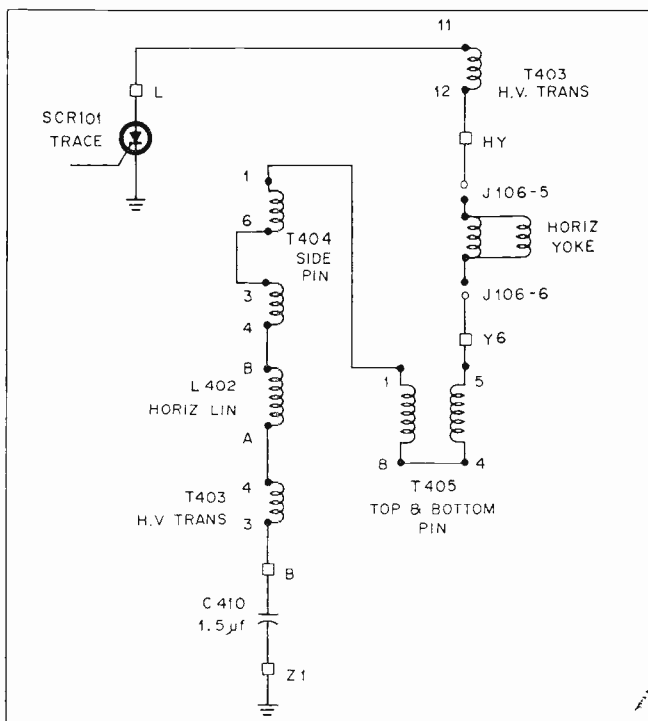
If during servicing, it is determined that the Trace SCR (SCR101) is defective, the following checks should be made before replacement. (1) Measure continuity from PW400-L to PW400-B. Resistance should measure approximately 1 ohm. If an open is indicated, further resistance checks of the series

path shown in the partial schematic below should be made to isolate the open. (2) If continuity is normal between PW400-L and PW400-B check for the possibility of an open in the SCR socket and/or the circuitry associated with the yoke return capacitor, C410. (3) Repair any open circuits located in Steps 1 and 2 then replace the SCR. **ETD**

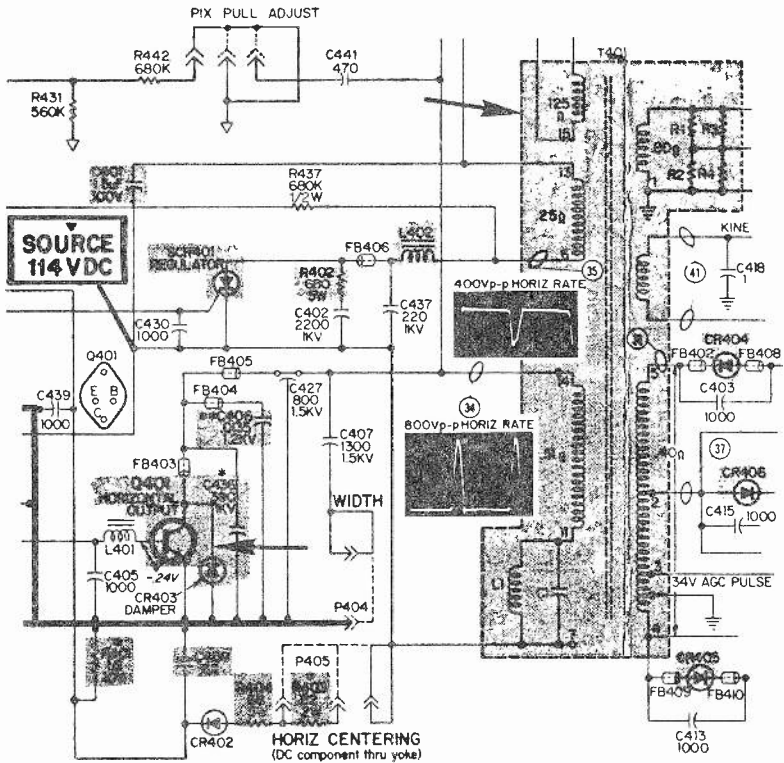
Repetitive failure of horizontal transistor, Q401.

Check T401 flyback transformer for high voltage leakage.

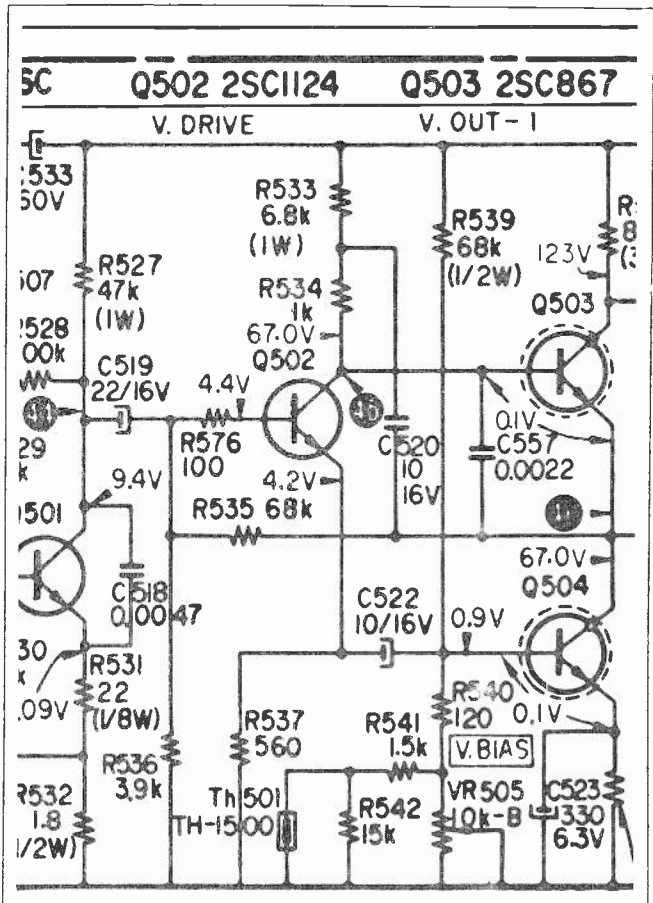
## Color TV Chassis KV 1722 — Vertical foldover. Horizontal Drive Line

If top half of the picture is streaked, replace resistor R535 (68K). It's probably shorted. (See diagram to right)

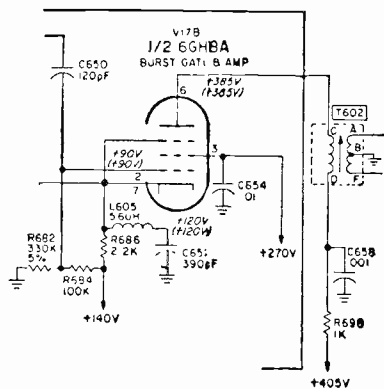
A very perplexing problem is color loss because of killer action or color sync loss. Actually, both problems are the same since killer cutoff is caused by a loss of color sync. Consequently, to determine the root of the problem the color killer must be opened. In most cases the color will exhibit a "barberpole" effect.

To correct this unstable condition, R682 (shown in schematic) located in the grid circuit of the burst gate am-

plifier should be changed to 330K. This resistor may presently be 270 or 240K. This change will make color sync more stable.

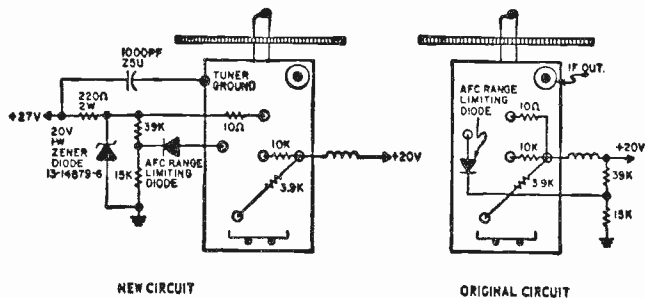
## Color TV Chassis D12/D13—Local Oscillator Stabilization on 54-23857-3 Tuner

To stabilize local shift with line voltage, a 27v B+ oscillator frequency source is connected from positive side of C522 to pin 4 of SK500. From pin 4 to PL500 the 27v B+ is

To correct for local oscillation radiation problems, a 1000pf-Z5U capacitor has been added from the + 27v side of a 220  $\Omega$  2w resistor to tuner ground.

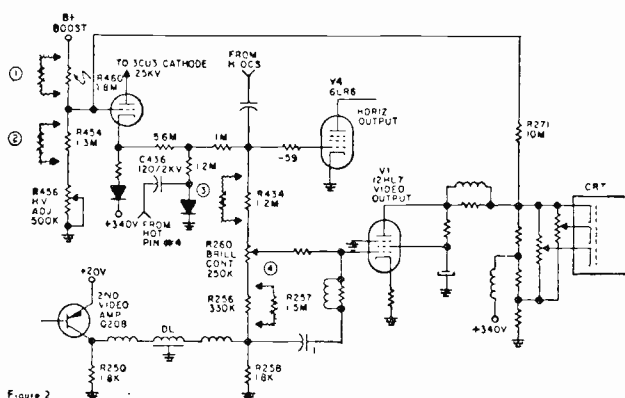
Figure 2

When the HV adjust is made, and the second anode voltage falls below 25kv, R445, a 22M resistor, is removed, making the grid voltage less positive, decreasing the 6BK4 conduction, raising the second anode voltage.

quire a high voltage reduction beyond the HV adjust control range, the IR drop ratios can be changed by removing R455, a 15M resistor, making the 6BK4 grid voltage more positive (increasing its conduction), and lowering the HV.

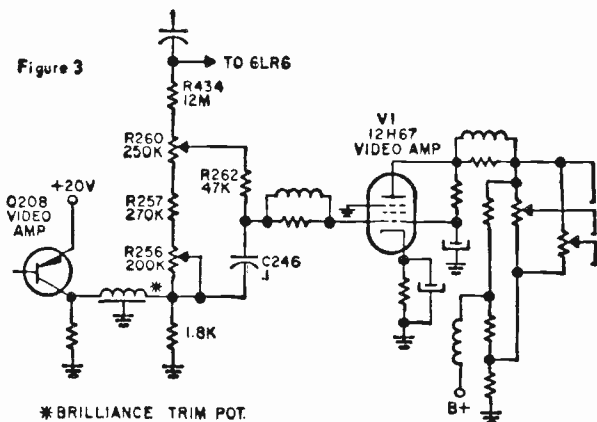
When the brightness is varied, the raster may compress, but this is normal if raster edges are not viewable.

However, should the raster edge show, its condition is fixed by removing a 1.5M resistor, R257, from the brightness control resistance network. The voltage ratios across the divider changes, placing the brightness control in a more negative voltage range. Now, the video amplifier conduction lowers, raising its plate voltage, making the CRT cathodes more positive turning down beam current.

Should the brightness level be too low, and the raster not compressed during brightness control changes, be certain R257, a 1.5M resistor, is in the circuit and then remove R435, a 10M resistor. This resistance change will shift the IR drop ratios, placing the brightness control in a less negative voltage range. This change shifts the video amplifier's dc level, lowering its plate and CRT cathode voltage, thus increasing the brightness.

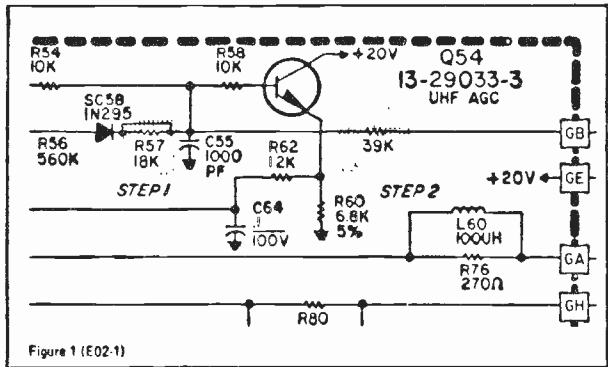
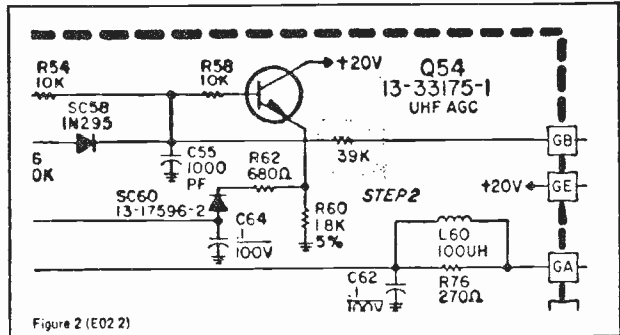
### Color-TV Chassis E02-1,2,—Vertical Jitter

At some signal levels, the VERTICAL-HOLD control can be adjusted to cause vertical jitter in the picture. To correct this condition for all signal levels, make the following changes: Remove resistor R57 (on E02-1 tuner panel only) and replace it with a jumper as shown in Fig. 1. Insert a 39K,  $\frac{1}{2}$ w, 10% resistor from tie point GB to the

junction of capacitor C55, resistor R54, R58 and diode

SC58 (on E02-1-2 tuner panel) as shown in Fig. 1 and 2.

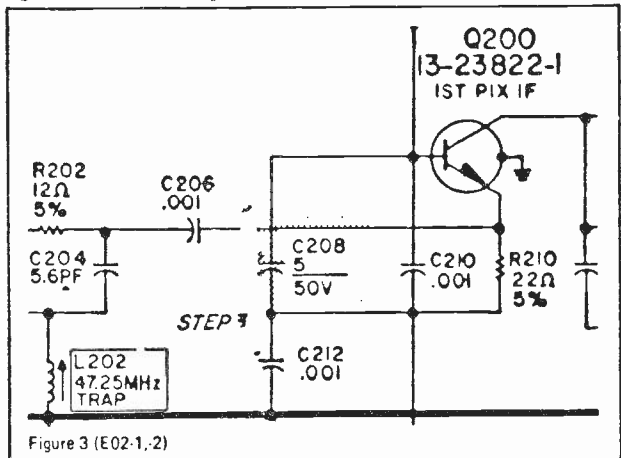
Remove capacitor C208 (on E02-1-2 IF panel) and replace it with a 5 $\mu$ f, 50v electrolytic capacitor, as shown in Fig. 3. Remove capacitor C302 (on E02-1-2 IF panel)

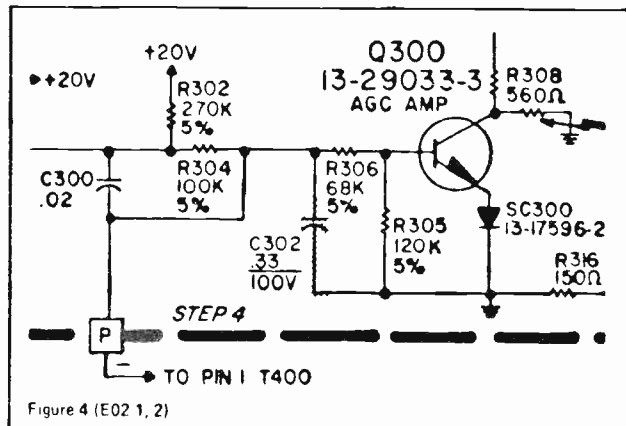
Figure 4 (E02 1, 2)

and replace it with a .33 $\mu$ f, 100v capacitor as shown in Fig. 4.

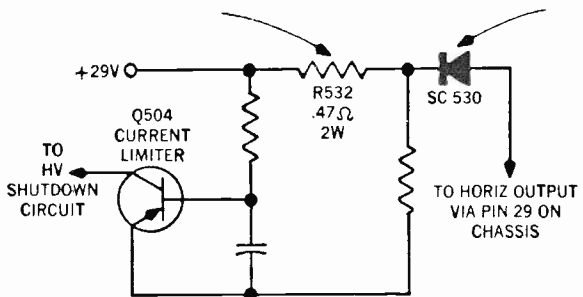
**CHASSIS:** GTE Sylvania E08

**TROUBLE SYMPTOM:** Picture and sound absent.

**CAUSE:** Diode SC530 shorted, burning open R532.

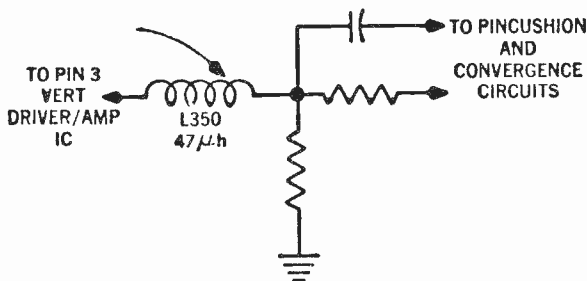
CHASSIS: GTE Sylvania E08

**TROUBLE SYMPTOM:** Vertical sweep absent

**CAUSE:** Choke L350 open

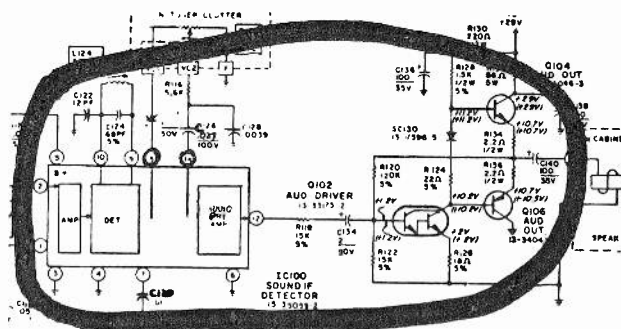
## Color TV Chassis E08—No sound.

Probable cause is defective IC100, Q104, Q106, or Q102.  
Replace defective component.

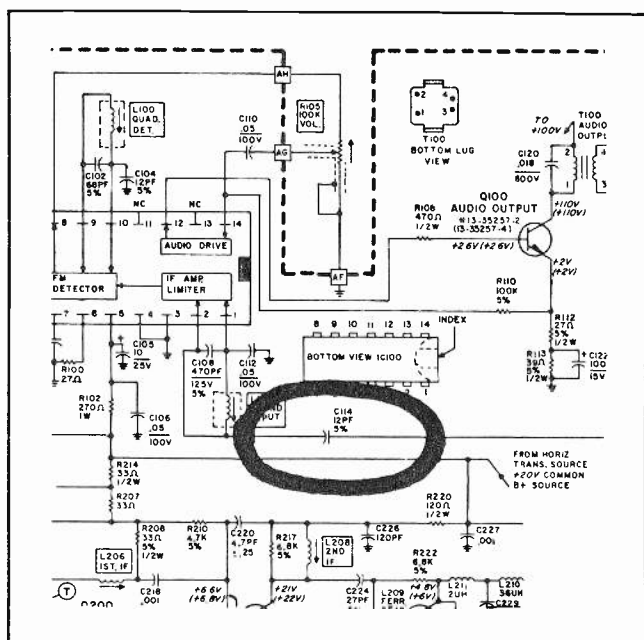
## B/W Television Chassis A19—Sound won't track best picture on all channels

Probable cause is a defective capacitor (C114, as shown in diagram). Replace capacitor.

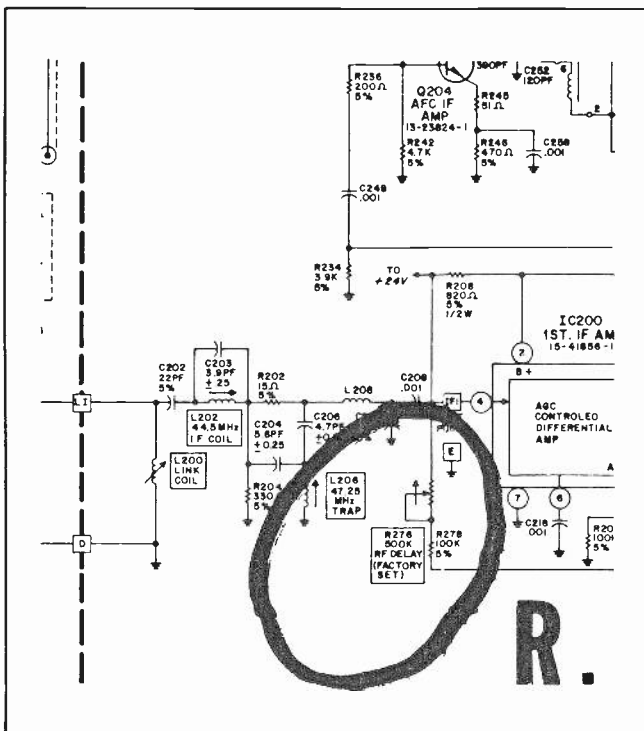
## Color TV Chassis E06/08/20/21—Snowy UHF picture

The cause is probably the RF AGC Delay (R276) set too high. Do not replace the UHF tuner. Instead, check the delay control.

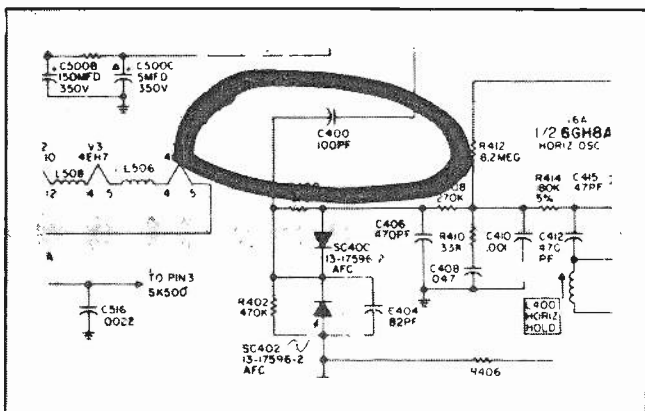
B/W Chassis B-10-7—Horizontal oscillator will not start except when set has been in 'instant on' mode. Then it is off frequency. The fault is capacitor C400 which is shorted. Replace.

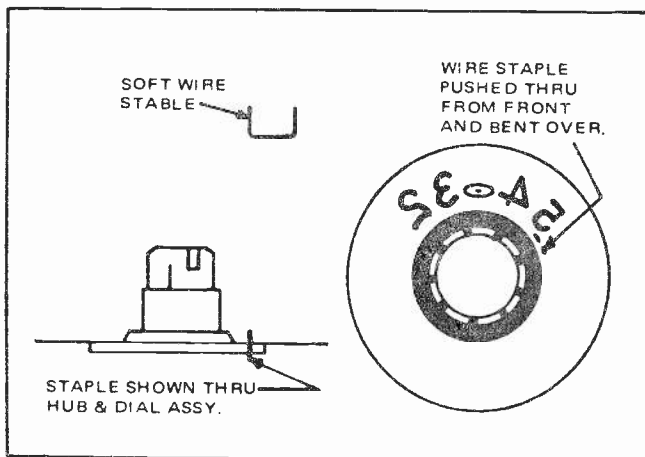
### B/W Television (console)—Correction of VHF dial slippage

Properly calibrate VHF dial, and then remove complete dial and hub assembly from tuner shaft. Install soft wire staple through the plastic dial and hub as shown in diagram. Use a low wattage soldering iron to heat staple as you push it through hub and dial. Then bend staple over on the backside.

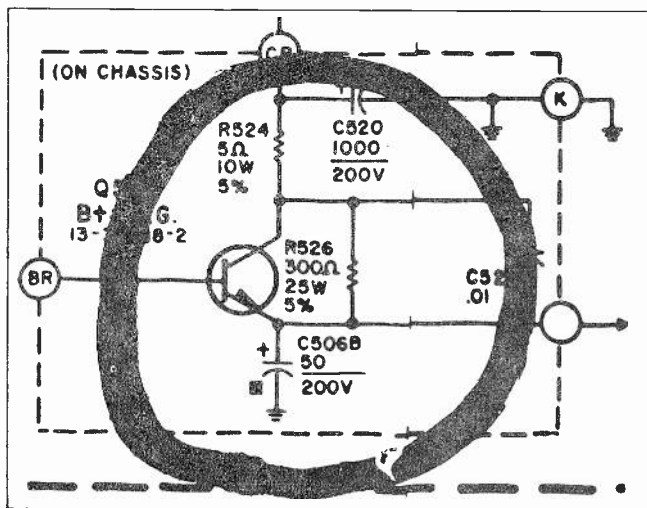
### E21-3 Chassis—The regulated B+ supply stopped 70 volts, with a ticking sound from the flyback.

The cause is probably an open 50mfd, 200V section filter capacitor C506B. Replace capacitor.

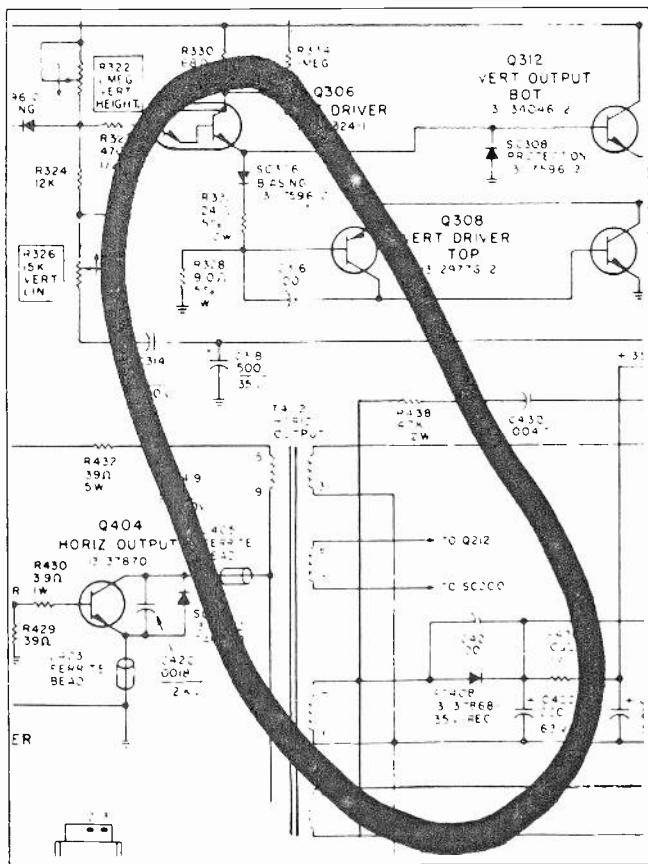
## A12 Chassis—No sound—no video—and SC408 shorts when replaced.

The cause is a partially short SC306, causing vertical stage to load down the 35V supply. To repair, replace both diodes—SC306 and SC408.

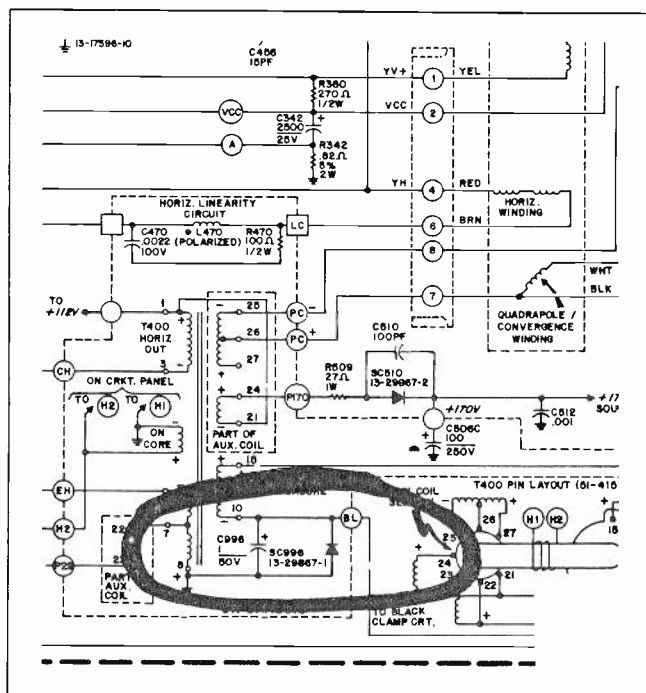
## Color TV Chassis E21 — Problem is low brightness

Check SC996 and/or C996 for an open. Replace if necessary.

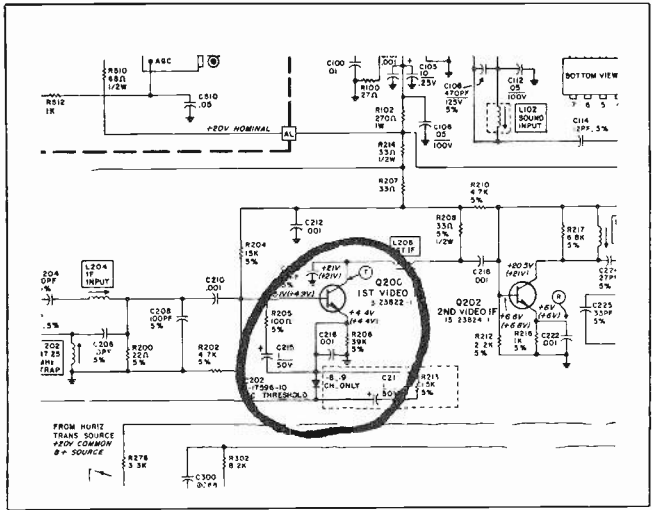
## A12 Chassis—AGC overload when horizontal hold is adjusted. Sync is critical.

Possible cause is a shorted AGC threshold diode (SC202).

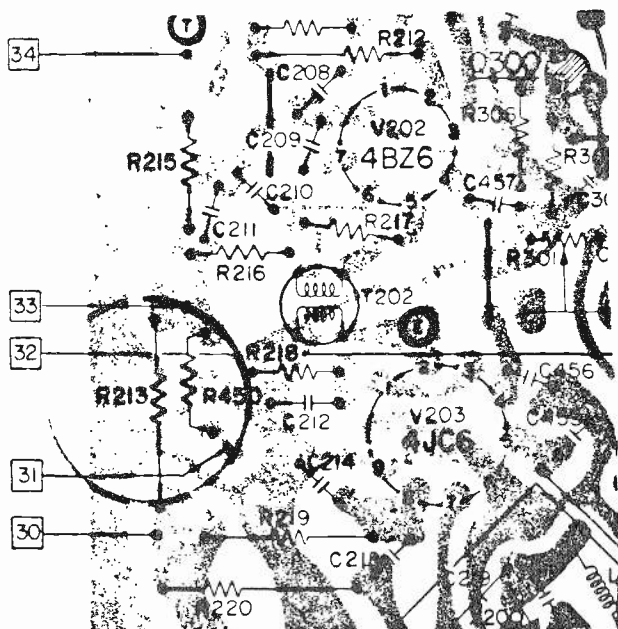
In early production of the IF printed circuit boards, the value of resistor R213, a 47 $\Omega$  resistor, was incorrectly marked 47K on the top of the PC board.

Resistor R213 is a stone-type fusible resistor which may

break apart under overload conditions. When this happens, the technician may see the 47K marking and replace the

burned out one with a 47K value (which is wrong), the correct value should be 47Ω. Please note the location of resistor R213 on the partial diagram of the IF PC board and replace it only with a 47Ω, 4w, fusible, stone-type resistor, Westinghouse part number 250V020H79.

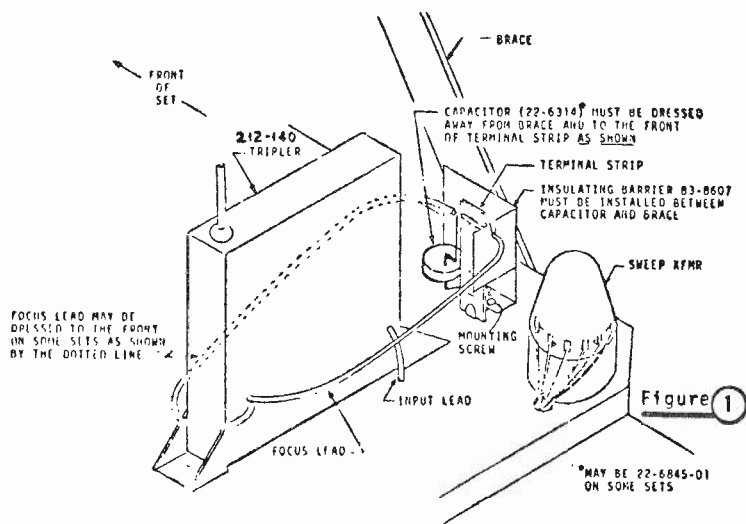
(22-6314 or 22-6845-01) was used. In some instances this capacitor has been improperly dressed too close to a metal bracket or too close to the cabinet surface, adversely affecting capacitor reliability.

If the 212-140 tripler and separate capacitor are present, and if either one is defective, replace both with a 212-130X tripler, which does not require a separate capacitor.

If these parts are present, and neither is defective, the capacitor location or dressing should be checked and corrected if necessary in accordance with Fig. 1 of these in-

structions. Also, an insulating barrier (83-8607) should be installed in accordance with the instructions (Fig. 2) if one is not already present. A supply of 83-8607 is available from your Zenith distributor without charge.

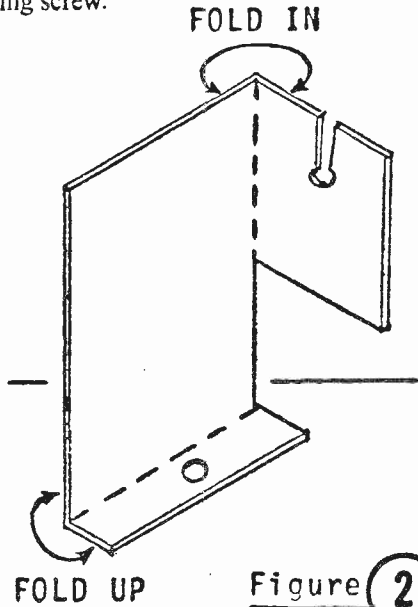
The installation of insulating barrier 83-8607 is recommended to ensure the proper location of the capacitor and to prevent damage to the capacitor due to high voltage arcing, which may occur if the capacitor is not properly located.

Prepare the insulating barrier for installation by making two right-angle folds along the perforation as shown in Fig. 2.

Refer to Fig. 1. Dress the capacitor (22-6314) away from the brace and to the front of the vertically mounted terminal strip as shown. Remove screw holding the terminal strip to the chassis. Place the insulating barrier under the terminal strip mounting tab, align holes and replace mounting screw.

Providing the tripler white focus lead is routed toward the back of set, position the lead through the notch provided in the insulating barrier as shown. Should the focus lead be routed to the front of set, the lead is not positioned through the notch in insulating barrier.

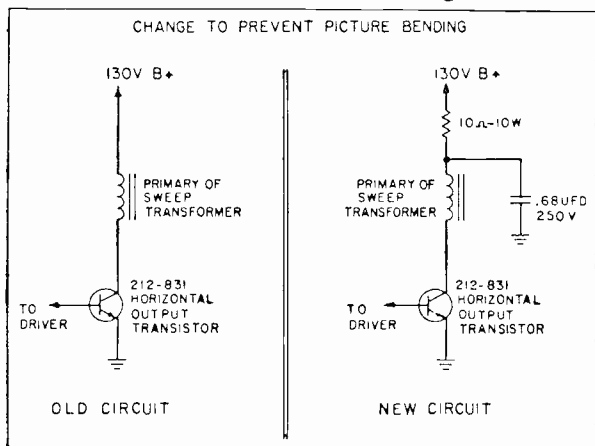
### Color TV Chassis 17/19EC45—Picture Bending

Under some signal conditions and control settings, a slight amount of picture bending could be observed in some E - Line chassis. This is found to be at a greater or lesser

degree at peak anode currents. An R - C decoupling network shown in the illustration consisting of a 10 ohm, 10 watt resistor and a .68 mfd, 200 DC WV capacitor installed between the sweep transformer primary and the + 130 volt supply.

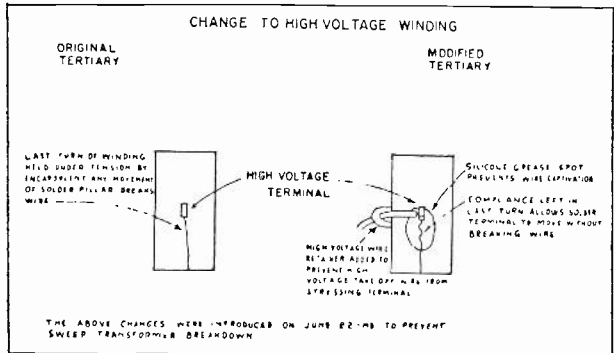
### Color TV Chassis 17/19EC45—Broken Tertiary Leads—Improved Sweep Transformer

A problem that has been encountered occasionally in the field has been the breakage of the tertiary winding where it

exits from the "tire" of the sweep transformer as shown in the illustration. In earlier versions, the last run was held

under tension by the incapsulant. Excessive movement of the solder - terminal could break the wire. The problem was resolved by use of silicone rubber to prevent rigid captivation and a retainer was added for stress relief.

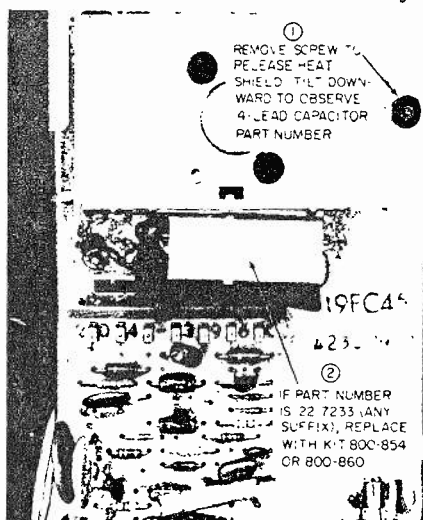
Typically, the failure occurs after many months of operation. The capacitor fails suddenly, causing a secondary failure of one or more other components and immediately disabling the receiver. Horizontal output transistor, tripler, vertical module, picture tube (neck crack), or other parts may be affected.

Inspect the four-lead capacitor below the heat shield and replace it if it is part number 22-7233 of any suffix version. (See Photograph). Use only kit 800-854 (with new capacitor 22-7465) for replacement or alternate kit 800-860 with capacitor 22-7504, which will also be supplied later this year. Always follow servicing guidelines and safety checks given in service manuals.

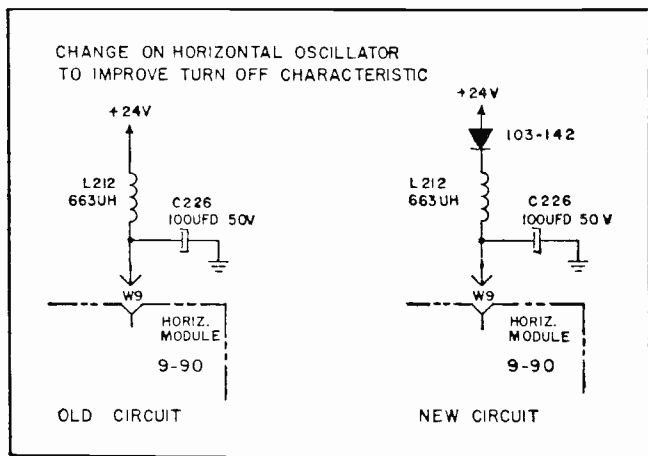
## Color TV Chassis 17/19EC45—Improved Horizontal Turn - Off Characteristics

In some receivers a bright vertical spot could be seen on the screen as the receiver is turned off. This could be caused by the horizontal scan decaying at a faster rate than the

vertical scan. A 103 - 142 diode was added as shown in the illustration to insure the 100 mfd capacitor (C226) discharges into the module rather than into the 24 volt supply, increasing the decay time of the horizontal system.

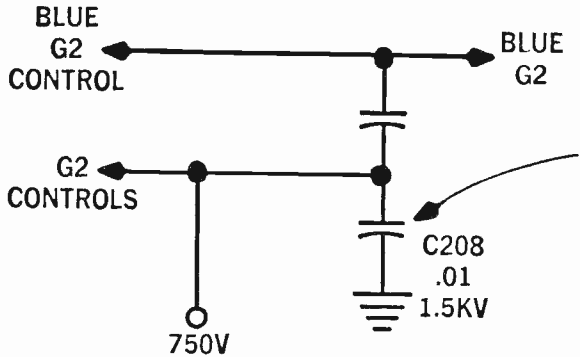
**TROUBLE SYMPTOM:** Color fidelity poor overall; color smeared on edges of dark objects in picture; G2 voltage reduced; absence of setup line in service position of NORMAL/SERVICE switch.

**CAUSE:** Leaky C28. About 5 megohms of leakage measured across C28.

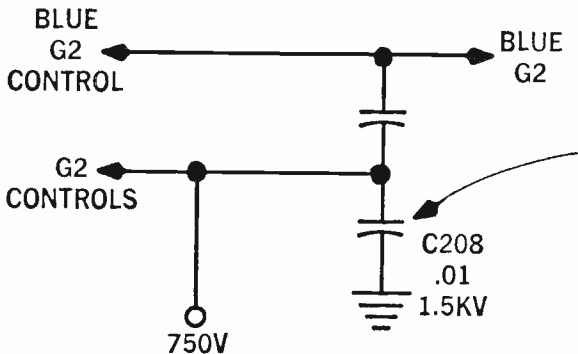
**TROUBLE SYMPTOM:** Low brightness; absence of setup line in service position of NORMAL/SERVICE switch.

**CAUSE:** Leaky or shorted C28, in CRT screen grid circuit. About 100K ohms of leakage measured across C28.

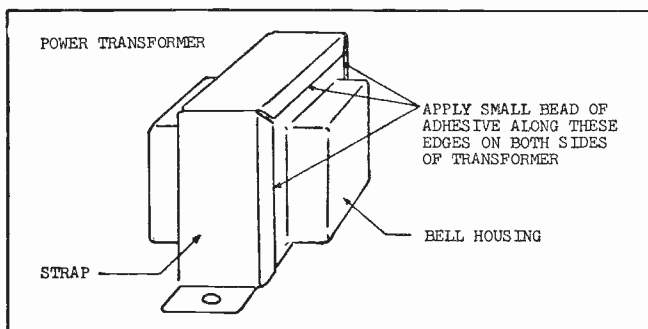
## Digital Clock Radio, Model H472W—Audible hum and vibration

The power transformer bell housings on certain early production H472W digital clock radios may vibrate and produce an audible hum. At very low volume levels, this may be noticeable to some people. If a repair is desired, apply a small bead of a good adhesive such as epoxy between adjoining edges of the bell housings and transformer strap as indicated by arrows in diagram below. Allow the adhesive time to cure thoroughly before plugging in the receiver for operation.
