**COLOR TV**

**FACTBOOK**

**-Problems & Solutions**

By the Editors of Electronic Technician/Dealer

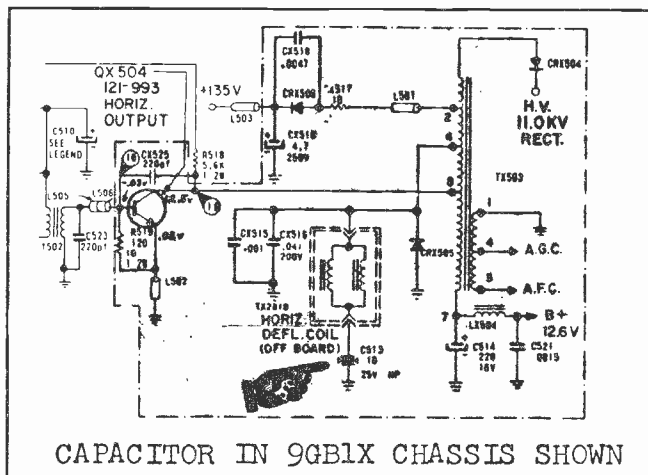
**B & W TV—Replacement capacitor in horizontal yoke circuit**

Special nonpolarized capacitors are used in series with the horizontal yoke coil of all Zenith 9 and 12-inch all-solid-state B & W TV. These capacitors are specially designed for high current application in this circuit. If they fail, be sure to replace them with the identical part available only from Zenith. Other replacement parts which seem to have similar characteristics (and even higher voltage ratings) will fail. ■

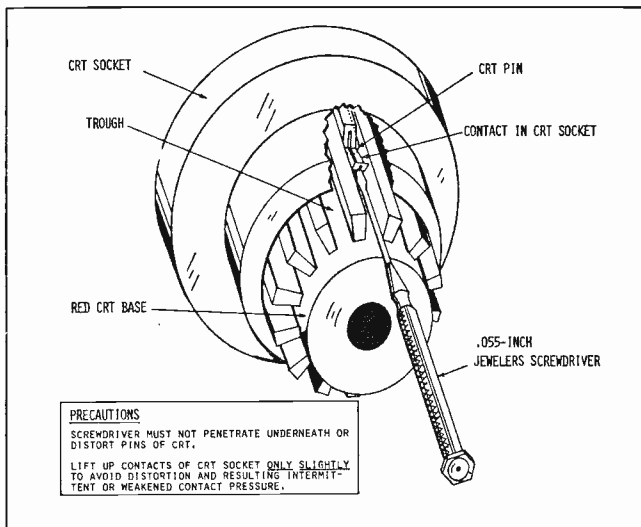
### Color TV Chassis "J" line—CRT sockets binding to CRT.

The CRT sockets of the video output module may in some instances bind to the base of the CRT in early production 13 and 17 inch "J" line receivers. This condition could be due to the contacts of the CRT socket binding near the bottom of the troughs of the CRT base. If binding does occur, do not pull excessively in trying to remove the socket, or you could break the CRT. Instead, obtain a "B" size jeweler's screwdriver. Carefully insert it within the troughs of the CRT base and gently "pry" each one of the contacts slightly as shown in illustration below. NOTE: BE SURE NOT TO ALLOW THE SCREWDRIVER TO PENETRATE UNDERNEATH AND DISTORT THE PINS OF THE CRT. ALSO, BE VERY CERTAIN NOT TO "PRY" THE SOCKET CONTACTS TOO MUCH, SINCE EXCESSIVE FORCE WILL DISTORT THE CONTACTS AND REDUCE CONTACT PRESSURE. INTERMITTENT OR NO OPERATION MAY RESULT. After each one of the 11 contacts of the CRT socket has been lifted gently, the CRT socket/module should pull off the CRT base with only a moderate amount of force. Mechanical changes have been implemented in later production receivers which will prevent the possibility of the aforementioned binding.

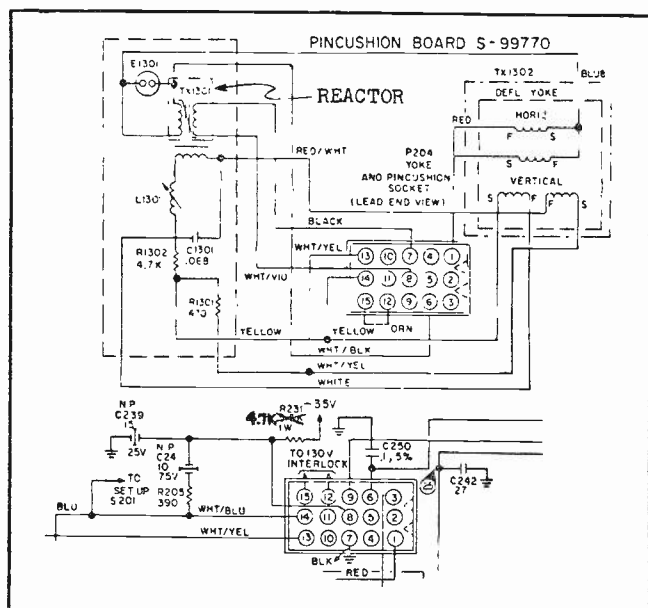
## Color TV Chassis 25HC50, 23HC50, 23HC50Z—Existence of drive line

A drive line in these early production H-line receivers may develop, caused by a pincushion reactor with excessive inductance. The drive line will be noticeable only in the zoom mode. It can be eliminated by replacing R231, a 5.6K, 1-watt resistor, with a 4.7K, 1-watt resistor. This lower resistance causes a slight increase in reactor current, which effectively lowers the inductance of reactor, 95-3182. In later H-line models this was factory modified.
