PHILCO SERVICEMAN

MAY, 1937

Two New Philco Aerials Recently Announced

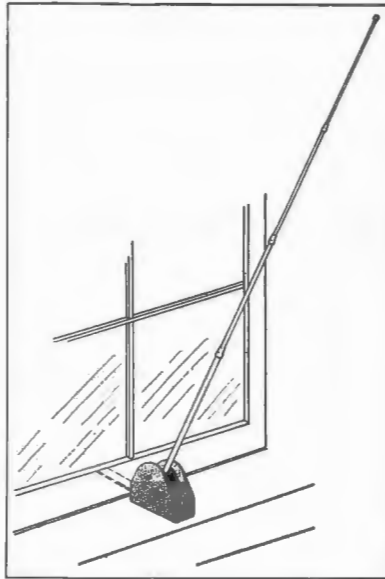
PHILCO Utility Aerial, Part 45-2450
List Price \$5.00

The telescopic rod is stainless steel of the highest quality. It is made in four sections so that it can be any length from 18 inches out to the full, extended position. The mounting bracket is adjustable by means of thumb screws so that the angle from the building can be varied at will. A flexible, weatherproof window lead-in strip is provided with the aerial.

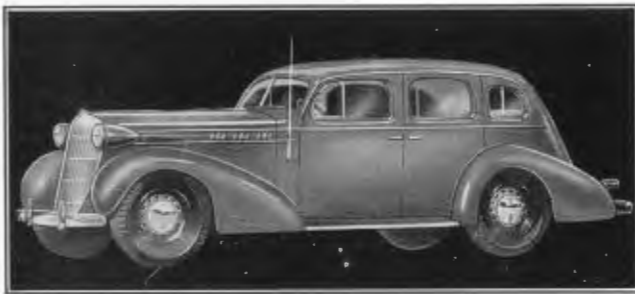
PHILCO Auto Radio Cowl Aerial, Part 45-2470

The appearance of the new cowl aerial is most attractive, the rod being one-piece, tapered, 7/32-inch solid steel, chromium plated, 54 inches long. The two insulating supports are black bakelite.

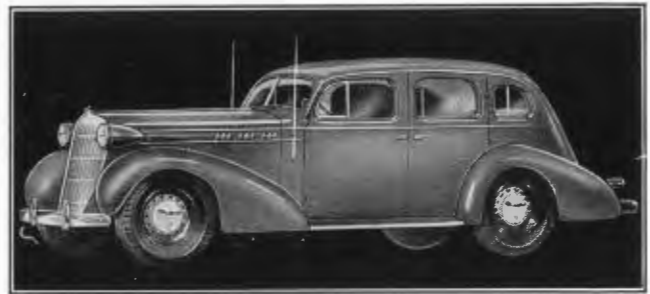
Showing two PHILCO Cowl Aerials installed. Engineering tests show that double the signal pickup may be obtained when two aerials are used. Appearance is greatly improved.

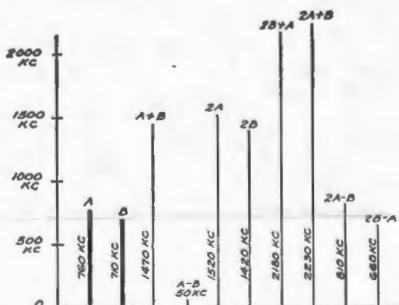
The two original frequencies which represent two different stations are indicated by the heavy black lines. As a result of rectification, eight new frequencies are introduced. These frequencies are responsible for the cross-modulation effect, as explained in the text.

It was pointed out that cross-modulation interference is very often caused in localities adjacent to powerful broadcasting stations by certain types of rectifying action in the R.F. circuit. In many instances it has been found that an unsoldered break in the aerial or lead-

in wire will produce a rectifying action between the copper oxide and the copper at the break. When rectification of this kind takes place on a very powerful signal, cross-modulation results, and there is nothing in the way of wave traps or other filters in the radio chassis that will help. It was found, for example, in the Newark area, which is adjacent to the 50 K.W. transmitters of WJZ and WOR, considerable cross-modulation resulted. It will be noted from the chart on page 4 that WJZ on 760 K.C. and WOR on 710 K.C. have a frequency difference of 50 K.C. Various combinations of points at which cross-modulation is obtained seem to result when
