TV and
radio
TUBE
TROUBLES

SOL HELLER

GERNSBACK LIBRARY, INC.
NEW YORK 11, N. Y.

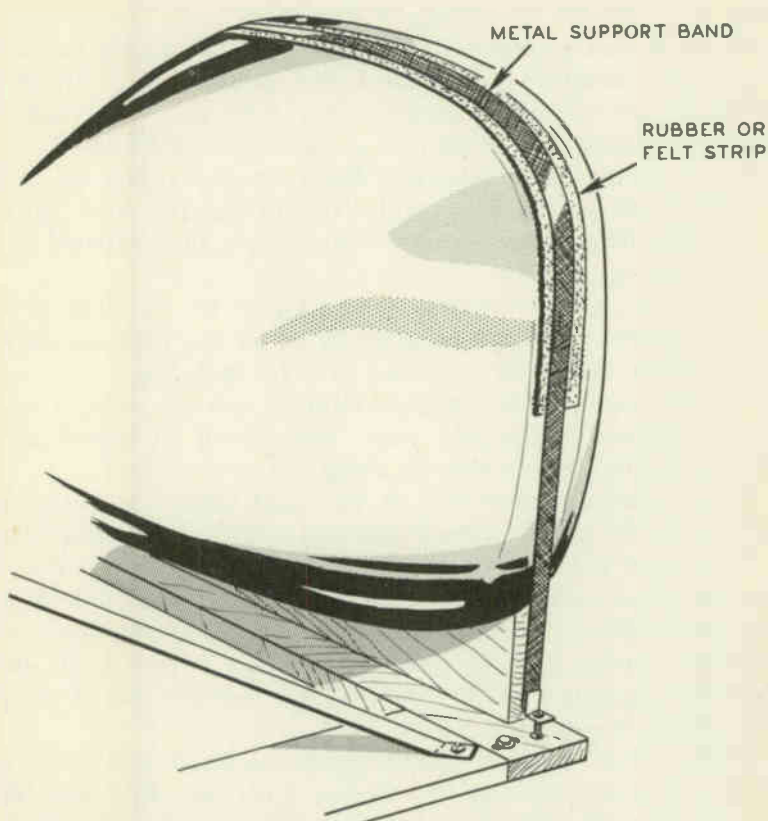
Fig. 101. Position of rubber or felt strip under metal band holding cathode-ray tube in place.

Make sure that protective rubber or felt strips (see Fig. 101) are reinserted between the metal support band and the tube when the support band is replaced after having been disassembled. These protective strips prevent possible breakage of the tube due to excessive tightening of the band. When they are out of position, put them back into place.

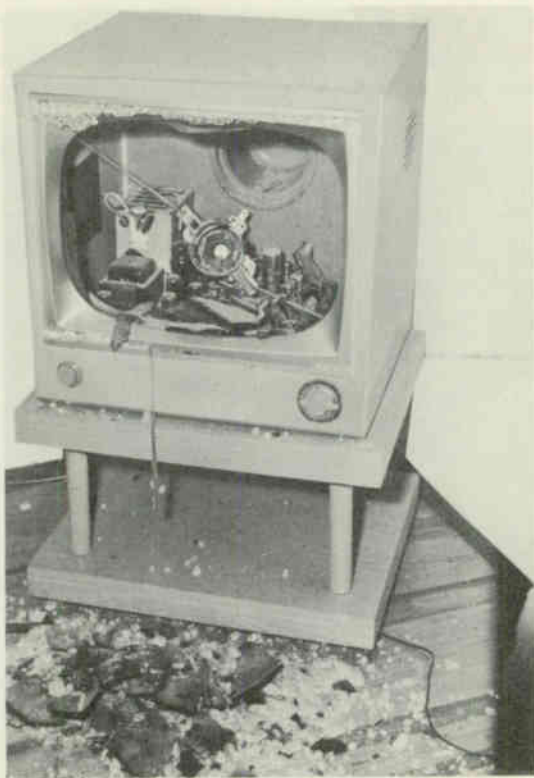
Fig. 102. *Result of a cathode-ray implosion due to inadequate safety precautions.*

hand between the tool and the tube to prevent the tube from being struck if the tool should slip. (The result of an implosion is shown in Fig. 102.)

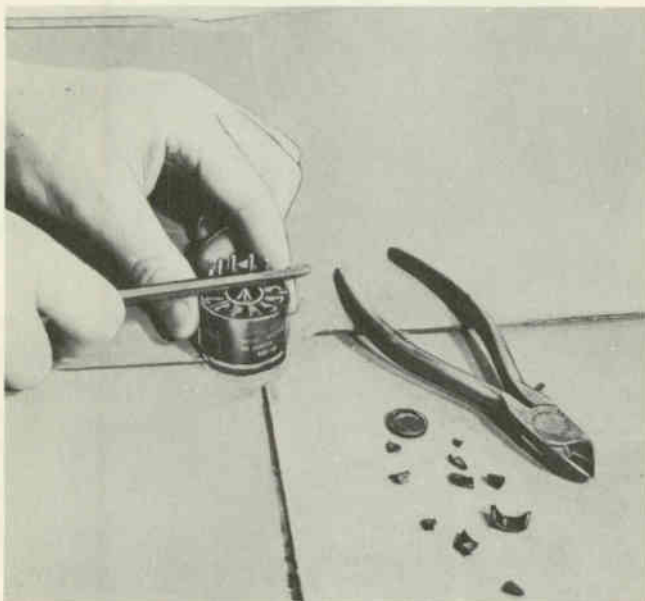
Fig. 103. Deactivating a picture tube. Drilling a hole in the keyway of the tube exposes the exhaust tip, which can then be broken.

1. Put the tube you want to dispose of into a carton designed to hold a unit of its size. Enough soft cloth should be placed under the face of the tube to make its base stick out at the top, outside the fold-over flaps of the carton (Fig. 103).
2. Drill a $\frac{1}{4}$ -inch hole in the center of the keyway or locating lug.

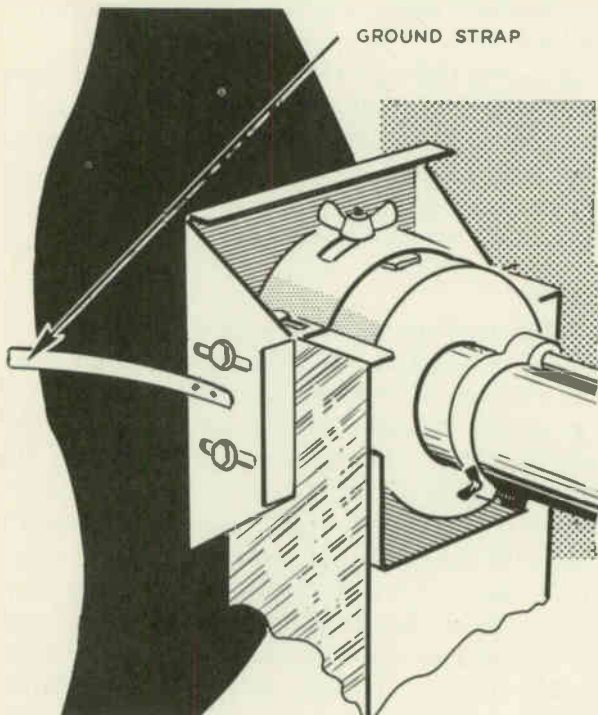
Fig. 104. Sketch showing ground strap on picture tube. Hairpin type clips are also used to place the glass envelope at ground potential.

The first precaution to take when a C-R tube is to be substituted in a TV set is to check whether the grounding clip or strap (if the tube is a glass type) is making contact with the Aquadag coating (Fig. 104). If it isn't, the proper adjustment should be made to remedy the condition and insure that no residual charge is left on the tube when the power is turned off and tubes are interchanged. The receptacle or cup of a disconnected glass C-R tube should be discharged to ground before the tube is handled.

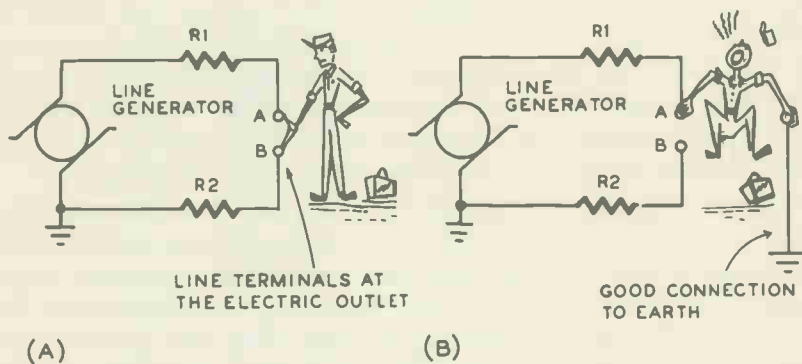
Fig. 105. When a technician (drawing A) puts two fingers of one hand across the line terminals, current flows through the fingers and hand only and does not pass through vital organs. Also, the current is limited by the resistance of the wiring in each branch of the line (R_1 and R_2 represent this resistance). When the technician (drawing B) puts one hand between the "hot" side of the line and a good external ground, current flows from one hand to the other through his body. The current will be greater than in A because R_2 is short-circuited.

Novices who see old-timers testing for line "juice" by putting their fingers across the ac line terminals should not confuse this with getting their body between one side of the line and a good ground. (See Fig. 105-a,-b. R1 and R2 represent the resistance of the line.) The current-delivering capacity of a line generator is somewhat less in the first case than it is in the second, making an electric shock less dangerous; more important, putting two fingers (of the same hand) across the line limits the path of current to the hand, leaving vital organs unaffected. Actually, the current going through the fingers is greater than that going through the body, but is not as dangerous.

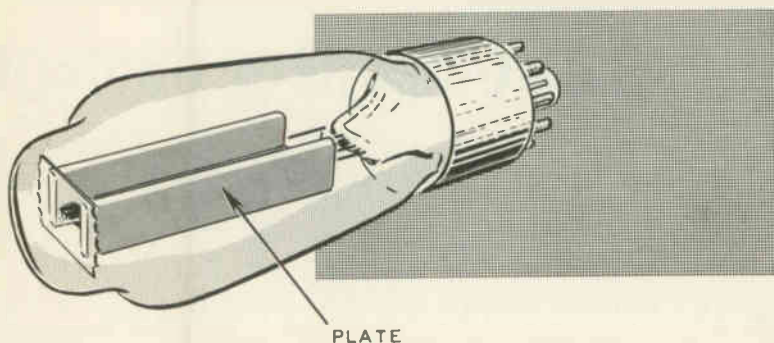
Fig. 201. When a 5U4-G is horizontally positioned, the long sides of the plates should be vertical.

in Fig. 201. The filaments are correctly positioned in this case, minimizing the possibility of filament sag. Sag of this kind can result in the development of a filament-to-plate short, which may damage the power transformer and filter capacitors as well as the rectifier tube.

a 5U4-GB that is horizontally mounted, to obtain a tube with a structure identical to the one in the set, one whose plate and base-pin orientation correspond to that of Fig. 201. Otherwise, damage to components may occur. It is desirable to avoid horizontal positioning of the 5U4-GB when servicing a set for any considerable length of time if the positioning of the plates with respect to the pins differs from the one illustrated in Fig. 201.

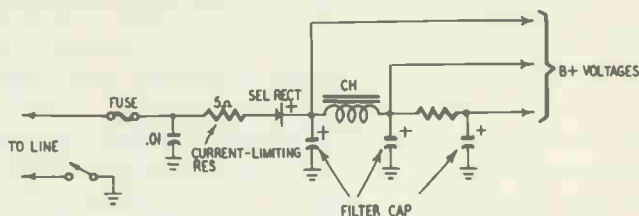
Fig. 202. Representative selenium rectifier power supply, showing one way in which a current-limiting resistor is inserted into the circuit.

Small current-limiting resistors (Fig. 202) are used in series

A resistor of this kind serves a protective function and should always be replaced. Selenium, as well as tube rectifiers, can safely pass a certain value of peak plate current; if this current is exceeded, the rectifier may be permanently damaged.

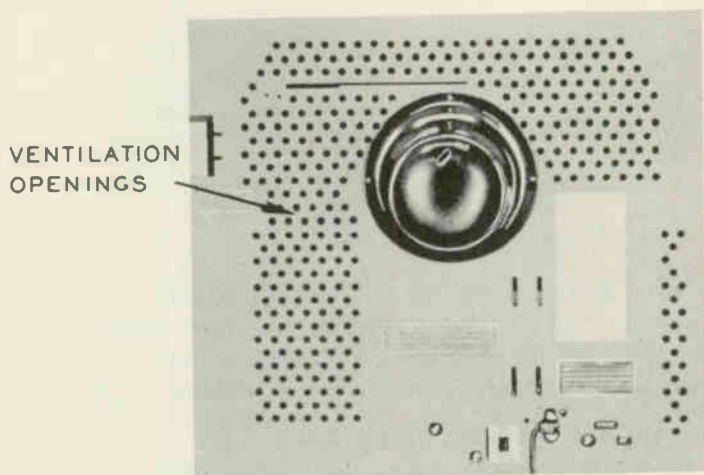
Fig. 203. Ventilation openings in the back of a TV set. Keeping the receiver some distance away from the wall will prevent obstruction of the openings.

Excessive heat is generated in a tube, impairing its performance and life, if ventilation is improper. An adequate supply of air must flow past the receiver's tubes, particularly its rectifier and power output tubes. If the set owner keeps the receiver flush against the wall or covers its ventilation openings (Fig. 203) in

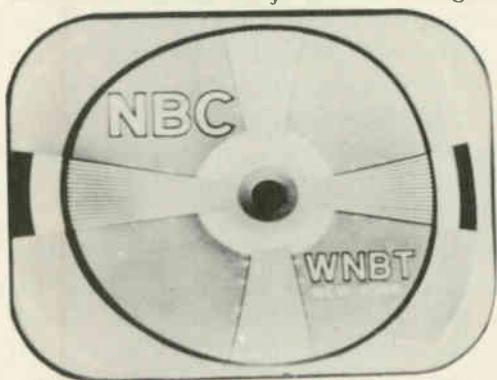
Fig. 205. Effect of horizontal nonlinearity on test pattern. Note greater width of horizontal wedge at left, compared to the corresponding wedge at the right.

Higher-than-normal line voltages may be responsible for premature horizontal output tube failures. Excessive width and/or horizontal nonlinearity are associated symptoms in such a case (Fig. 205). A line-voltage check will verify whether this voltage is above normal.

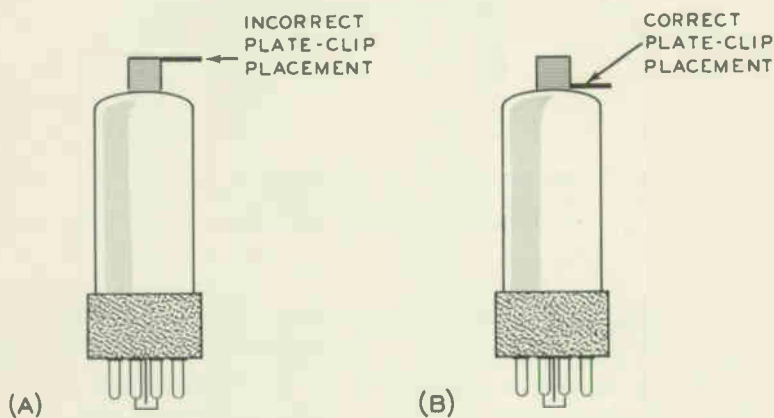
Fig. 206. In receivers where the top of the high-voltage cage is close to the plate clip of the 1B3-GT rectifier, improper placement of the plate clip may be the cause of corona or arcing.

In cases where the top of the high-voltage cage is very close to the plate cap of the rectifier tube, it is possible to introduce arcing and corona by improper placement of the high-voltage anode clip (Fig. 206). In such "low-bridge" cases, make sure the placement of the clip puts the maximum distance between the grounded cage top and the wire leading to the clip.

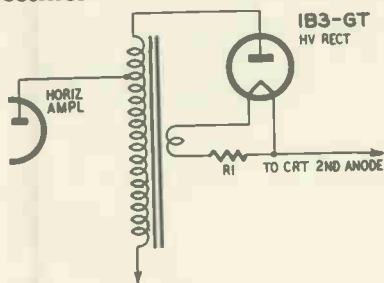
Fig. 207. Portion of high-voltage rectifier circuit, showing location of the filament-dropping resistor (R1).

Excessive filament voltage of the high-voltage rectifier is rather difficult to detect since it cannot be measured directly. The voltage across the filament is usually 1.25, but the voltage between either filament pin and chassis is measured in kilovolts. Check the value of the resistor in series with the filament (see R1 in Fig. 207) when frequent rectifier burnout is the complaint. If the resistor has decreased as much as 1 ohm in value (compared to the value specified in the set schematic) replace it with a unit of the correct resistance.

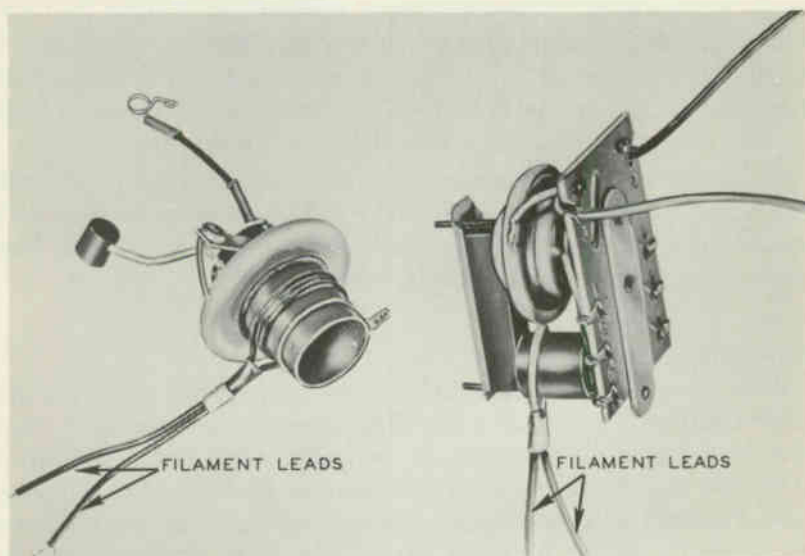
Fig. 208. Photos of flyback units, showing number and position of filament windings. One or two turns may be used, depending on the filament voltage requirements and the construction of the flyback transformer.

A shift in the coupling of the high-voltage rectifier filament winding on the flyback transformer may be the source of frequent tube burnouts (Fig. 208). If a similar flyback is present in another receiver, a comparison can be made to verify whether such a shift has occurred. If it has, the filament winding may be moved a short distance—perhaps $\frac{3}{16}$ inch or thereabouts—away from the high-voltage winding on the transformer. If set performance remains satisfactory, the winding may be left in this position.

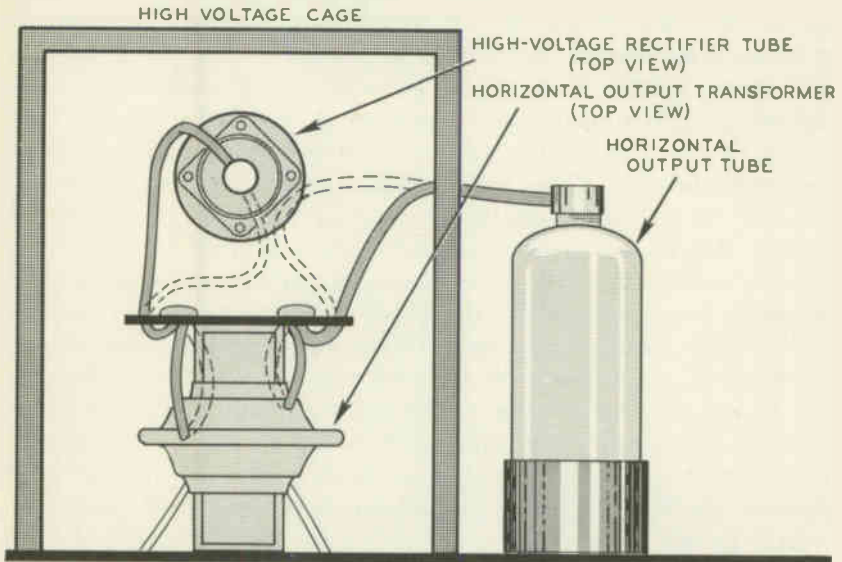
Fig. 209. Proper and improper lead dress in the high-voltage cage. Dotted lines indicate incorrect positioning of leads; high-voltage wires are too close to each other.

dress after a tube replacement in the high-voltage section (Fig. 209).

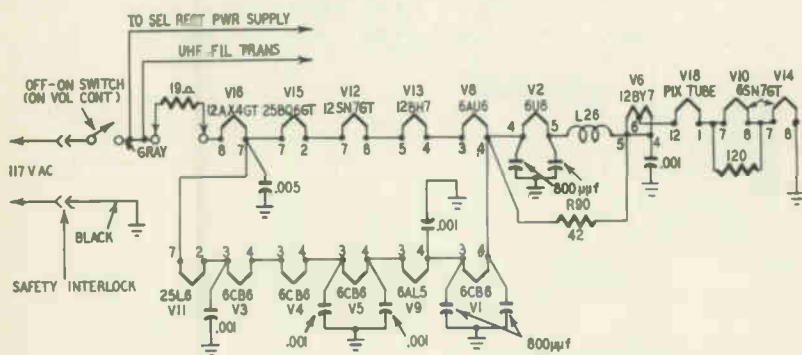
Fig. 211. Series-filament circuit in which two strings of tubes are in parallel. The two parallel strings are in series with a third group of filaments.

There are a number of facts about series-filament circuits (Figs. 210, 211) that the technician should know to minimize the possibility of damage in servicing tubes connected in this way.

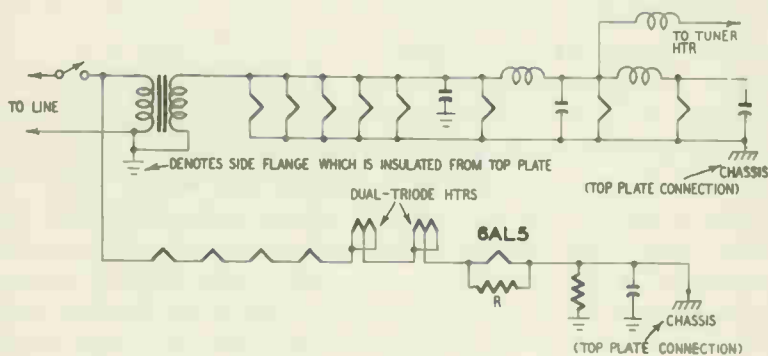
Fig. 212. Series-filament circuit in which a shunt resistor R is used across one of the tube filaments (6AL5).

possibility of failure of tubes for other reasons is increased as well. If a resistor (R) is in shunt with the tube that has been removed (Fig. 212), the resistor will overheat since an excessive voltage will now be present across it; in a few seconds, it may be permanently damaged.

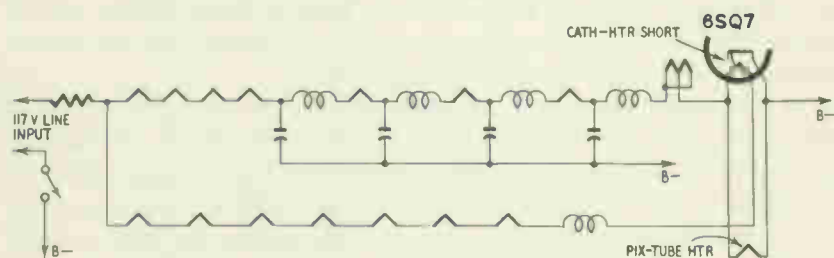
Fig. 303. Filament circuit of a typical TV chassis. A filament-cathode short in the 6SQ7 can shunt the filament current to ground before it passes through the picture tube, causing the cathode-ray tube to remain unlit.

When filament voltage is absent, a short in some tube other than the cathode-ray tube may be responsible (Fig. 303). In certain TV sets, the filament of the picture tube is in parallel with that of the damper. A short in either tube may eliminate filament voltage in both. Try a new damper, in sets of this kind, when the picture-tube filament does not light. In the case of series-filament receivers, trouble in any tube filament in series with that of the picture tube can eliminate its filament lighting; check for the presence of such a defect when receivers of this kind are being worked on.

In some receivers using a filament circuit setup such as the one shown in Fig. 303, a cathode-to-heater short in the first audio tube will eliminate filament voltage from the picture tube and kill the raster. The short will also eliminate the sound signal, leaving only a hum audible. If, in sets of this type, raster and desired sound are missing, hum is audible and the picture tube is unlit, try another first audio tube.

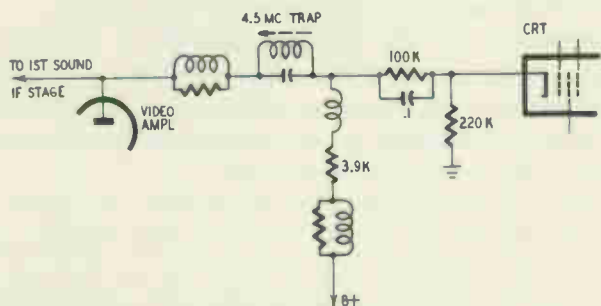
Fig. 304. Direct coupling between video amplifier and cathode-ray tube. Loss of emission in the video amplifier will increase the cathode voltage of the tube, possibly increasing its bias to cutoff in some cases.

If the grid-to-cathode voltage cannot be reduced to zero or to a few volts negative by manipulation of the brightness control, but remains excessively negative at all times, a defective tube may be the cause of the trouble in some cases. In a receiver in which direct coupling between the video amplifier and picture tube is used (Fig. 304), a defective video amplifier may cause an excessive picture-tube bias to be developed, blanking out the raster. Try replacing the video amplifier to check on this source of trouble.

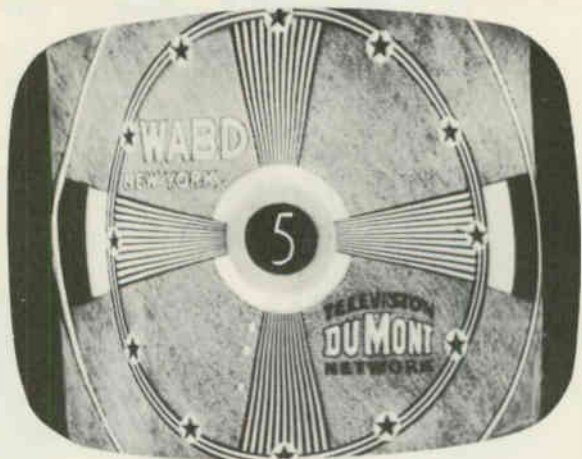
Fig. 305. Photo of test pattern indicates insufficient width.

Insufficient width (Fig. 305) may be due to a weak damper, horizontal output tube or low-voltage rectifier. When the rectifier is weak, other symptoms will generally (but not always) be mani-

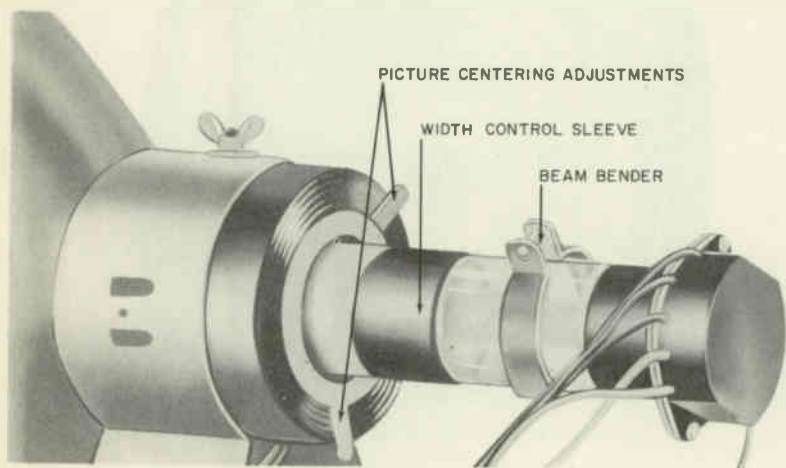
Fig. 306. Sleeve made of brass or aluminum can be used as a width control.

In some receivers a brass or aluminum sleeve is used on the picture-tube neck for adjusting width (Fig. 306). Improper setting of this sleeve may be responsible for a slight loss in width.

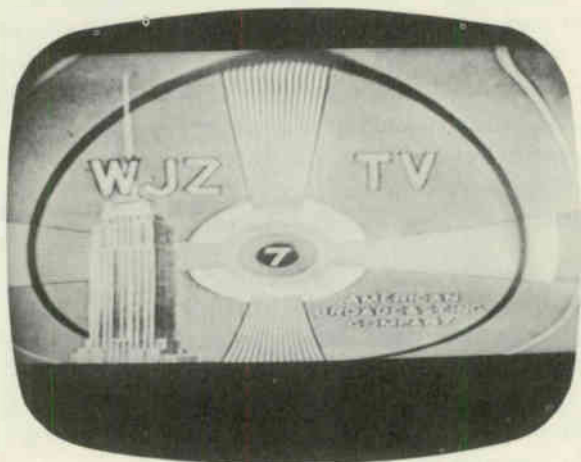
Fig. 307. Photo shows insufficient height.

When insufficient height is the complaint (Fig. 307) either the vertical oscillator or vertical amplifier tube may be responsible. If height and vertical linearity adjustments do not restore the height to normal, replace these tubes. If replacement one at a time does not eliminate symptoms, try replacing both tubes simul-

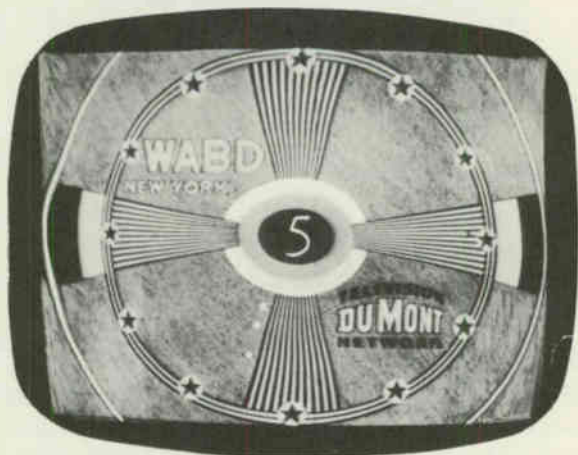
Fig. 308. *The test pattern is pulled in. The photo shows inadequate width and height.*

When both height and width are inadequate (Fig. 308) and height and width adjustments do not restore raster size to normal, try a new low-voltage rectifier. Such a substitution is particularly indicated if there is an accompanying reduction in sound volume or insufficient contrast or if the focus control achieves or approaches proper focus only at one end of its range.

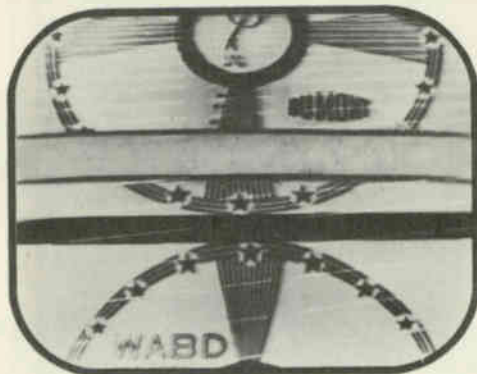
Fig. 309. The vertical blanking bar can be examined by adjustment of the vertical-hold control.

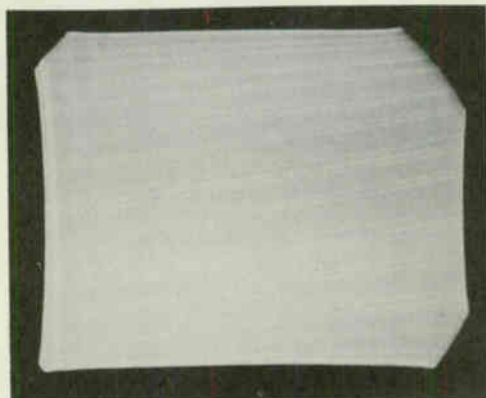
Fig. 402. How raster will look when sync pulses are not reaching the vertical oscillator. The vertical retrace lines will drift up and down, indicating that the vertical oscillator is free-running or uncontrolled.

If no noise pattern is seen on the screen, examine the vertical retrace lines on the raster. If these diagonal white lines jump up and down and will not remain stationary (Fig. 402), trouble in some stage preceding the sync takeoff point is indicated. Sync pulses are evidently not reaching the vertical oscillator and the retrace lines are unsynchronized.

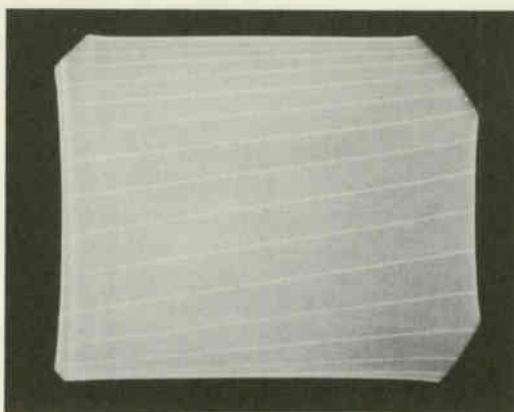
Fig. 403. What the raster will look like when sync pulses reach the vertical oscillator. The vertical retrace lines will be steady, provided the vertical hold control has been properly adjusted.

If, on the other hand, the retrace lines *are* steady (Fig. 403), vertical sync pulses are generally getting through to the vertical oscillator. (Retrace lines can be steady due to residual hum.) The video signal must, in consequence, be reaching the sync takeoff point and trouble *after* this point is indicated. When a two-stage video amplifier is present in which the sync pulses are picked off

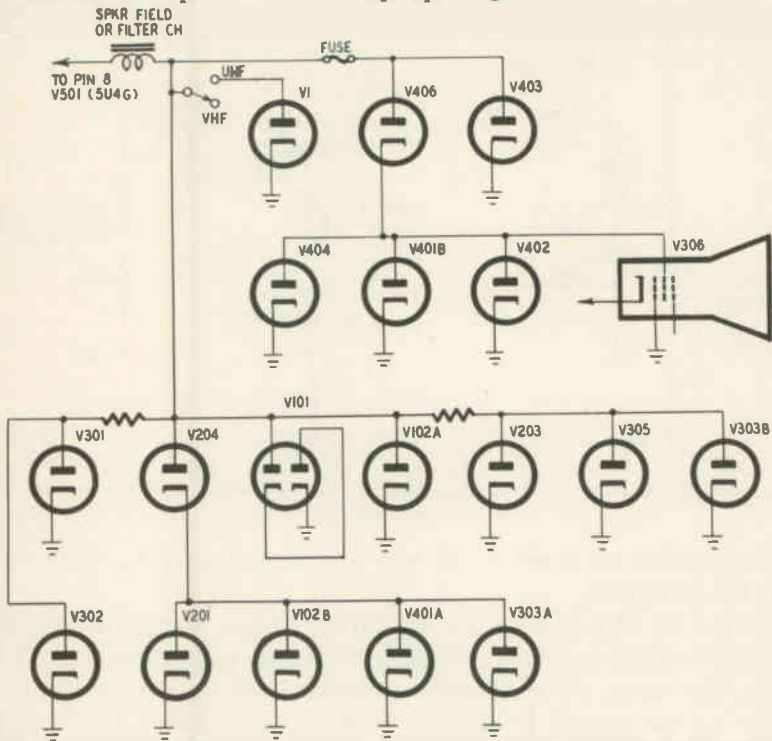
Fig. 407. Block diagram showing tube stacking. V204 is the sound output tube. Its heavy current will be reduced when it loses emission, causing the plate voltages on V101, V102A, V203, V305 and V303B to rise. The tubes are shown as diodes for the sake of simplicity

receiver's sound volume is above normal), a defect in an agc tube may be present. In a circuit such as the one shown in Fig. 407, a loss in agc bias will cause an excessive signal input to the video amplifier. The video amplifier may be driven into cutoff, thus killing the picture. The sound signal, on the other hand, will be

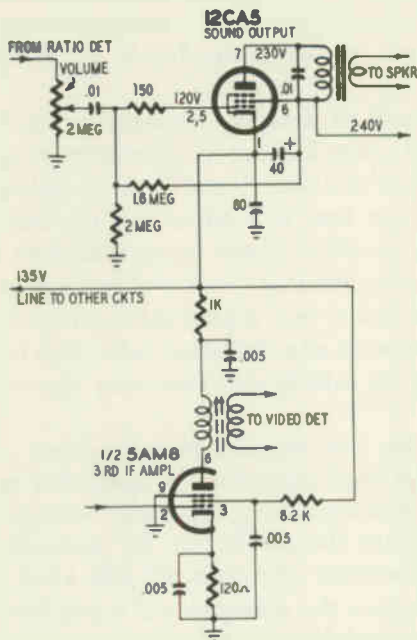
Fig. 408. The audio output and the third if amplifier tubes are in series and act as a voltage divider. A defect in the sound tube can cause loss of picture and sound.

Another example of circuitry in which a defective sound tube may affect both picture and sound is shown in Fig. 408. B-plus voltage to the tuner, video amplifier and agc circuits, as well as the sync separator and clipper, are affected when a fault develops in the audio output tube.

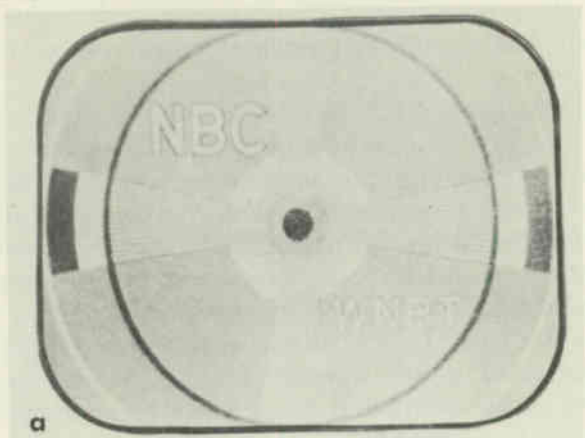
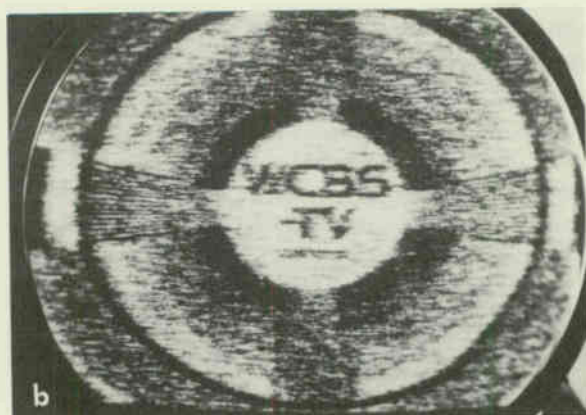
Fig. 409. (a) Weak picture with snow present. (b) Effect of advancing the contrast control setting with a snowy picture.

When insufficient contrast is accompanied by snow in the picture (Fig. 409), try substituting new front-end tubes. If no snow is present, substitute tubes—or crystal—in video signal stages.

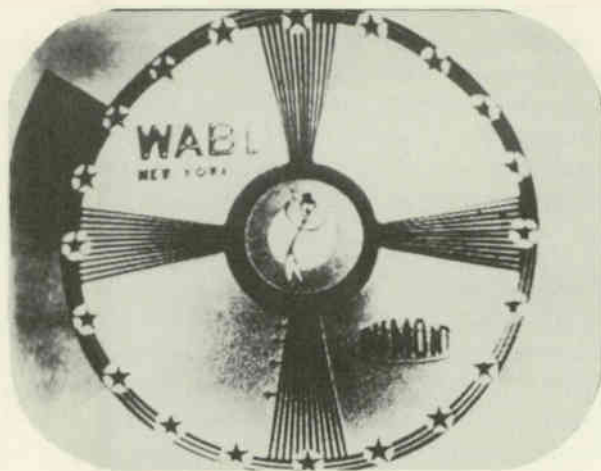
Fig. 410. Photo of test pattern showing excessive picture contrast. Note smearing.

The presence of excessive picture contrast (Fig. 410) is fre-

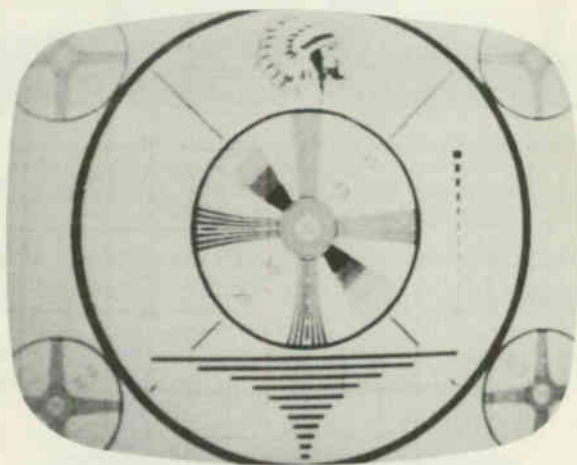
Fig. 411. Test-pattern photo illustrating white compression due to overloading in the if amplifier. Note washed-out appearance of the picture, poor rendition of whites. No snow is present, however. The condition is most likely to be noted on strong signals.

Overload characterized by white compression (loss of grays in the picture, causing the pix to look flat and washed out) is often due to a faulty rf amplifier (Fig. 411). Defects in either the rf

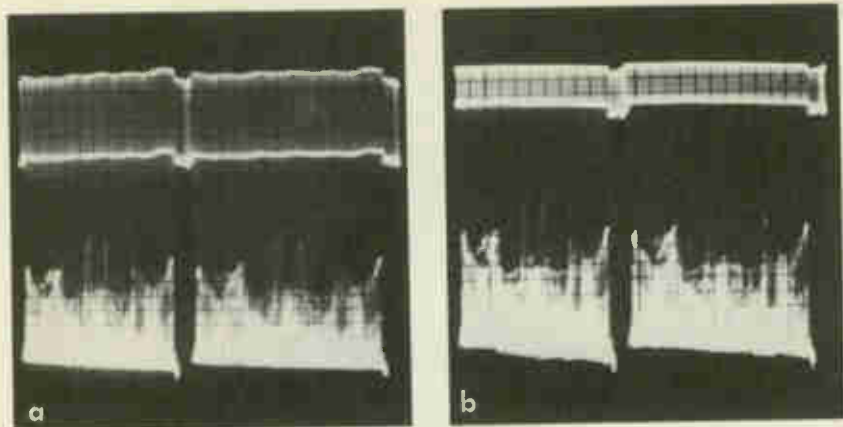
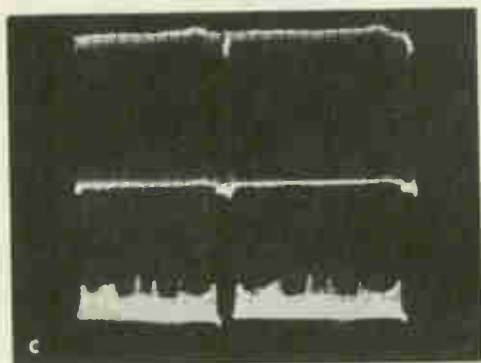
Fig. 412. (a) Normal video detector output waveform. (b) Video detector waveform when black compression is present. Signals in the gray-black region are compressed, causing grays to fall into the black region. Sync pulses are also compressed and reduced in amplitude.

Fig. 412. (c) Video detector output waveform when white compression is present. Note smaller range of variation at bottom of waveform where the white signals are, compared to the normal variation in this region shown in Fig. 412-a.

amplifier, agc or video if tubes can be the cause of the trouble. The presence of white or black compression can be verified by making a scale waveform check at the output of the video detector (Fig. 412).

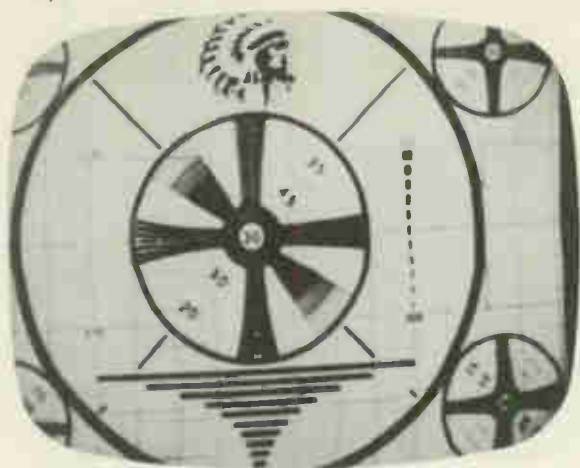
Fig. 413. Test pattern illustrating black compression. Grays are rendered as black, causing the picture to look dark and excessively contrasty.

Sync and black compression (Fig. 413) frequently indicates overload in the video if stages due to insufficient agc bias. Such compression may readily be detected by advancing the brightness control and adjusting the vertical hold control until the picture hovers with the horizontal blanking bar positioned somewhere around the middle of the tube. If the sync pulse hammer is not much darker than the blanking bar proper, sync and black compression is indicated (Fig. 414). The picture will be dark and excessively contrasty when this kind of trouble is present; sync will tend to be lost if the condition is severe.

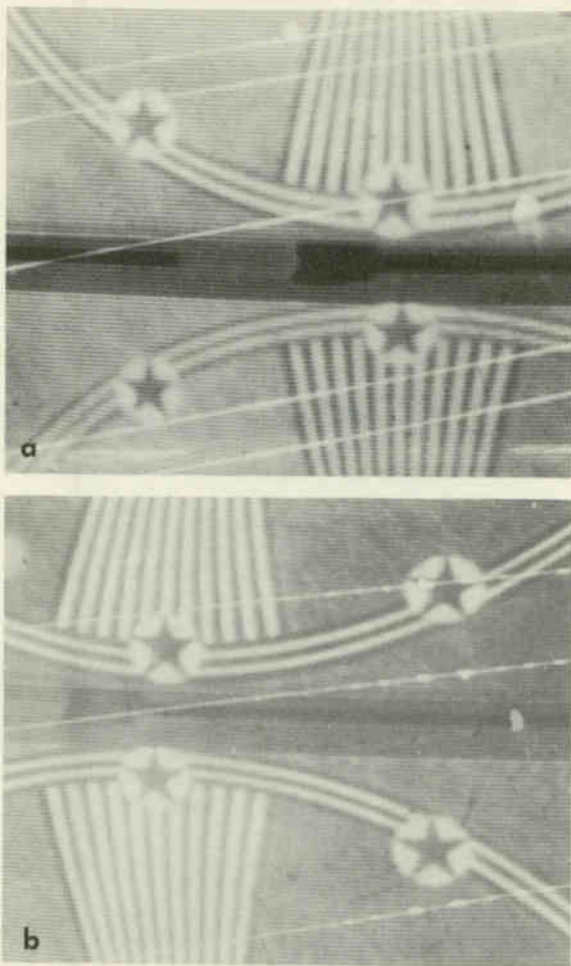
Fig. 414. The photo at the top shows the normal appearance of vertical blanking bar. Note that the sync hammer is black, while the blanking bar proper is gray. The lower photo illustrates the effect of sync compression on the sync pulse and blanking bar. The reduction in sync-pulse amplitude causes the height of the sync pulse to fall closer to the blanking signal level. As a result the shading of both becomes similar.

A good preliminary check to make is an inspection of the sync pulse in the vertical and/or horizontal blanking bar (see Figs. 414 and 501). The brightness control should be turned up somewhat to permit the shading of the sync and blanking pulses to become visible. If there isn't much difference in contrast between the sync pulse and the blanking bar, as shown on the screen of the picture tube, sync compression is indicated.

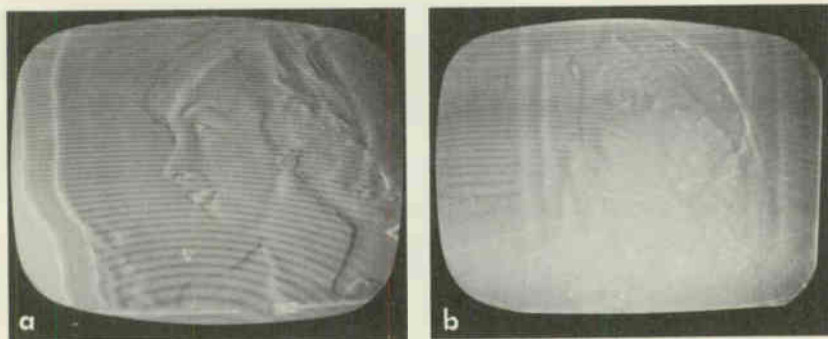
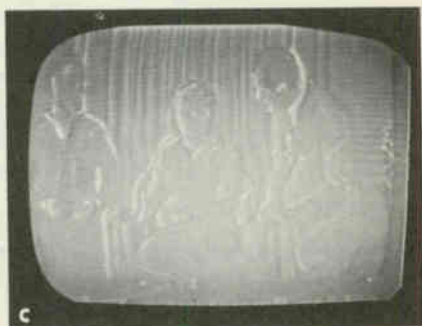
Fig. 415. (a) Negative picture caused by overloading. An inoperative agc tube can cause such overloading by removing the bias from agc-controlled stages. Erratic horizontal and vertical synchronization are often associated with the negative picture. (b) Another example of a negative picture caused by agc trouble. In this case, synchronization has not been impaired. The symptoms illustrated were seen when a medium-strength signal was coming in. With a weak signal and the contrast control setting advanced, the picture may look normal in some cases.

Fig. 415. (c) Negative picture caused by low emission in a 5U4-G rectifier. The 5U4-G in question provided high B plus for the horizontal amplifier tube. Reduction of the rectifier tube's output resulted in the feeding of a smaller pulse from the horizontal amplifier to the plate of the keyed agc tube, decreasing the agc voltage and causing overloading of the agc-controlled stages.

The technician not infrequently encounters a set in which negative pictures are received—one in which normally black areas are white and normally white areas are black (Fig. 415). Overloading is frequently the cause of such phase reversals, particularly when vertical and/or horizontal synchronization is continuously or intermittently affected. An excessive signal in the video if tube grid circuit can produce a negative picture.

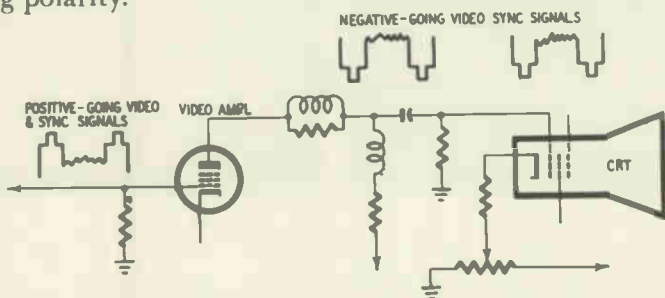
Fig. 416. The sync pulses should be negative-going on a scope waveform test when the video amplifier output signal goes to the grid of the cathode-ray tube. It is assumed that the scope does not invert the signal. When the video amplifier feeds to the cathode of the picture tube, the sync pulses should be positive-going.

Trouble in a picture tube itself can produce a negative picture. Before making a laborious substitution to test for such a source of trouble, simply check the scope waveform at the point where the video signal is fed to the tube. If the signal is applied to the grid, the polarity of the sync pulses should be *negative*; they should be *positive* if the video is fed to the cathode (Fig. 416). If the signal polarity is correct but a negative picture is obtained anyway, trouble in the C-R tube is indicated and another tube should be substituted. (It is assumed that voltage and resistance tests between picture-tube elements and ground have eliminated the possibility of circuit trouble.)

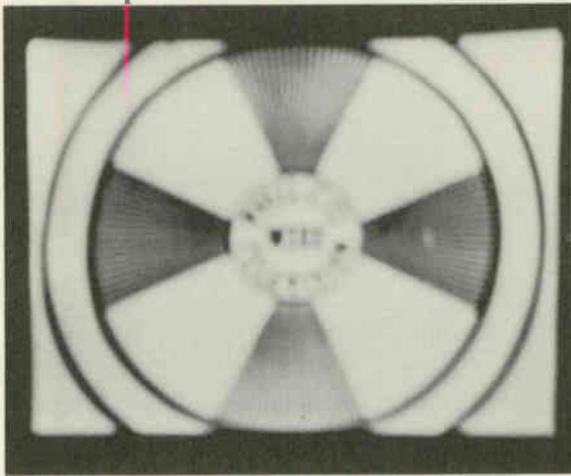
Fig. 418. Effect of improper focus on the test pattern.

A blurring of the entire picture is generally produced by improper focus. The vertical and horizontal wedges in the test pattern will not be sharply defined when this condition is present

(Fig. 418) and neither will the scanning lines of the raster. (Reduce the contrast setting to zero, eliminating the picture, to examine these lines.) When adjustment of the focus control and/or focus magnet proves ineffective in clearing up the condition, one of the following troubles may be present:

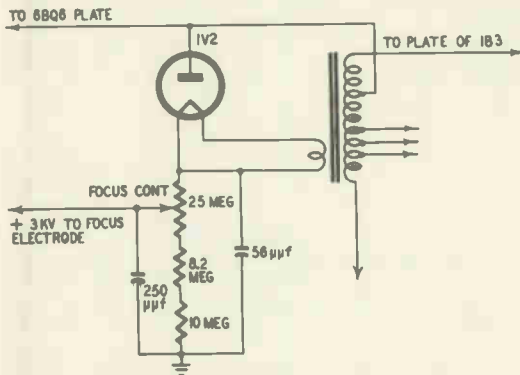
Fig. 419. Focus tube and associated circuit used with picture tubes employing high-voltage electrostatic focus.

a 1V2) to provide the focus voltage needed, reduced emission or some other defect in this tube may make it impossible to achieve proper picture focusing (Fig. 419). The same is true of magneti-

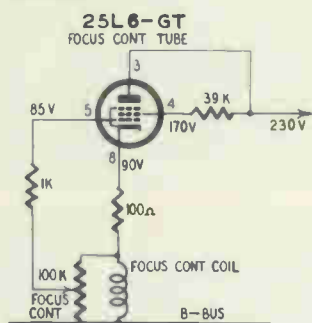
Fig. 420. Focus control tube and associated circuit used in some receivers.

cally focused sets that use a separate focus control tube. (Fig. 420).

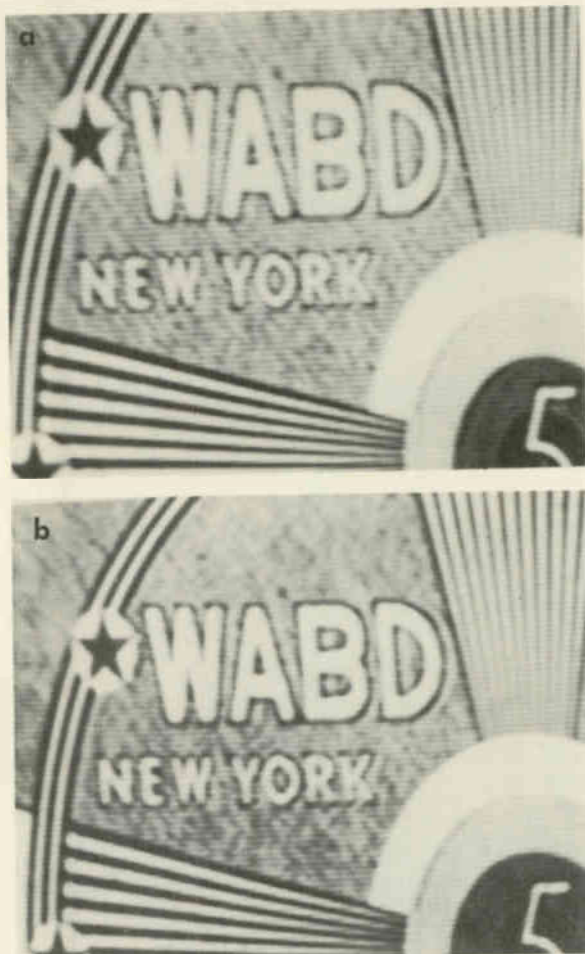
Fig. 421. (a) Appearance of section of test pattern when scanning-spot size is correct. Appearance of same portion of test pattern (b) when scanning-spot size is larger than normal. Note that the dark spaces between scanning lines are no longer clearly visible.

A condition similar to a slight impairment of focus may be noted (Fig. 421) when the size of the scanning spot has increased for some reason. Possible causes for such an increase include: improper positioning of the ion magnet; gassy C-R tube; loss of emission in a tube in the horizontal or high-voltage section (leading to a reduction in the high voltage) and, of course, an improper focus-control setting.

To check the spot size, observe the white scanning lines in the picture or test pattern. In Fig. 421-a illustrating a normal condition, the scanning lines are narrow and the black horizontal spaces between them are clearly visible. In Fig. 421-b illustrating the

effect of an enlarged spot, the increase in the width of the scanning lines has caused the dark in-between spaces to become narrower, poorly defined and almost invisible.

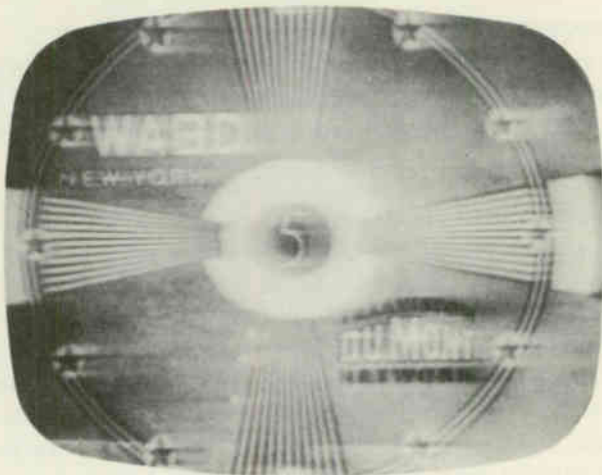
Fig. 422. *Effect of smearing on the test pattern. Symptoms vary somewhat from case to case.*

When response is impaired at low frequencies, smearing may be introduced into the picture. Smearing most noticeably affects large

objects (Fig. 422). White or black edges in the picture, instead of being sharply defined, are smeared generally in the direction of the right side of the screen. Trailing shades ranging from black to white may be seen after large black objects; these shadings go from white to black after large white objects. The picture as a whole will look fuzzy. Smearing is usually due to poor reproduction of low video frequencies.

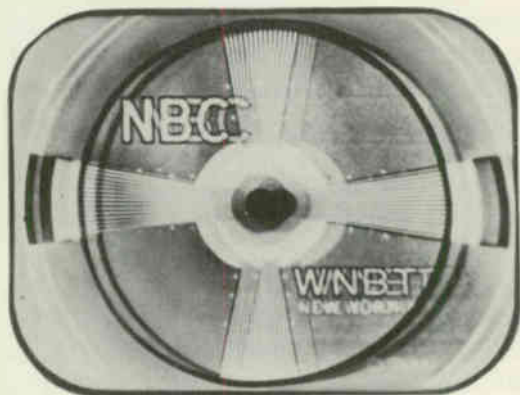
Fig. 423. Ghosts in test pattern.

It is not too well known that a defective tube may cause ghosts or multiple images (Fig. 423) to be seen in the picture. The condition may be explained as follows:

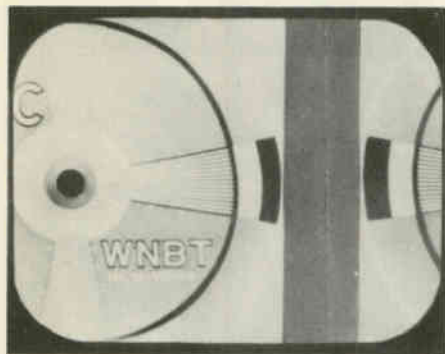
Fig. 501. *Horizontal blanking bar is black when brightness and contrast control settings are normal and no defect is present. The horizontal sync pulses are not visible.*

A horizontally out-of-phase picture (Fig. 501) that cannot be made normal by suitable manipulation of the horizontal hold or afc control points to a defective afc section. Substitute tubes in this section to check on this possibility.

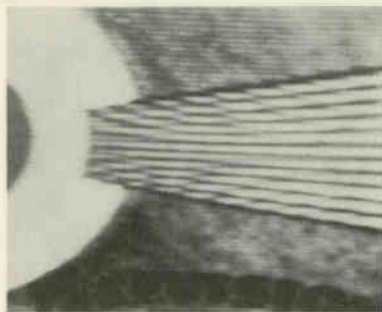
Fig. 503. *Mottling of the horizontal wedges (moire effect) due to poor interlace.*

A loss in interlace can be readily detected when a test pattern is present by inspecting the horizontal wedges. When a moire (see Fig. 503) is noticeable—i.e., circular movement in the horizontal wedges—interlace is being lost.

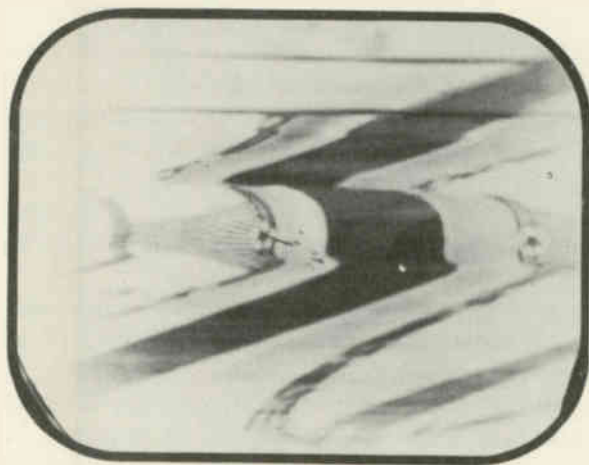
Fig. 506. Complete loss of horizontal synchronization.

When horizontal synchronization is completely absent and cannot be brought in by manipulation of the horizontal hold control (see Fig. 506), trouble in the afc or horizontal oscillator section is indicated. A defect in one of the sync stages through which both

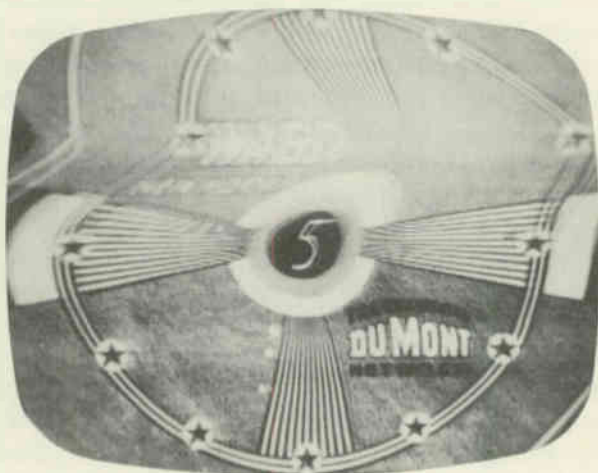
Fig. 507. A case of severe picture "hook" in the test pattern.

A certain type of horizontal movement in the picture (see Fig. 507) is referred to as pulling, snaking, bending, hooking or S distortion. Straight vertical sides of objects in the picture are bent when such a defect is present. This should not be confused with tearing, wobble or jitter.

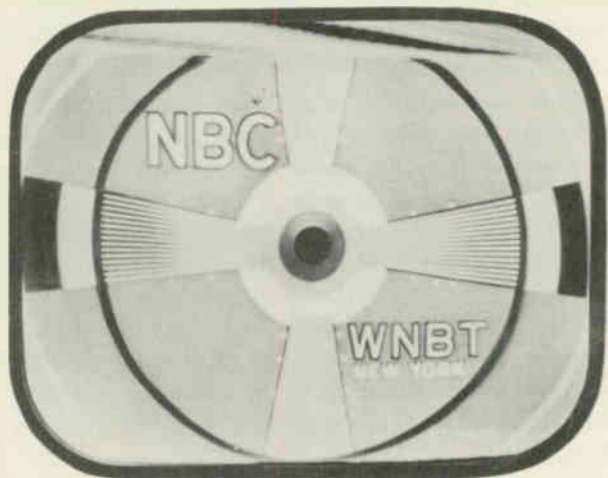
Fig. 508. Tearing out of lines at the top of the picture. The condition may be intermittent or practically continuous.

Tearing out of lines at the top of the picture (Fig. 508) is due to insufficient agc voltage. If the contrast and agc control settings are correct, substitute a new agc tube or tubes.

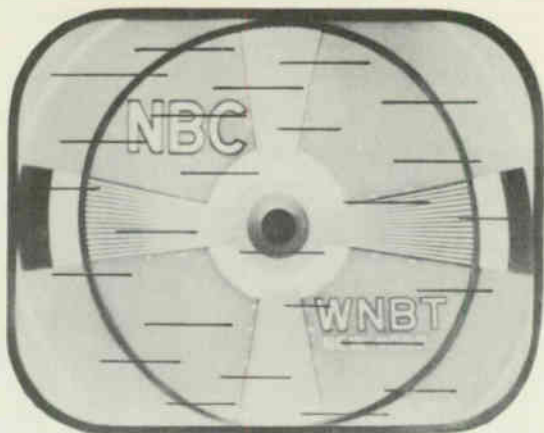
Fig. 509. Lines in picture due to auto-ignition interference. The picture has been retouched to emphasize the effect. Similar lines may be caused by corona trouble at the high-voltage rectifier socket.

Corona due to improper spacing of the high-voltage rectifier's socket lugs may produce lines in the picture (Fig. 509) similar to those produced by auto ignition interference. Inspect the tube socket terminals of the high-voltage rectifier to check on this source of trouble.

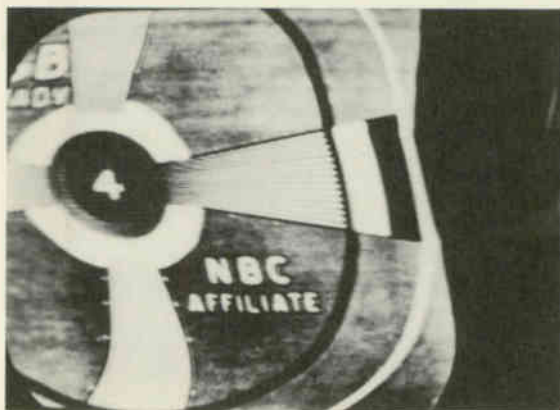
Fig. 510. Horizontal jitter or weaving. The trouble in this case was due to a short between cathode and heater of a sync clipper-amplifier tube.

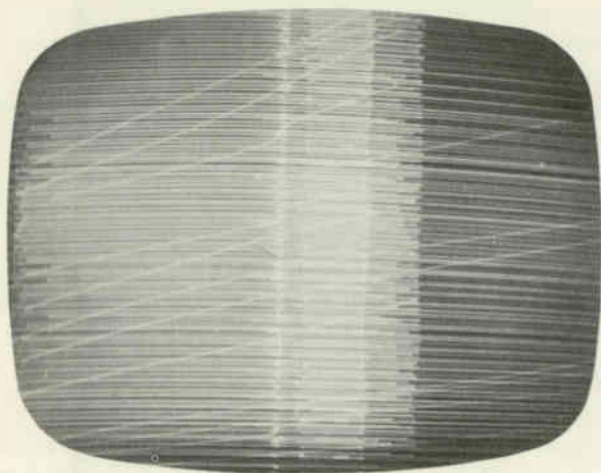
Fig. 511. "Christmas-tree" effect.

In the presence of certain defects, the picture and raster may break up into several sections of varying width. Their faint resemblance to a Christmas tree has led to the symptoms being labeled "Christmas tree" effect. When the breakup is more severe, the raster may disintegrate into a series of bright horizontal lines that cover the central portion of the raster (Fig. 511) and occupy about 50% of the normal raster area. A loud singing or frying noise coming from the horizontal output transformer often accompanies the symptoms just described. These symptoms, incidentally, are most often seen (in certain cases of trouble) when the station selector is set at an unoccupied channel or when channels are switched.

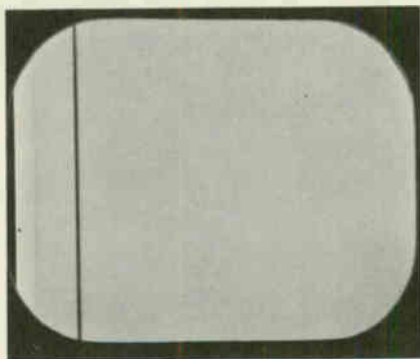
Fig. 602. Appearance of Barkhausen oscillation in the raster.

by the front end or video if section and amplified in succeeding stages. The condition generally manifests itself as one or more vertical black lines on the left-hand side of the screen (see Fig. 602). The lines may appear white if the oscillation is relatively weak.

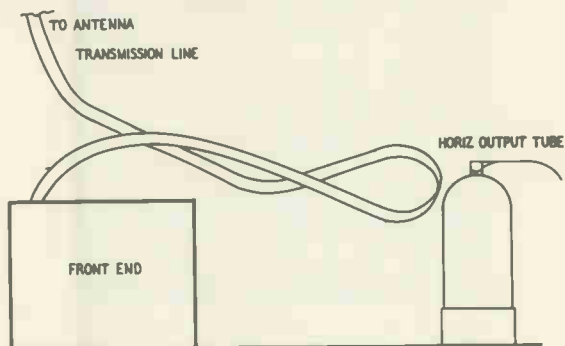
Fig. 603. Bringing the loop near the horizontal-output tube will increase the intensity of Barkhausen lines.

One way to determine whether Barkhausen oscillation is present is to loop a section of the lead-in (see Fig. 603) and hold it near the horizontal output tube. If the intensity of the lines increases or if they change from white to black, Barkhausen oscillation is causing them. Another test consists of putting a magnet (ion magnet or a pm speaker core) near the horizontal amplifier tube. If symptoms are diminished or disappear, they are due to Barkhausen oscillation.

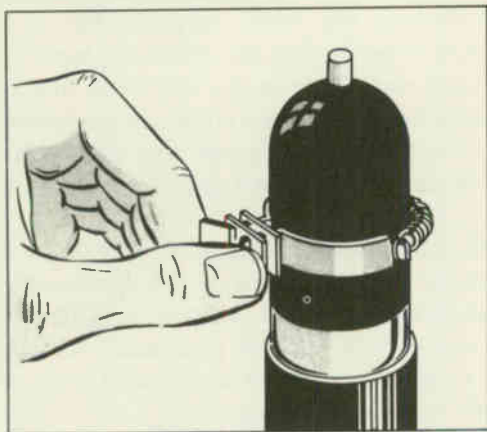
Fig. 604. Barkhausen oscillation eliminator. The magnet is placed over the horizontal-output tube.

anti-Barkhausen magnet (Fig. 604), may be placed around the horizontal output tube in such a position that the symptoms are eliminated. The output tube can also be replaced to cure the condition. Don't discard the original tube—it will probably function normally in some other set.
