TV and
radio
TUBE
TROUBLES

SOL HELLER

GERNSBACK LIBRARY, INC.
NEW YORK 11, N. Y.

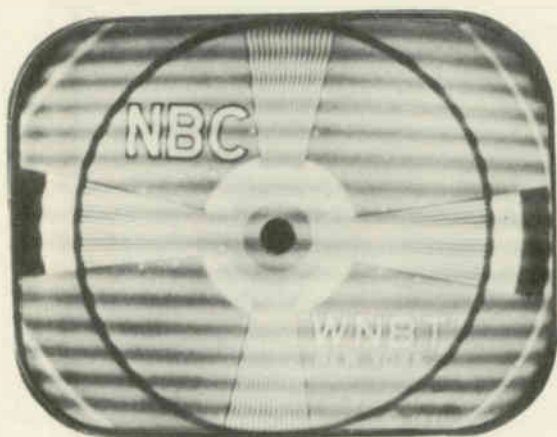
Fig. 606. *Sound bars in the picture.*

Possible causes of sound bars in the picture (Fig. 606) other than microphonic tubes are few if we exclude circuit troubles. A defective video detector crystal may be one such source—the correct tuning point may no longer coincide with the point where sound ripple is absent. The crystal used as video detector should be checked by substitution if sound appears in the picture when the fine-tuning control is adjusted for optimum resolution and likelier sources of trouble have been eliminated.

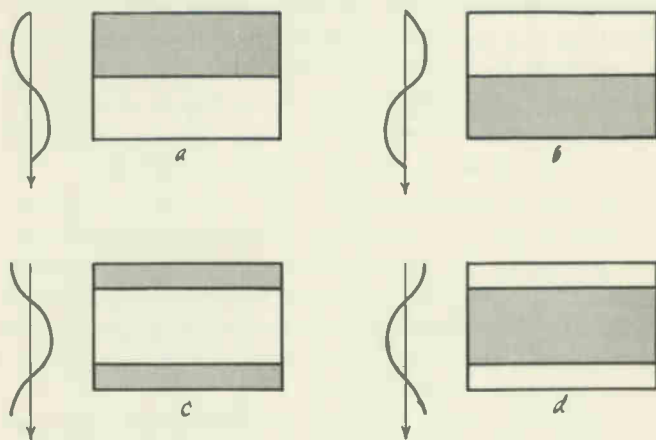
Fig. 607. Bar patterns that may be seen when a 60-cycle hum signal reaches the picture tube. Which pattern will be seen depends on the phase of the hum with respect to the line voltage. Drawings a and c show a 90° phase difference. The drawings in b and d show the effects of reversing the line plug.

Horizontal bars due to 60-cycle hum may cause the picture to have a dark bar over approximately half of its vertical area and a light bar over the other half. See Fig. 607. Or else a single prominent hum bar—either light or dark, depending on the polarity with which the line plug is inserted into the outlet—will be visible. Closer inspection will reveal that the shading of the picture sections not covered by the bar is improper (too light when the bar is dark; too dark when the bar is light).

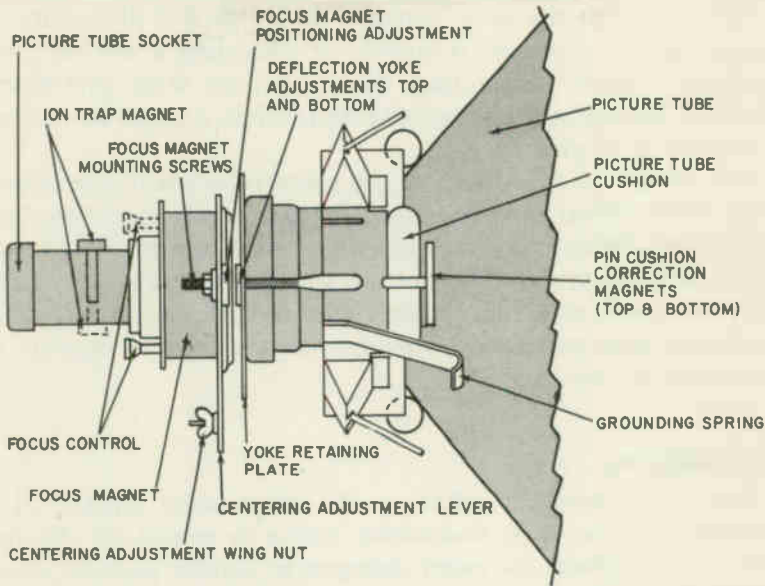
Fig. 701. Components mounted on the neck of the picture tube. The grounding spring connects the outer Aquadag coating to the chassis.

When an external Aquadag coating is used to form a capacitor with the internal coating, some means of grounding the external coating must be employed to make the capacitance effective in the circuit. Metal clips, bands or spring type wires are used for this purpose (see Fig. 701).

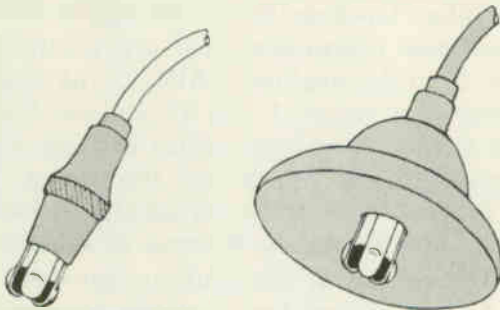
Fig. 702. Picture-tube anode lead and rubber cap. The drawing at the left shows the appearance of the anode lead after the flange portion of the rubber cap has been trimmed.

Either replace the cap with a new one or trim it off as shown in Fig. 702.

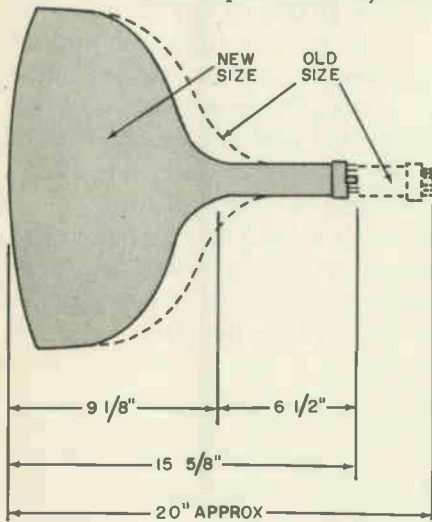
Fig. 704. Picture tubes can be made shorter as the deflection angle is increased. A picture tube with a deflection angle of 110° is less than 16 inches in length. This drawing shows the difference in length between two tubes having different deflection angles.

to match the higher deflection angles of large-screen tubes as these were developed. (Higher picture-tube deflection angles mean shorter tubes, as indicated in Fig. 704.)³

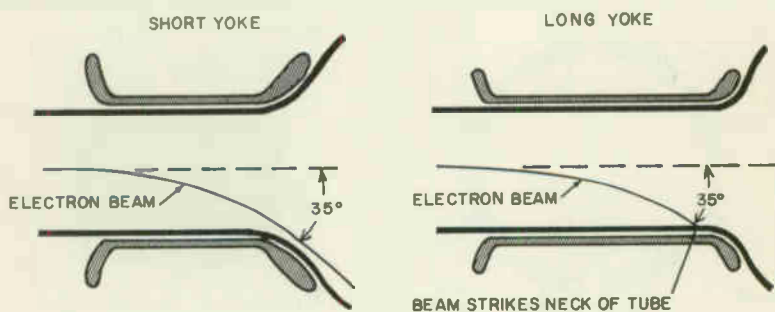
Fig. 705. Wide-angle yokes are shorter, use ferrite cores and have a higher inductance than other types of yokes.

To sweep a large-sized screen with a wide-angle yoke, the yoke must be very efficient. Let's see why this is so. The basic difference between the wide-angle yoke and its predecessors lies in the yoke length. The wide-angle yokes are *shorter*. With a long yoke, the possibility of increasing the deflection is limited by the fact that the electron beam tends to strike the neck of the tube if the angle is made too large (see Fig. 705).

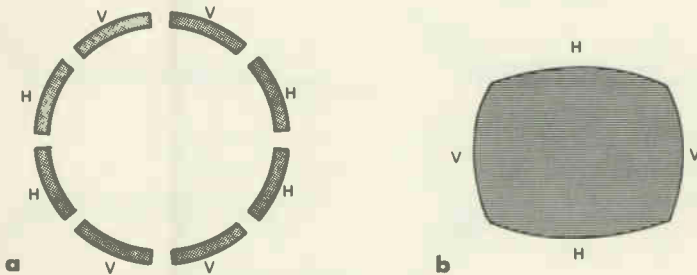
Figs. 706-a,b. Cross-section of the yoke used in older receivers. The field of this yoke is equivalent to four magnets placed as shown in the drawing at the right.

Early-make yokes tended to produce a nonuniform field because of their interlocked-winding construction. A cross-section drawing indicating this construction is shown in Fig. 706-a. The effect of such a construction is comparable to that produced by four permanent magnets, arranged as shown in Fig. 706-b. Because the field of the magnets is strongest in their immediate vicinity, deflection in these areas is greatest. The effect on the raster is *barreling*—a condition which causes a bowing outward of the raster sides (Fig. 707).

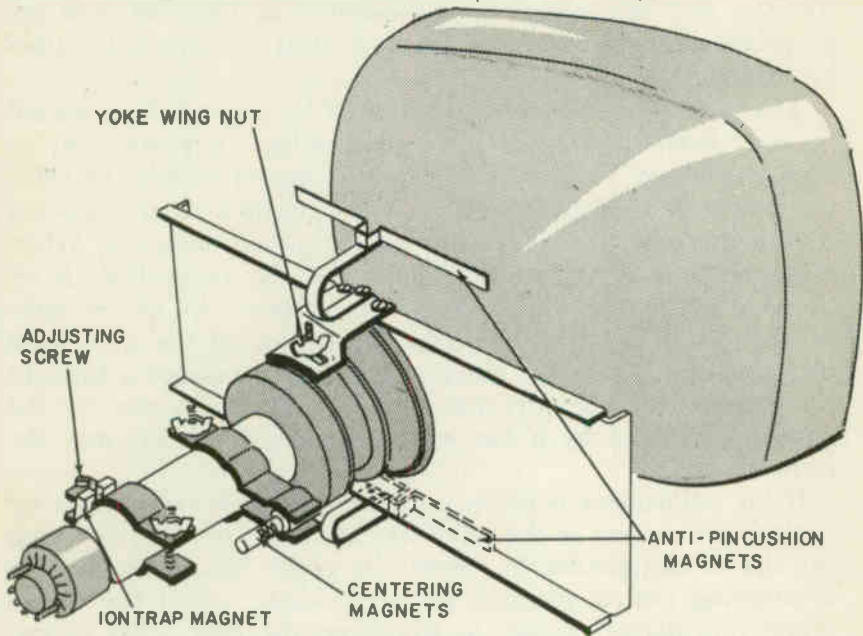
Fig. 709. This drawing shows how the anti-pincushion magnets are mounted.

Anti-pincushion magnets are used to correct the tendency of the cosine yoke to produce a nonlinear raster with squeezed-in sides. The magnets are variously known as *anti-pincushion*, *pincushion*, *pincushion correction*, *picture straightener* and *beam corrector* magnets. Small and nonstandard in size, frequently taking the form of a bar, they are mounted on or near the yoke at the side closer to the picture-tube screen (Fig. 709). The magnets come in pairs. One or two pairs of magnets may be used. A set may be found mounted above and below the yoke, as illustrated in Fig. 709, or at each side of the yoke, or both above and below the yoke *and* on each side.

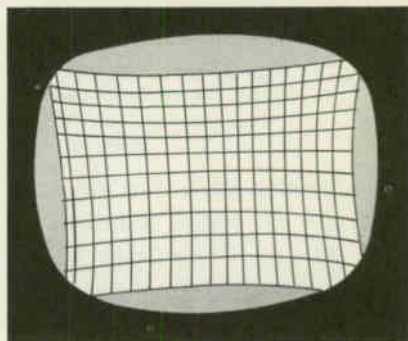
Fig. 710. Cross-hatch pattern showing nonlinearity and pincushioning.

or vertical pincushioning is to be checked for. Vertical bars are used in testing for horizontal pincushioning; horizontal bars for vertical pincushioning. When a cross-hatch generator is available, tests and adjustments may be made without the necessity of feeding two different inputs successively to the receiver (since the cross-hatch generator output is composed of both horizontal and vertical lines). A cross-hatch pattern which shows non-linearity and pincushioning is illustrated in Fig. 710. The appropriate magnets should be adjusted until the cross-hatch lines are straight.

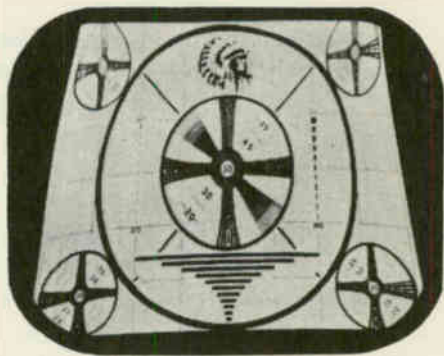
Fig. 712. *The photo shows the effect of keystoneing on a test pattern.*

A short in the horizontal yoke-balancing capacitor will greatly reduce the width of the raster; a characteristic *keystoning* will also be produced (Fig. 712).

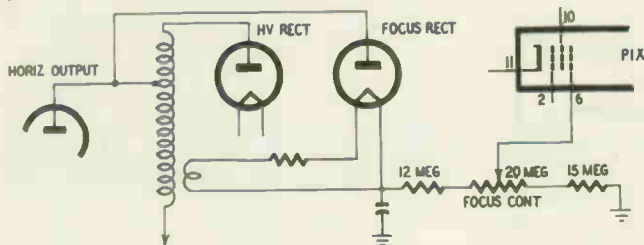
Fig. 713. High-voltage electrostatic focus.

In this system (Fig. 713) the focusing anode is connected to a high dc voltage (between 1,000 and 5,000 volts). Because of its high potential, the focus anode draws some current, causing its voltage to vary when the current through it changes for some

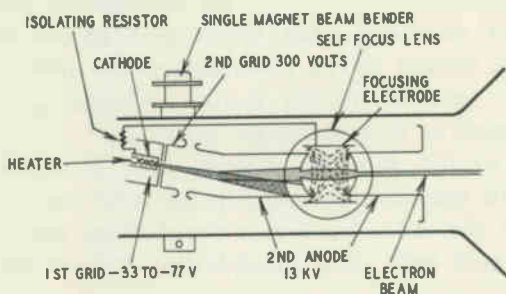
Fig. 715. Gun structure in the automatic or self-focus picture tube.

Variations in line voltage, brightness control resettings, etc. are not likely to cause defocusing because of the structure of the electron gun (Fig. 715). In this type of gun (as in the older electrostatic-focus gun) the second anode is split into two sections and the focus anode is mounted within the gap. A large-diameter focus electrode is used whose field overlaps that of the adjacent electrodes. Since the voltage between the first and second anodes at one side of the gap is always identical with the voltage between the same two anodes at the other side, the focus field remains substantially constant. A resistor, internally connected between the cathode and the focus anode, keeps the two electrodes at the same potential, preventing the defocusing that voltage variations between them might introduce. No external connection to the focus electrode is required for most automatic-focus tubes.

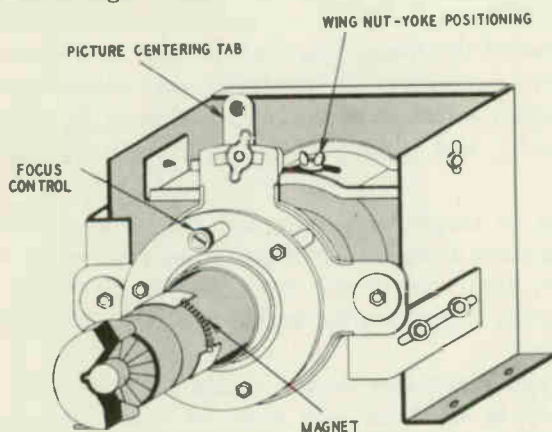
Fig. 716. Adjustment of the centering tab positions the picture.

In some receivers using a focus coil, and in most or all of those using a permanent-focus magnet, a lever on a plate or disk separate from but attached to the focus unit is employed for centering (Fig. 716). Sometimes, movement of the lever up or down provides horizontal centering; moving it right or left produces vertical centering. In other instances, up and down movement of the plate moves the picture up or down; sideways adjustment repositions the picture from side to side. Any nuts holding the lever in position must be loosened before it is free to be adjusted; these nuts are subsequently tightened.

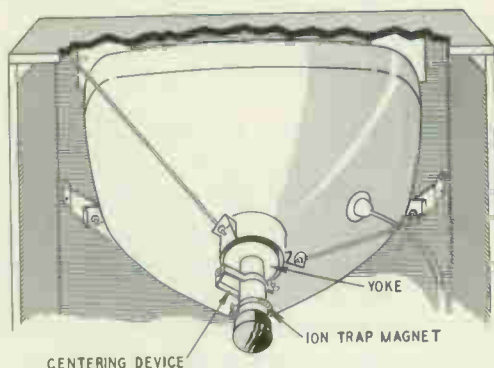
Fig. 717. The centering device is mounted on the neck of the picture tube.

A clamp type centering device completely separate from the focus assembly is used on the neck of some electrostatically-focused picture tubes (Fig. 717). To adjust such a unit, rotate it to the left or right and turn the knob at its top until centering is proper.

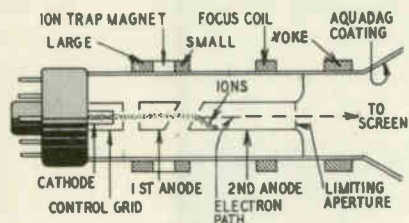
Fig. 718. The straight gun requires a double ion-trap magnet.

In the *straight-gun* (also called the *slashed-field* or *diagonal-cut*) ion trap the axis of the electron gun coincides with that of the tube neck (Fig. 718). A double ion-trap magnet is used around the tube neck. The warped electrostatic field set up in the oblique gap between the first and second anodes causes both ions and electrons to be deflected toward the neck of the tube. The rear or larger of the two ion magnets bends the electrons back to some extent. The smaller front magnet—the weaker of the two—finishes the bending job, causing the electron beam to travel through the second-anode aperture. Two internal pole pieces known as flags are attached to the gun. These units help shape the magnetic

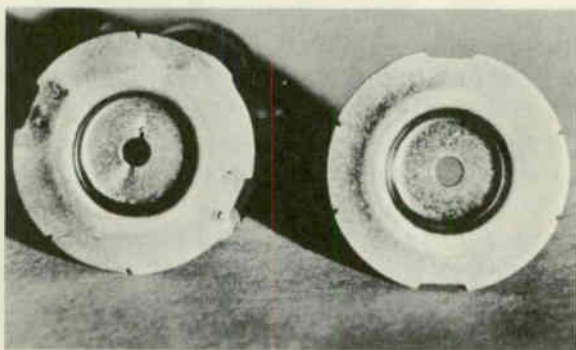
Fig. 721. *Improper setting of the ion-trap magnet can cause damage to the gun structure in the picture tube.*

A far more likely consequence of ion-magnet misadjustment is damage to the top disk of the high-voltage anode cylinder. When the adjustment is correct, beam electrons stream through the aperture in this disk. When the adjustment is incorrect, on the other hand, the direction of the beam is improper and some of the electrons in the beam may now bombard the edges of the aperture. The heat generated by this bombardment can vaporize parts of the aperture, as illustrated in Fig. 721. The damage will impair focus (since the aperture regulates the size and shape of the beam), causing a blurred or poorly defined picture. In some cases, bits of metal that have been torn away from the aperture are deposited on the screen, producing dark areas there.

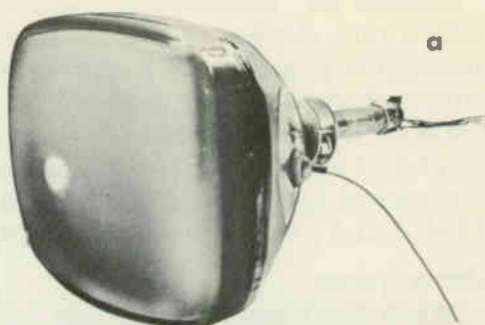
Fig. 722-a. The photo shows the appearance of the scanning spot on the picture-tube screen

Figs. 722-a through j illustrate the kinds of spot that may be seen on the screen. Figs. 722-a,-b show what the spot will look like when a new good tube is present. Note the round, uniformly illuminated appearance of the spot in this case. Fig. 722-c shows what the scanning spot will look like when the tube has been in use for some time. The scattered light shadows are normal. In Figs. 722-d,-e,-f the shadows become progressively darker and more numerous. There is little or no cathode emission from the dark areas. Tubes that produce spots of this kind may or may not perform properly. If a picture-tube checker indicates that the emission is normal, the tube can be considered as still usable. Figs. 722-g,-h-i and j show scanning spots in which extensive areas are dark. The shape of the spot in these cases is effectively distorted as well. Tubes that produce such scanning spots will have impaired focus as well as inadequate contrast.

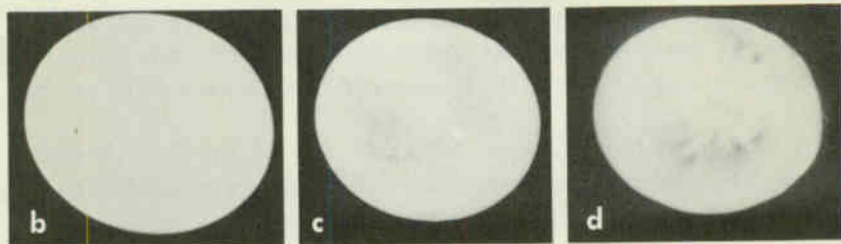
Figs. 722-b,-c,-d. The photo at the left shows the appearance of the scanning spot in a new tube. The other two photos illustrate the effect on the scanning spot after the picture tube has been in operation for some time.

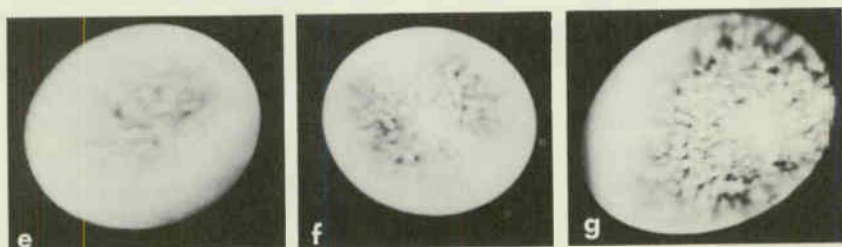
Figs. 722-e,-f,-g. These photos show how the scanning spot becomes progressively worse. Note the distortion of the spot and the appearance of shadows.

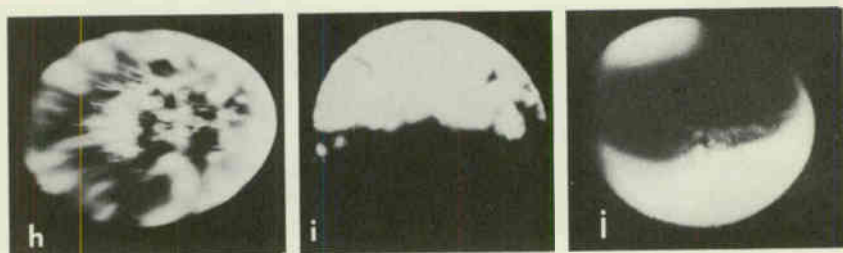
Figs. 722-h,-i,-j. These photos of the scanning spot indicate that a large area of the picture-tube cathode is dead. The dark shadows mean loss of cathode emission. The scanning spots are also severely distorted.

The test just described is a useful supplementary one to a test with a tube checker. When the tube checker indicates that the emission is passable, but a scanning-spot inspection reveals that large cathode areas are dead, the verdict of the spot-inspection test is the more reliable one. (It is assumed the symptoms pointing to a loss of emission in the tube are present.) If emission reads below normal and the spot resembles one of those shown in Figs. 722-h, i, and j, replacement of the tube is also called for.

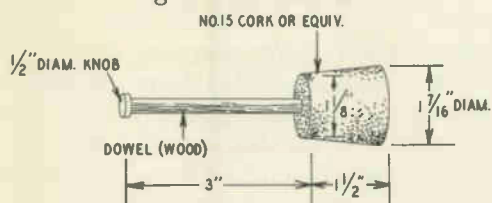
Fig. 723. A cork and a wooden dowel make a very suitable tube tapper.

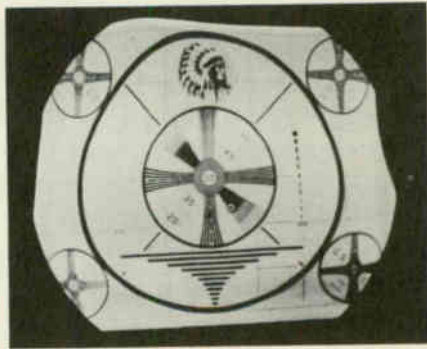
Fig. 724. This photo shows the effect on a test pattern when the metal cone of a picture tube becomes magnetized.

The metal cone of a metal-glass picture tube will become magnetized if a strong magnetic field is brought near it. Contact of the cone with the magnet of a PM speaker is the commonest cause of cone magnetization. The characteristic symptom produced is a distortion of the picture and raster. The raster's edges are generally twisted out of shape. (Fig. 724). Magnetization of

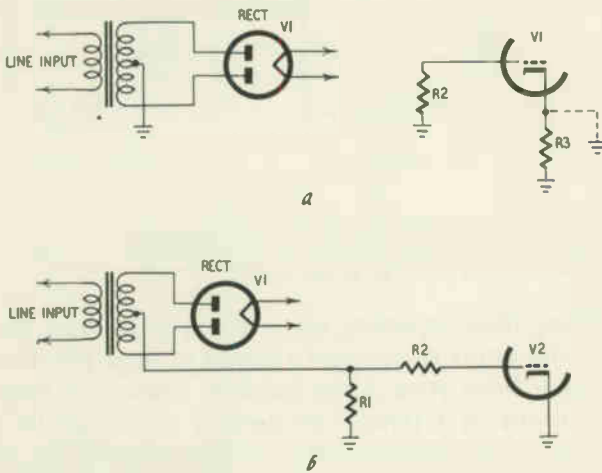
Figs. 803-a, -b. One method for eliminating hum caused by heater-to-cathode leakage is to short the cathode resistor (upper drawing) and replace it with a bias network connected to the power supply (lower drawing).

leakage (other than replacing the tube) is to ground the cathode of the tube and apply the correct amount of negative dc voltage to the grid (as a bias) from some suitable source in the set. The center-tap circuit of a power-transformer secondary in an ac receiver may provide such a source, as illustrated in Fig. 803.

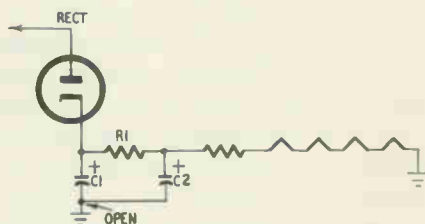
Fig. 810. Increased ripple voltage applied to the filaments (when the filter is open) can result in damage to the tubes.

4. Open in the common negative of a filter capacitor at the point indicated in Fig. 810. While such trouble is not common, it can and does occur. The filtering action is partially impaired

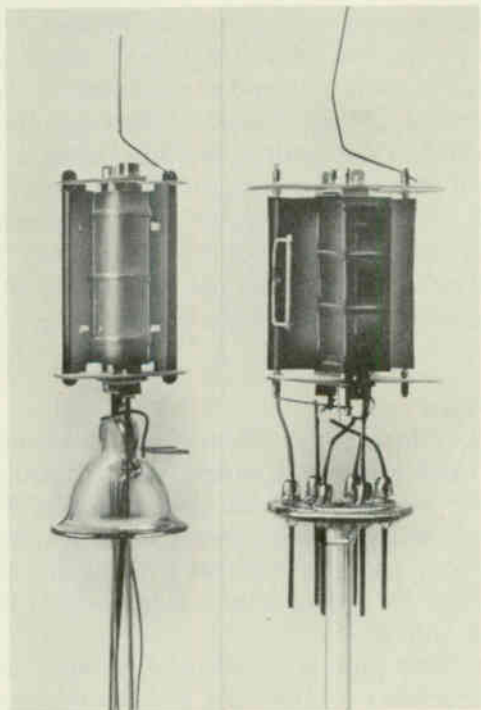
Fig. 901. *Types of stem construction.*

Significant for longer life was the changeover from the old press-stem construction to the newer button-stem construction. In press-stem construction the base leads enter the tube through the glass stem in a straight line (Fig. 901). Lead wires are necessarily thin and there is a considerable distance between the base pins and the tube mount. In button-stem construction the leads go directly from the base pin through the glass into the tube mount, being arranged in a circle similar to that used in miniature tubes. This type of construction uses heavier and shorter leads, resulting in better heat transfer from inside the tube through the base pins. It also leaves more room between the top of the tube mount and the glass, which results in improved heat radiation.
