# TV and radio TUBE TROUBLES

SOL HELLER

GERNSBACK LIBRARY, INC.  
NEW YORK 11, N. Y.

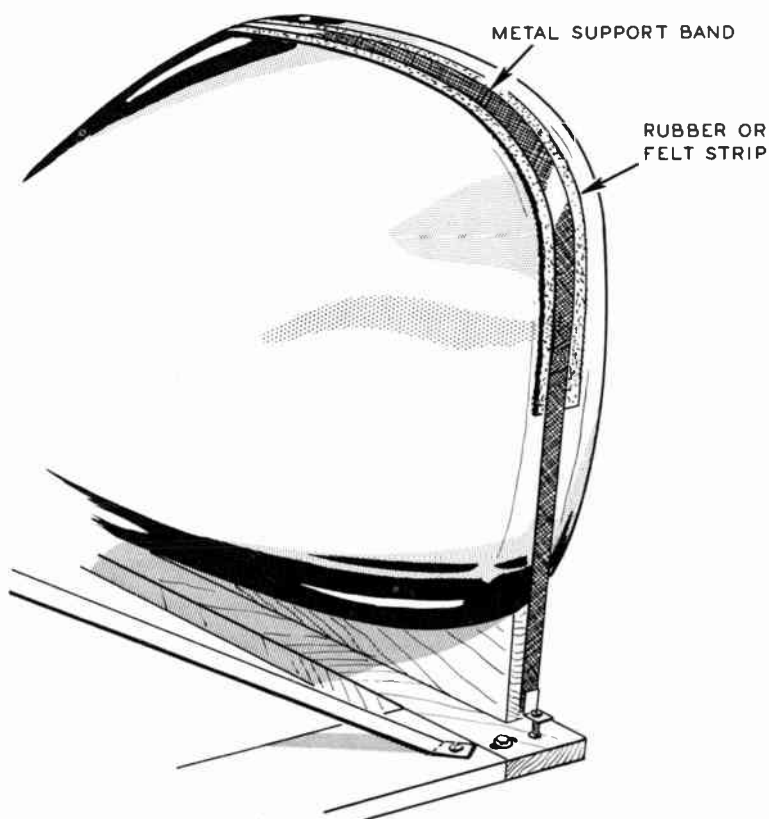
Fig. 101. Position of rubber or felt strip under metal band holding cathode-ray tube in place.

Make sure that protective rubber or felt strips (see Fig. 101) are reinserted between the metal support band and the tube when the support band is replaced after having been disassembled. These protective strips prevent possible breakage of the tube due to excessive tightening of the band. When they are out of position, put them back into place.

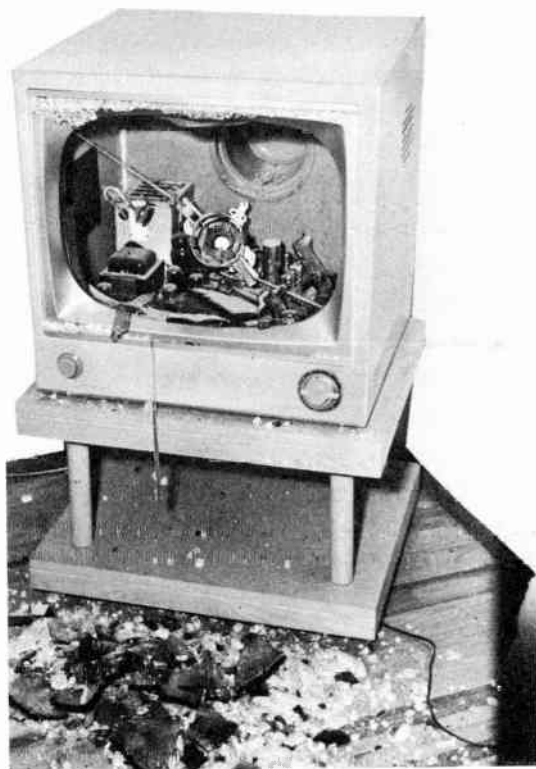
*Fig. 102. Result of a cathode-ray implosion due to inadequate safety precautions.*

hand between the tool and the tube to prevent the tube from being struck if the tool should slip. (The result of an implosion is shown in Fig. 102.)

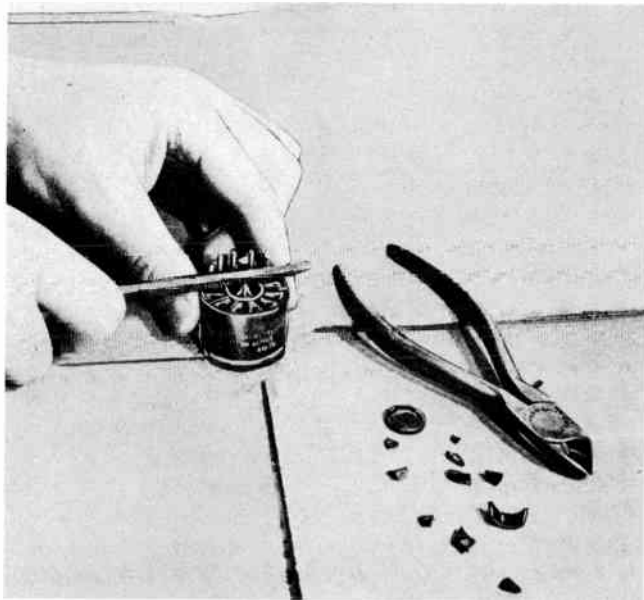
Fig. 103. Deactivating a picture tube. Drilling a hole in the keyway of the tube exposes the exhaust tip, which can then be broken.

1. Put the tube you want to dispose of into a carton designed to hold a unit of its size. Enough soft cloth should be placed under the face of the tube to make its base stick out at the top, outside the fold-over flaps of the carton (Fig. 103).

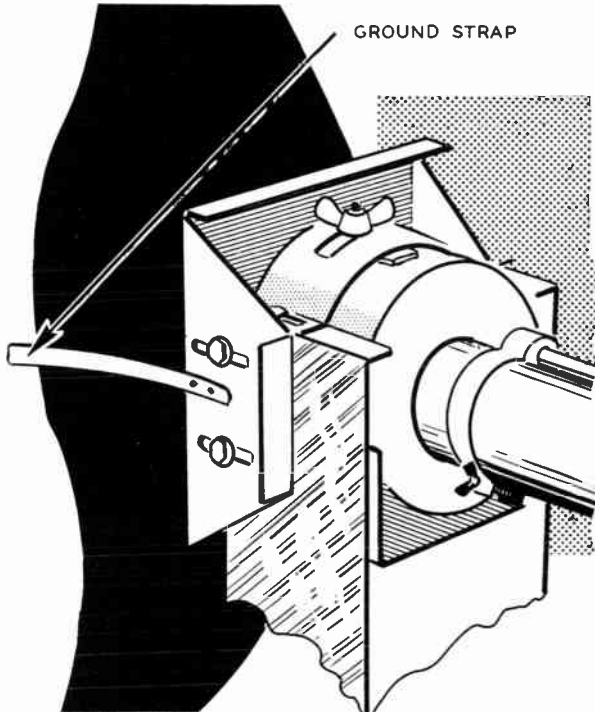
Fig. 104. Sketch showing ground strap on picture tube. Hairpin type clips are also used to place the glass envelope at ground potential.

The first precaution to take when a C-R tube is to be substituted in a TV set is to check whether the grounding clip or strap (if the tube is a glass type) is making contact with the Aquadag coating (Fig. 104). If it isn't, the proper adjustment should be made to remedy the condition and insure that no residual charge is left on the tube when the power is turned off and tubes are interchanged. The receptacle or cup of a disconnected glass C-R tube should be discharged to ground before the tube is handled.

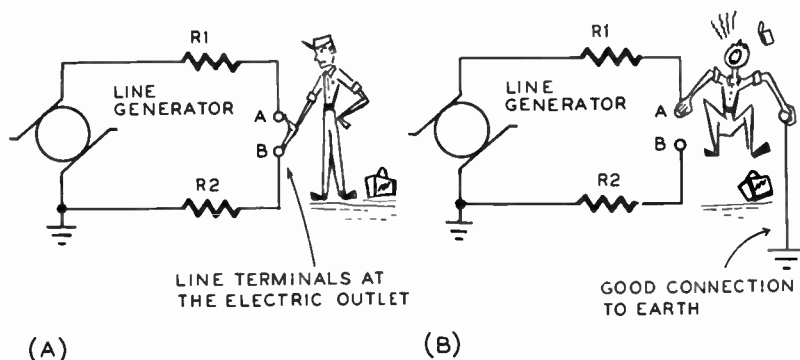
Fig. 105. When a technician (drawing A) puts two fingers of one hand across the line terminals, current flows through the fingers and hand only and does not pass through vital organs. Also, the current is limited by the resistance of the wiring in each branch of the line ( $R_1$  and  $R_2$  represent this resistance). When the technician (drawing B) puts one hand between the "hot" side of the line and a good external ground, current flows from one hand to the other through his body. The current will be greater than in A because  $R_2$  is short-circuited.

Novices who see old-timers testing for line "juice" by putting their fingers across the ac line terminals should not confuse this with getting their body between one side of the line and a good ground. (See Fig. 105-a,-b. R1 and R2 represent the resistance of the line.) The current-delivering capacity of a line generator is somewhat less in the first case than it is in the second, making an electric shock less dangerous; more important, putting two fingers (of the same hand) across the line limits the path of current to the hand, leaving vital organs unaffected. Actually, the current going through the fingers is greater than that going through the body, but is not as dangerous.

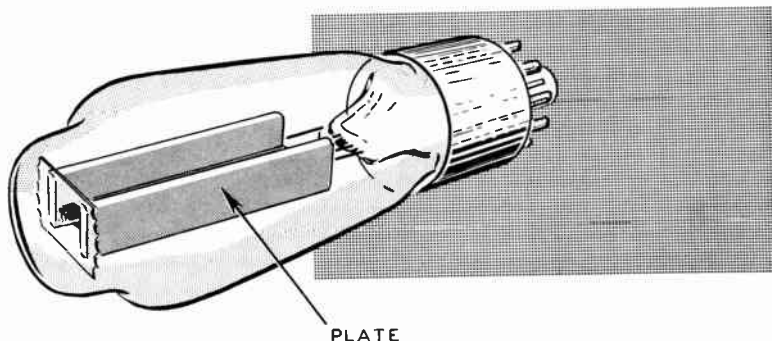
Fig. 201. When a 5U4-G is horizontally positioned, the long sides of the plates should be vertical.

in Fig. 201. The filaments are correctly positioned in this case, minimizing the possibility of filament sag. Sag of this kind can result in the development of a filament-to-plate short, which may damage the power transformer and filter capacitors as well as the rectifier tube.

a 5U4-GB that is horizontally mounted, to obtain a tube with a structure identical to the one in the set, one whose plate and base-pin orientation correspond to that of Fig. 201. Otherwise, damage to components may occur. It is desirable to avoid horizontal positioning of the 5U4-GB when servicing a set for any considerable length of time if the positioning of the plates with respect to the pins differs from the one illustrated in Fig. 201.

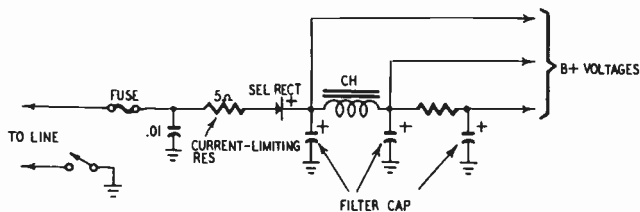
Fig. 202. Representative selenium rectifier power supply, showing one way in which a current-limiting resistor is inserted into the circuit.

Small current-limiting resistors (Fig. 202) are used in series

A resistor of this kind serves a protective function and should always be replaced. Selenium, as well as tube rectifiers, can safely pass a certain value of peak plate current; if this current is exceeded, the rectifier may be permanently damaged.

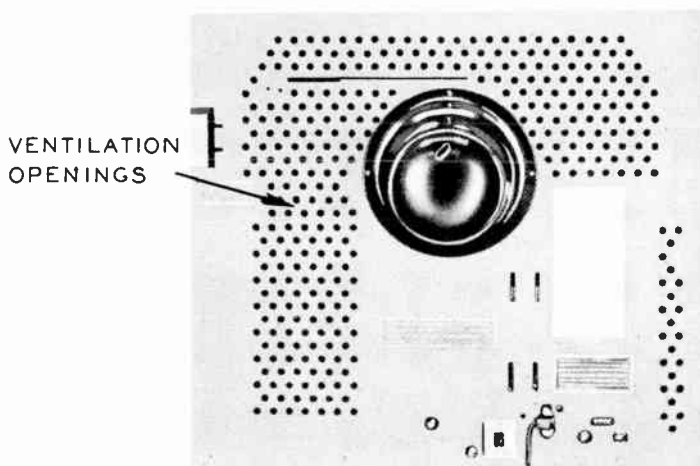
*Fig. 203. Ventilation openings in the back of a TV set. Keeping the receiver some distance away from the wall will prevent obstruction of the openings.*

Excessive heat is generated in a tube, impairing its performance and life, if ventilation is improper. An adequate supply of air must flow past the receiver's tubes, particularly its rectifier and power output tubes. If the set owner keeps the receiver flush against the wall or covers its ventilation openings (Fig. 203) in

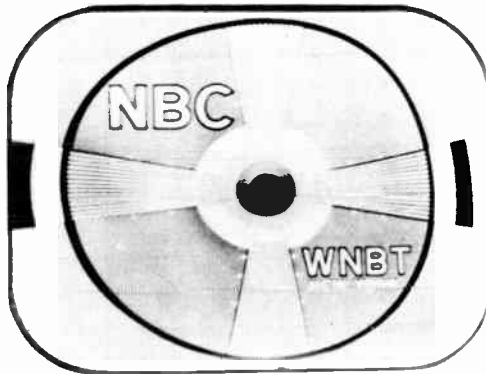
*Fig. 205. Effect of horizontal nonlinearity on test pattern. Note greater width of horizontal wedge at left, compared to the corresponding wedge at the right.*

Higher-than-normal line voltages may be responsible for premature horizontal output tube failures. Excessive width and/or horizontal nonlinearity are associated symptoms in such a case (Fig. 205). A line-voltage check will verify whether this voltage is above normal.

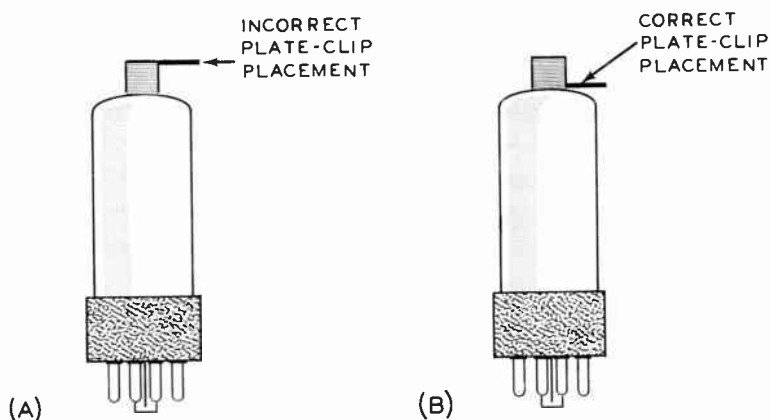
Fig. 206. In receivers where the top of the high-voltage cage is close to the plate clip of the 1B3-GT rectifier, improper placement of the plate clip may be the cause of corona or arcing.

In cases where the top of the high-voltage cage is very close to the plate cap of the rectifier tube, it is possible to introduce arcing and corona by improper placement of the high-voltage anode clip (Fig. 206). In such "low-bridge" cases, make sure the placement of the clip puts the maximum distance between the grounded cage top and the wire leading to the clip.

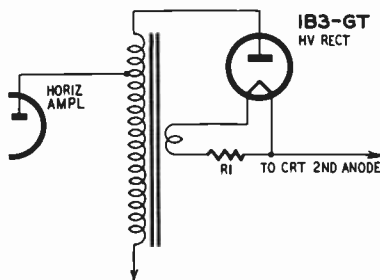
Fig. 207. Portion of high-voltage rectifier circuit, showing location of the filament-dropping resistor (R1).

Excessive filament voltage of the high-voltage rectifier is rather difficult to detect since it cannot be measured directly. The voltage across the filament is usually 1.25, but the voltage between either filament pin and chassis is measured in kilovolts. Check the value of the resistor in series with the filament (see R1 in Fig. 207) when frequent rectifier burnout is the complaint. If the resistor has decreased as much as 1 ohm in value (compared to the value specified in the set schematic) replace it with a unit of the correct resistance.

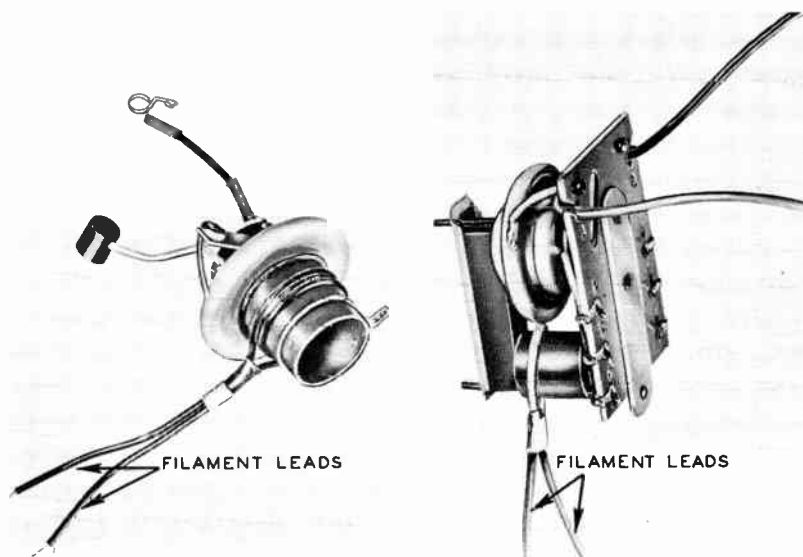
Fig. 208. Photos of flyback units, showing number and position of filament windings. One or two turns may be used, depending on the filament voltage requirements and the construction of the flyback transformer.

A shift in the coupling of the high-voltage rectifier filament winding on the flyback transformer may be the source of frequent tube burnouts (Fig. 208). If a similar flyback is present in another receiver, a comparison can be made to verify whether such a shift has occurred. If it has, the filament winding may be moved a short distance—perhaps  $\frac{3}{16}$  inch or thereabouts—away from the high-voltage winding on the transformer. If set performance remains satisfactory, the winding may be left in this position.

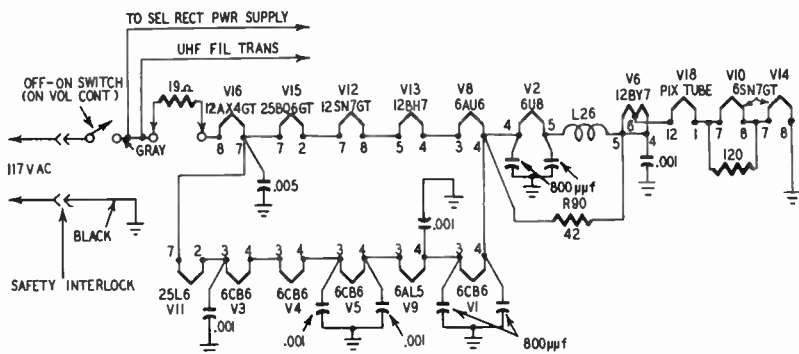
Fig. 211. Series-filament circuit in which two strings of tubes are in parallel. The two parallel strings are in series with a third group of filaments.

There are a number of facts about series-filament circuits (Figs. 210, 211) that the technician should know to minimize the possibility of damage in servicing tubes connected in this way.

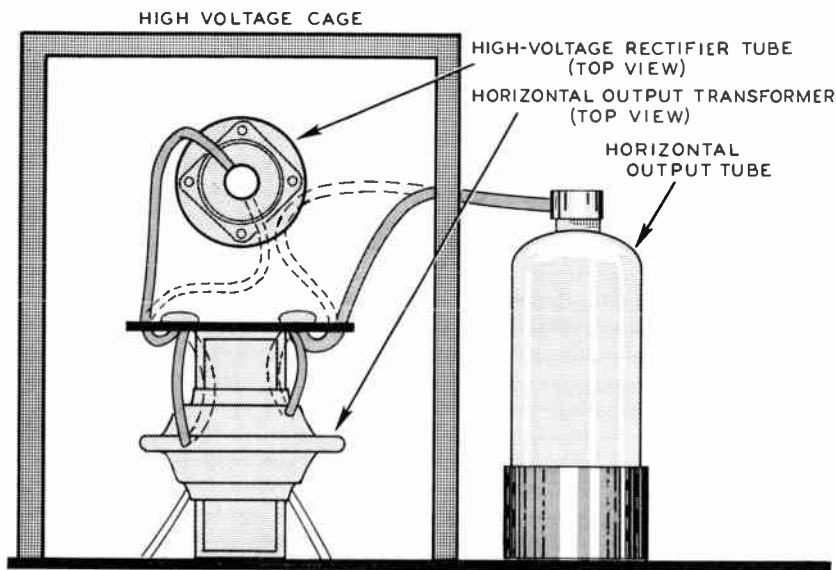
Fig. 209. Proper and improper lead dress in the high-voltage cage. Dotted lines indicate incorrect positioning of leads; high-voltage wires are too close to each other.

dress after a tube replacement in the high-voltage section (Fig. 209).

If the lead to the horizontal amplifier plate cap is incorrectly oriented and lies too close to a wall of the high-voltage cage, a severe undetected corona may cause the output tube to fail within several weeks. The presence of a shiny little circle on the

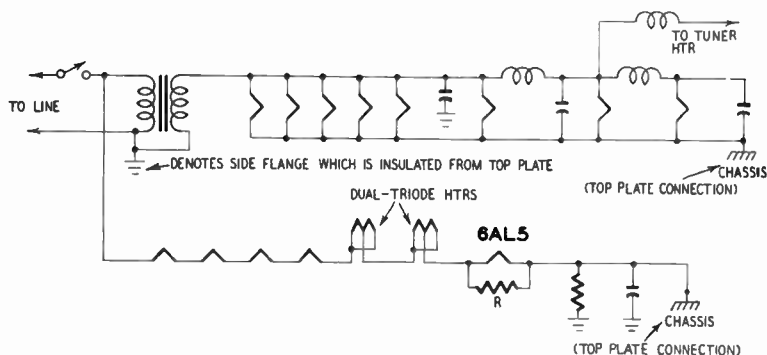
Fig. 212. Series-filament circuit in which a shunt resistor  $R$  is used across one of the tube filaments (6AL5).

possibility of failure of tubes for other reasons is increased as well. If a resistor (R) is in shunt with the tube that has been removed (Fig. 212), the resistor will overheat since an excessive voltage will now be present across it; in a few seconds, it may be permanently damaged.

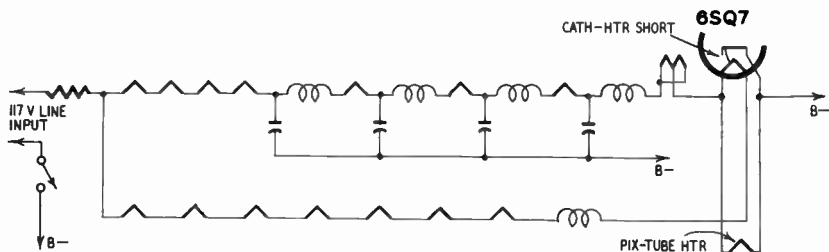
When filament voltage is absent, a short in some tube other than the cathode-ray tube may be responsible (Fig. 303). In certain TV sets, the filament of the picture tube is in parallel with that of the damper. A short in either tube may eliminate filament voltage in both. Try a new damper, in sets of this kind, when the picture-tube filament does not light. In the case of series-filament receivers, trouble in any tube filament in series with that of the picture tube can eliminate its filament lighting; check for the presence of such a defect when receivers of this kind are being worked on.

Fig. 303. Filament circuit of a typical TV chassis. A filament-cathode short in the 6SQ7 can shunt the filament current to ground before it passes through the picture tube, causing the cathode-ray tube to remain unlit.

In some receivers using a filament circuit setup such as the one shown in Fig. 303, a cathode-to-heater short in the first audio tube will eliminate filament voltage from the picture tube and kill the raster. The short will also eliminate the sound signal, leaving only a hum audible. If, in sets of this type, raster and desired sound are missing, hum is audible and the picture tube is unlit, try another first audio tube.

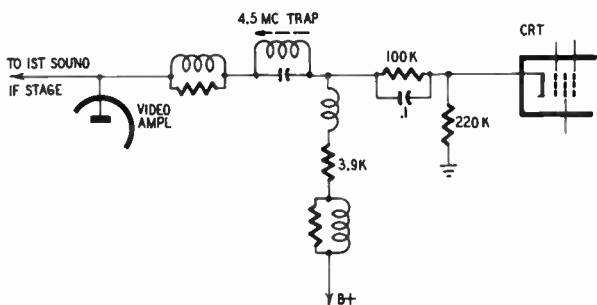
Fig. 304. Direct coupling between video amplifier and cathode-ray tube. Loss of emission in the video amplifier will increase the cathode voltage of the tube, possibly increasing its bias to cutoff in some cases.

If the grid-to-cathode voltage cannot be reduced to zero or to a few volts negative by manipulation of the brightness control, but remains excessively negative at all times, a defective tube may be the cause of the trouble in some cases. In a receiver in which direct coupling between the video amplifier and picture tube is used (Fig. 304), a defective video amplifier may cause an excessive picture-tube bias to be developed, blanking out the raster. Try replacing the video amplifier to check on this source of trouble.

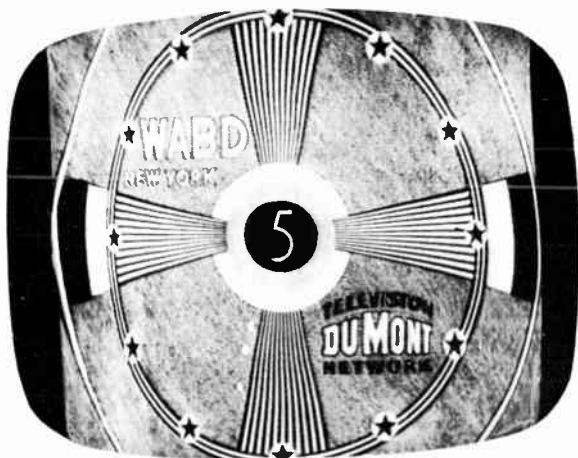
Fig. 305. Photo of test pattern indicates insufficient width.

Insufficient width (Fig. 305) may be due to a weak damper, horizontal output tube or low-voltage rectifier. When the rectifier is weak, other symptoms will generally (but not always) be mani-

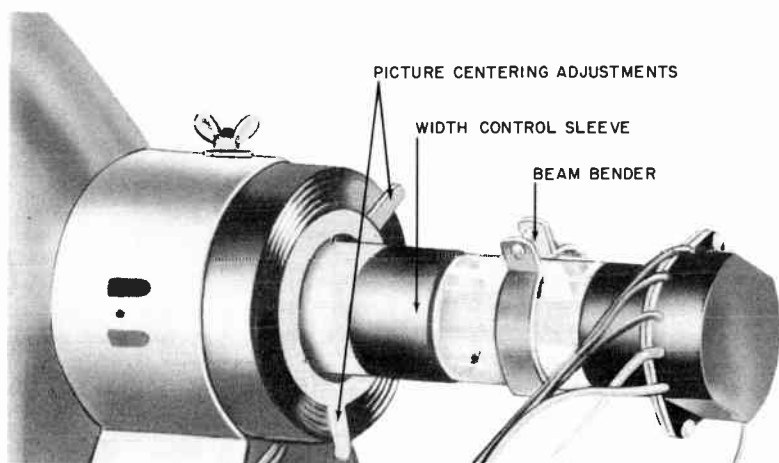
Fig. 306. Sleeve made of brass or aluminum can be used as a width control.

In some receivers a brass or aluminum sleeve is used on the picture-tube neck for adjusting width (Fig. 306). Improper setting of this sleeve may be responsible for a slight loss in width.

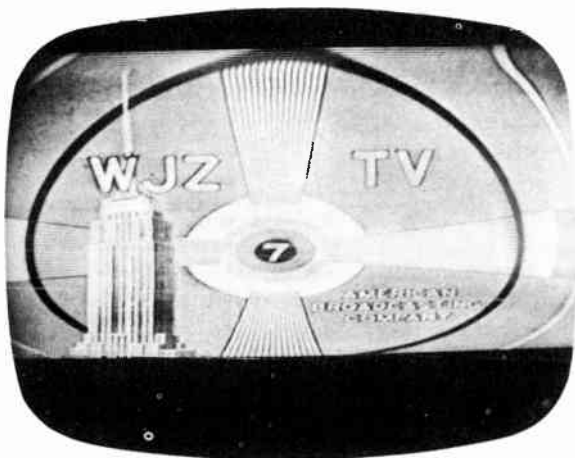
Fig. 307. Photo shows insufficient height.

When insufficient height is the complaint (Fig. 307) either the vertical oscillator or vertical amplifier tube may be responsible. If height and vertical linearity adjustments do not restore the height to normal, replace these tubes. If replacement one at a time does not eliminate symptoms, try replacing both tubes simul-

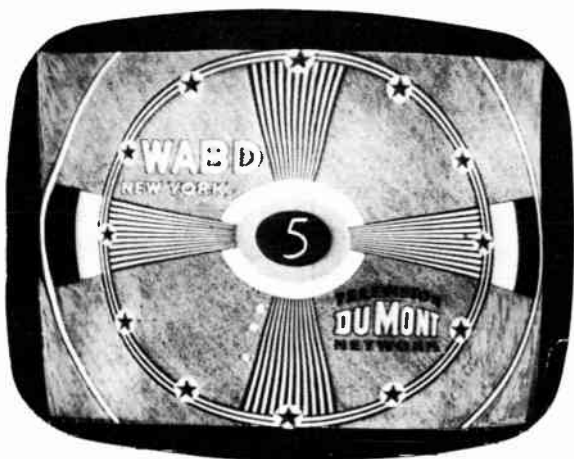
Fig. 308. *The test pattern is pulled in. The photo shows inadequate width and height.*

When both height and width are inadequate (Fig. 308) and height and width adjustments do not restore raster size to normal, try a new low-voltage rectifier. Such a substitution is particularly indicated if there is an accompanying reduction in sound volume or insufficient contrast or if the focus control achieves or approaches proper focus only at one end of its range.

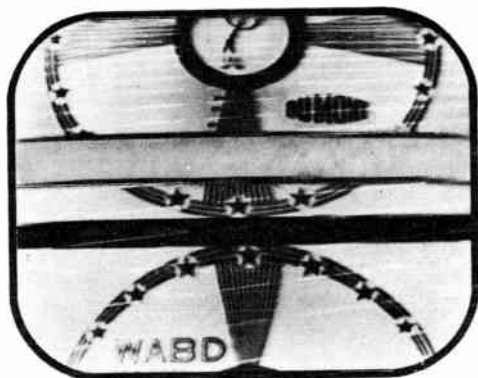
Fig. 309. The vertical blanking bar can be examined by adjustment of the vertical-hold control.

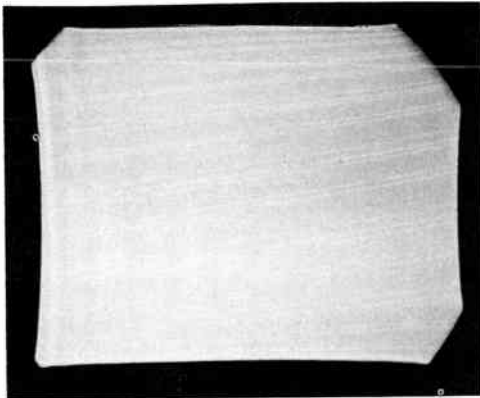
*Fig. 402. How raster will look when sync pulses are not reaching the vertical oscillator. The vertical retrace lines will drift up and down, indicating that the vertical oscillator is free-running or uncontrolled.*

If no noise pattern is seen on the screen, examine the vertical retrace lines on the raster. If these diagonal white lines jump up and down and will not remain stationary (Fig. 402), trouble in some stage preceding the sync takeoff point is indicated. Sync pulses are evidently not reaching the vertical oscillator and the retrace lines are unsynchronized.

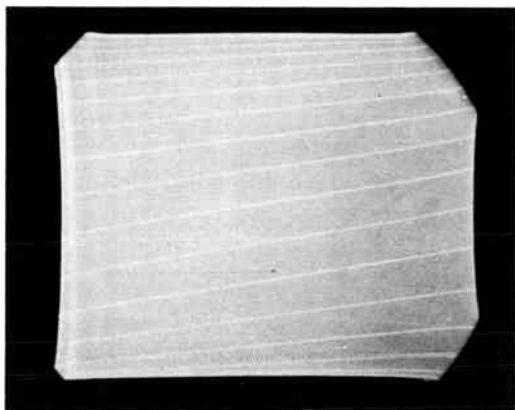
*Fig. 403. What the raster will look like when sync pulses reach the vertical oscillator. The vertical retrace lines will be steady, provided the vertical hold control has been properly adjusted.*

If, on the other hand, the retrace lines *are* steady (Fig. 403), vertical sync pulses are generally getting through to the vertical oscillator. (Retrace lines can be steady due to residual hum.) The video signal must, in consequence, be reaching the sync takeoff point and trouble *after* this point is indicated. When a two-stage video amplifier is present in which the sync pulses are picked off

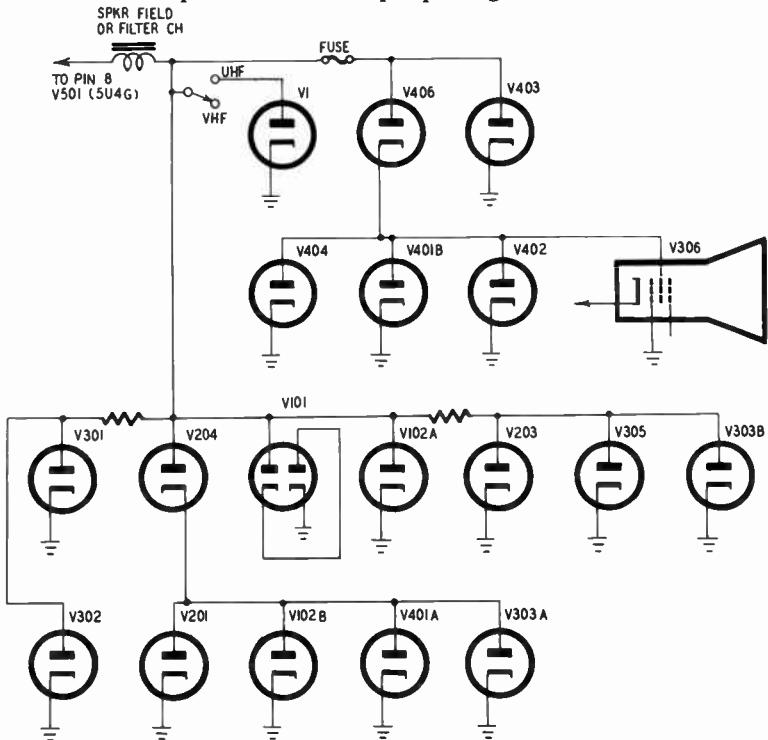
Fig. 407. Block diagram showing tube stacking. V204 is the sound output tube. Its heavy current will be reduced when it loses emission, causing the plate voltages on V101, V102A, V203, V305 and V303B to rise. The tubes are shown as diodes for the sake of simplicity

receiver's sound volume is above normal), a defect in an agc tube may be present. In a circuit such as the one shown in Fig. 407, a loss in agc bias will cause an excessive signal input to the video amplifier. The video amplifier may be driven into cutoff, thus killing the picture. The sound signal, on the other hand, will be

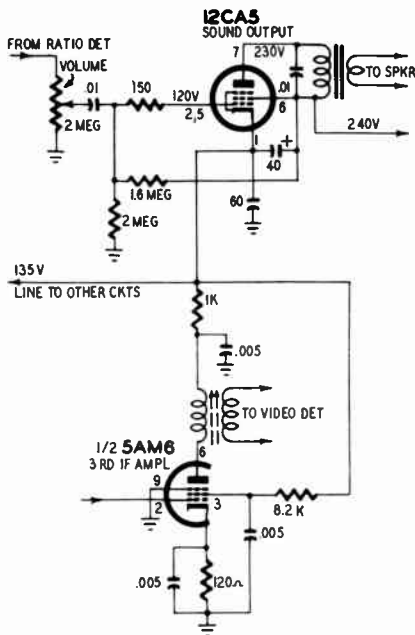
Fig. 408. The audio output and the third if amplifier tubes are in series and act as a voltage divider. A defect in the sound tube can cause loss of picture and sound.

Another example of circuitry in which a defective sound tube may affect both picture and sound is shown in Fig. 408. B-plus voltage to the tuner, video amplifier and agc circuits, as well as the sync separator and clipper, are affected when a fault develops in the audio output tube.

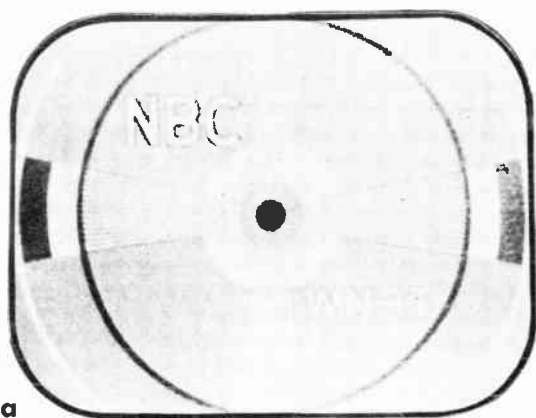
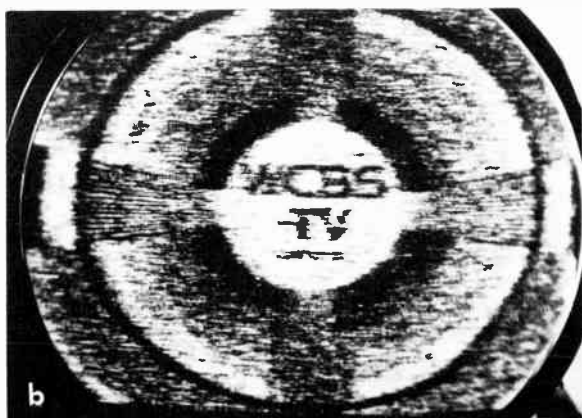
Fig. 409. (a). Weak picture with snow present. (b) Effect of advancing the contrast control setting with a snowy picture.

When insufficient contrast is accompanied by snow in the picture (Fig. 409), try substituting new front-end tubes. If no snow is present, substitute tubes—or crystal—in video signal stages.

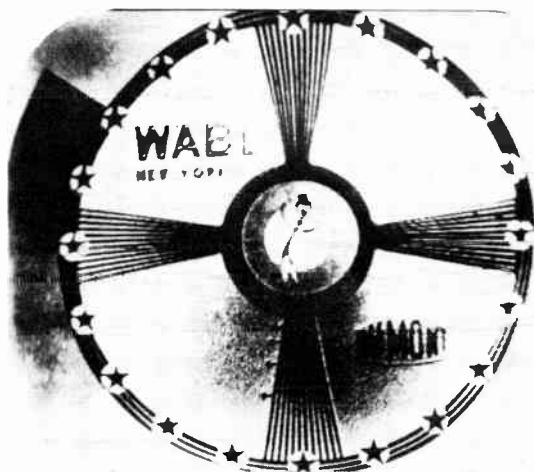
Fig. 410. Photo of test pattern showing excessive picture contrast. Note smearing.

The presence of excessive picture contrast (Fig. 410) is fre-

quently due to agc trouble (loss of agc bias). The existence of such trouble is especially likely when a strong signal produces too much contrast or a blackout ( a black-and-white raster) whereas insufficient contrast, possibly associated with snow, is evident when weak signals are being received.

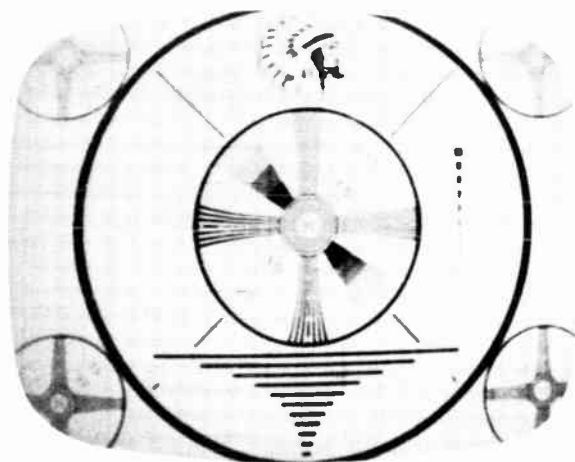
*Fig. 411. Test-pattern photo illustrating white compression due to overloading in the if amplifier. Note washed-out appearance of the picture, poor rendition of whites. No snow is present, however. The condition is most likely to be noted on strong signals.*

Overload characterized by white compression (loss of grays in the picture, causing the pix to look flat and washed out) is often due to a faulty rf amplifier (Fig. 411). Defects in either the rf

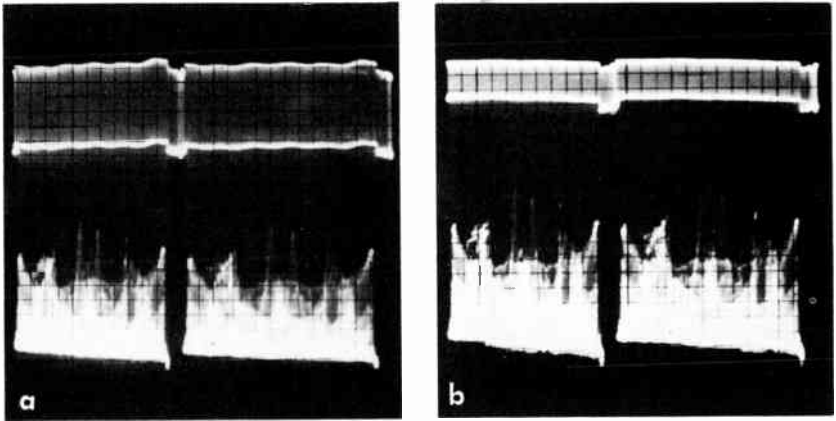
Fig. 412. (a) Normal video detector output waveform. (b) Video detector waveform when black compression is present. Signals in the gray-black region are compressed, causing grays to fall into the black region. Sync pulses are also compressed and reduced in amplitude.

amplifier, agc or video if tubes can be the cause of the trouble. The presence of white or black compression can be verified by making a scale waveform check at the output of the video detector (Fig. 412).

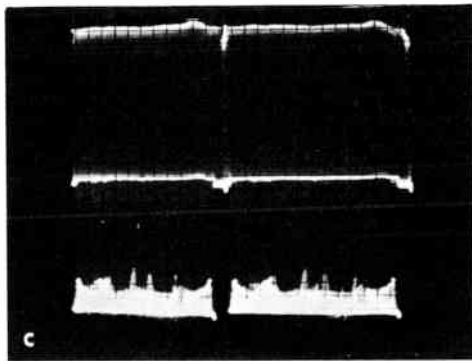
Fig. 412. (c) Video detector output waveform when white compression is present. Note smaller range of variation at bottom of waveform where the white signals are, compared to the normal variation in this region shown in Fig. 412-a.

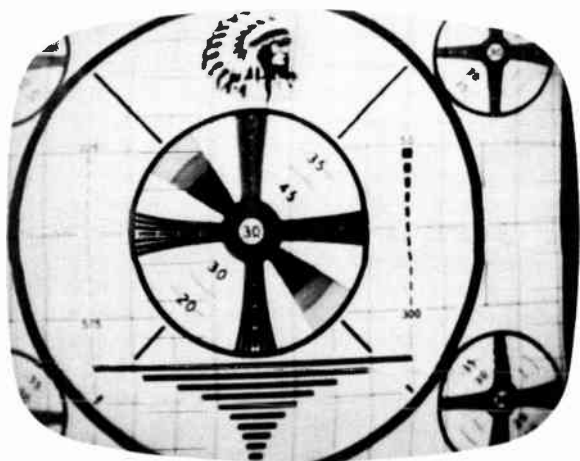
Fig. 413. Test pattern illustrating black compression. Grays are rendered as black, causing the picture to look dark and excessively contrasty.

Sync and black compression (Fig. 413) frequently indicates overload in the video if stages due to insufficient agc bias. Such compression may readily be detected by advancing the brightness control and adjusting the vertical hold control until the picture hovers with the horizontal blanking bar positioned somewhere around the middle of the tube. If the sync pulse hammer is not much darker than the blanking bar proper, sync and black compression is indicated (Fig. 414). The picture will be dark and excessively contrasty when this kind of trouble is present; sync will tend to be lost if the condition is severe.

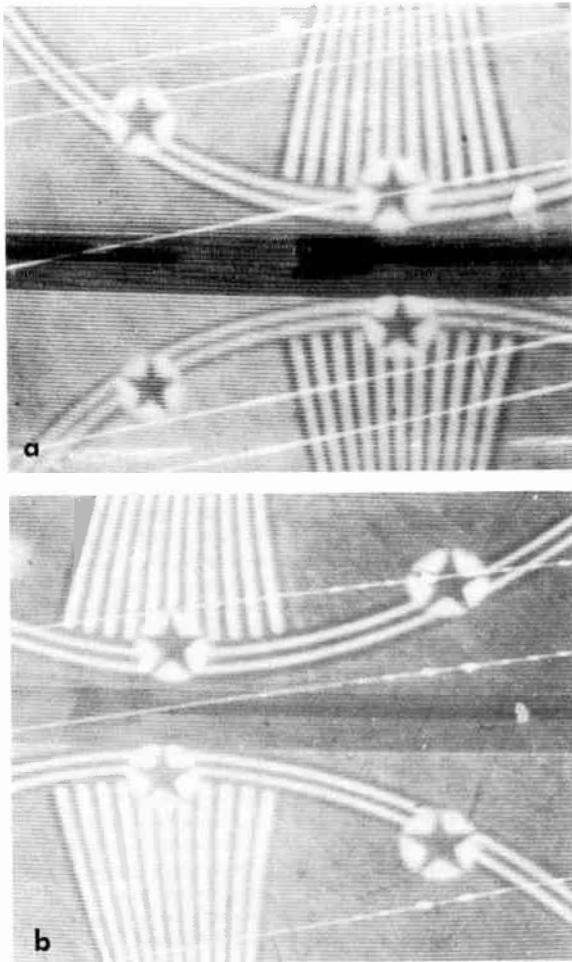
*Fig. 414. The photo at the top shows the normal appearance of vertical blanking bar. Note that the sync hammer is black, while the blanking bar proper is gray. The lower photo illustrates the effect of sync compression on the sync pulse and blanking bar. The reduction in sync-pulse amplitude causes the height of the sync pulse to fall closer to the blanking signal level. As a result the shading of both becomes similar.*

A good preliminary check to make is an inspection of the sync pulse in the vertical and/or horizontal blanking bar (see Figs. 414 and 501). The brightness control should be turned up somewhat to permit the shading of the sync and blanking pulses to become visible. If there isn't much difference in contrast between the sync pulse and the blanking bar, as shown on the screen of the picture tube, sync compression is indicated.

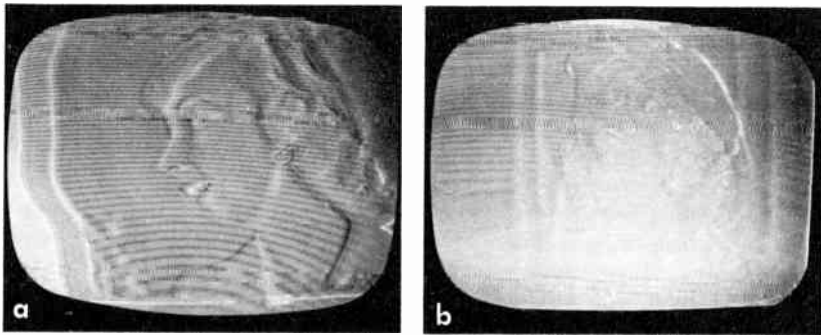
Fig. 415. (a) Negative picture caused by overloading. An inoperative agc tube can cause such overloading by removing the bias from agc-controlled stages. Erratic horizontal and vertical synchronization are often associated with the negative picture. (b) Another example of a negative picture caused by agc trouble. In this case, synchronization has not been impaired. The symptoms illustrated were seen when a medium-strength signal was coming in. With a weak signal and the contrast control setting advanced, the picture may look normal in some cases.

The technician not infrequently encounters a set in which negative pictures are received—one in which normally black areas are white and normally white areas are black (Fig. 415). Overloading is frequently the cause of such phase reversals, particularly when vertical and/or horizontal synchronization is continuously or intermittently affected. An excessive signal in the video if tube grid circuit can produce a negative picture.

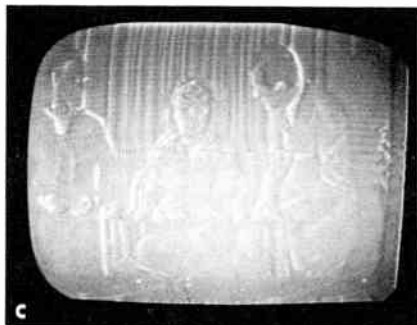
Fig. 415. (c) Negative picture caused by low emission in a 5U4-G rectifier. The 5U4-G in question provided high B plus for the horizontal amplifier tube. Reduction of the rectifier tube's output resulted in the feeding of a smaller pulse from the horizontal amplifier to the plate of the keyed agc tube, decreasing the agc voltage and causing overloading of the agc-controlled stages.

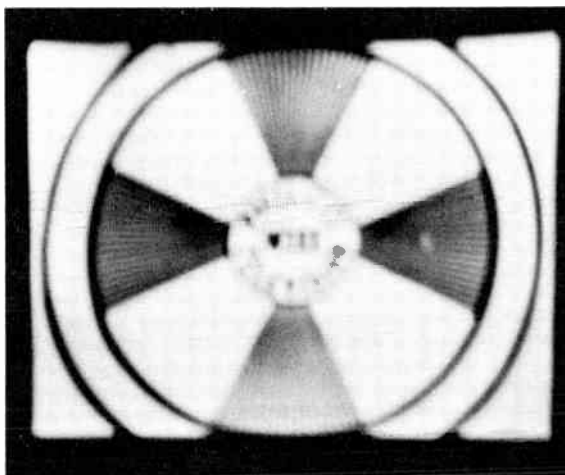
Fig. 418. Effect of improper focus on the test pattern.

A blurring of the entire picture is generally produced by improper focus. The vertical and horizontal wedges in the test pattern will not be sharply defined when this condition is present

(Fig. 418) and neither will the scanning lines of the raster. (Reduce the contrast setting to zero, eliminating the picture, to examine these lines.) When adjustment of the focus control and/or focus magnet proves ineffective in clearing up the condition, one of the following troubles may be present:

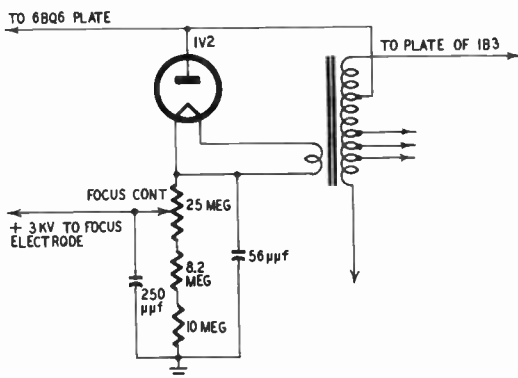
Fig. 419. Focus tube and associated circuit used with picture tubes employing high-voltage electrostatic focus.

a 1V2) to provide the focus voltage needed, reduced emission or some other defect in this tube may make it impossible to achieve proper picture focusing (Fig. 419). The same is true of magneti-

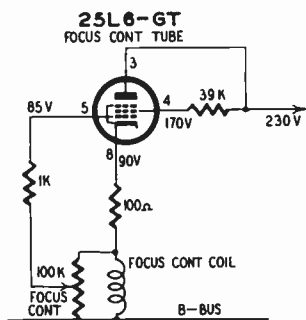
Fig. 420. Focus control tube and associated circuit used in some receivers.

cally focused sets that use a separate focus control tube. (Fig. 420).

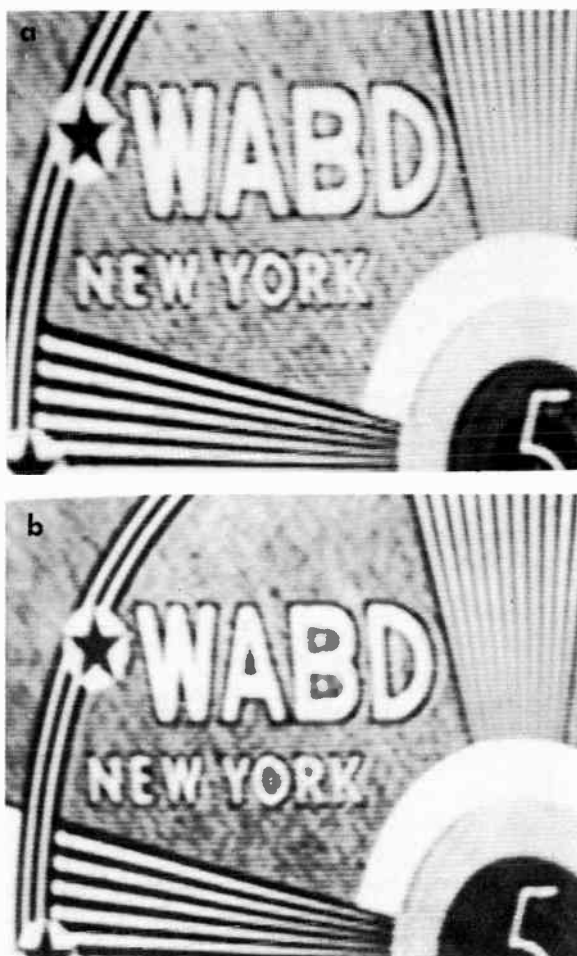
Fig. 421. (a) Appearance of section of test pattern when scanning-spot size is correct. Appearance of same portion of test pattern (b) when scanning-spot size is larger than normal. Note that the dark spaces between scanning lines are no longer clearly visible.

A condition similar to a slight impairment of focus may be noted (Fig. 421) when the size of the scanning spot has increased for some reason. Possible causes for such an increase include: improper positioning of the ion magnet; gassy C-R tube; loss of emission in a tube in the horizontal or high-voltage section (leading to a reduction in the high voltage) and, of course, an improper focus-control setting.

To check the spot size, observe the white scanning lines in the picture or test pattern. In Fig. 421-a illustrating a normal condition, the scanning lines are narrow and the black horizontal spaces between them are clearly visible. In Fig. 421-b illustrating the

effect of an enlarged spot, the increase in the width of the scanning lines has caused the dark in-between spaces to become narrower, poorly defined and almost invisible.

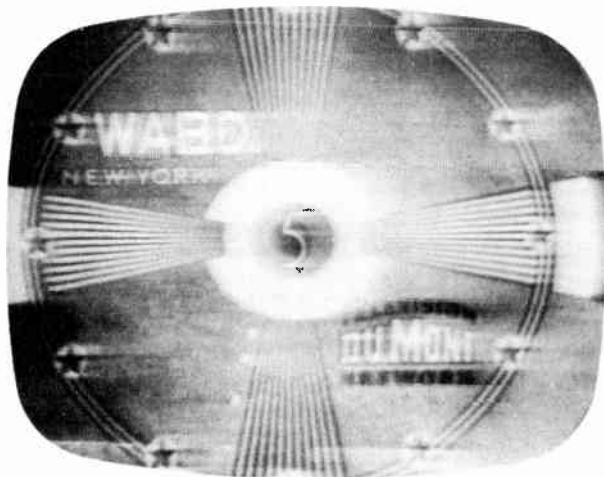
Fig. 422. *Effect of smearing on the test pattern. Symptoms vary somewhat from case to case.*

objects (Fig. 422). White or black edges in the picture, instead of being sharply defined, are smeared generally in the direction of the right side of the screen. Trailing shades ranging from black to white may be seen after large black objects; these shadings go from white to black after large white objects. The picture as a whole will look fuzzy. Smearing is usually due to poor reproduction of low video frequencies.

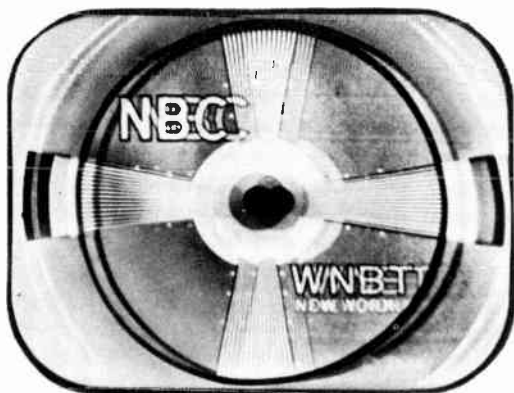
Fig. 423. Ghosts in test pattern.

It is not too well known that a defective tube may cause ghosts or multiple images (Fig. 423) to be seen in the picture. The condition may be explained as follows:

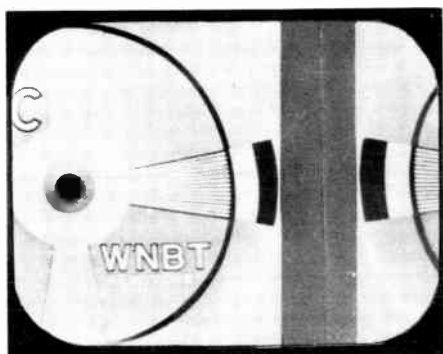
Fig. 501. Horizontal blanking bar is black when brightness and contrast control settings are normal and no defect is present. The horizontal sync pulses are not visible.

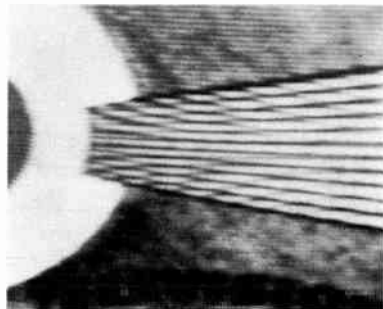
Fig. 503. *Mottling of the horizontal wedges (moire effect) due to poor interlace.*

A loss in interlace can be readily detected when a test pattern is present by inspecting the horizontal wedges. When a moire (see Fig. 503) is noticeable—i.e., circular movement in the horizontal wedges—interlace is being lost.

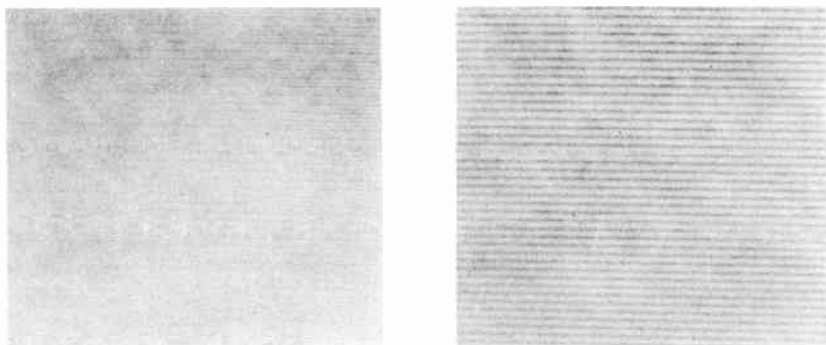
Fig. 504. Good interlace is shown in the photo at the left, but in the photo at the right the scanning lines of one field fall over those of the second field. The dark spaces between lines become wider, more visible.

In the absence of a test pattern, a loss in interlace may be detected by inspecting the scanning lines of the picture or raster. If the dark spaces between scanning lines are nonuniform in width (most obvious when two successive spaces are compared) or the spaces are too wide, interlace is imperfect. See Fig. 504-a,b. The condition will also affect the vertical retrace lines, causing these to pair off. Advancement of the brightness control to the point where the retrace lines become visible will permit their inspection.

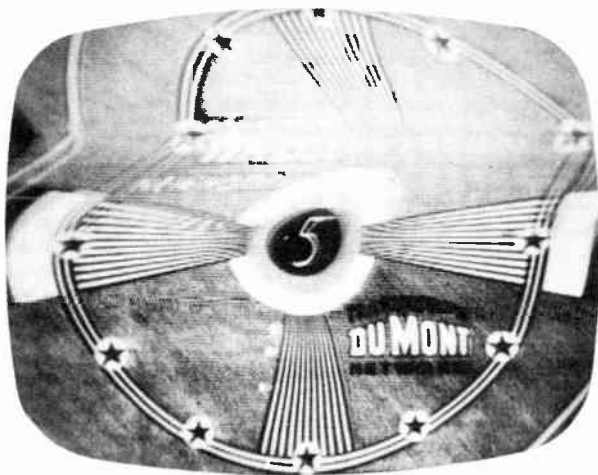
Fig. 507. A case of severe picture "hook" in the test pattern.

A certain type of horizontal movement in the picture (see Fig. 507) is referred to as pulling, snaking, bending, hooking or S distortion. Straight vertical sides of objects in the picture are bent when such a defect is present. This should not be confused with tearing, wobble or jitter.

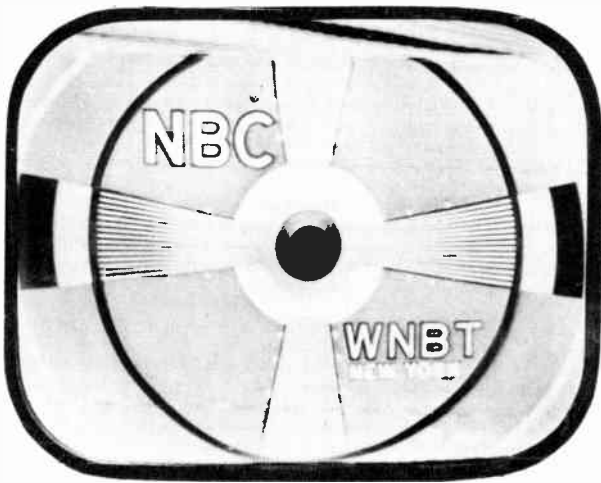
Fig. 508. Tearing out of lines at the top of the picture. The condition may be intermittent or practically continuous.

Tearing out of lines at the top of the picture (Fig. 508) is due to insufficient agc voltage. If the contrast and agc control settings are correct, substitute a new agc tube or tubes.

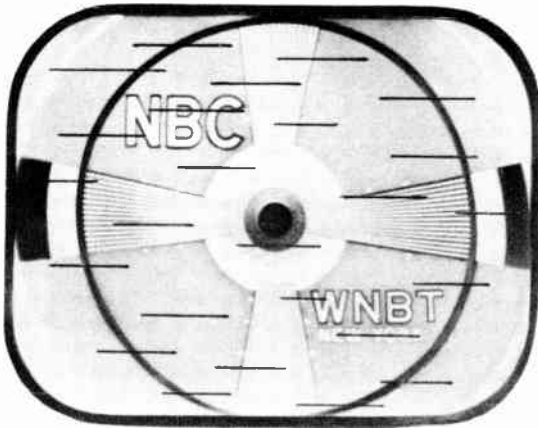
*Fig. 509. Lines in picture due to auto-ignition interference. The picture has been retouched to emphasize the effect. Similar lines may be caused by corona trouble at the high-voltage rectifier socket.*

Corona due to improper spacing of the high-voltage rectifier's socket lugs may produce lines in the picture (Fig. 509) similar to those produced by auto ignition interference. Inspect the tube socket terminals of the high-voltage rectifier to check on this source of trouble.

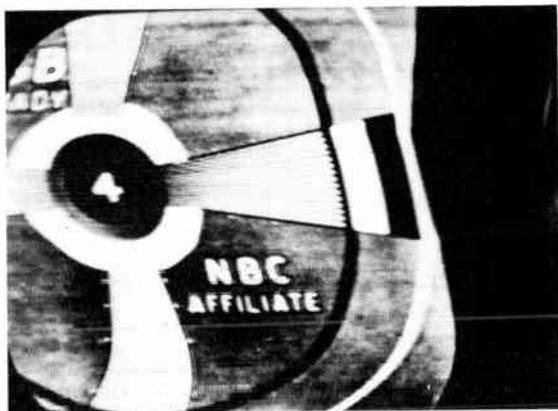
*Fig. 510. Horizontal jitter or weaving. The trouble in this case was due to a short between cathode and heater of a sync clipper-amplifier tube.*

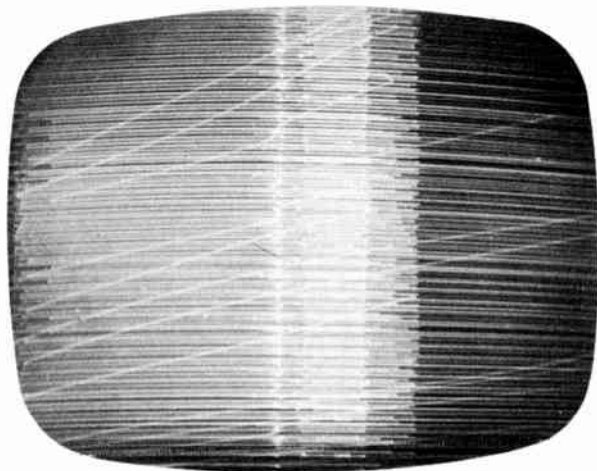
Fig. 511. "Christmas-tree" effect.

In the presence of certain defects, the picture and raster may break up into several sections of varying width. Their faint resemblance to a Christmas tree has led to the symptoms being labeled “Christmas tree” effect. When the breakup is more severe, the raster may disintegrate into a series of bright horizontal lines that cover the central portion of the raster (Fig. 511) and occupy about 50% of the normal raster area. A loud singing or frying noise coming from the horizontal output transformer often accompanies the symptoms just described. These symptoms, incidentally, are most often seen (in certain cases of trouble) when the station selector is set at an unoccupied channel or when channels are switched.

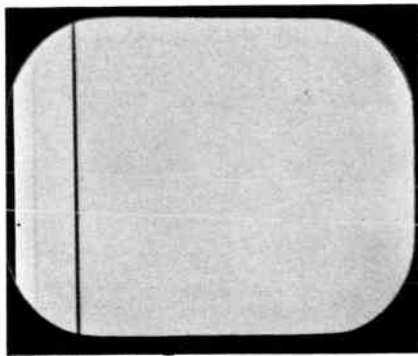
Fig. 602. *Appearance of Barkhausen oscillation in the raster.*

by the front end or video if section and amplified in succeeding stages. The condition generally manifests itself as one or more vertical black lines on the left-hand side of the screen (see Fig. 602). The lines may appear white if the oscillation is relatively weak.

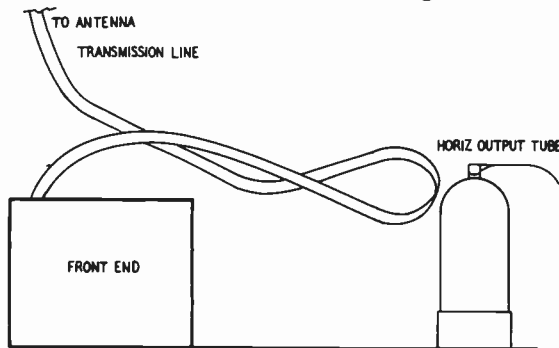
Fig. 603. Bringing the loop near the horizontal-output tube will increase the intensity of Barkhausen lines.

One way to determine whether Barkhausen oscillation is present is to loop a section of the lead-in (see Fig. 603) and hold it near the horizontal output tube. If the intensity of the lines increases or if they change from white to black, Barkhausen oscillation is causing them. Another test consists of putting a magnet (ion magnet or a pm speaker core) near the horizontal amplifier tube. If symptoms are diminished or disappear, they are due to Barkhausen oscillation.

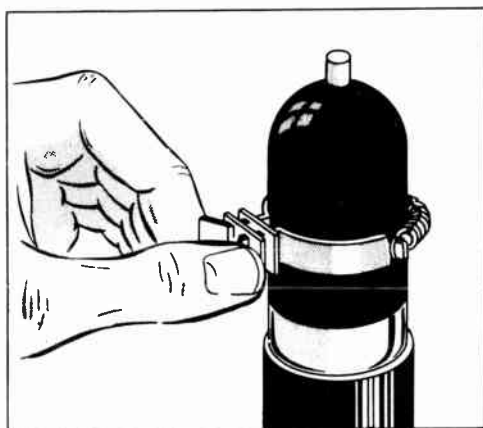
Fig. 604. Barkhausen oscillation eliminator. The magnet is placed over the horizontal-output tube.

anti-Barkhausen magnet (Fig. 604), may be placed around the horizontal output tube in such a position that the symptoms are eliminated. The output tube can also be replaced to cure the condition. Don't discard the original tube—it will probably function normally in some other set.

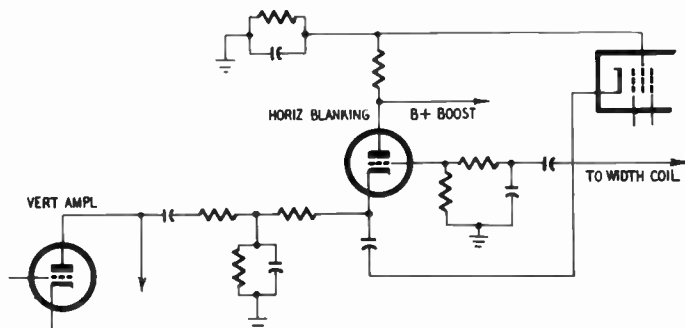
Fig. 605. Horizontal retrace blanking circuit. A sample of the fly-back pulse is fed to the grid of the horizontal-blanking tube. A positive voltage is sent to the picture tube cathode through a capacitor and cuts off the picture tube during horizontal blanking time.

In some TV receivers a horizontal retrace blanking circuit (Fig. 605) is employed. A circuit of this type eliminates the effects of *sync overshoot* at the transmitter. Sync overshoot refers to a narrow spike that is created at the transmitter by the sync pulse and directly follows it. The spike is opposite in polarity to the sync pulse and extends into the white region. Since it effectively un-blanks the picture tube during the blanking interval, it becomes visible as a vertical white line at the left-hand side of the picture. The line generally has a jagged or irregular appearance due to the fact that noise is associated with the sync pulse. It may become readily visible if the horizontal retrace blanking tube becomes defective.
