# TV and radio TUBE TROUBLES

SOL HELLER

GERNSBACK LIBRARY, INC.  
NEW YORK 11, N. Y.

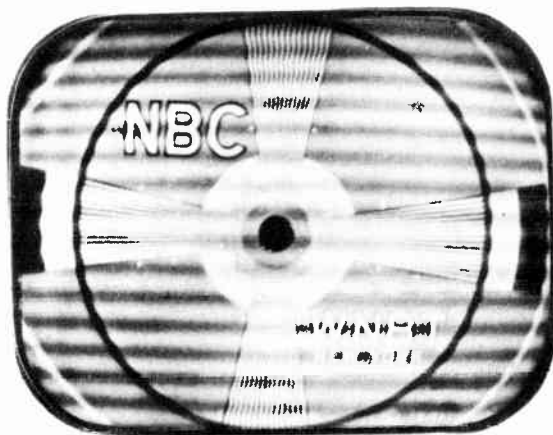
Fig. 606. *Sound bars in the picture.*

Possible causes of sound bars in the picture (Fig. 606) other than microphonic tubes are few if we exclude circuit troubles. A defective video detector crystal may be one such source—the correct tuning point may no longer coincide with the point where sound ripple is absent. The crystal used as video detector should be checked by substitution if sound appears in the picture when the fine-tuning control is adjusted for optimum resolution and likelier sources of trouble have been eliminated.

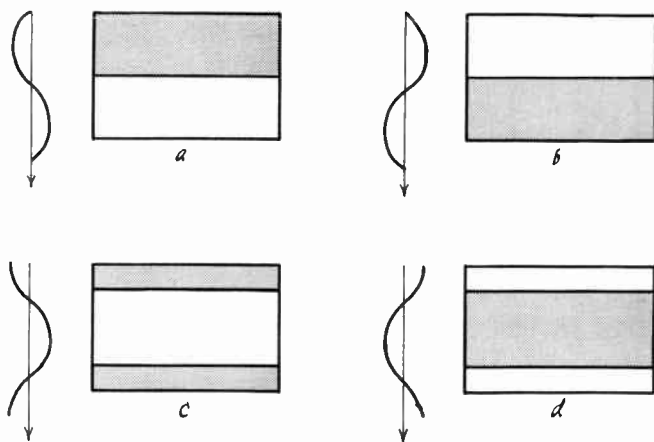
Fig. 607. Bar patterns that may be seen when a 60-cycle hum signal reaches the picture tube. Which pattern will be seen depends on the phase of the hum with respect to the line voltage. Drawings a and c show a 90° phase difference. The drawings in b and d show the effects of reversing the line plug.

Horizontal bars due to 60-cycle hum may cause the picture to have a dark bar over approximately half of its vertical area and a light bar over the other half. See Fig. 607. Or else a single prominent hum bar—either light or dark, depending on the polarity with which the line plug is inserted into the outlet—will be visible. Closer inspection will reveal that the shading of the picture sections not covered by the bar is improper (too light when the bar is dark; too dark when the bar is light).

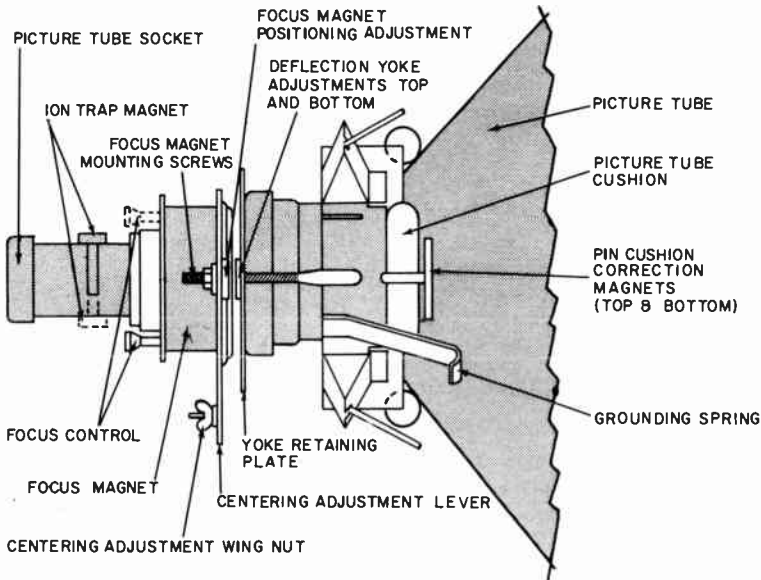
Fig. 701. Components mounted on the neck of the picture tube. The grounding spring connects the outer Aquadag coating to the chassis.

When an external Aquadag coating is used to form a capacitor with the internal coating, some means of grounding the external coating must be employed to make the capacitance effective in the circuit. Metal clips, bands or spring type wires are used for this purpose (see Fig. 701).

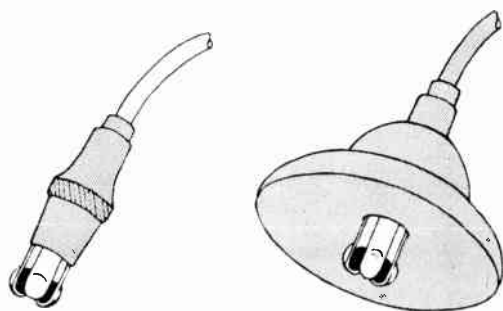
Fig. 702. Picture-tube anode lead and rubber cap. The drawing at the left shows the appearance of the anode lead after the flange portion of the rubber cap has been trimmed.

Either replace the cap with a new one or trim it off as shown in Fig. 702.

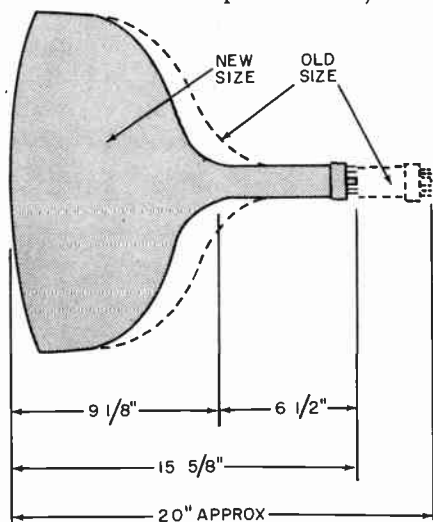
Fig. 704. Picture tubes can be made shorter as the deflection angle is increased. A picture tube with a deflection angle of  $110^\circ$  is less than 16 inches in length. This drawing shows the difference in length between two tubes having different deflection angles.

to match the higher deflection angles of large-screen tubes as these were developed. (Higher picture-tube deflection angles mean shorter tubes, as indicated in Fig. 704.)<sup>3</sup>

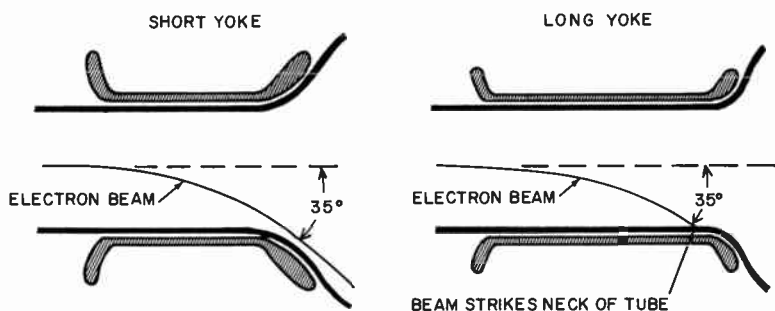
Fig. 705. Wide-angle yokes are shorter, use ferrite cores and have a higher inductance than other types of yokes.

To sweep a large-sized screen with a wide-angle yoke, the yoke must be very efficient. Let's see why this is so. The basic difference between the wide-angle yoke and its predecessors lies in the yoke length. The wide-angle yokes are *shorter*. With a long yoke, the possibility of increasing the deflection is limited by the fact that the electron beam tends to strike the neck of the tube if the angle is made too large (see Fig. 705).

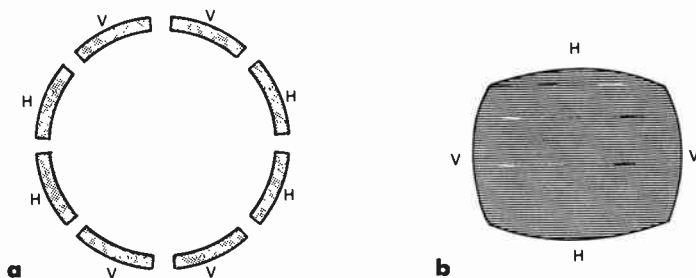
Figs. 706-a,-b. Cross-section of the yoke used in older receivers. The field of this yoke is equivalent to four magnets placed as shown in the drawing at the right.

Early-make yokes tended to produce a nonuniform field because of their interlocked-winding construction. A cross-section drawing indicating this construction is shown in Fig. 706-a. The effect of such a construction is comparable to that produced by four permanent magnets, arranged as shown in Fig. 706-b. Because the field of the magnets is strongest in their immediate vicinity, deflection in these areas is greatest. The effect on the raster is *barreling*—a condition which causes a bowing outward of the raster sides (Fig. 707).

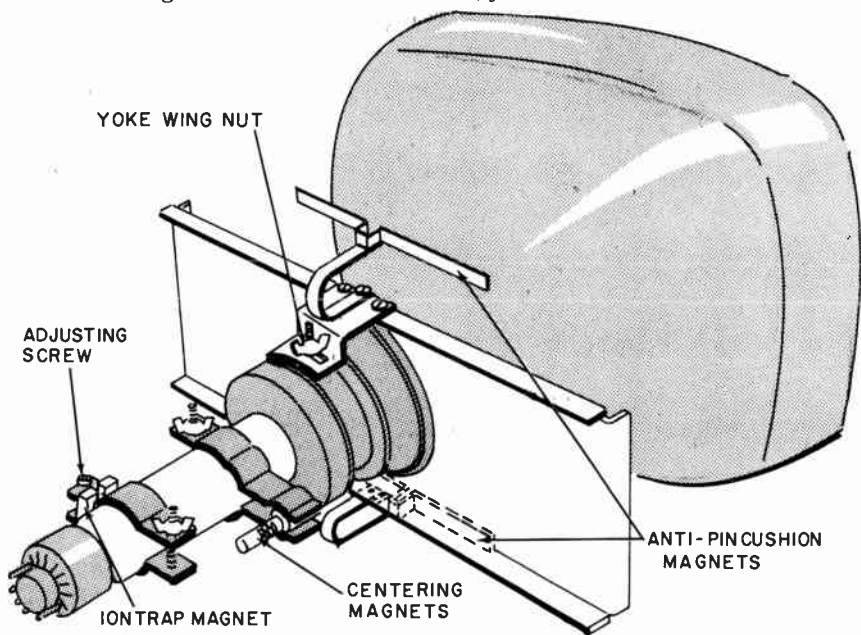
Fig. 709. This drawing shows how the anti-pincushion magnets are mounted.

Anti-pincushion magnets are used to correct the tendency of the cosine yoke to produce a nonlinear raster with squeezed-in sides. The magnets are variously known as *anti-pincushion*, *pincushion*, *pincushion correction*, *picture straightener* and *beam corrector* magnets. Small and nonstandard in size, frequently taking the form of a bar, they are mounted on or near the yoke at the side closer to the picture-tube screen (Fig. 709). The magnets come in pairs. One or two pairs of magnets may be used. A set may be found mounted above and below the yoke, as illustrated in Fig. 709, or at each side of the yoke, or both above and below the yoke *and* on each side.

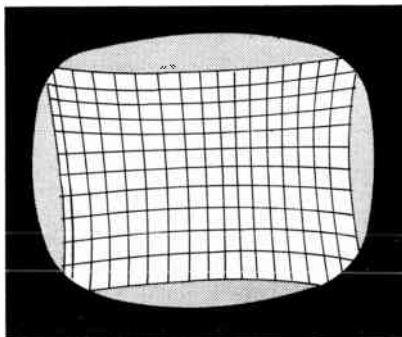
Fig. 710. Cross-hatch pattern showing nonlinearity and pincushioning.

or vertical pincushioning is to be checked for. Vertical bars are used in testing for horizontal pincushioning; horizontal bars for vertical pincushioning. When a cross-hatch generator is available, tests and adjustments may be made without the necessity of feeding two different inputs successively to the receiver (since the cross-hatch generator output is composed of both horizontal and vertical lines). A cross-hatch pattern which shows non-linearity and pincushioning is illustrated in Fig. 710. The appropriate magnets should be adjusted until the cross-hatch lines are straight.

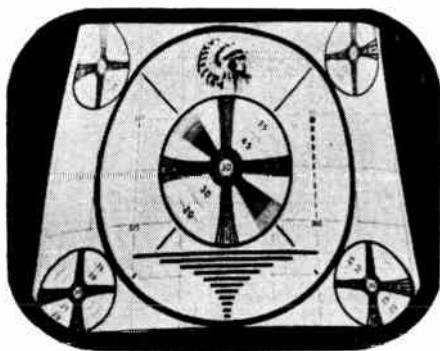
Fig. 712. The photo shows the effect of keystoneing on a test pattern.

A short in the horizontal yoke-balancing capacitor will greatly reduce the width of the raster; a characteristic *keystoning* will also be produced (Fig. 712).

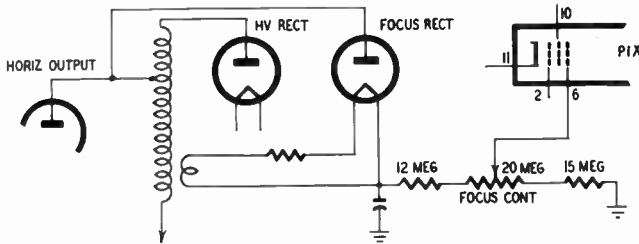
Fig. 713. High-voltage electrostatic focus.

In this system (Fig. 713) the focusing anode is connected to a high dc voltage (between 1,000 and 5,000 volts). Because of its high potential, the focus anode draws some current, causing its voltage to vary when the current through it changes for some

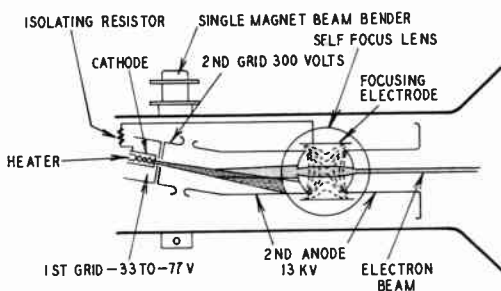
Fig. 715. Gun structure in the automatic or self-focus picture tube.

Variations in line voltage, brightness control resettings, etc. are not likely to cause defocusing because of the structure of the electron gun (Fig. 715). In this type of gun (as in the older electrostatic-focus gun) the second anode is split into two sections and the focus anode is mounted within the gap. A large-diameter focus electrode is used whose field overlaps that of the adjacent electrodes. Since the voltage between the first and second anodes at one side of the gap is always identical with the voltage between the same two anodes at the other side, the focus field remains substantially constant. A resistor, internally connected between the cathode and the focus anode, keeps the two electrodes at the same potential, preventing the defocusing that voltage variations between them might introduce. No external connection to the focus electrode is required for most automatic-focus tubes.

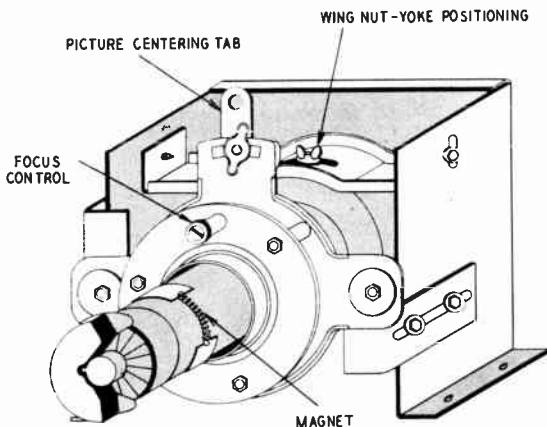
Fig. 716. Adjustment of the centering tab positions the picture.

In some receivers using a focus coil, and in most or all of those using a permanent-focus magnet, a lever on a plate or disk separate from but attached to the focus unit is employed for centering (Fig. 716). Sometimes, movement of the lever up or down provides horizontal centering; moving it right or left produces vertical centering. In other instances, up and down movement of the plate moves the picture up or down; sideways adjustment repositions the picture from side to side. Any nuts holding the lever in position must be loosened before it is free to be adjusted; these nuts are subsequently tightened.

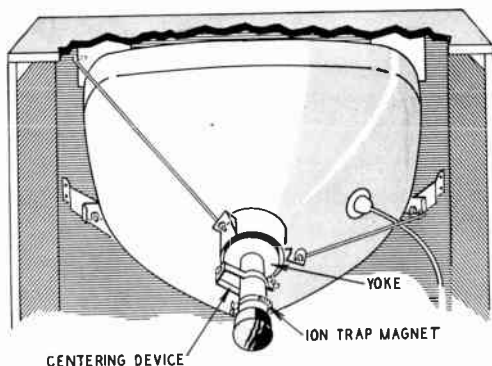
Fig. 717. The centering device is mounted on the neck of the picture tube.

A clamp type centering device completely separate from the focus assembly is used on the neck of some electrostatically-focused picture tubes (Fig. 717). To adjust such a unit, rotate it to the left or right and turn the knob at its top until centering is proper.

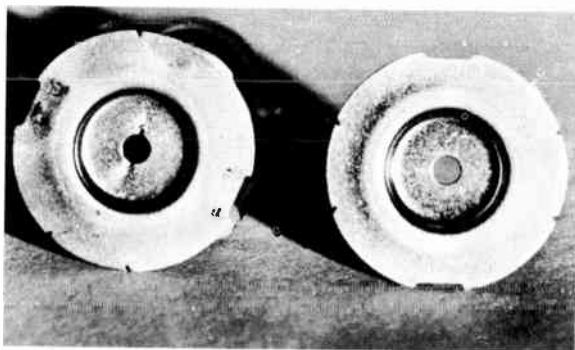
Fig. 721. *Improper setting of the ion-trap magnet can cause damage to the gun structure in the picture tube.*

A far more likely consequence of ion-magnet misadjustment is damage to the top disk of the high-voltage anode cylinder. When the adjustment is correct, beam electrons stream through the aperture in this disk. When the adjustment is incorrect, on the other hand, the direction of the beam is improper and some of the electrons in the beam may now bombard the edges of the aperture. The heat generated by this bombardment can vaporize parts of the aperture, as illustrated in Fig. 721. The damage will impair focus (since the aperture regulates the size and shape of the beam), causing a blurred or poorly defined picture. In some cases, bits of metal that have been torn away from the aperture are deposited on the screen, producing dark areas there.

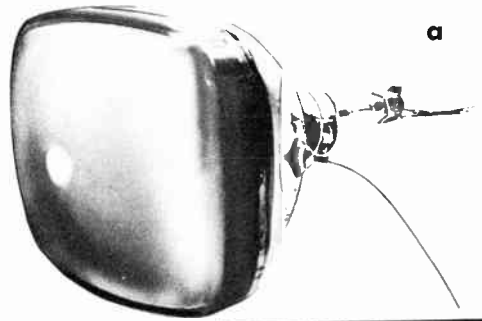
Fig. 722-a. The photo shows the appearance of the scanning spot on the picture-tube screen

Figs. 722-a through j illustrate the kinds of spot that may be seen on the screen. Figs. 722-a,-b show what the spot will look like when a new good tube is present. Note the round, uniformly illuminated appearance of the spot in this case. Fig. 722-c shows what the scanning spot will look like when the tube has been in use for some time. The scattered light shadows are normal. In Figs. 722-d,-e,-f the shadows become progressively darker and more numerous. There is little or no cathode emission from the dark areas. Tubes that produce spots of this kind may or may not perform properly. If a picture-tube checker indicates that the emission is normal, the tube can be considered as still usable. Figs. 722-g,-h-i and j show scanning spots in which extensive areas are dark. The shape of the spot in these cases is effectively distorted as well. Tubes that produce such scanning spots will have impaired focus as well as inadequate contrast.

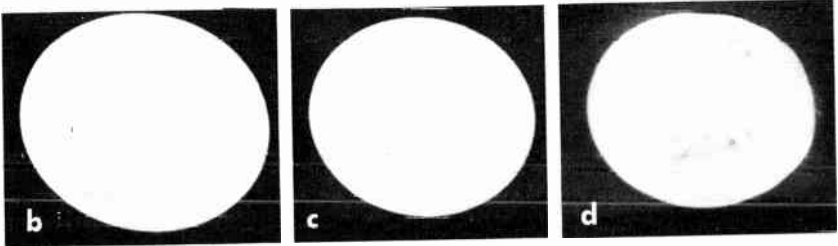
Figs. 722-b,-c,-d. The photo at the left shows the appearance of the scanning spot in a new tube. The other two photos illustrate the effect on the scanning spot after the picture tube has been in operation for some time.

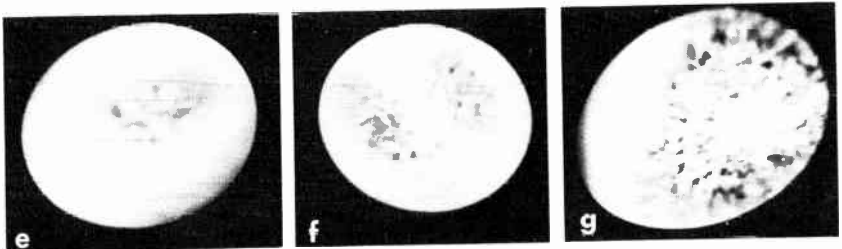
Figs. 722-e,-f,-g. These photos show how the scanning spot becomes progressively worse. Note the distortion of the spot and the appearance of shadows.

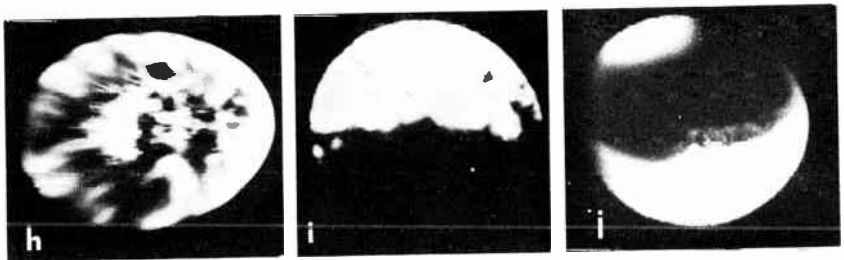
Figs. 722-h,-i,-j. These photos of the scanning spot indicate that a large area of the picture-tube cathode is dead. The dark shadows mean loss of cathode emission. The scanning spots are also severely distorted.

The test just described is a useful supplementary one to a test with a tube checker. When the tube checker indicates that the emission is passable, but a scanning-spot inspection reveals that large cathode areas are dead, the verdict of the spot-inspection test is the more reliable one. (It is assumed the symptoms pointing to a loss of emission in the tube are present.) If emission reads below normal and the spot resembles one of those shown in Figs. 722-h,-i, and j, replacement of the tube is also called for.

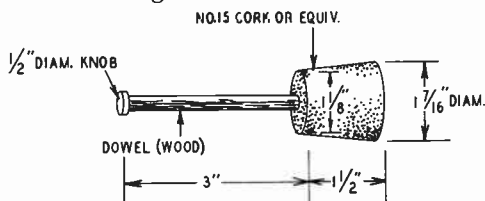
Fig. 723. A cork and a wooden dowel make a very suitable tube tapper.

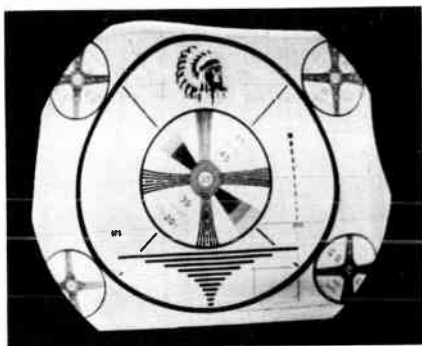
Fig. 724. This photo shows the effect on a test pattern when the metal cone of a picture tube becomes magnetized.

The metal cone of a metal-glass picture tube will become magnetized if a strong magnetic field is brought near it. Contact of the cone with the magnet of a PM speaker is the commonest cause of cone magnetization. The characteristic symptom produced is a distortion of the picture and raster. The raster's edges are generally twisted out of shape. (Fig. 724). Magnetization of

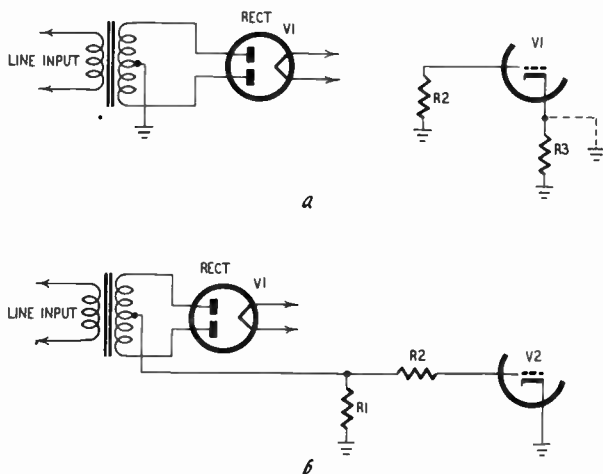
Figs. 803-a, -b. One method for eliminating hum caused by heater-to-cathode leakage is to short the cathode resistor (upper drawing) and replace it with a bias network connected to the power supply (lower drawing).

leakage (other than replacing the tube) is to ground the cathode of the tube and apply the correct amount of negative dc voltage to the grid (as a bias) from some suitable source in the set. The center-tap circuit of a power-transformer secondary in an ac receiver may provide such a source, as illustrated in Fig. 803.

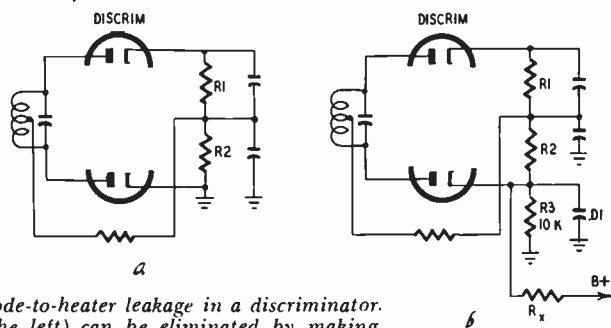
Figs. 804-a, b. Cathode-to-heater leakage in a discriminator tube (drawing at the left) can be eliminated by making circuit changes (drawing at the right).

Hum generated by heater-to-cathode leakage may prove troublesome in some discriminator stages used in FM radios, particularly if a miniature tube (in which the spacing between cathode and heater is very small) is used in this stage. The trouble may be eliminated either by a suitable tube substitution or by making

the normally grounded cathode positive with respect to the filament (the other cathode is already positive). This may be readily achieved by inserting a resistor of about 10,000 ohms, bypassed by a .01- $\mu$ f capacitor, in series with R2 (Figs. 804-a,-b). Now add series resistor  $R_x$  as indicated in Fig. 804-b. The value of the resistor should be such that 10 to 15 volts is developed across R3, the 10,000-ohm resistor. When the B voltage is 250, use of a resistor of about 160,000 ohms for  $R_x$  will provide the correct voltage drop across R3.

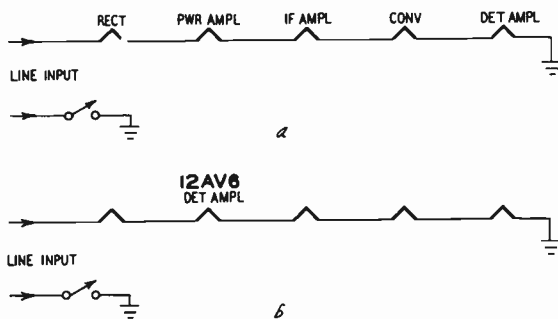
Figs. 805-a, -b. *Improper wiring of the series filaments in an ac-dc receiver can be a source of hum.*

tioned at too high a point in the filament string (Figs. 805-a,-b). The above-normal ac voltage present between heater and cathode of the 12AV6 produced a greater-than-usual amount of leakage between the two elements; since hum in the first audio amplifier receives more amplification than hum developed in any other stage, audio trouble resulted.

The service technician should know the correct lineup of tube filaments in ac-dc sets to recognize similar trouble. The first audio amplifier (and detector) should be at the bottom of the string or nearest ground (Fig. 805-a); next to this filament should be that of the converter (since this tube is very prone to modulation hum); then the if amplifier, power amplifier and rectifier filaments, in that order.

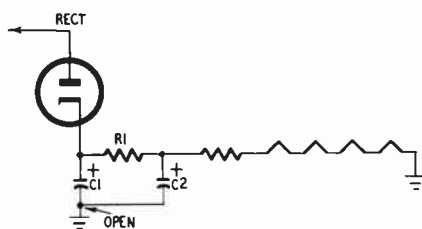
Fig. 810. Increased ripple voltage applied to the filaments (when the filter is open) can result in damage to the tubes.

4. Open in the common negative of a filter capacitor at the point indicated in Fig. 810. While such trouble is not common, it can and does occur. The filtering action is partially impaired

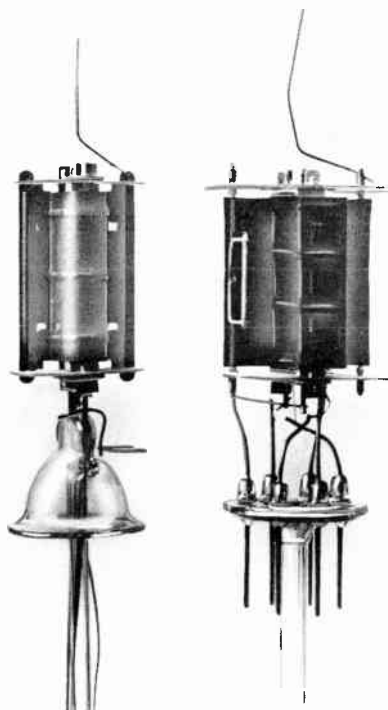
Fig. 901. *Types of stem construction.*

Significant for longer life was the changeover from the old press-stem construction to the newer button-stem construction. In press-stem construction the base leads enter the tube through the glass stem in a straight line (Fig. 901). Lead wires are necessarily thin and there is a considerable distance between the base pins and the tube mount. In button-stem construction the leads go directly from the base pin through the glass into the tube mount, being arranged in a circle similar to that used in miniature tubes. This type of construction uses heavier and shorter leads, resulting in better heat transfer from inside the tube through the base pins. It also leaves more room between the top of the tube mount and the glass, which results in improved heat radiation.
